DB 7/2/18

096

S10.7

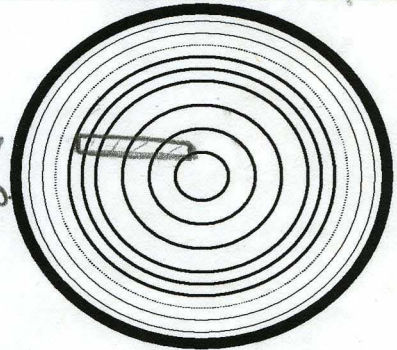
In situ rove + lined nail on forward scarf. Also incomplete augered hole (10.9 mm diam) inboard, upper edge. Is this a 'mistake'? 2 near complete wooden nails on lower edge. One opposite base on upper edge. Scribed line near TN at F41. Related one bet F42 + F43. Irregular punched feature near scribed line of F41. 3 small nails at end of scarf.

3 small Fe nails on upper edge (2 blind)

Intermediate ^{targeted} pith edge on 215/110 upper edge. $c110H$ ARW = $\frac{110}{110}$. Dog trend. One knot.

Photo: nail + rove at fore scarf, wooden nails, blind augered hole
