Cow Tag 098	Function Code 59.2	
Brief Description: [timber element, p/s, condition, fragments] COMPLETE PLANK		
Notable Features: [tool marks, scribed lines, decoration, repairs] POINTS TO LOOK OUT FOR WHEN RECORDING ufos <p>MANY AX MARKS VISIBLE ON ^{FACE OF FORWARD} OUTBOARD SCARF, AND OUTBOARD LAND.</p> <p>5 GROUPS OF INTENTIONAL MARKS ALONG INBOARD FACE OF PLANK. (1 modern?)</p> <p>1 EXTRA NAIL AT STERN END OF PLANK.</p> <p>1 EXTRA NAIL AT CENTRE, LOWER EDGE.</p> <p>Small wooden plugs at aft scarf.</p>		
Wood Science: [rings, ARW, knots, sapwood, conversion] <p>No ^{end} grain visible on forward edge. rays far from straight!</p> <p>c70 H + S</p> <p>ARW = 197 / 90</p> <p>NOT good for dendro with spiral grain?</p>

COWTAG
098

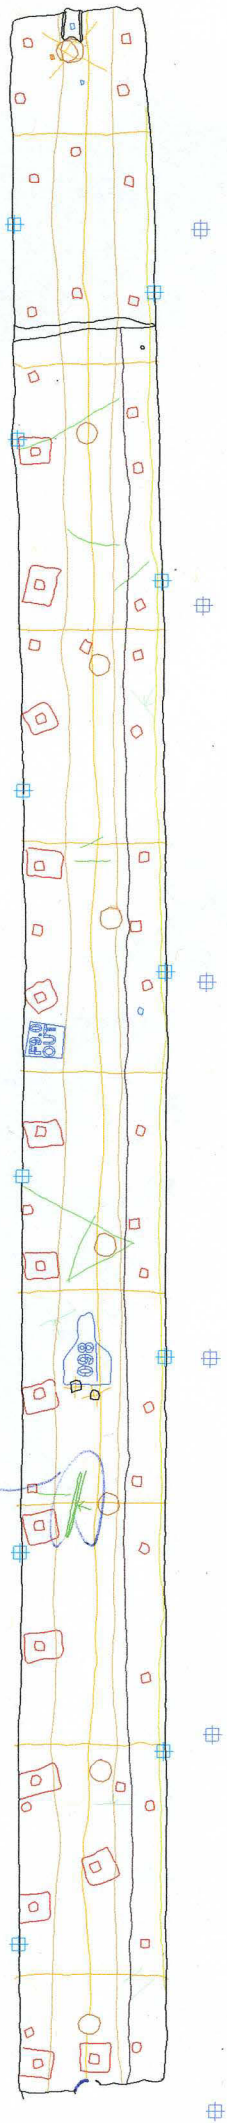
wedges

the trained
the wedges
the rings

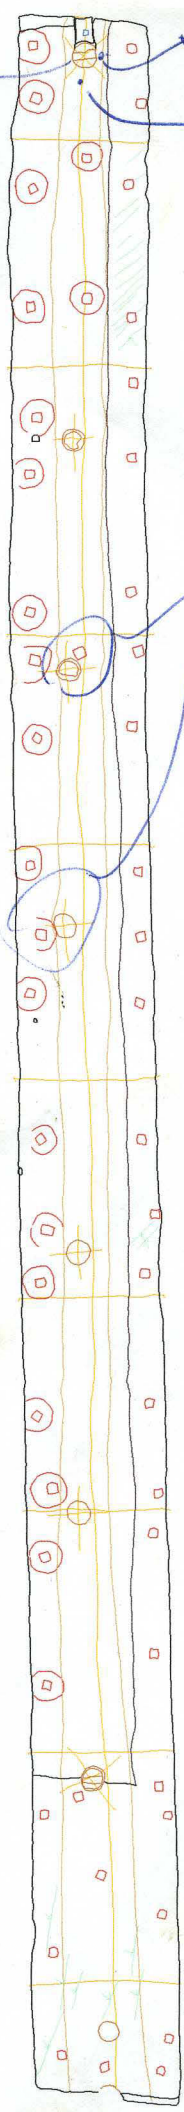
missed
nail (wooden)

needs close examination
- relationship
