Cow Tag 9	Type function unknown
--------------	-----------------------

Description

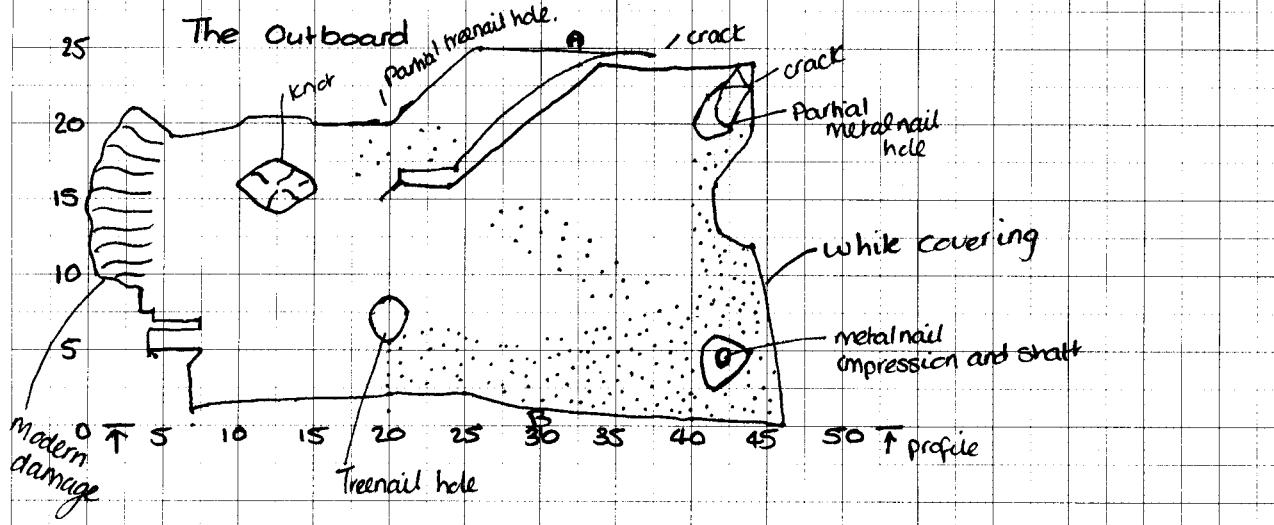
Profile

The outboard side has two treenail holes and two metal nail holes. One treenail hole is intact and is 3cm in diameter. The second is a partial treenail and is 3cm in diameter. The metal nail head impression is 3cm in diameter while the shaft is 1cm in diameter. The second is slightly spur and is the head impression is 3cm in diameter while the shaft is 1cm in diameter. Next to the intact metal nail hole are two cut marks. At one end there is modern damage, there is one large crack and a few smaller cracks. There is also one knot.

The outboard side has patchy white covering which may possibly be sealing or covering.

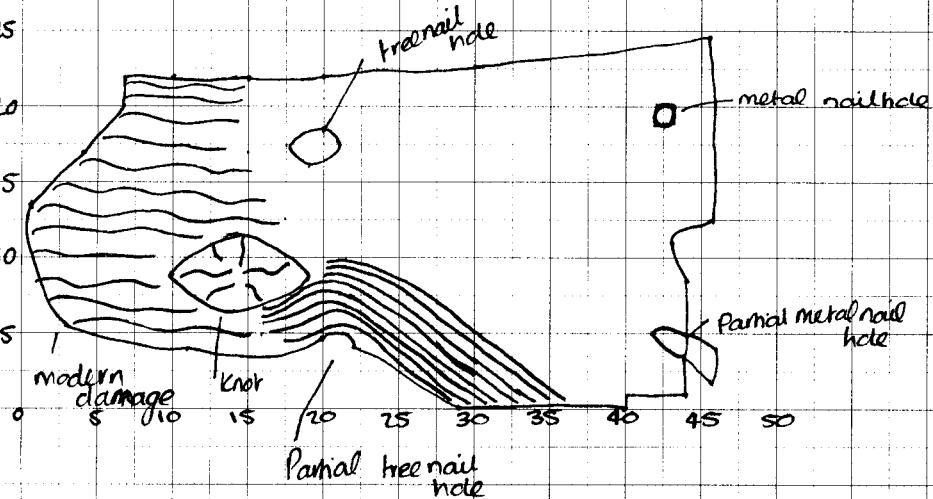
Inboard

The inboard side has two treenail holes and two metal nail holes. The intact treenail hole is slightly oval and is 3cm long and 2.3cm wide. The partial treenail hole is 3cm in diameter. The intact metal nail hole is 1.2cm in diameter and the partial metal nail hole is 1.5cm in diameter. The damage is longer on the inboard side at 17.5cm long. A large knot is visible and 7cm long. The surface has one large crack.
