YORK ARCHAEOLOGICAL TRUST

Burdale, BUR06

Report on the investigative conservation of selected iron small finds for

20.10.2006

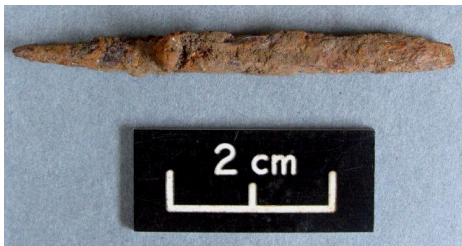
SF70 before treatment

SF70 Mineral preserved organics on the tang of this possible awl were investigated. Although some mineral preserved organics were detected these were not coherent enough to indicate that they may have been from a handle.

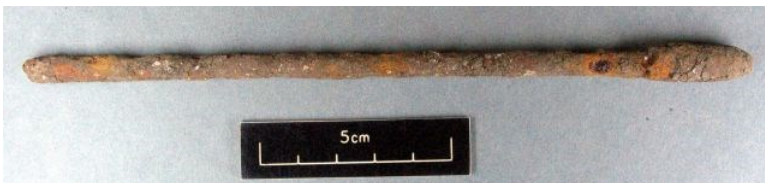
SF157 before treatment

SF157 One end of this object was cleaned on one side to reveal the possible wire shown by the X-ray (X6634). An iron band with an orange/white substance inlaid into it was revealed, the orange/white substance surviving to a greater extent in certain areas. Although it is possible to say that the substance is non-metallic due to the lack of resistance to the X-rays, further analysis may be needed to identify this if required.

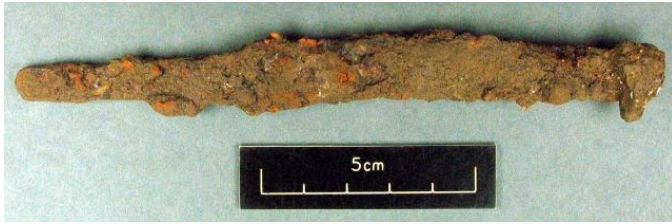
SF200 before treatment

SF200 Mineral preserved organics on the tang of this knife blade were investigated by removing the adhering soil. Several areas of mineral preserved wood were revealed, but, again, not coherent enough to suggest part of a handle. Probably organic remains from the burial environment.

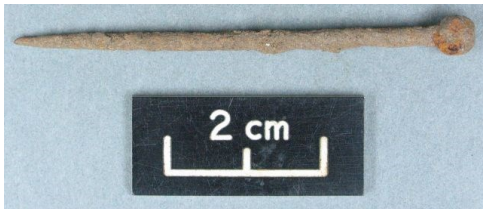
SF201 before treatment

SF201 The head of this pin was cleaned to reveal the shape. It is polyhedral and is similar to a number of pins found at Coppergate from Period 4B (c.930/5-c.975) (Mainman & Rogers, p2577), although not decorated. The pin seems to have been made from one piece of iron with no evidence of soldering or other forms of join visible.

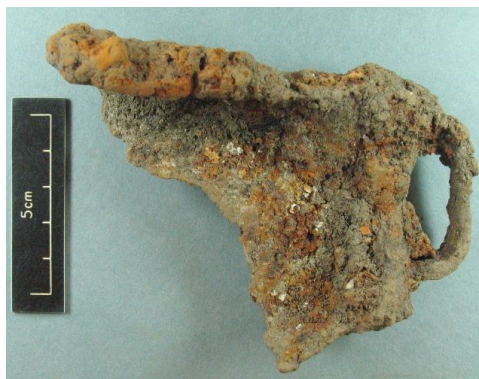
SF203 before treatment

SF203 This object is very similar in construction to bells found at Coppergate (Ottaway, p557) although slightly larger in size. These were made from a single sheet of iron, folded over and brazed together at the seams (*ibid.*). A small section of the object was cleaned revealing a sheet of iron between two sheets of non-ferrous metal. The broken edge reveals the cross-section which shows the non-ferrous metal folded at the edge which is possibly a way of joining the two seams of the bell. The non-ferrous metal is probably copper alloy due to the green colouration in some areas but XRF would confirm this if necessary.

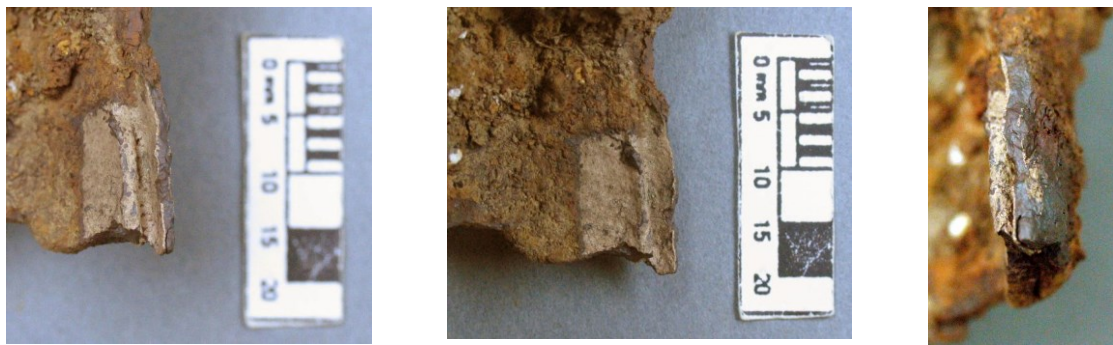
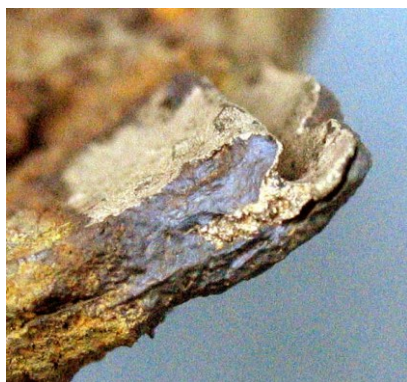
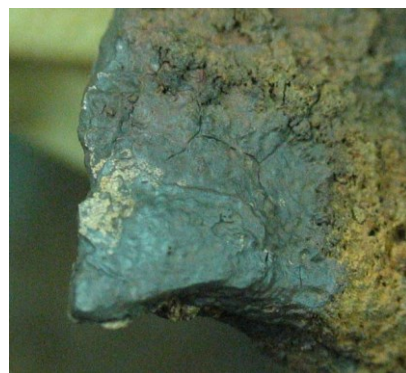
SF203 after treatment; several views showing the structure of the possible bell

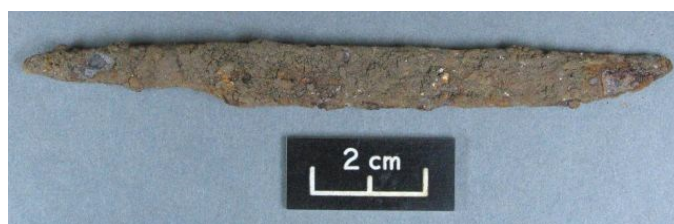
SF204 before treatment

SF204 Mineral preserved organics were investigated by removing the adhering soil. The mineral preserved remains which are probably wood do not appear coherent enough to suggest that they were part of a handle.

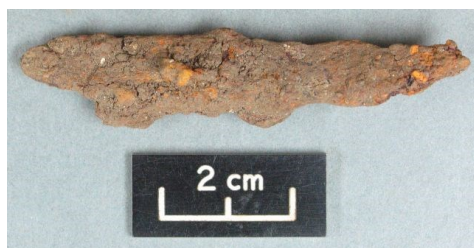
SF205 before treatment

SF205 Again, mineral preserved organics were observed and revealed by removing the adhering soil, but did not form coherent remains.

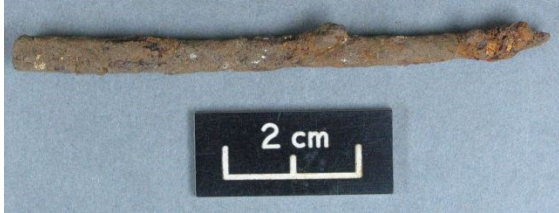
SF209 before treatment

SF209 Four different cross-sections were cleaned to reveal the shape of the metal core beneath the corrosion products: both ends and two central areas. The working end tapers to a point and the other, flat end appears broken. The central cross-section is sub-rectangular, becoming flatter towards the tip. Possibly a textile processing spike.

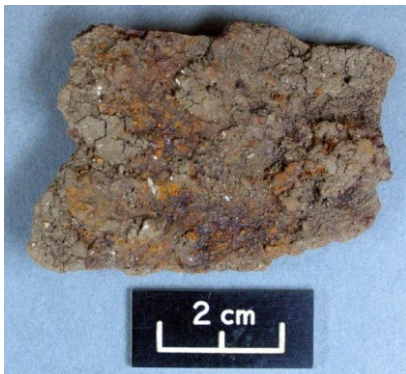
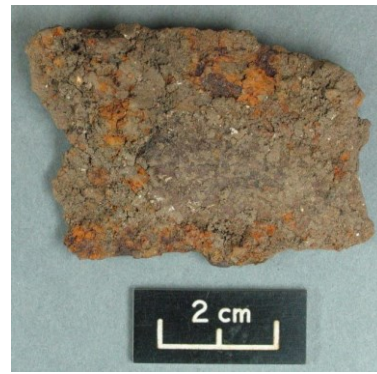
SF211 before treatment (two views)

SF211 Possible perforation and nail was investigated and this conclusion was confirmed. The nail has a large, flattened head, with the shank on the other side of the sheet fragment bent over at an angle with some smaller pieces of metal wedged beneath. Part of the thin fragile sheet became detached during cleaning and this was re-adhered using Paraloid B72 (methyl methacrylate co-polymer).

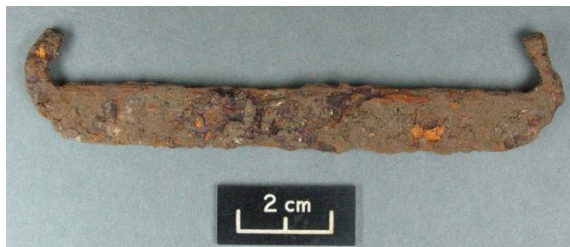
SF215 before treatment

SF215 The mineral preserved organics observed during assessment were investigated by removing the adhering soil. Substantial amounts of wood can be seen running along the back of the blade and extending upwards to the curved tips. These are coherent enough to suggest that the blade would have been set into a wooden handle.

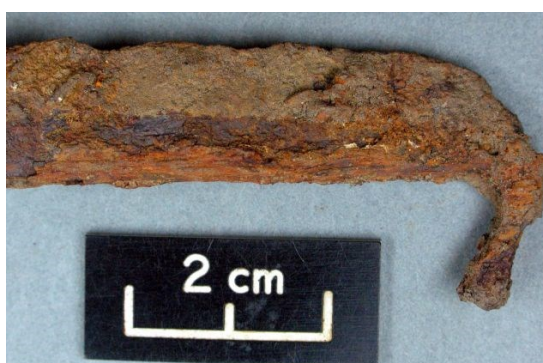
SF215 after treatment showing mineral preserved wood

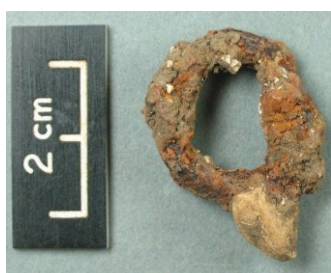
SF294 before treatment

SF294 The terminal ends of this iron ring were investigated. The ends are slightly offset and one of them terminates at an angle. It is possible that these ends originally joined but are now broken.
