WHISPERING COTTAGE,
12 WESTBOURNE STREET, WRIBBENHALL,
BEWDLEY
HISTORIC BUILDING ASSESSMENT

Whispering Cottage,
12 Westbourne Street, Wribbenhall,
Bewdley
historic building assessment

WCM47457

Mike Napthan MIFA
21st January, 2013

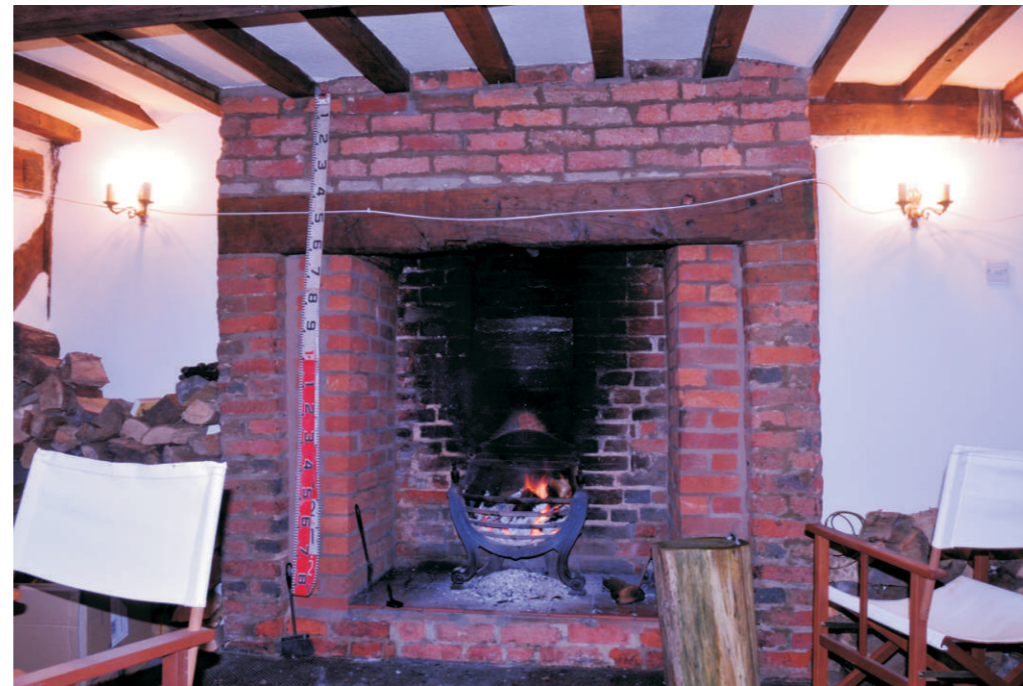
Modified inserted late 18th C chimney and fireplace - note reduced floor level around hearth

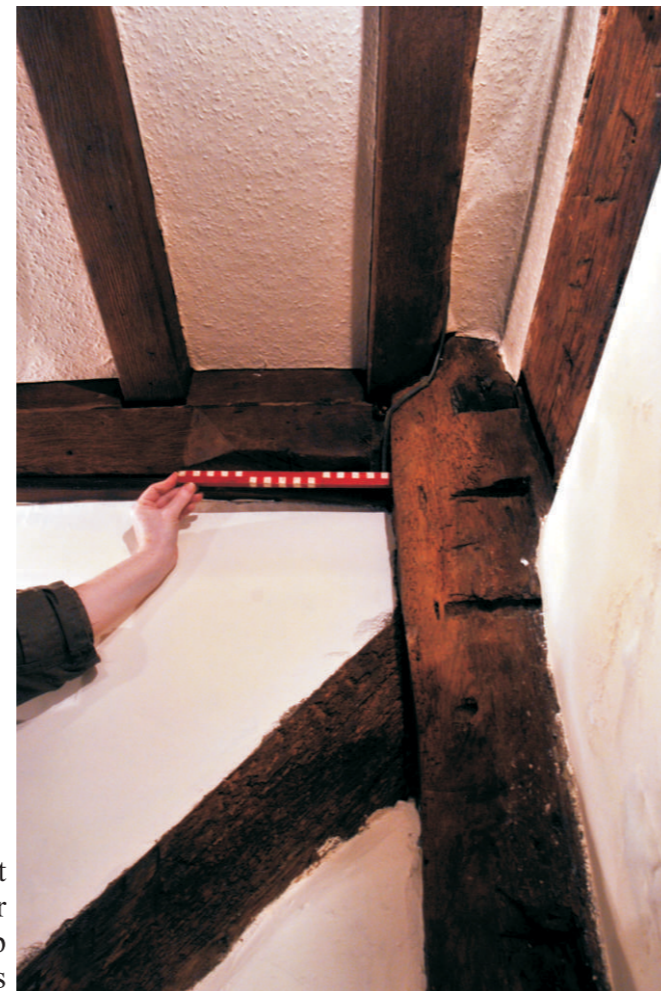
Detail of eastern storey post of Truss 2 - note the two redundant mortices representing a mid rail (lower mortice) and probable tension brace (above) - these prove that there was originally no doorway opening between Bay 1 and 2 at ground floor - two pairs of peg holes at mid rail level disprove any original link to Building 2 at this point

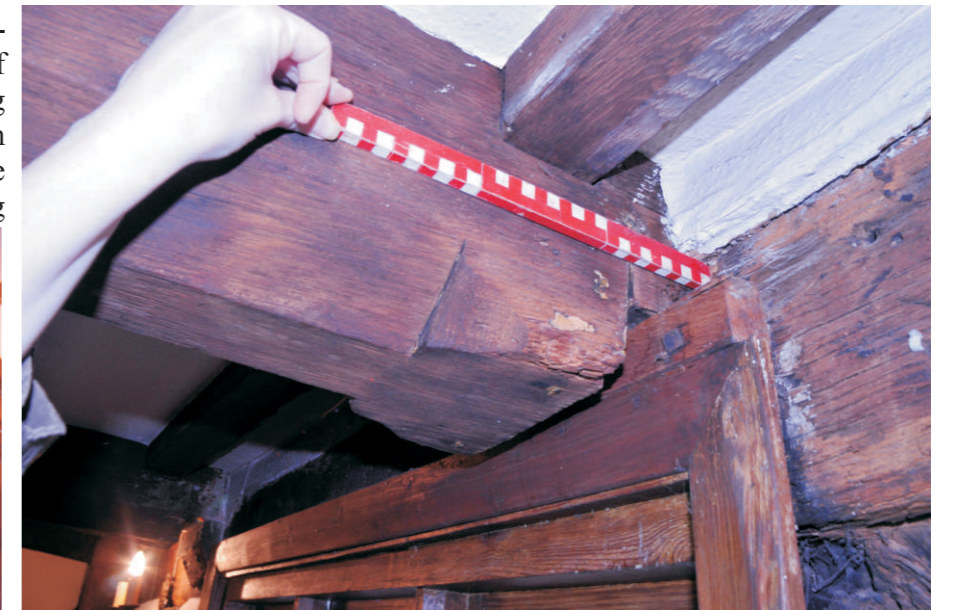
Chamfer stop detail- note also that lap of bridging beam bearing has moved out by 75mm reducing the effective bearing

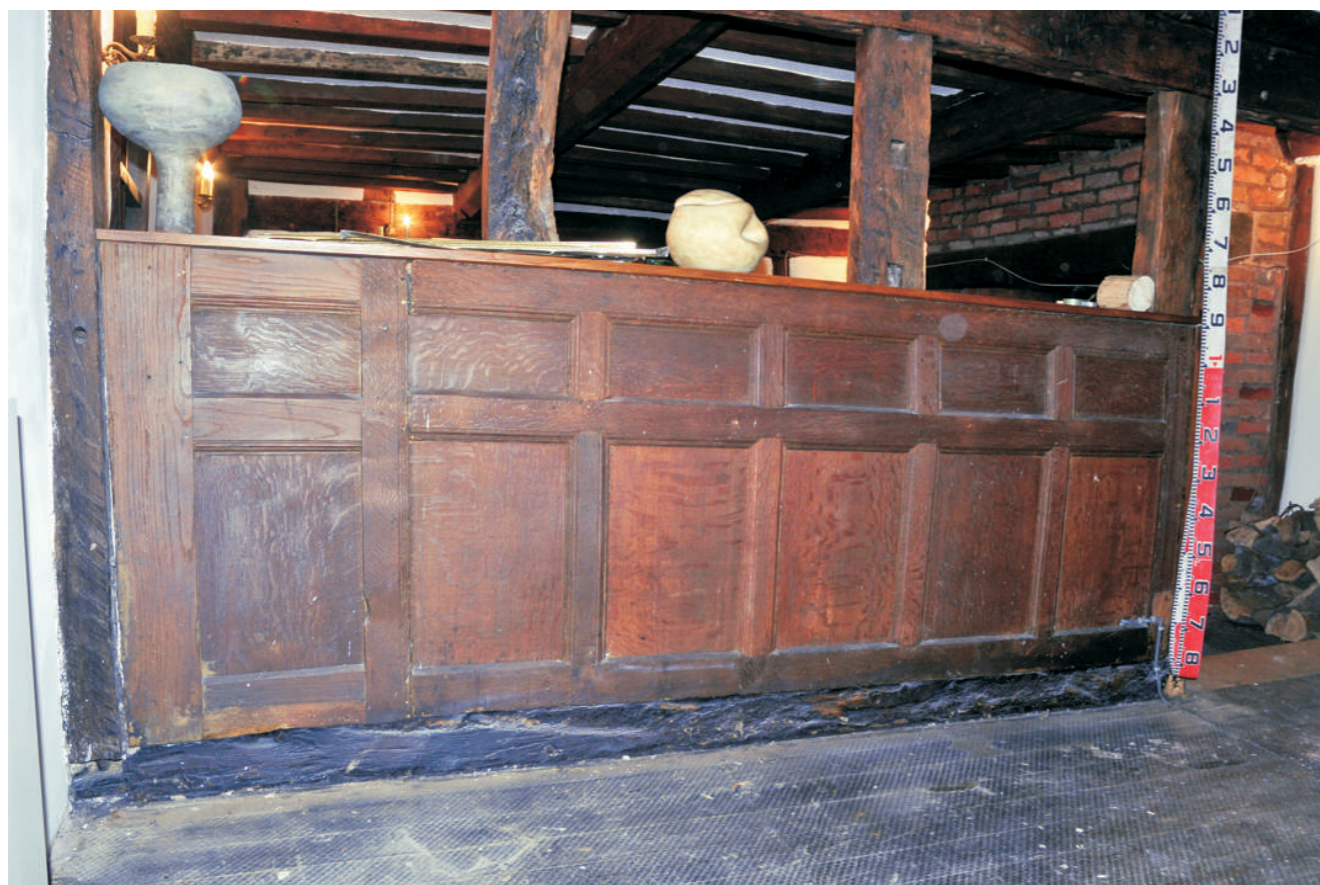
Re-used panelling - oak section is probably mid-late 17th Century, pine section to RHS is probably 18th Century - detail of oak mouldings below

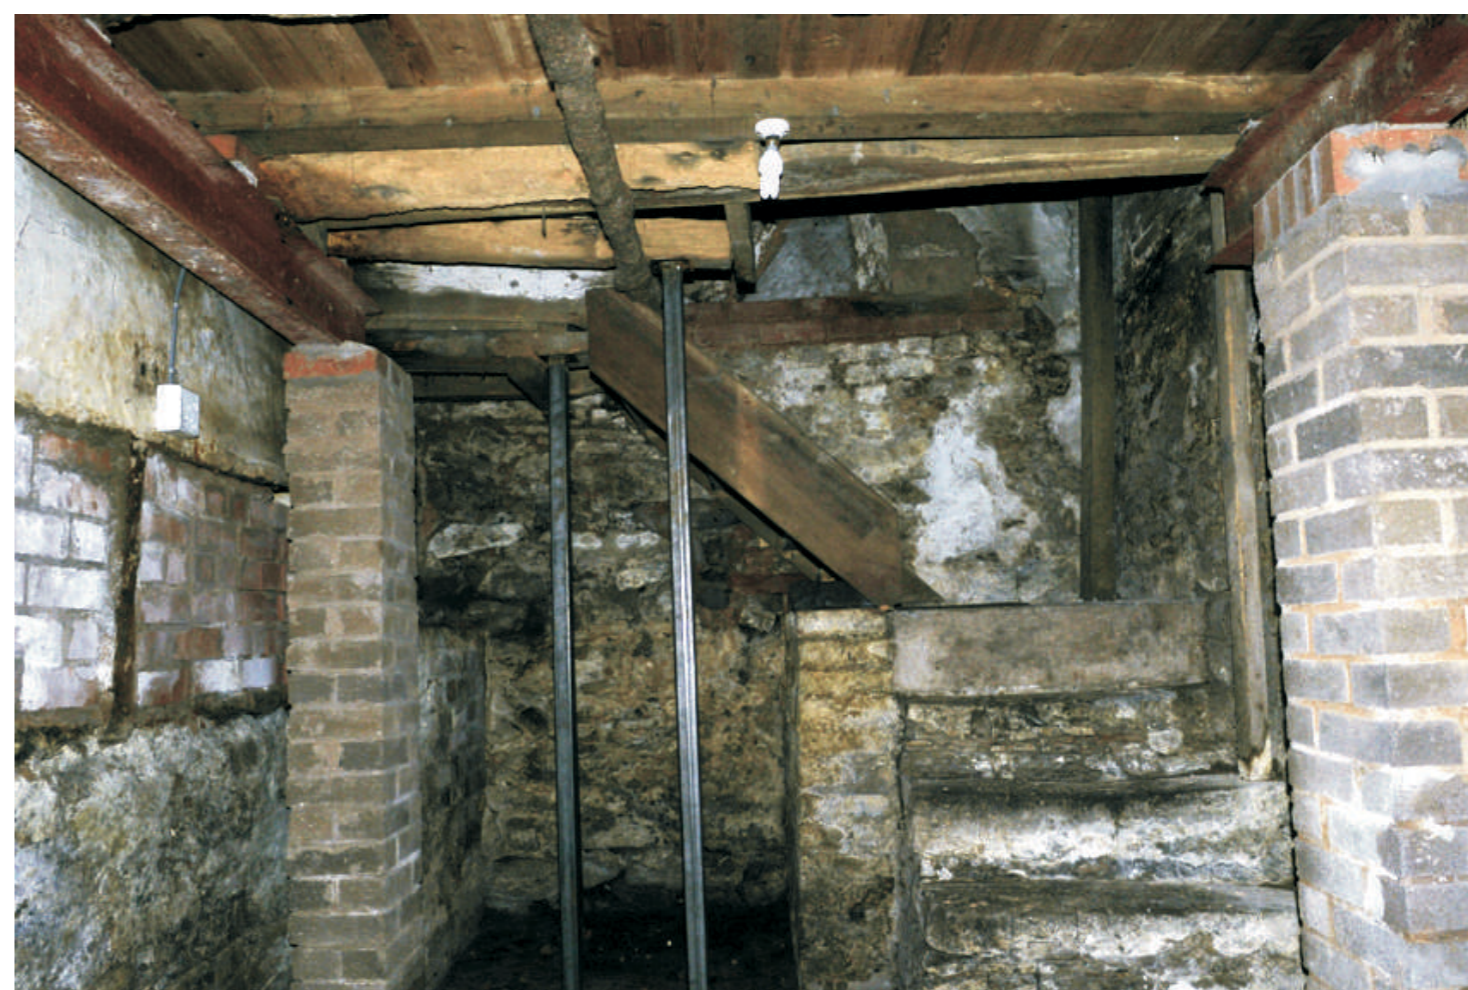
View facing towards cellar steps, note blocked recess below electrical socket

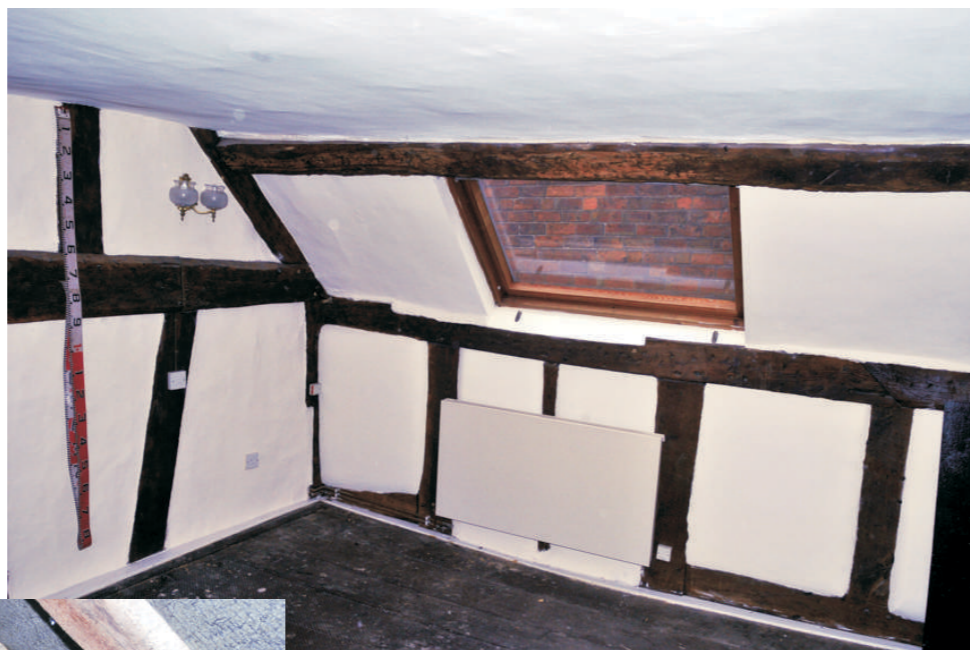
Front bedroom - view facing west - note notching of wall plate for former dormer window

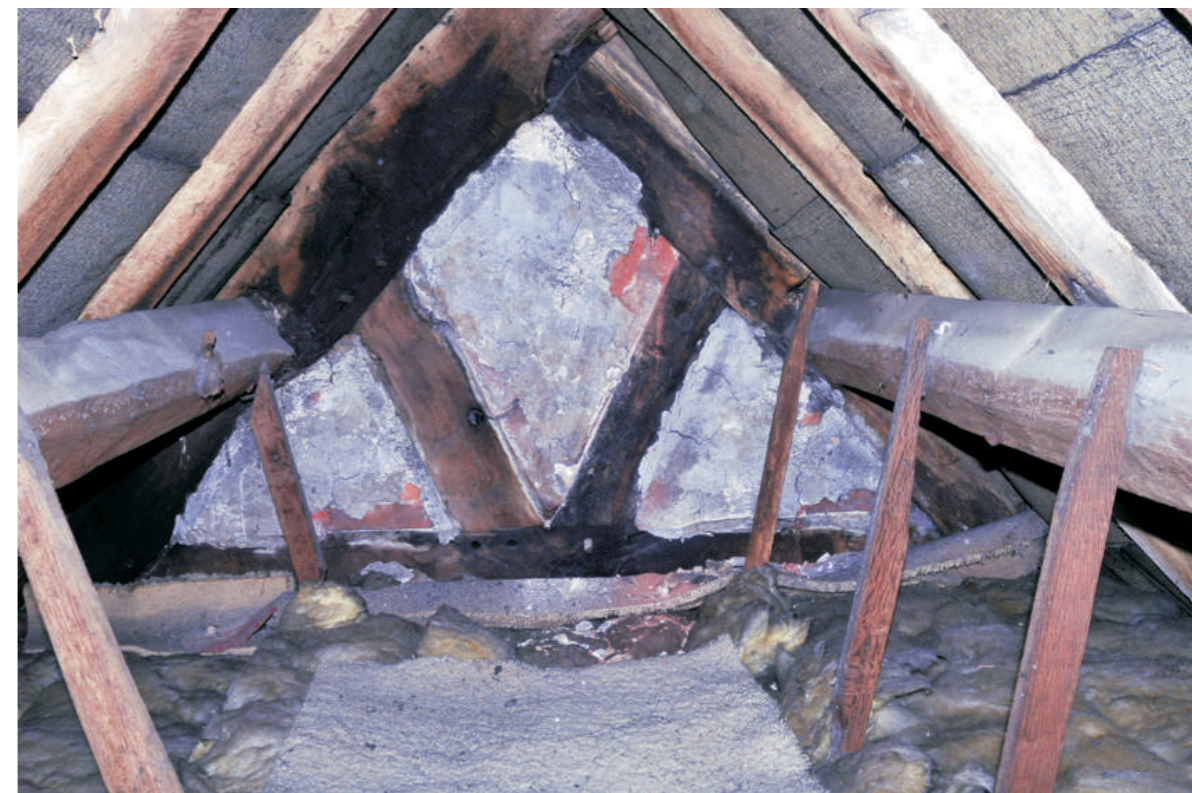
Roof space facing north, note extensive sooting of truss which does not extend to purlins - interior of Truss 3 infill panels are plastered. Timber hangers for ceiling are nailed to purlins

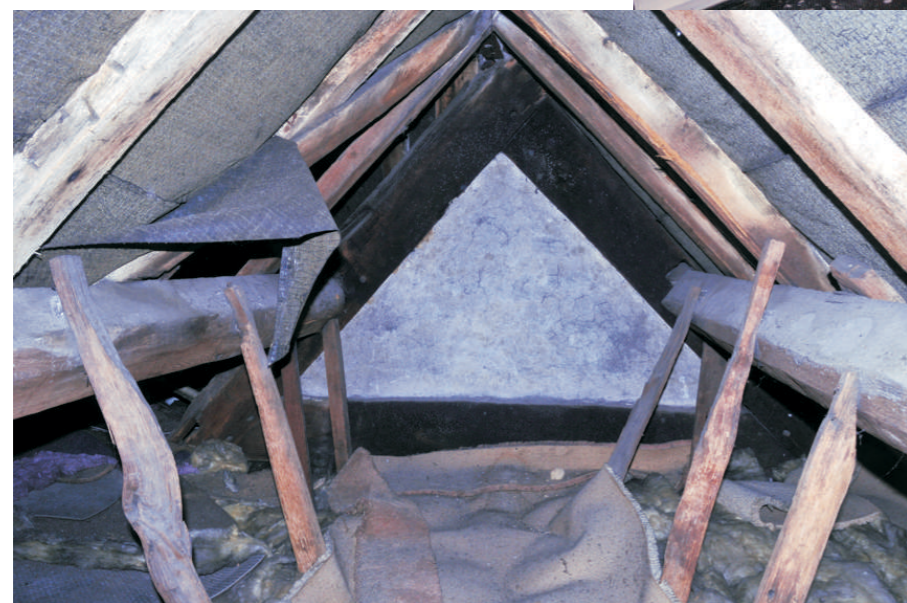
Roof space facing south - note sooting of truss but clean purlins. Note also redundant mortice possibly for wind-brace beneath LH purlin. Brick infill of Truss 2 apex is plastered and colourwashed indicating that it was formerly exposed.

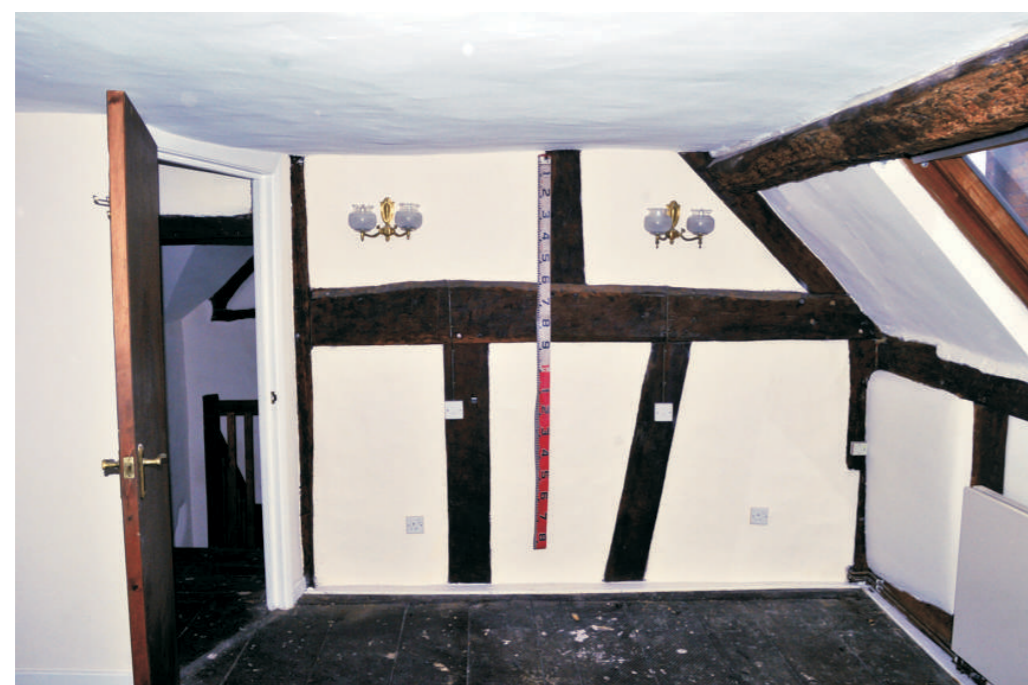
Truss 2

7.5.1 Truss 2, which divides Bay 1 from Bay 2, appears to have been very substantially modified. The two principal storey posts survive and both have matching long narrow plugged mortices on the inner faces at shoulder height. These do not correspond to the present intermediate framing, and quite possibly housed diagonal braces. The ground floor partition framing includes at least one re-used timber as an intermediate post, and the “tie beam” appears to also be a secondary timber, or possibly the original tie beam dropped from the conventional position where it would have tied the two girth beams. The present lateral restraint at girth beam level is apparently only a single large peg at each storey post. The ground plate survives in part, but has been cut away beneath the inserted doorway between Bays 1 and 2. Surviving mortices in the adjacent posts and the “tie beam” indicate that there was not originally any opening in the partition at ground floor level. The present 1st floor structure is lodged on the partition framing. At 1st floor level there is a corresponding inserted doorway, cut through the tie beam, the intermediate posts either side of the doorway show redundant mortices and peg holes, and appear to be re-used. The door head timber is also a later insertion. The principal rafters are both morticed at collar level for either a third purlin (which seems improbable) or for a curved wind-brace. The upper parts of the principal rafters are smoke blackened. The brick infill of the apex panel is plastered and formerly whitewashed on both faces, indicating that the rooms below were formerly open to the underside of the roof. There are no signs of either sooting, whitewash or lath nails on the common rafter soffits or purlins in either bay indicating a possibility that the roof has been rebuilt in its entirety though the dendrological dates obtained in 2008 indicate that at least one of the purlins is contemporary with the original structure.

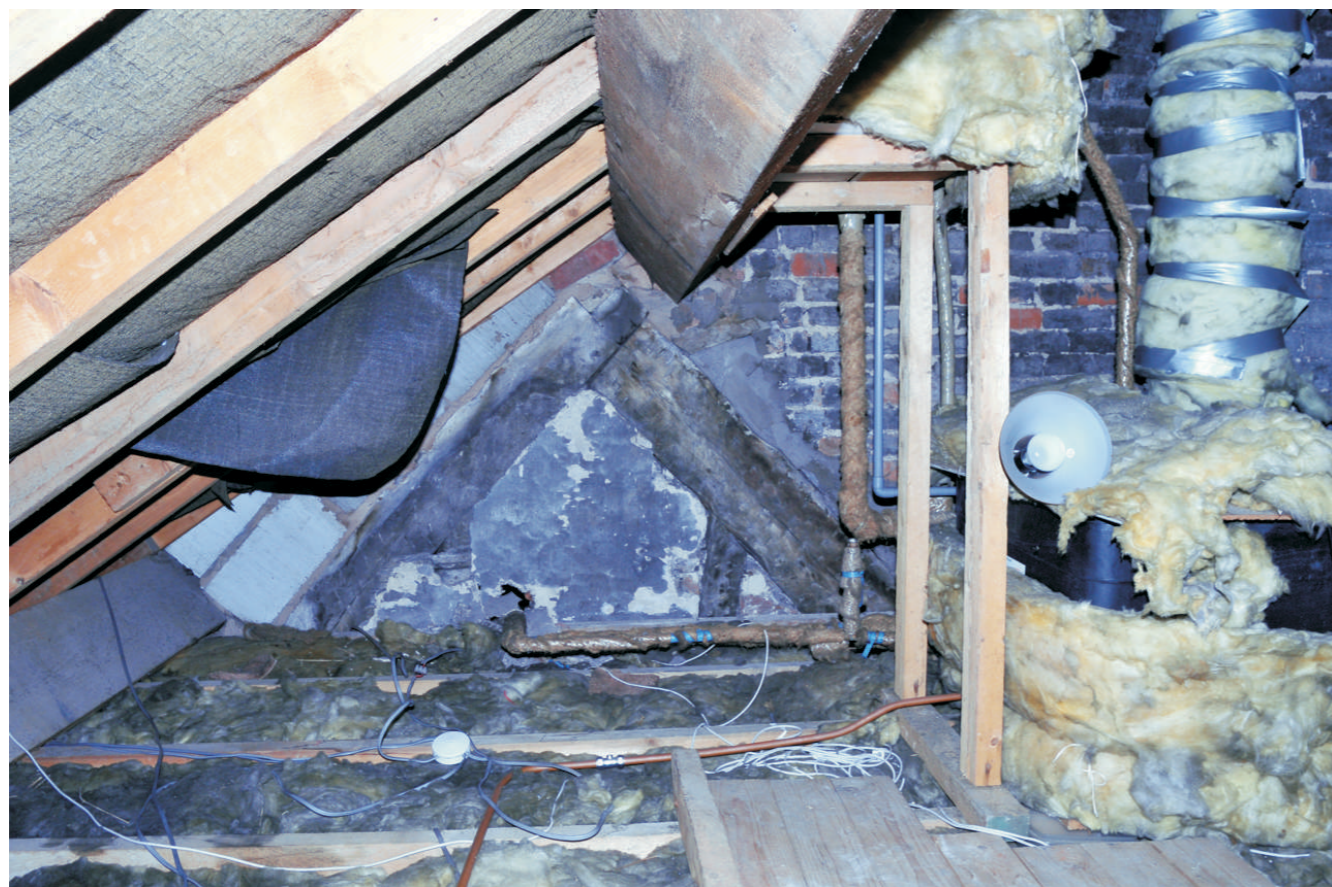
7.8.1 In the roof spaces of Building 1 and Building 2 Truss 4 is exposed, - to the east (within Building 2) the apex infill of the truss between the near vertical queen struts is plastered and painted with grey colourwash on a brick backing, within the roofspace of Building 1 this brickwork is bare and roughly finished and of late 18th-early 19th C appearance. One of the queen struts appears to be a re-used window head. The principal rafters are trenched for purlins, which extend out from Building 2 to meet the rafters of Building 1, but are not jointed to them. A secondary, double pitched roof, much rebuilt and incorporating both reused and modern rafters covers the junction of the two roofs, suggesting that the two buildings were not completely integrated originally.

Truss 4 within the roofspace of Building 2

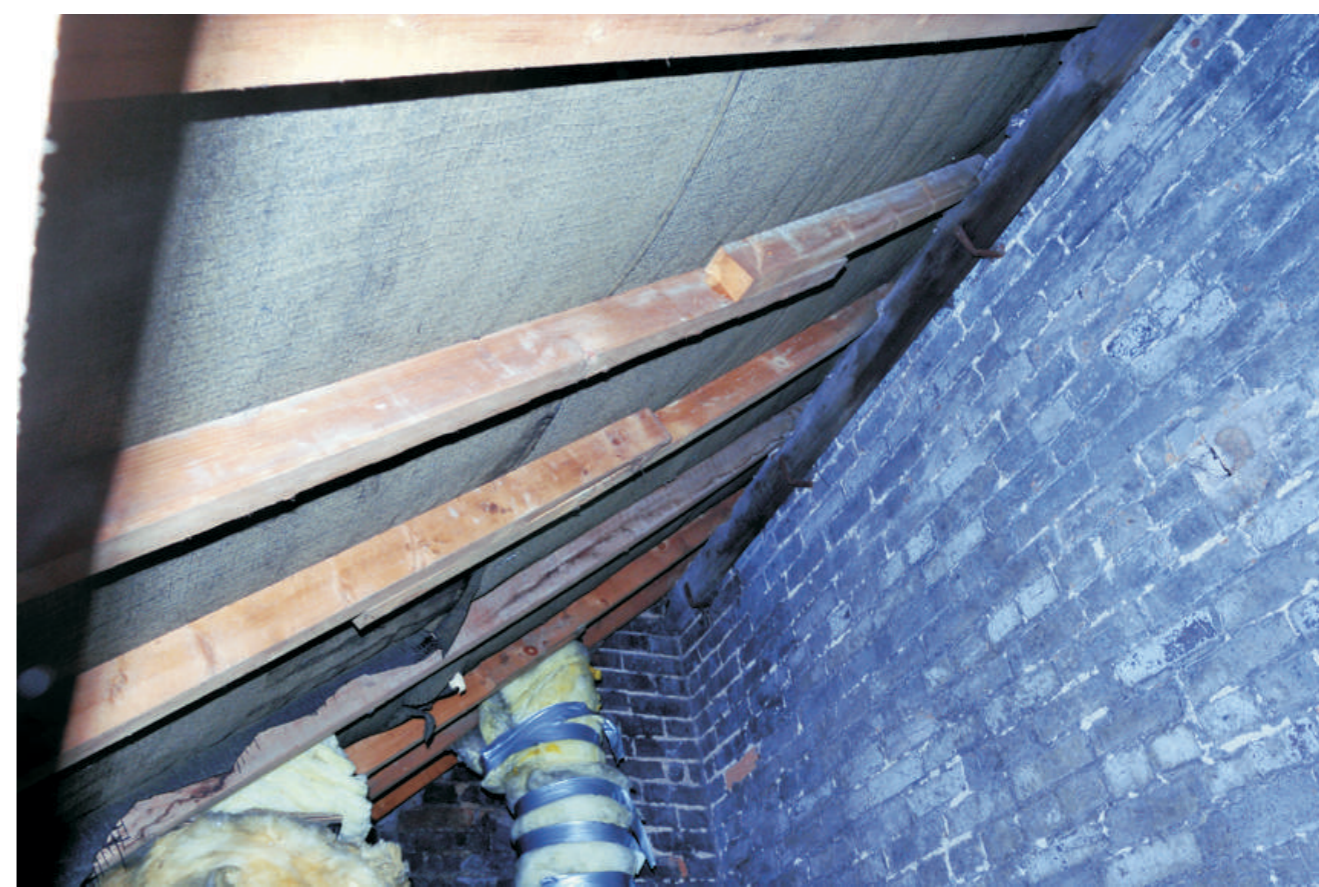
Lodging of modern Building 2 roof on earlier timber spiked to rear wall of Building 3

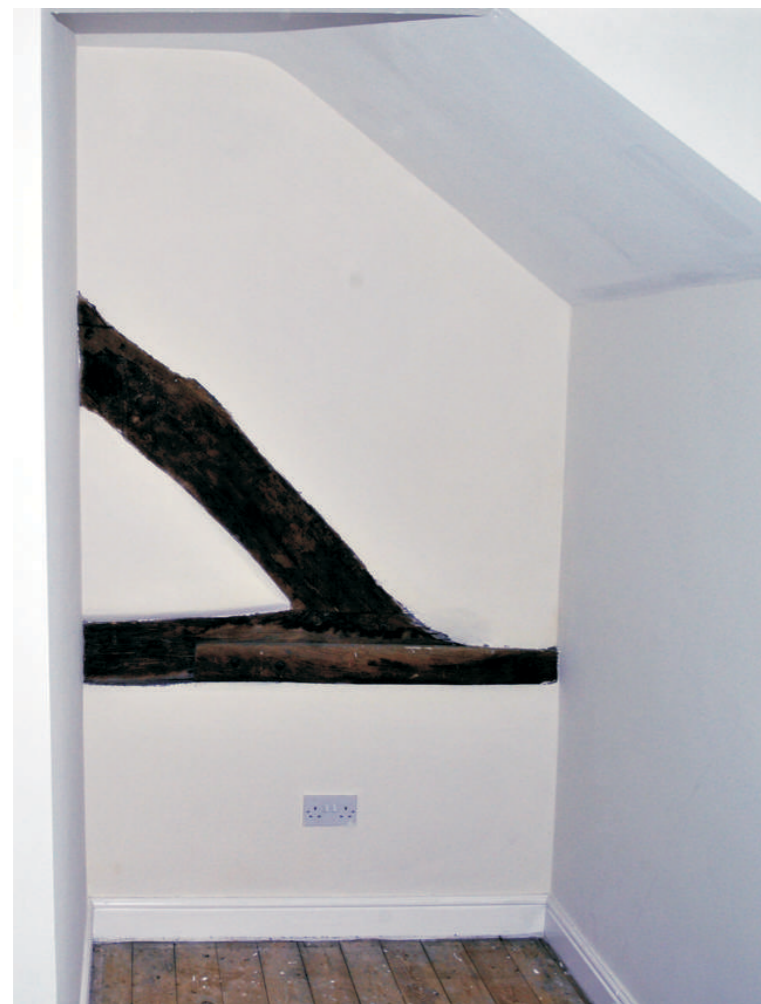
7.9.1 This truss is only partially exposed in the eastern party wall of Building 2, and extends outside the study area into the stairwell of the eastern portion of No.12 (now a separate flat). It is of traditional framed construction, and possibly of 17th C date, though detailed examination was not possible.

Truss 5 visible at 1st Floor of Building

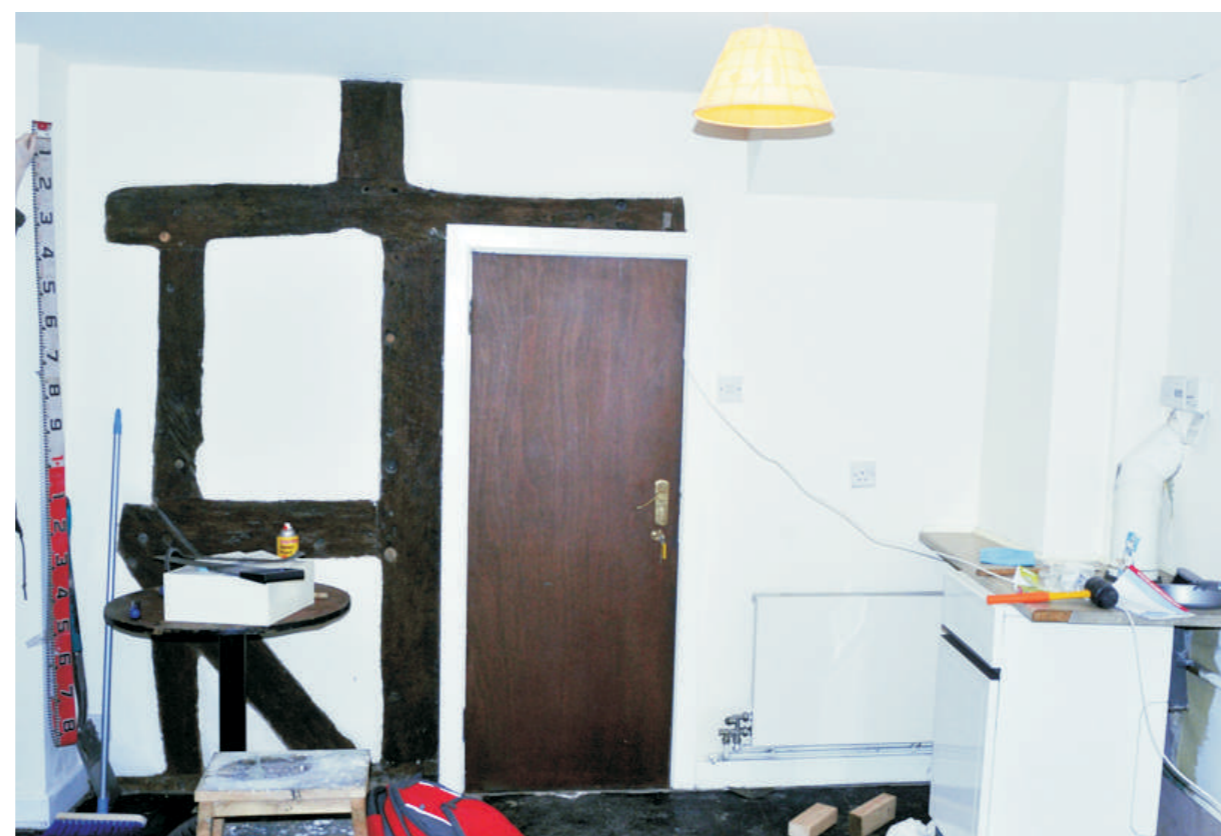
Framing of Building 1 visible from kitchen of Building 2

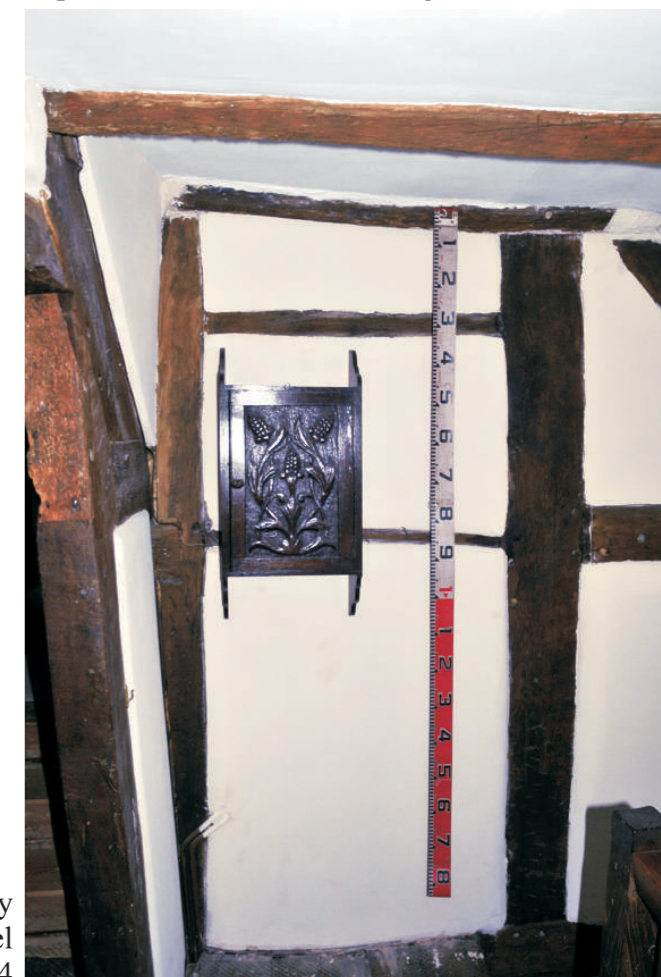
Inserted (and later blocked) former doorway linking Building 2 with Building 1 at 1st floor level (visible only from west side of Truss 4)

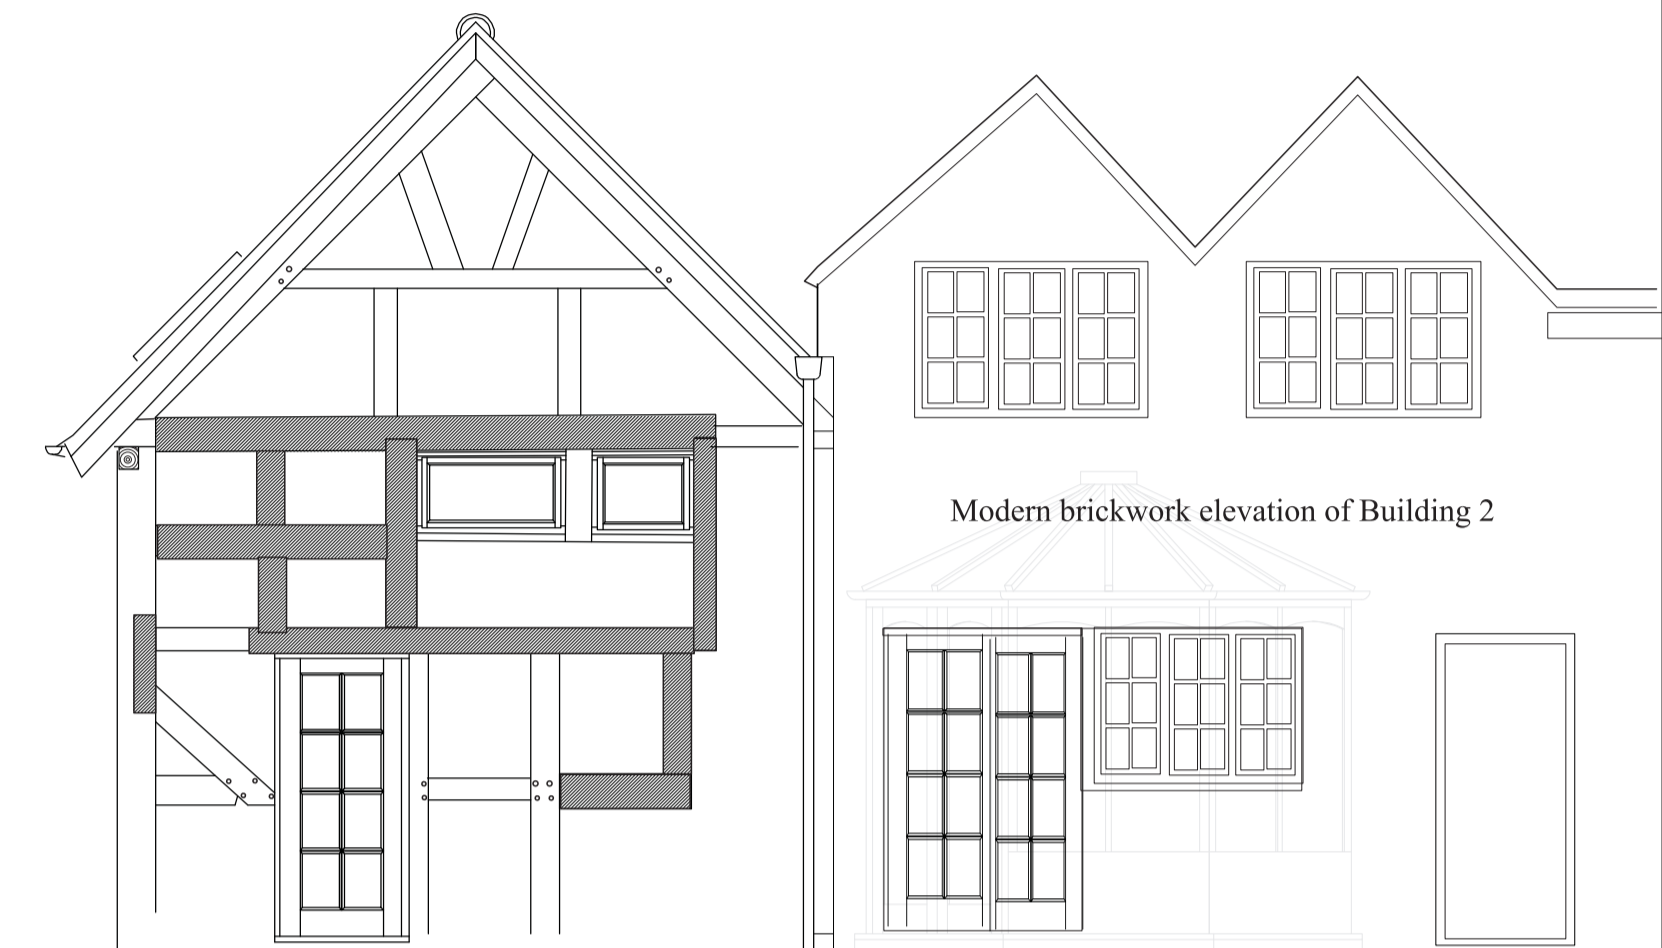
yard elevation as existing

Nb: the original framing on this elevation is largely concealed by modern boarding
