WALTON FARM, WALTON POOL,  
CLENT, WORCESTERSHIRE –  
HISTORIC BUILDING RECORDING AND  
HERITAGE ASSESSMENT

# **Walton Farm, Walton Pool, Clent – Historic building recording and heritage assessment**

## **WSM 77849**

**25<sup>th</sup> November, 2021**

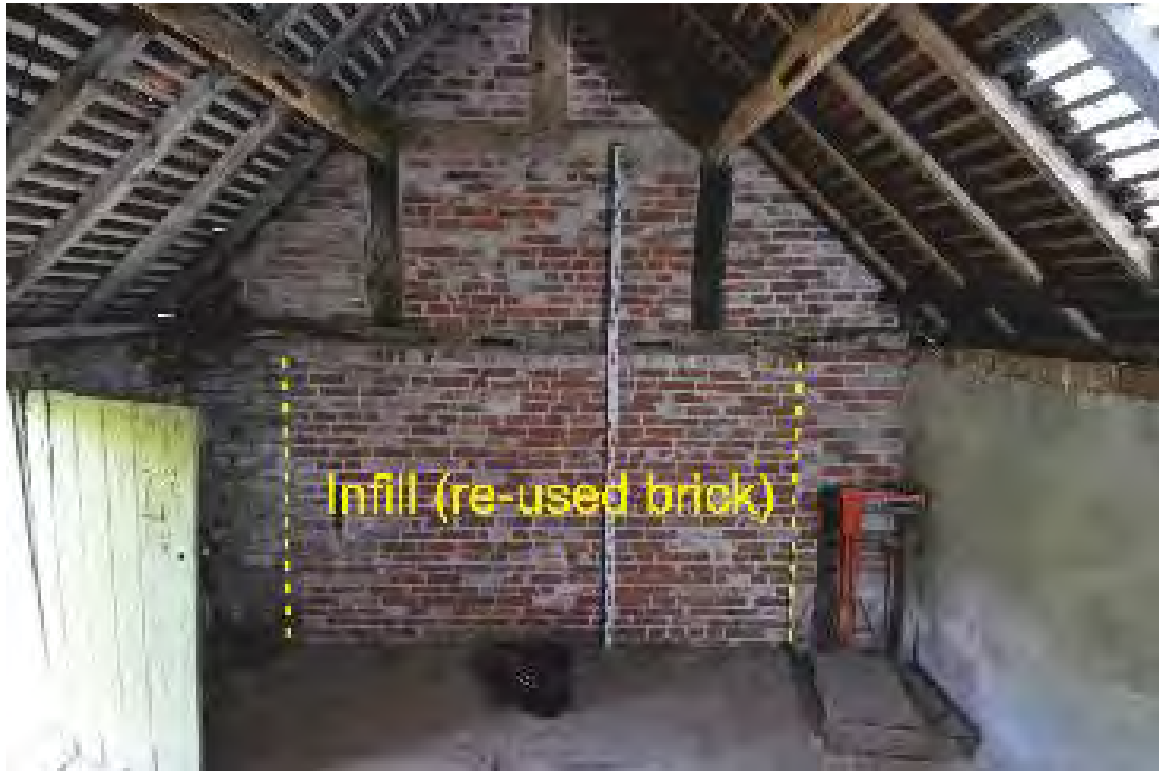
5.1.7 The end bay, nearest the barn appears to have been originally linked to the barn - there is brick infill under the tie beam, which rests on engaged brick pillars at the upper level – see below. This arrangement is rather unusual, and the infilled central

panel beneath the tie beam has been filled with re-used mid 18<sup>th</sup> Century brick. The infill panel is also clearly visible from within the barn (see below).

*View of infill area from stable block side – this truss formerly open to barn*

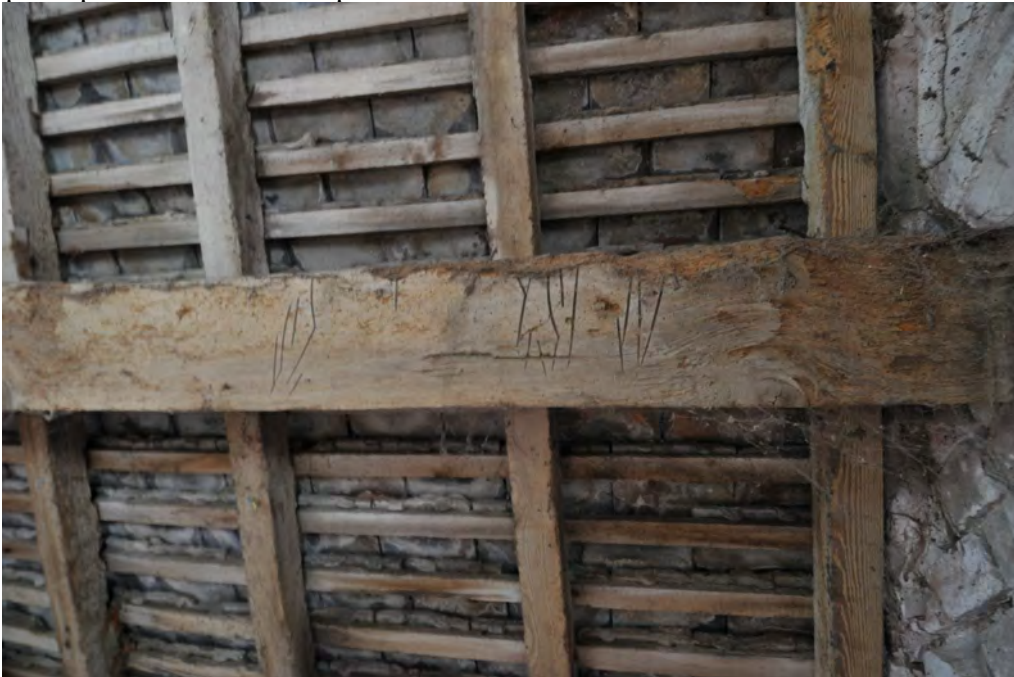
*Baltic timber merchant's marks on purlin*

Whilst only one purlin has currently visible timber merchant's marks it is likely that all of the principal timbers are imports from the Baltic ports. Such marks are not found on UK grown timber. Later in the 19<sup>th</sup> C sources of North American softwood became more competitive, especially for smaller scantlings.

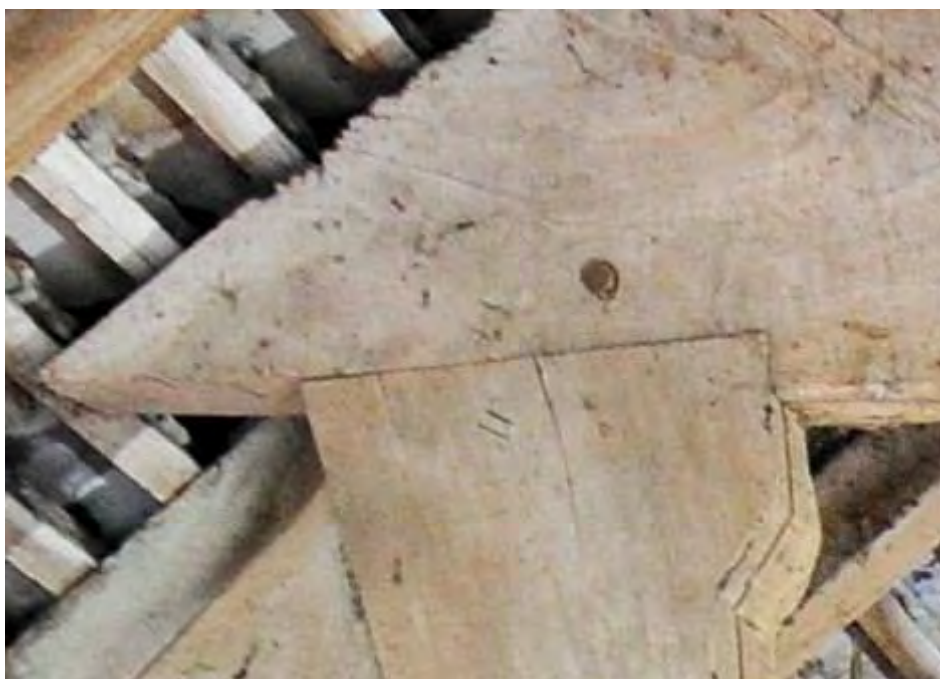
5.3.2 The framing of the two trusses is noticeable for the very small diameter pegging (circa 10mm) and the small size of the carpenter's assembly marks (vertical strokes of around 15mm). Some of the subsidiary timbers (eg horizontal braces to the wall plate) are spiked to the frame, and it would appear that the common rafters are spiked to the purlins. These are all features compatible with late-period framing.

*Enlarged detail of queen-post/collar joint showing small diameter pegging*

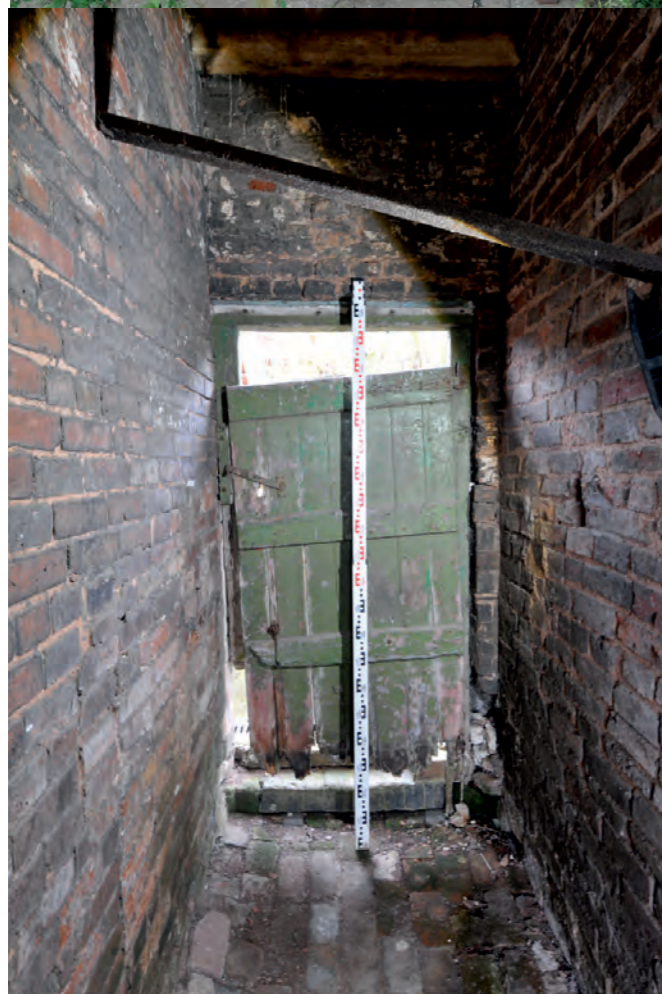
Through passage facing NE

Note that original back wall has been underbuilt to provide stepped access

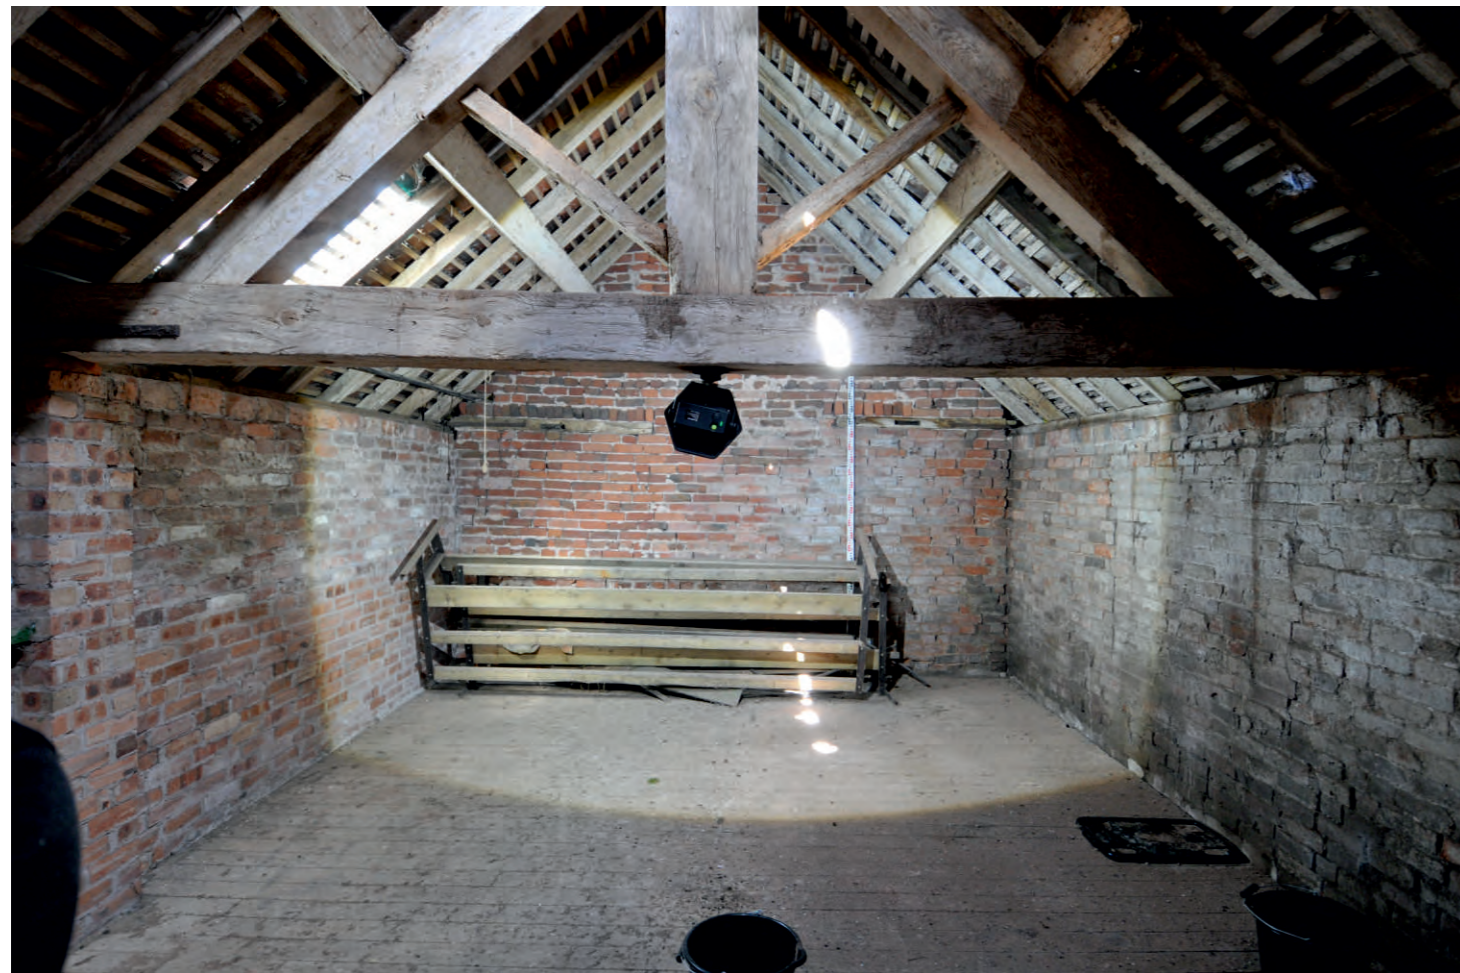
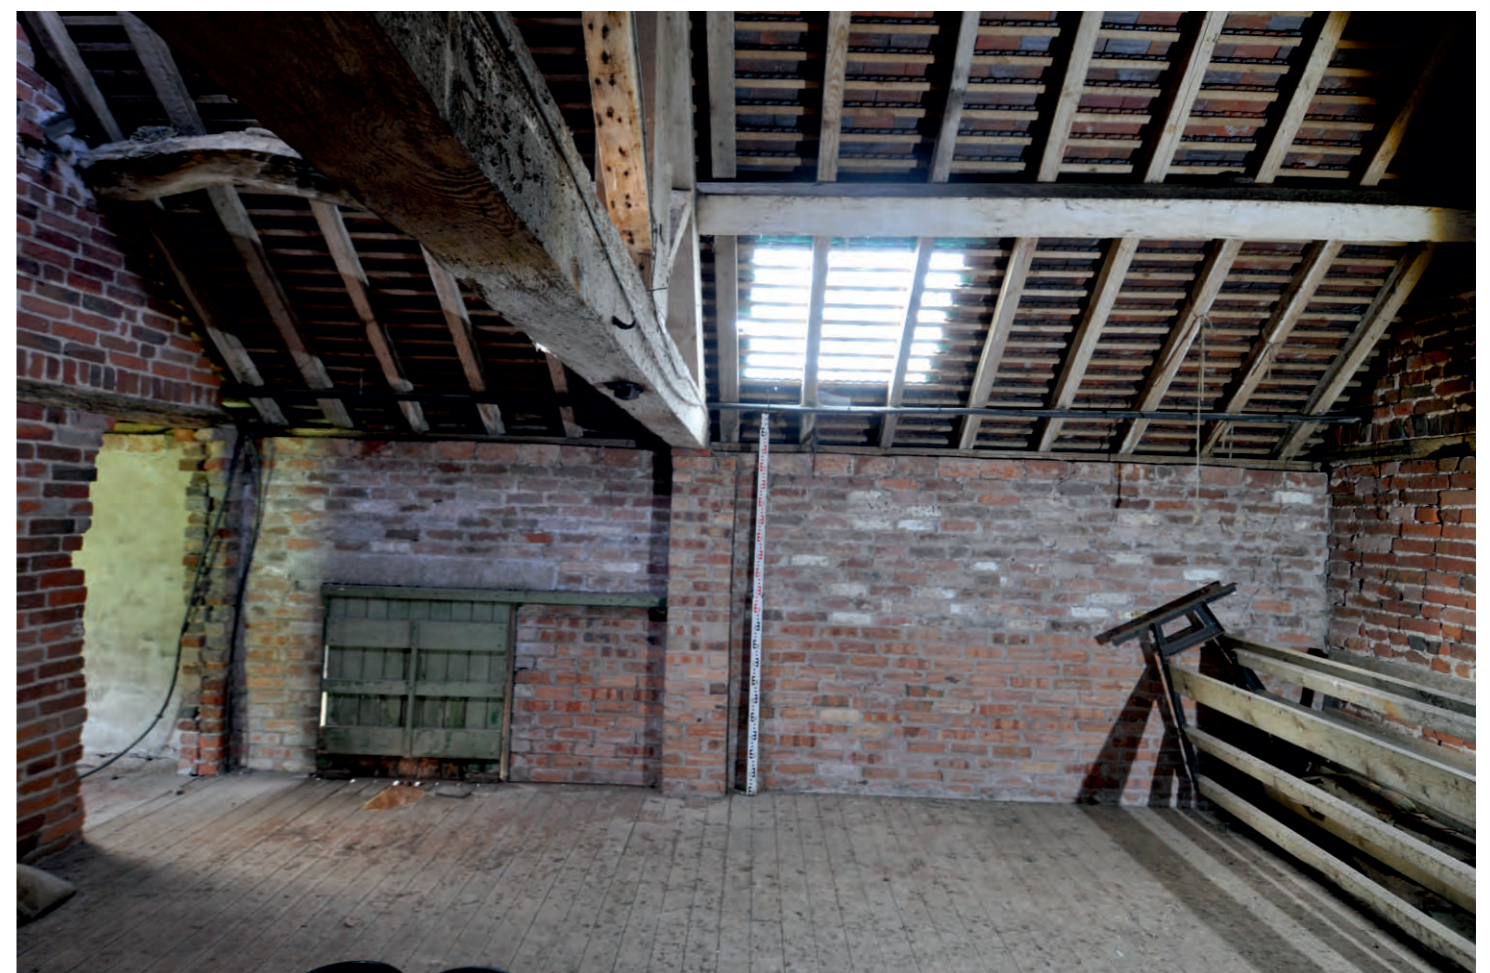
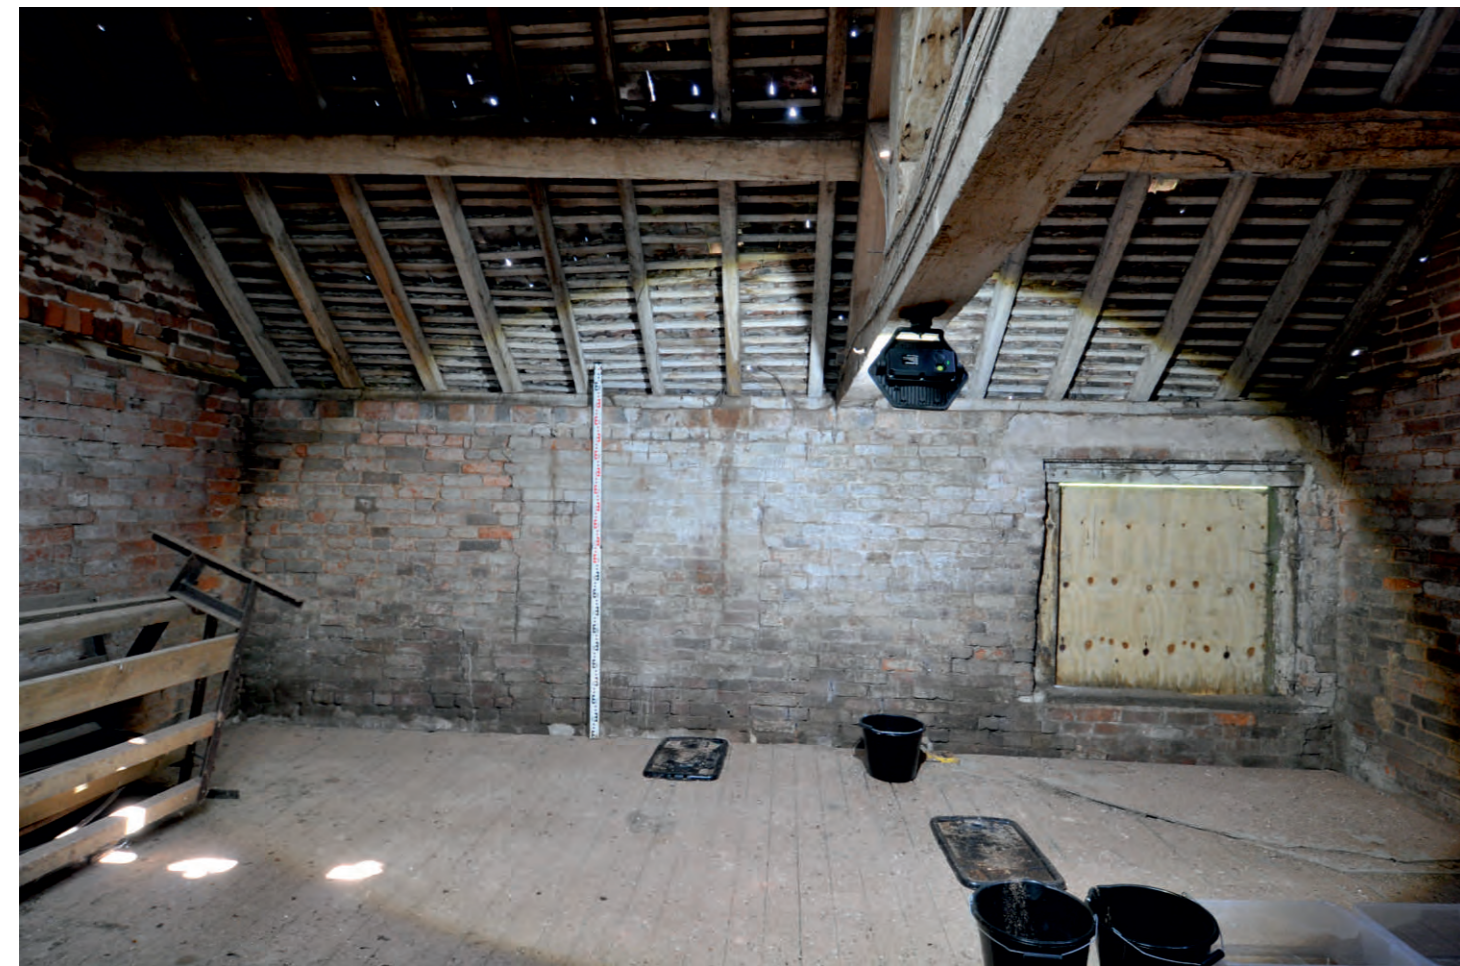
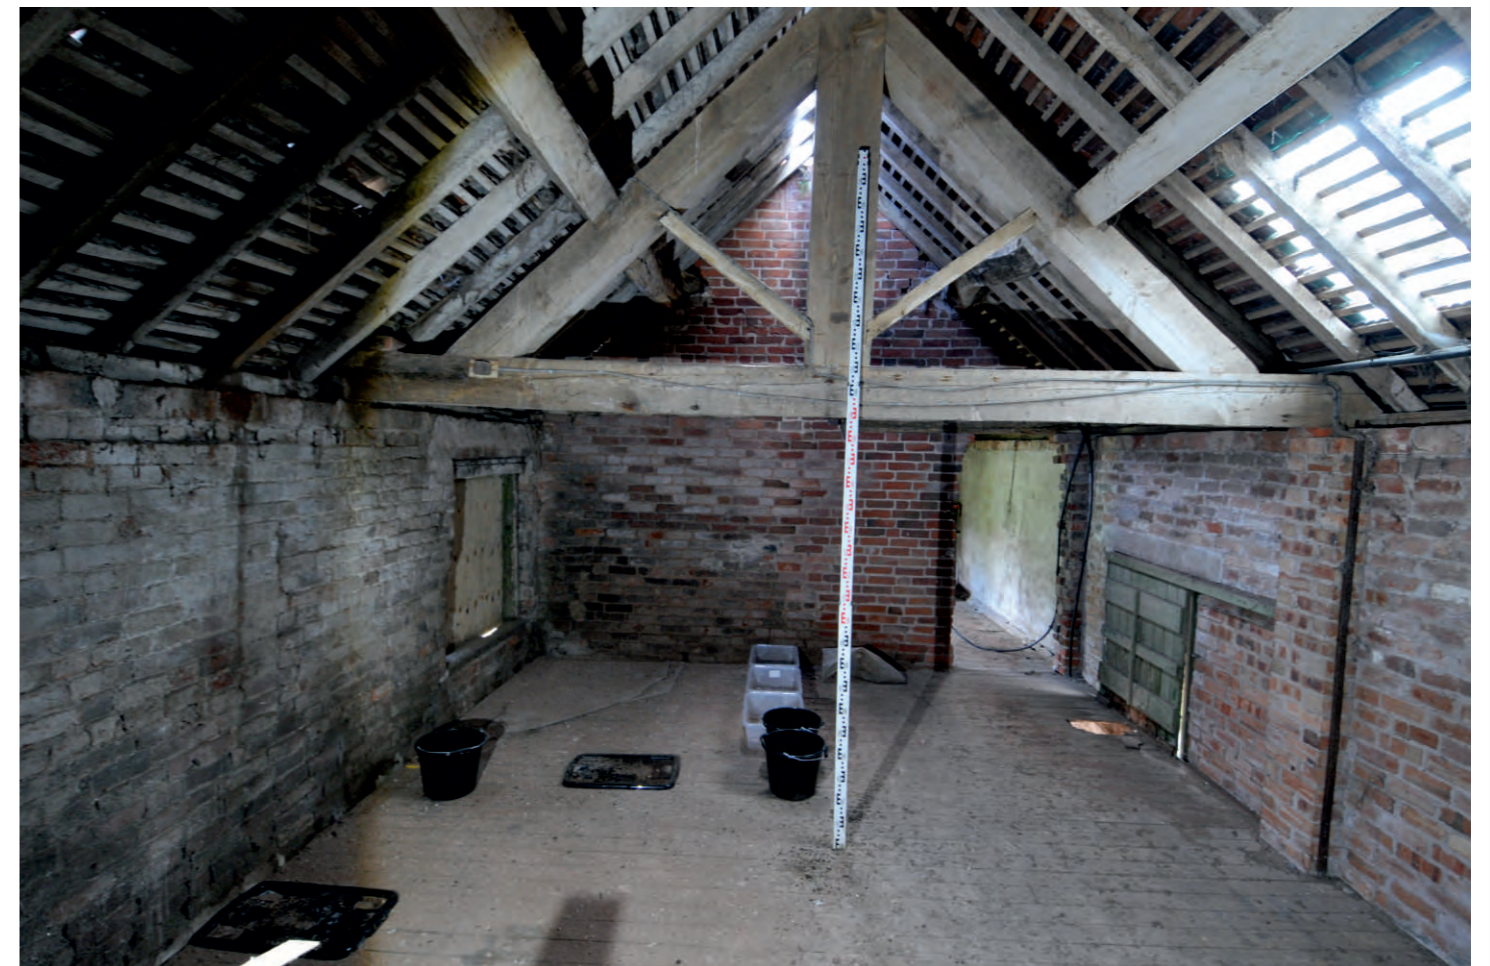
Figure 8: Middle section of former hayloft

5.1.6 The middle section of the upper level (Fig 8) is rather featureless, lit primarily through glass tile panels in the roof, though two loading hatches have been boarded over and may have given some original natural light. The floor has been replaced with tongue and groove boarding, and the upper part of the wall facing the foldyard appears to have been re-built. The mid section truss is of oak and of later 18<sup>th</sup> Century character, traditional pegged construction with very slender queen struts.

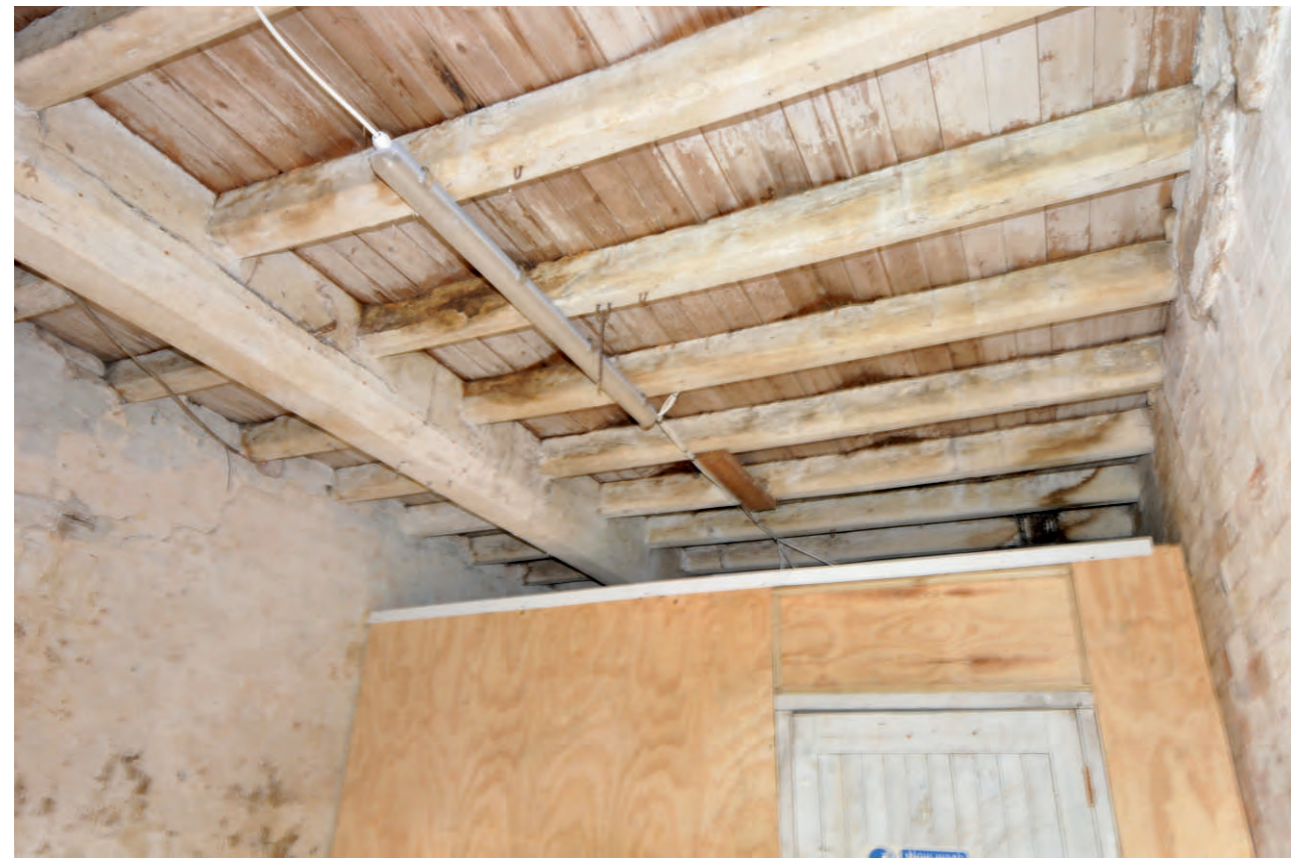
Westernmost room - part converted to washroom

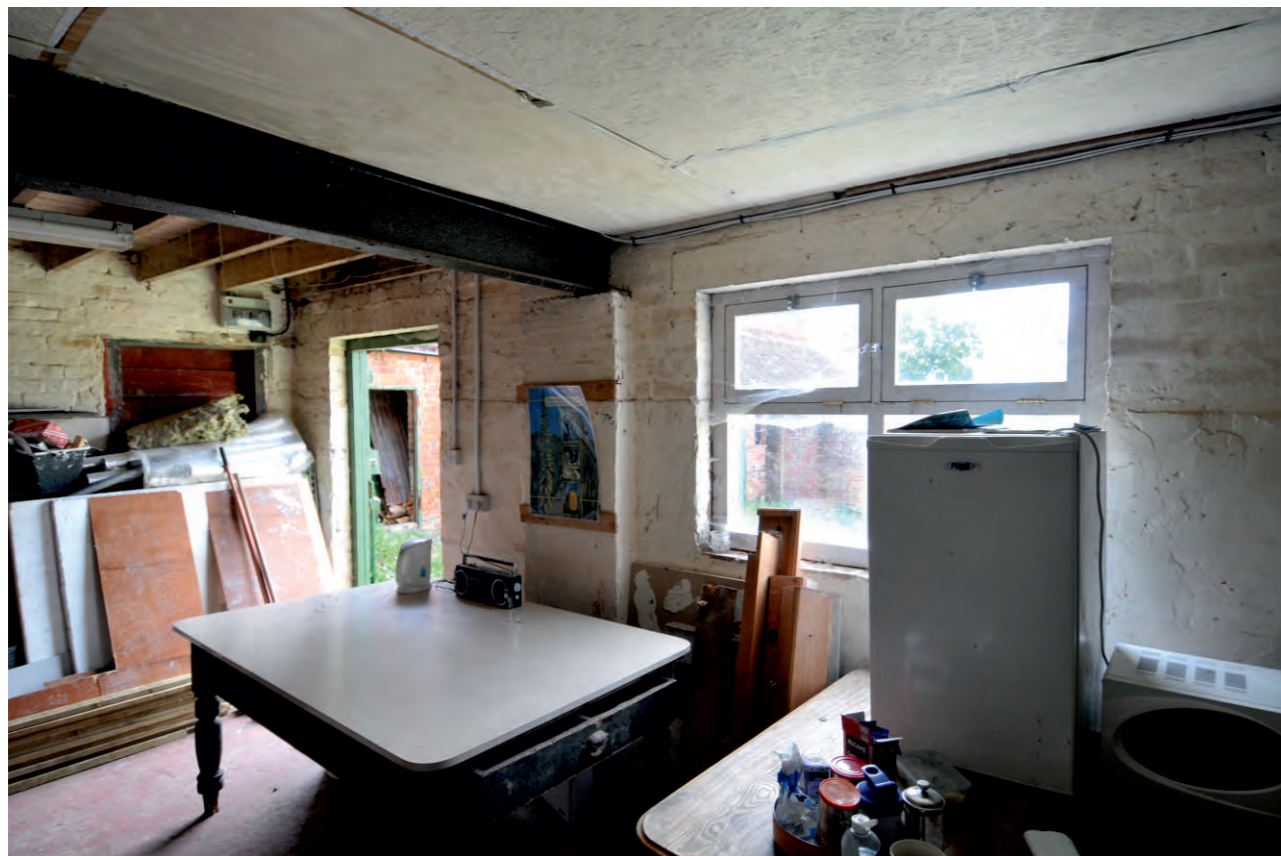
5.1.2 The central section of the stable range has been re-modelled as a workshop meeting room, a dividing wall having been replaced with an RSJ, and a modern window inserted. It appears that this section of the elevation had previously been rebuilt /refaced, apparently in the early 20<sup>th</sup> Century. The rebuilding is more evident internally at 1<sup>st</sup> floor level.

Middle ground floor room created by removal of stable partitions - note relatively recent RSJ on former wall line

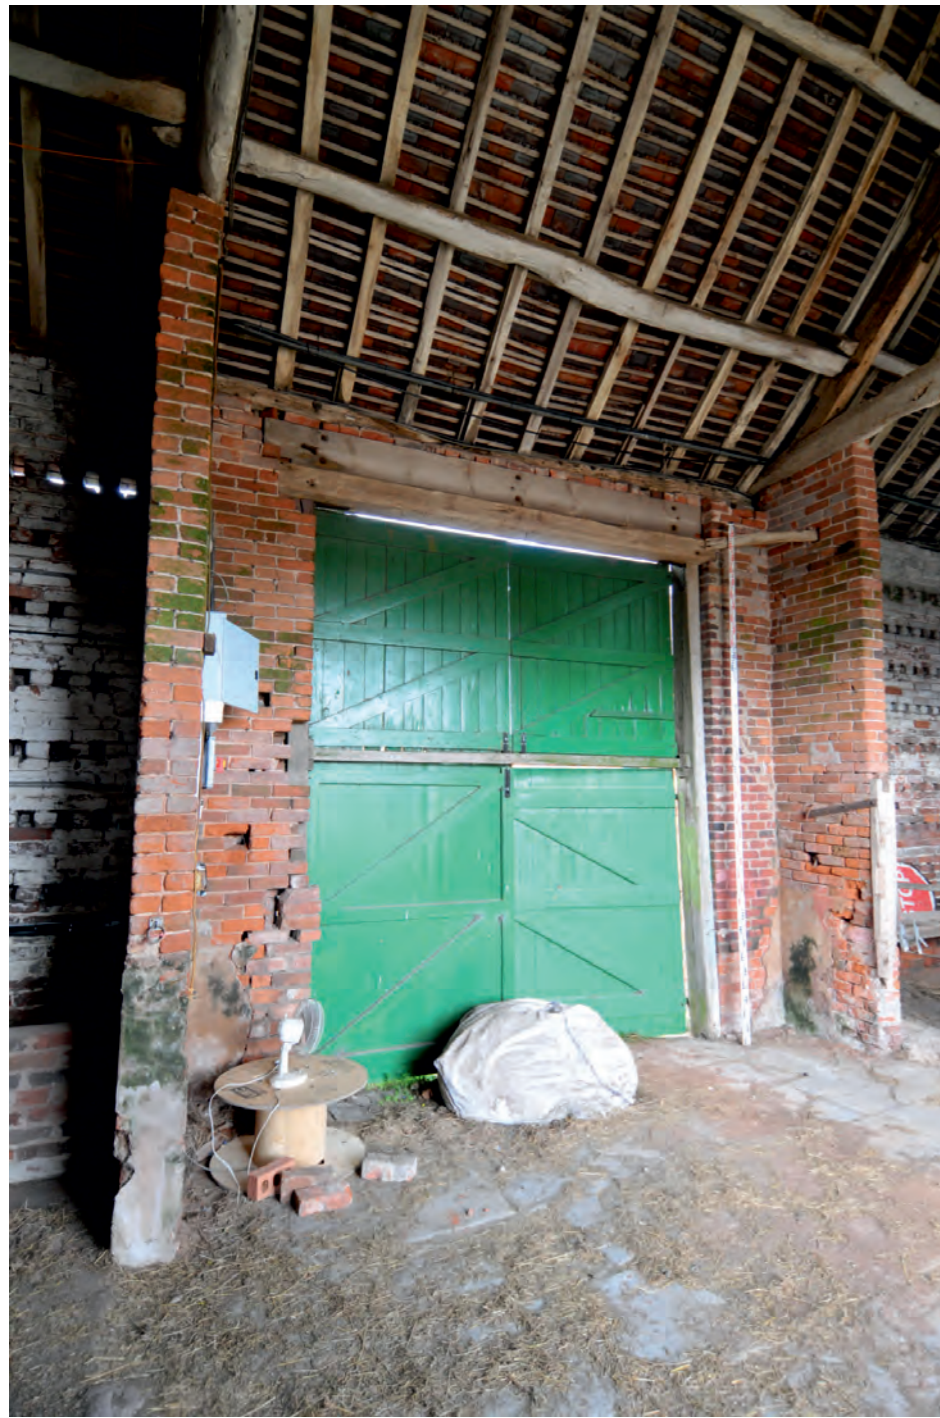
5.2.1 The main body of the barn is aligned broadly north-south, with large wagon doors to both the east and west elevations. The central bay retains some stone slabs from a former threshing floor. The barn doors are 20<sup>th</sup> Century replacements hung on

new hinges – the original pintles were differently placed. The barn is almost entirely of mid-late 18<sup>th</sup> Century brick, but incorporates some reused earlier brick and a section of possibly re-used stonework internally beneath the hayloft staging. The floors are predominantly rough concrete.

Threshing floor and (replacement) doors

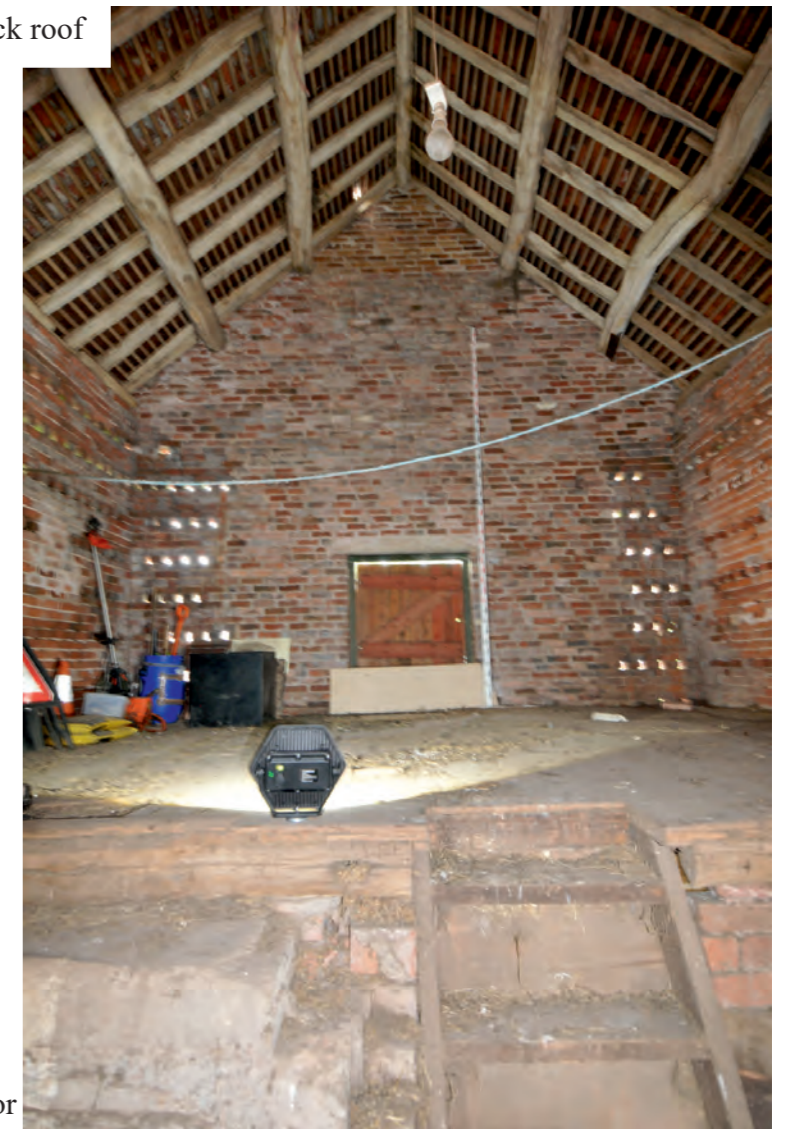
Rebuilt western gable end interior

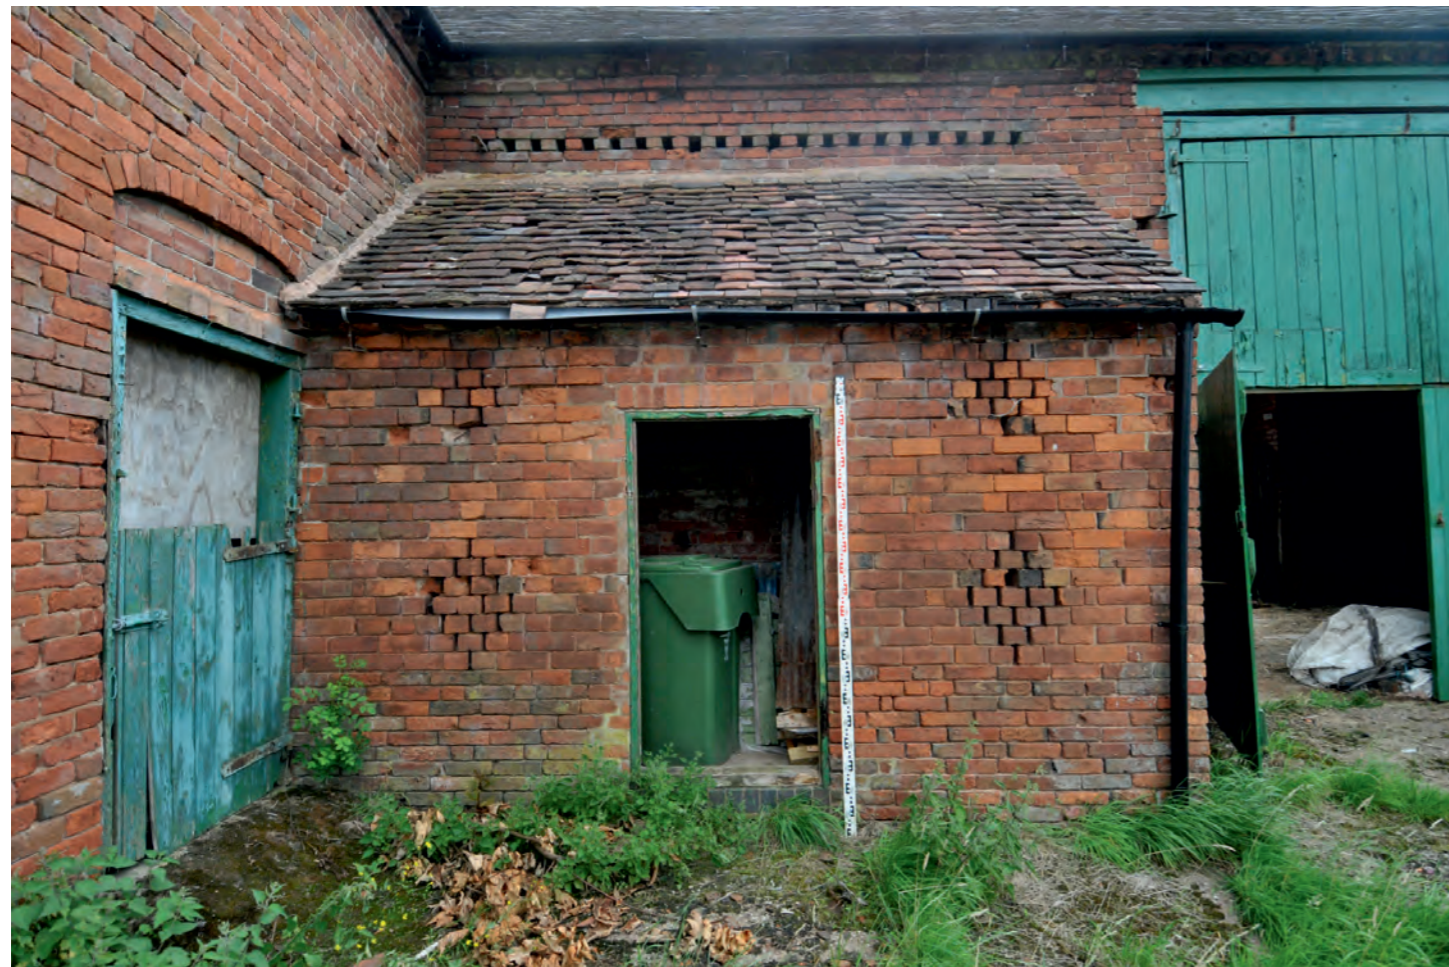
5.2.5 Adjoining the barn, on the foldyard side facing the house are a small brick built lean-to structure in the angle of stable block and barn (almost certainly a root house) and a much converted and extended structure in recent times used as a tack room but converted from a row of three pig sties visible on the 1<sup>st</sup> edition Ordnance Survey. Both structures are likely to be of early 19<sup>th</sup> Century origins, but only the root-house survives in its original form. The presence of brick through vents indicates probable use for fodder storage, and the size is in keeping with a root house.

Probable former root house

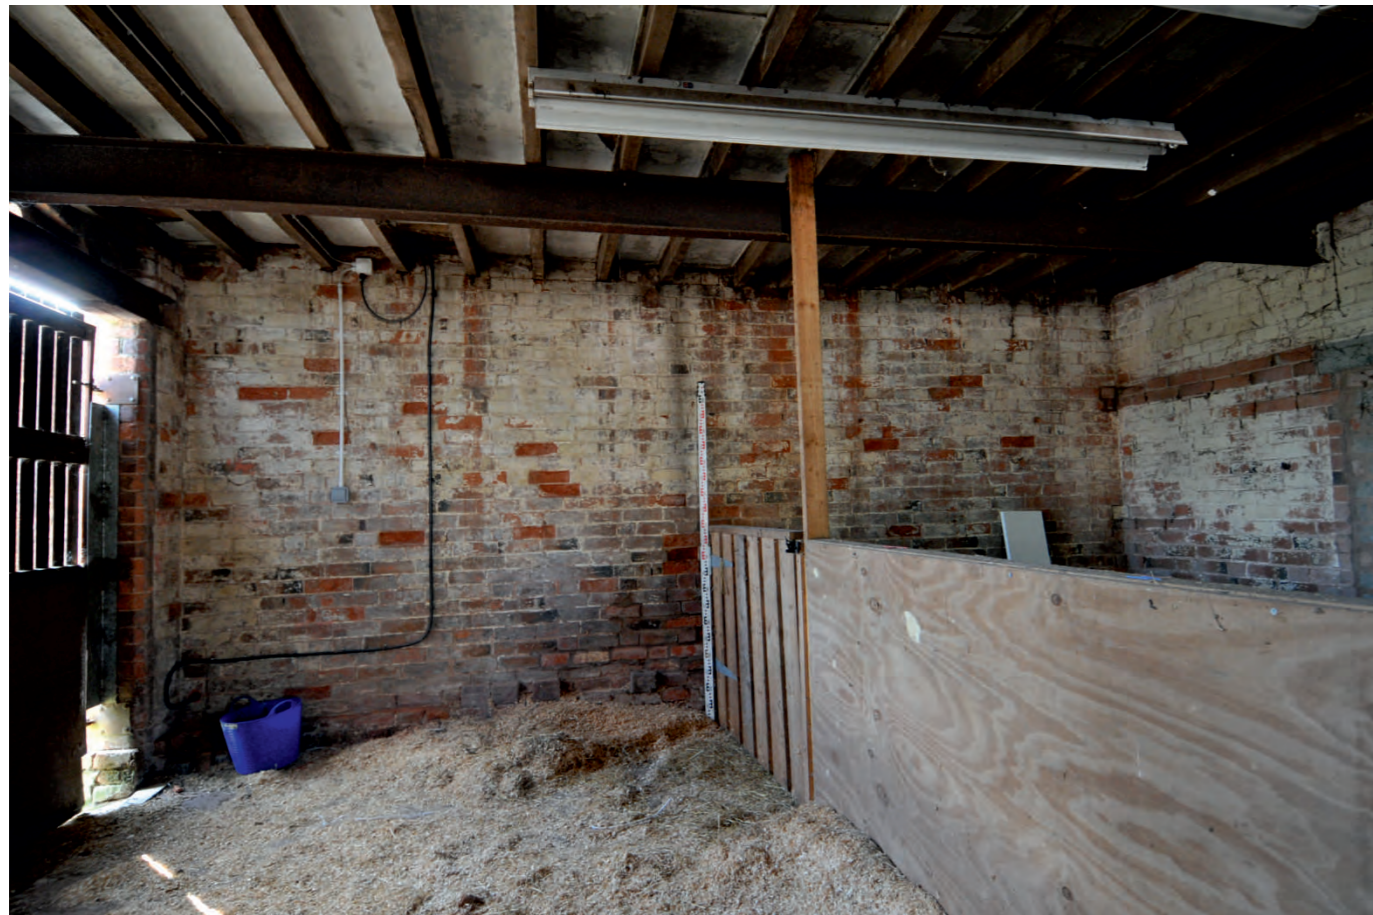
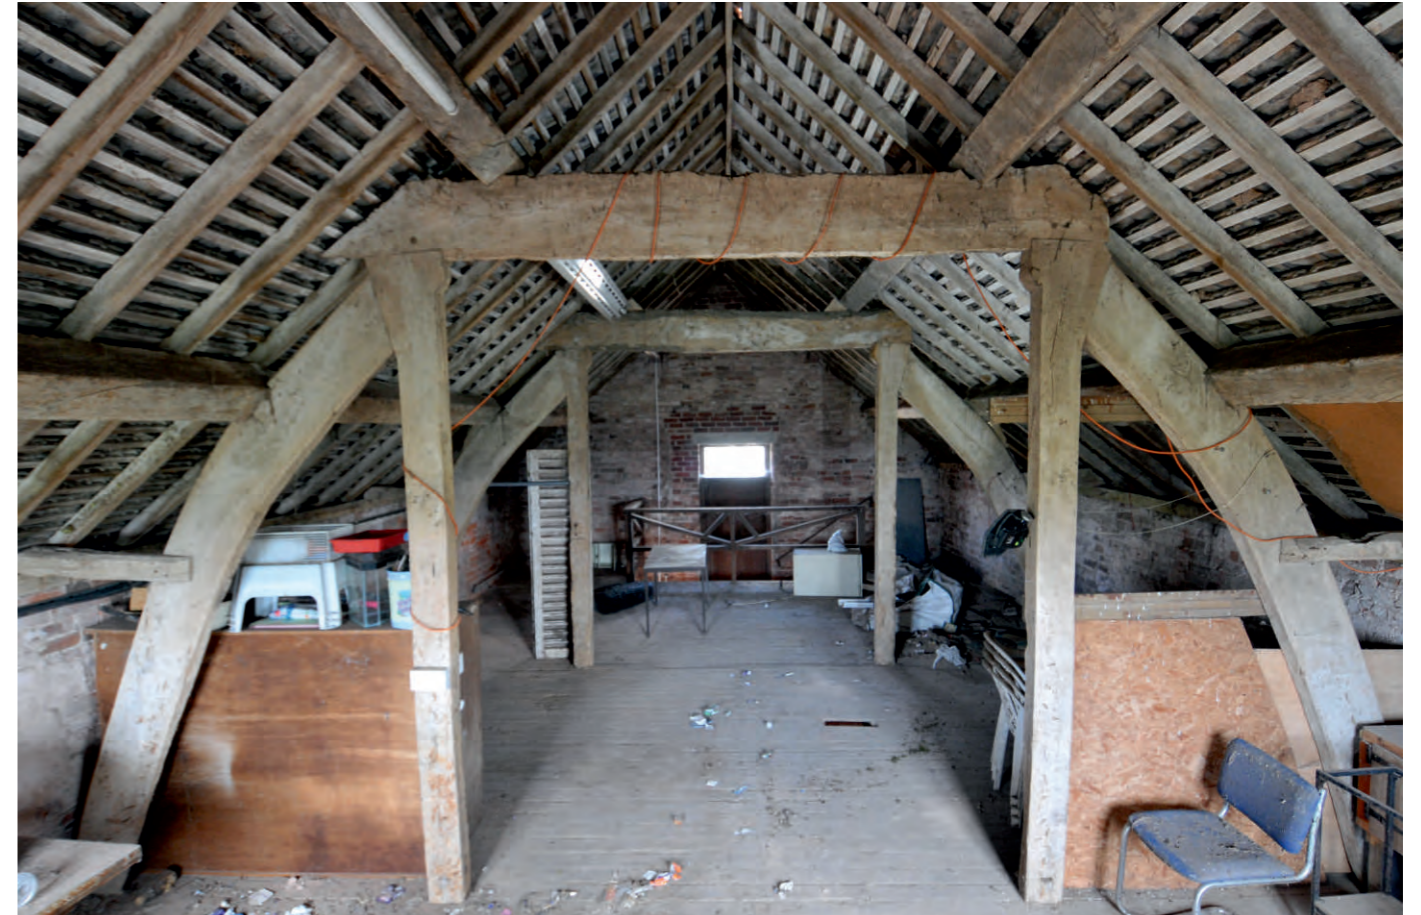
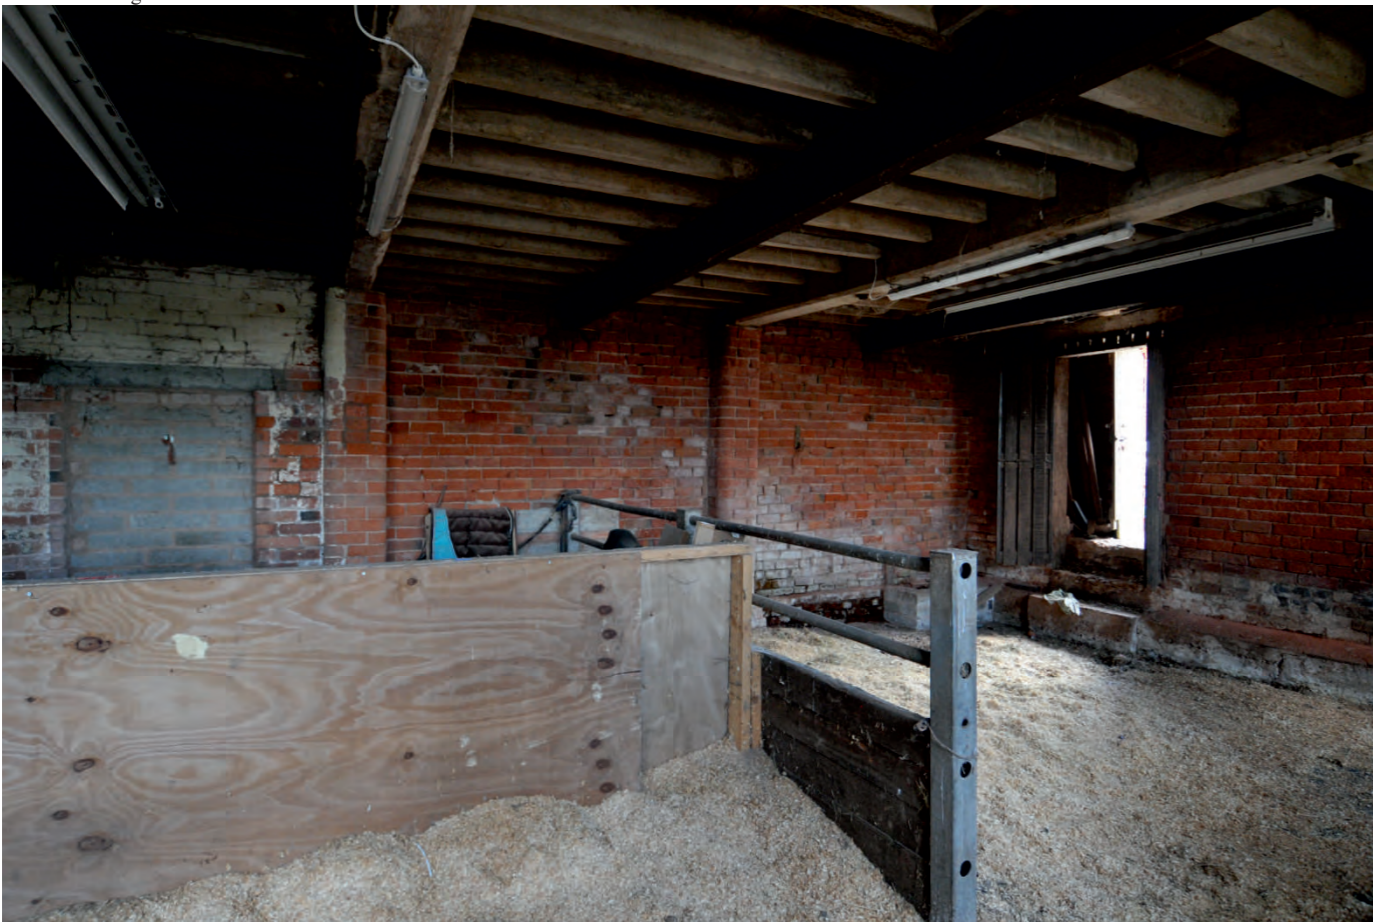
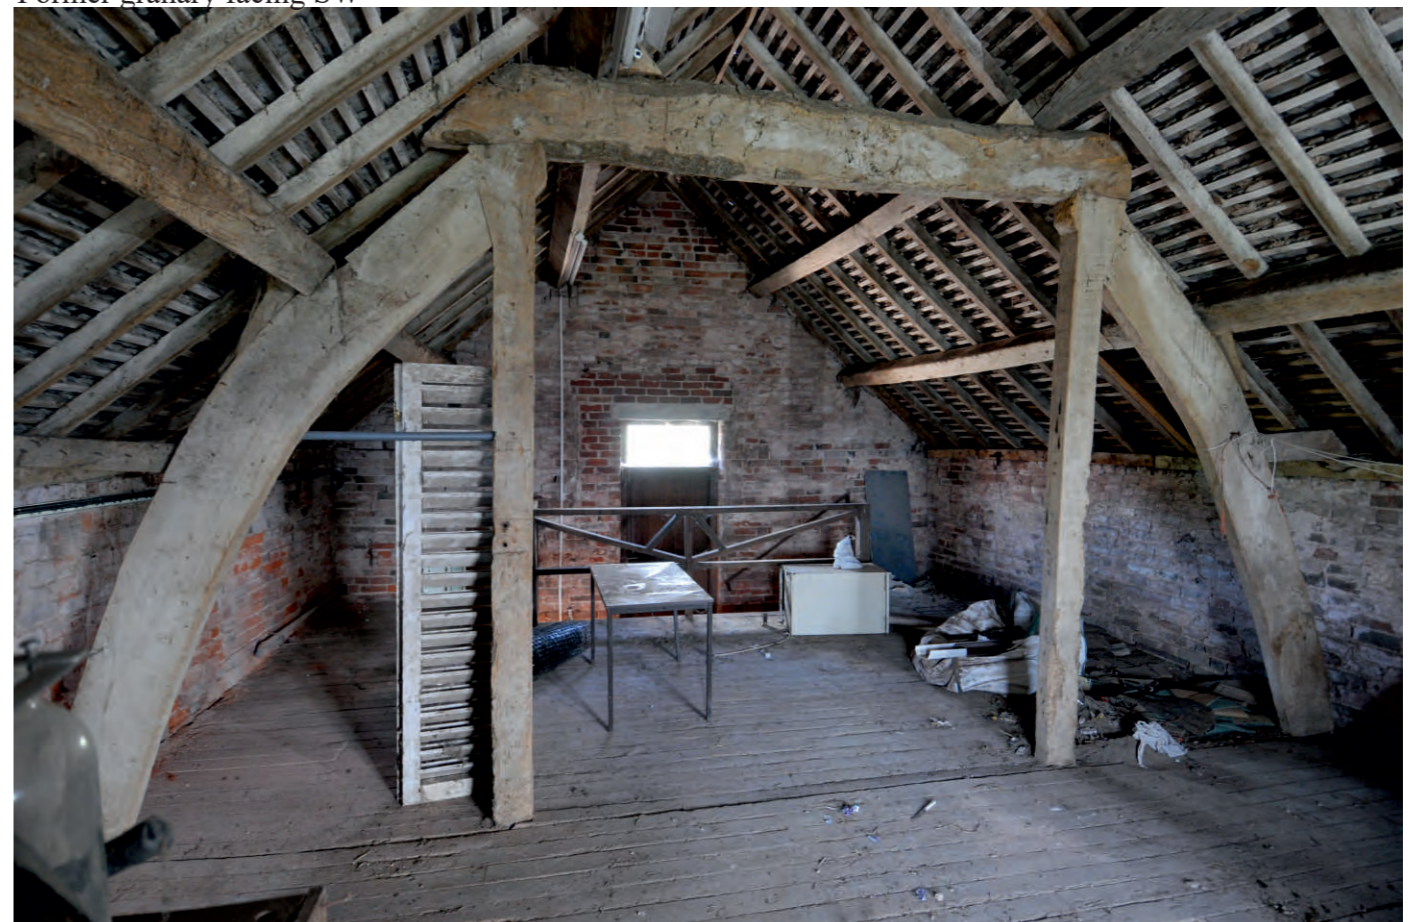
Figure 19: Former cart house/ granary interior - upper floor structure has been re-inforced with RSJs
