Peterborough Cathedral

Galilee Court Landscaping Project

A Report on a Programme of Archaeological Observation and Recording.

Planning Reference Number: 13/00505/FUL
HER Event Reference: 53791
Archaeological contractor's Site Code: PCGC

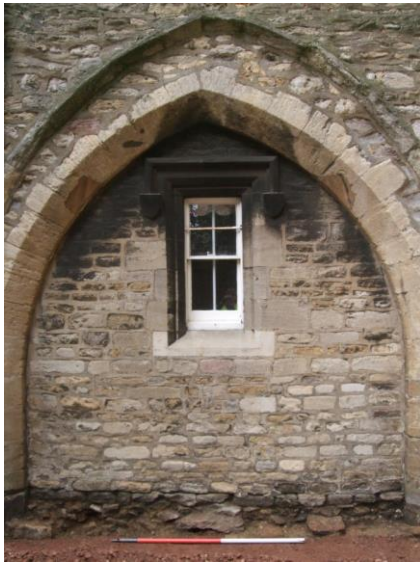
Plate 11
(Archive image PCGC 380)
Eastern Gateway: west side, east elevation with exposed footing.
Photograph: Caroline Atkins

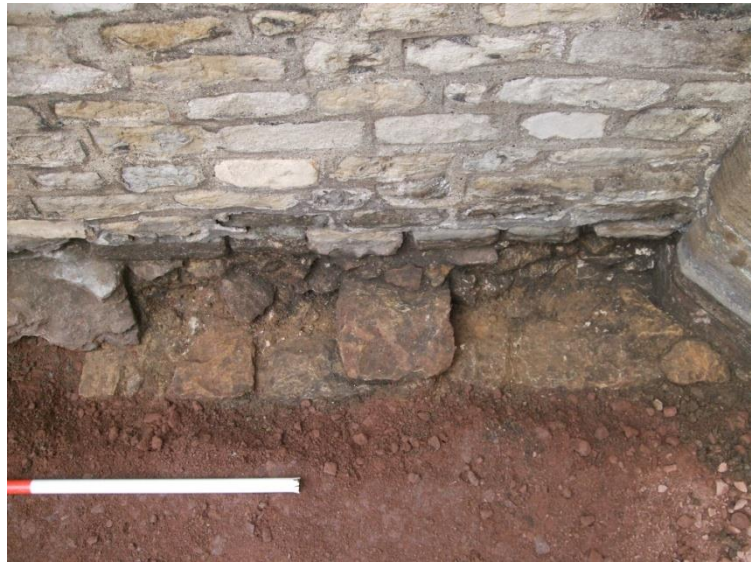
Plate 12
(Archive image PCGC 384)
Eastern Gateway: west side, east elevation with the footing courses of the wall blocking the arch.
Photograph: Caroline Atkins

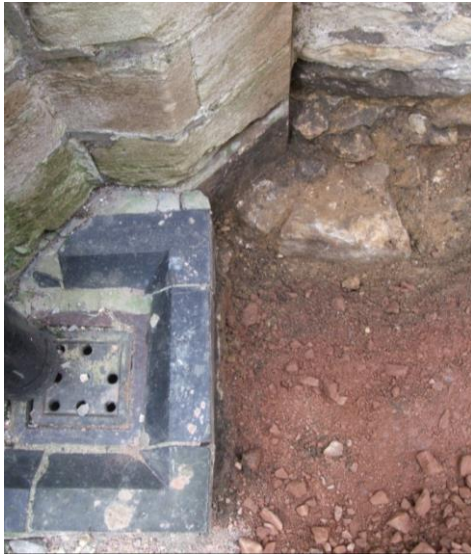
Unfortunately, the retention of a brick-edged gully (Plate 13) and the existing iron railings to the north of the arch limited the horizontal area of excavation and prevented investigation of the lower courses of the arch itself and of its relationship with the adjacent parts of the gate passage wall.

Plate 13
(Archive image PCGC 389)
Eastern Gateway: west side, east elevation:
blocking wall footing, south end.
Photograph: Caroline Atkins

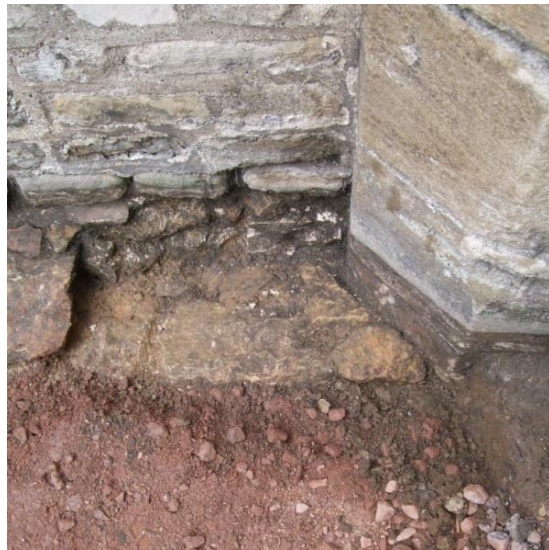
Plate 14
(Archive image PCGC 390)
Eastern Gateway: west side, east elevation:
blocking wall footing, north end.
Photograph: Caroline Atkins

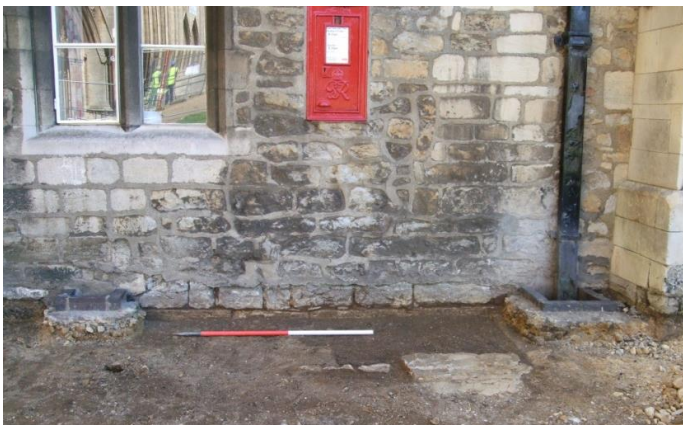
Plate 15
(Archive image PCGC 59)
No.24: north elevation, east of front
door, showing evidence for a strip of
front garden edged with stones and
possibly a railing.

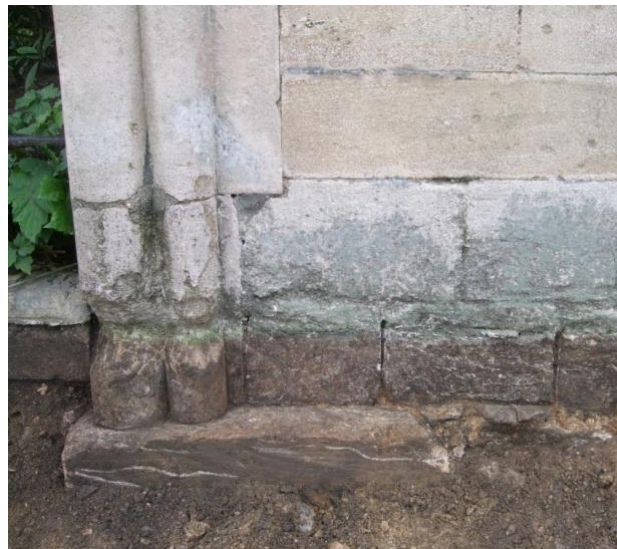
As elsewhere, but particularly regrettable in this medieval structure, there was a very marked horizontal band of damage and erosion (Plates 21 and 23) straddling the line of the modern ground surface. Hair-line cracks between the wall face and abutting, hard, pavement surface permit water and soil to collect against the stonework, and ice-formation and plant roots to expand the crack and damage the stone.

Plate 21
(Archive image PCGC 142)
Bishop's Gate: east side, north elevation, showing
the offset course exposed by the groundworks.
Photograph: Caroline Atkins

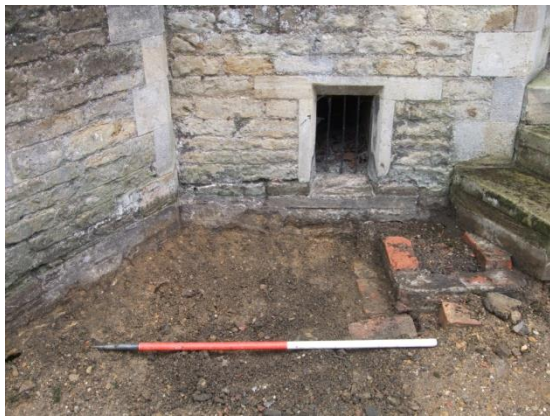
Plate 26
(Archive image PCGC 153)
No. 27: north elevation, east of the front door, showing the location of the coal-hole.
Photograph: Caroline Atkins

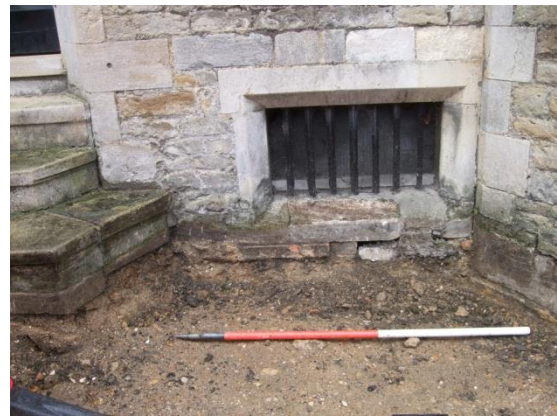
Plate 27
(Archive image PCGC 157)
No. 27: north elevation, west of the front door, showing the basement window.
Photograph: Caroline Atkins

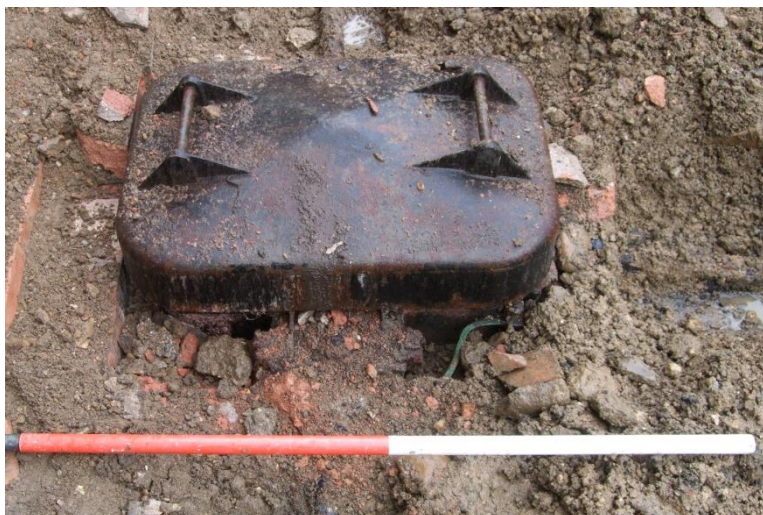
Plate 30
(Archive image PCGC 160)
The transformer after removal of the
brick walls of the inspection chamber.
Photograph: Caroline Atkins

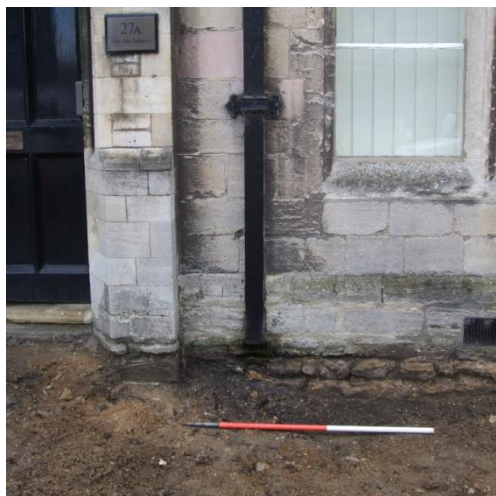
Reduction of levels immediately to the west of the door leading to No. 27A (Plates 31 and 32) exposed two courses of an offset stone footing, so different in character to the stonework above it and so irregularly offset (by an average of 10cm) that it appears likely that it belongs to an earlier, potentially medieval, building, still well-represented by internal features (section 1.4.2).

Plate 31
(Archive image PCGC 163)
No. 28: potential medieval footings
to the east of the buttress.
Photograph: Caroline Atkins

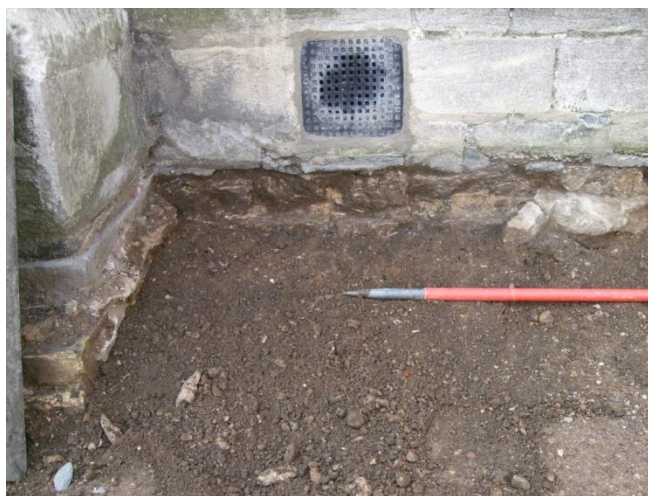
Plate 32
(Archive image PCGC 127)
No. 28: potential medieval footings
to the west of the buttress.
Photograph: Caroline Atkins

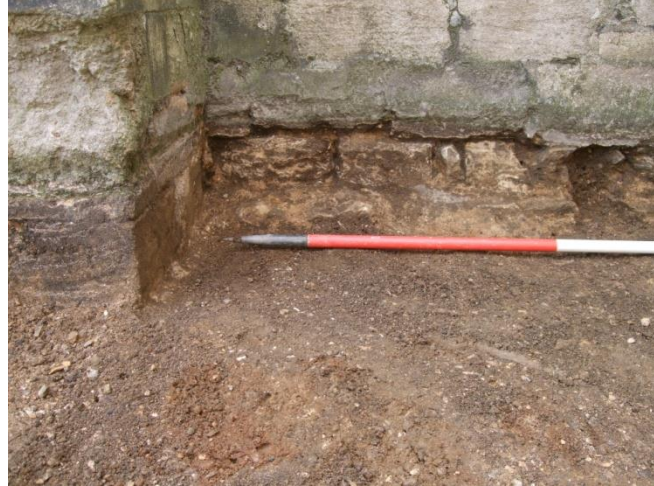
Plate 34
(Archive image PCGC 112)
No. 28: potential medieval footings
to the west of the buttress.
Photograph: Caroline Atkins

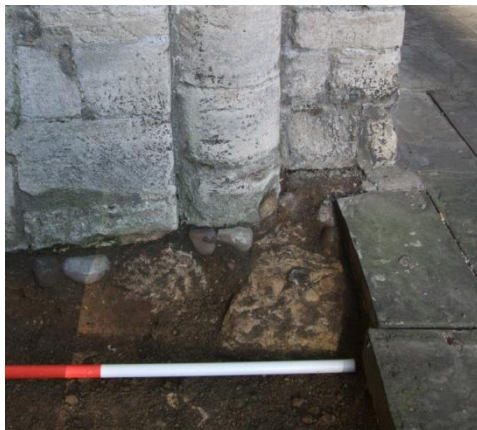
Plate 35
(Archive image PCGC 078)
Norman Gate: east elevation, medieval
footings exposed by reduction of levels
prior to the reopening of the service trench.
Photograph: Caroline Atkins

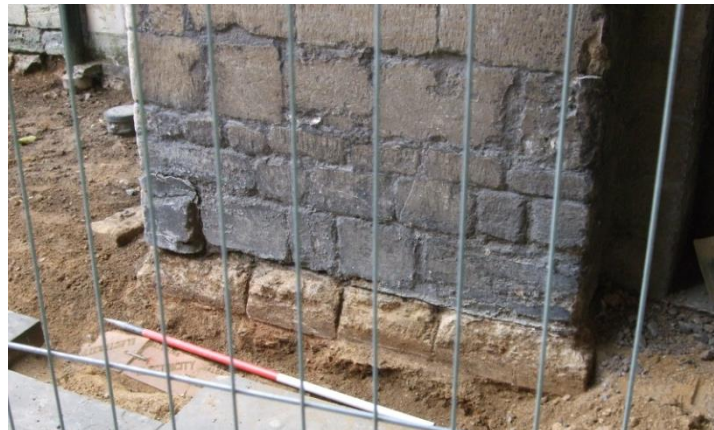
Plate 36
(Archive image PCGC 103)
Norman Gate: east gate arch, south side - medieval
footings exposed in the reopened service trench.
Photograph: Caroline Atkins

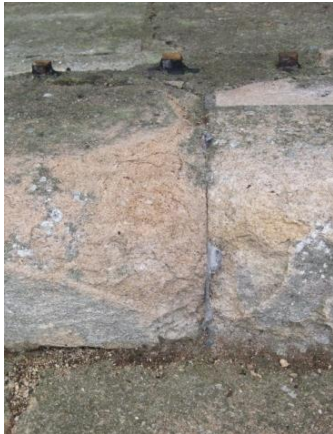
Plate 43
(Archive image PCGC 194)
North Portico, top step:
lead visible in the vertical
joint between the 2nd and
3rd stones from the N end.
Photograph: Caroline Atkins

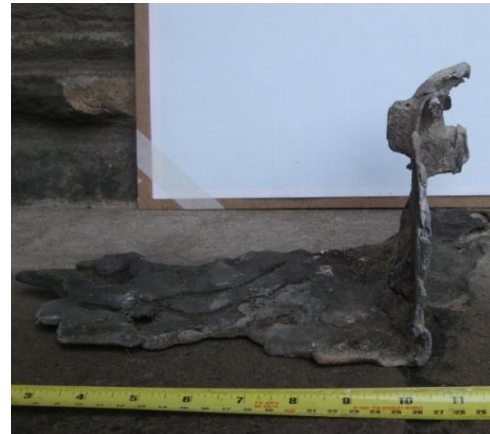
Plate 45
(Archive image PCGC 200)
North Portico, top step:
the lead cramp extracted.
Photograph: Caroline Atkins

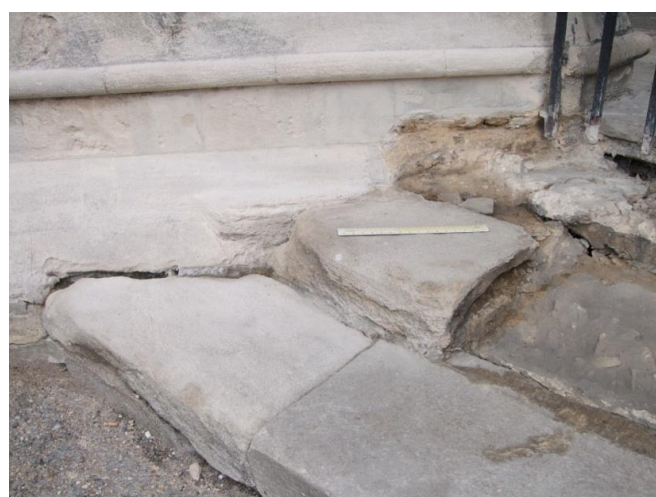
Several of the Clipsham stones at the north end of the steps (Plates 46 and 47) were not replaced in 2014 and therefore their relationship with the lower courses of the pier base remains as found. They pre-date the replacement plinth to the north-west tower.

Plate 47
(Archive image PCGC 235)
North Portico steps, north end:
with evidence for the original Clipsham step profiles.
Photograph: Caroline Atkins

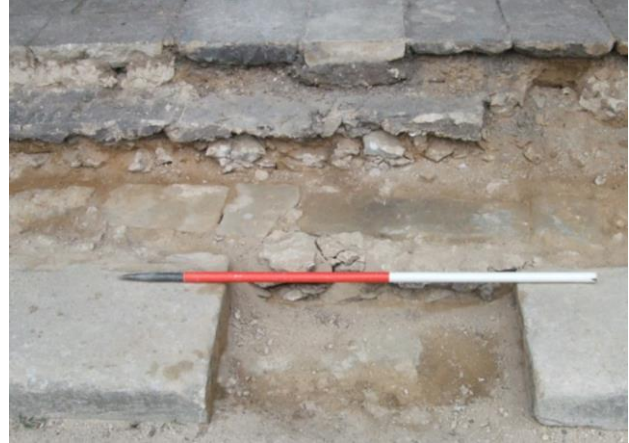
Lifting of the stones from the middle step exposed an alignment of small flat stones (Plates 48 and 49), which might be the capping on a duct or drain. The small flat stones did not need to be lifted, therefore the feature was not investigated, but it appears likely that it is a duct for cables serving new lights installed in the 1920s or 1930s and that the stones of the portico step were lifted and replaced for that purpose.

Plate 49
(Archive image PCGC 302)
North Portico steps, north of centre:
stone-capped duct beneath the middle step.
Photograph: Caroline Atkins

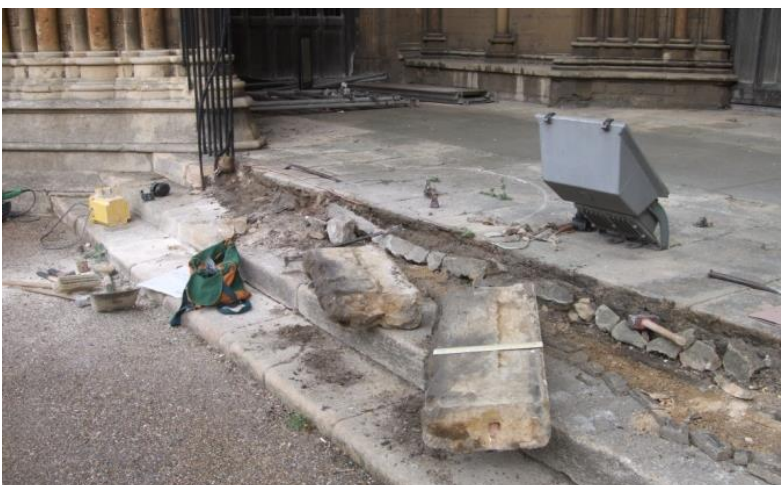
Plate 50
(Archive image PCGC 217) South Portico
Steps: reused memorial stones SR
002 and SR 001 as lifted from the
top step.

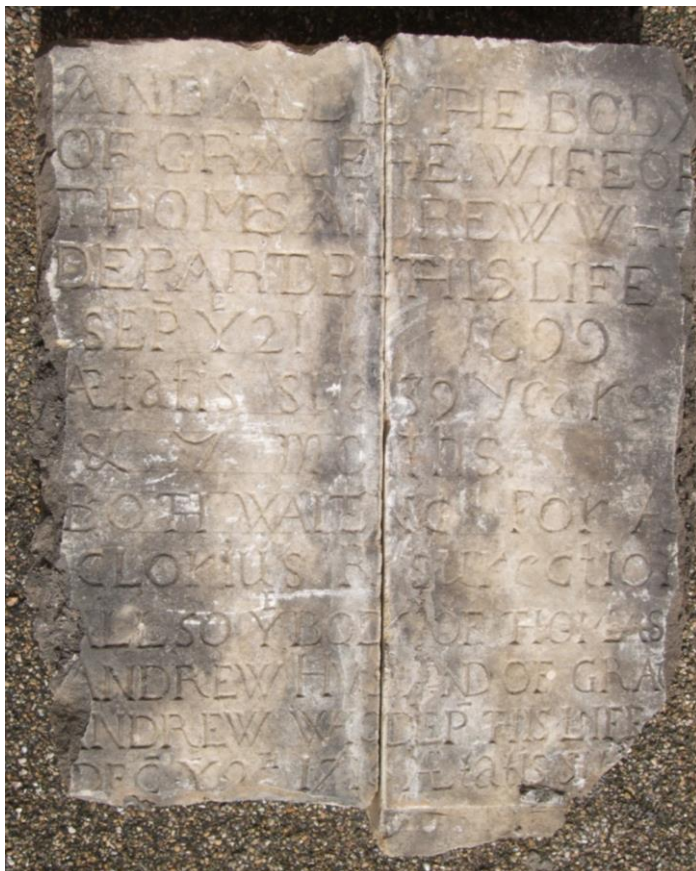
Plate 53
 (Archive image PCGC 228) South Portico steps:
 Stones SR 003 & SR 004 reunited to form what appears to be the lower half of a memorial stone dedicated to the ANDREW family.
 Photograph: Caroline Atkins

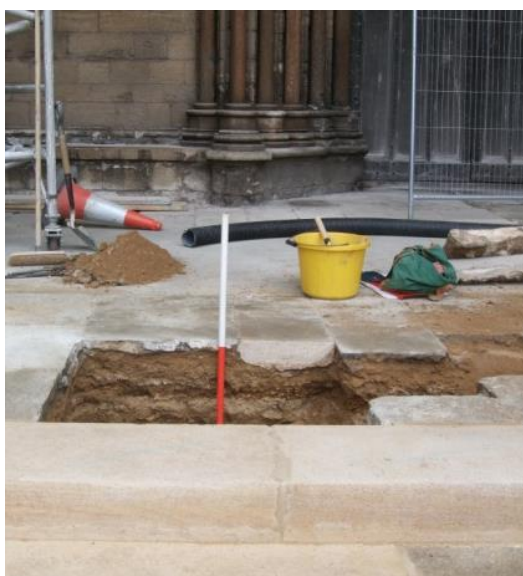
Plate 65
(PCGC 331)
North Portico floodlight trench.
Photograph: Caroline Atkins

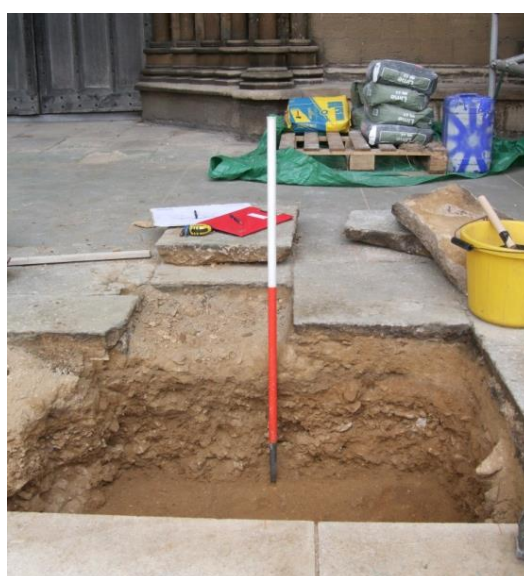
Plate 66
(PCGC 328)
South Portico floodlight trench.
Photograph: Caroline Atkins

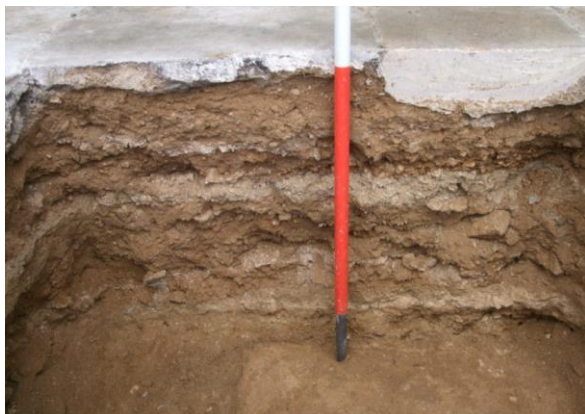
Plate 67
(PCGC 333)
North Portico floodlight trench, west-facing
section. Scale unit = 0. 5m
Photograph: Caroline Atkins

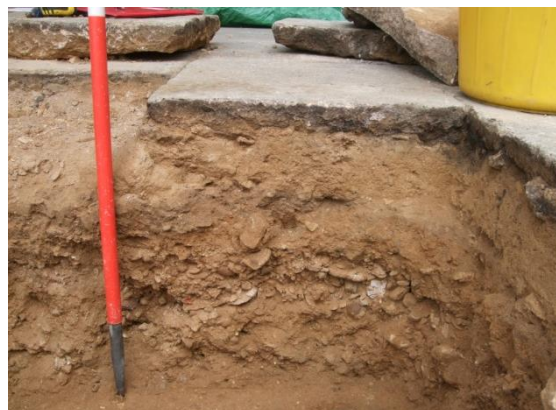
Plate 68
(PCGC 326)
South Portico floodlight trench, west-facing
section. Scale unit = 0. 5m
Photograph: Caroline Atkins

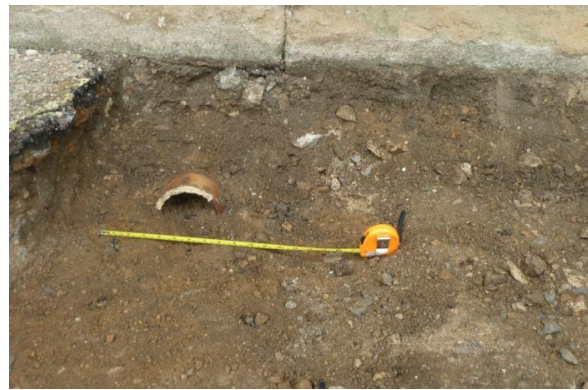
Plate 74

The presence of a 4-inch (102mm), salt-glazed, drain pipe projecting from beneath the lower step of the north portico (Plate 74) is of particular interest, given that a capped duct or drain was exposed beneath the middle step (Section 3.1.1, Plates 48 and 49) during stone replacement. Unfortunately, only part of the drain pipe was exposed and therefore its purpose remains unknown. It seems unlikely that even a prevailing south-westerly wind would cause water to pool on the portico steps, or that the drain carried water from the interior of the portico, but this must remain a possibility. Perhaps rather more likely is the possibility that the capped feature and the drain pipe served as a cable duct for a pre-floodlight scheme of portico lighting.
