WEST LOGGIA ROOF

Hardwick Hall, Derbyshire

Historic Building Record

July 2021

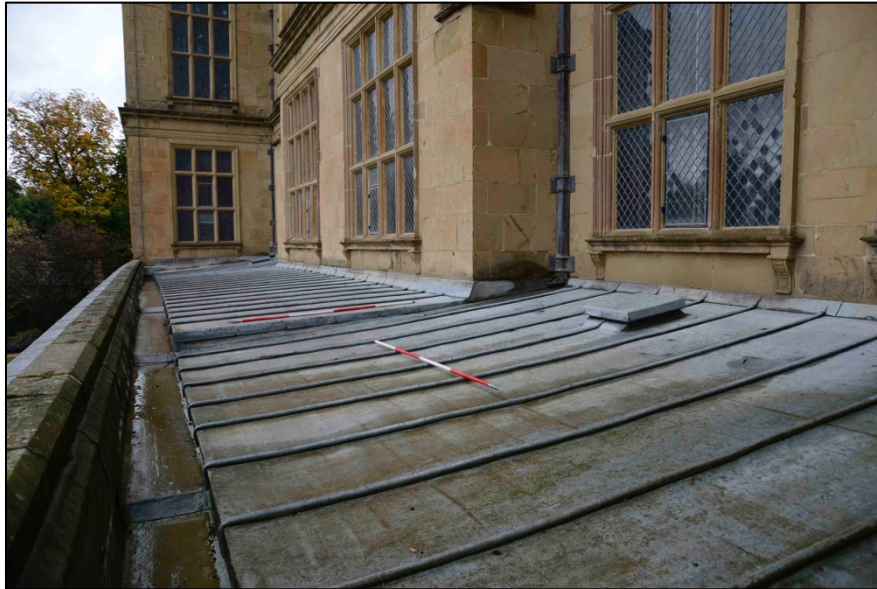
This phase comprised of a comprehensive programme of repairs across the whole roof. This entailed the partial replacement of historic timbers (mainly rafters) with softwood. Sections of the softwood boards were replaced along with all of the lead sheeting, the base of the downpipes, flashing and a new gutter along the eastern side of the roof (**Appendices 1.6-1.15**) were installed. The central section of the roof was re-modelled and raised with a shallow step (**Appendix 1.6**) and two access inspection hatches were created (**Appendix 1.11**).

Appendix I.6: View of roof prior to repairs in October 2020, looking north-east.

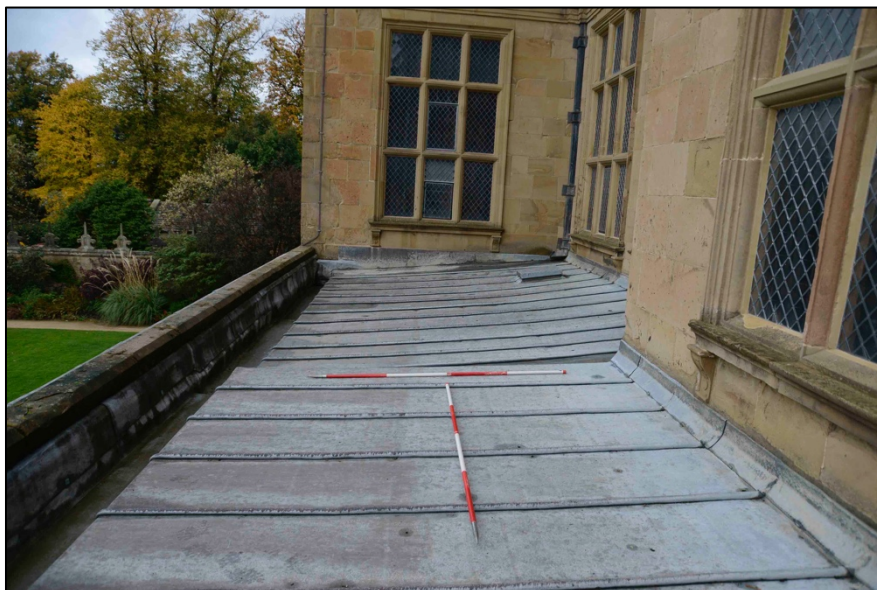
As part of the repairs undertaken in Phase 3 the central section of the roof (**Area B**) was raised by 20cm (**Appendices 1.6-1.8**). This involved the construction of a softwood super structure that sat above the existing rafters being nailed together with round wire headed nails.

Appendix I.7: View of roof prior to repairs in October 2020, looking north.

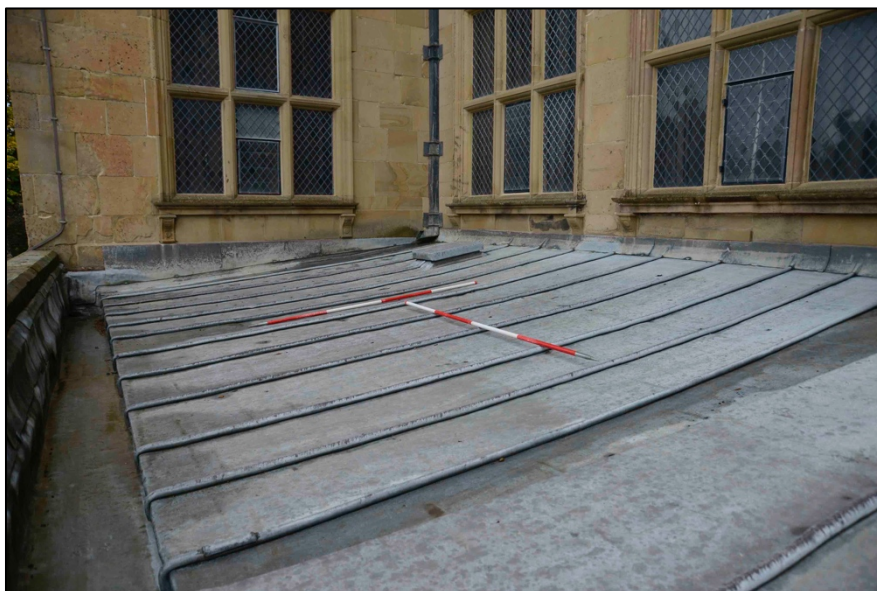
In the corners of each area of the roof, square sectioned lead gutters directed rainwater from the main roof of the house, down onto the roof of the West Loggia. The base of the downpipes are angled (**Appendices I.5, I.8, I.9**) and appear to have been remodelled in Phase 3.

Appendix I.8: View of roof prior to repairs in October 2020, looking north-east.

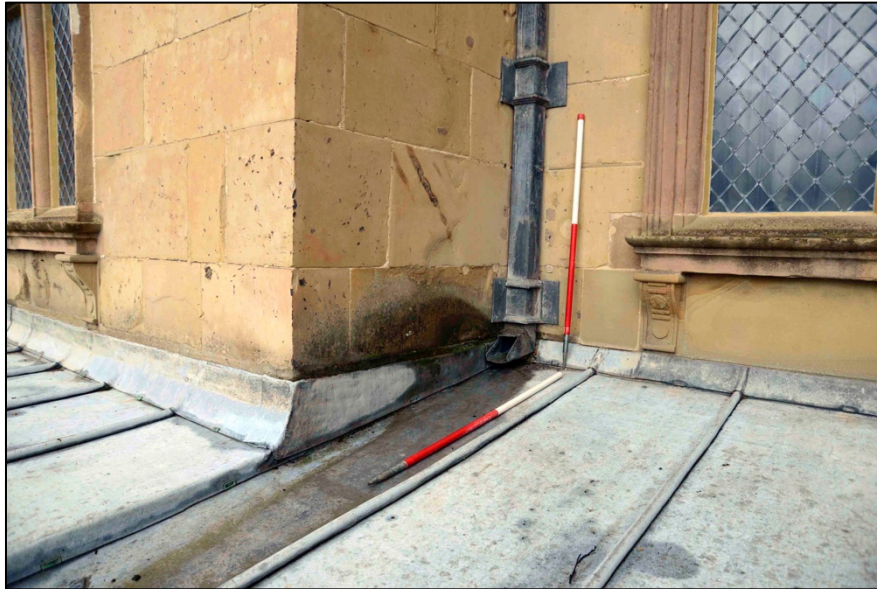
Appendix I.9: Detail of gutter outflow and flashing prior to repairs in October 2020, looking north-east.

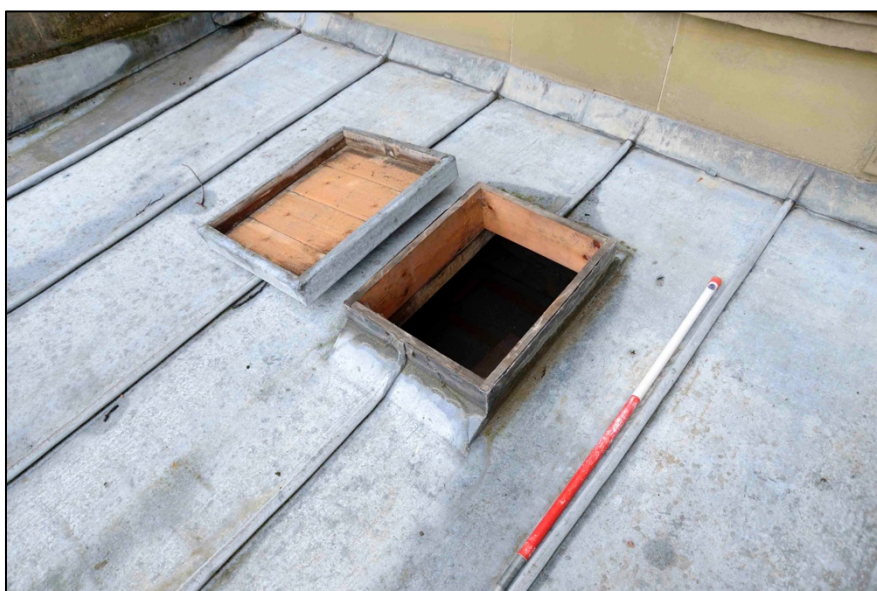
Appendix I.11: Detail of secondary roof hatch in **Area A**.

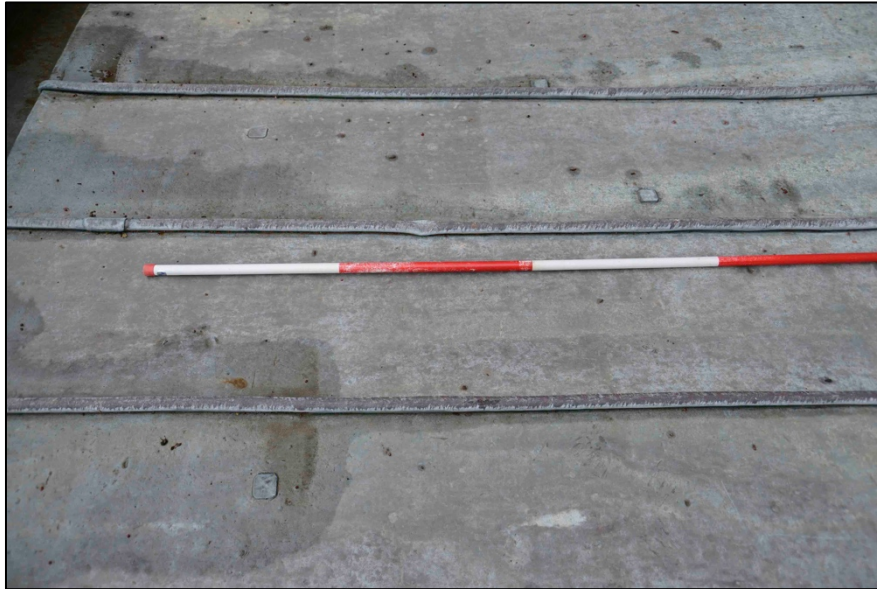
Appendix I.12: Detail of lead and patch repairs in central part of roof (**Area B**).

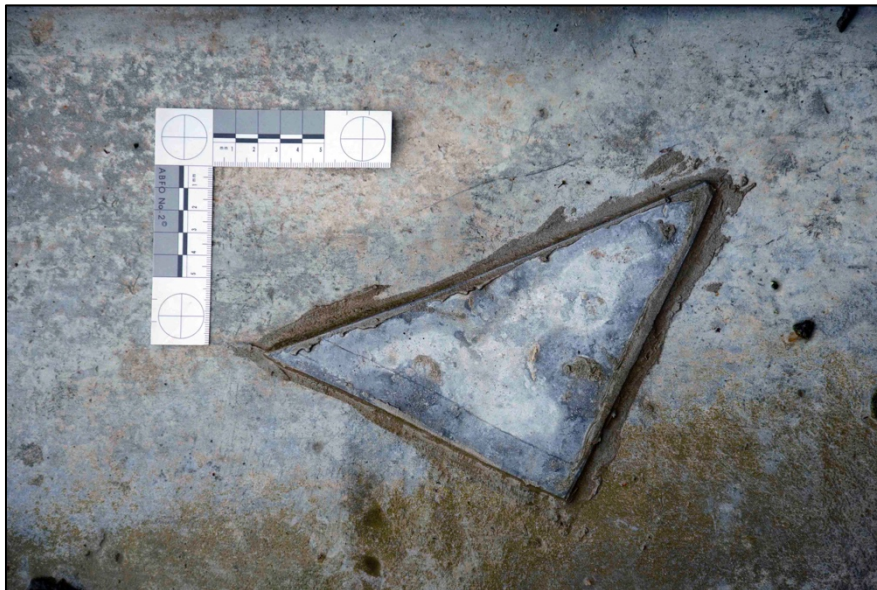
Minor patch repairs were undertaken to the lead sheet (**Appendices 1.13-1.14**).

A number of lead repairs in the form of irregular shaped patches (**Appendices I.13-1.14**) had been soldered onto the upper face of the lead, mainly within the central part of **Area C** and which are ascribed to Phase 4.

Appendix I.13: Detail of patch repair in lead.

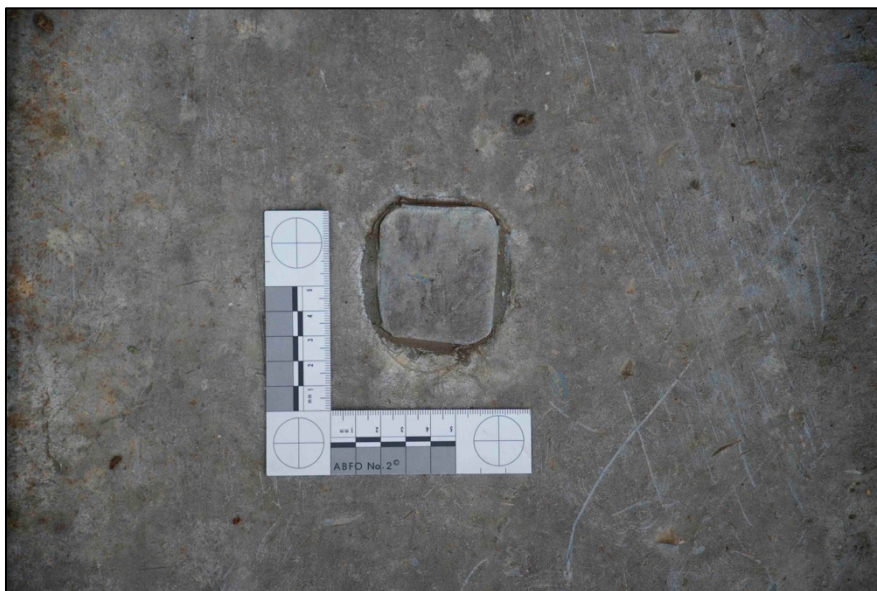
Appendix I.14: Detail of patch repair in lead.

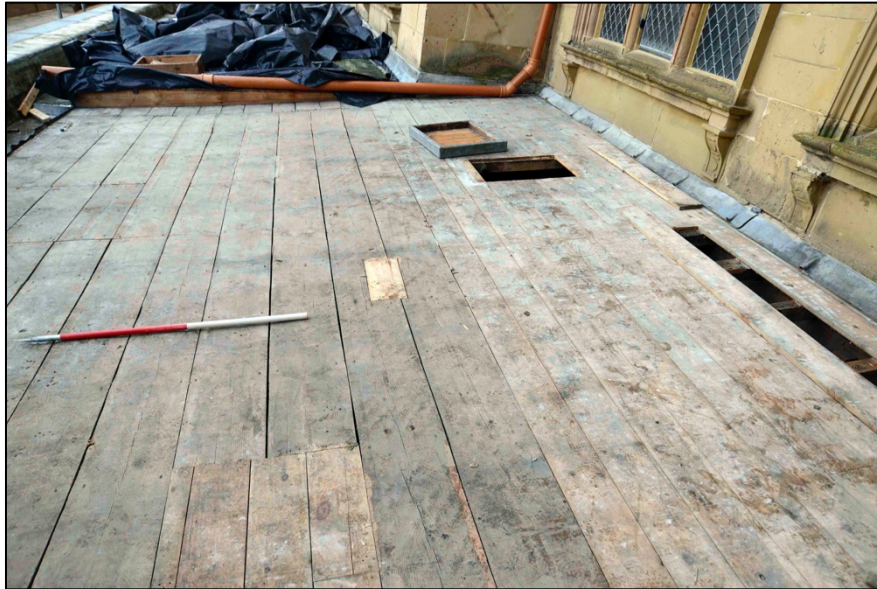
Appendix I.15: Detail of exposed boards in **Area A**; note narrow replacements, looking north.

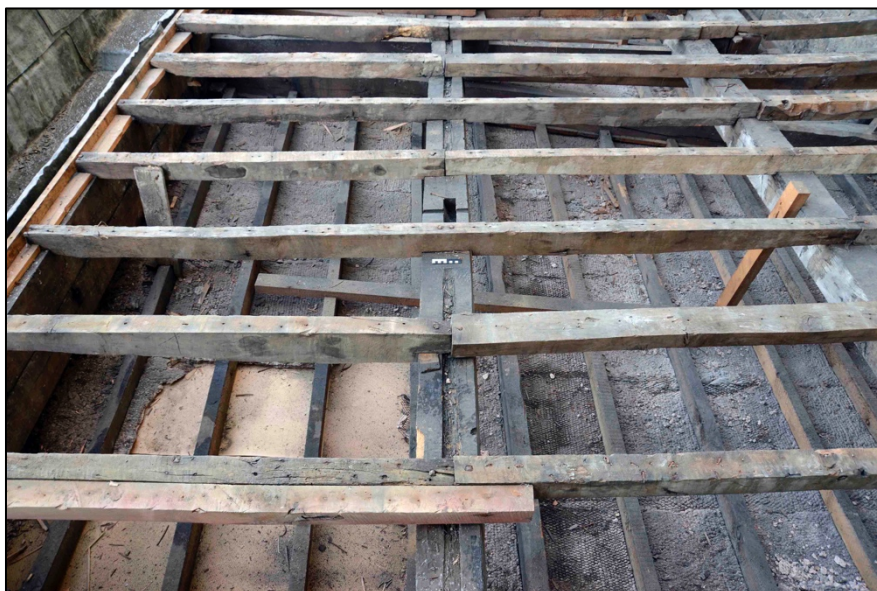
Within the roof occasional timbers contain features such as redundant mortices (**Appendices I.24, I.29**), rows of nails, or pegs (**Appendix I.27**) which suggest that when the roof was built the carpenters were recycling structural timbers from elsewhere.

Appendix I.24: Detail of **Area B** following removal of boards, looking north; note reused prulin and patched hole in plaster ceiling below.

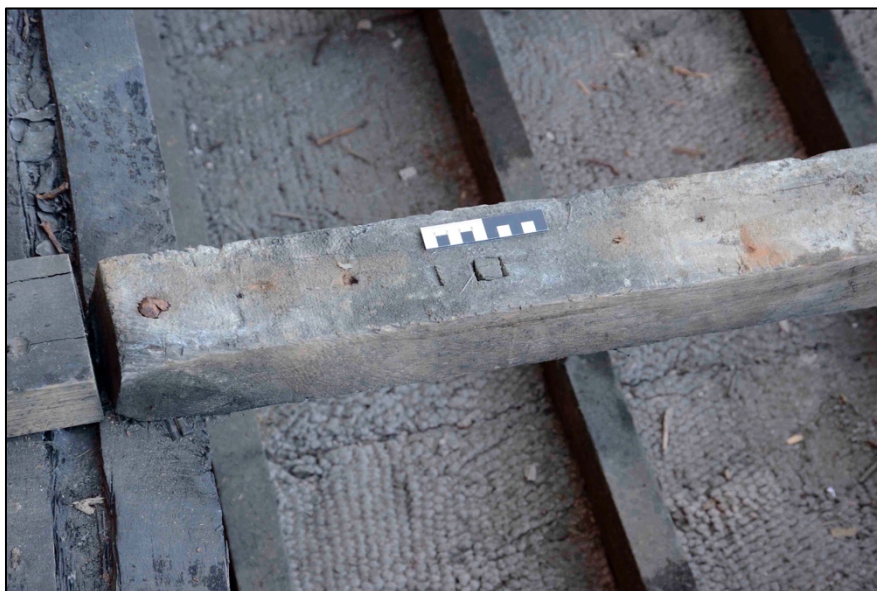
Appendix I.27: Detail of reused rafter with redundant square peg and chisel cut assembly mark.

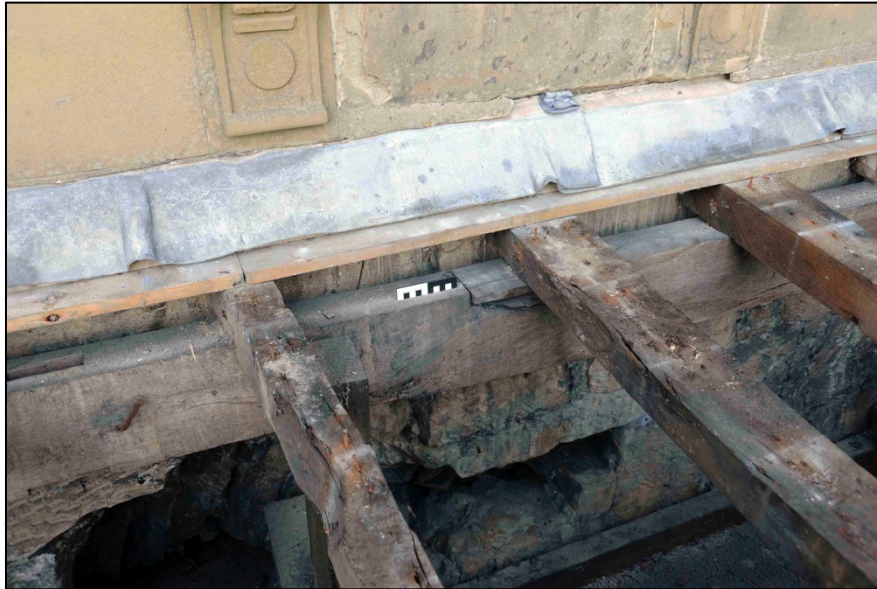
At the east end of the **T9** is a curious feature in the form of a large hole within the wall fabric in the south part of the roof (**Appendices 1.28, 1.38**). This hole is crudely cut and appears to be a secondary insertion, resulting in the re-orientation of the truss at an angle. The reason for this hole is unclear, but it did contain a cut off lead pipe and may represent the installation of a water supply to this part of the hall, either for a sink or water closet.

Further localised alterations were noted in the form of a large hole at the east end of **T9** within the wall fabric of the west elevation of the Hall (**Appendices I.28, I.38**). This hole is crudely cut and appears to be a secondary insertion, resulting in the re-setting of the truss. The reason for this hole is unclear, but it did contain a cut off lead pipe and may represent the installation of a water supply to this part of the hall, either for a sink or water closet.

Appendix I.28: Detail of timber construction along the west wall of the Hall in **Area A**; note inset hole in masonry within roof void.

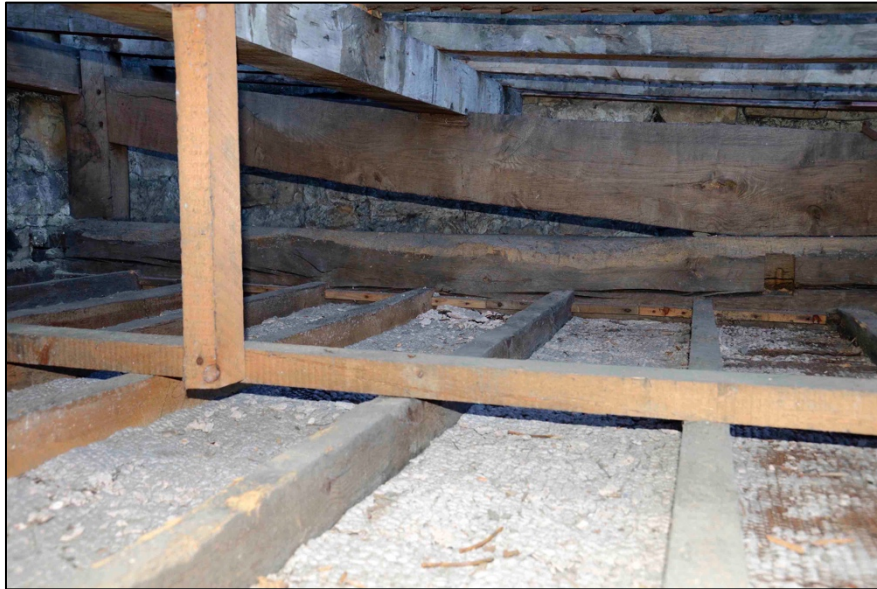
Area A were introduced to strengthen a number of the trusses (**Appendices 1.39, 1.40, 1.48**). It is suggested that following these repairs expanded mesh was applied to the whole of the underside of the ceiling before replastering (**Appendices 1.32, 1.33**).

Appendix I.32: Detail of roof void in **Area A**, looking south.

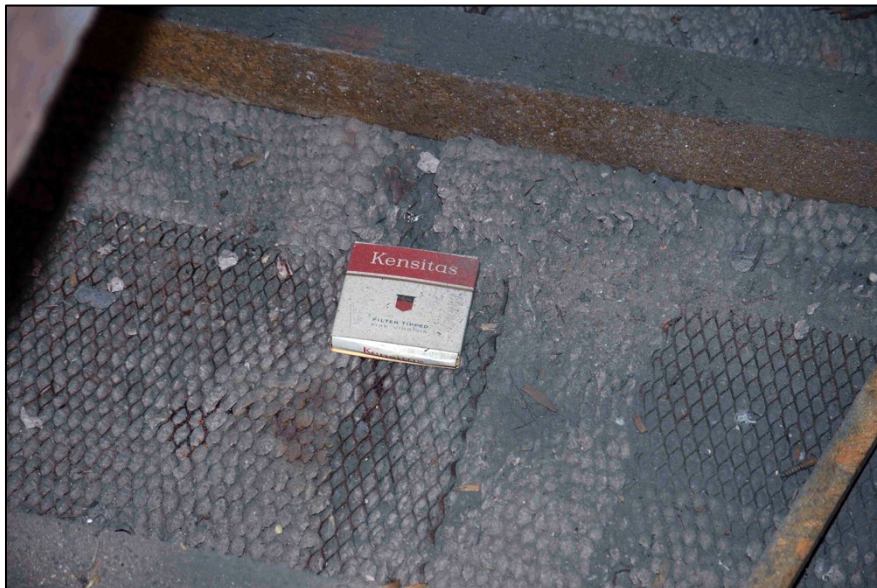
Appendix I.33: Detail of cigarette packet left within the roof void of **Area A**; note expanded mesh for plasterwork below.

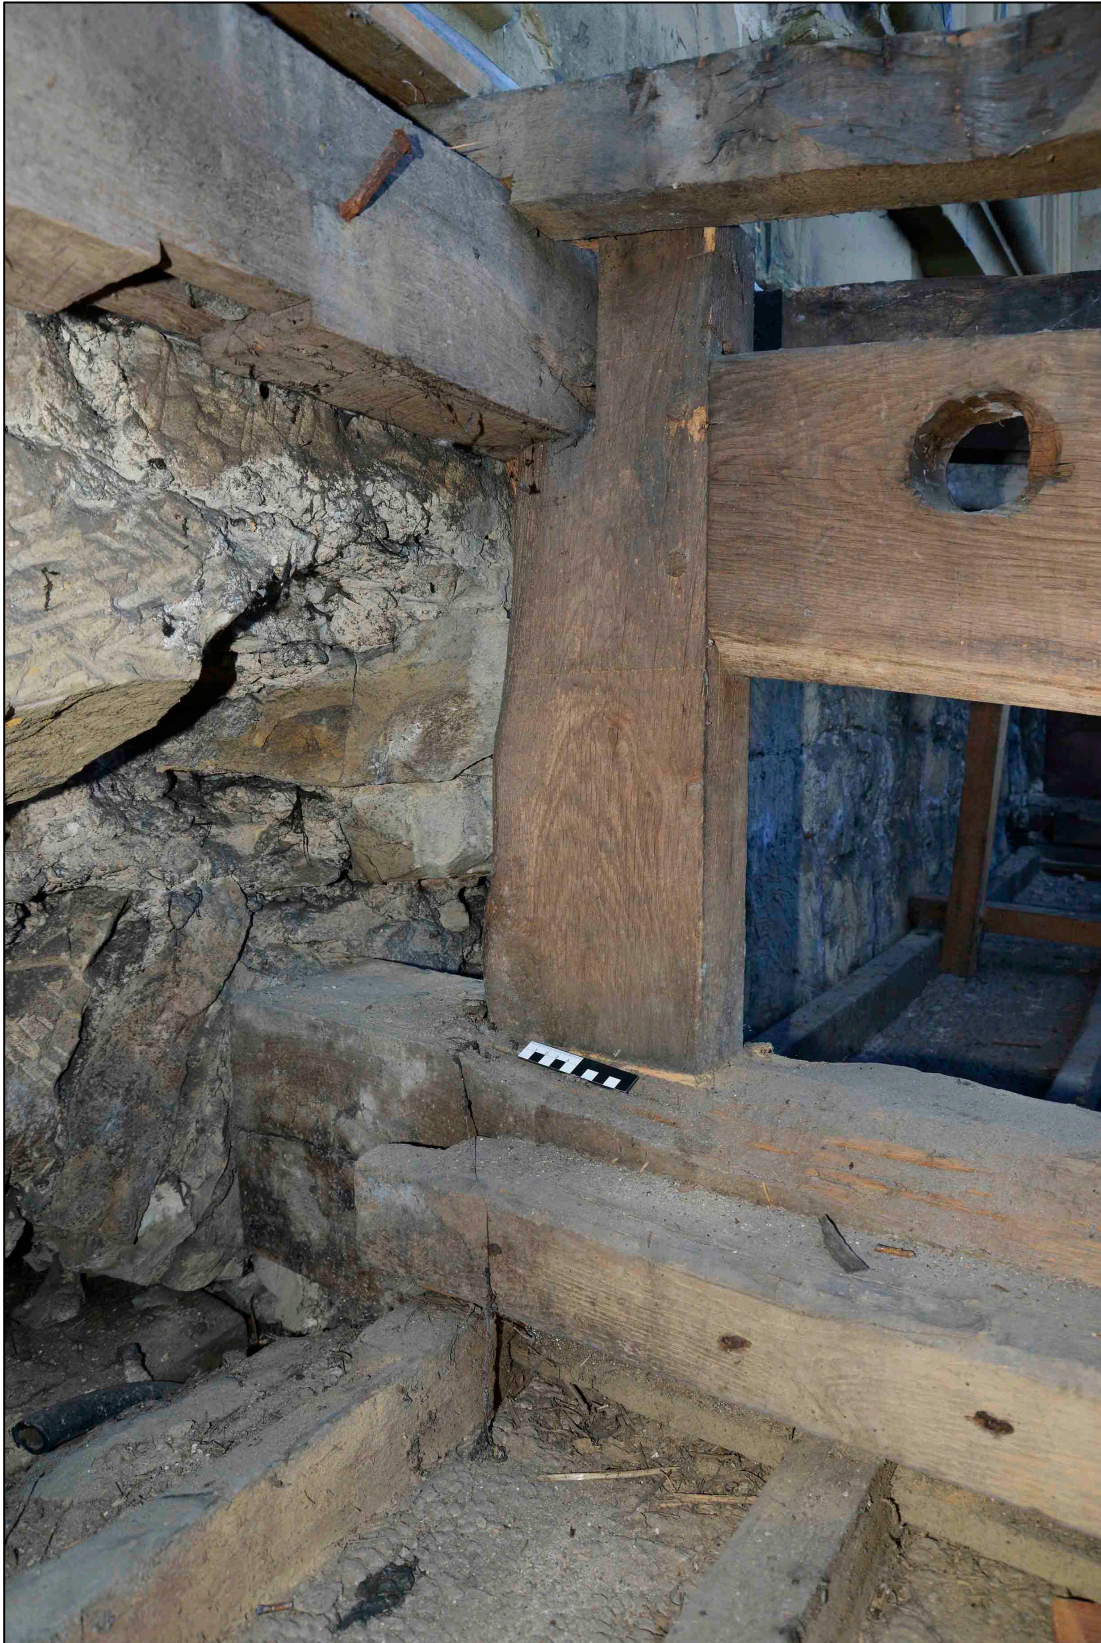
Appendix I.38: Detail of post at east end of T9; note inserted hole in walling.

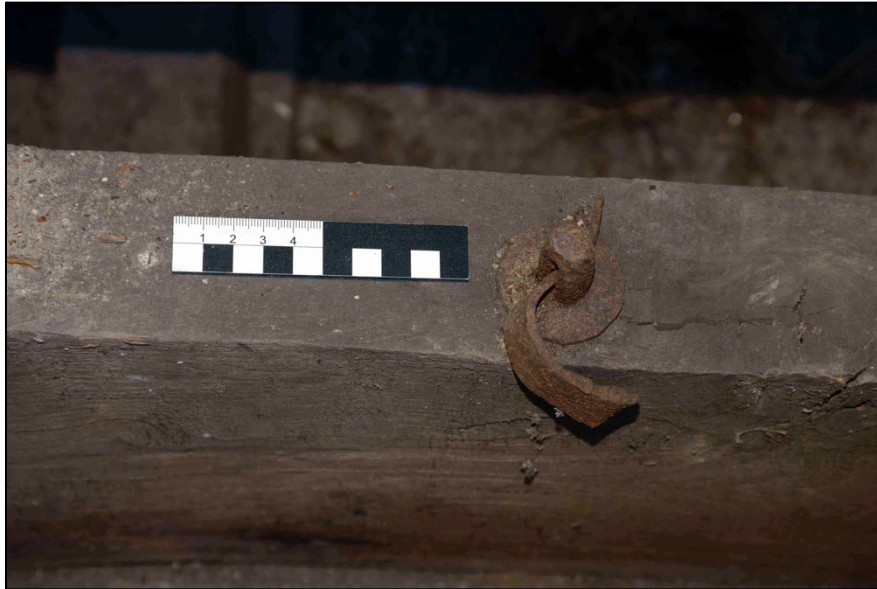
Alterations during this phase appear to have concentrated upon the ceiling of the colonnade. A group of ceiling joists within Area A have been replaced in softwood and set on a new north-south alignment. A small group of lower ceiling joists having the date 1950 written on them in pencil (**Appendices I.35, I.36**). It is also probable that more substantial structural repairs were undertaken during this period in **Area C**, where iron straps and vertical tie rods and threaded bolts or pins in

Appendix I.39: Detail of iron peg with cotter pin on T9.

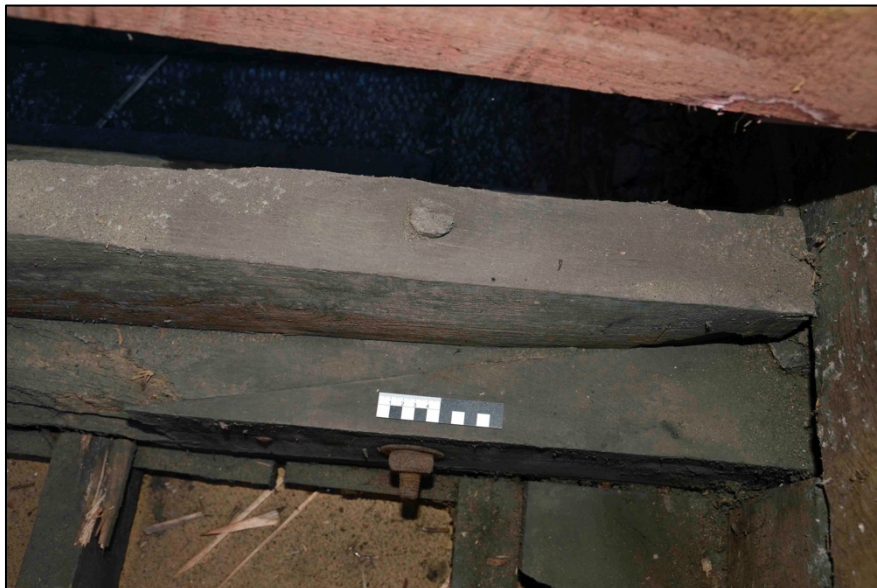
The south-east corner of the roof has evidence for repair due to water ingress, with timbers being replaced in softwood (**Appendix 1.42**). There are large bolts with threaded square heads (**Appendices 1.40, 1.46**), along with an iron peg with a cotter pin (**Appendix 1.39**). Further repairs using iron rods and straps were noted in the north-east section of **Area C**.

Appendix I.40: Detail of bolted repair on T10.

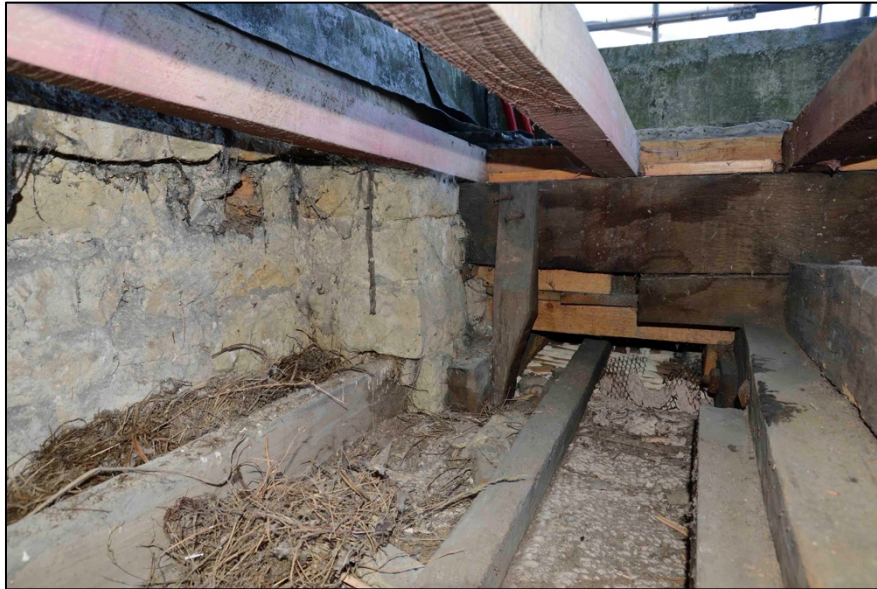
Appendix I.42: Detail of south-west corner of **Area A**; note stone pier and replaced rafters.

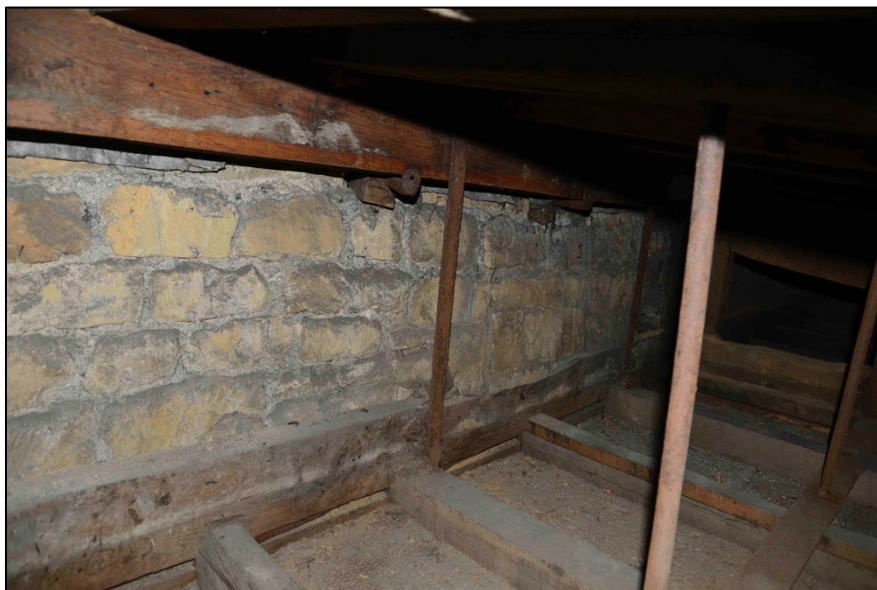
Appendix I.43: Detail of rough coursed walling (not ashlar) within ceiling void of **Area C**; note inserted iron rods.

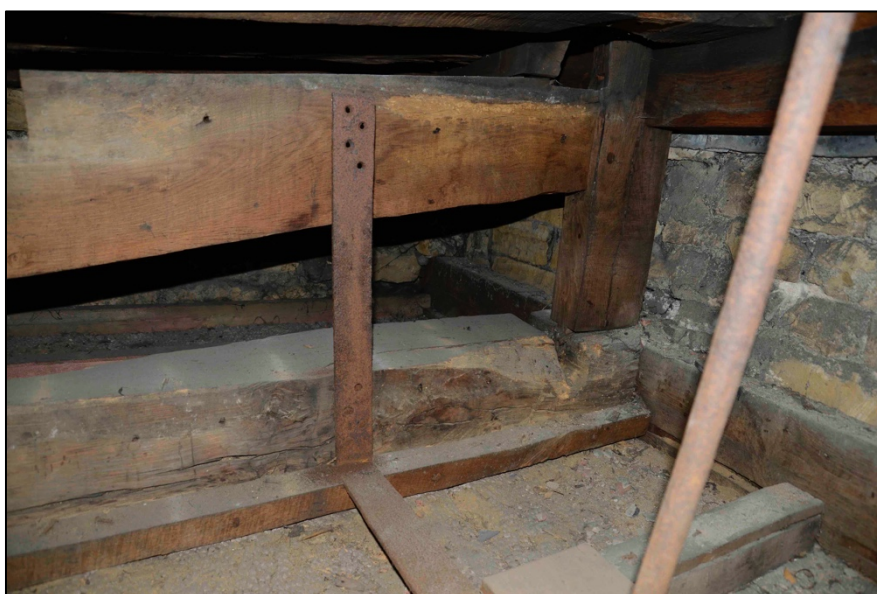
Appendix I.44: Detail of iron strap against T1 in **Area C**.

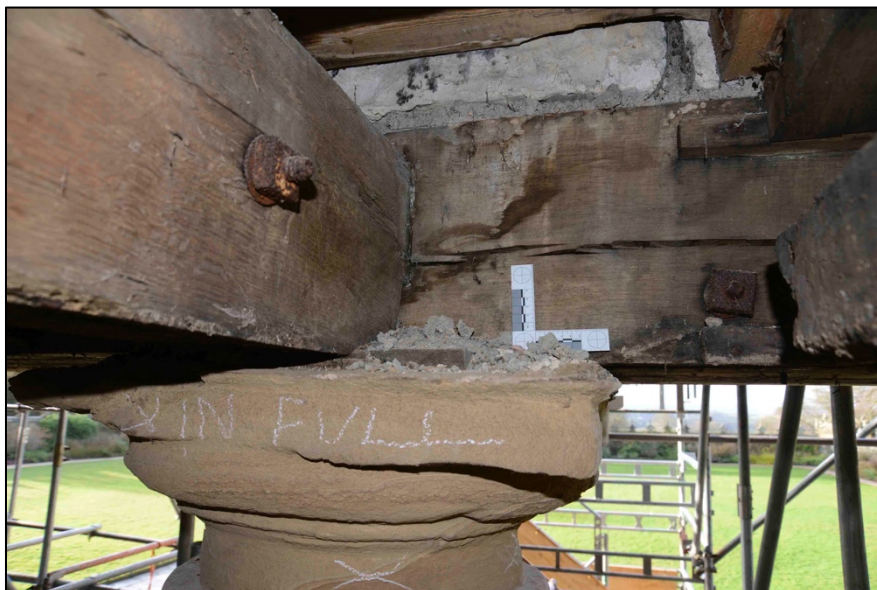
Appendix I.46: Detail of tie beam tenoned into entablature beam above column; note bolted fixings.

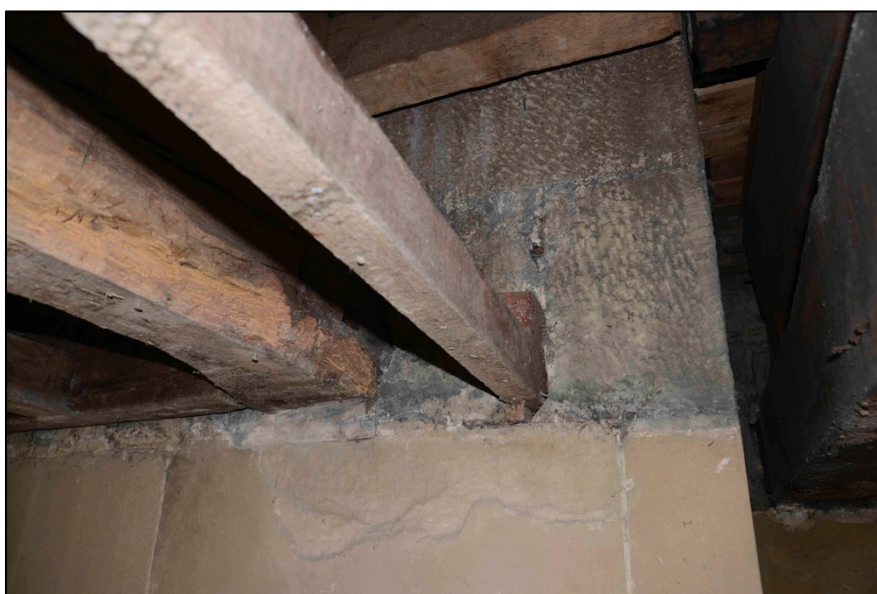
Both the rafters and ceiling joists are orientated west-east (**Appendix I.31**), although southern end of the ceiling joists has been replaced in 1950 with softwood timbers measuring 6cm x 8cm on a north-south alignment (**Appendix I.47**). The earlier ceiling joists measure 5.5cm x 7cm.

Appendix I.47: Detail of secondary ceiling beam inserted into masonry of Hall at south end of **Area B**; note rough tooling above and ashlar below.

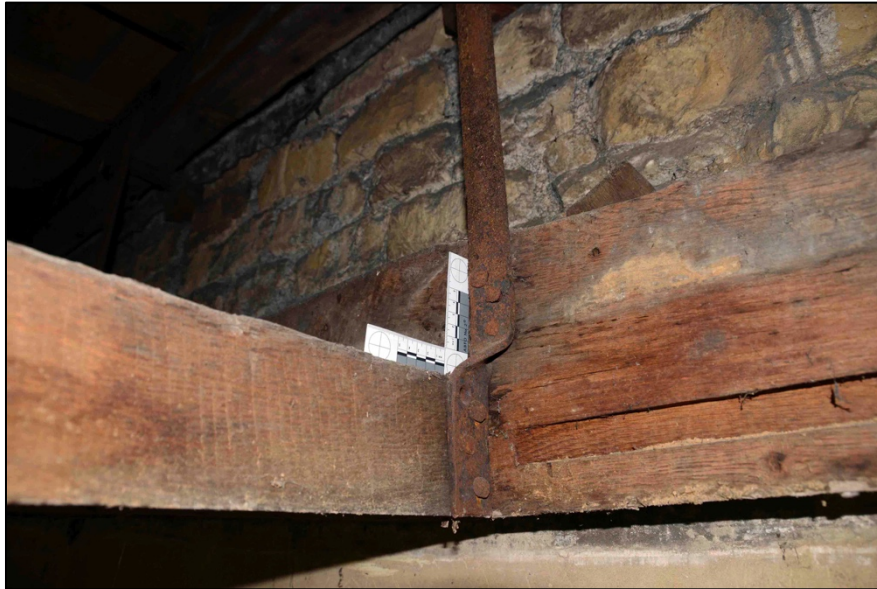
Appendix I.48: Detail of wrought iron strap within **Area C**; note horizontal slot for tenon of lower ceiling joist.

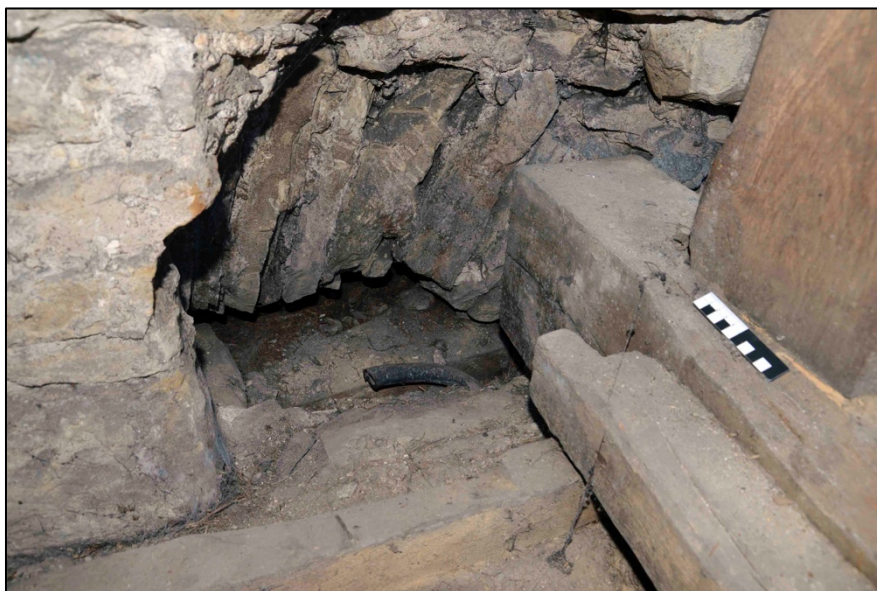
Appendix I.56: Detail of inserted hole within west wall of **Area A**; note internal relieving arch of window below and cut back lead pipe.
