EAST CORRIDOR, STOWE HOUSE

Buckinghamshire

Historic Building Survey
December 2013

Document No: TJC2013.32

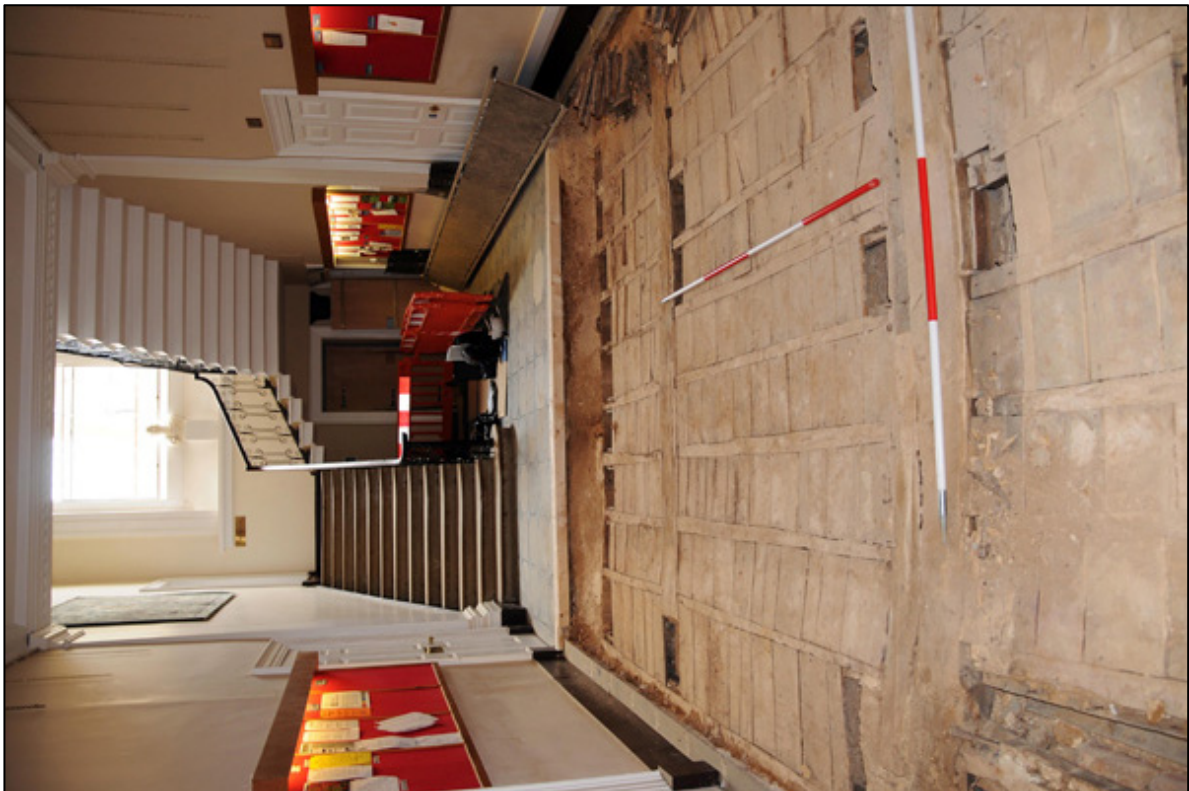
Appendix 1.2: Exposed timber floor structure, looking east; note deflection in beams (scale 2m).

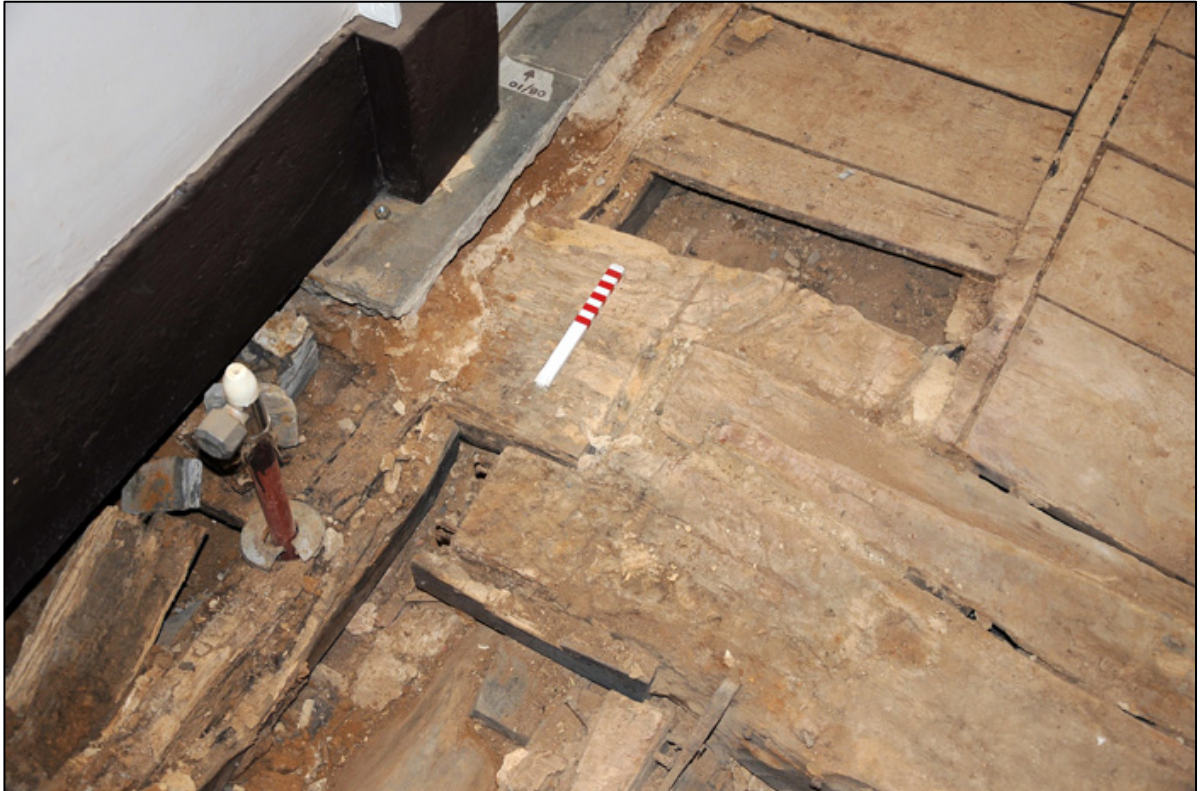
Appendix 1.4: Detail of cut back beam **P2**, and subsequent addition of timbers **P3** and **P4** (scale 20cm).

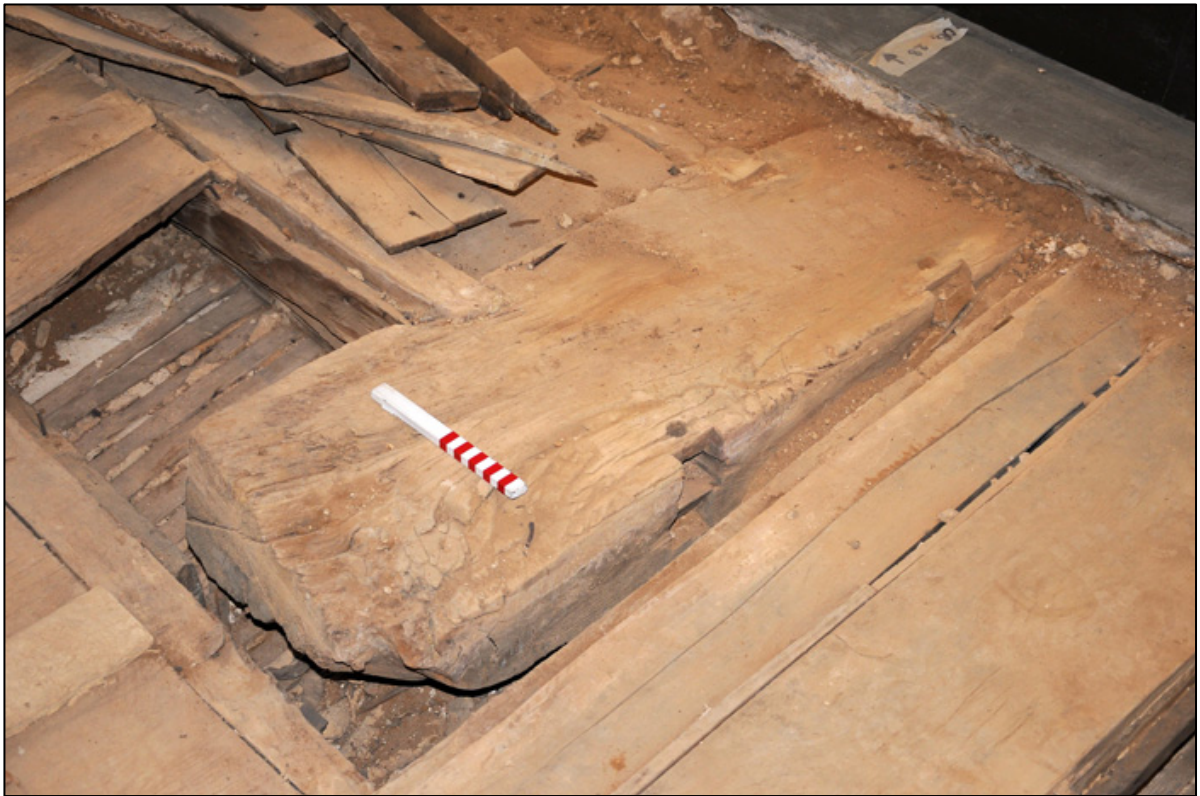
Appendix 1.5: Detail of **P1**, with damaged end resulting from the cutting back of main part of beam (scale 20cm).

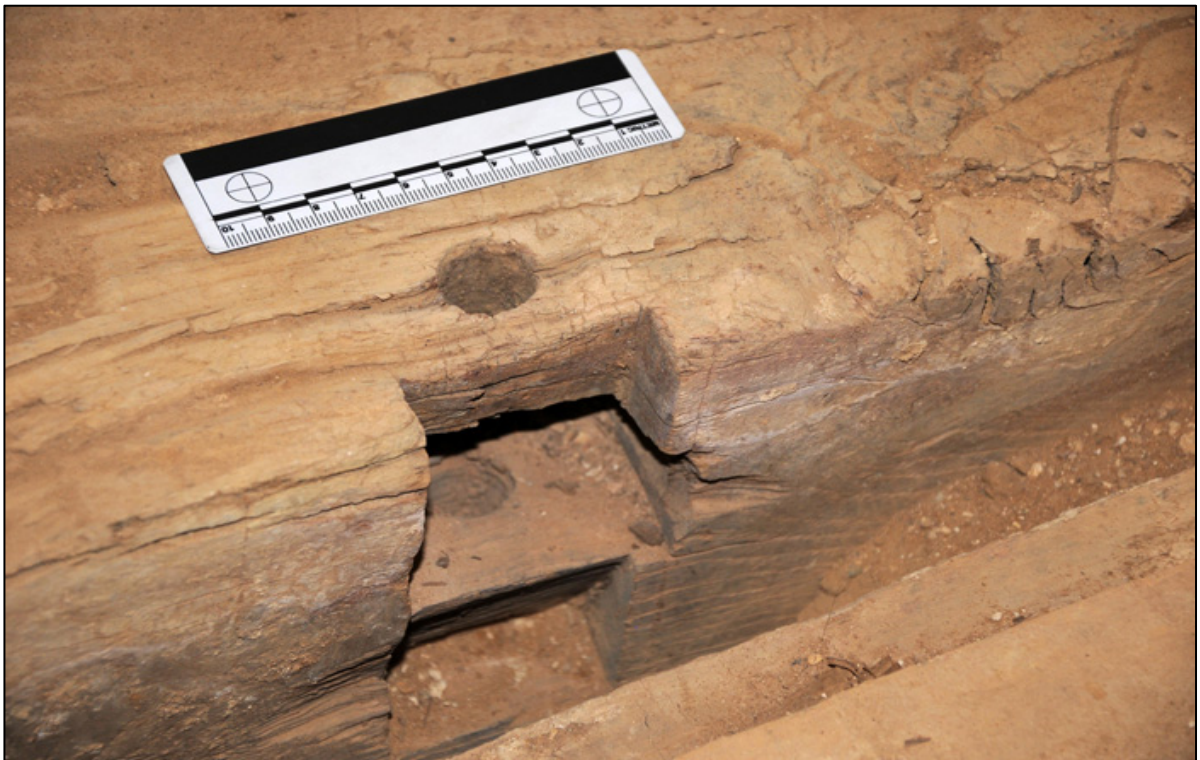
Additional evidence that **P1** and **P2** were separate timbers with differing functions within the floor structure is that unlike **P2**, **P1** has redundant mortices (**Appendix 1.5**); two on either side. The mortices would have been intended to securely locate floor joists and comprised of a recess for a central shouldered tenon, with an angled stub tenon below and a vertical peg above (**Appendix 1.6**). This form of joint is typical for floors dating to the late 17th century and indicates that the south-west part of the East Corridor was originally floored. This detail is significant in that it correlates with the plan from the Huntington Library (**Figure 4**), which depicts that the staircase to the upper floor started with a straight flight along the south wall, rising up from the south-west corner. Although not illustrated on the plan there may have been

Appendix 1.6: Detail of surviving mortice and peg-hole in west side of beam **P1** (Scale 10cm).

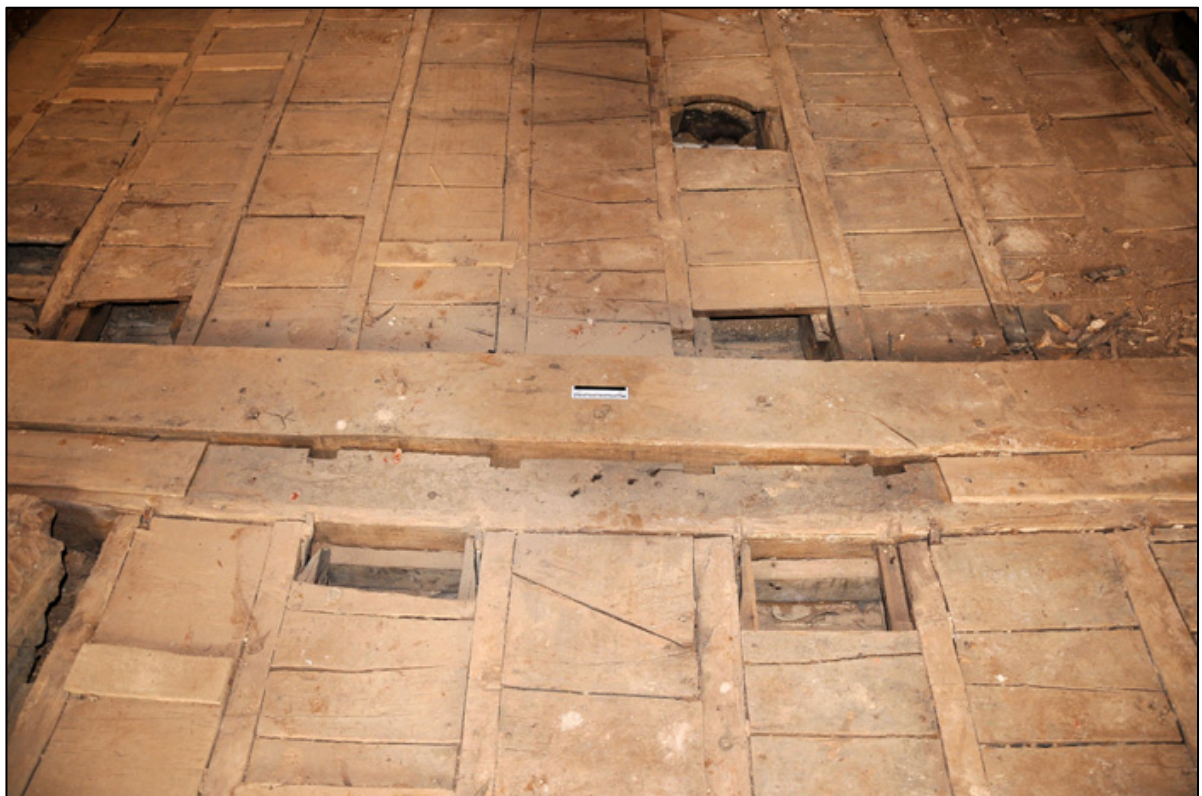
There is additional circumstantial evidence for a staircase within this part of the house, in that many of the thin wooden boards that cover the phase 2 floor have angled edges (**Appendices 1.7, 1.8**). These are interpreted as the reused and cut down treads from a timber staircase. One of these angled boards still retained a rounded edge that would have formed the upper front edge, or nose, of such a tread. The majority of the boards were formed from planks with parallel edges, with widths of 11.5cm (4½"), 19cm (7½") and 23cm (9") being the standard sizes. Whilst there could be numerous explanations for the appearance of these boards, those that were angled may have originated as winders from a former staircase.

Appendix 1.8: Detail of **P3** and **P4**, looking west; note reused stair treads with angled edges (scale 10cm).

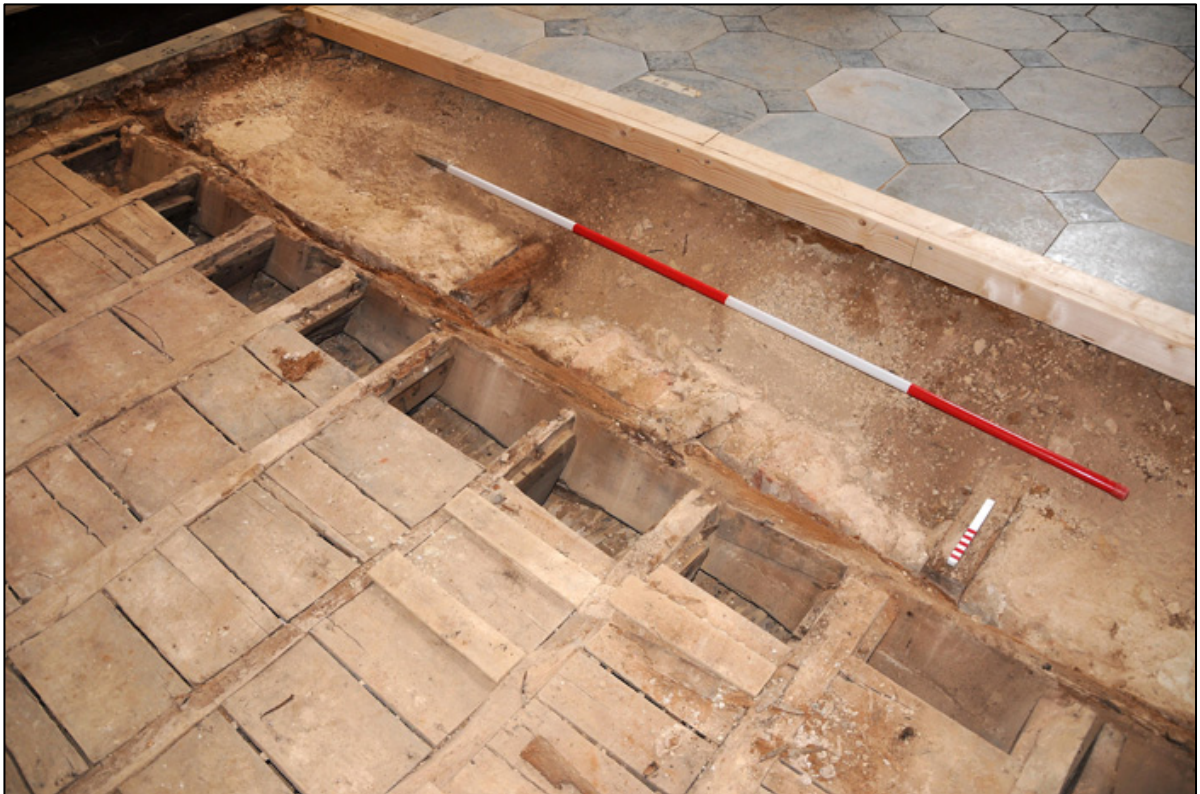
(**Appendix 1.16**) presumably this junction of different materials was considered as a point of weakness.

Appendix 1.16: East end of timber flooring at junction with vaulted ceiling of Plug Street below (scale 20cm; 2m).

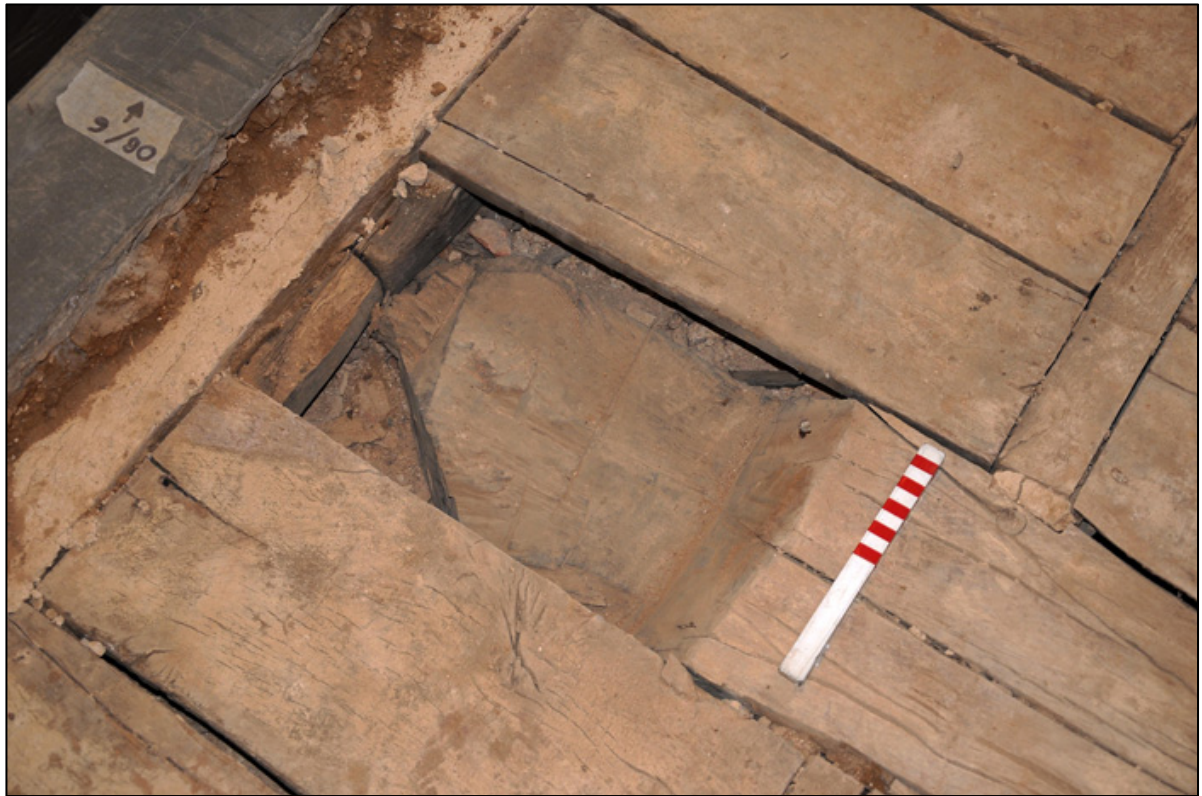
Appendix 1.17: Detail of shaped north end to **P5**, indicating its re-use (scale 20cm).

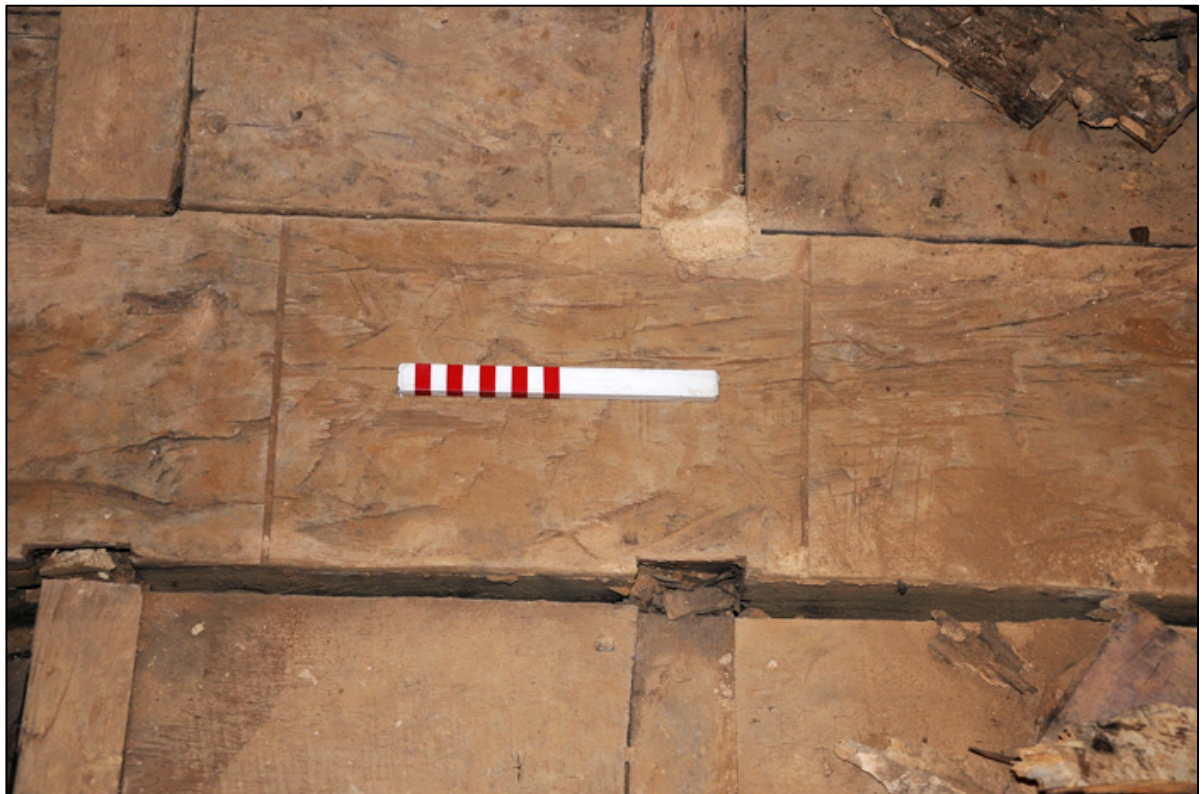
Appendix 1.18: Detail of saw cuts on upper face of **P5** indicating re-use (scale 20cm).

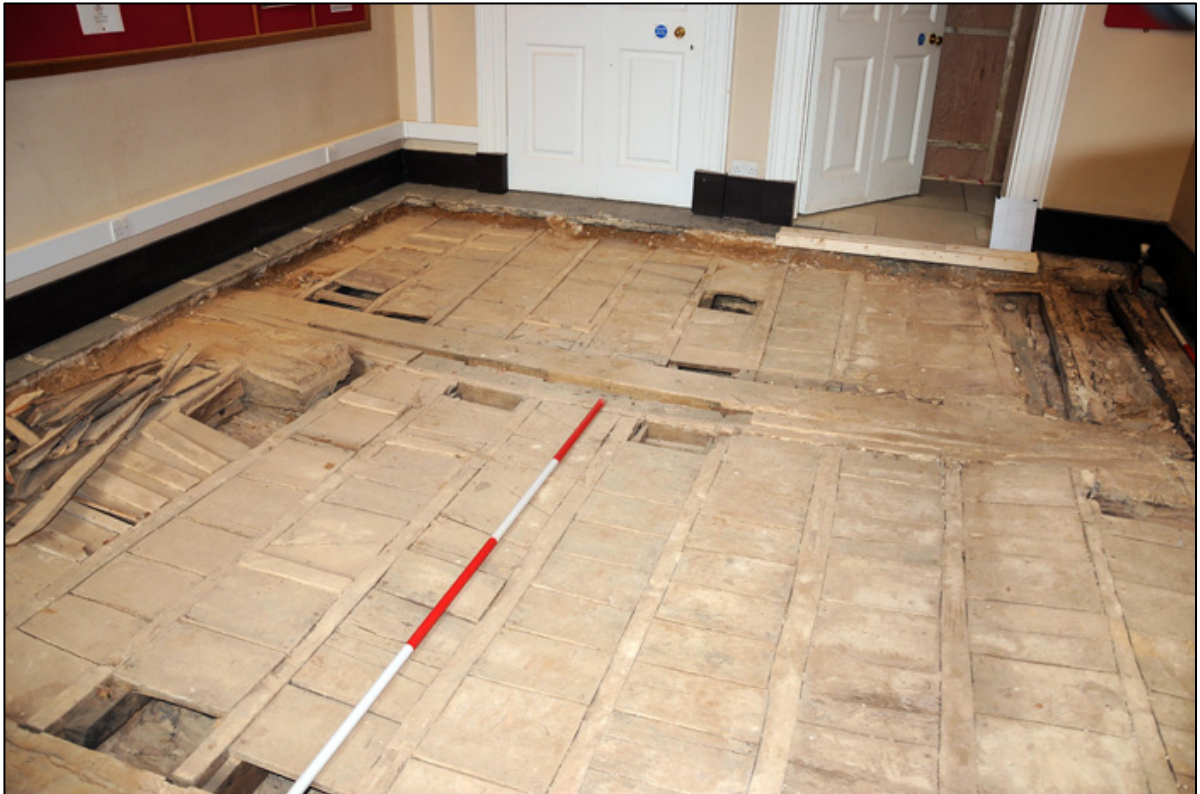
The archaeological recording of the floor has confirmed that it has historically suffered from a former episode of deflection and repair. This can be demonstrated by an examination of the timbers **P3** and **P4** (**Appendix 1.23**). The phase 2 beam **P4** has deflected by 3-4cm when compared to **P3**, which is a secondary insertion. To introduce this beam and support the floor, the east ends of the joists in **Bay 1** were cut back, and removed from their mortices which are still visible in the west side of **P4** (**Appendix 1.7**). The two beams were then secured together, by driving large iron nails, or pegs between them (**Appendix 1.24**). The cut back joists in **Bay 1** were then re-attached to the new timber **P3** with flat hooked bars secured into the sides of the joists and face of **P3** (**Appendices 1.25, 1.26**).

Appendix 1.23: General view of west section of timber flooring, looking west; note tight fitting boards (scale 2m).

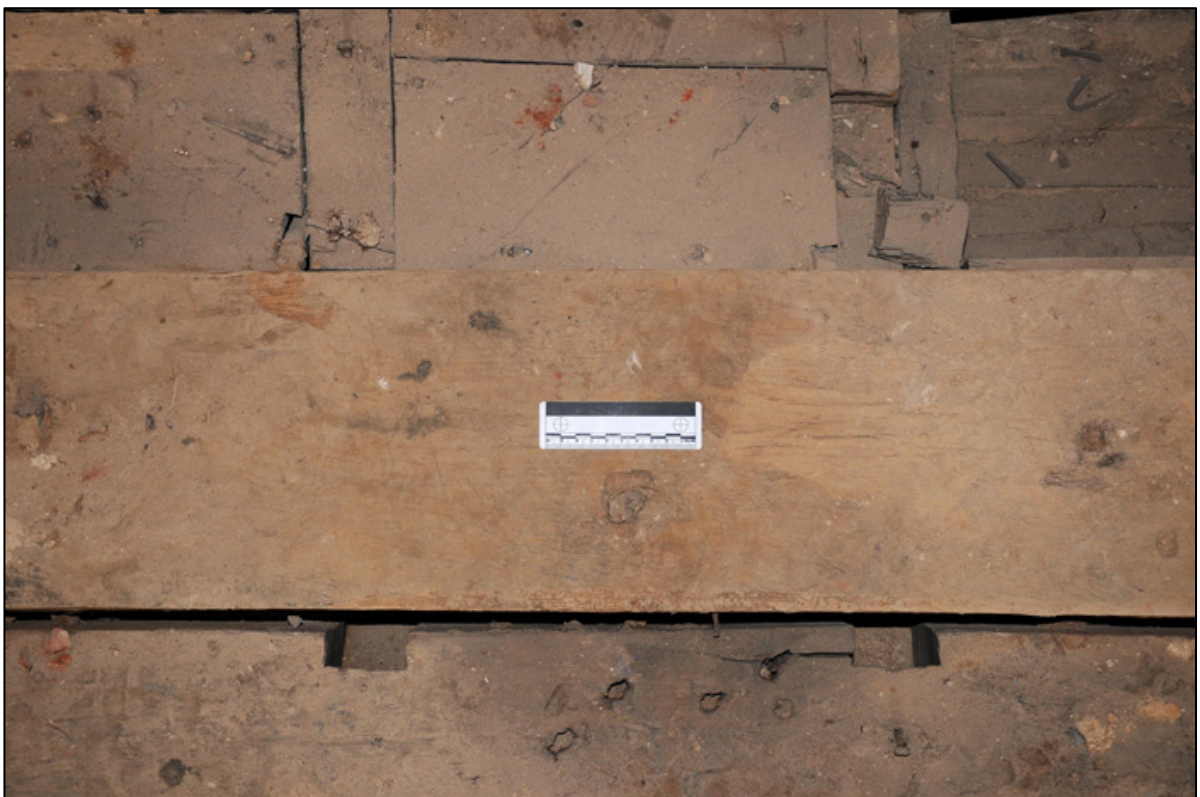
Appendix 1.24: Detail of large metal nails hammered through **P4**, to connect with **P3** (scale 10cm).

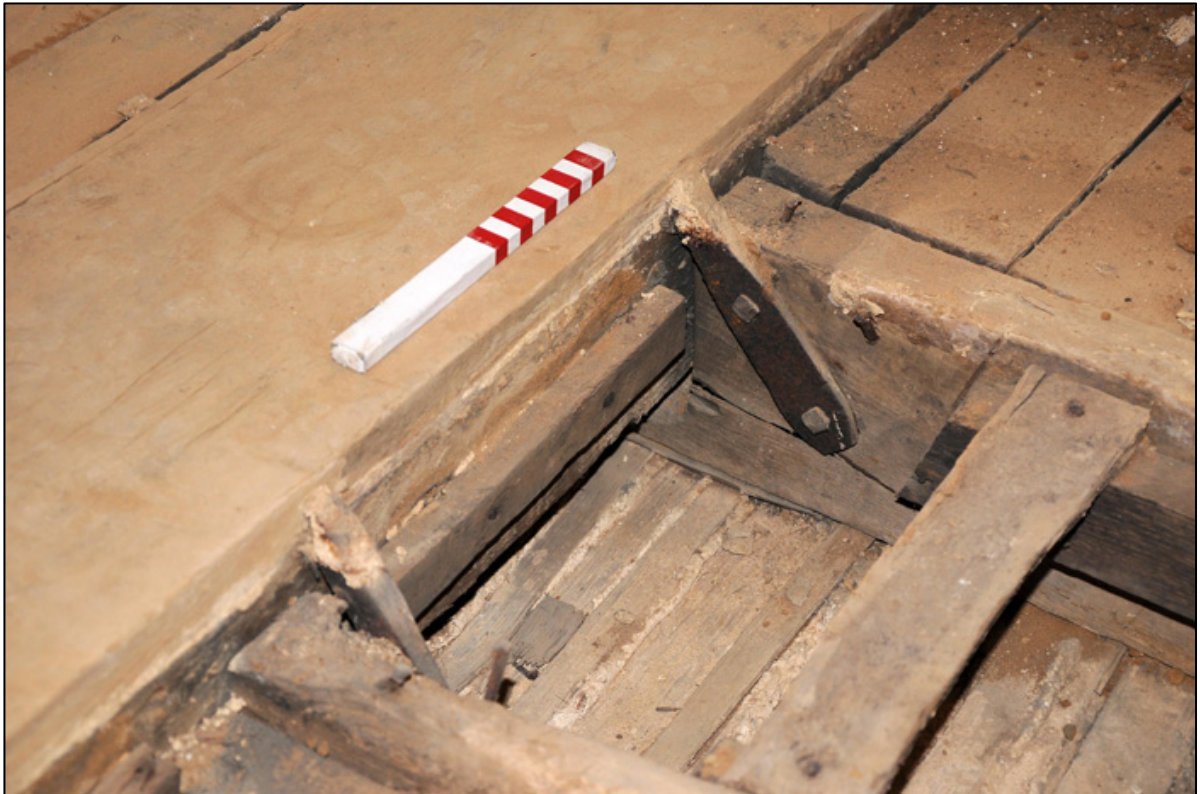
Appendix 1.25: Detail of metal side hooks securing cut back joists on to **P3** (scale 20cm).

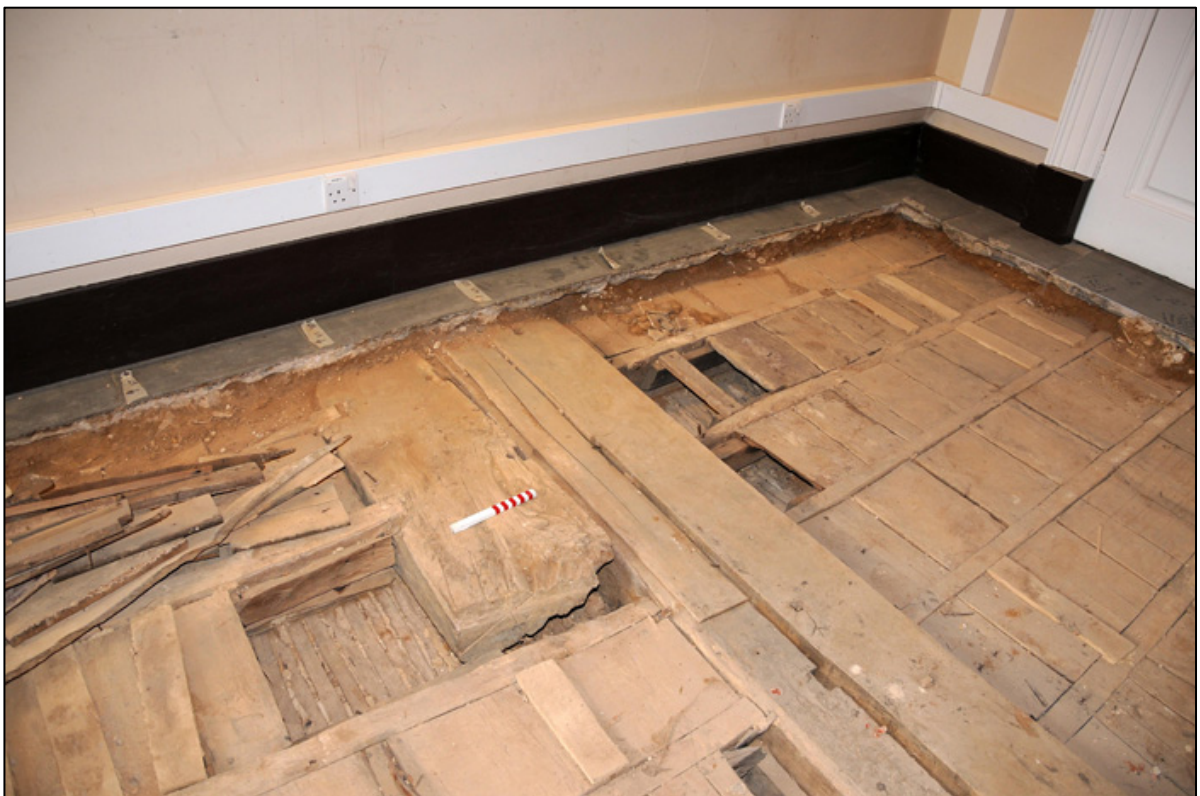
Appendix 1.26: General view of timbers **P1**, **P3** and **P4** looking south (scale 20cm).
