WOODSEATS FARMHOUSE

Windy Bank, Low Bradfield, South Yorkshire

Historic Building Appraisal and Heritage Assessment

May 2018
Final

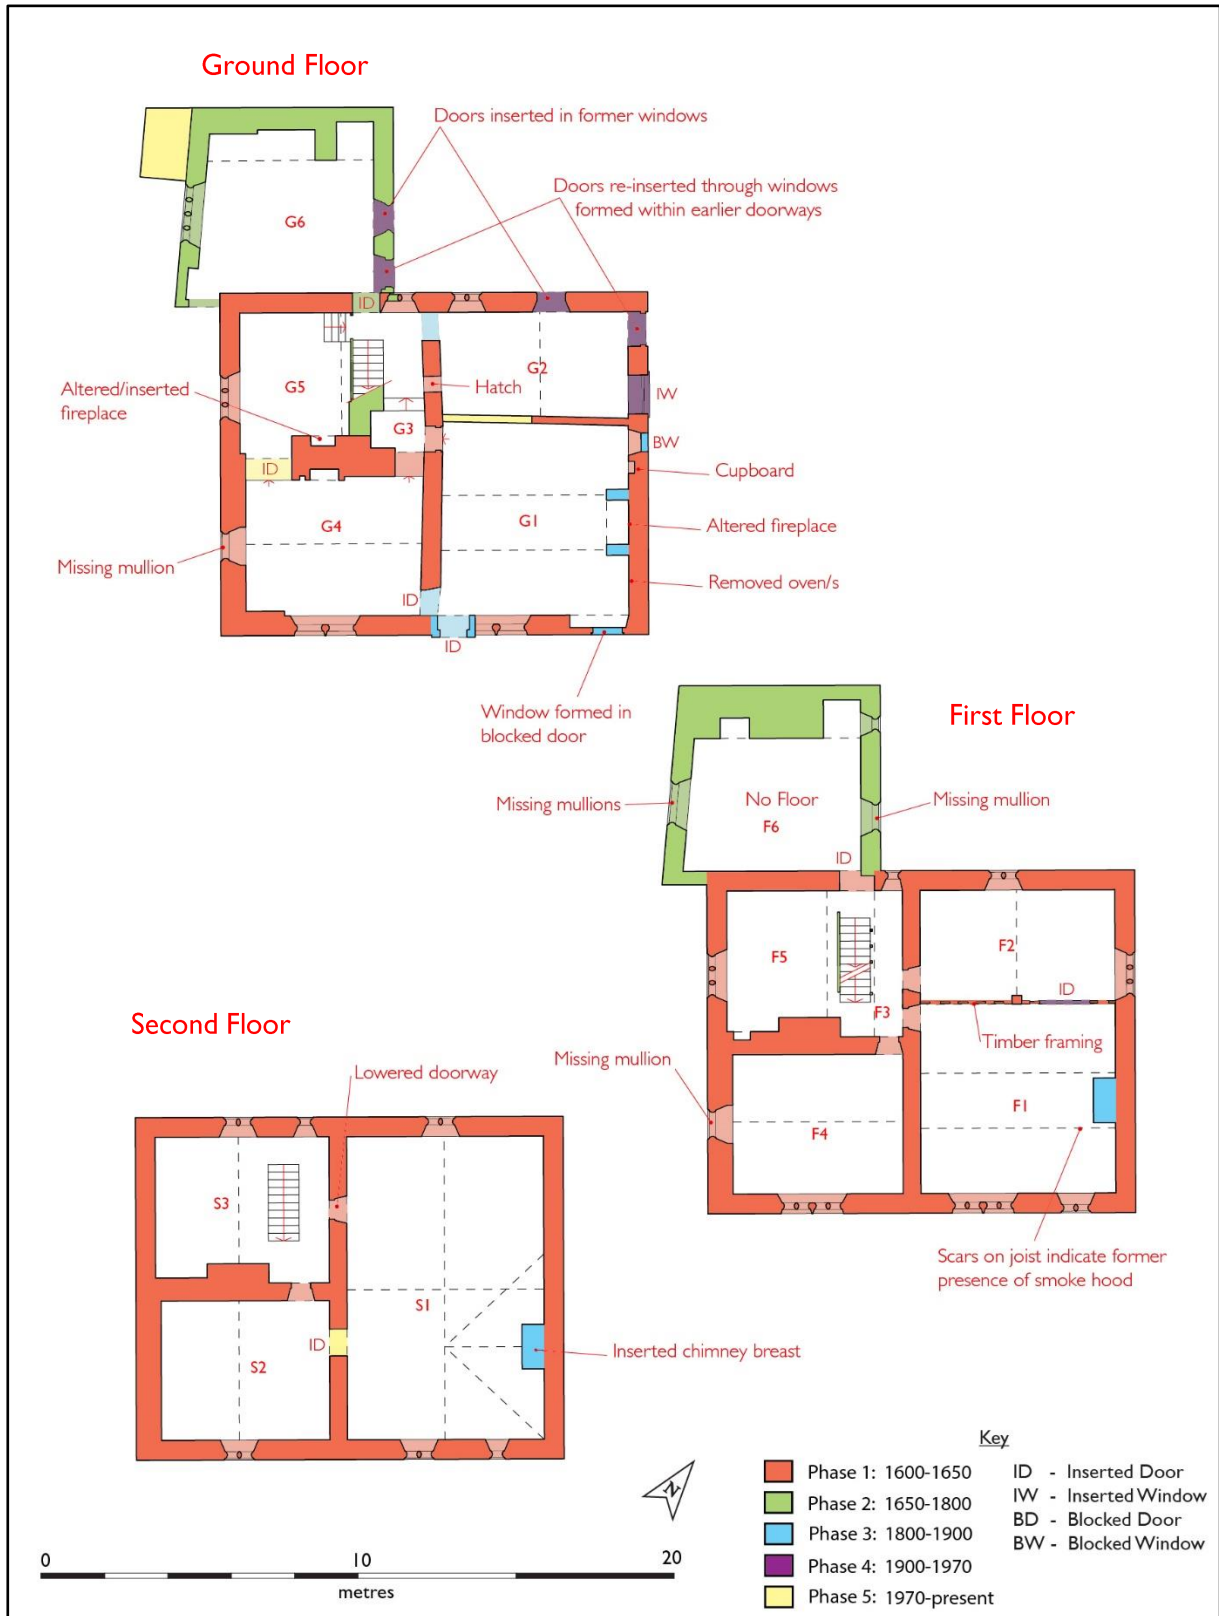
Figure 3: Phased building plan of Woodseats farmhouse

Phase 1: 1600-1650	Construction of the hall
Phase 2: 1650-1800	Development of the farm
Phase 3: 1800-1900	Re-organisation of the farm
Phase 4: 1900-1970	Extension of farm accommodation
Phase 5: 1970-Present	Alterations and renovations to the house

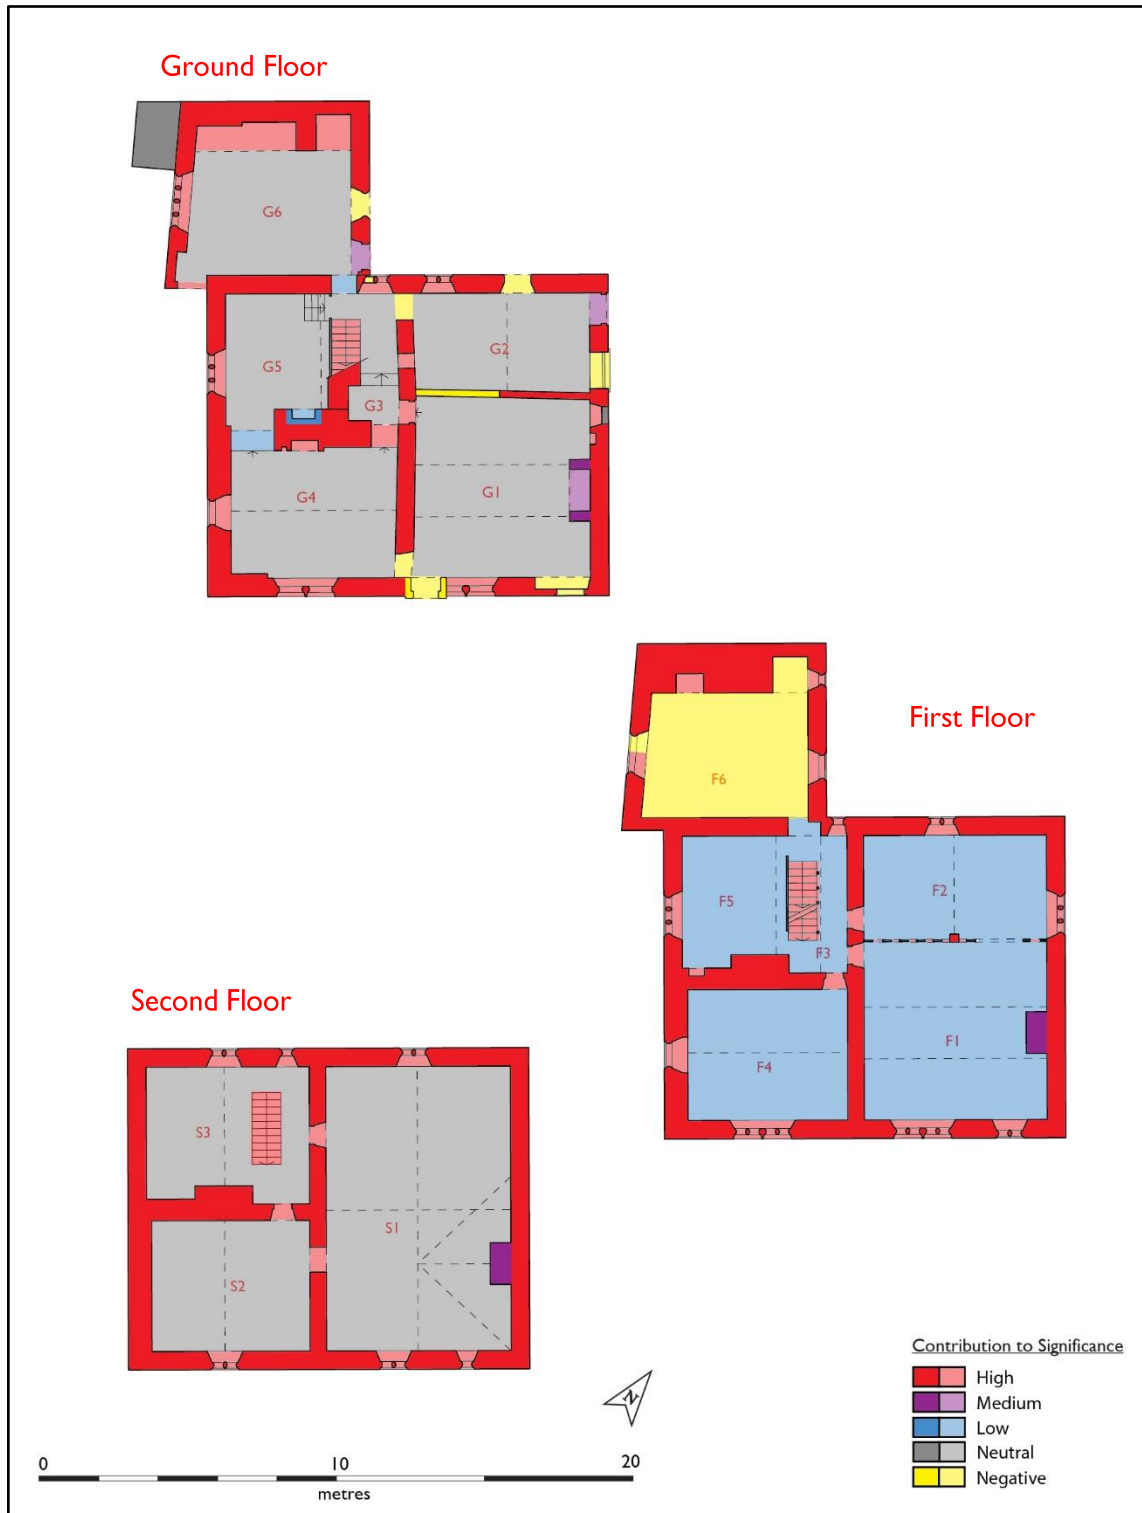
Figure 4: Plan showing the contribution made by fabric to the significance of Woodseats farmhouse.

Overall the building is considered to possess a national level of significance, reflecting its rarity, quality of architecture, preservation, and its representation of local building traditions at an early point in the development of yeomanry housing in Yorkshire.

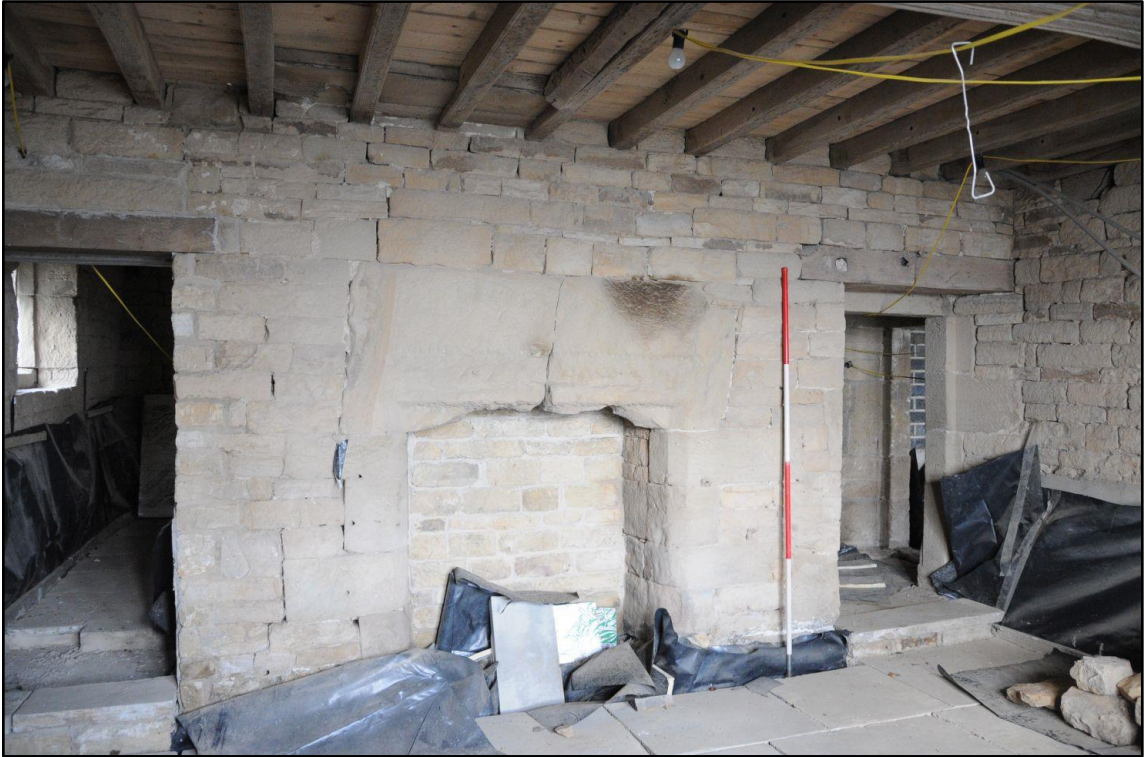
Appendix 2.21: General view of G4, looking north (2m scale)

A fireplace is situated within the northern wall of **G4** (**Appendix 2.21**). A deep stone lintel above the fireplace is cracked and has been damaged on its lower edge such that it is not clear whether it was flat arched or shallow four-centre arch. The jambs of the fireplace are chamfered, whilst the back of the fireplace has been rebuilt. A further fireplace is located within **G5** (**Appendix 2.22**), to the rear of that in **G4**. The jambs and lintel of this fireplace are altered, indicating it is either inserted or a reworking of an earlier fireplace.

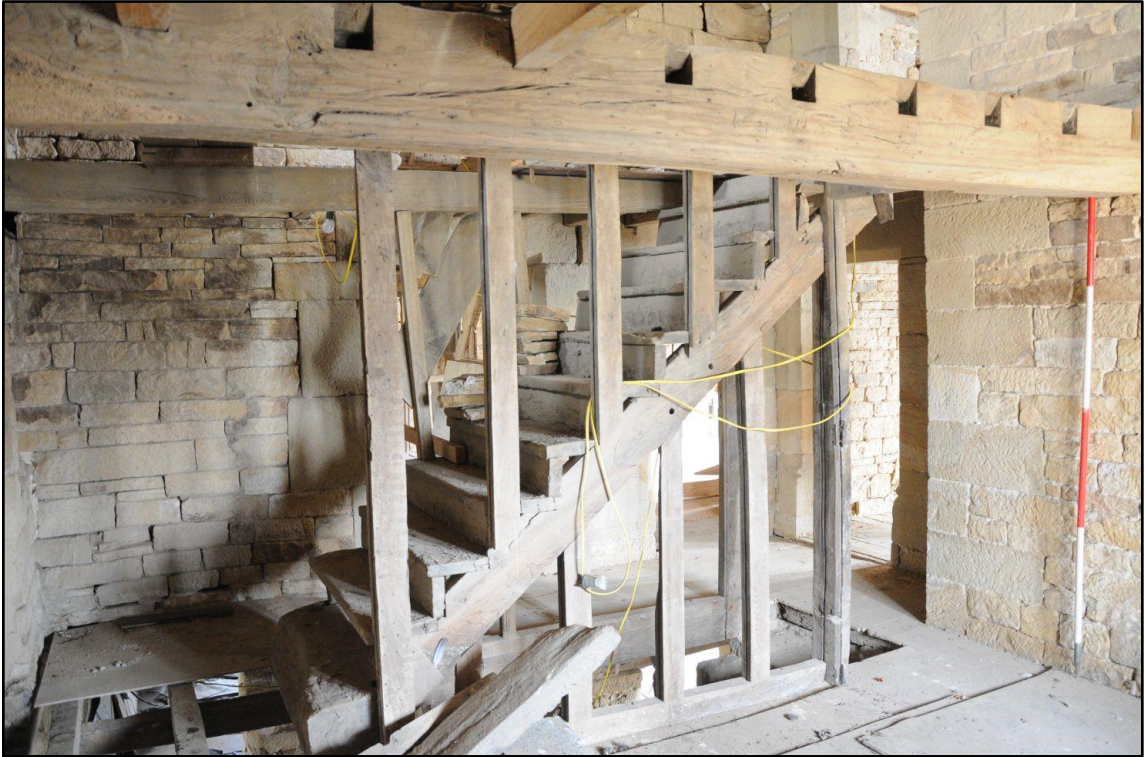
The floors throughout this level are tongue-and-groove, with those in **F1**, **F2**, **F3** and **F4** being of a dimension and character indicative of 19th century date or later. A few boards in **F5**, viewed from below as boarded over above, appear to be earlier but are in a poor condition.

Appendix 2.31: General view of F5, looking east (2m scale)
