# CANNON HALL PORCH, BARK HOUSE LANE, CAWTHORNE, BARNSLEY, SOUTH YORKSHIRE

## Archaeological Photographic Survey and results of a Watching Brief

February 2016

Document No: TJC2018.08

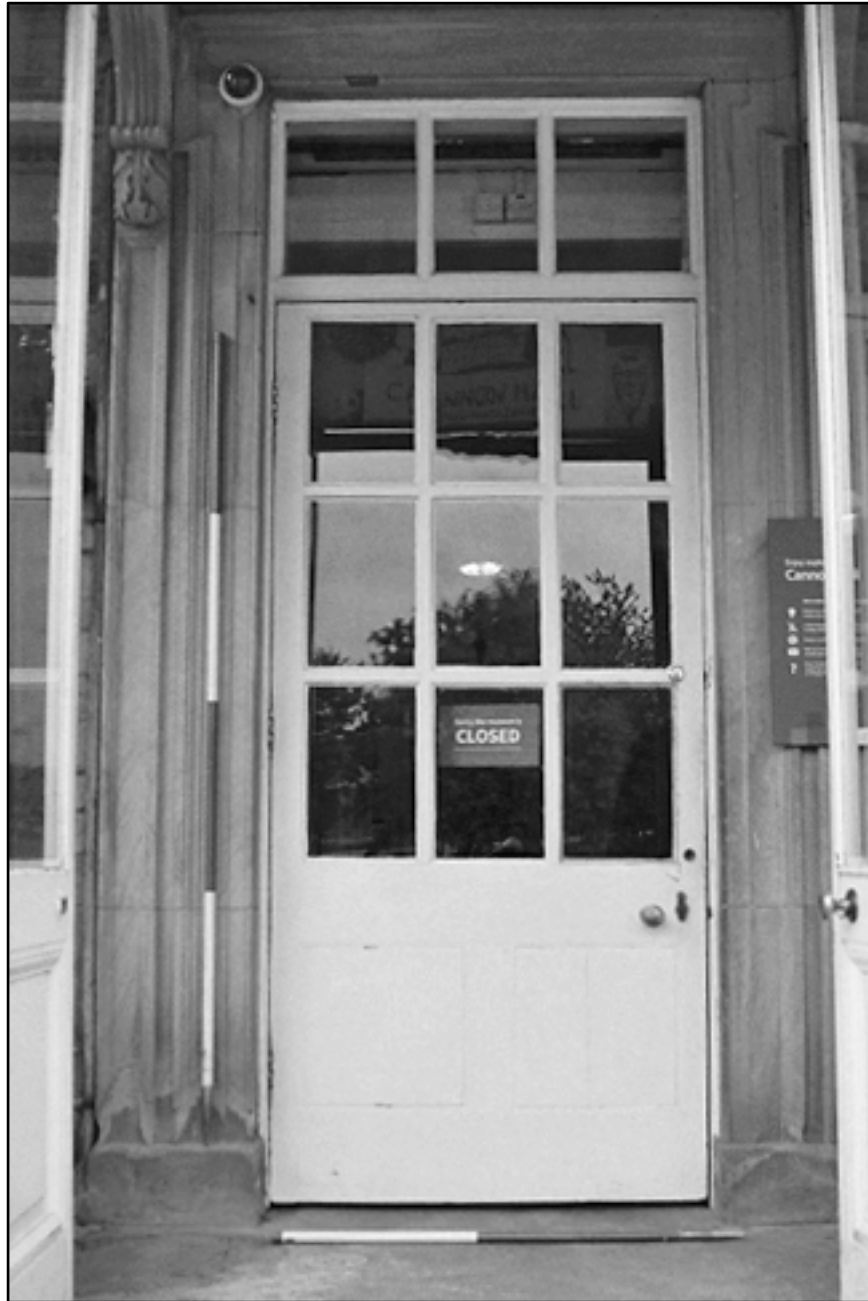
**Appendix I.8:** Detail of inner door into Hall (1m/2m scale). **Film I.18.**

The Porch is a secondary addition to the Hall (**Appendix I.8**), but was originally intended to be open sided and exposed to the elements.

The photographic survey has produced a detailed photographic record of the condition and appearance of the Porch at Cannon Hall at the time of survey. It appears to have been a secondary addition to the north elevation of the building, evidenced by a mis-match in the stone courses at the interface between the wall and the Porch. The timber framed fenestration and double doors within the porch are also secondary insertions - the molding styles indicate a mid 19<sup>th</sup> century date is likely.

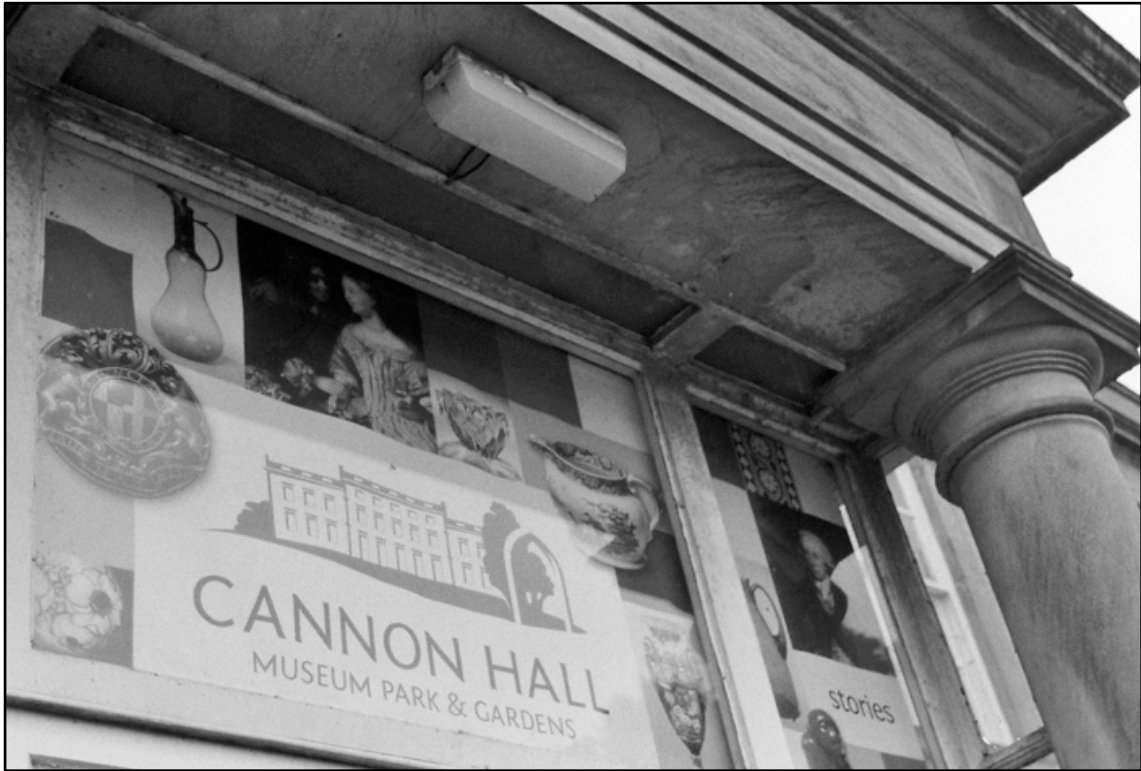
**Appendix I.9:** Detail of entablature above entrance to Porch, looking north. **Film I.9.**

It was noted that the timber glazing bars above the doors was plain by comparison to the joinery on the side elevations (**Appendix I.9**). This may indicate that this upper section has been repaired.

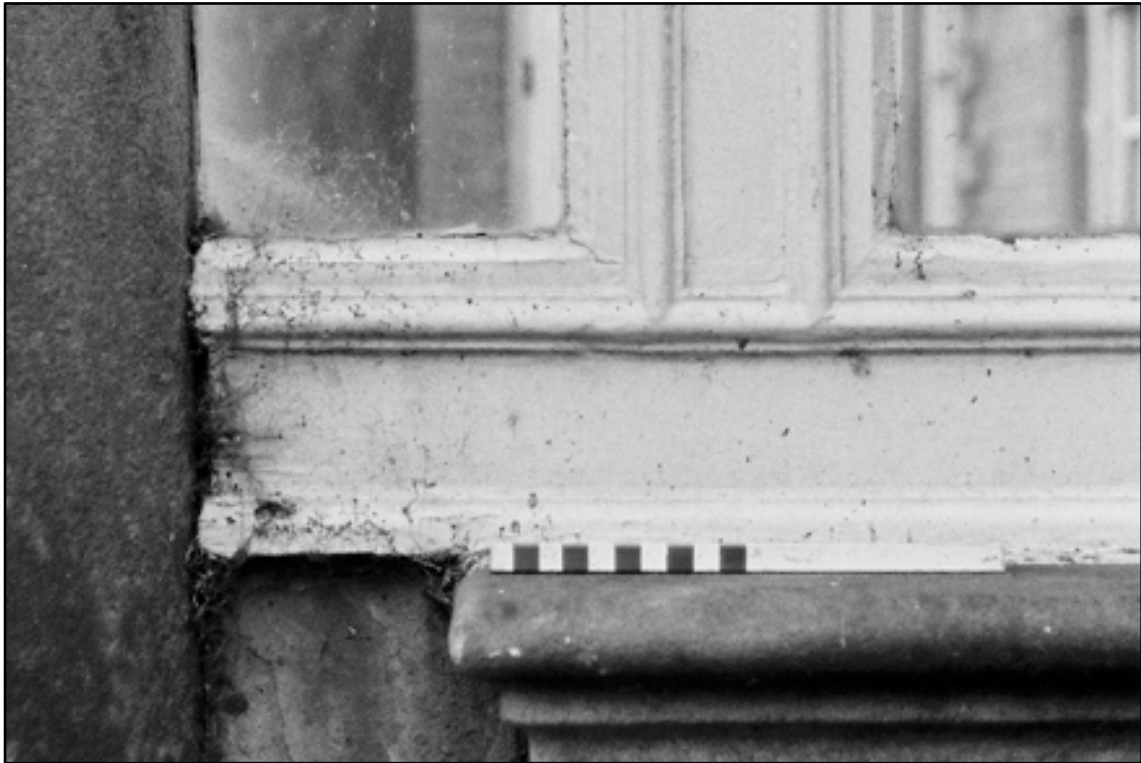
**Appendix I.11:** Detail of joinery on west elevation (20cm scale). **Film I.13.**

The glazing was supported by a timber frame with two large mullions, and thinner profiled transoms or rails (**Appendix I.11**). The mullions measured 6.5cm x 11.5cm in size and were externally decorated by two half round parallel mouldings. The internal faces had a simple cyma

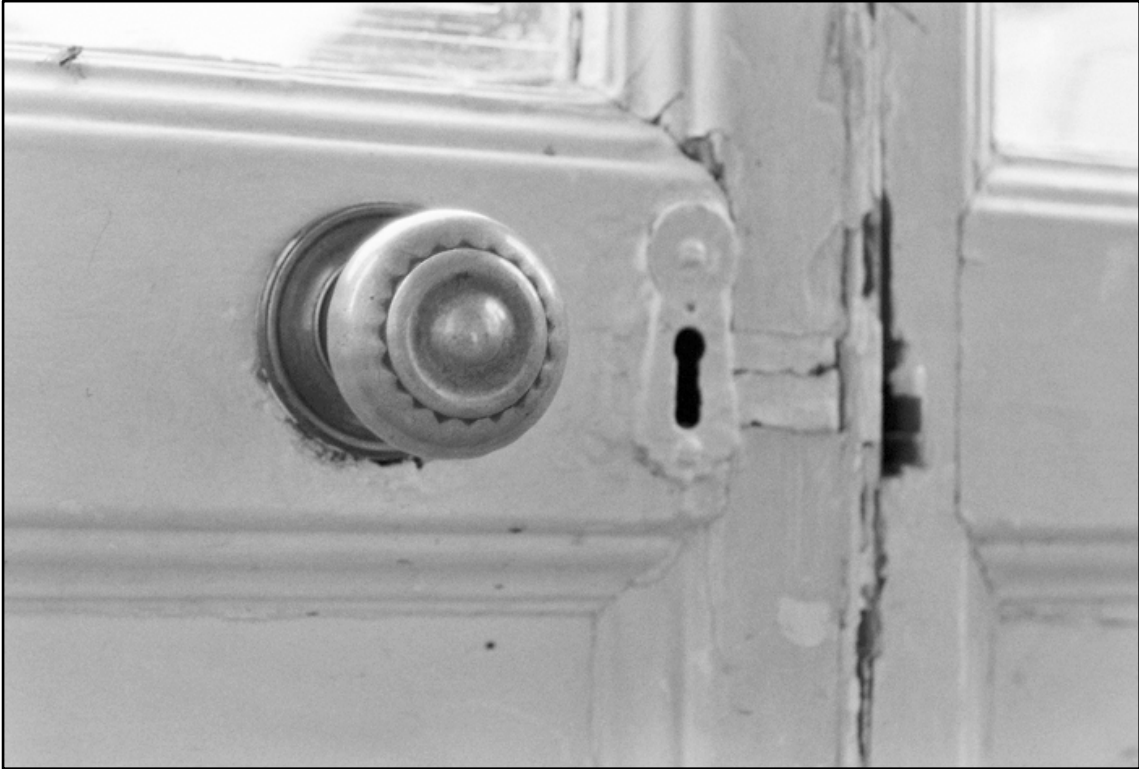
**Appendix I.14:** Detail of internal door handle. **Film I.21.**

The doors opened inwards and each was supported on three large iron hinges (**Appendix I.15**). There was an internal security bolt (**Appendix I.13**) and a decorated brass handle (**Appendix I.14**) which was heavily worn.

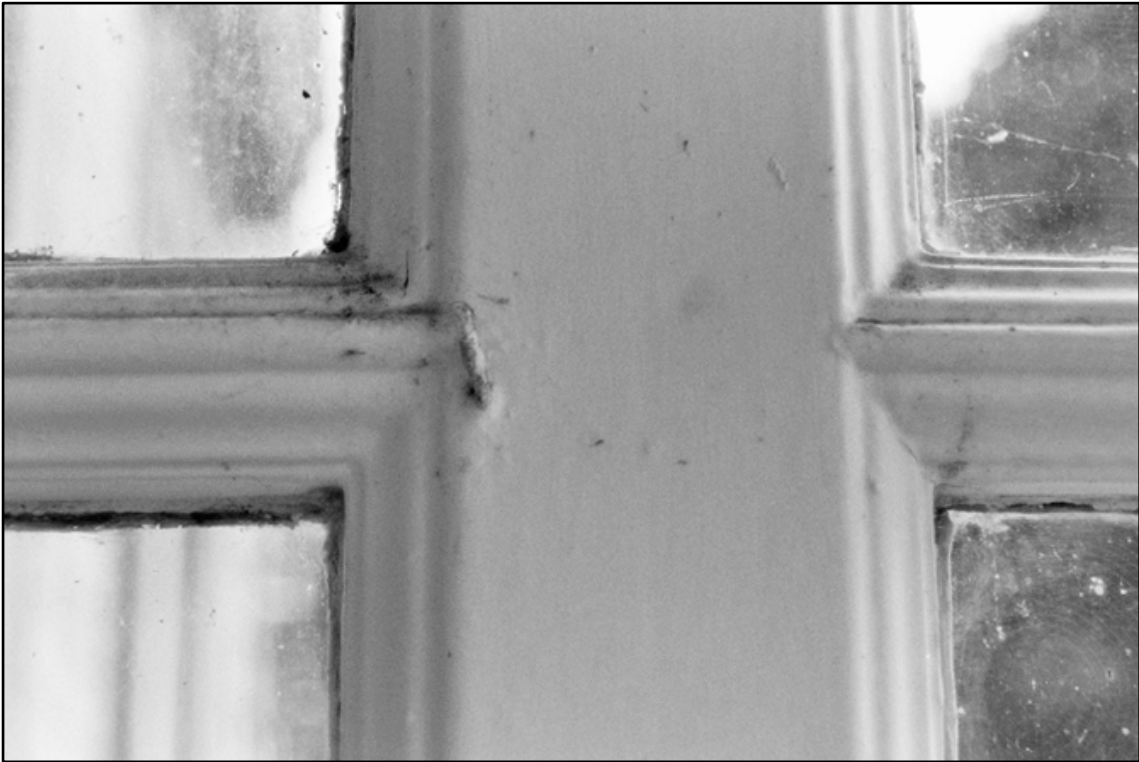
**Appendix I.20:** Detail of internal joinery, looking south. **Film I.32.**

reversa profile (**Appendix I.16**). The joinery was thickly painted with white gloss paint (**Appendix I.20**).

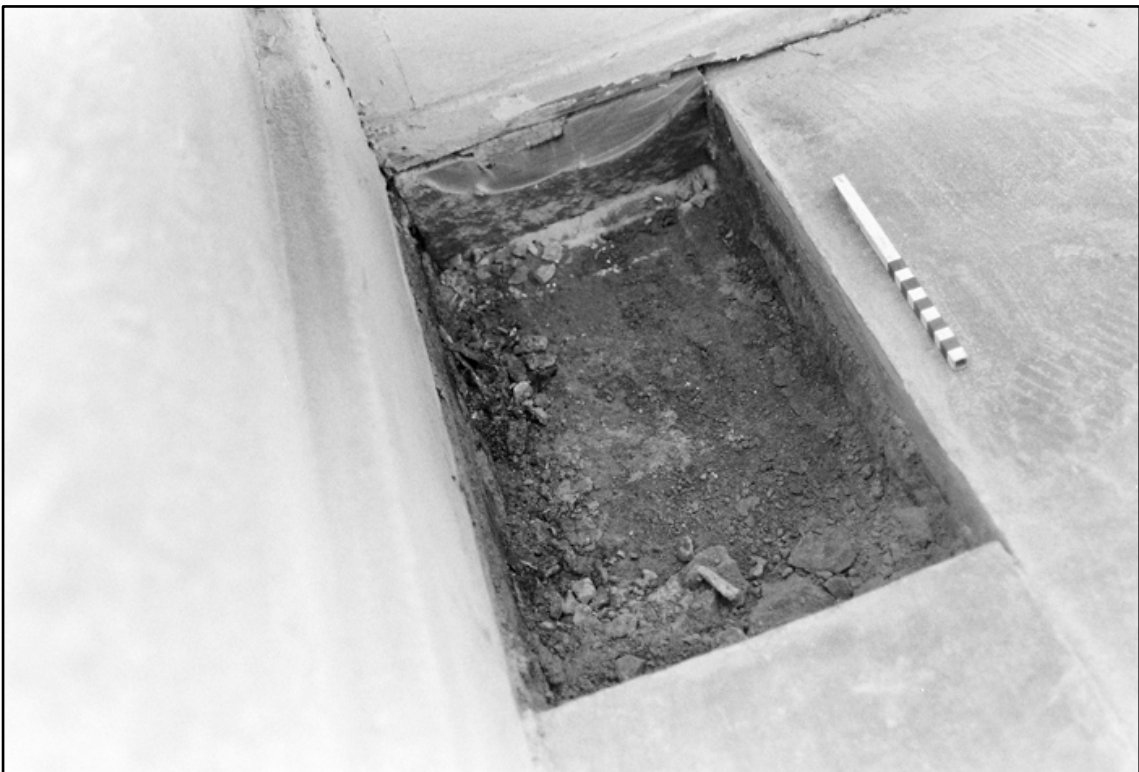
**Appendix I.23:** Detail of excavated trial hole I, following removal of slab (20cm scale). **Film I.34**

**TP1** – This hole measured 27cm x 49cm and located in the northwest corner of the Porch (**Appendix I.22**) and the York Stone slab that was removed was 11cm in thickness. The stone was found to be bedded on a deposit of yellow sand (**Appendix I.23**).

The monitoring of the lifting of the floor slabs provided no meaningful results, apart from the confirmation of their thickness and that they were bedded on a layer of yellow sand.

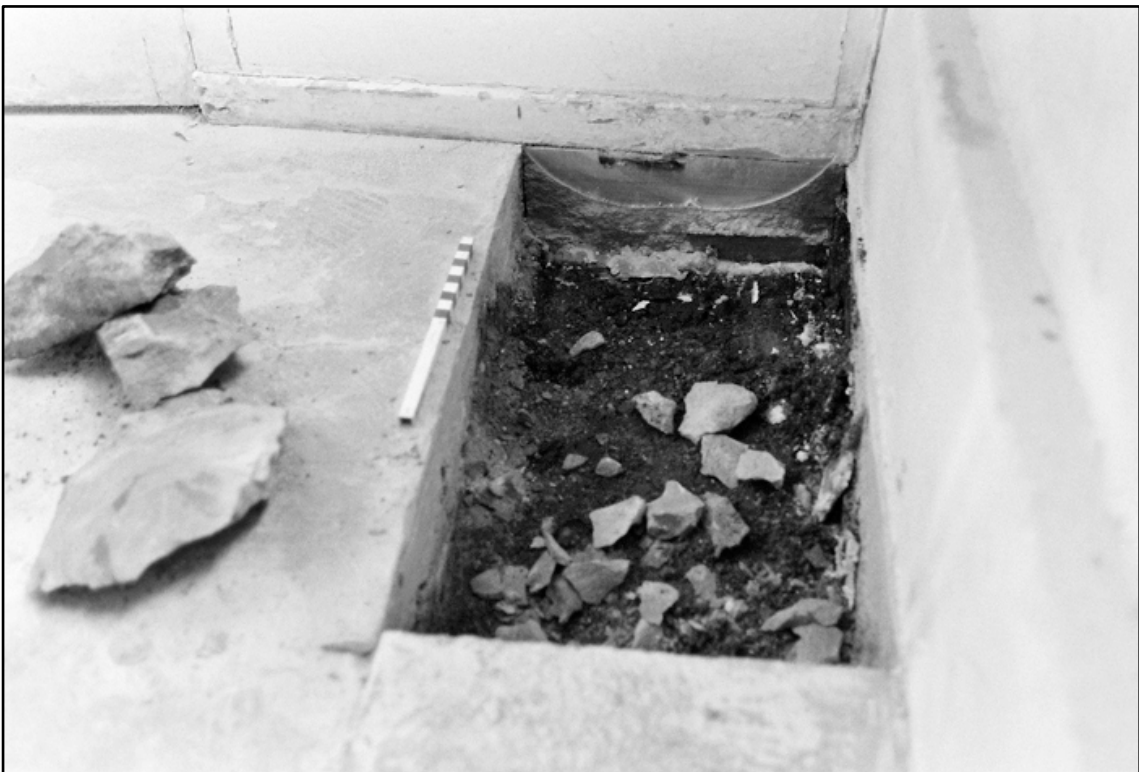
**Appendix I.25:** Detail of excavated trial hole 2, following removal of slab (20cm scale). **Film I.35**

**TP2** – This hole measured 28cm x 48cm and located in the northeast corner of the Porch (**Appendix I.24**) and the York Stone slab that was removed was 11cm in thickness. The stone was found to be bedded on a deposit of yellow sand (**Appendix I.25**).
