Porthcurno Telegraph Museum

Historic Building Photographic Recording

March 2012

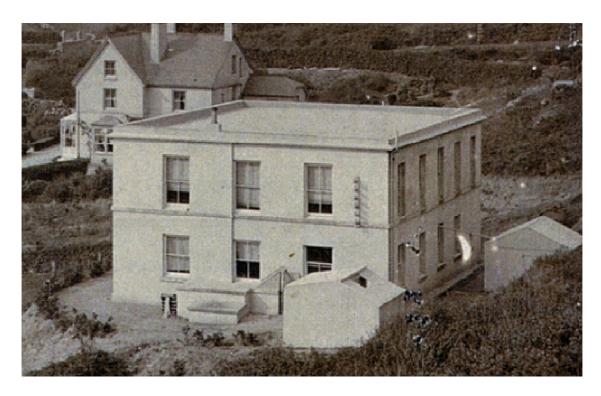
Figure 4: Eastern House soon after erection in 1904, from SE; with chimney on S elevation and separate boiler and coke bunker, and what appear to be ceramic insulators for electrical cables to run onto on top right corner of wall

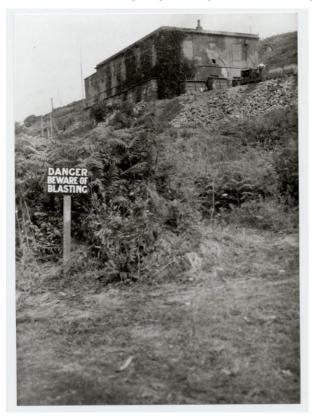
Figure 7: Eastern House from SW, 1940/41; with boarded-up windows, camouflage paint & ivy cover

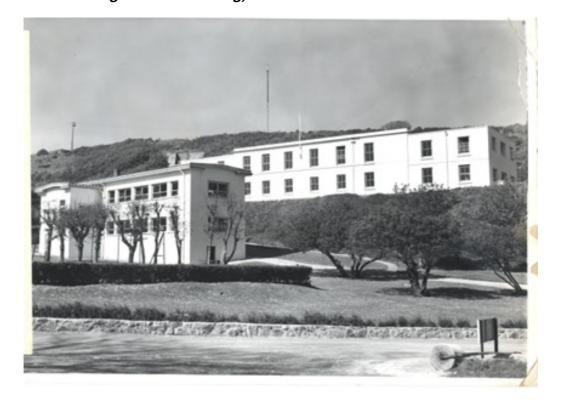
Figure 11: Eastern House 1962, from WSW, with final (S) extension of that date now built (note lightening conductor rising above 1906 façade)

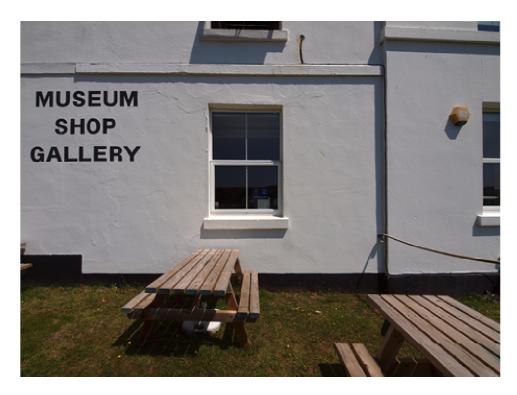
Figure 14: Eastern House – west (front) elevation, 1906 window to be converted to door, from WSW

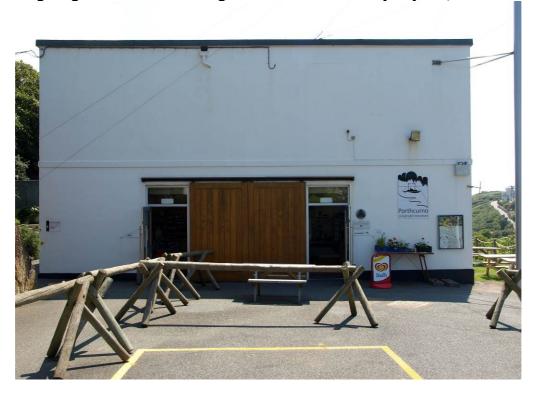
The **north (side) elevation** is architecturally basic, consisting of a plain wall with string course and a pair of (modern) glass doors together with sliding timber security. The faint outline of two blocked first floor windows are visible in the render; the two ground floor windows having been replaced by the modern doors.

Figure 19: Eastern House – north (side) elevation, from NW

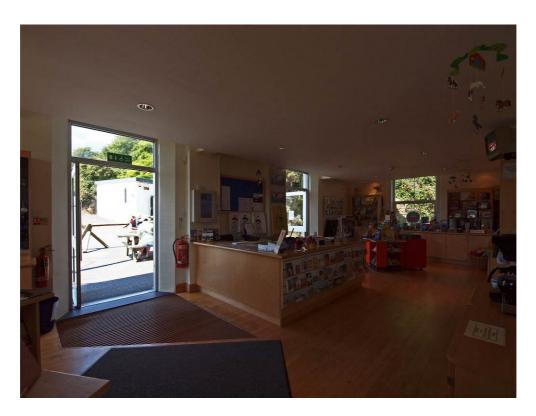
Figure 20: Eastern House – ground floor, inside 1950 extension, looking towards Museum entrance doors (converted windows), from S

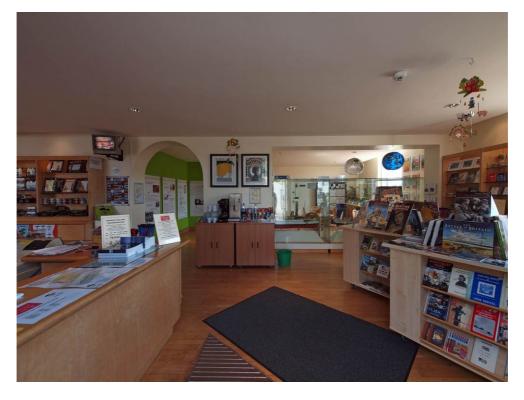
Some original concrete walling has been removed – at the junction of the 1954 and 1962 extensions, and part of the north wall of the 1906 extension. A number of original windows (now inside the building) have been blocked or converted into doorways, and a few new doorways have been punched through originally external concrete walls. Parts of the building have been refurbished with the insertion of partitions and false ceilings.

Figure 21: Eastern House – ground floor, inside 1950 extension (now Museum entrance hall & shop), looking towards partially removed wall of 1906 extension, from NW

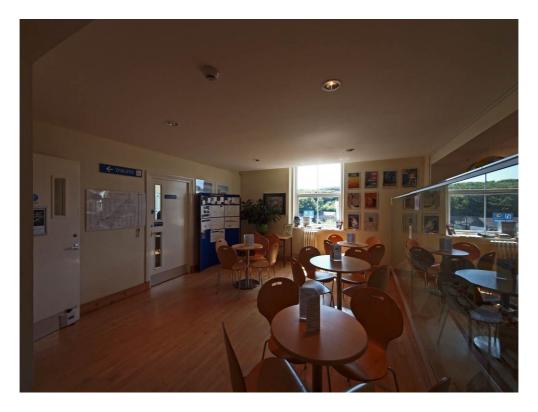
Figure 22: Eastern House – ground floor, inside 1906 extension (now Museum cafe), looking towards window to be converted to doorway, from NE

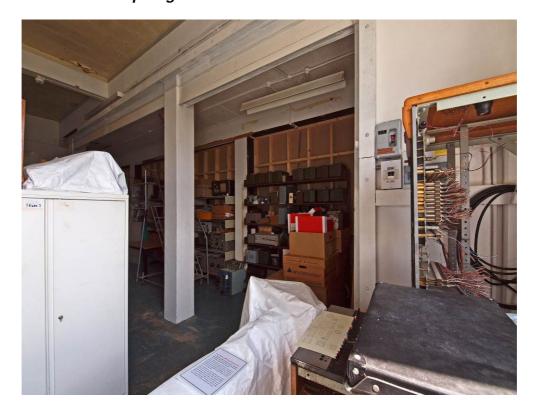
Figure 27: Eastern House – first floor, collections store (in 1954 extension), looking E towards pillar on former line of 1954 end wall

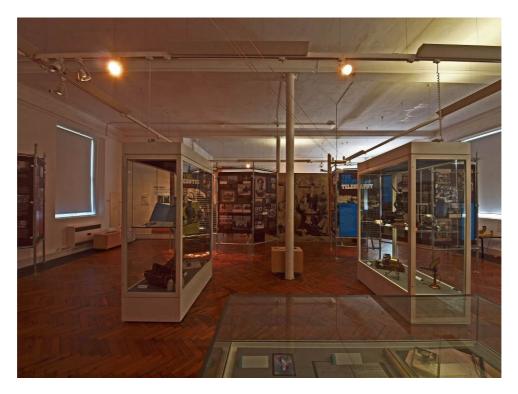
The top floor of the original (1904) building consists of a large open space with a high (concrete, gloss-painted) ceiling supported by substantial metal girders carried on round profile iron pillars. The floor is of single herringbone parquet and around the base of the wall is a skirting box, with picture rail and decorative coving above.

Figure 28: Eastern House – exhibition room (originally the instrument room), occupying the whole of the first floor of the 1904 building

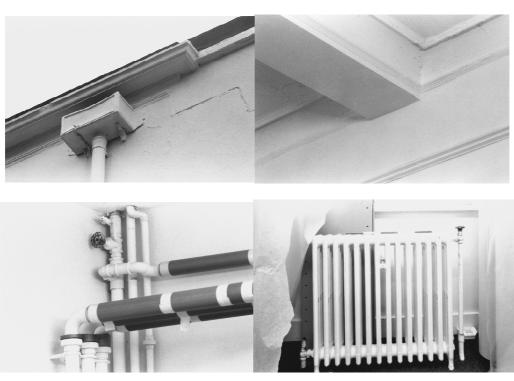
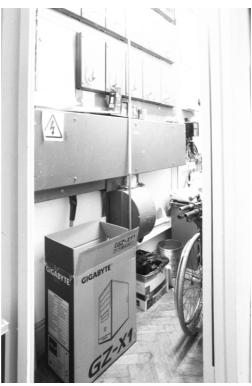
Figure 30: Eastern House – 1906 moulded entablature & cast iron rainwater head; 1906 decorative coving & picture rail; 1950s/60s pipes and cast iron radiator; electrical switch board

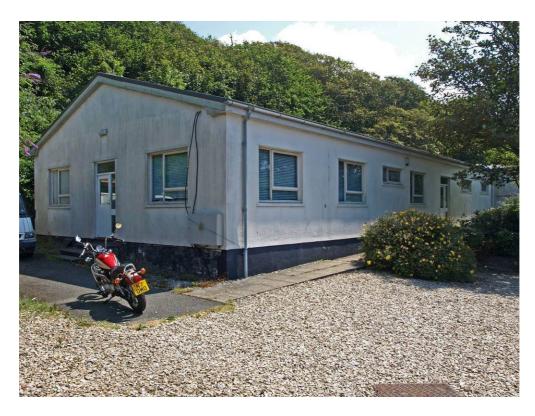
Built in the 1970s/80s, on a paved concrete plinth, with steps leading up to its main door, the Maintenance Block (Figures 31-33) is of rendered concrete block construction. It retains evidence for two phases of build – a larger, northern part, with painted soft wood windows and doors, timber rafters and an asphalt roof, and a southern lean-to with corrugated aluminium doors on steel frames and corrugated asbestos over. Internally, the main block has a series of small rooms arranged along a central corridor, divided by partition walls, while the lean-to has 2-3 rooms separated by un-rendered concrete-block walling.

Figure 31: Maintenance Block, from NE
