MODEL FARM, THE GREEN, UPPER POPPLETON,
YORK.

REPORT ON A HISTORIC BUILDING RECORDING SURVEY
OSA REPORT NO: OSA19BR04

April 2019.

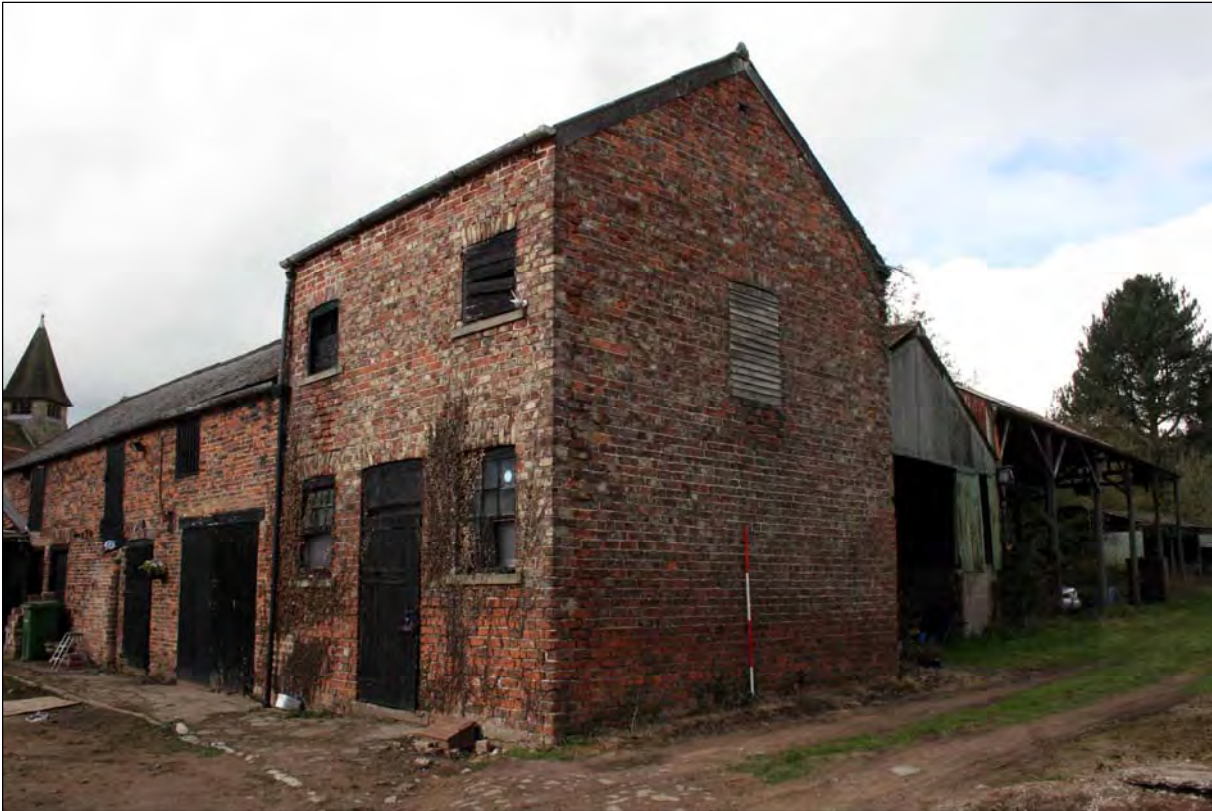
The stable comprised of a two storey red brick building constructed in English garden wall bond with a pitched corrugated asbestos roof and guttering with downpipes (Plates 1 and 2). The southeast elevation fronting into the courtyard had two boarded up window openings with wooden frames, brick lintels and stone sills at first floor level (Plate 3). At ground level there were two wooden sash window openings with upper eight (left side) and six light panes (right side), also with brick lintels and stone sills. Central was a doorway opening with a wooden stable door and above four light fanlight and brick lintel. At the base of the door was a stone step. The northeast gable end had a boarded up central window opening at first floor level with a brick lintel (Plate 4). The southwest elevation was mostly masked by the lower building B3. The northwest elevation was mainly obscured by modern barn structure and vegetation (Plate 5). A construction joint between B1 and B3 was clearly seen on both the southeast and northwest elevations (Plate 6).

Plate 1. B1 exterior looking west (image no. 298).

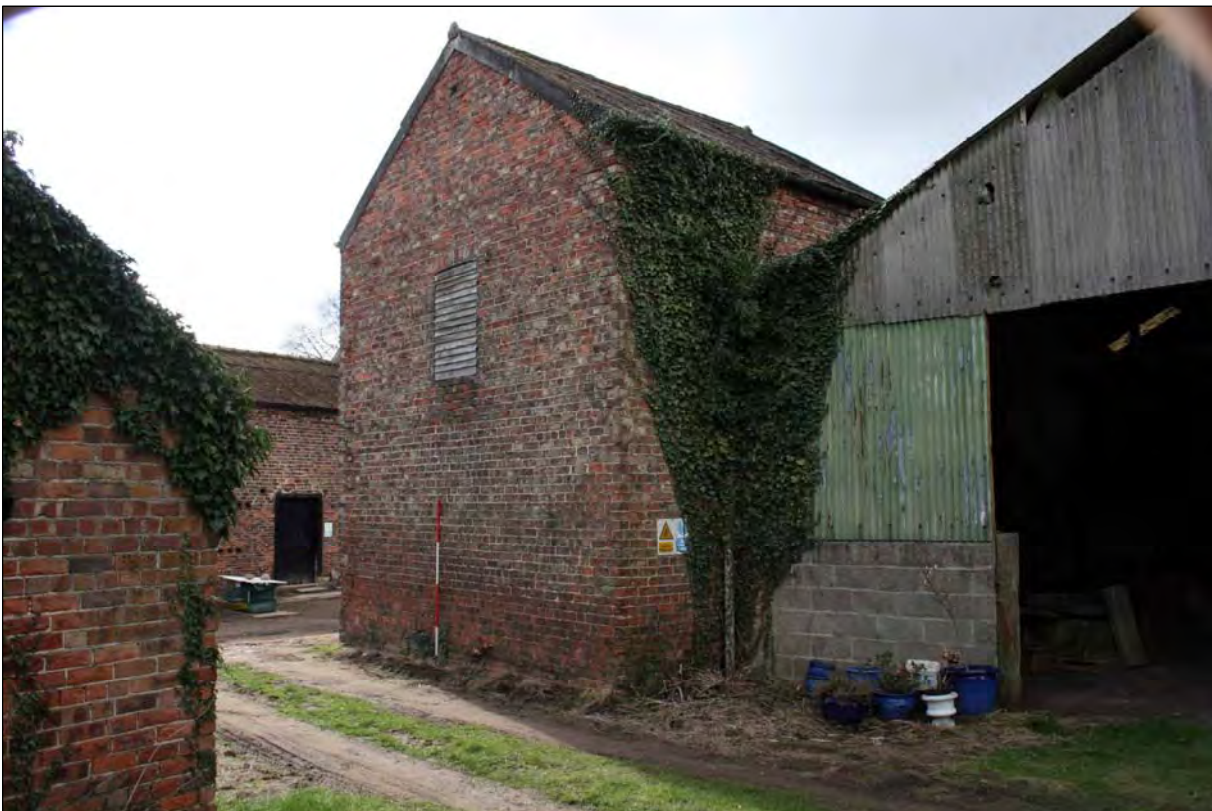
Plate 2. B1 exterior looking south (image no. 300).

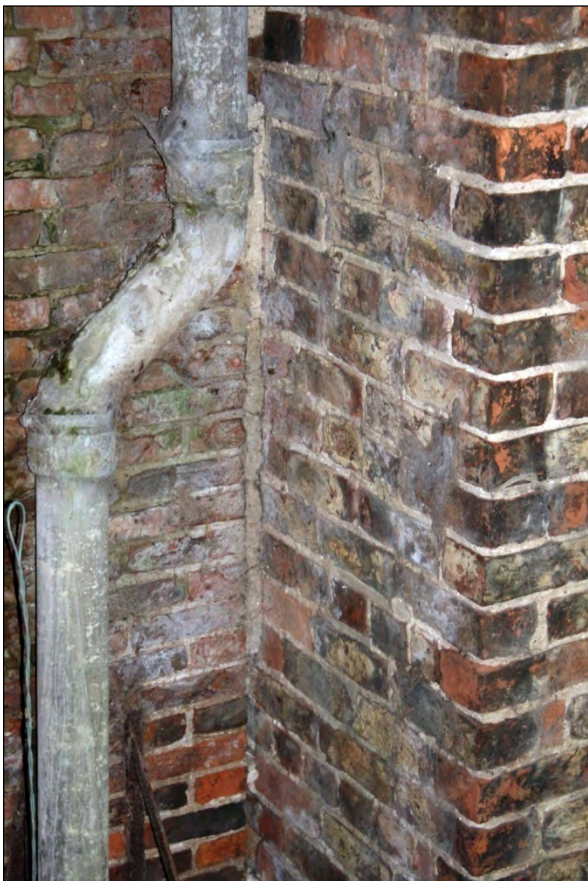
Plate 6. B1 exterior join with B3 looking east (image no. 342).

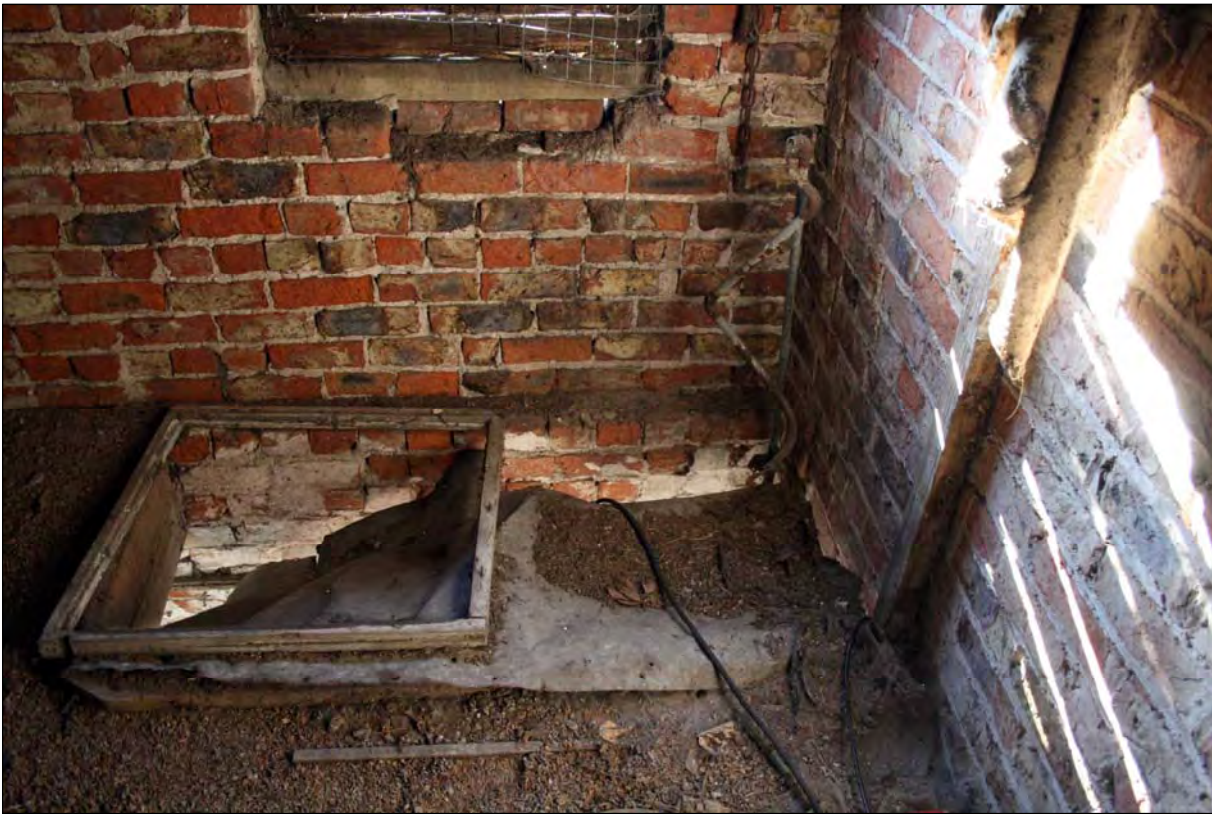
B1 interior had first and ground floors. The first floor was only accessed through stable B3 first floor and was only partly accessed due to unsound flooring. The first floor had wooden trusses, rafters and base plates (Plates 7 and 8). The walls were of plain brick with a boarded window opening with a wooden lintel on the northwest elevation and two boarded window openings with wooden lintels on the southeast elevation (Plates 9, 10 and 11). The southwest elevation had a central narrow doorway opening with a wooden lintel (Plate 12). This opening appeared to have been a modified from an earlier window opening of B3 prior to construction of B1. The wooden floor had an opening within the southern corner from which access could have been gained from the ground floor via ladder steps (removed) (Plate 13).

Plate 13. B1 interior first floor. Floor opening looking SE (image no. 035).

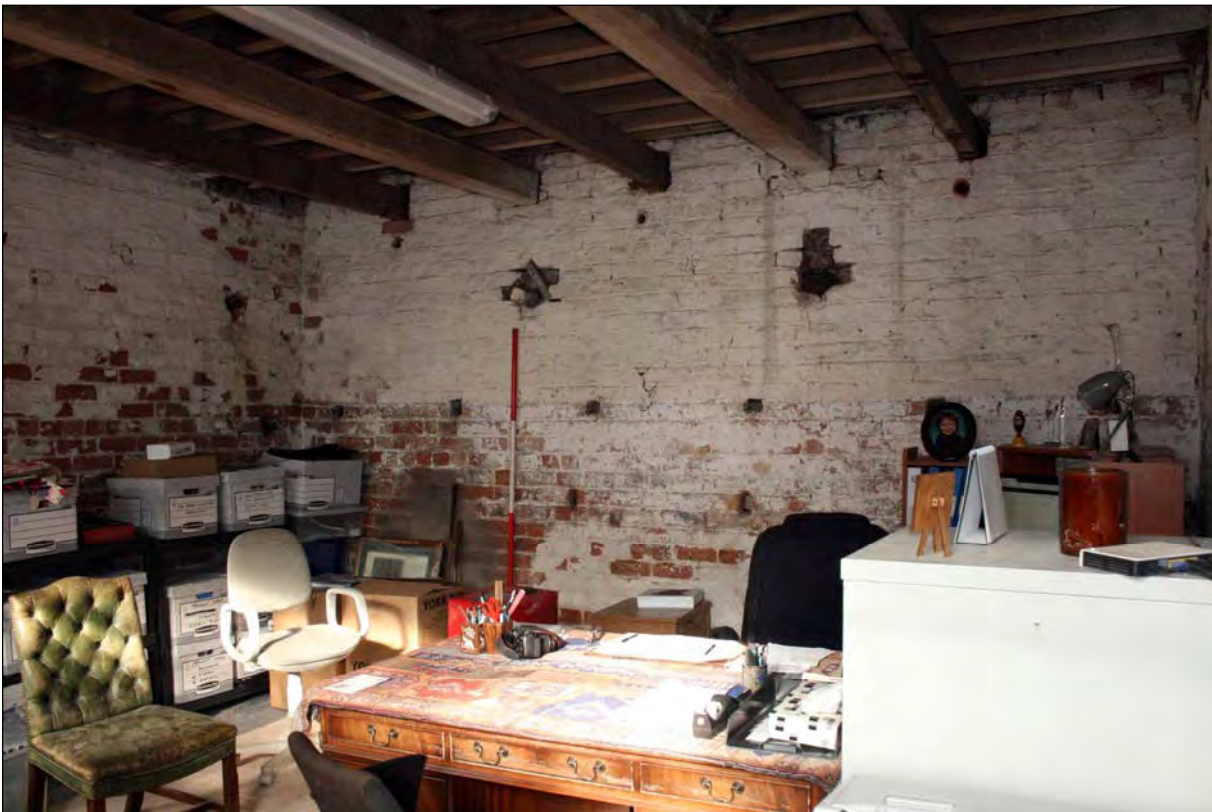
B1 ground floor had whitewashed walls with wooden ceiling beams and was currently used as an office with a carpeted floor (Plates 14 and 15). Four wooden beams supported above storey floor rafters (Plate 16). Notches within overhead beams appear to mark the vertical and horizontal divisions of the former horse wooden stalls. Two putlogs were located on the northwest elevation probably associated with scaffolding during the construction of the stable block. Located within the southern corner of the ceiling was an opening up to the first floor (Plate 17). The southeast elevation had two window openings with bull-nosed reveals and wooden lintels (Plate 18). These openings flanked a central stable door also with bull-nosed reveals. Stable details included wooden tack hooks on the southeast and northeast walls and a small water-piped metal water trough within the southern corner of the room (Plates 19 and 20).

Plate 14. B1 interior ground floor looking east (image no. 123).

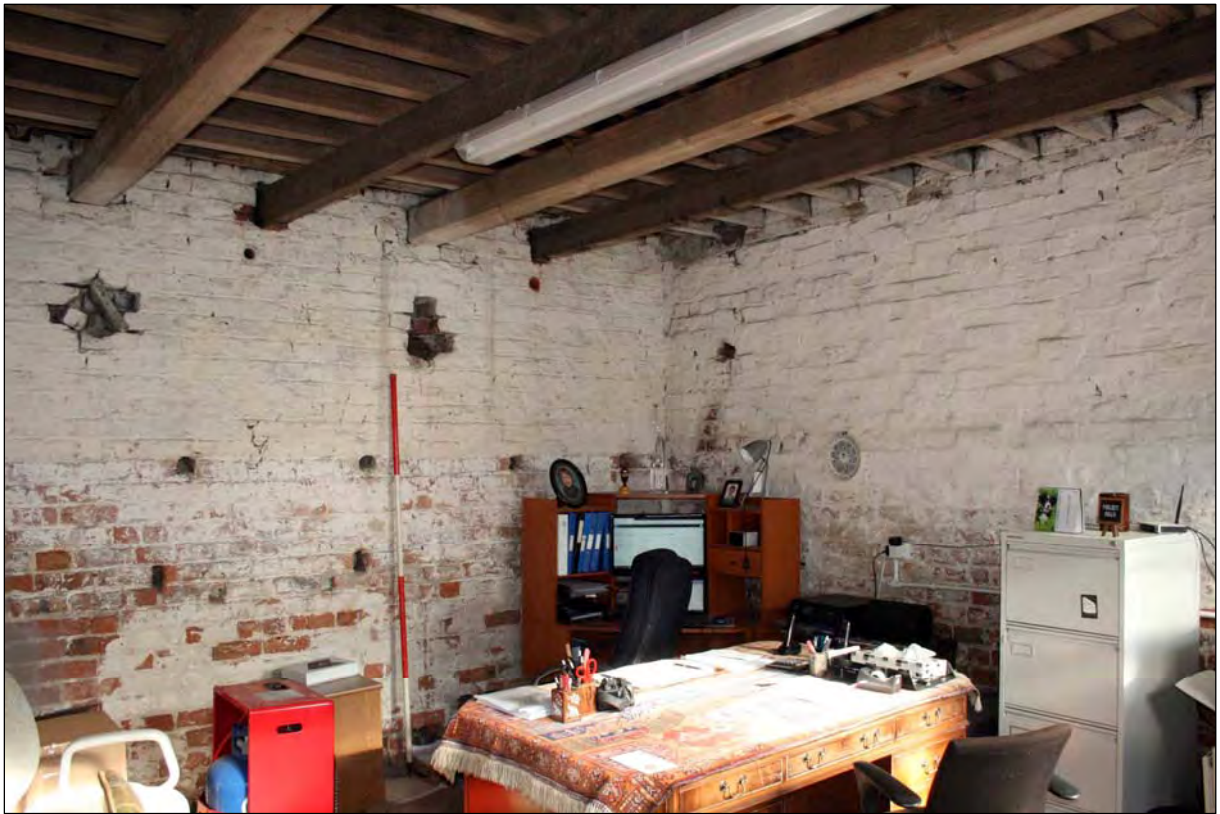
Plate 15. B1 interior ground floor looking north (image no. 124).

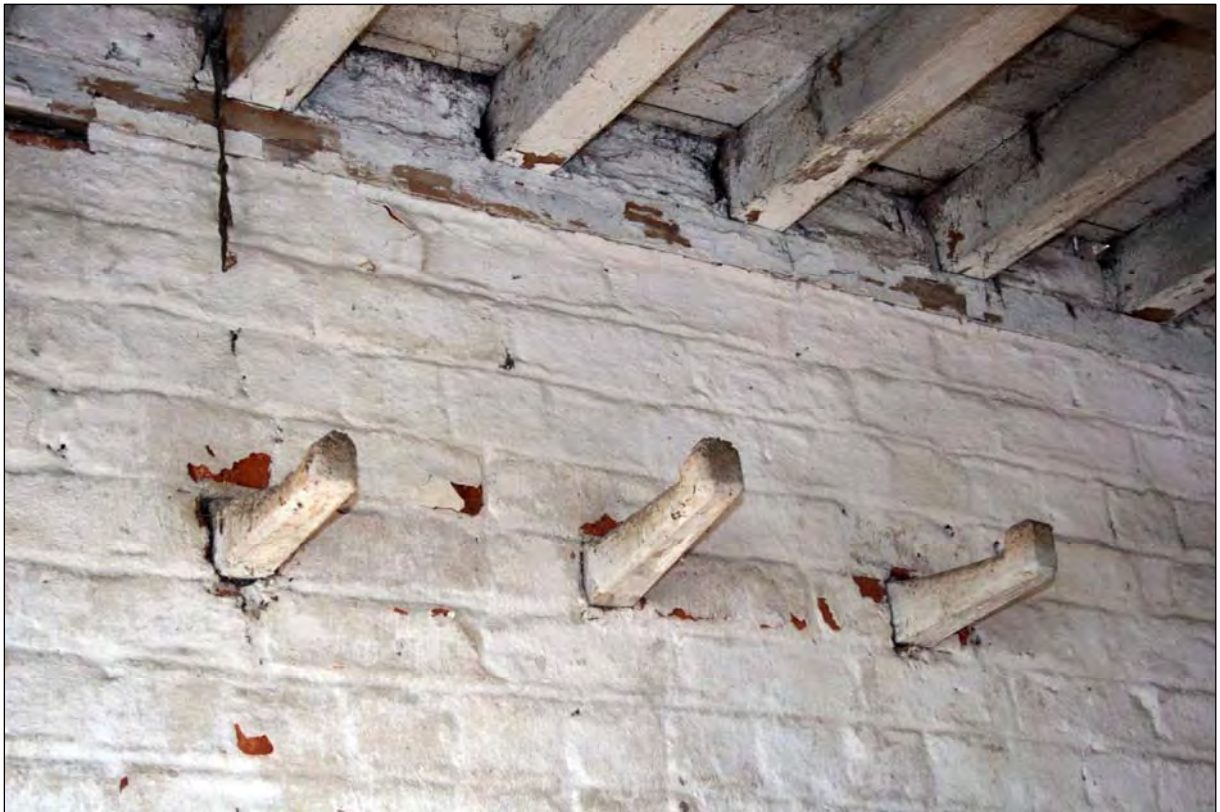
Plate 19. B1 interior ground floor tack detail looking west (image no. 161).

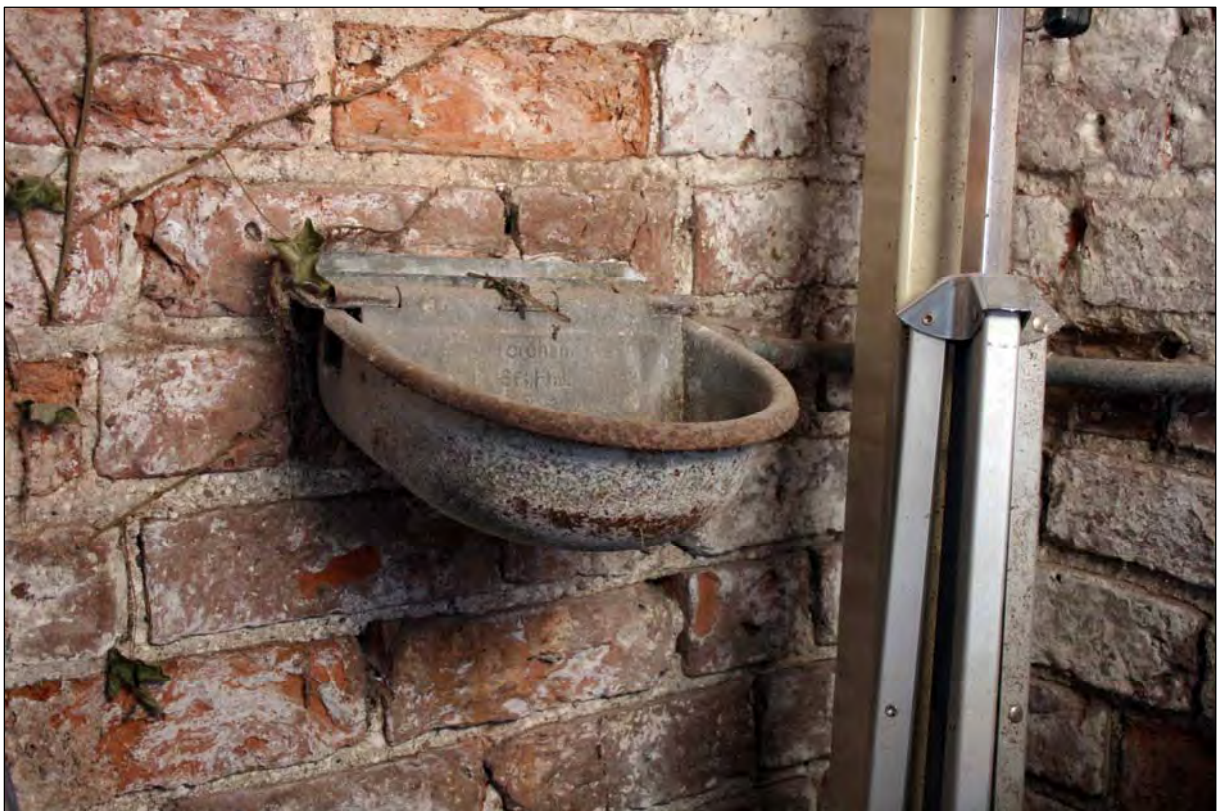
Plate 20. B1 interior ground floor small water trough looking south (image no. 165).

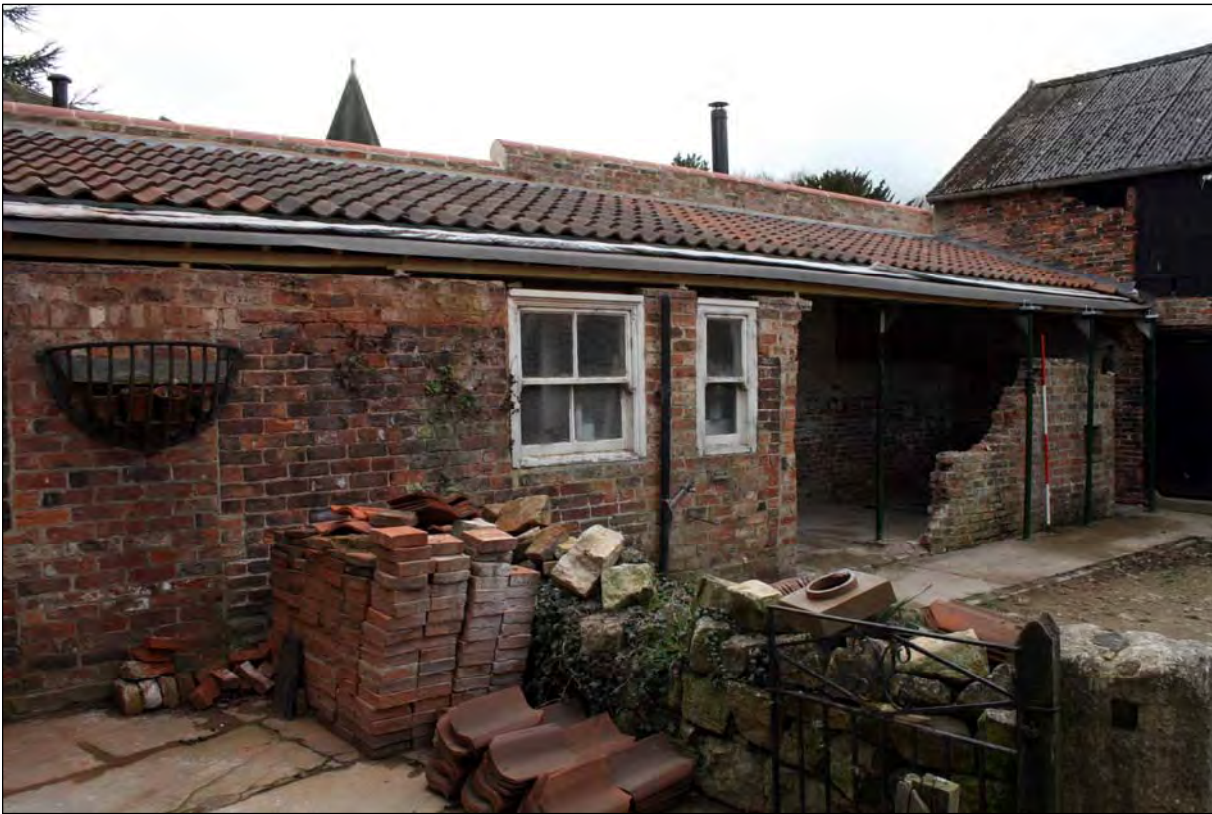
The southwest range comprised of a single storey red brick building a mono pitched pan-tiled roof (recently installed) (Plates 21 and 22). The only visible elevation was the southwest that fronted the courtyard. The northwest half of the elevation was undergoing conversion and restoration with only a small portion of the original walling surviving with a doorway opening to the northwest (Plate 23). The surviving brick work displayed a patchwork of different alterations with a small opening with a stone lintel and sill, probably a former feeding hatch. The southwest half of the elevation had three window openings with wooden sash windows and a doorway opening (Plate 24). To the northwest of the doorway was a bricked up former doorway/window opening. It is clear that this elevation has under gone a number of alterations throughout the years and its original configuration has changed considerably.

Plate 21. B2 exterior looking west (image no. 387).

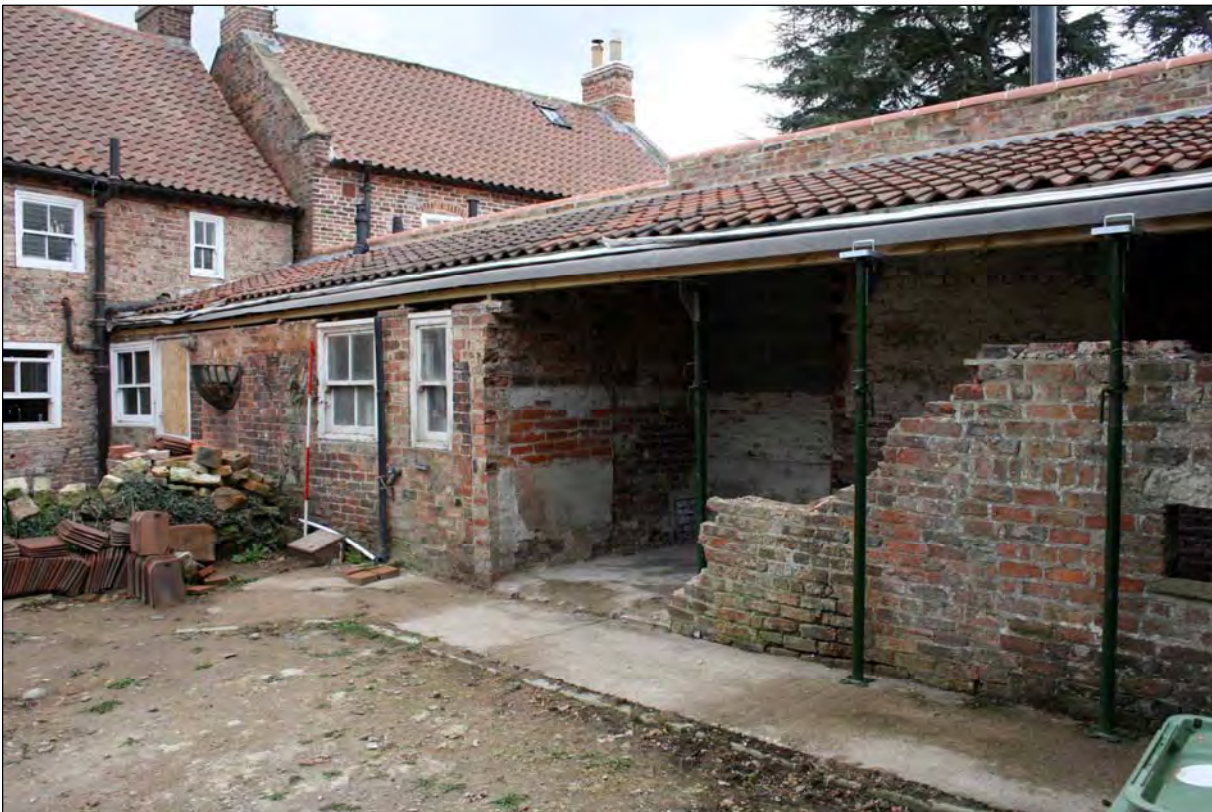
Plate 22. B2 exterior looking SE (image no. 388).

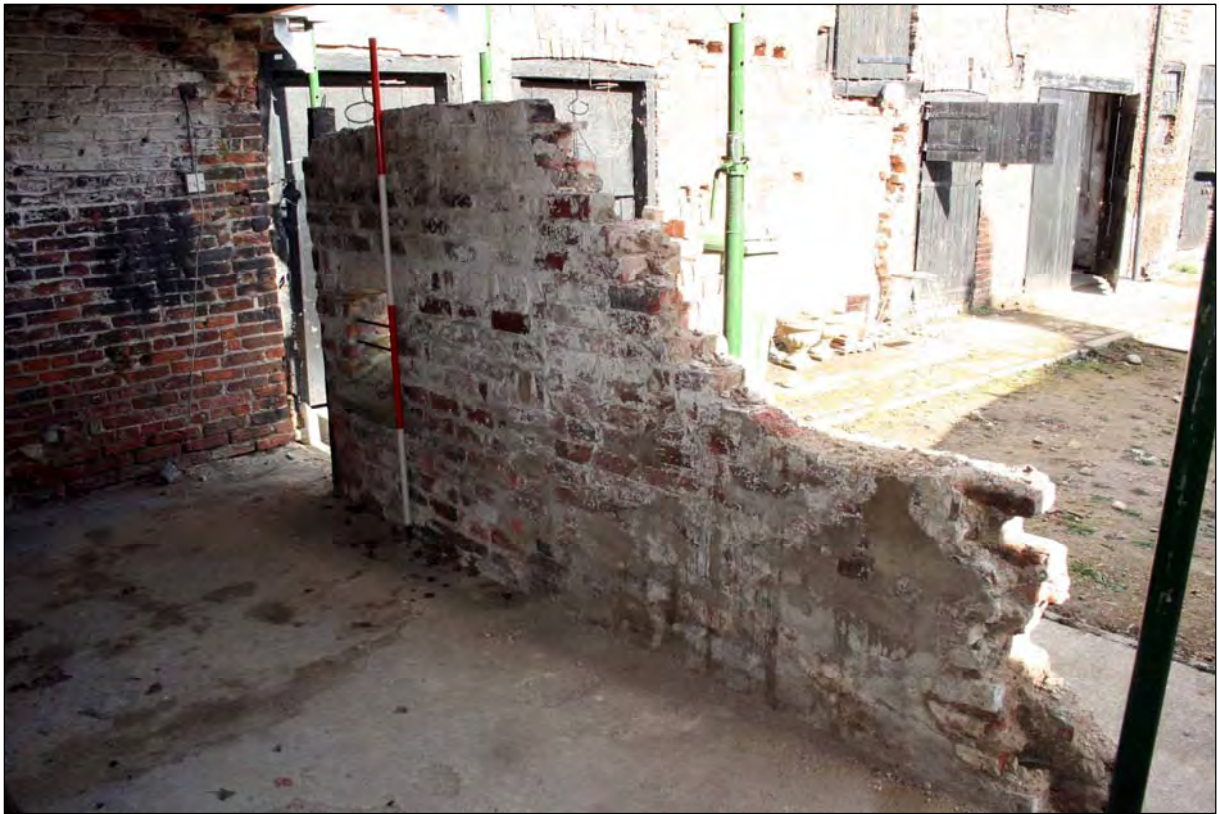
The northwestern half of B2 interior was bare with different patchwork of brick. Within the southwest elevation was the shadow of an internal wall and two bricked up window openings (Plates 25). The southeast elevation had a small bricked up opening and a possible former doorway opening (Plate 26). The northeast elevation was a reflection of the external elevation with a patchwork of brick with a small feeding hatch (Plate 27). The northwest elevation was

Plate 27. B2 interior NW looking north (image no. 262).

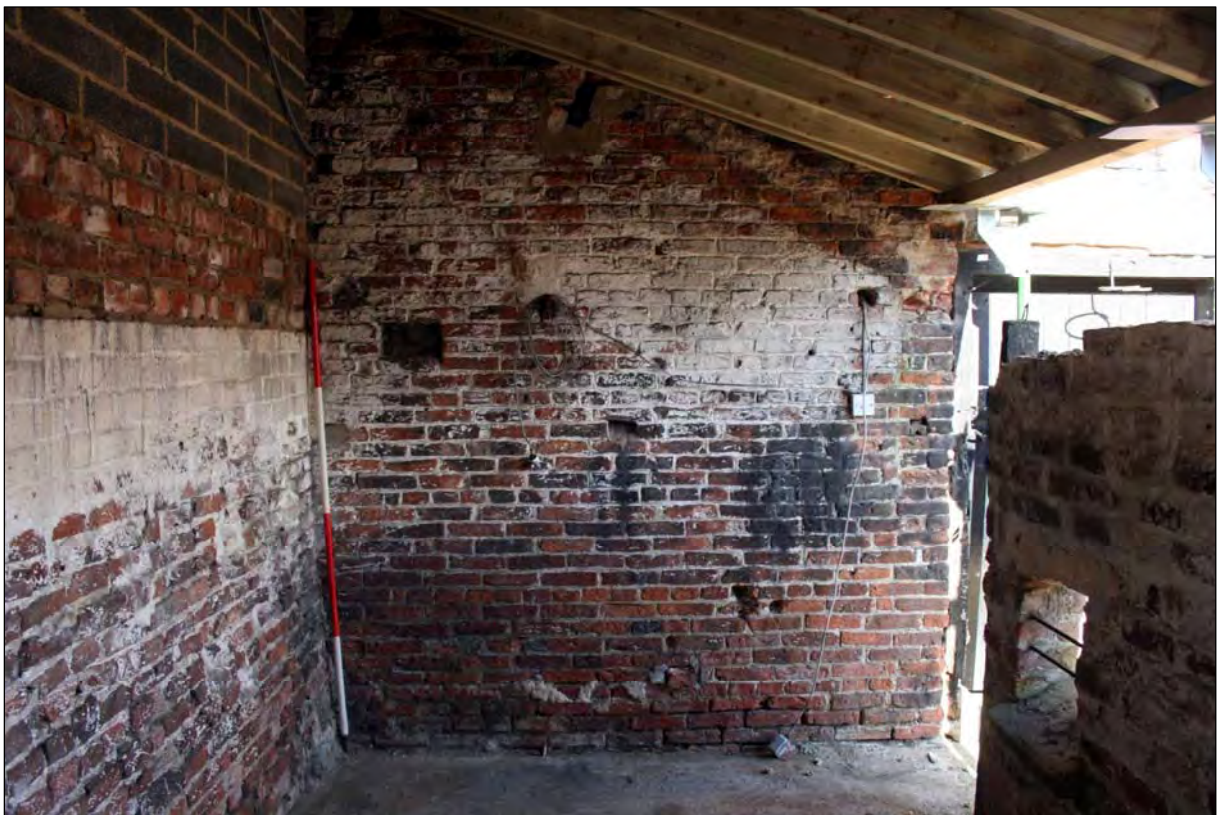
formed by the earlier constructed stable B4 (Plate 28). The construction joined between the two builds could be clearly seen (Plate 29). The southeastern half of the range was part way through conversion and restoration and original wall elevations were exposed. Again these elevations displayed a patchwork of different brick with a blocked up doorways within the northwest southeast and northeast elevations (Plates 30 and 31). Small blocked up openings were visible within the southwest and northwest elevations (Plate 32).

Plate 28. B2 interior NW looking NE (image no. 247).

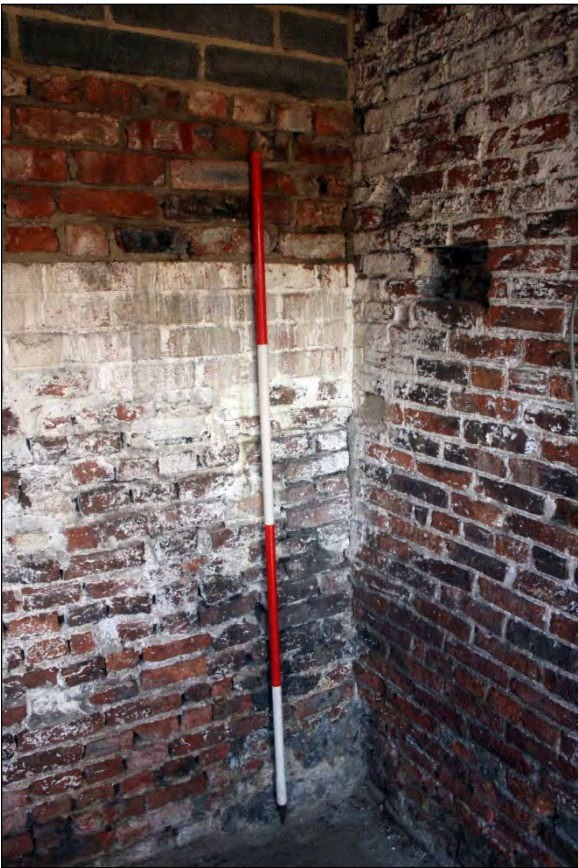
Plate 29. B2 interior NW looking west (image no. 249).

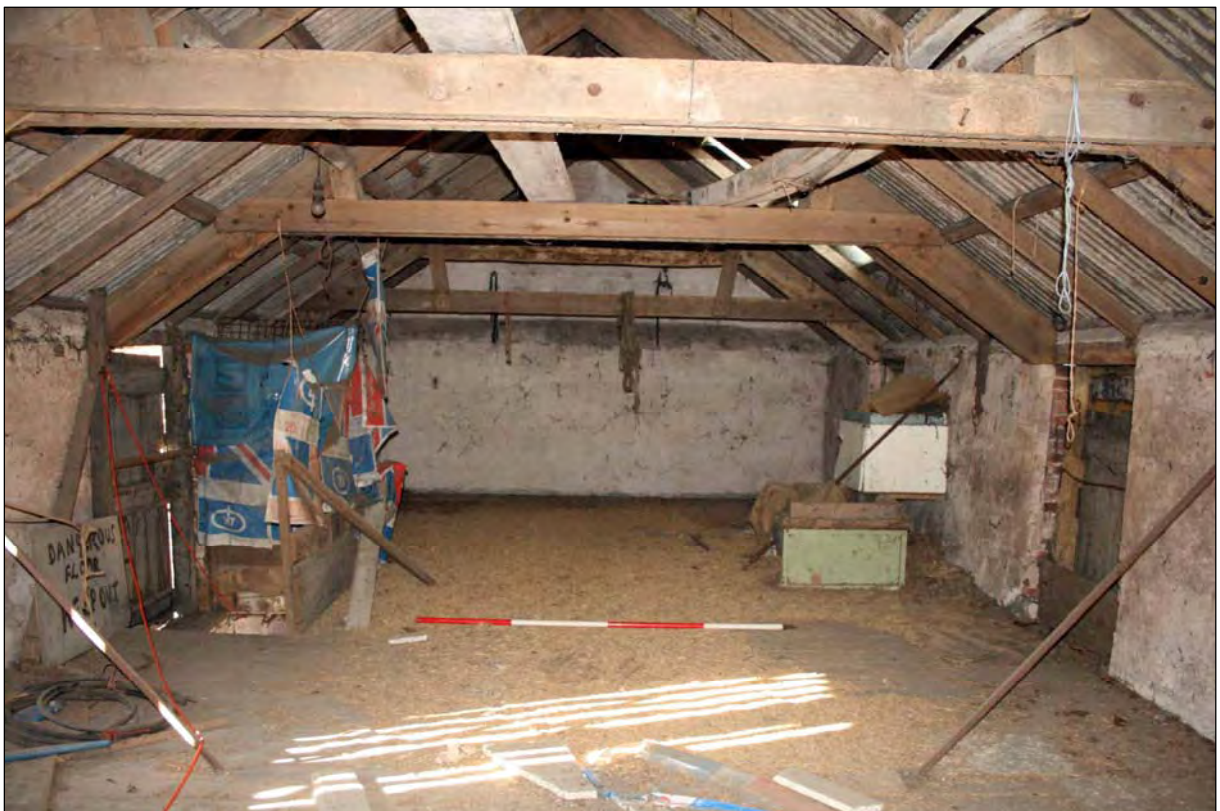
B3 first floor had wooden flooring with rendered whitewashed walls with wooden trusses and rafters (Plate 40). The northwest elevation had a doorway and a window opening (Plate 41). Located in the floor between the doorway and window was a high sided wooden opening. The northeast elevation had a narrow doorway opening leading to B1 first floor (Plate 42). The southeast elevation had window opening and a doorway opening above wooden steps leading down to the ground floor (Plate 43). B3 ground floor had whitewashed walls with wooden ceiling beams supporting the above storey floor rafters (Plates 44 and 45). The northwest elevation had a doorway opening with a metal lintel (Plate 46). Located to the side of the doorway was an electric operated thresher machine. The southeast elevation had a double and single doorway openings, the single doorway had bull-nosed reveals. Also located on the southeast elevation were wooden steps leading to the first floor.

Plate 40. B3 interior first floor looking SW (image no. 044).

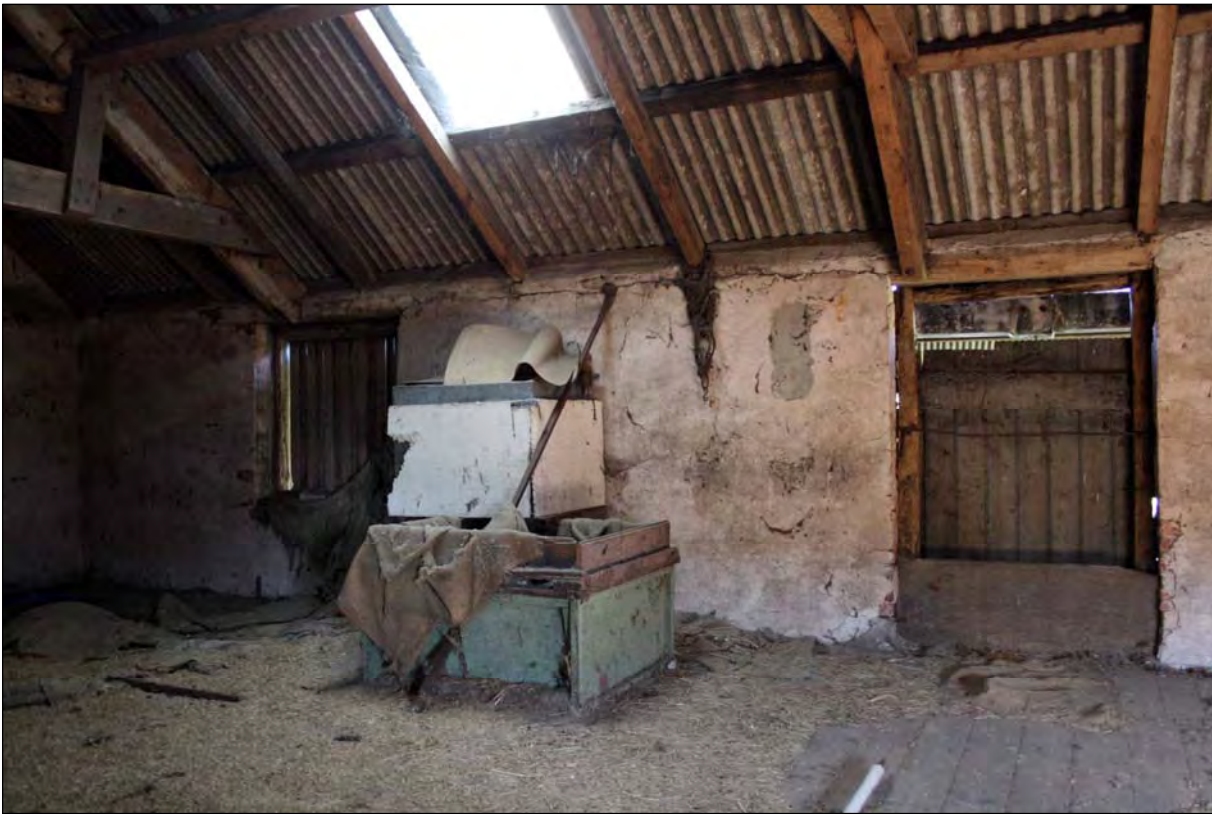
Plate 41. B3 interior first floor looking west (image no. 067).

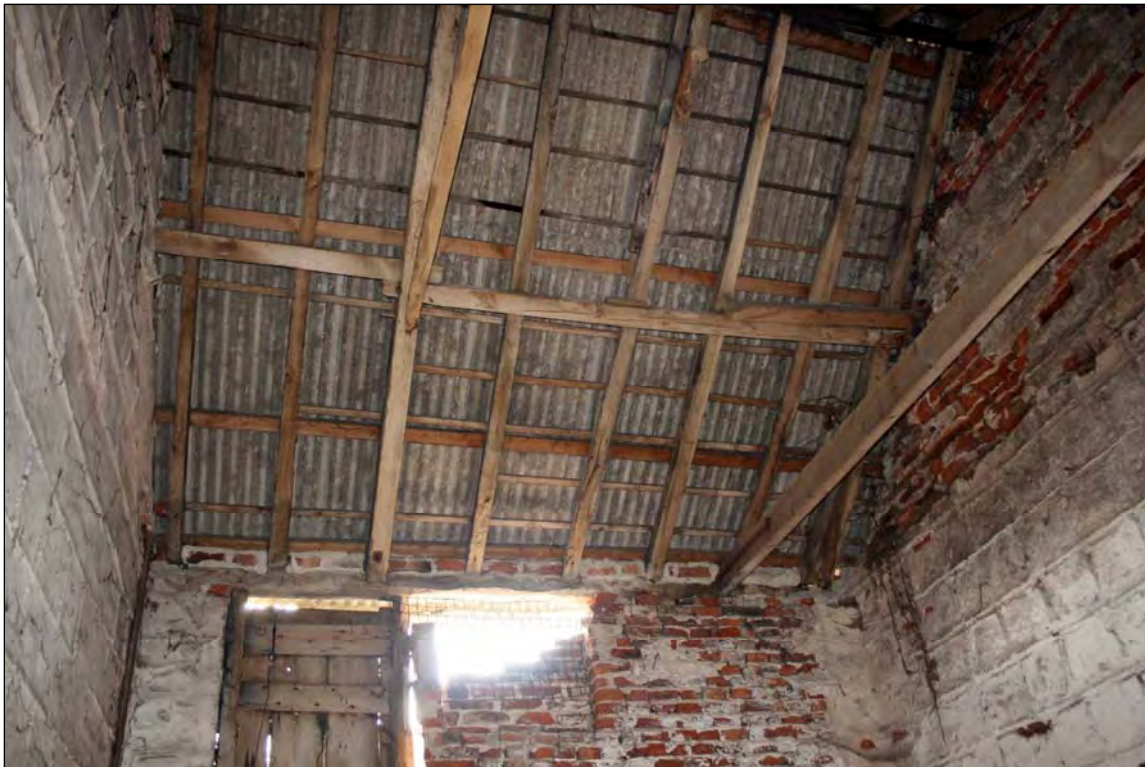
B4 interior had whitewashed walls with wooden trusses and rafters (Plates 47 and 48). Originally this building had a first floor but this had been removed, evidence of this could be seen at first floor level. The northwest elevation had blocked up doorway and a small water-piped metal water trough within its northern corner (Plates 49 and 50). Located on the southeast elevation was a loft door and blocked window openings at first floor level and a stable door at ground floor level.

Plate 47. B4 interior looking SE (image no. 191).

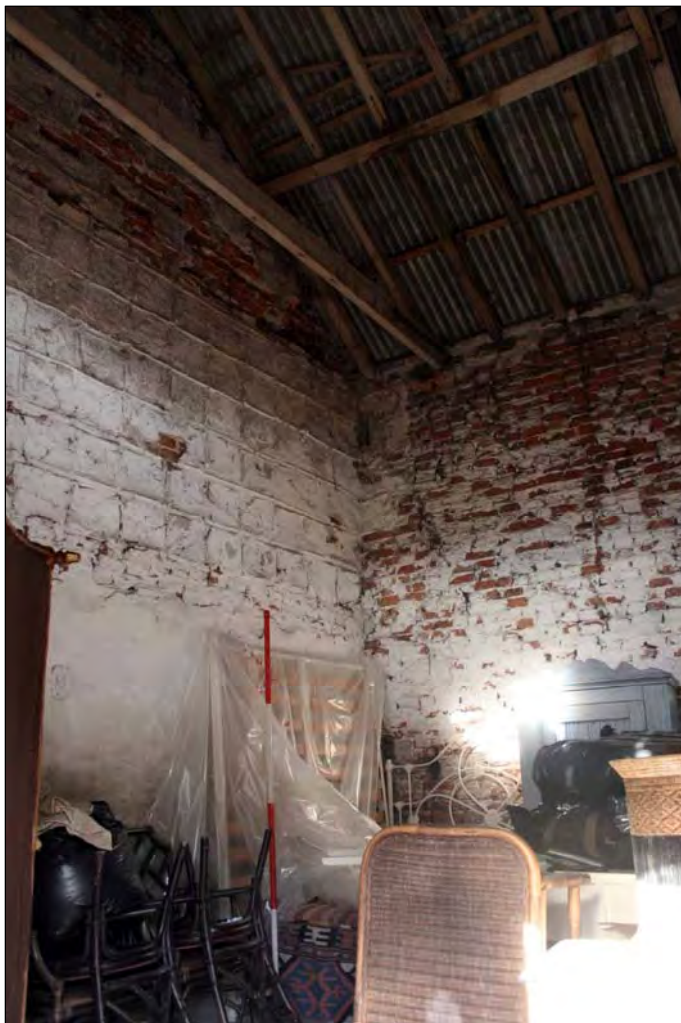
Plate 48. B4 interior looking west (image no. 169).

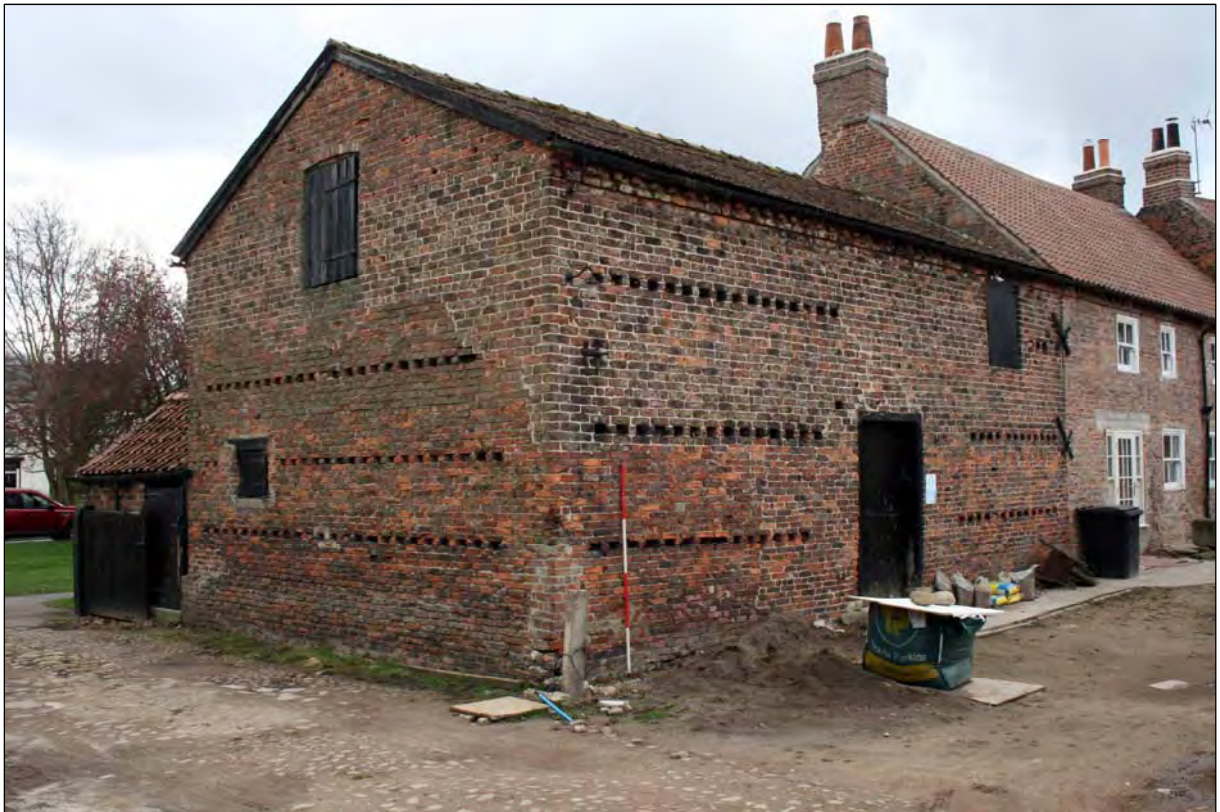
The barn was constructed in red brick in English garden wall bond with dentilated brickwork eaves with a pitched corrugated iron roof and guttering (Plate 51). Located on the southeast elevation was a central tall double door with a large thick wooden lintel (Plate 52). Flanking the doorway were rows of brick ventilation holes. To the northeast side was a small single storey shed. The northeast gable elevation had a high window opening with a hinged wooden shutter (Plate 53). Below the window was a later intrusion of a small opening and three rows of brick ventilation holes. To the southeast was the small extension. The northwest elevation had a central ground floor doorway opening and a high window opening with a hinged wooden shutter to the southwest (Plate 54). This elevation also had three rows of brick ventilation holes. Construction joins between the cottage and the barn could be clearly defined on both the southeast and northwest elevations. Tie plates were visible on both these elevations where both buildings join each other.

Plate 51. B5 exterior looking south (image no. 406).

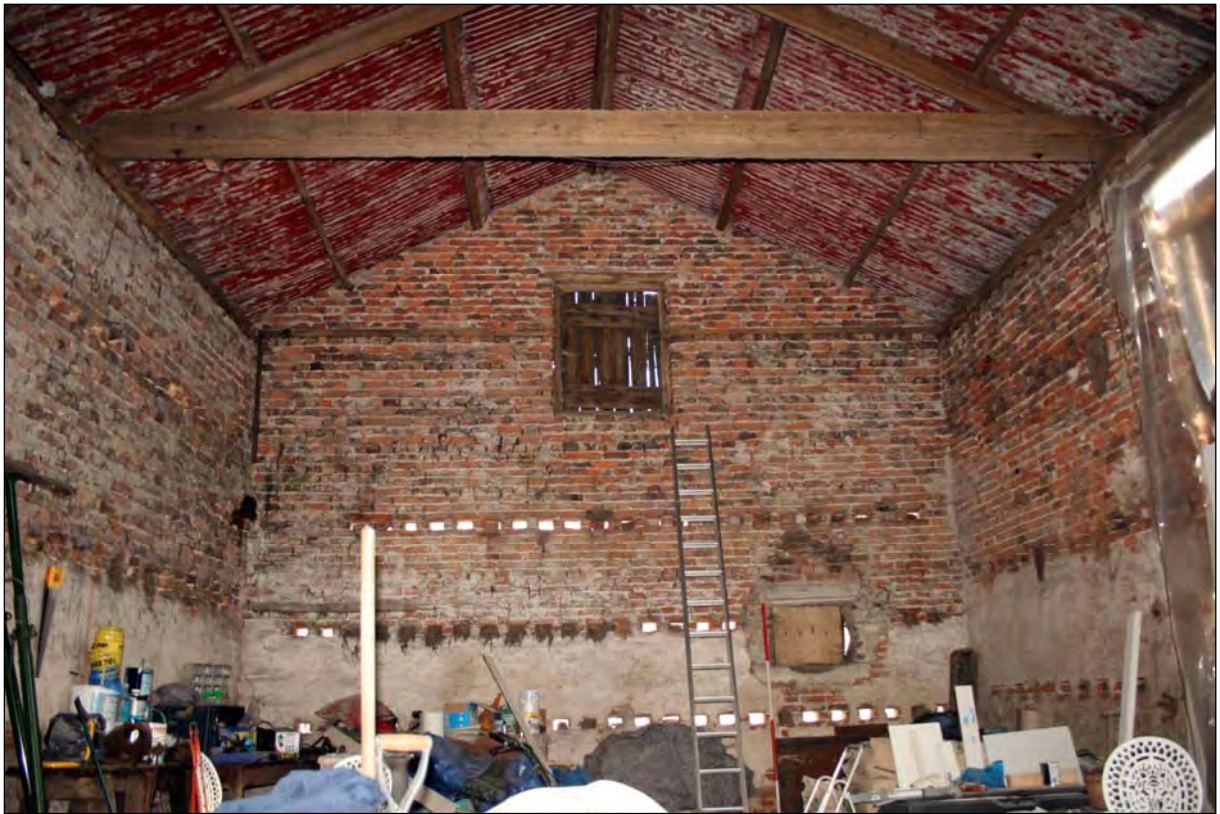
B5 interior was one large space lower ground level rendered whitewashed walls with wooden trusses and rafters (Plates 55 and 56). Located within the southeast elevation was the large central tall barn door and on the opposing elevation a small central doorway opening and a higher first floor level window opening (Plates 57 and 58). The northeast elevation had a high central loft window and a later intrusion of a small opening. The southwest elevation formed the northeast wall of the cottage and appeared to have been constructed against by the barn. With the exception of the southwest elevation the brick ventilation holes were seen throughout.

Plate 55. B5 interior looking NE (image no. 281).

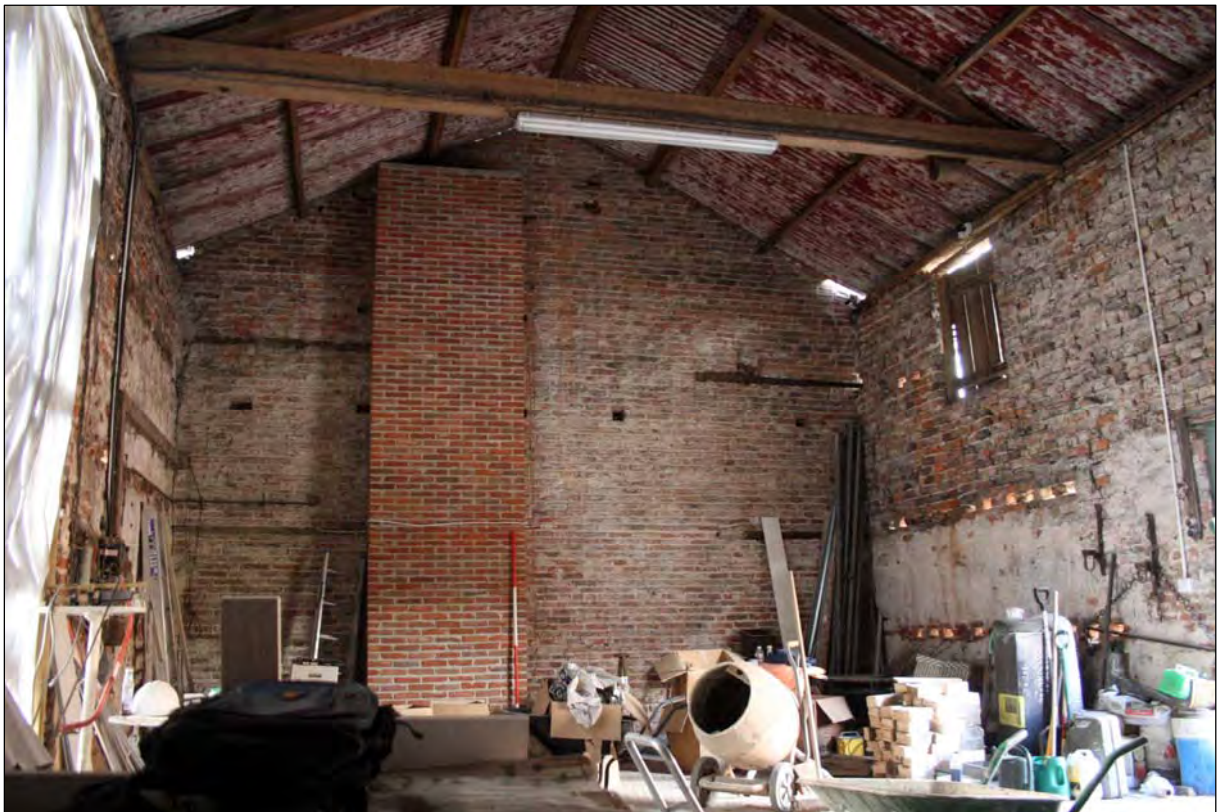
Plate 56. B5 interior looking SW (image no. 296).

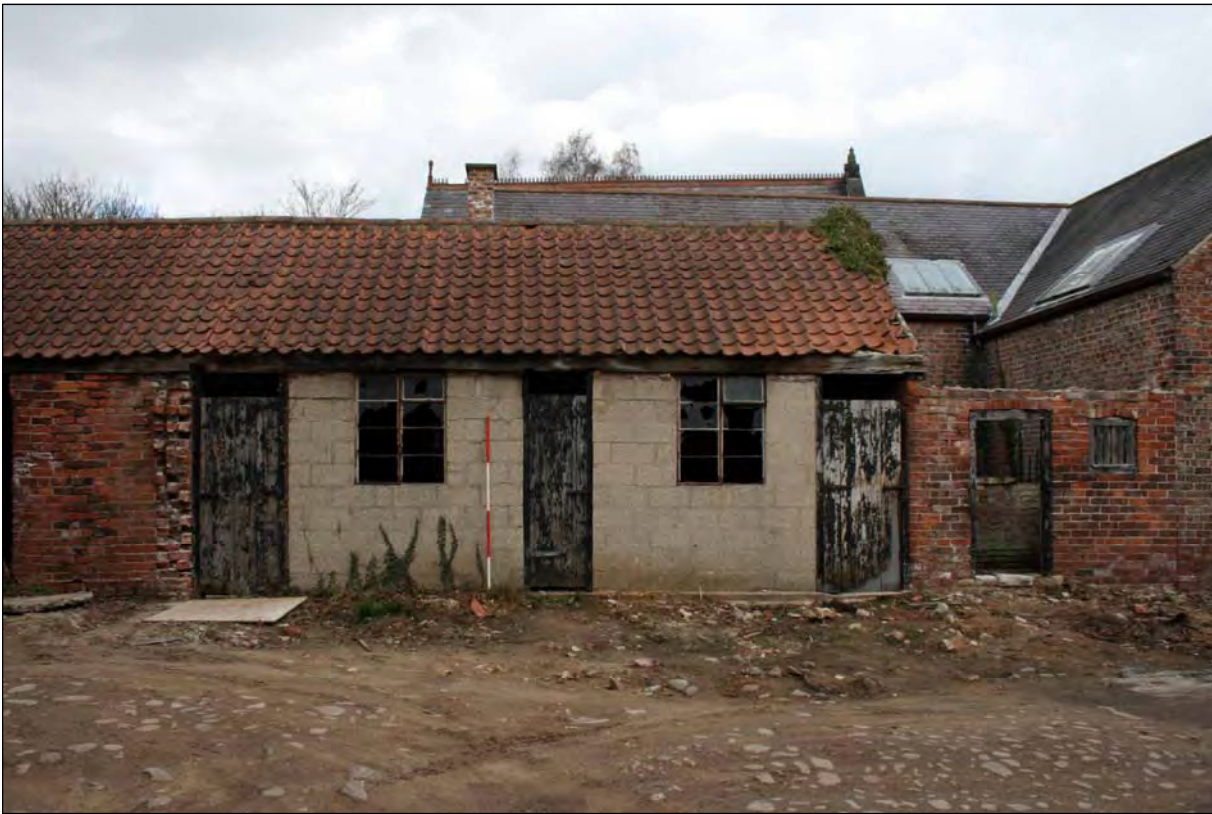
B6 formed a separate northwest to southeast range set back from courtyard to the northeast. This range comprised of a single storey with two main cells that probably once formed open fronted cart storage sheds (Plate 59). B6 was constructed in red brick in English garden wall bond with a pitched pan-tiled roof. The southwest elevation had a long continuous wooden lintel (possibly re-used) at roofline level with a wide opening to the northwest with bull-nosed sides (Plate 60). This opening appeared to have been reflected to the southeast where the former opening was in-filled in with modern breeze blocks window and doorway openings (Plate 61). To the southeast was a roofless low extension with a doorway and window opening (Plate 61).

Plate 61. B6 exterior SE looking northeast (image no. 459).

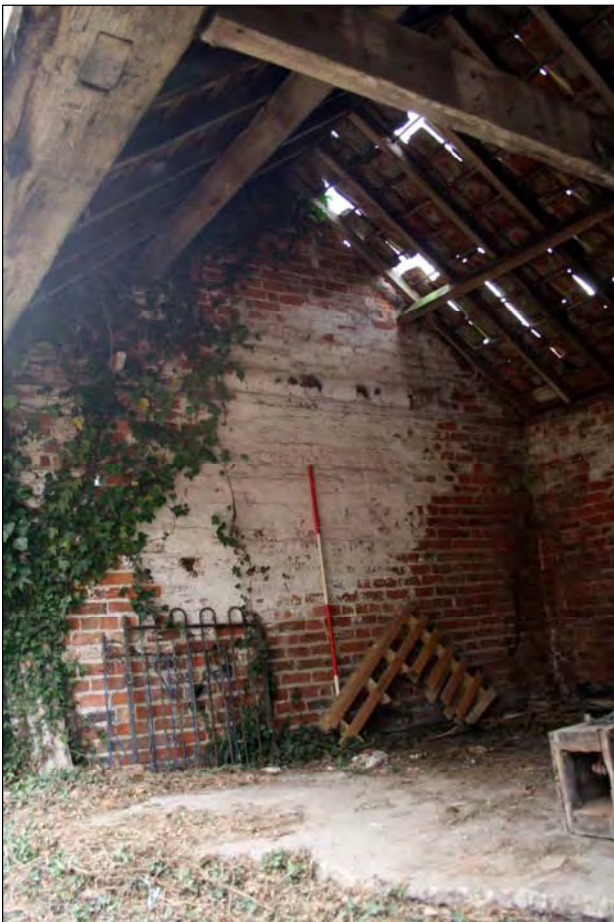
Both of the cell interiors were similar with whitewashed walls with wooden trusses and rafters (Plate 62). The southeast cell had modern low breeze block divisions and a long wooden feeding rack along the northeast elevation (Plate 63).

Plate 62. B6 interior NW looking north (image no. 467).
