MODEL FARM, THE GREEN, UPPER POPPLETON,
YORK.

REPORT ON A HISTORIC BUILDING RECORDING SURVEY
OSA REPORT NO: OSA19BR04

April 2019.

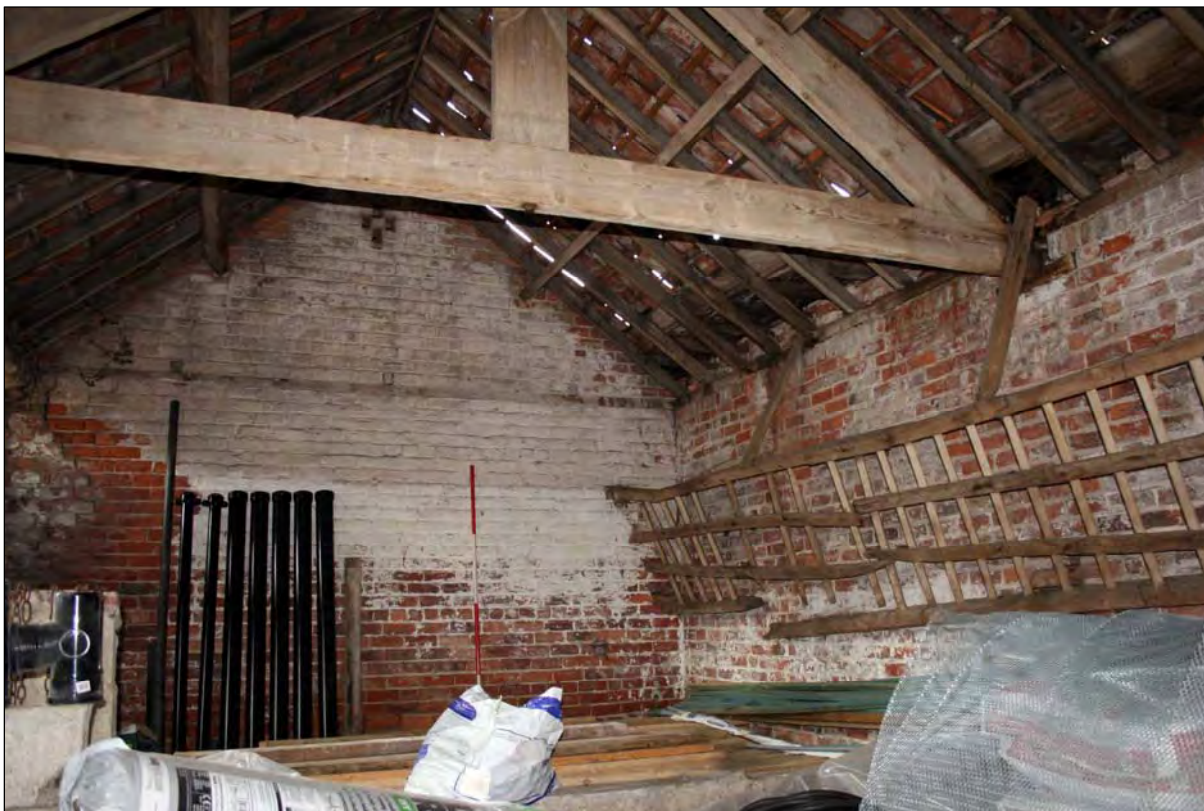
Both of the cell interiors were similar with whitewashed walls with wooden trusses and rafters (Plate 62). The southeast cell had modern low breeze block divisions and a long wooden feeding rack along the northeast elevation (Plate 63).

Plate 63. B6 interior looking NW (image no. 478).
