St Chad's Church, Montford, Shropshire:
Repairs to Churchyard Wall

Archaeological Monitoring

SLR Ref : 406.04217.00001

November 2012

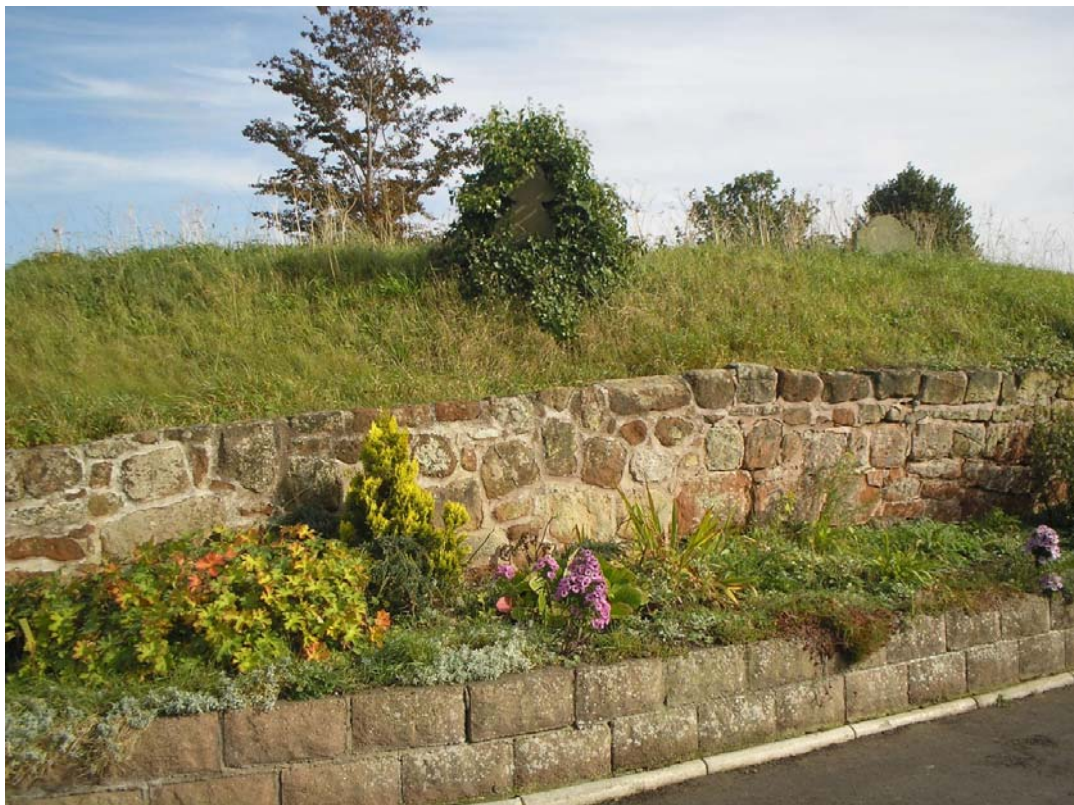
Figure 2 Detail of part of wall requiring repair 19/10/12

Repairs were undertaken to an eight metre length of the churchyard wall on the north-western side of the churchyard (Figures 1 and 2), which acts as the boundary between the churchyard and the driveway to a bungalow. The height of the churchyard deposits behind the wall had resulted in pressure against the wall in this location, destabilizing it so that it had bulged out and was likely to collapse in the near future. The design for the rebuilding of the wall and a specification for the engineering work is attached as Appendix A.

1. An 8m long section of the churchyard retaining wall is leaning badly into the neighbouring property. This needs to be taken down and rebuilt. See attached photograph.

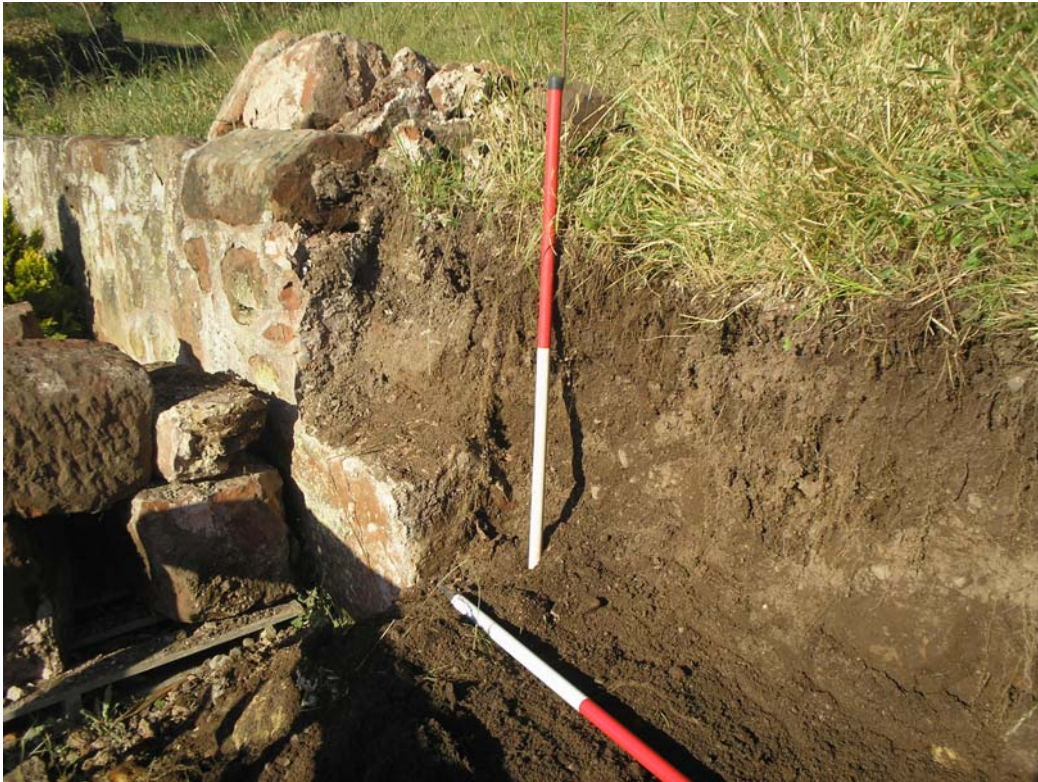
Figure 3 North-west end of dismantled wall section 5/11/12

View looking north showing part of wall which was not dismantled, with coping stone capping it. The backfill material behind the dismantled section of wall comprised loose sandy soil, with some root disturbance to c.0.5m depth from ground surface. This was then cut into by c.0.5m by mechanical excavator to form the foundation for the new wall construction (compare to Figure 8).

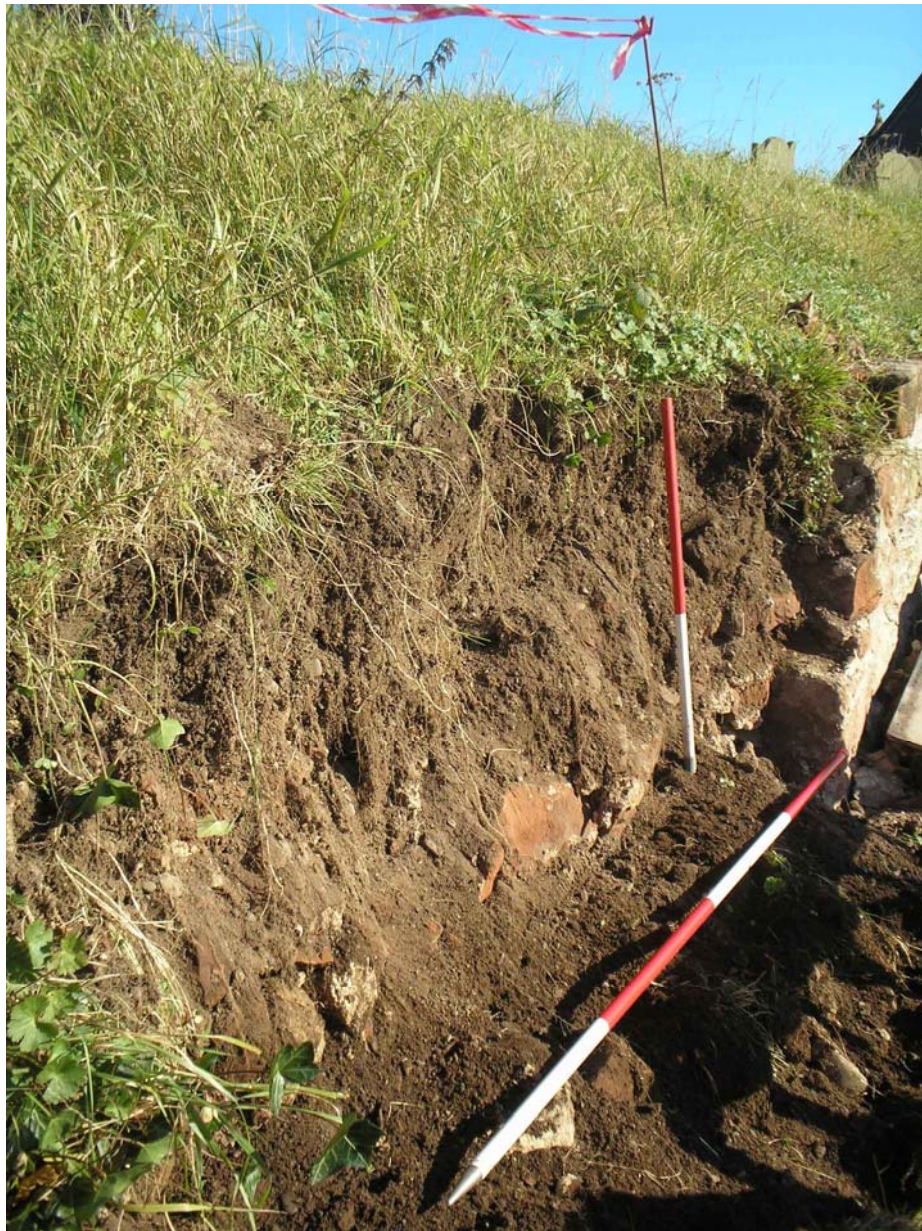
Figure 4 North-eastern end of dismantled wall section 5/11/12

Note some stone rubble infill behind the dismantled wall line, and loose backfilled soil matrix above and around the rubble, before the machine excavation of c.0.5m into the face of the deposit sequence (compare to Figures 5 and 6).

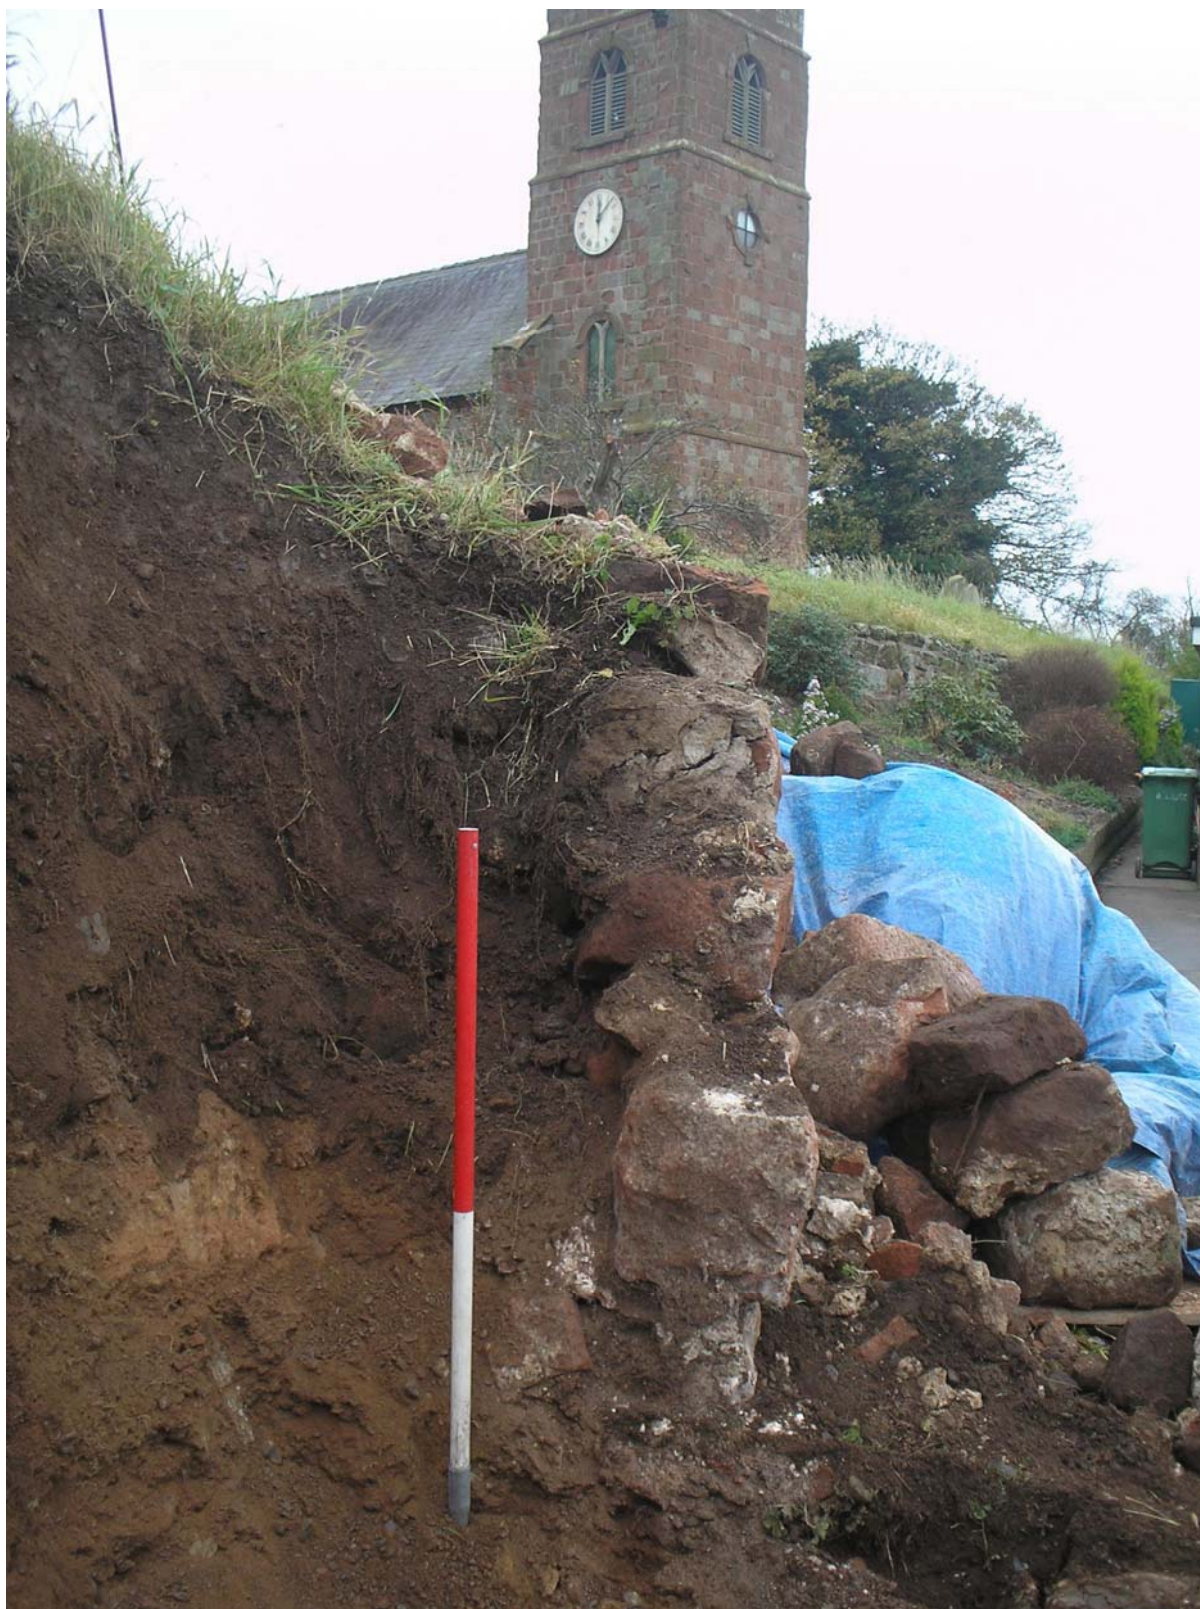
Figure 5 North-eastern end of excavated section 6/11/12

View looking south-east showing section of wall which was not dismantled, and sequence of deposits that form the churchyard behind it. This photograph also shows the relationship to ground surface, slope of ground down towards the wall, its relative proximity to the west end of the church, and how the repaired wall projects at an angle from the more curving boundary wall around the church itself.

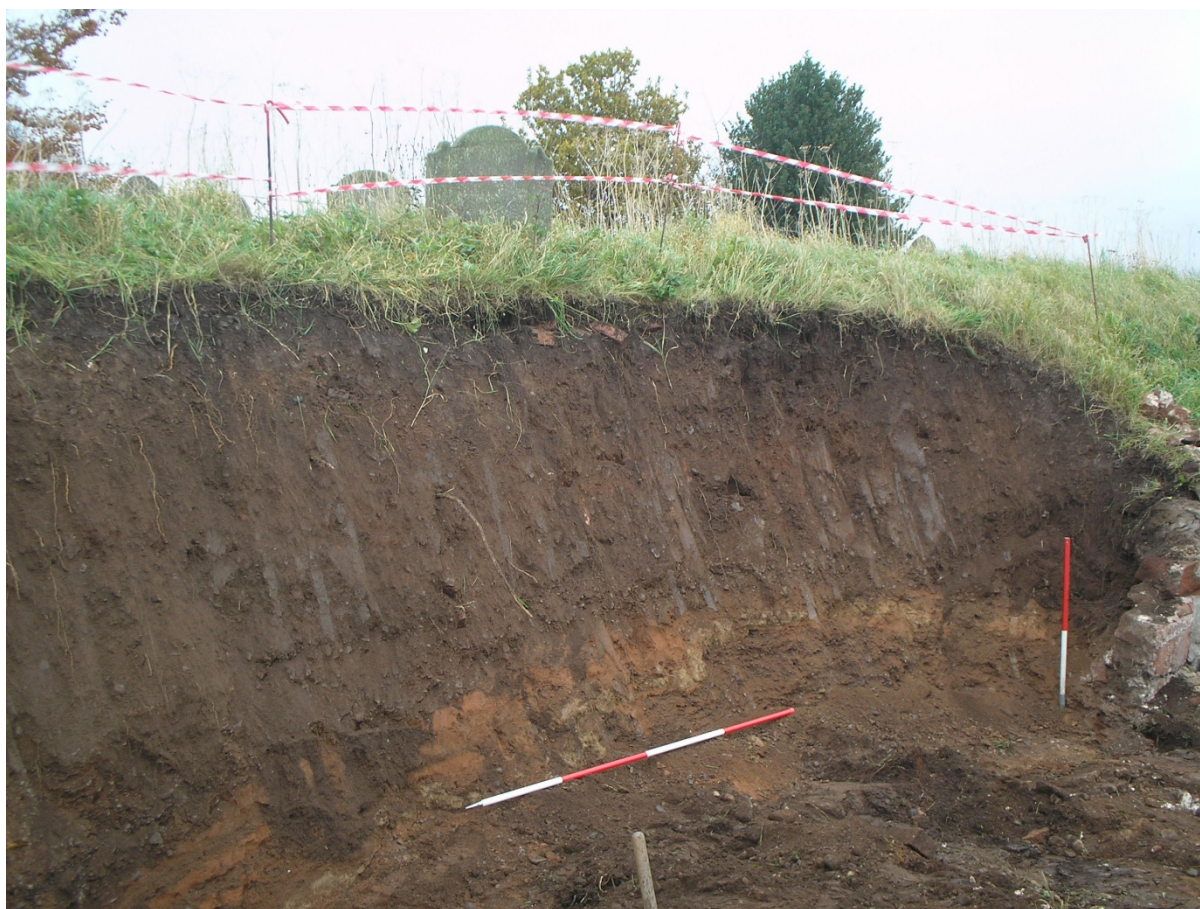
Figure 6 North-eastern part of excavated section 6/11/12

The repair works did not disturb any archaeological remains, and the exposed section has demonstrated that graves do not extend right to the edge of the churchyard (Figure 6 shows the proximity of gravestones). The stratigraphic sequence revealed a thick sandy loam that had accumulated above the natural river terrace deposits.

This photograph, looking east, shows the scraped face of the excavation into the churchyard deposit sequence. Beneath the topsoil 2m of sandy loam has accumulated above a 0.2m band of clay, which capped the loose pebbly river terrace deposits beneath (compare to Figure 8).

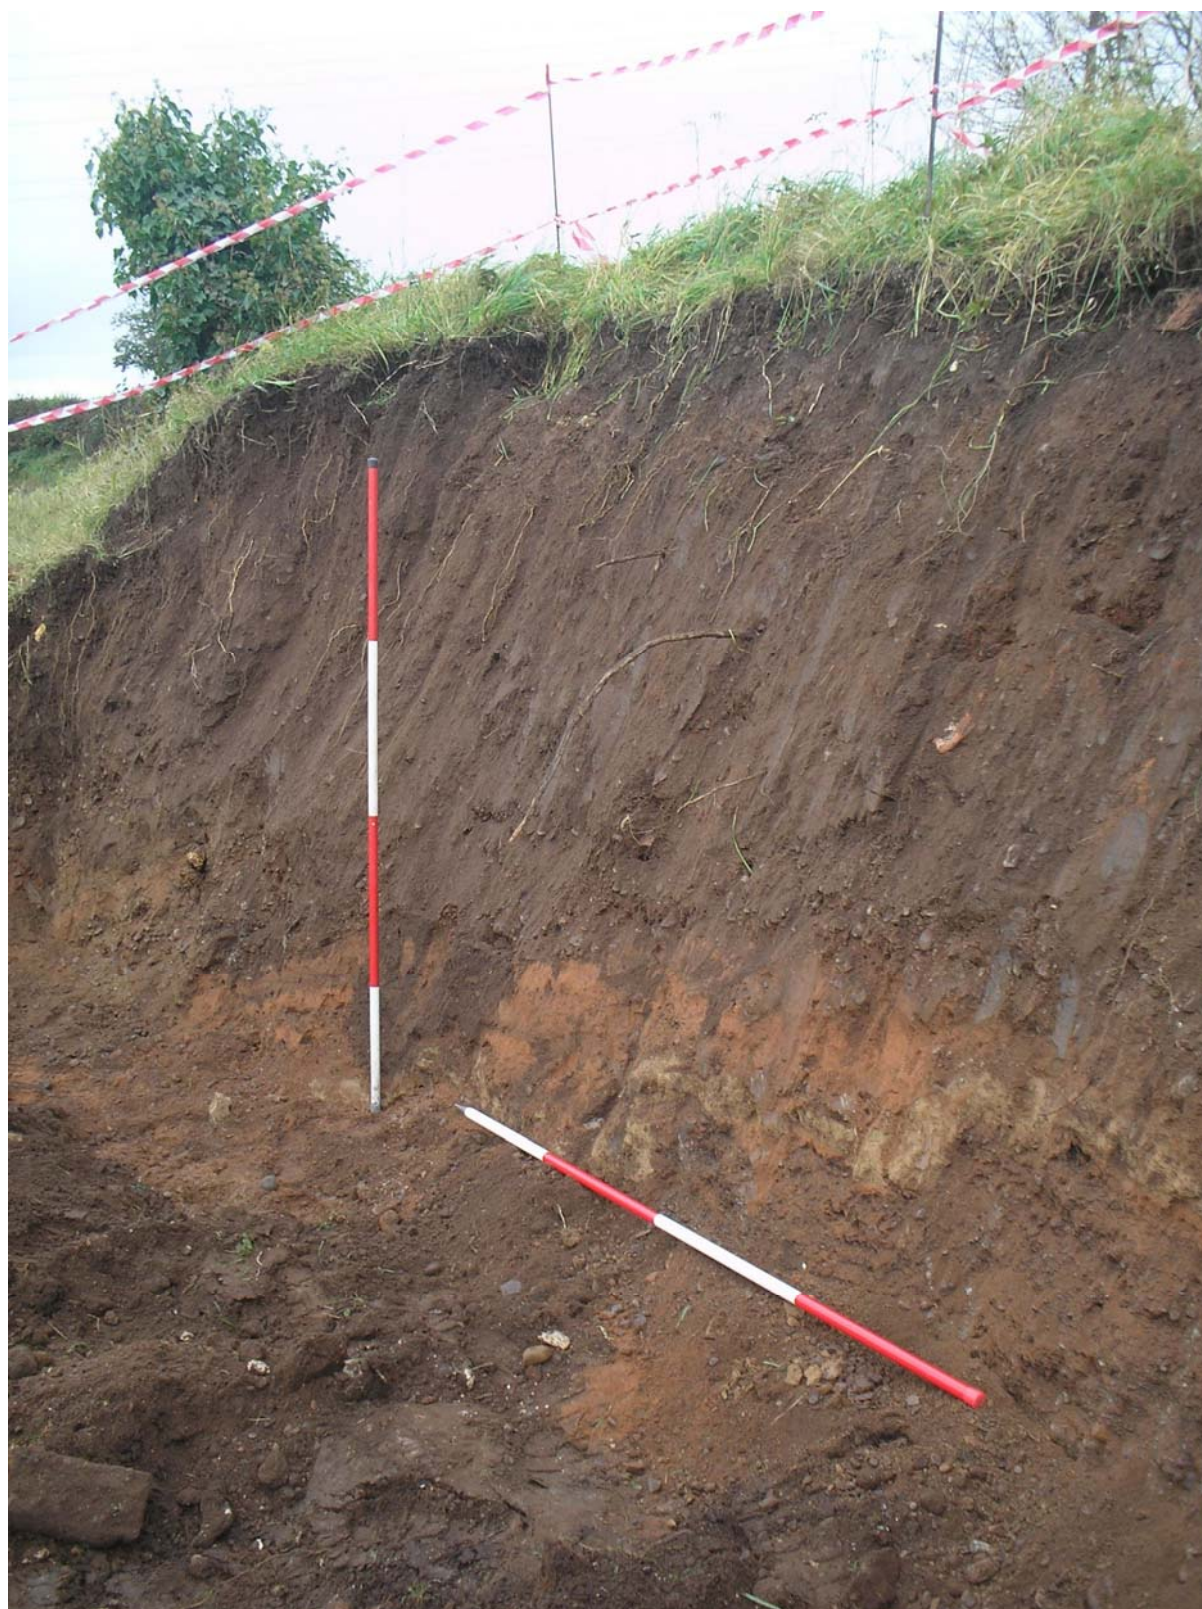
Figure 7 Central part of excavated section looking north 6/11/12

Detail of deposit sequence, looking north. Note the layered pebbles (river terrace deposit) beneath the clay layer on right of photograph.

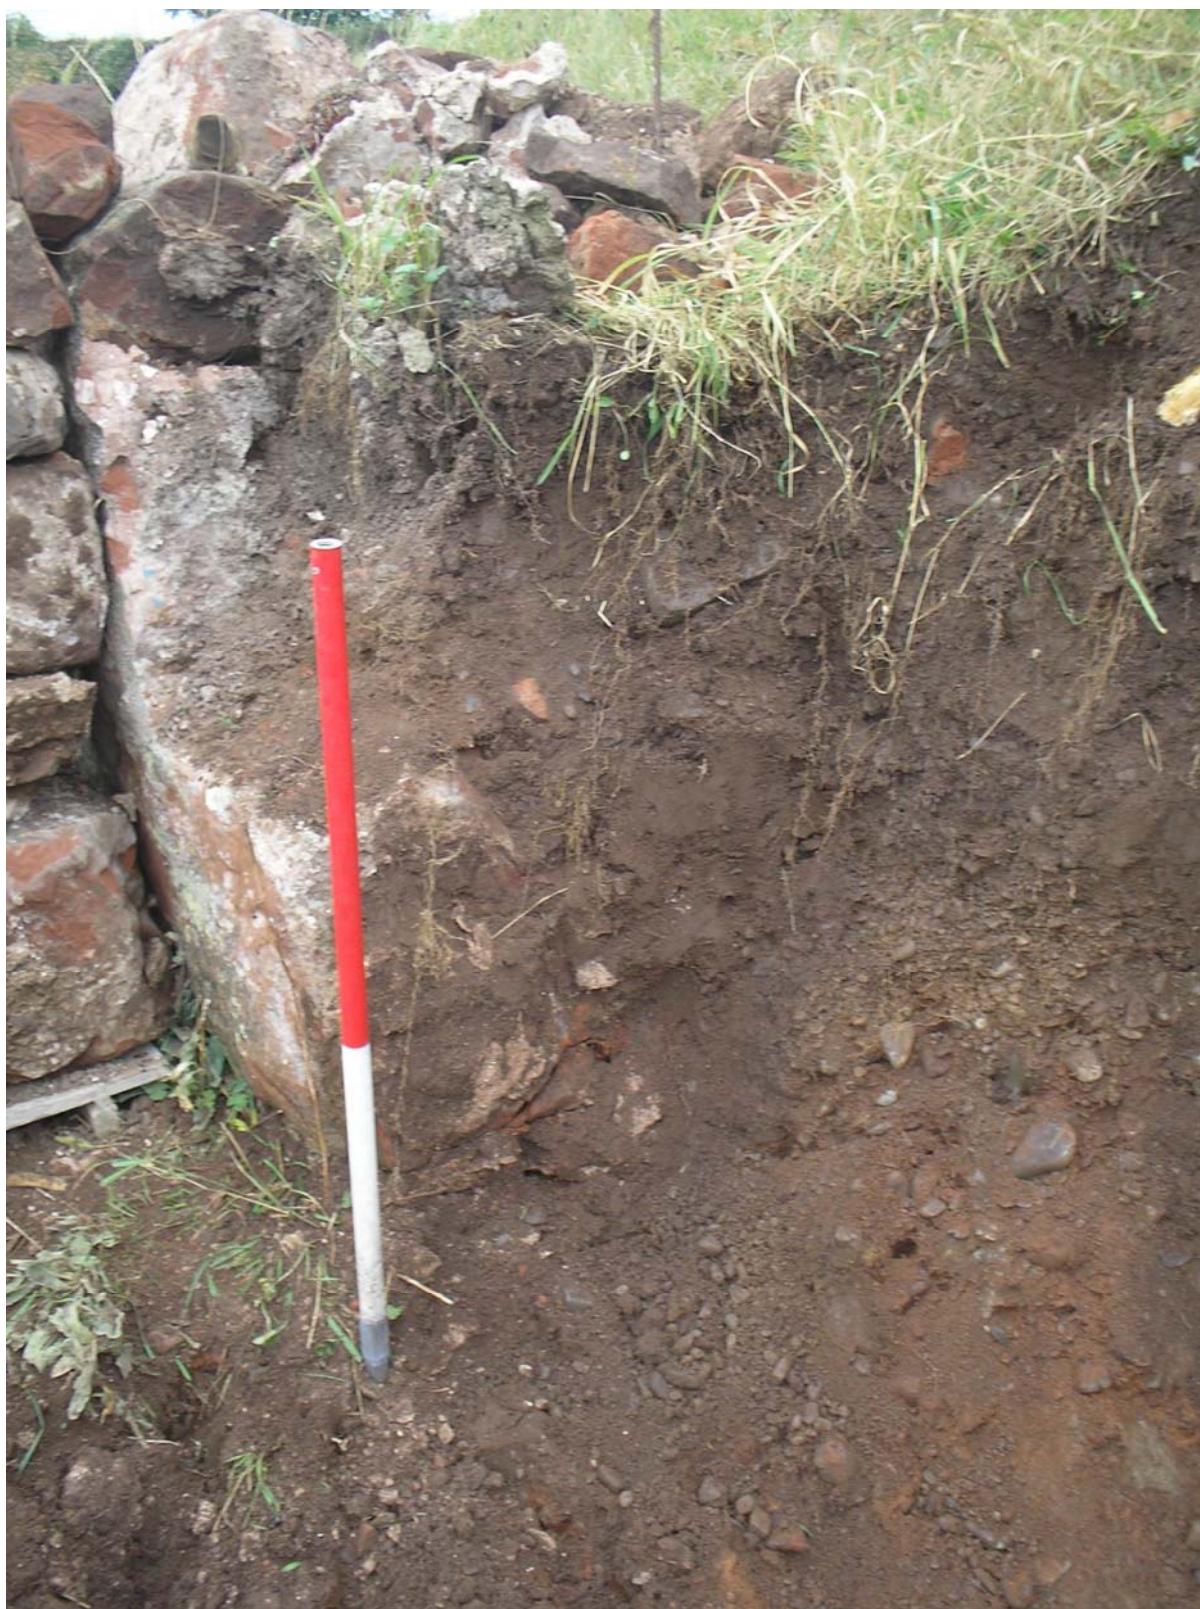
Figure 8 North-western part of excavated section 6/11/12

North-western end of dismantled wall showing less accumulation of the churchyard sequence above the river terrace pebbly deposit, than at the other end of the dismantle wall where c.2m of build-up has occurred.

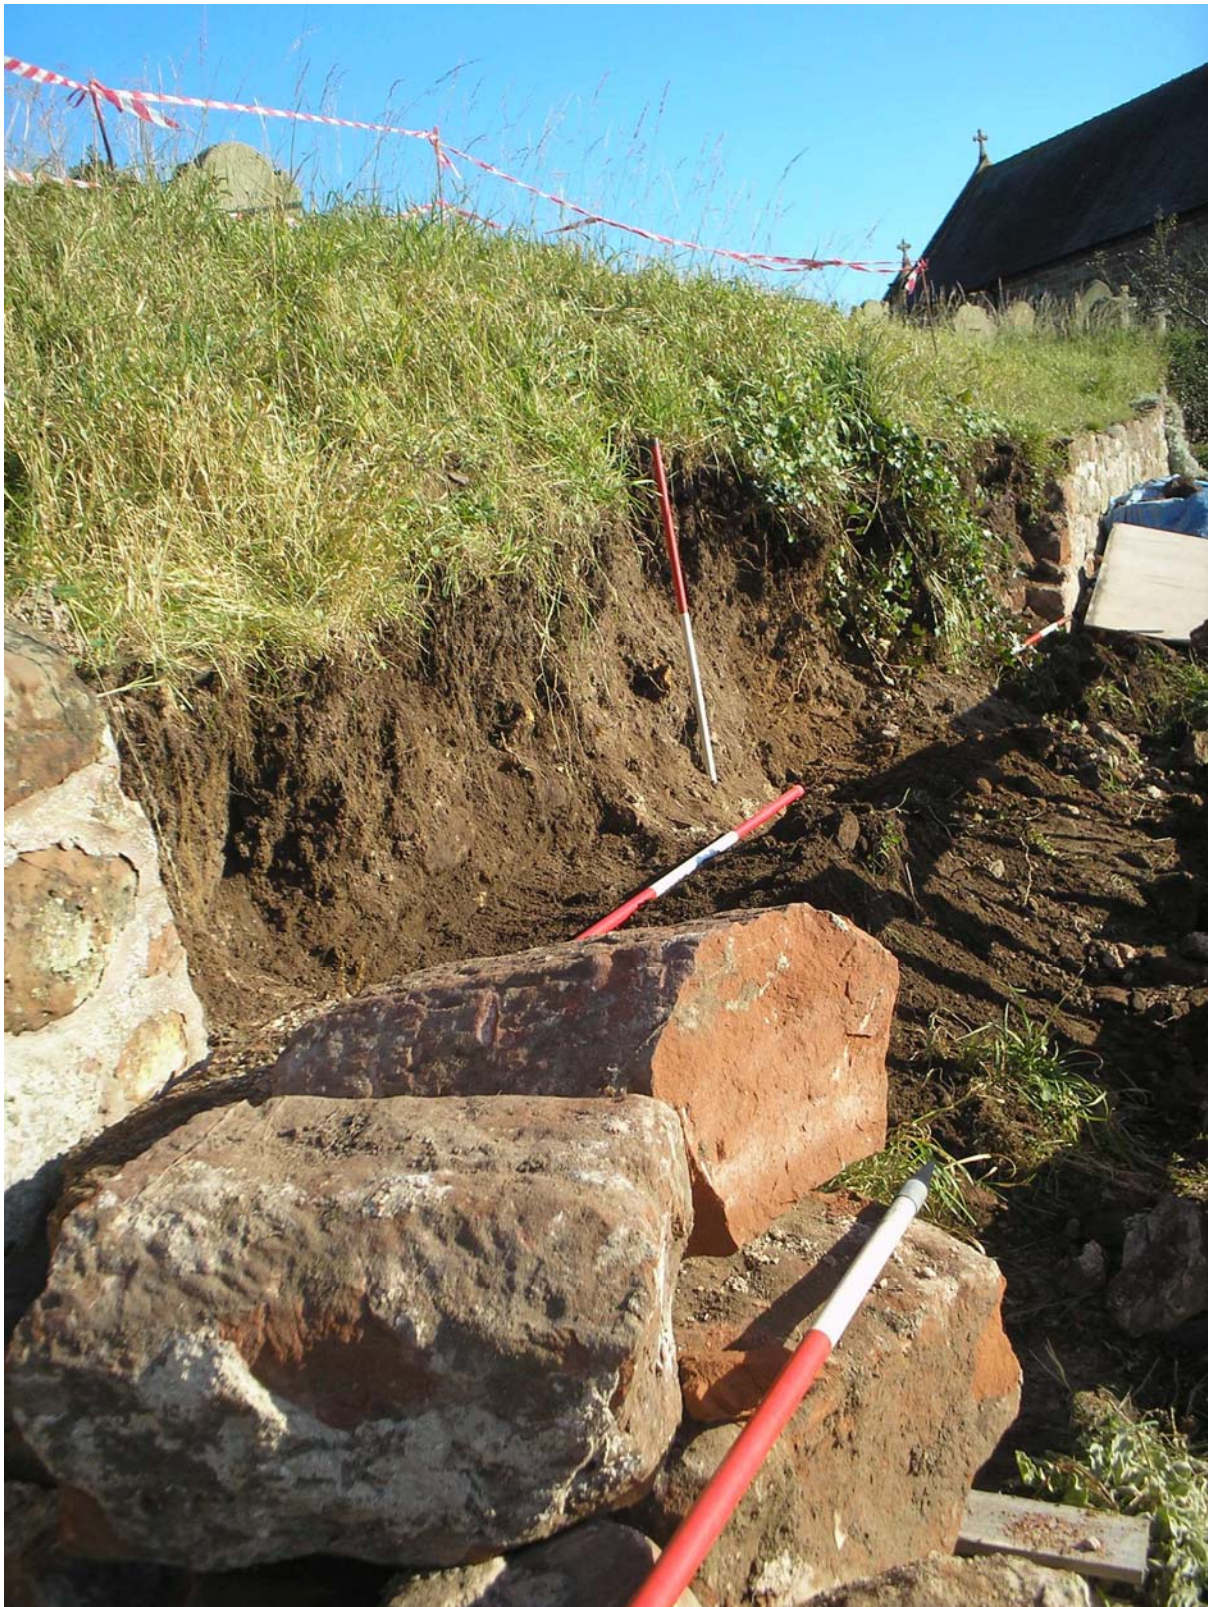
Figure 9 Carved coping stones reused as part of dismantled wall 5/11/12

The original construction of the dismantled wall had included cutting back into these deposits and then building the wall with roughly-cut, irregular red sandstone blocks (25 x 30 x 25 – 25 x 45 x 25cm), mortared together. Shaped coping stones (30 x 35 x 50cm) had been re-used within this wall construction, similar to those still visible as capping the churchyard wall on its

western and northern sides (Figures 3 and 9). The void between the old wall and the churchyard deposits had been filled with broken bits of sandstone and other rubble, as well as backfilled with loose soil.
