Land to the Rear of The Habit, 30 - 32 East Castle Street,
Bridgnorth

Heritage Statement:
survey of wall sections, analysis and historic mapping
along Castle Terrace and Bank Street

SLR Ref : 406-04694-00001

December 2013

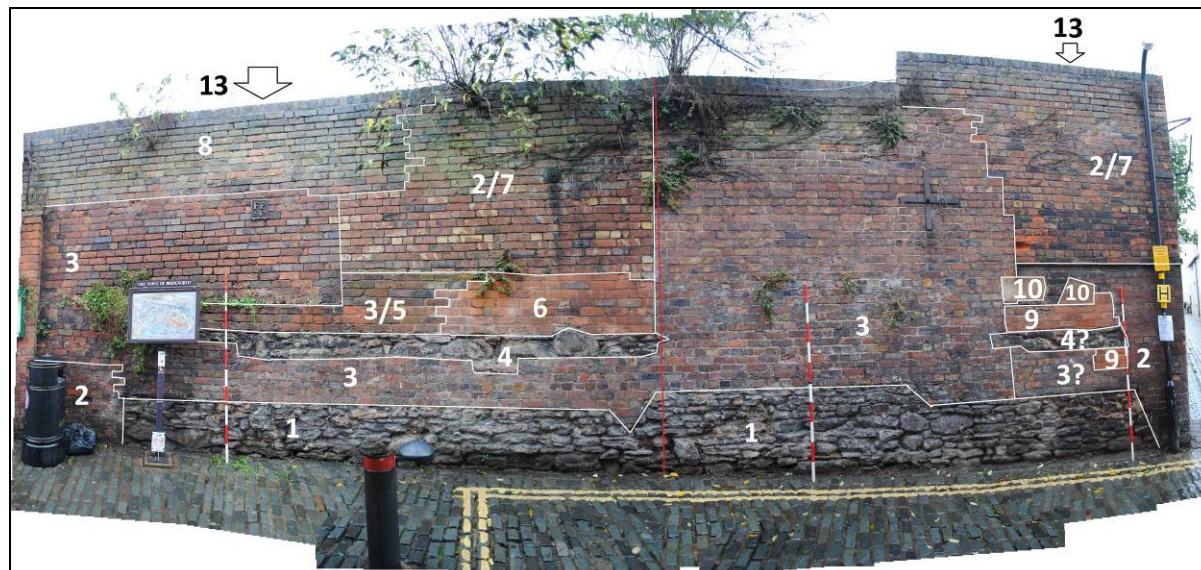
The Castle Terrace wall section (Figure 1) measures c. 13m in length and stands around 4.6m in height. It comprises mainly of unfrogged brick types that sit on a stone plinth (once forming a complete wall section). Identified within this wall section were ten construction phases (see Table 1; Phase 1 to 10), the earliest probably dating to the late medieval/early post-medieval period and comprising stone rubble coursing and forming the north-eastern section of a curtain wall belonging to Bridgnorth Castle (Phase 1). Laid onto this phase is a further nine construction phases (Phases 2-10) including a number of rebuilding phases (e.g. Phase 3) and a phase that involved raising the height of the wall (Phase 2/7).

The earliest brickwork (Phase 2), comprising unfrogged 18th/19th century imperial size 3" brick is located in two areas; the most intact area is within the southern section of the wall (Figure 1). Originally both areas may have formed one continuous section, extending from the junction between Castle Terrace and Bank Street south to a sandstone-block arched entrance with ogee-type head. This medieval-style entrance with castellated brick capping, once provided access to the former Ball Hotel from Castle Terrace (Figure 3). Despite the medieval appearance of this entrance, this structure probably dates to the mid-19th century.

At some point within the late 19th or early 20th century history of the wall, the northern section appears to have become unstable, resulting in the insertion of a cast-iron cross-tie into Phase 3. Within the same brickwork phase there is a clear interface between Phase 3 and Phases 2/7, 6 and 4, (shown as a vertical red line on Figure 1) suggesting the convergence of two buildings, as seen on a photograph dated c. 1900 where there is evidence that the wall section represented three buildings, possibly dwellings (Figure 4)⁵.

Figure 1
The Castle Terrace wall section, looking west

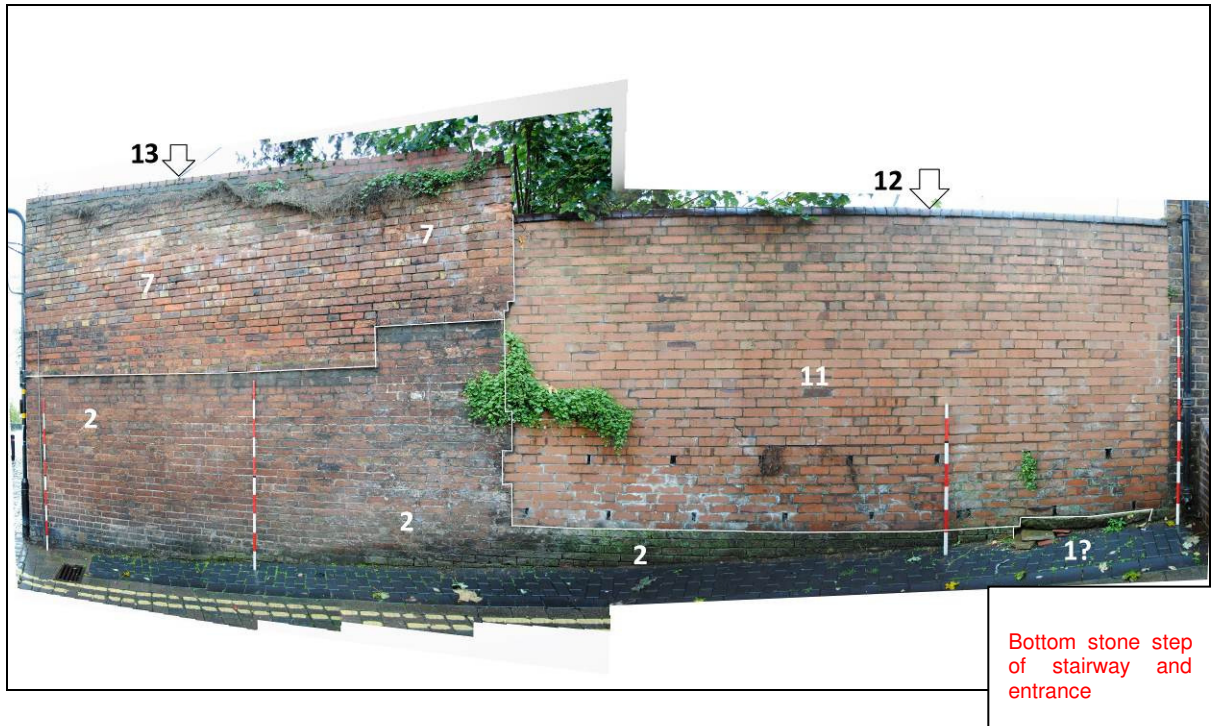
The wall section in Bank Street extends c. 12m in length and abuts the eastern elevation of No. 5 Bank Street. The earliest phase within this wall section (Phase 2) is identical to brickwork located on the Castle Terrace wall section (and is physically connected). The western section of the wall is constructed of a 20th century frogged rustic-type brick (Phase 11). This phase, the latest in the brick sequencing, probably represents a recent blocked-in entrance or a complete rebuild of this section of the wall. A clear vertical line exists between this wall section and the earlier wall phasing (Phases 2 and 7). The rustic brickwork sits on top of the earlier Phase 2 brick coursing. Along the entire Bank Street wall section, both the earlier and modern brickwork has been finished with mounded curvilinear brick capping, using conventional terracotta red brick sets and blue engineering brick (Phases 12 and 13).

Figure 2
The Bank Street wall section, looking south, and detail of western end with step (below)

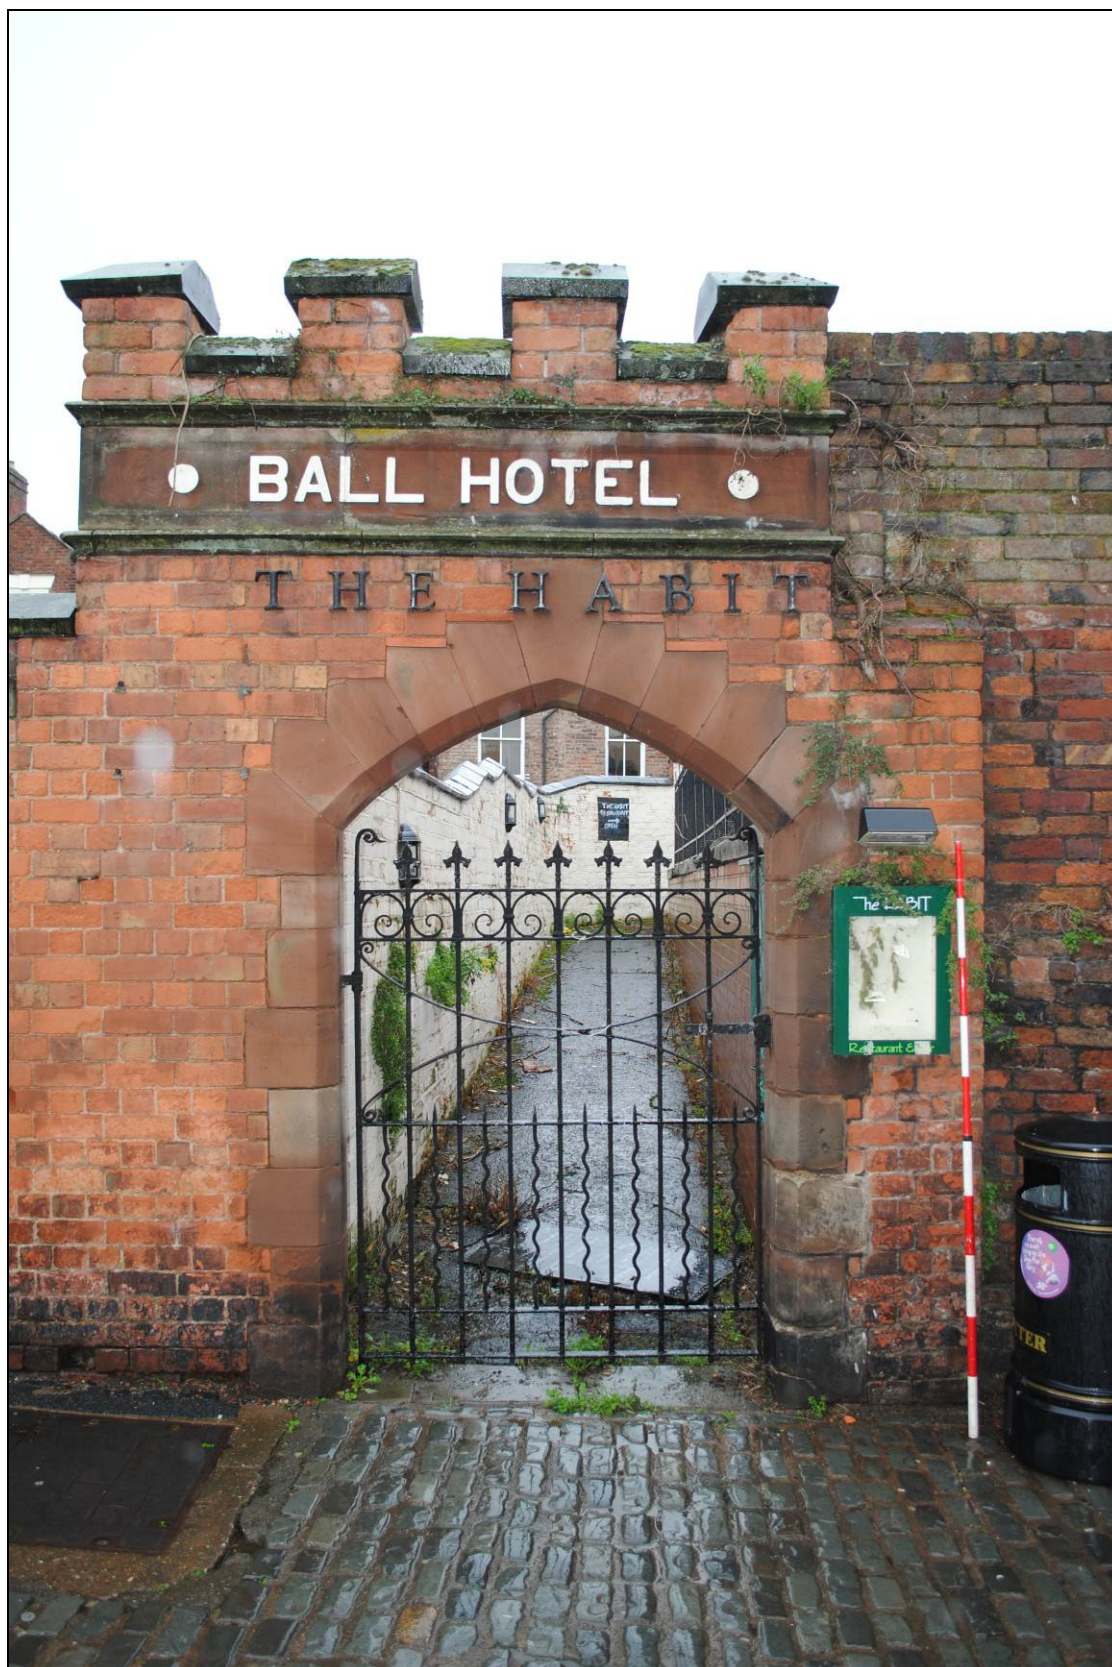
Figure 3
Entrance leading to the former Ball Hotel, located along Castle Terrace, looking west

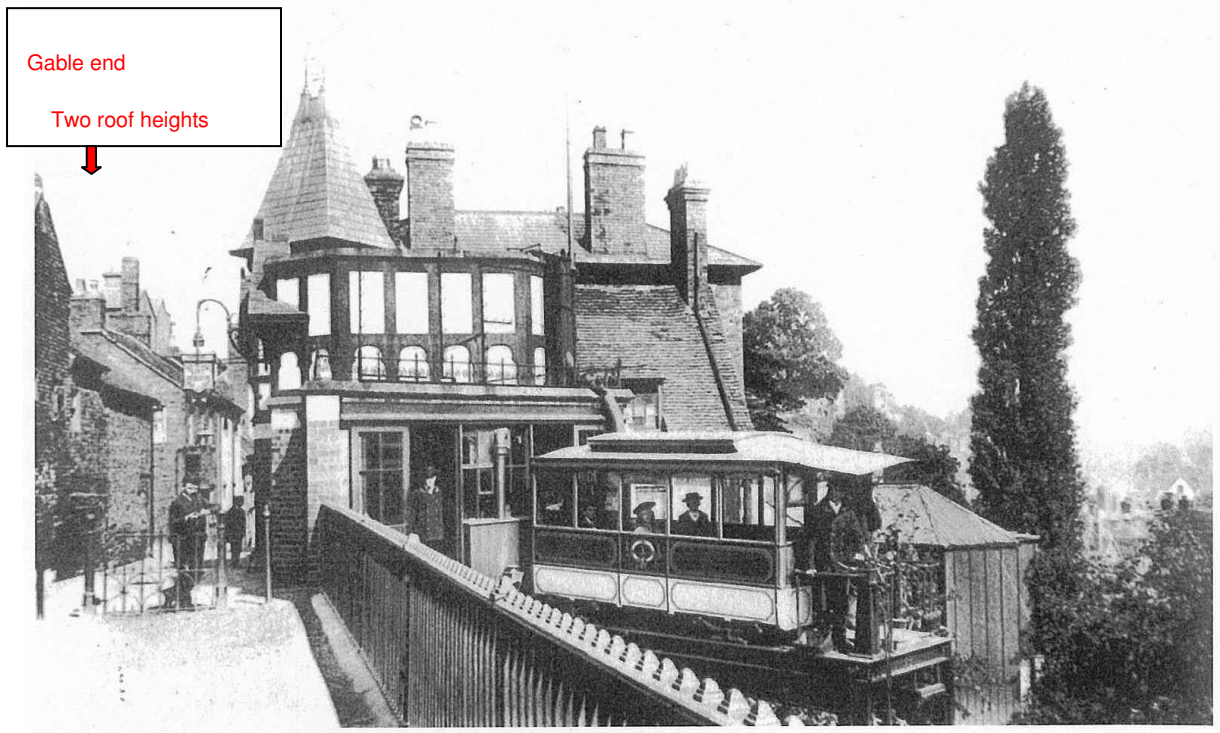
Figure 4 Castle Terrace c.1900 looking north (adapted from Brew and Gwilt 2005, P.52)
(note gable and two roof levels at left of photograph, and window in wall)

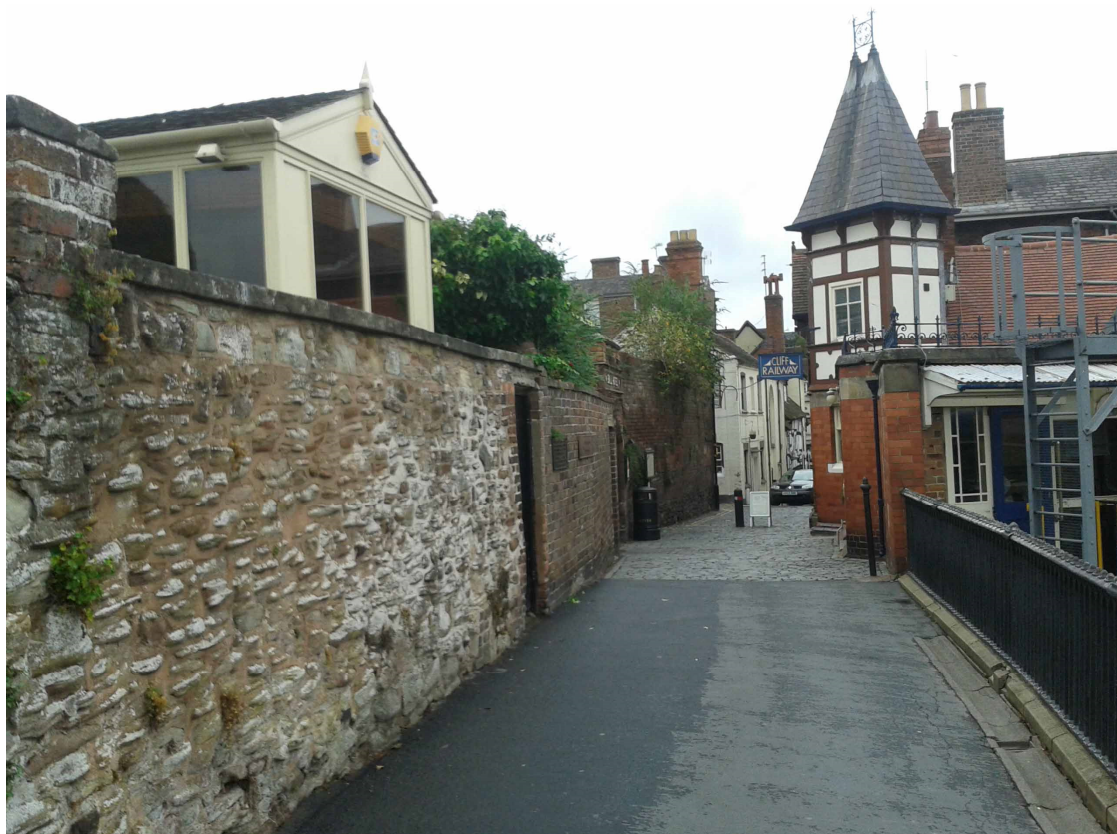
Figure 10 Looking north along Castle Terrace showing original stone coursed wall, with brick rebuilds at the northern end forming the boundary of the application site

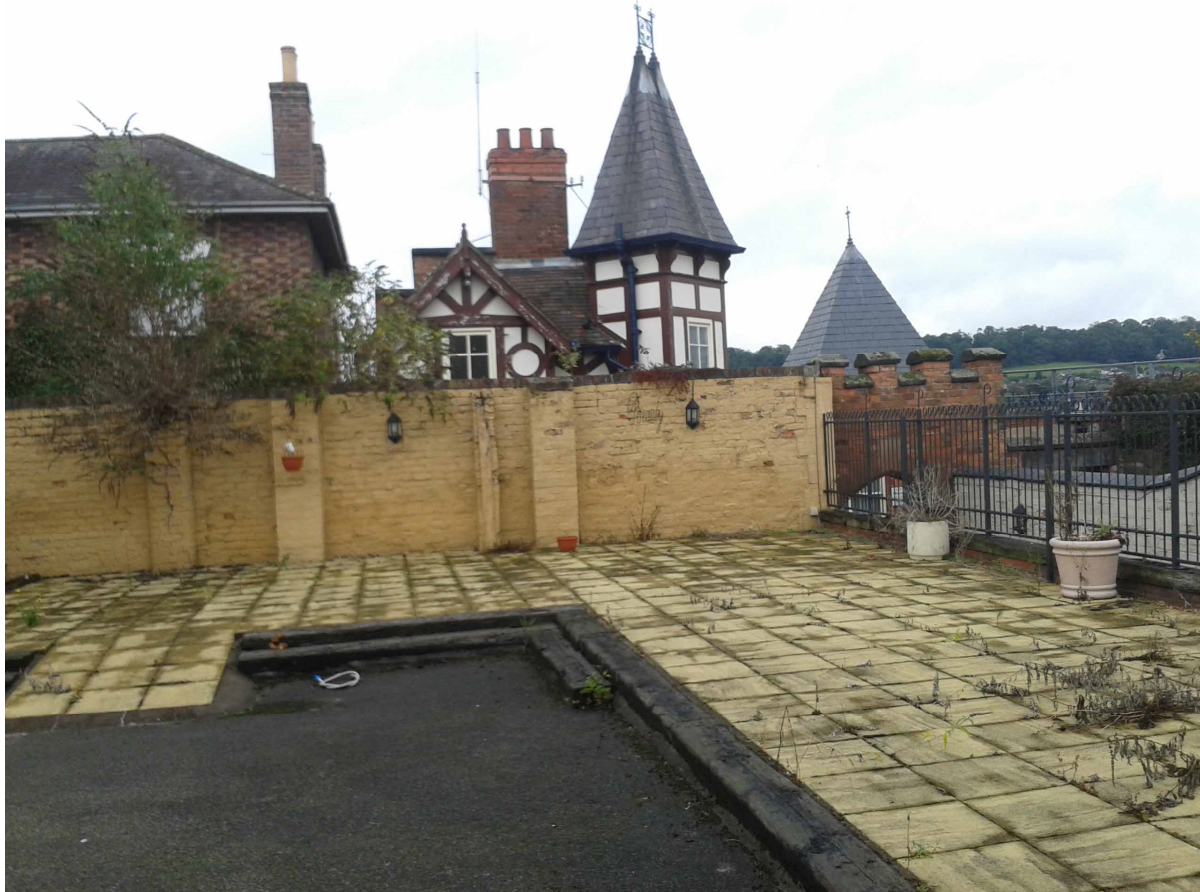
Figure 11 interior view of Castle Terrace wall showing cracking and buttresses to wall

Given the complex phasing of both walls, it is the view of SLR Consulting that the Castle Terrace wall section should not be demolished, although cracking is visible internally (Figure 11) and the wall will definitely require remediation works to ensure its continued stability. The photograph also shows buttresses which have been added in the past to retain the wall internally, whilst externally the poor state of repair is also evident. The complexity of the phasing is a result of the three different buildings that were in existence c.1900, with abutting brickwork and windows onto Castle Terrace. The wall is an important addition to the historic street scene, although the Bank Street wall phasing has, within its recent history, been radically altered with a later rebuilding phase occurring within its western section (Phase 11), of probable mid- to late-20th century date, which has blocked up an historic entranceway and stairwell to the application site. A possible new access point could be incorporated into this 20th century brickwork. This proposed access point would not interfere with the historic character or vista of Bank Street, especially if the development was to use suitable historic brick types. The development proposals could also consider replacing the complete brickwork of Phase 11 with a more suitable historic brick and finished with a suitable lime mortar. Such works would considerably enhance the character of the Conservation Area and would help replace original access points through the wall which have been bricked up in more modern times.
