SHUGBOROUGH WALLED GARDEN, STAFFORDSHIRE

Phase 1 Archaeological Watching Brief
Prepared for: Speller Metcalfe

SLR Ref: 406.06341.00008
Version 1
October 2018

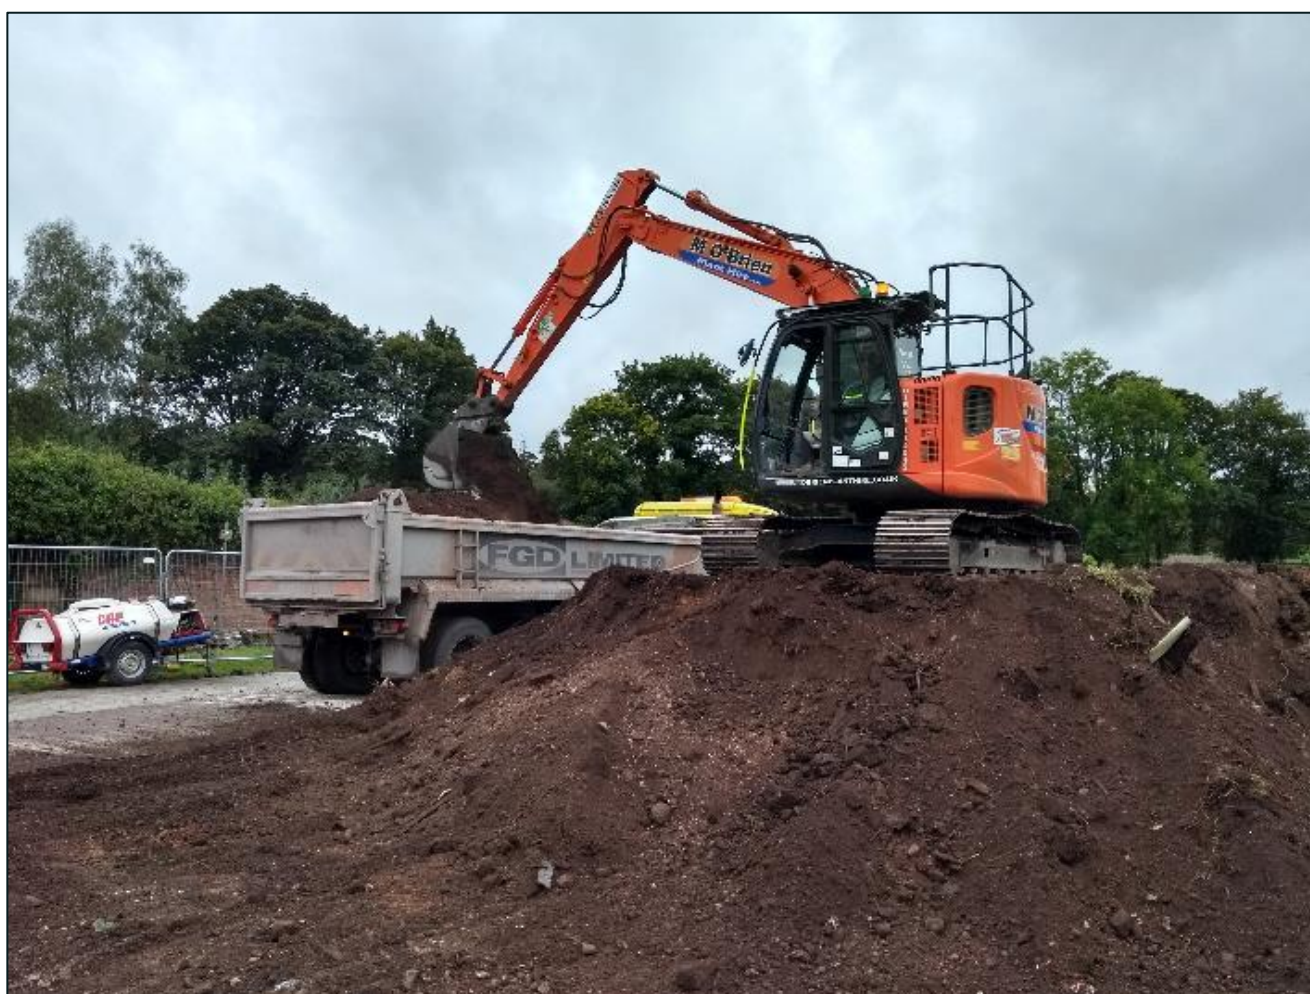
The central spoil heap was removed between 9th October and 15th October 2018. Spoil was moved by a tracked excavator with a toothless bucket to the south of the site where a haul road had been constructed to allow lorries to enter the site. The spoil was then deposited in the lorries by the tracked excavator. Door furniture, a tea pot and other metal objects of modern origin were recovered from the spoil.

Figure 3-1
Central spoil heap being removed looking south west

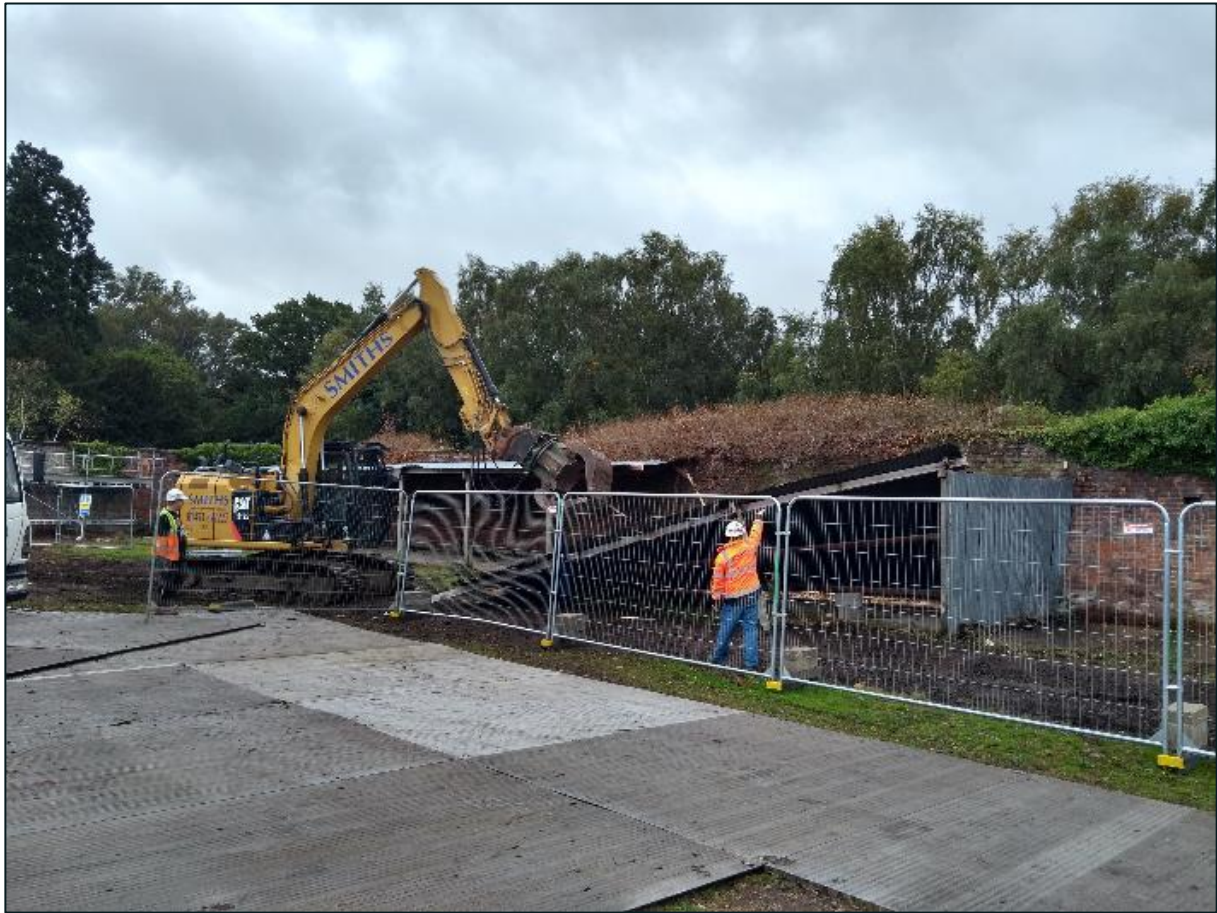
The removal of the lean-to structures took place on dates between 2th October and 12th October 2018. Supports attached to the surrounding garden wall were first cut to ensure no damage was done to the wall. The structures were then dismantled (Figure 5-2). No markings were observed on the wall behind any of the lean-to structures.

Figure 3-2
Removal of lean to structures at south east of site looking south east

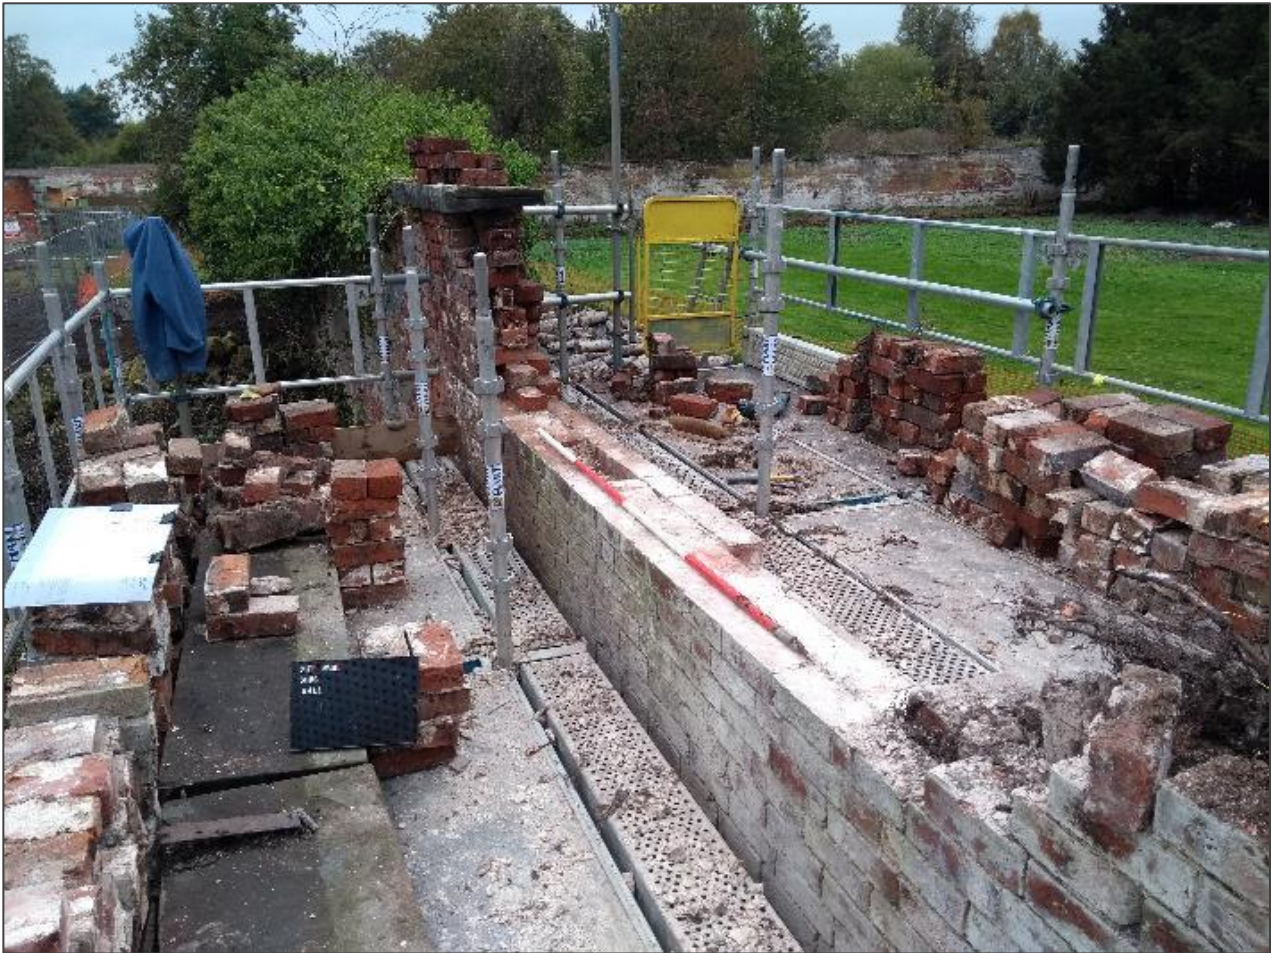
The top ten courses of bricks in a section at the south east of the garden wall had to be taken down and rebuilt due to the wall leaning (Figure 5-3). This was carried out on 16th October 2018. The wall was topped with sandstone coping stones that measured 1.3m long by 0.45m wide and between 0.13m and 0.08m thick. The wall was three bricks thick. Below the coping stone were three courses of brick laid in a stretcher style. Below the top three courses the wall was constructed using a combination of the English Garden Wall and Flemish styles (Figure 5-4).

Figure 3-3
Area of garden wall after bricks taken down prior to rebuilding

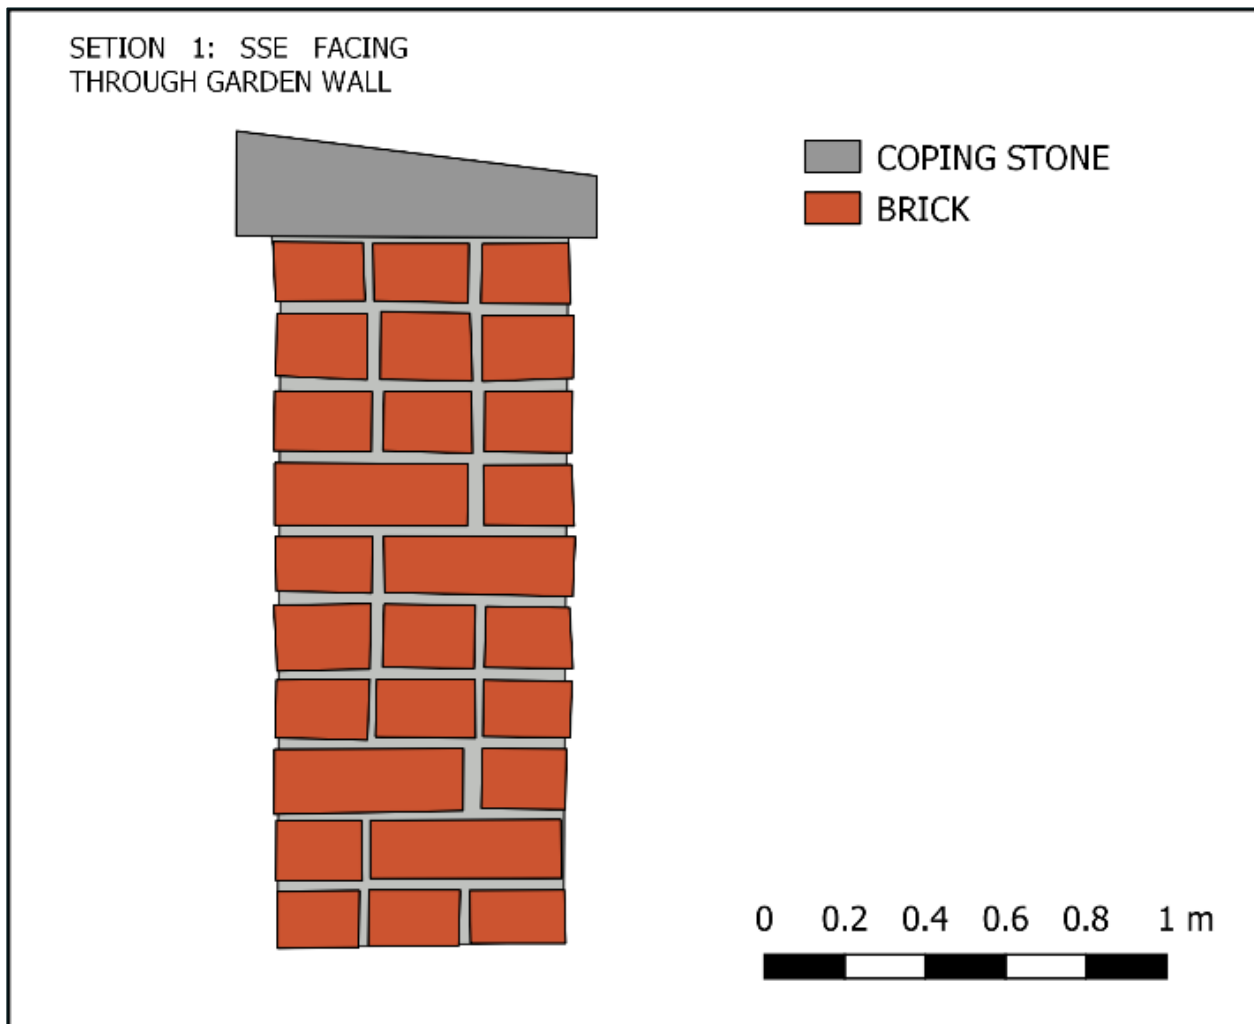
Figure 3-4
Section of wall garden

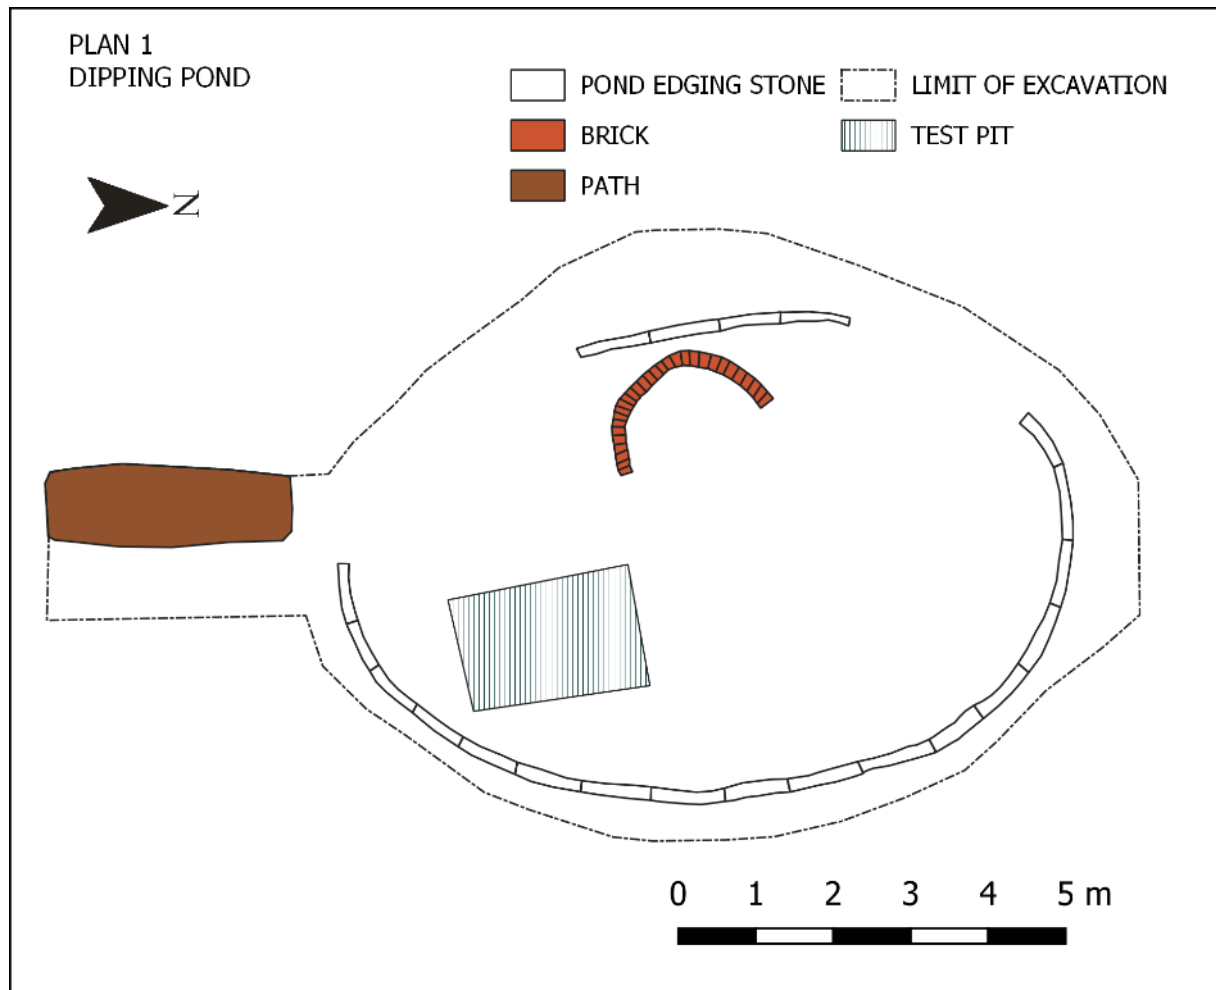
The top of the central dipping pond was revealed using a tracked excavator with a flat ditching bucket on 15th October 2018 (Figures 5-5 and 5-6). It was identified at between 0.3m and 0.4m below the current ground surface (between 82.48 and 82.52m AOD)

Figure 3-5
Plan of dipping pond

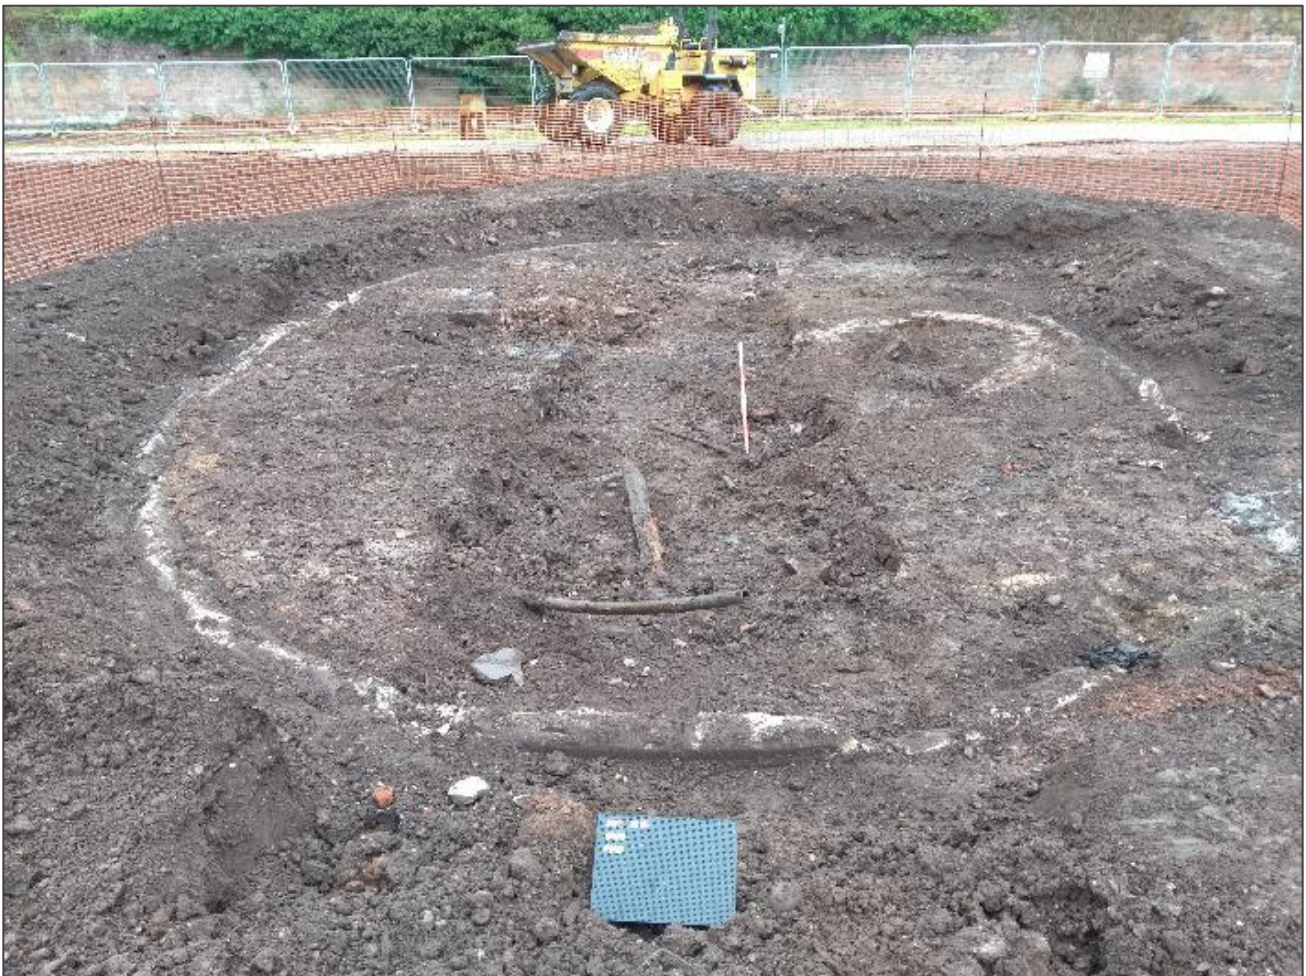
The top of the outer wall of the pond is made up of rounded sandstone pieces measuring approximately 0.9m long by at least 0.15m wide. These are the same as those that line the extant pond in the northern walled garden. A semi-circular brick feature was identified at the western side of the dipping pond which may represent part of a fountain or other water feature (Figure 5-7). This had an internal diameter of 1.8m and was made up of bricks measuring 23cm x 12cm x 7.5cm. A large piece of metal identified at the centre of this feature did not appear to be related and sat within the made ground that filled it.

At least two portions of the top of the outer wall were missing in the western part of the pond. A test pit previously excavated by Birmingham Archaeology in 2009 was identified at the south-eastern end of the pond (Figure 5-5).

Figure 3-6
Dipping pond looking south

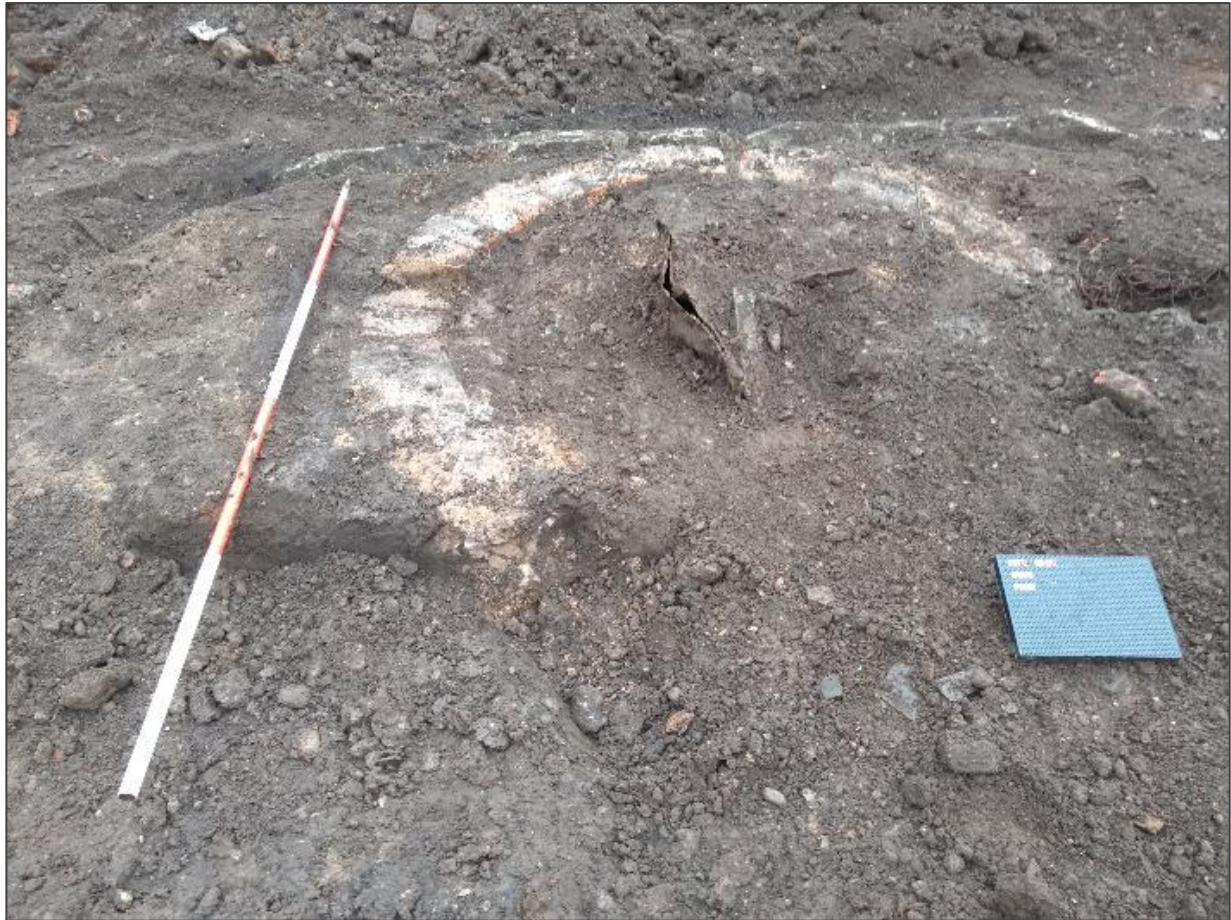
Figure 3-7
Brick feature at west of dipping pond, metal at centre of feature did not appear to be related

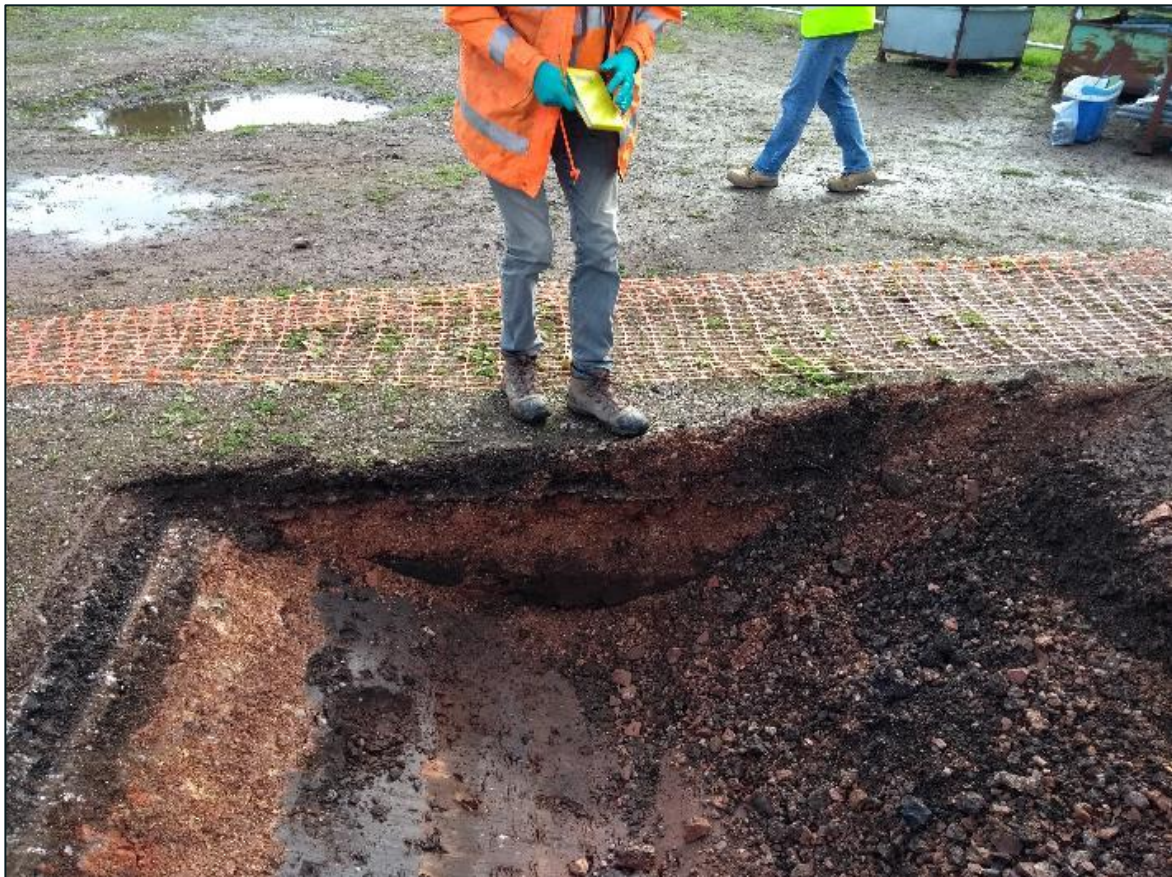
In the three test pits excavated around the diesel tank red brown silt clay natural subsoil was observed between 0.5m and 0.6m below the current ground surface level (Figure 5-8). Dark grey silt clay containing occasional bits of rubble was observed in two of these test pits, above the natural subsoil, which may represent the original topsoil at the site. In each test pit a layer of crushed brick/ceramic was observed which may represent the remains of a path. This was between 0.05m and 0.2m thick and was covered by rubble and a layer of tarmac. The test pit excavated through the base of the diesel bund only identified the concrete and brickwork of the bund above the red brown silt clay natural subsoil.

Figure 3-8
Test pit D1 looking south east

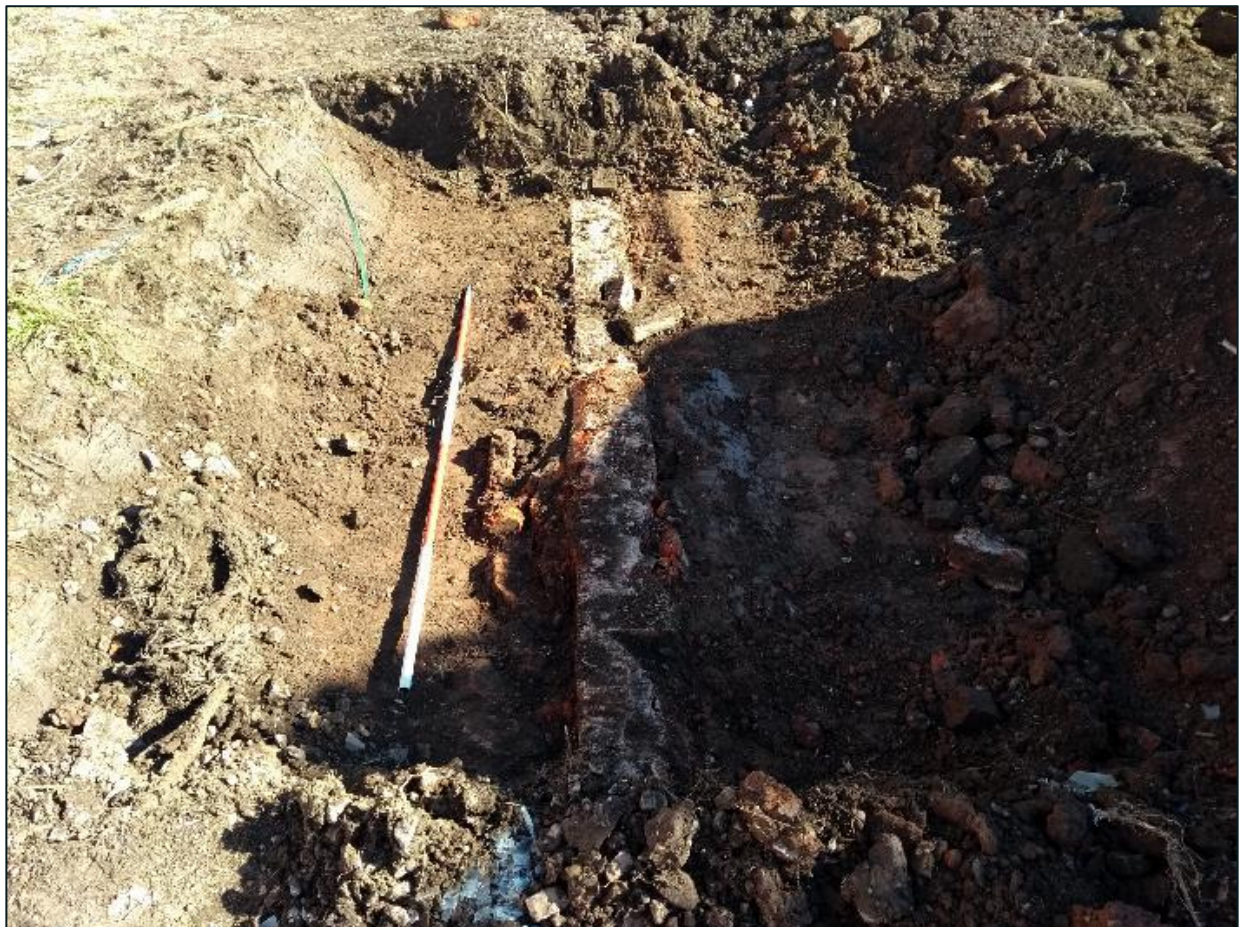
Test pits TP09 and TP24 were both excavated to a depth of 0.5m below current ground level. In both test pit 0.4m of dark grey sandy silt was observed overlying the natural subsoil. In TP09 a brick wall was observed (Figure 5-9), orientated similarly to the garden wall to the north, made of bricks measuring 23cm x 11.25cm x 7.5cm. The wall was two bricks thick, appeared to be constructed using an English style bond and was held together with a lime mortar. It may be part of the Apricot House shown on 19th century OS mapping although it was not clear from the small area that was observed. No floor or other features were observed related to it. The wall was left *in situ* and re-covered with soil.

Figure 3-9
Trial Pit 9 showing wall looking east
