ALL SAINTS' CHURCH, BASCHURCH, SHROPSHIRE

ARCHAEOLOGICAL WATCHING BRIEF REPORT

**On behalf of the Parochial Church Council of
All Saints' Church, Baschurch**

SLR Ref: 406.10768.00001
Version No:2
September 2020

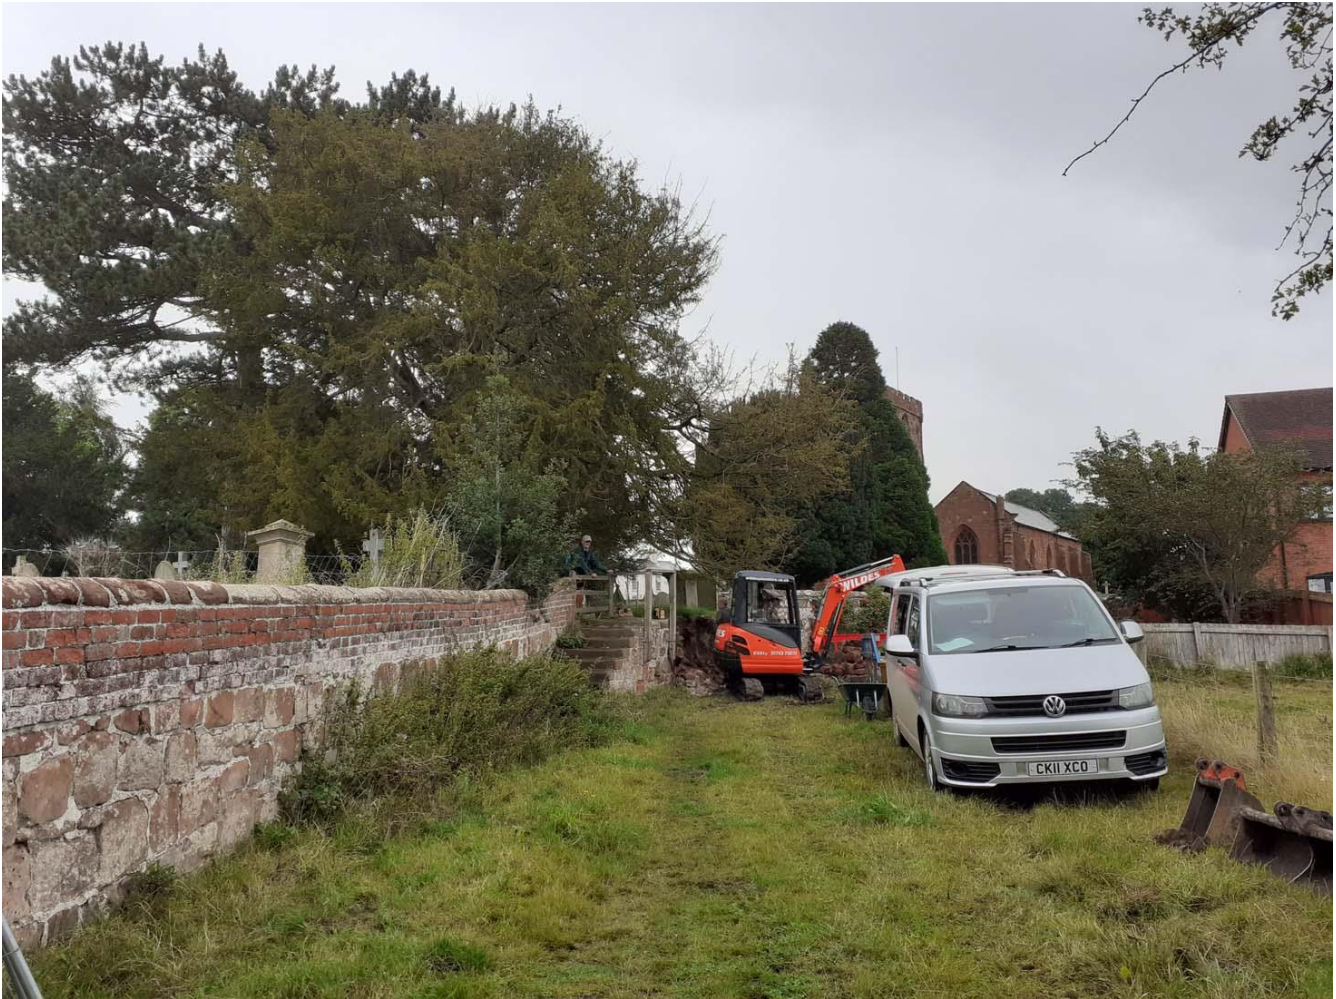
Figure 4
View towards collapsed wall from south-west with church in background

In March 2020 SLR was approached by Michael Randall, acting on behalf of the Parochial Church Council for All Saints Church, Baschurch, Shropshire, for assistance with the archaeological implications in relation to the repair of a graveyard retaining wall which collapsed into a neighbouring garden following storms earlier in the year. The site is centred at National Grid reference SJ 422 218 (Figures 1 and 2), and forms the southern boundary wall to the graveyard, which is a western extension to the churchyard surrounding the church. The graveyard is c.1.6m higher than the surrounding land (Figure 4), and the wall has collapsed into land that formerly formed part of the adjacent Moor Farm, recently converted into residential units as part of a development called Bassa Road.

51: REMOVE collapsed stone and other materials from the garden. Take care to avoid disturbance to the retained earth. If necessary, provide temporary shoring. At each end of the collapse check adjacent stones remaining in the wall and remove any that are loose or where the mortar is not sound.

52: EXCAVATION AND CONCRETE FOUNDATION Remove stones within the lower level of the wall down to bare earth, but do not excavate back into the churchyard. If necessary, provide shoring to retain the churchyard earth.

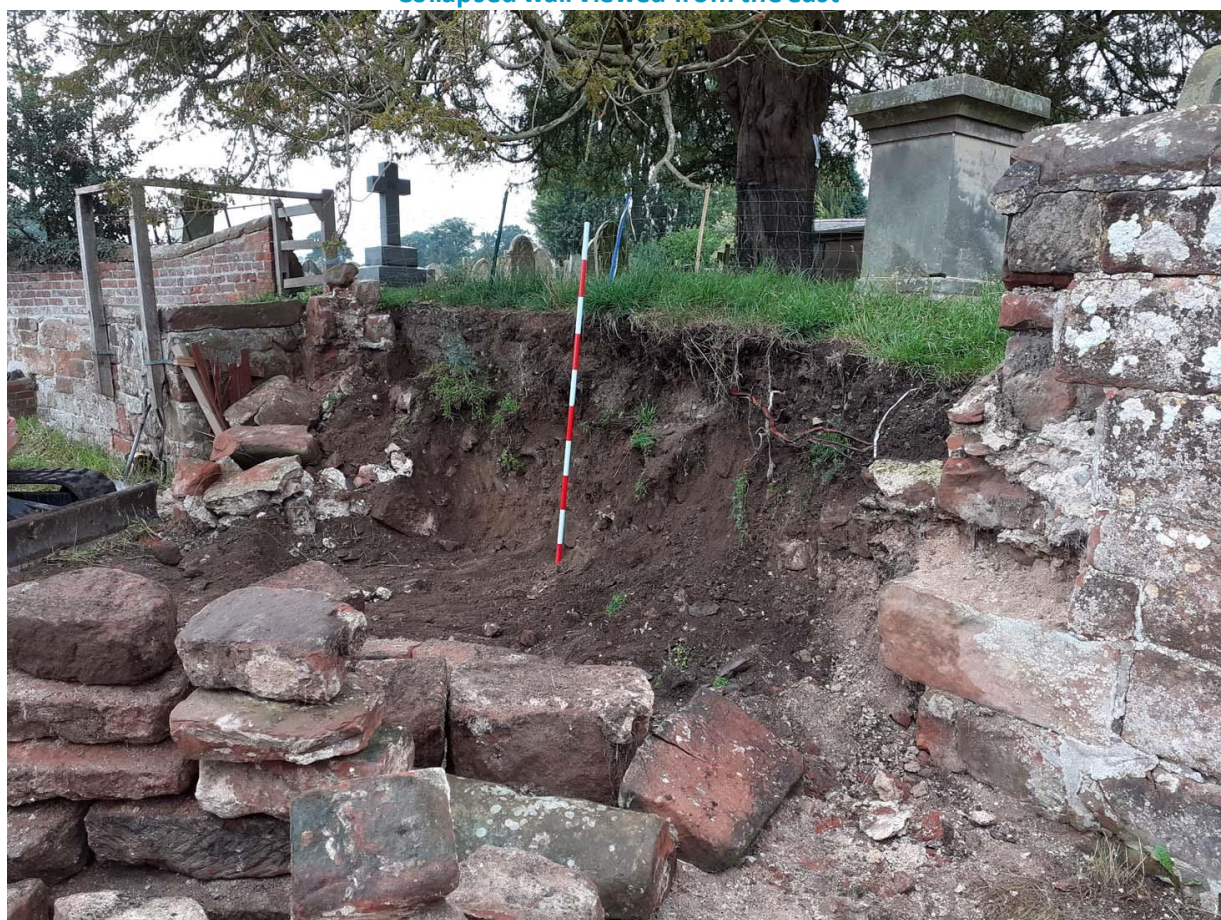
Figure 7
Collapsed wall viewed from the east

A site inspection was carried out prior to groundworks beginning on 19th August and an archaeologist examined the loose soils and rubble for archaeological deposits or features, specifically human remains (Figure 7).

The existing wall which had not collapsed was c.2m in height on the external face, and 0.6m wide, constructed of large sandstone blocks and lime mortar with small stones and charcoal inclusions, capped with triangular worked coping stones (Figure 8). During the rebuilding work it was clear that the original wall had two external good stone faces and very poor bits of stone and mortar between. The sandstone blocks used for the wall where it had collapsed ranged in size and shape considerably, from c. 700 x 400 x 200mm to 1200 x 600mm (Figure 7).

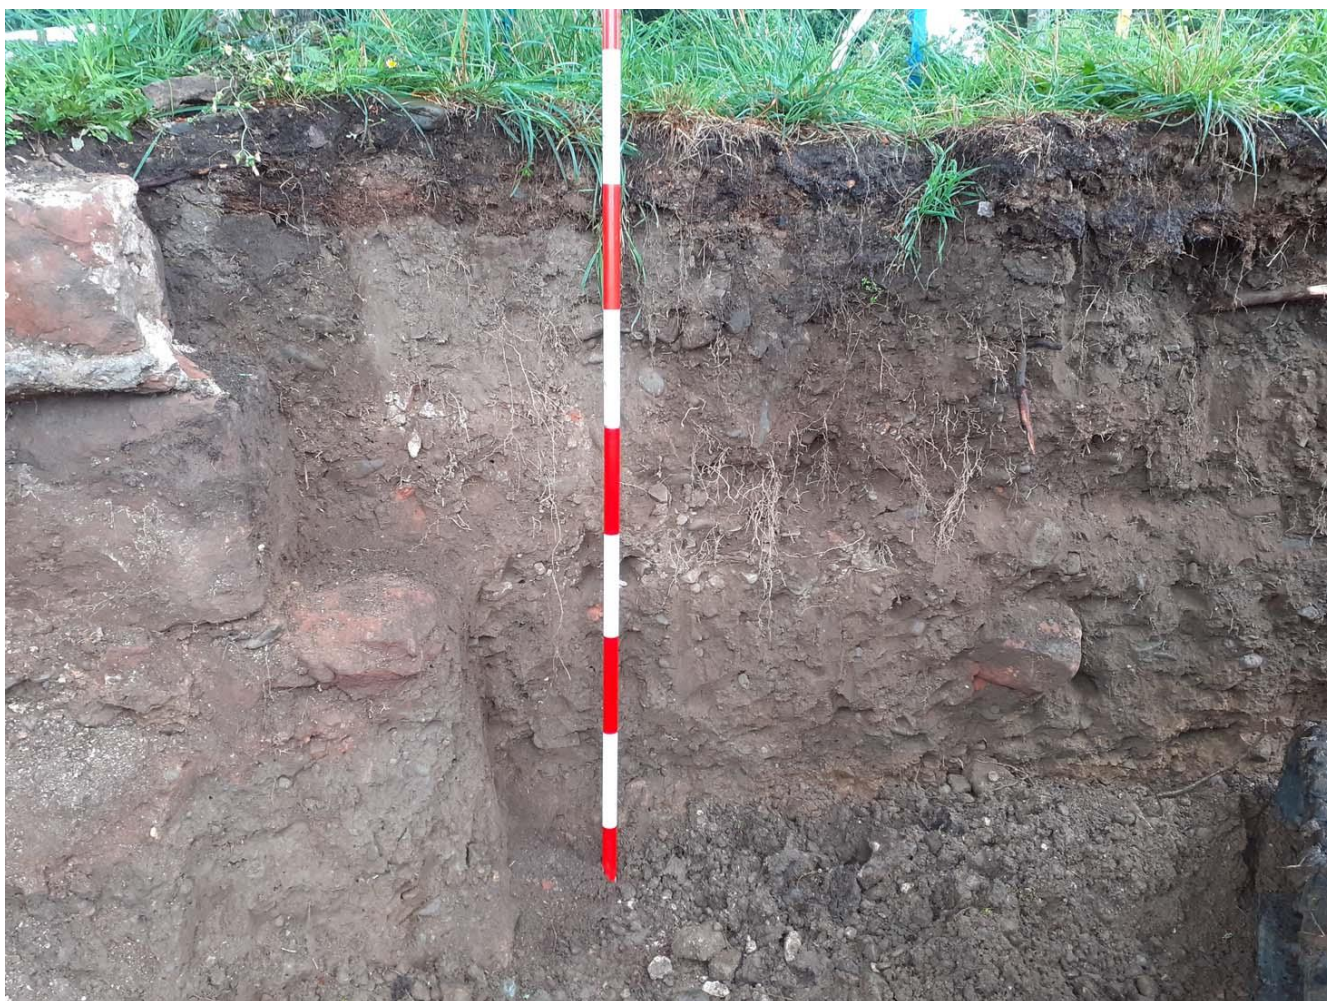
Figure 9
West end of wall showing plinth of soil and lower zone with large boulders

At the west end the wall, which was adjacent to the steps leading from a footpath to the higher graveyard, extended externally to 1.6m depth from the ground surface. Internally a soil plinth or step was found at 0.9m depth which coincided with a band of boulders in the exposed section (Figure 9). This suggests that a deliberate infill of sandstone pieces and large river cobblestones formed a support to the rear of the lower section of the wall, but that only soil infill was used for the higher section behind the wall and the undisturbed graveyard.

The deposit sequence (Figures 9 and 10) revealed by the collapsed wall with depths below ground surface (bgs):

- 0 – 0.5m bgs Topsoil – dark slightly humic earth with roots
- 0.5 – 0.9m bgs B horizon – slightly dark brown silty sand with (worm-sorted) pebbles and sandstone pieces
- 0.9 – 1.3m bgs Subsoil – brown silty sand loam with pebbles (including large boulders and sandstone rubble)
- 1.3 – 1.5m bgs Subsoil – yellow silty sand
- 1.5 – 1.9m bgs Natural – pebbly sand with peagrit (these natural deposits continued beneath the base of foundations at 1.9m bgs)

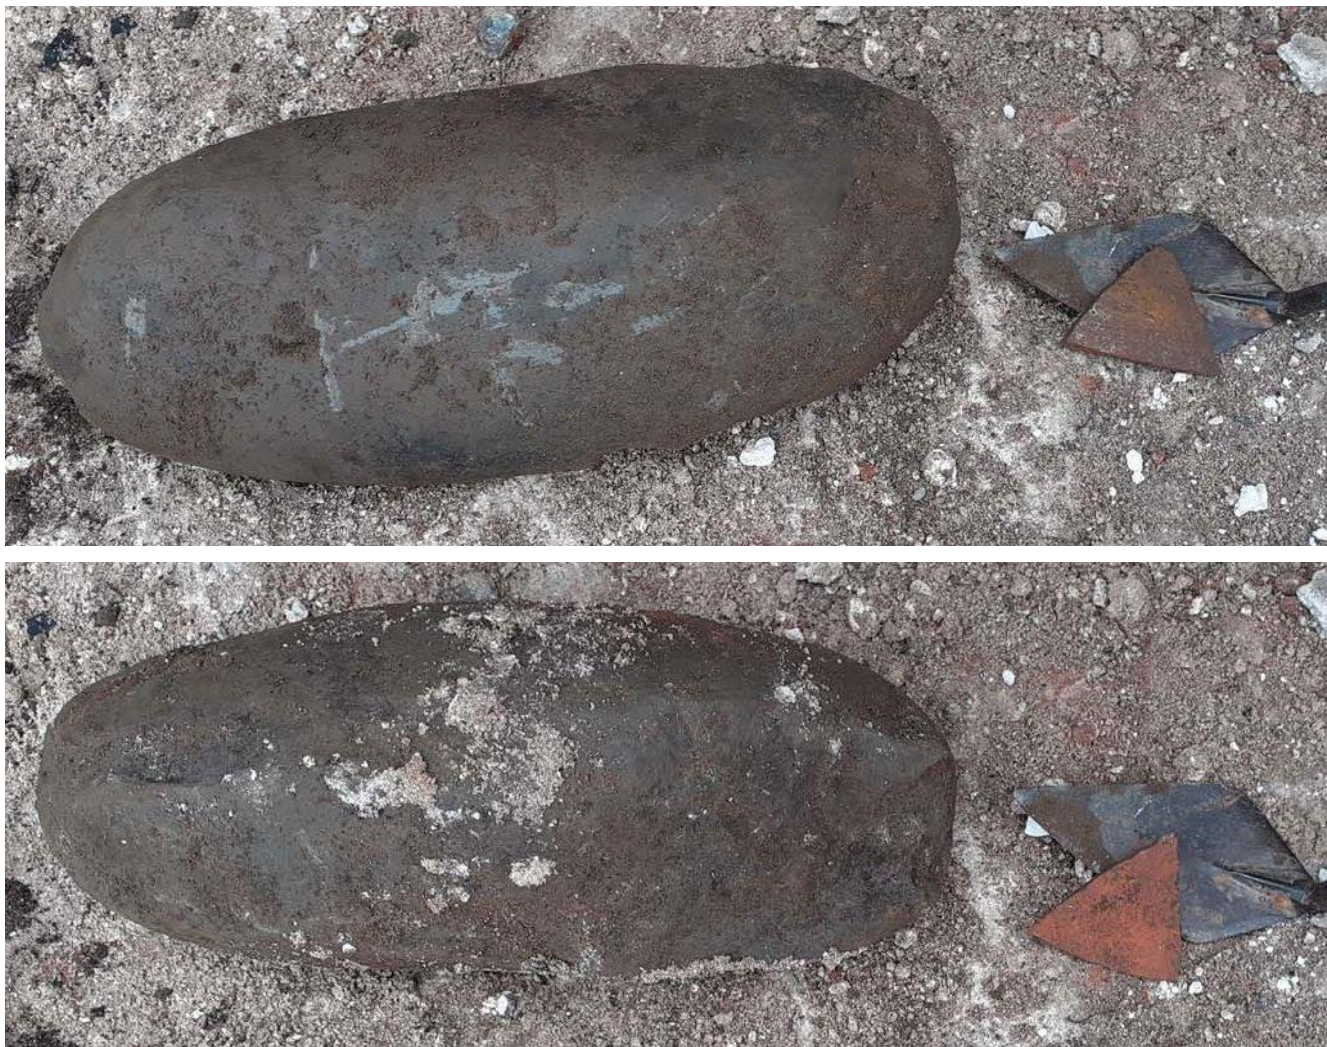
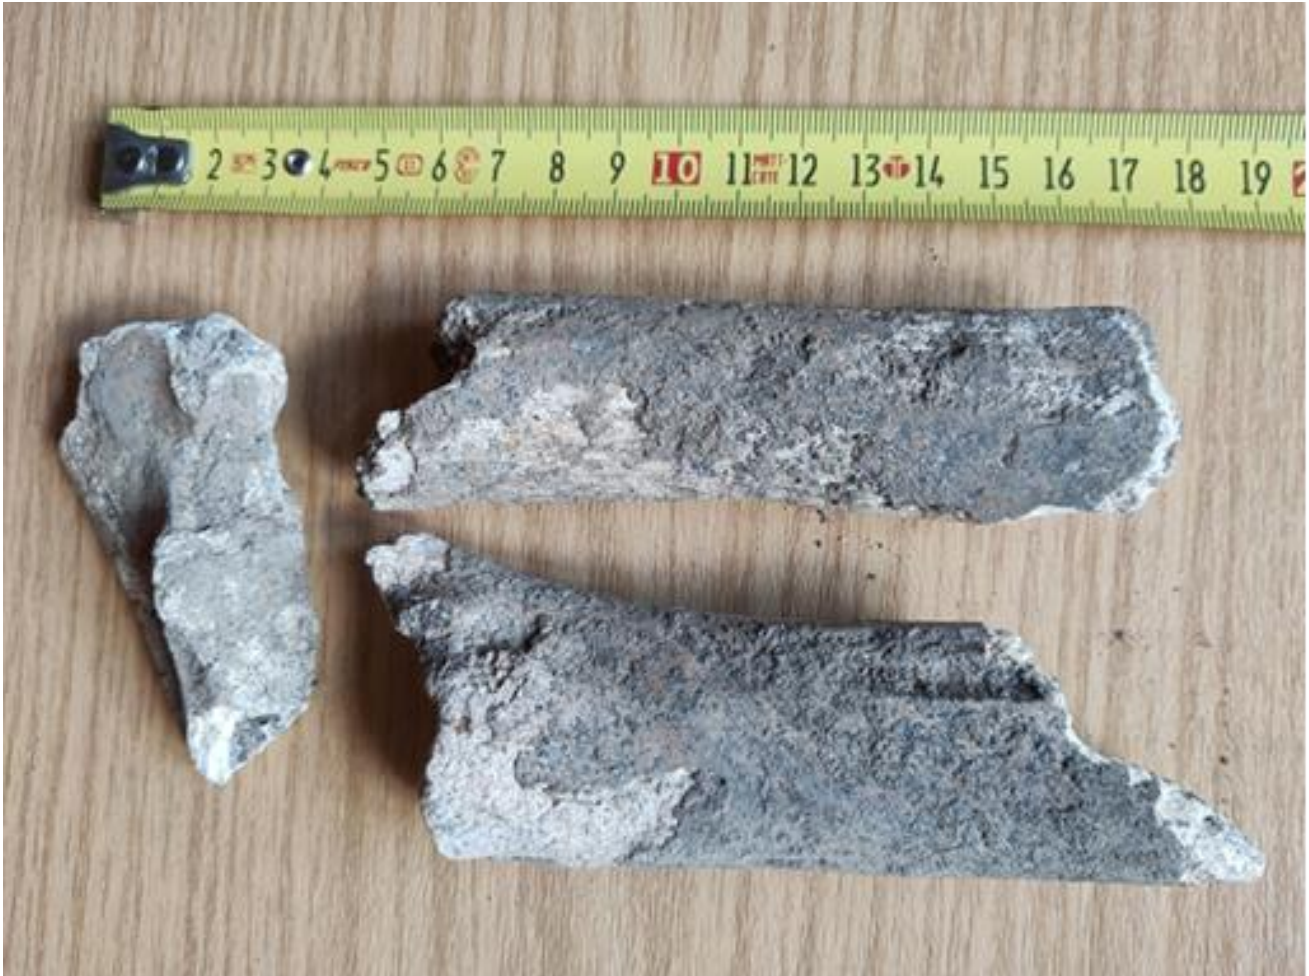
Figure 11
Finds from disturbed soil

No human bone was visible prior to start of work, but during removal of loose material and cleaning of the exposed soil section some fragments were recovered which will be reinterred (Figure 11). In addition, a single piece of pottery was also found, which was well-fired and had a green glaze on one side, of early post-medieval date (Figure 11). A potential artefact of a large oblong smoothed stone was found, but this is probably of fluvio-glacial origin rather than manufactured and polished by human agency (Figure 11).
