NORTHLIGHT HERITAGE House of Dun Mausoleum

REPORT: 84 Montrose, Angus

DATA STRUCTURE REPORT Standing Building Survey

House of Dun Mausoleum

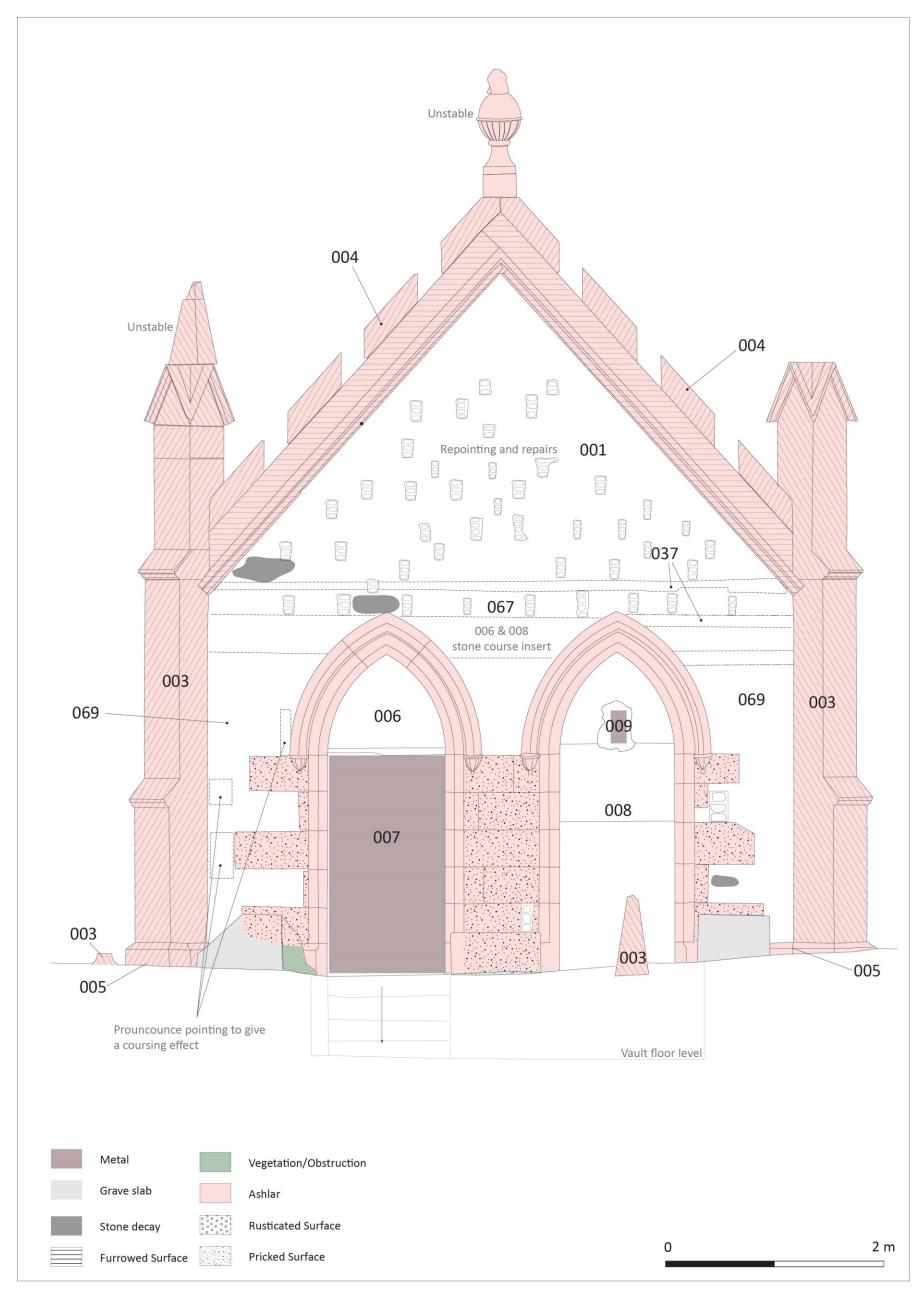
Illus. 10: West gable elevation

6.2 The overall height of the west gable wall is 6.20 m to the pitched roof, 6.79 m to the top of the skews and 7.94 m to the finial. Its width is 5.33 m and its overall depth is 0.54 m. Stone decay is evident at two points in the upper north part (illus 12 and 13). The lower part of the elevation 069, to a level coinciding the tops of the inserted door apertures **006** and **008**, is of square random sandstone rubble construction. A course of smaller stones 067 runs across the gable wall at this level. Above it the elevation is of different construction, consisting of coursed blonde sandstone ashlar masonry and pinning 001. At each corner are red sandstone ashlar graduated buttresses with gableted heads 003. A pyramidal apex stone caps the north-west buttress with what appears to be a fragment lying on the ground near its base, while the stone which formerly capped the south-east buttress has fallen and lies in front of aperture 008. Red sandstone crenellated skews 004 run from the buttresses to the elevation's apex and a finial bearing a funerary urn (illus 14). A plinth course 005 of dressed, chamfered sandstone is visible at the base of both buttresses and also extending onto the southern edge of 069 (illus 15). The pointed-arch doorways 006 and 008 are both defined by red sandstone surrounds in neo-Gothic style with projecting hoodmolds/dripstones and chamfered margins (illus 16 and 17). A heavy cast-iron door 007 set in aperture 006 leads down four steps into Chamber 1. Aperture 008 is sealed with three sandstone panels pierced by a rectangular vent 009. Mixed cement-based mortar **002** has been applied across much of the elevation.

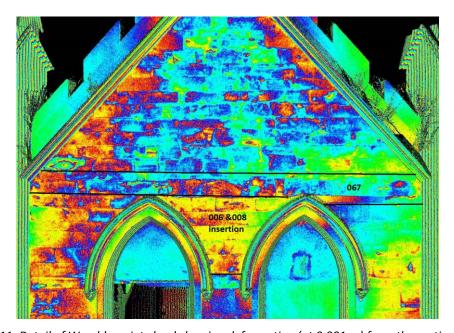
Illus. 11: Detail of W gable point cloud showing deformation (at 0.001 m) from the vertical plan on a scalar ramp.

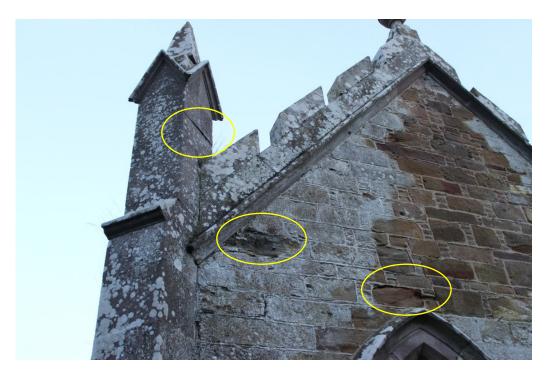
Illus. 13: West gable stone decay.

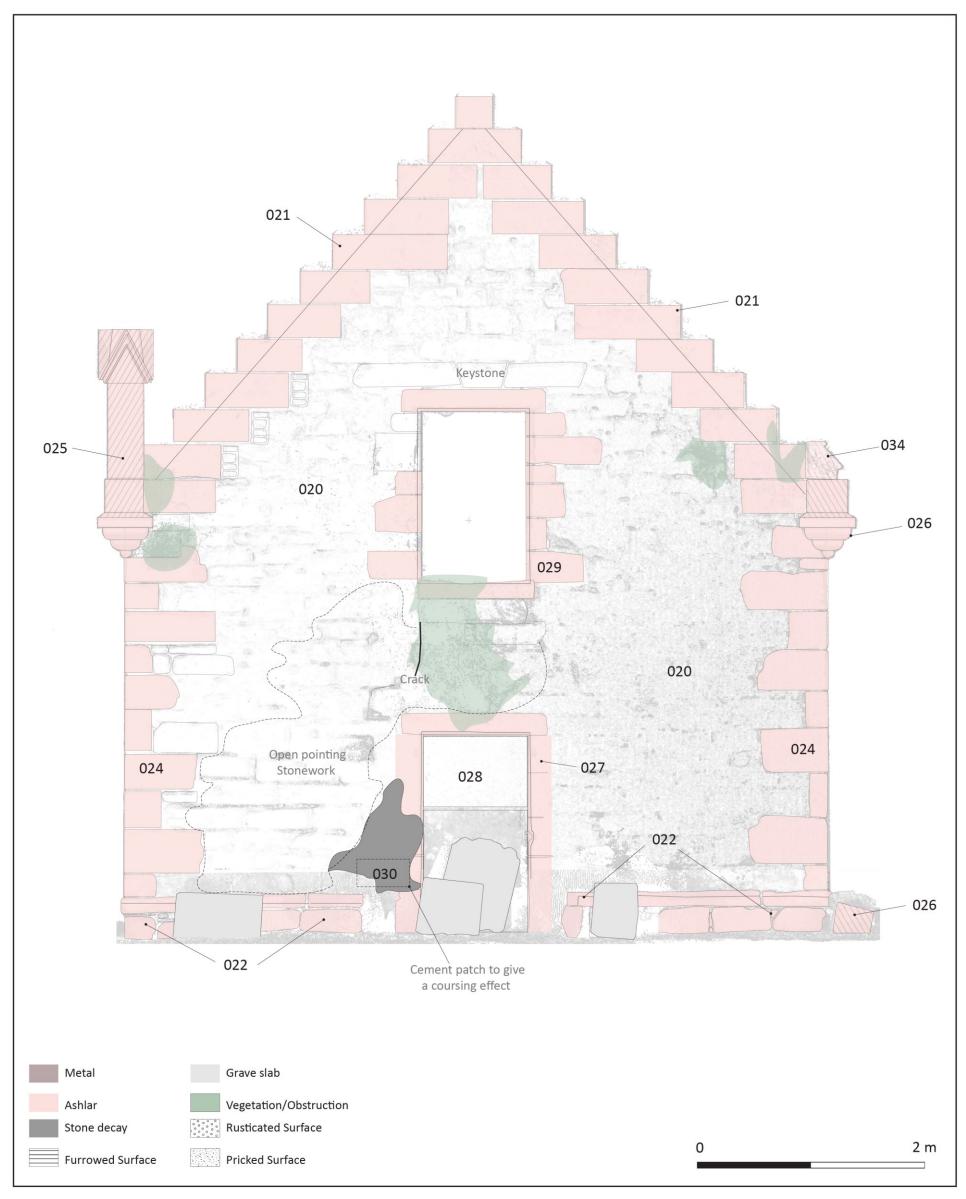
Illus. 23: East gable elevation.

6.4 The east gable wall measures 6.90 m to the top of the pitch and 7.37 m to the top of the crowstep, its width is 6.15 m and its depth is 0.60 m. It leans slightly to the ESE. The wall 020, which appears to be of a single phase of construction, is built of square sandstone rubble with various repairs evident (illus 24). Red sandstone quoins 024, well-knitted to the stonework, form returns to the south and north. Dressed stone skews 021 create a crowstepped, pitched roofline (illus 25). Corbelled pinnacles 025 and 026 sit atop the quoins at each corner; the south-east pinnacle still bears its gabbleted head, but the head of the north-east pinnacle has fallen and lies at its base. The elevation is pierced at its centre by a door aperture 027 with a chamfered sandstone jamb and lintel. The doorway is blocked with two large grey sandstone slabs 028. A hammered foundation 022, visible as a chamfered sandstone plinth (illus 26-29), runs along the base of much of the elevation and appears to return at the doorway 027 (illus 30-32). A deeply splayed loft window aperture 029 occurs in the wall directly above the doorway; dressed, chamfered stones form the jamb, lintel and projecting sill (illus 33-36). There is evidence on several parts of the elevation for damage due to water: on the lower part to the south, the pointing has been washed out; repairs are evident in the pinning to the north below the skews; poor drainage provision through the window is causing overburden and displacement, and the hammered foundation has been subject to longterm erosion from water pouring through the window above. A brick patch 030 has been applied immediately south of doorway **025** in response to water ingress.

30 Repair Brick patch immediately south of doorway 025 due to water ingress.	029	Window aperture	Dressed chamfered stone forming jamb, lintel and projecting sill. Poor water
	30	Repair	Brick patch immediately south of doorway 025 due to water ingress.

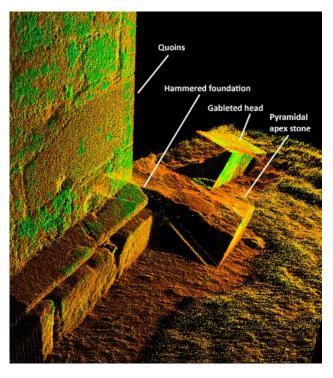
the elevation. A similar example is visible at Auchterarder Old, Perth & Kinross (illus 29). Erosion of the foundation has been ongoing for some time due to lack of water run-off provision: the water from the roof's central alley gutter spouts through the window directly onto the foundation. As a result, the stonework has been washed out, exposed and damaged. (see brick patching 030). Red sandstone quoins, well knitted to the stonework. Appear to be contemporary with the hammered foundation 022. Corbelled pinnacle with gabbleted head at SE corner. Corbelled pinnacle at NE corner. Gabbleted head has fallen and rests at base of elevation on N. Door aperture Doorway with chamfered jamb and lintel. Height = 1.77 m, width = 0.92 m, depth (visible) = 0.142 m. May be an original opening, as suggested by the return on the hammered foundation 022 (see illus 34-36). In very poor condition. Blocking Door 025 is blocked by two large grey sandstone slabs. Utf window opening. Height = 1.54 m, width = 0.92 m, depth (visible) = 0.60 m. Dressed chamfered stone forming jamb, lintel and projecting sill. Poor water drainage through the opening is causing overburden and displacement.	021	Skews	Dressed stone skews creating crowstepped pitched roof.

Illus. 28: Detailed view of the hammered **022**.

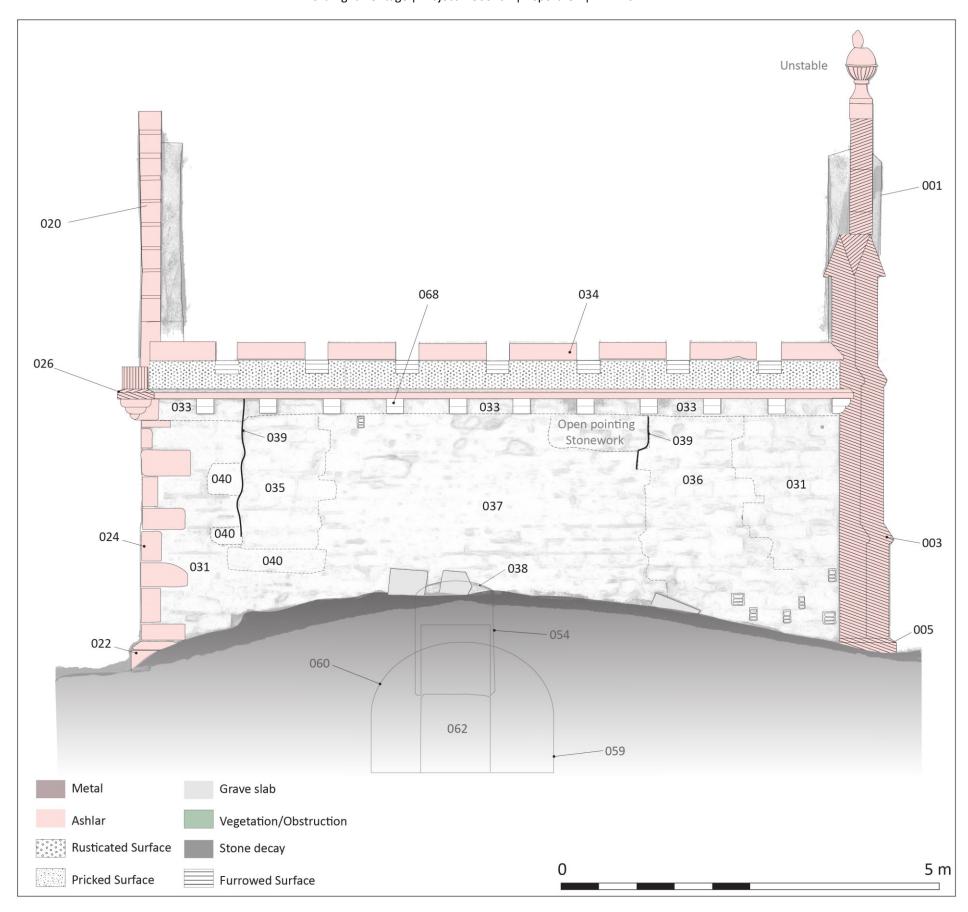
Illus. 37: North elevation.

038	Structure	Exposed keystone for the Chamber 2 barrel vault 060 .
039	Cracks	Two long vertical cracks visible to east and west of blockings 035 and 036 . On the east in particular the stone knitting is very poor with no keystone to tighten the stonework. Cuts 031 .
040	Window aperture	Aperture represented by possible jamb and sill visible to E of crack 039 . Width = 1.27 m, height = 0.3 m. The cement mixed mortar and false coursing 032 make it difficult to see the extent of the stone.
060	Barrel vault	Barrel vault in Chamber 2.
068	Cornice	Red sandstone projecting corbelled cornice.
070	Aperture	Possible aperture for window or door, represented by rebuild 036 . No sill apparent.

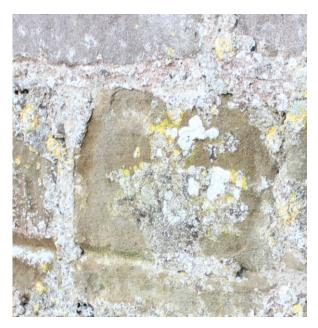
Illus. 38: Detail of the pronounced pointing on stonework rebuilt 032 and 037.

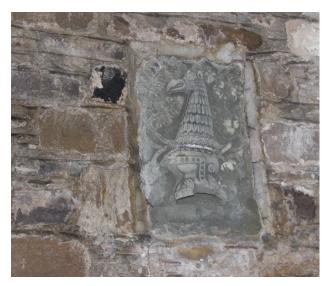
fixed with cement. The barrel vault **044** that forms the south, north and east walls and roof is built of mixed stones, including whinstone (illus 47). A decaying sandstone plaque **046** bearing the Erskine family coat of arms in relief is set in the east side (illus 48). Another stone plaque **047** dated 1702 is set in the south side; the inscription is detailed below (illus 49).

Illus. 48: Stone plaque **046**.

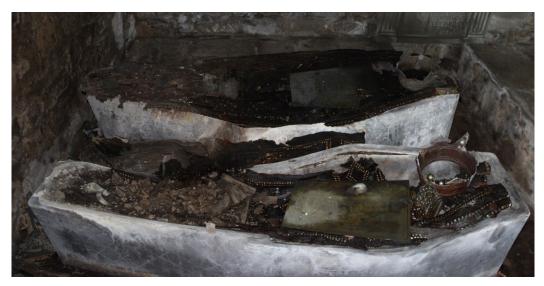
6.9 A large plinth **048**, measuring 2.4 m east/west by 2.4 m north/south, runs across the east end of the chamber. It bears two lead coffins **051** and **052**, both bearing decayed wood, leather and cloth cladding (illus 50). The associated plaques, described below, indicate that these are the coffins of Margaret and Archibald Erskine, who died in 1848 and 1846 respectively. Two smaller plinths **049** and **050** extend into the chamber from the south wall. A child's lead coffin **053** with decomposed wooden cladding sits on plinth **049** (illus 51). The flagstone floor **045** extends as far as the aperture **054** leading to Chamber 2 (illus 52). The arched aperture is stone-built with a stone lintel leading down 0.64 m to the chamber and it appears not to cut the barrel vault **044**, though the relationship is not entirely clear due to similarities in the stonework and mortar (illus 53). Iron door fittings **055** in the aperture suggest it may have once been covered with an iron gate. One of two large sandstone slabs **062** blocking the aperture is still in place, held by heavy iron pins (illus 57), while the other leans against plinth **048**. In the roof, a ventilation pipe **057** has been cut through the stonework. Doorway **006** has indications of an earlier door or gate, as well as an earlier wooden lintel **056** (illus 54, 55 and 56).

Illus. 50: Coffins **051** in foreground, **052** in background in Chamber 1.

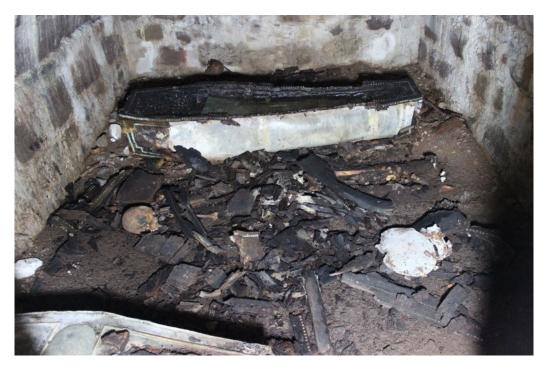
Illus. 61: Burials in Chamber 2.

6.10 The inner chamber measures 3.94 m north/south by 2.52 m east/west, and the height of barrel vault is c 1.7 m. The chamber is very damp, as evident from stalagmites and stalactites of lime; no damage is evident to the stonework, but damage has been caused to the burials and wooden coffins. The wall forming its north, east and west sides 059 is of blond sandstone rubble construction (illus 58). It is markedly different from the stonework of the barrel vault haunch 060, which consists of dressed red sandstone and has been inserted (illus 59 and 60). The floor 061 is of packed earth. Three highly degraded wooden coffins 063, 064 and 065 rest in the chamber, laid roughly parallel (illus 61). Only the southernmost 063 is inscribed (see below) and indicates it is that of Margaret Erskine, who died in 1881 before she reached the age of two. Human remains are visible in the northernmost coffin 065, and a human skull 066 lies exposed to the north of it.

065	Coffin	Northernmost of three highly degraded wooden coffins. Human remains, including longbones and a skull with the jaw displaced, are visible in it. Damage has been caused by water ingress.
066	Human remains	Exposed skull visible in northern part of the chamber, behind coffin 064 .
