# **St Oswald's Church, Crowle, North Lincs.**

**Archaeological Recording**

**PA report no CRPCC01-PAL 2012/21**

**September 2012**

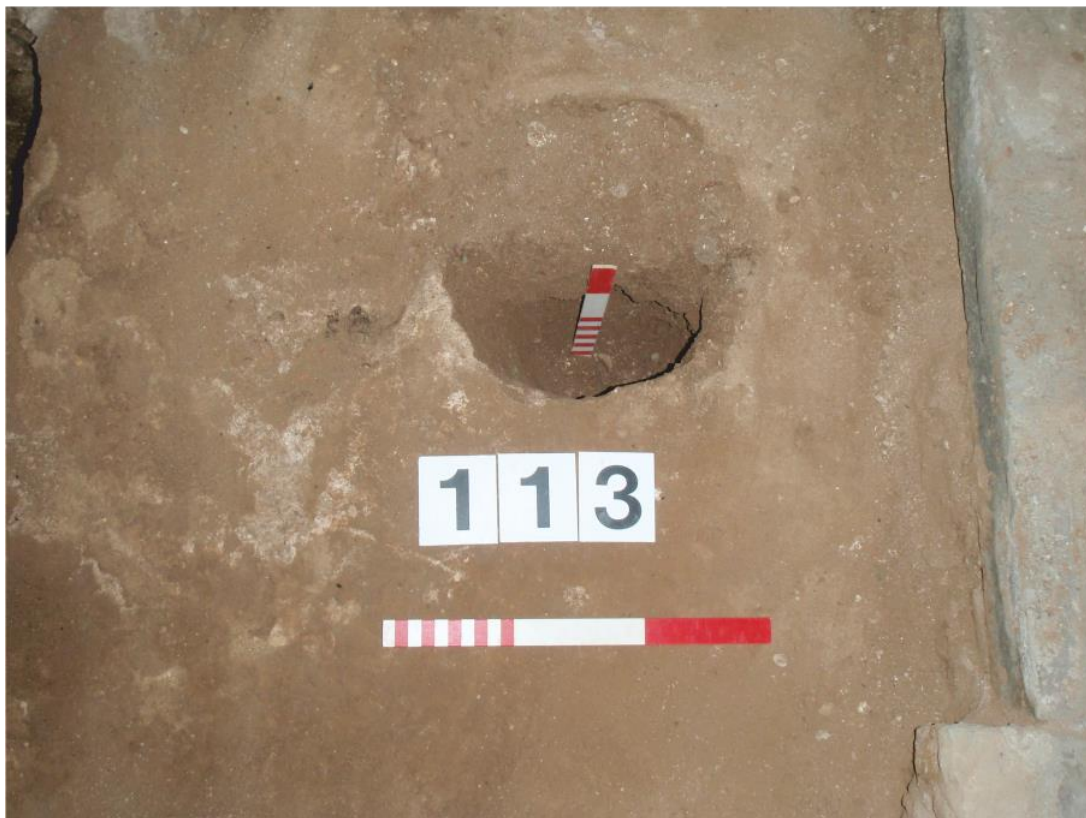
Cutting through floor layer **103** was posthole **113**, which measured 0.30m x 0.35m and a minimum of 0.25m deep (PI. 8). Its loose fill **114** contained pieces of wall plaster and flecks of wood from the removed pews were also present. The bottom of the posthole was not reached as it lay below the required level for the new floor. South of posthole **113** was a smaller circular posthole **111**, 0.24m in diameter and at least 0.20m deep; it was not fully excavated, for the same reason as above. Its fill was a mixed brown soil with clay lumps (PI. 9).

Pl. 8 Posthole 113, part excavated, looking west. Scale 0.30m

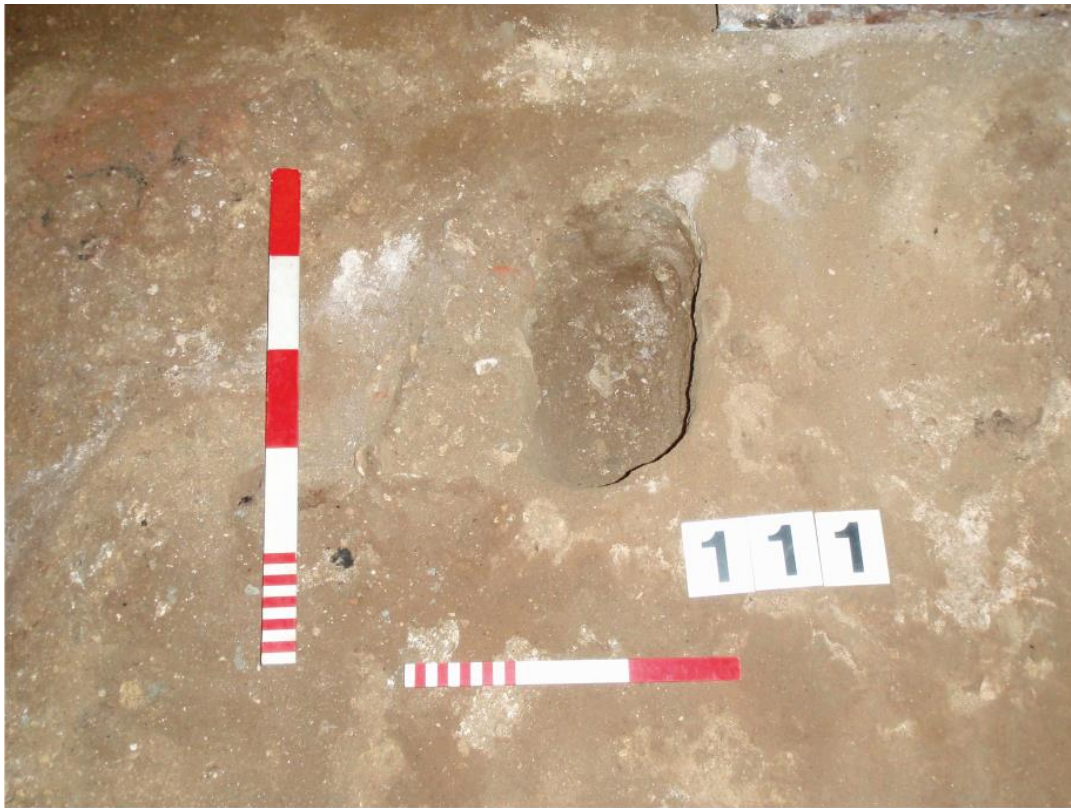
Pl. 9 Posthole 111, part excavated, looking west. Scales 0.50m and 0.30m

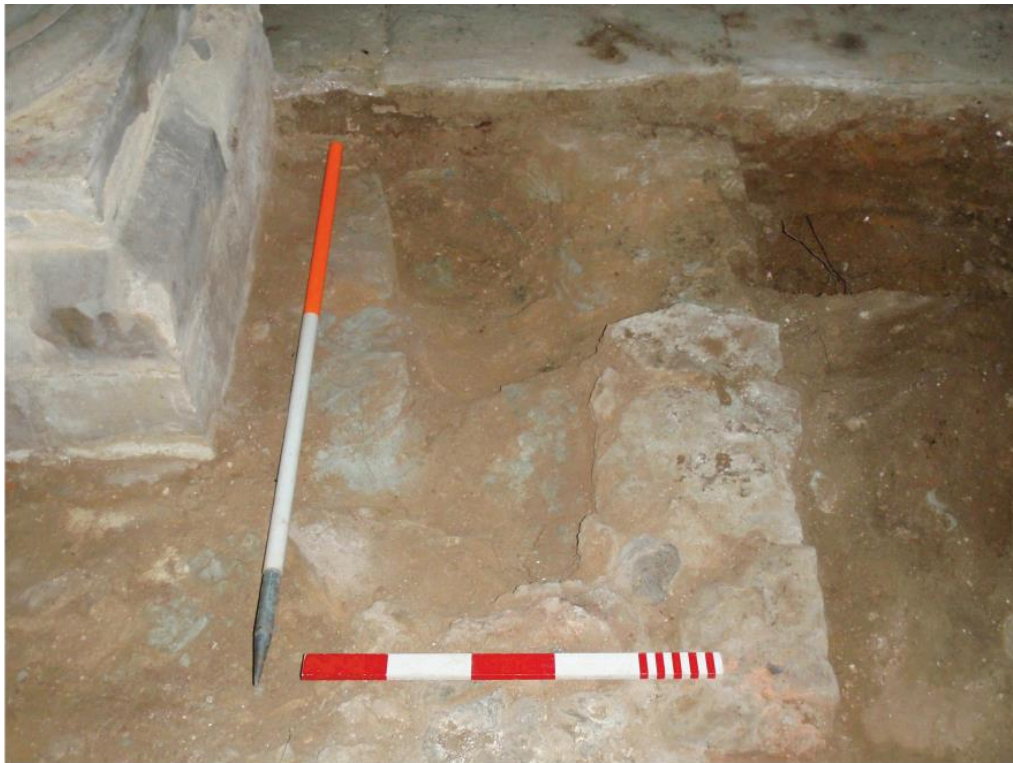
Pl. 13 Damaged area of wall 201 for pew support, looking east. Scales 1m and 0.50m

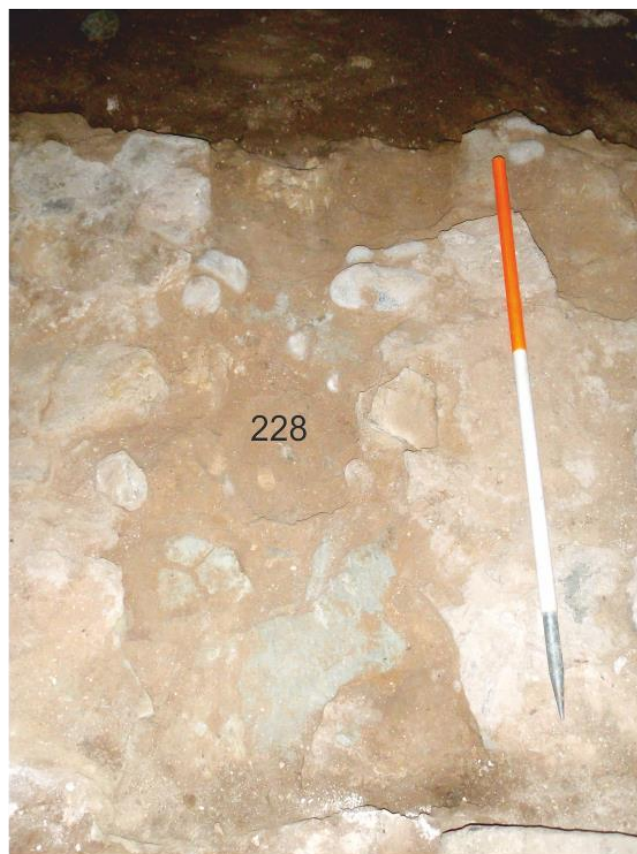
Two postholes were cut into the masonry of the wall foundations and may mark the position of scaffold poles used in the construction of the clerestory. Oval posthole **228** lay east of the Crowle Stone within the N-S channel cut for the pew frames (Pl. 14). Circular posthole **222** was next to the south side of the respond and contained a large water worn pebble in the base, surrounded by blue clay (Pl. 15).

Pl. 14 Damaged area of wall 201 for pew support, with posthole 228 beneath, looking south. Scale 1m

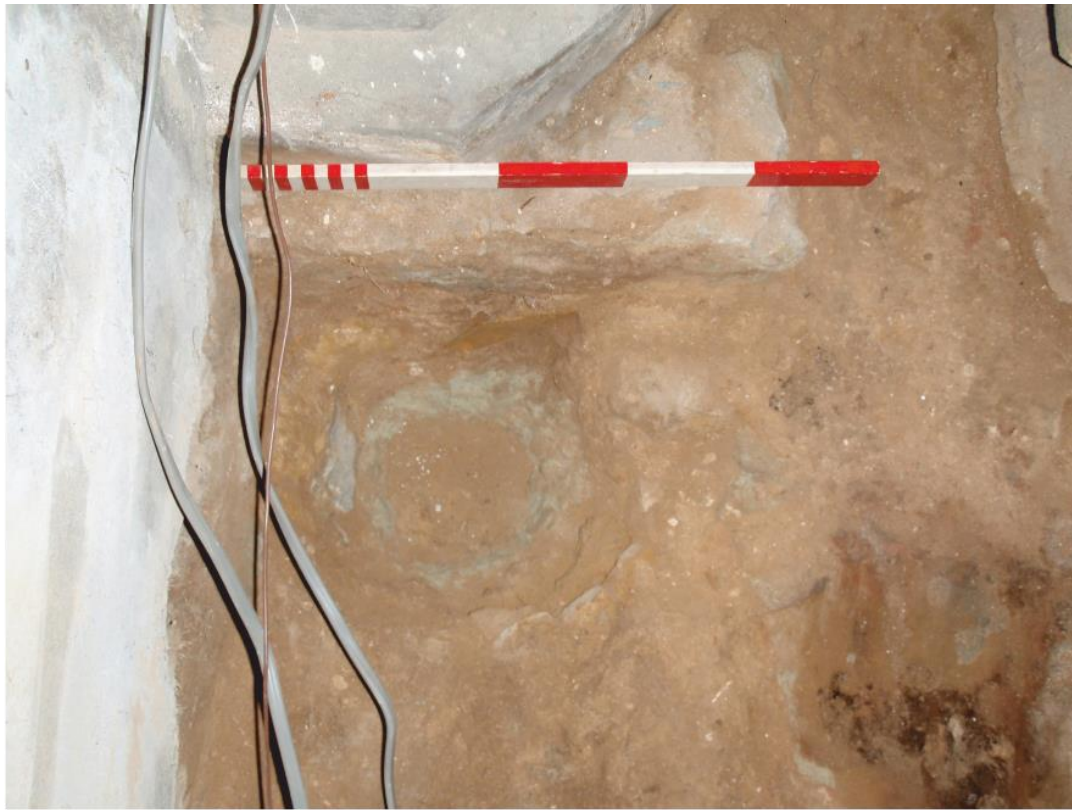
Pl. 15 Posthole 222, looking north. Scale 0.50m

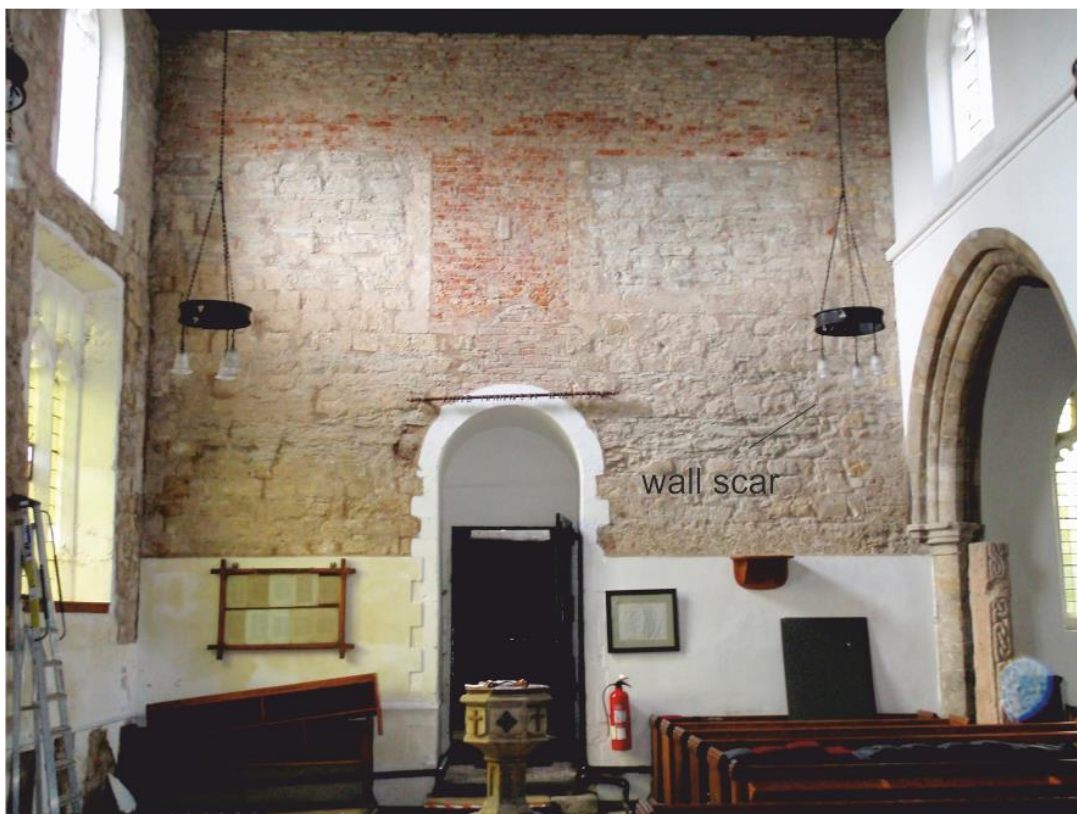
Once the foundation had been discovered it was easy to identify the wall scar on the nave west wall, above the plasterwork, which shows the original position of the nave north wall (Pl. 16). When the

Pl. 16 Nave west wall showing wall scar for original position of the nave north wall

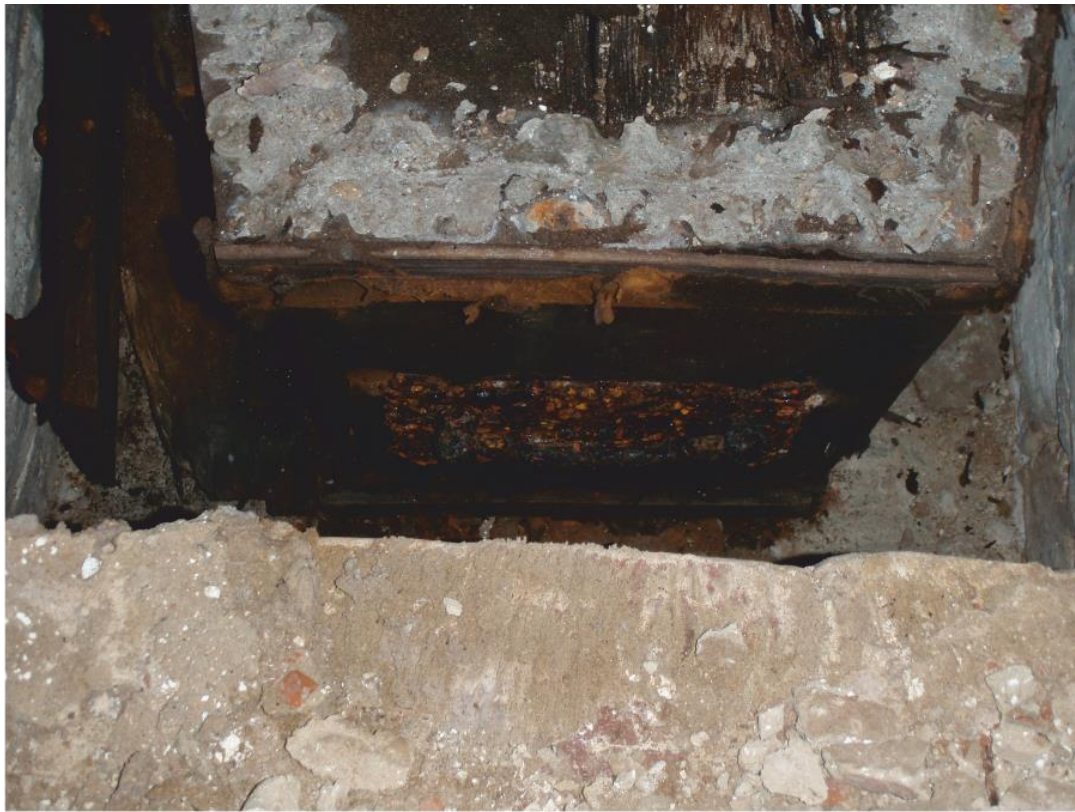
Pl. 41 Coffin handle at west end

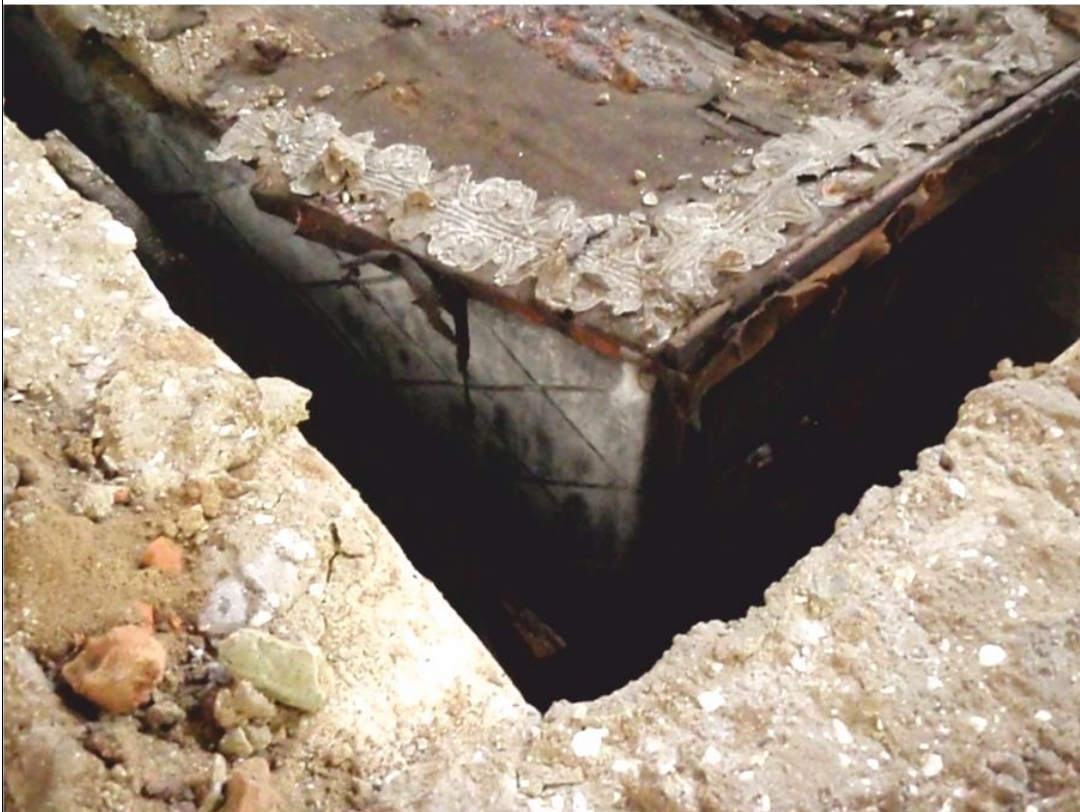
Pl. 42 Lead coffin exposed at east end, looking north-west.

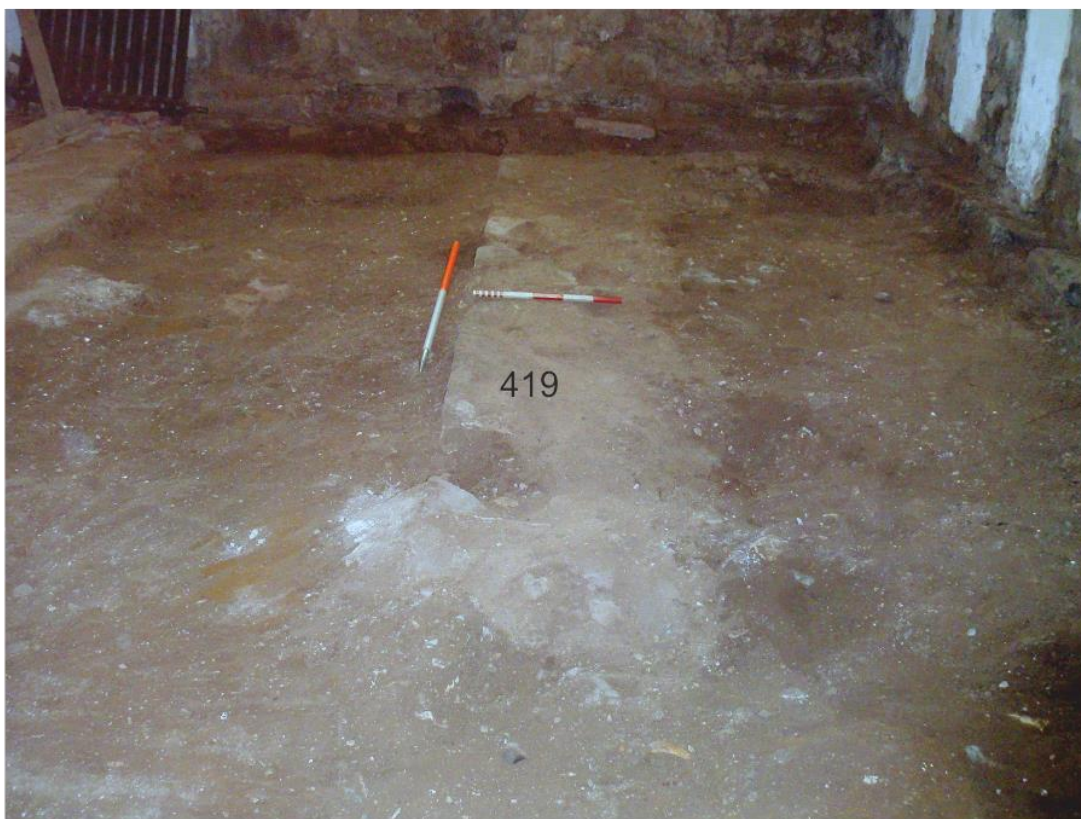
The medieval north wall of the aisle, **419**, was most clear at the west end of the present aisle. At the west end of the north aisle is a wall whose external facing of stones has been robbed but the internal edge survives (Pl. 46). It was recorded for a length of c.4.80m extending from its junction with the west wall foundations as far as grave **422**, described above. It was approximately 0.80m wide, the internal facing stones being present but those on the external face had been removed. A spread of mortar, **442**, which extended over the wall and into the north-west corner of the present aisle may have concealed a corner buttress but was not removed. The foundation construction of the present aisle west wall was very different south and north of wall **419**. This is because the foundations **402**, belong to the medieval aisle while **418** north of wall **416** belong to the Victorian rebuild (Pl. 47). Two stones lying between Vaults 3 and 1 probably belong to wall **419** (Pl. 48). East of double vault 1 and 2 was a narrow spread of mortar which may represent the wall line **419**. This spread east of the pew sleeper trench and was associated with three chamfered stones (Pls 49 and 50). These were the only surviving edge of the external wall face. The outline of a buttress east of the double vault was defined by the mortar. To the south of **419** was a yellow mortar spread **437**, remnant of a floor base.

Pl. 46 Wall foundation of north wall of medieval north aisle, looking west. Scales 1m and 0.50m.

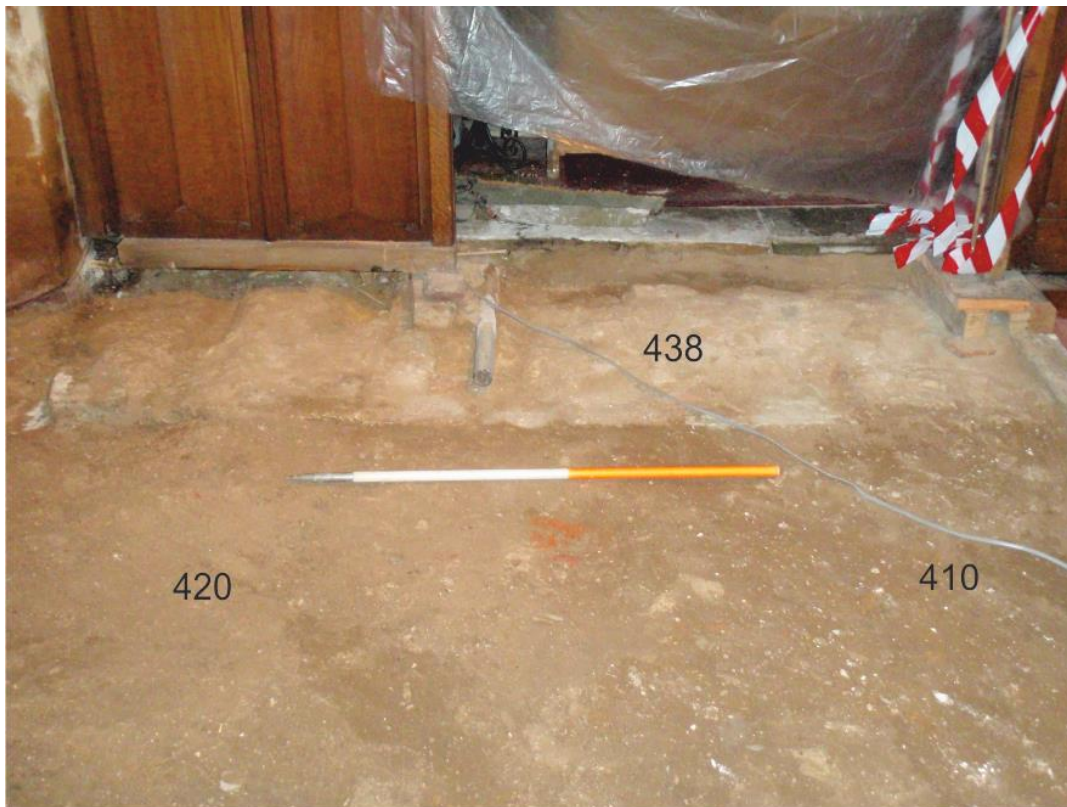
At the east end of the north aisle was the east wall foundation, **438**, running beneath the floor of the organ chamber (Pl. 51). The exposed width was 0.90m wide. The north wall could not be traced as far as the east wall and there was no indication of a break in construction as there had been on the west wall. It is possible that the east wall is part of the 1884 rebuild and that the medieval east wall was not found.

Pl. 51 Nave east wall, 438, looking east. Scale 1m

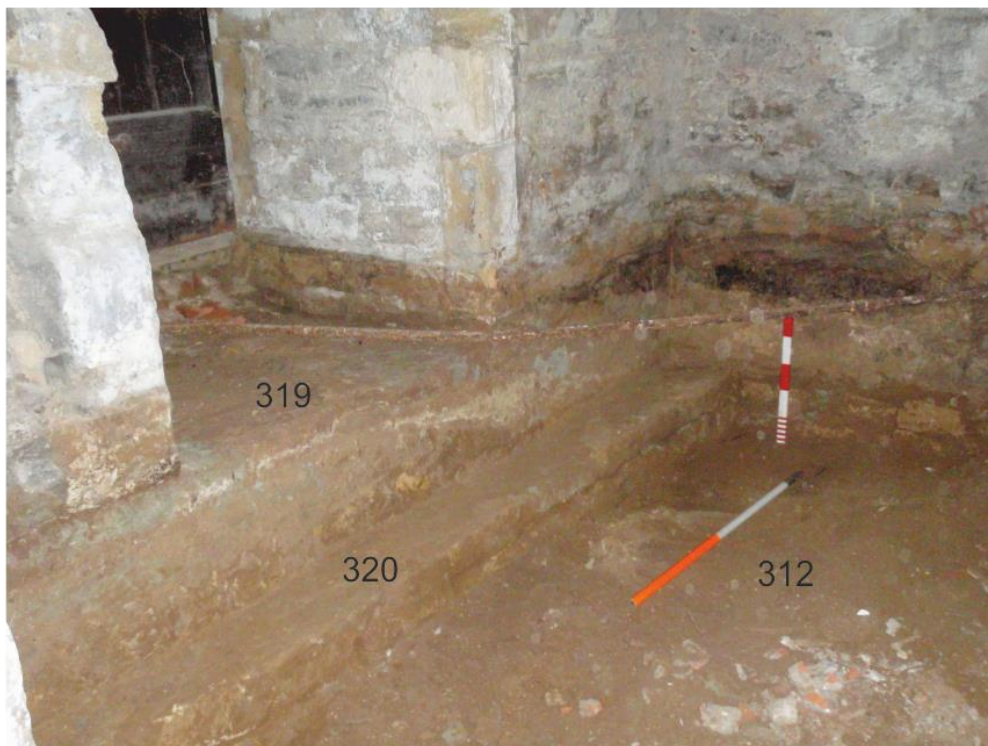
Pl. 62 Tower foundations in the south and west walls, looking south-west. Scales 1m and 0.50m

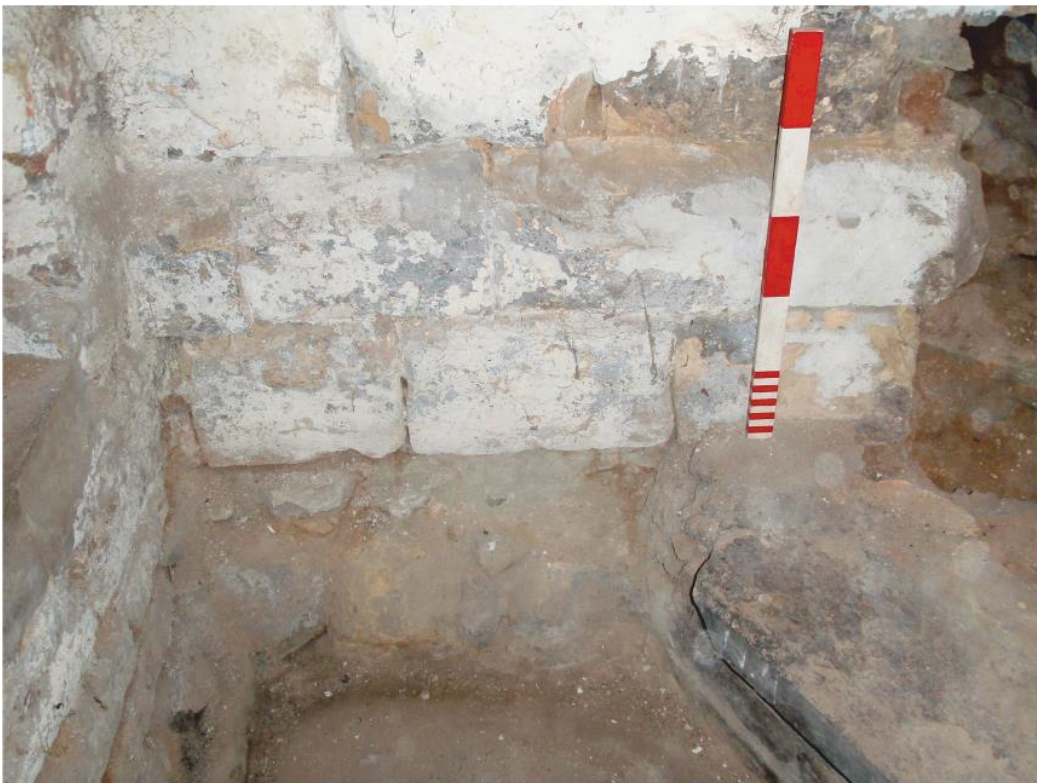
Pl. 66 Detail of chamfered course north of doorway . Scale 0.50m

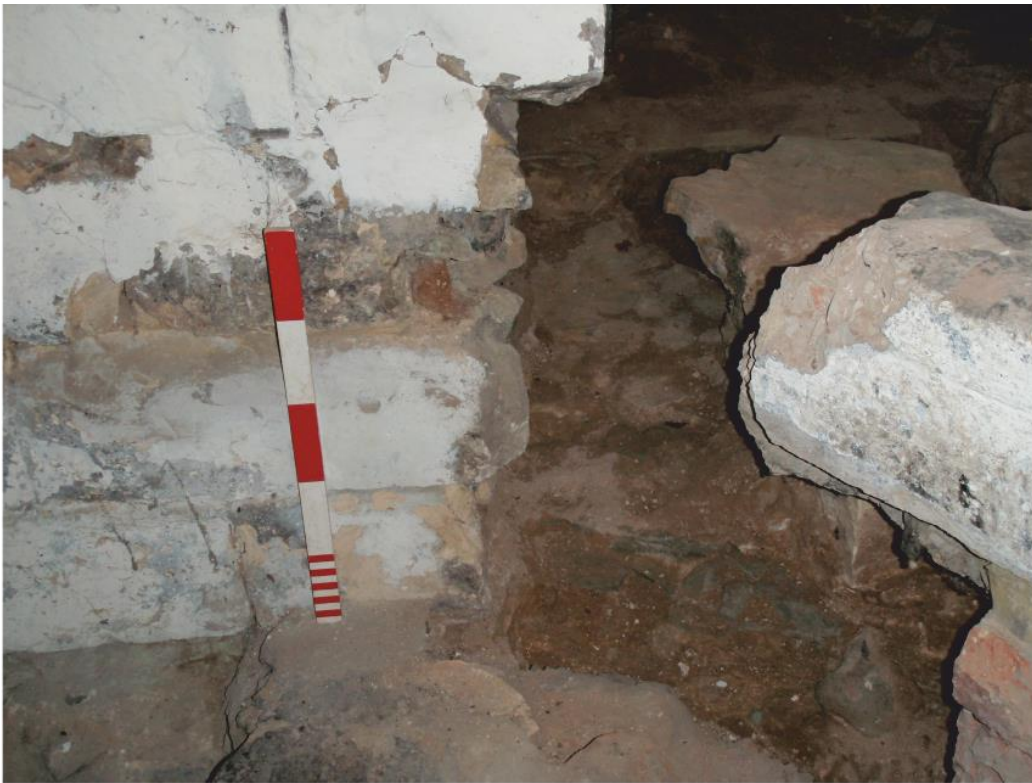
The north side of the opening was damaged when the heating pipe from the boiler was installed and the plinth does not survive (Pl. 64, 66 and 67). The original threshold had been removed by the later insertion of three steps from the nave into the tower, whose most recent form post-dated the insertion of the heating pipes.

Pl. 67 Detail of north-west corner of opening showing damage caused by insertion of heating pipes, looking east. Scale 0.50m

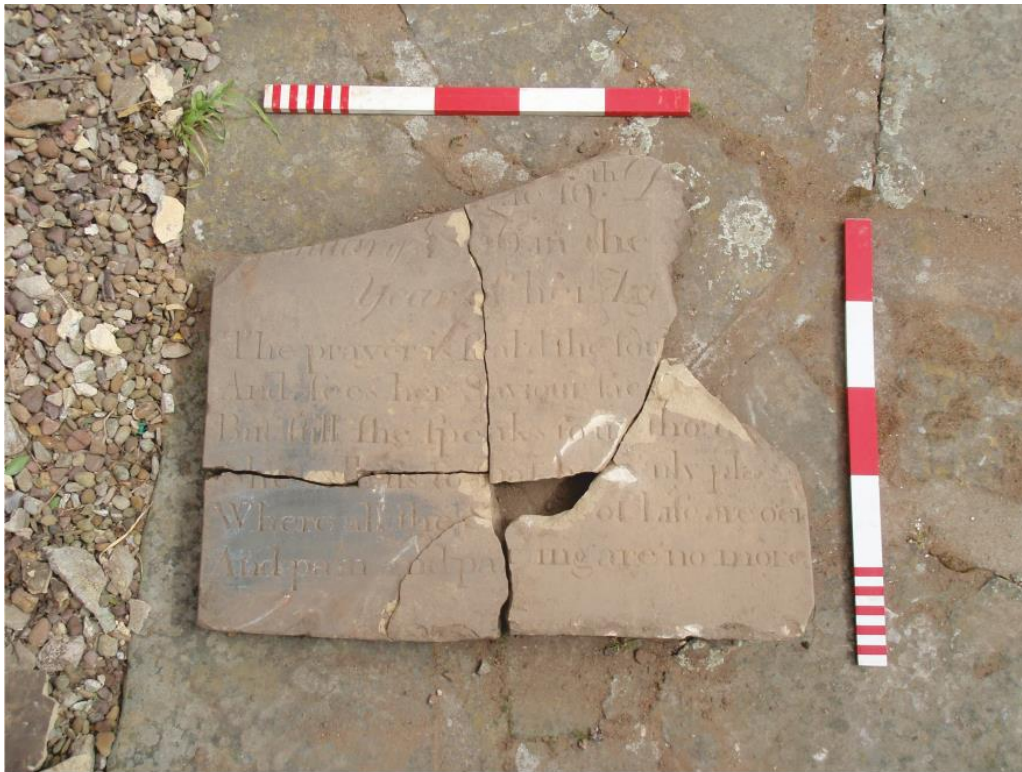
Fragments of a grave slab were found near to the Inspection chamber at the south-west corner of the tower. Only the lower part was found and no name was present on the surviving part of the inscription (Pl. 81).

Pl. 81. Fragments of graveslab found near tower. Scales 0.50m and 0.30m
