Former e2v Site, Carholme Rd,

Newsom & Son Offices

Building Recording Report

Report No: LIN-03 -LPA 2013/31

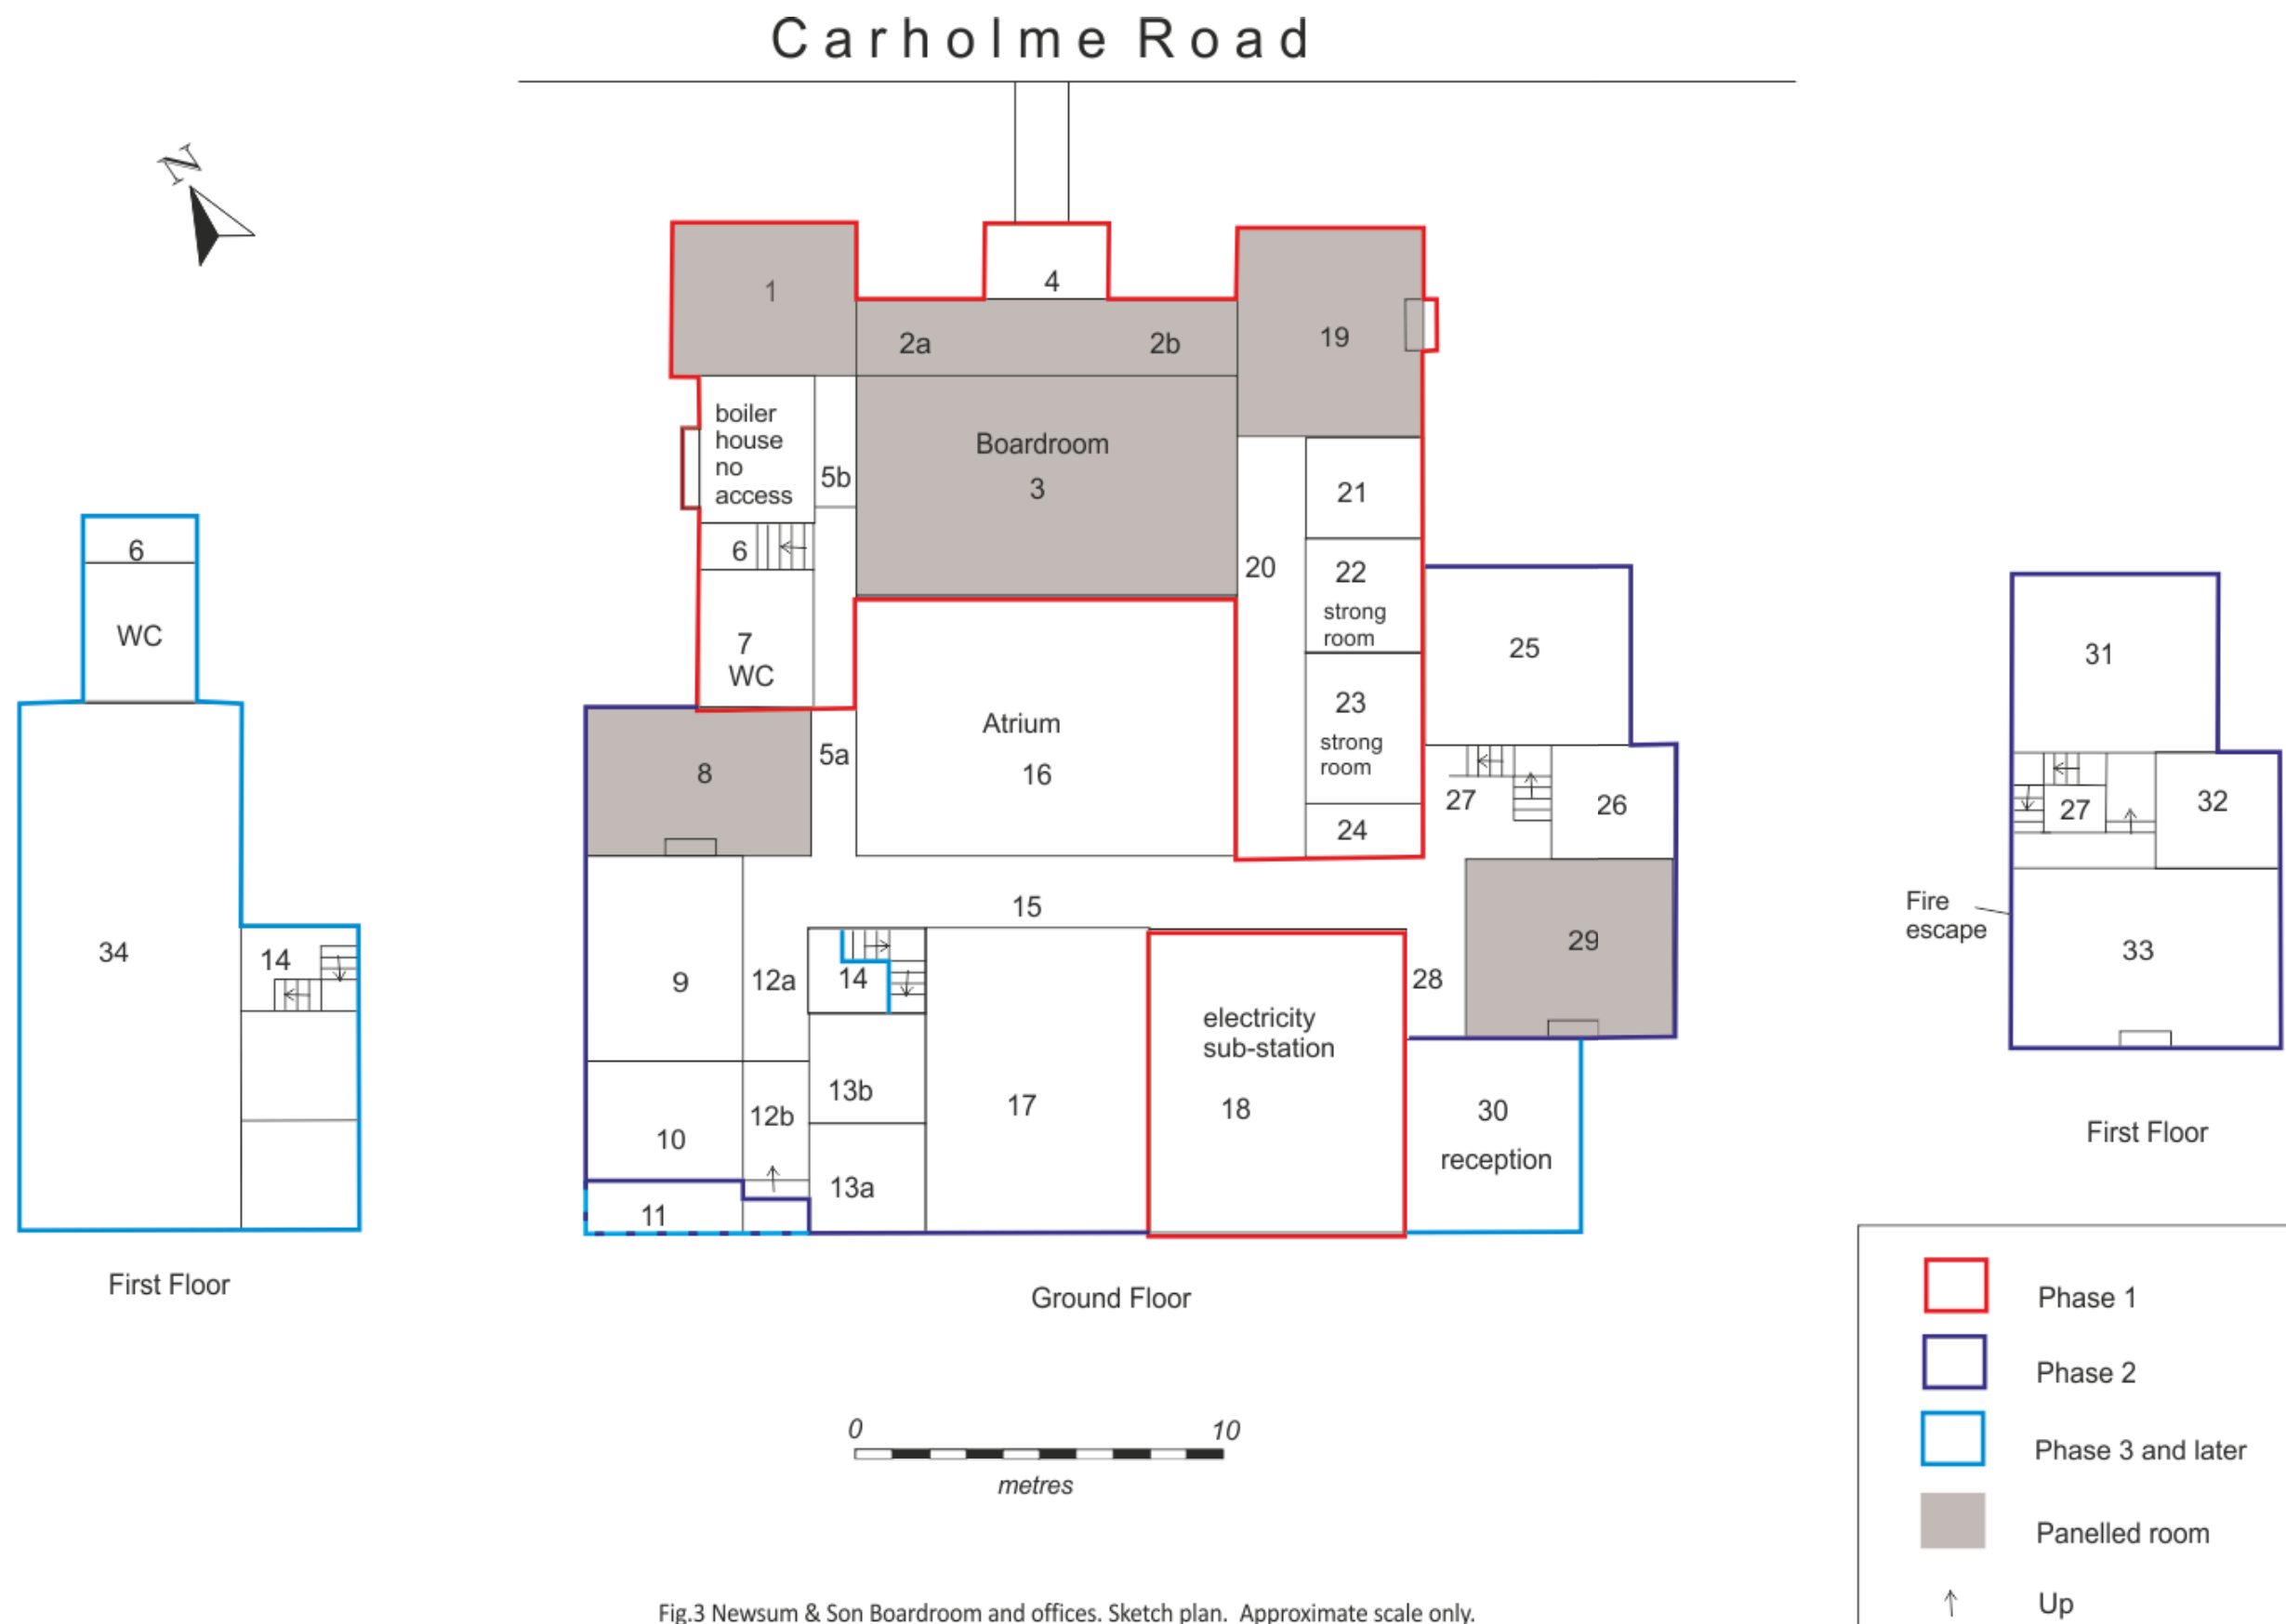
4.0.2 There was no surviving plan of the office building, so a sketch was made of the layout during the photographic survey (Fig. 3). This is only approximately to scale. The rooms were numbered for purposes of the record and are described below and marked on the plates. The survey was carried out between January 16th and 31st 2013.

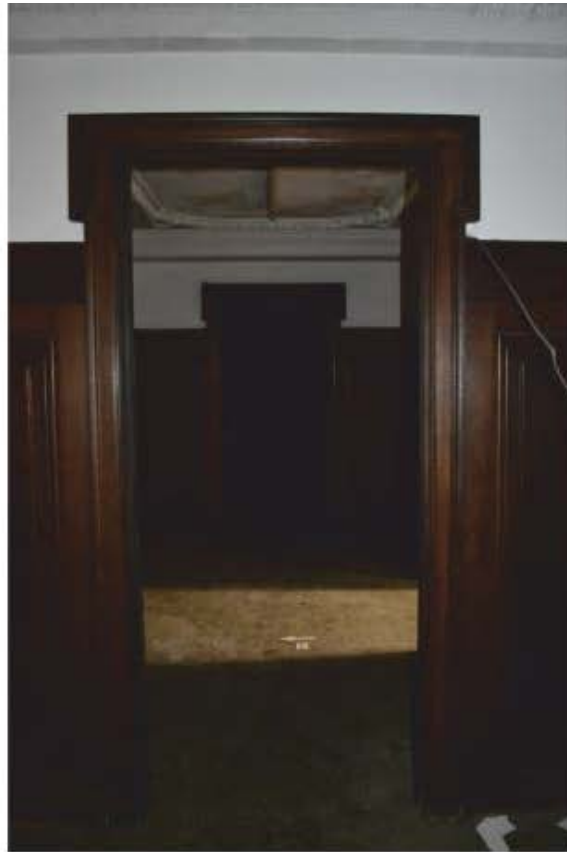
Pl. 11 View east through arch into Foyer area 2b

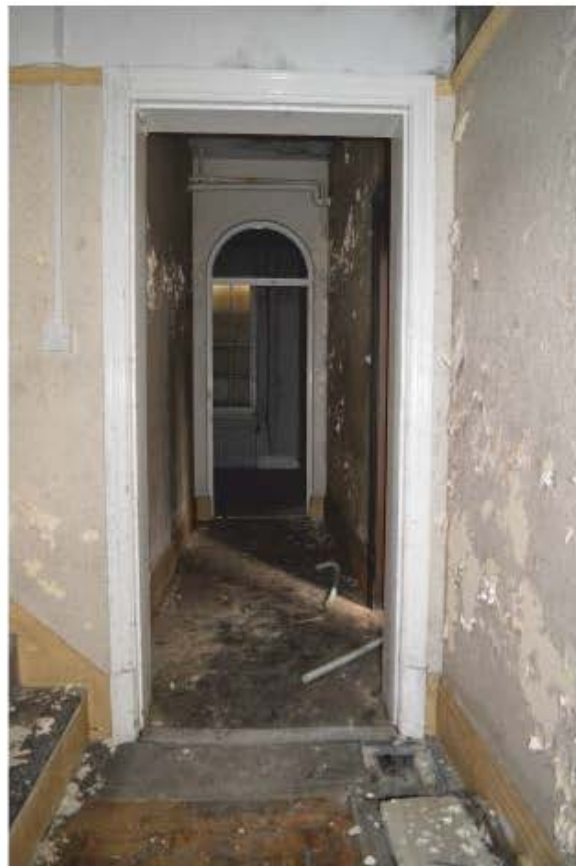
5. Western corridor accessed direct from the office 1 and also from the west door in the boardroom 3. An arch south of the door into the boardroom splits the corridor into two uneven lengths. This probably had a door, thus sealing the business area from the less important administrative offices.

Pl. 16 Corridor 5, looking north. Architrave shows former position of door that separated the northern part of the building from the area used by junior employees. Stair 6 to left

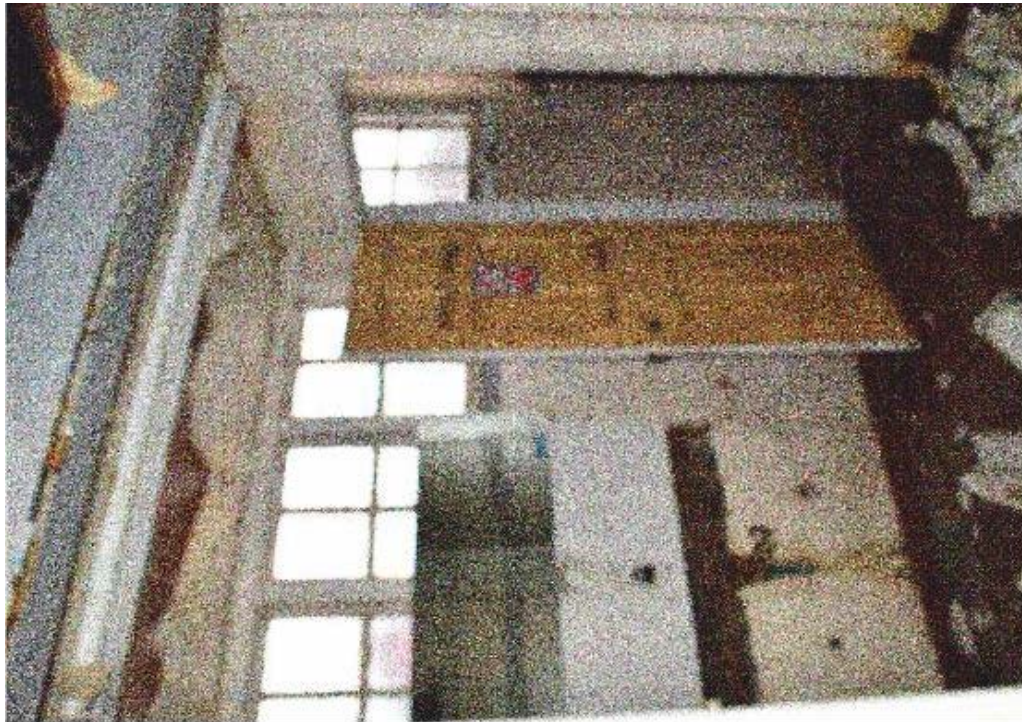
6. Inserted stairs on the west side of the corridor. The stairs conceal an original door in the west wall, now only visible on the exterior. 13 steps lead up to ladies' toilets on south side of the staircase. Two WCs and 2 washbasins. Small dormer windows in the roof are inserted.

Pl. 18 Ladies' toilets, 6. Inserted dormer windows
in west wall.

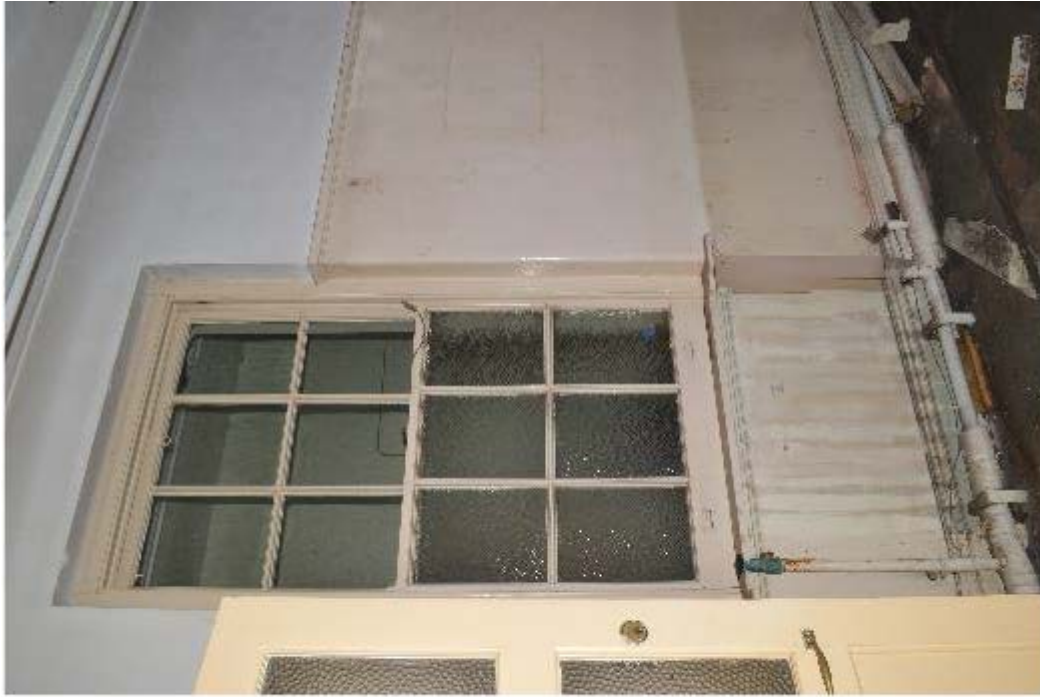
10. Office south of 9. Accessed via door on Corridor 12. One sash window in west wall. Lino floor over parquet. The south wall of this room was originally the external wall of the building, and has a blocked window.

Pl. 24 Room 10, blocked window in south wall.

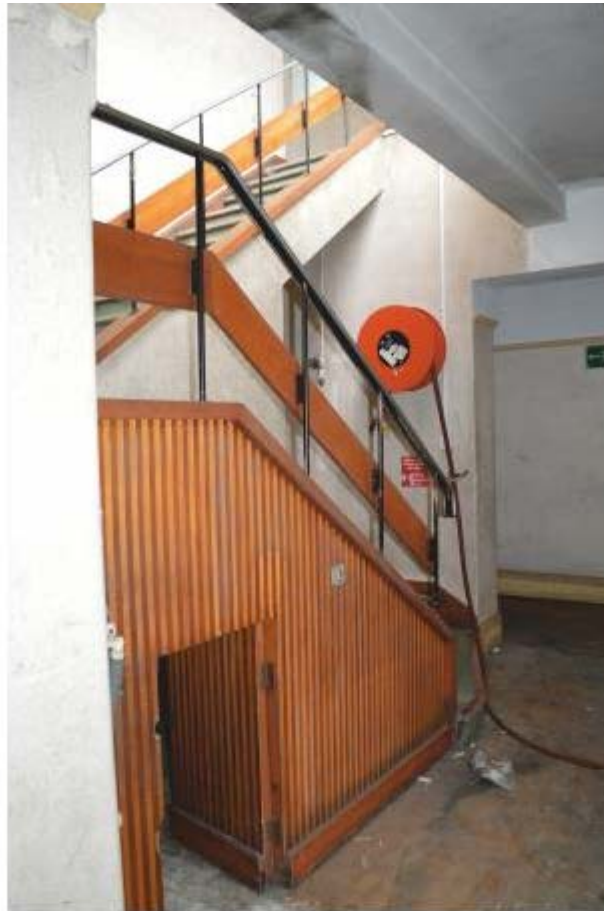
14. Inserted stair up to the first floor drawing offices (34) which extend over offices 8, 9, 10, 11 and 13 below. C. 1960. The corridor wall was cut away, with the an RSJ over. Access through from corridor 5 into 12 was probably cut through at the same time. There may have been a room in this position prior to the construction of the staircase.

Pl. 29 Inserted staircase 14, looking west

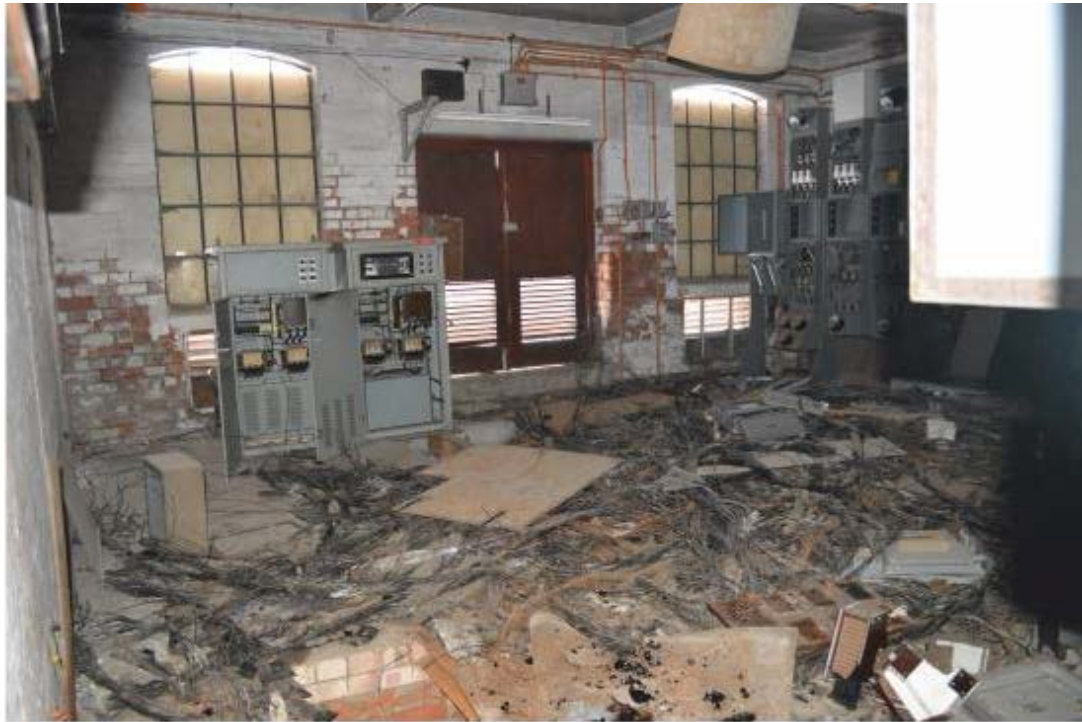
18. Electricity substation accessed from an inserted door at the east end of corridor 15, down three steps (0.65m below corridor level). This room was not recorded as it still contained the generating equipment. This building was originally freestanding.

Pl. 35 Room 18, electricity sub-station, looking south

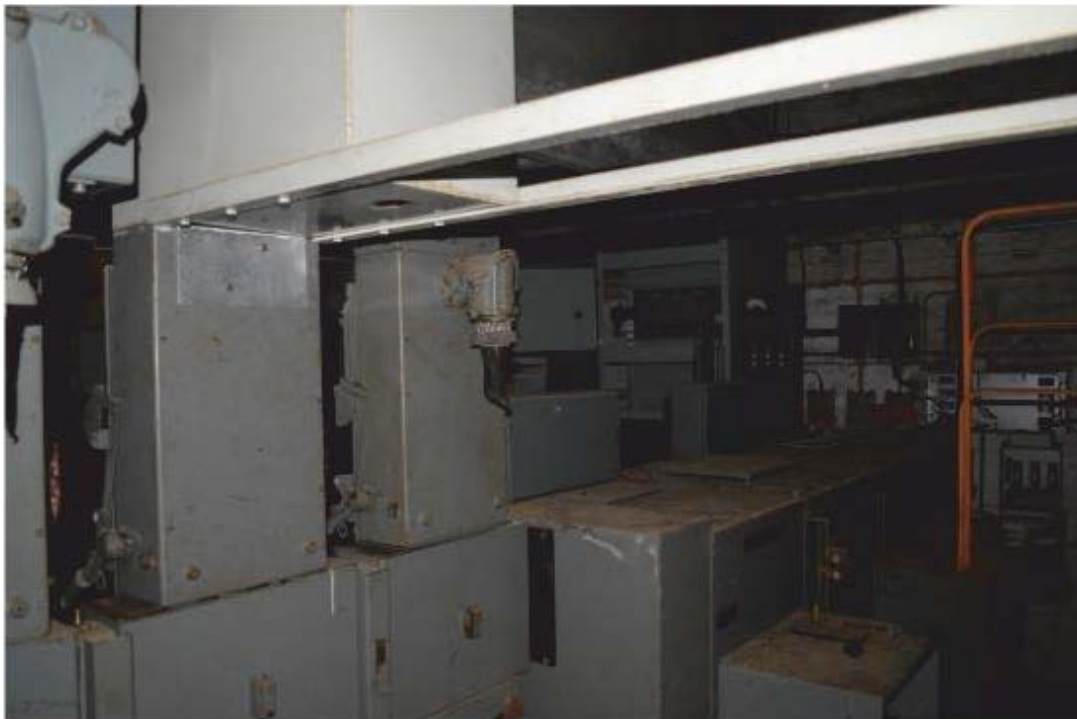
Pl. 36 Room 18, electricity sub-station, looking west.

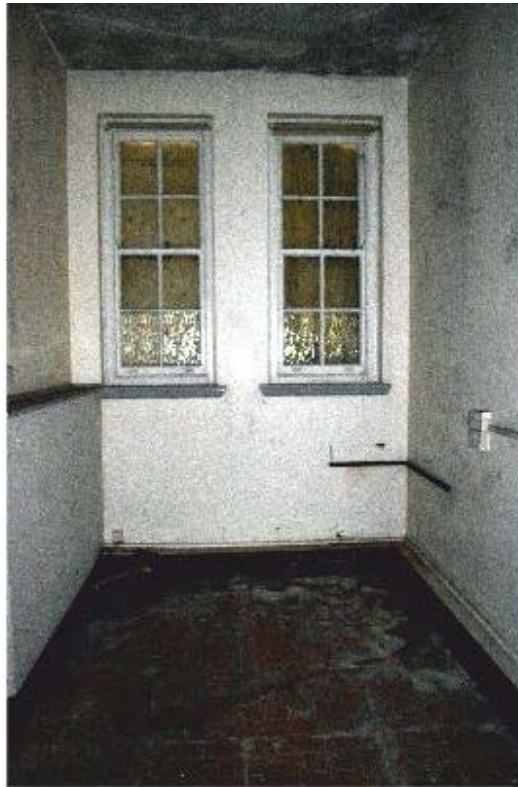
21. Side office with direct access from both corridor 20 and room 19. Was this originally a toilet? Quarry tiles on the floor and frosted glass on the lower window panes. This may have been private facilities for the director or similar who occupied Room 19, the largest of the panelled offices.

Pl. 41 Room 21, former toilet converted to office, looking east.

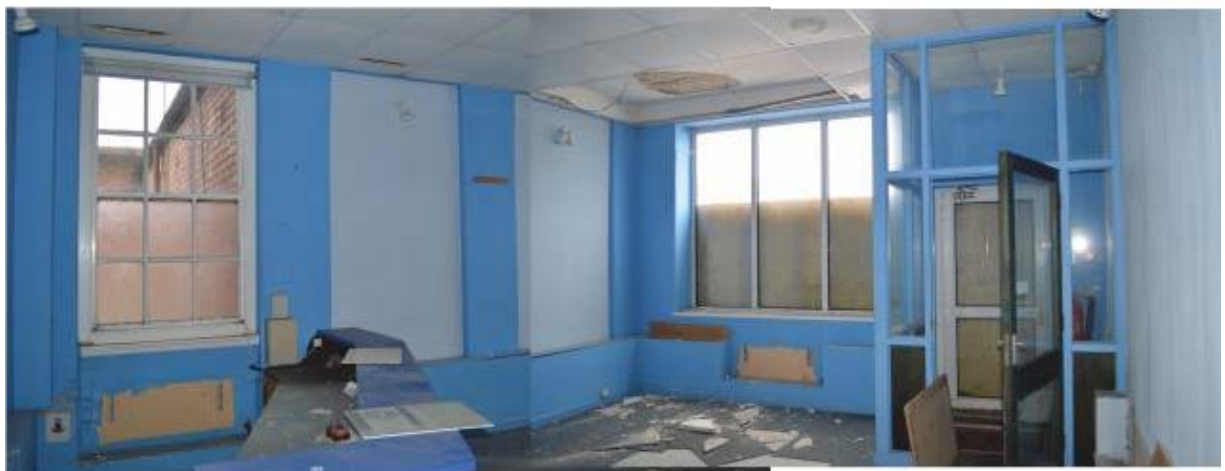
30. Inserted door at south end of corridor 28 gives access to single storey extension, reception area 30. Originally had three windows on the east wall but two were blocked and UPVC windows inserted on south wall, together with UPVC door. Suspended false ceiling.

Pl. 54 Room 30, composite view, looking south-east

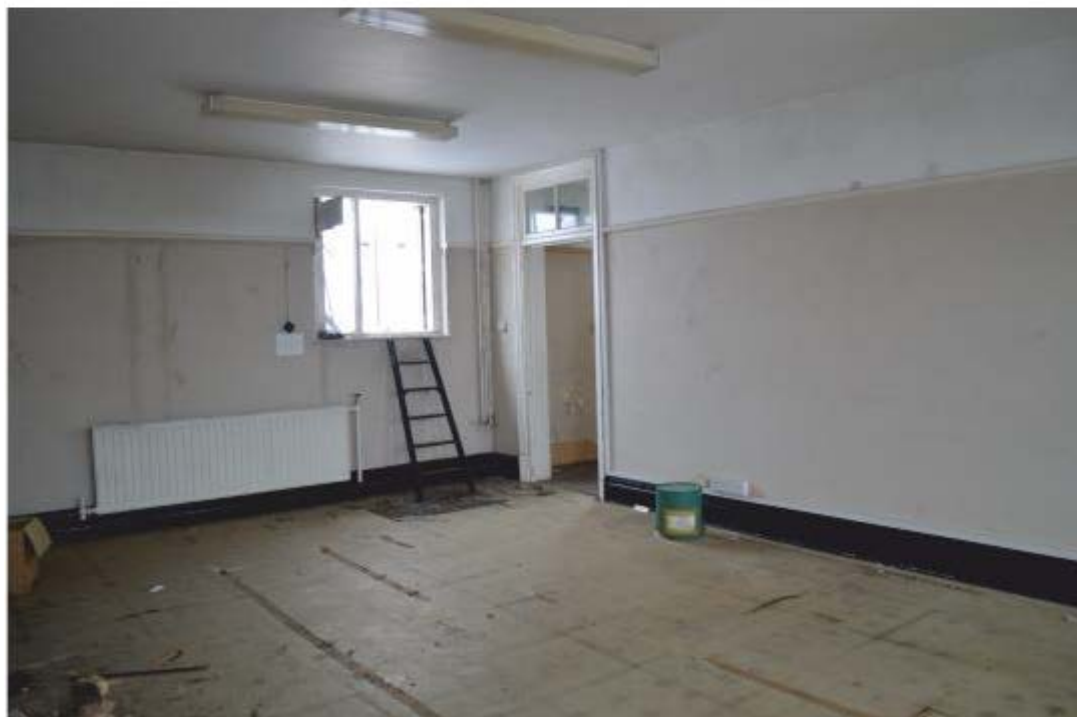
panelled rooms downstairs, indicating an office for a manager of lower rank. Inserted fire escape hatch on west wall gives access to roof valley.

Pl. 62 Room 33, looking north-west towards fire escape and landing 27
