**Barns adjacent to Pickrill Play,
Gibsmere, Bleasby, Notts.**

Archaeological Building Recording

Capla Developments Limited

Report No.: LPA-186

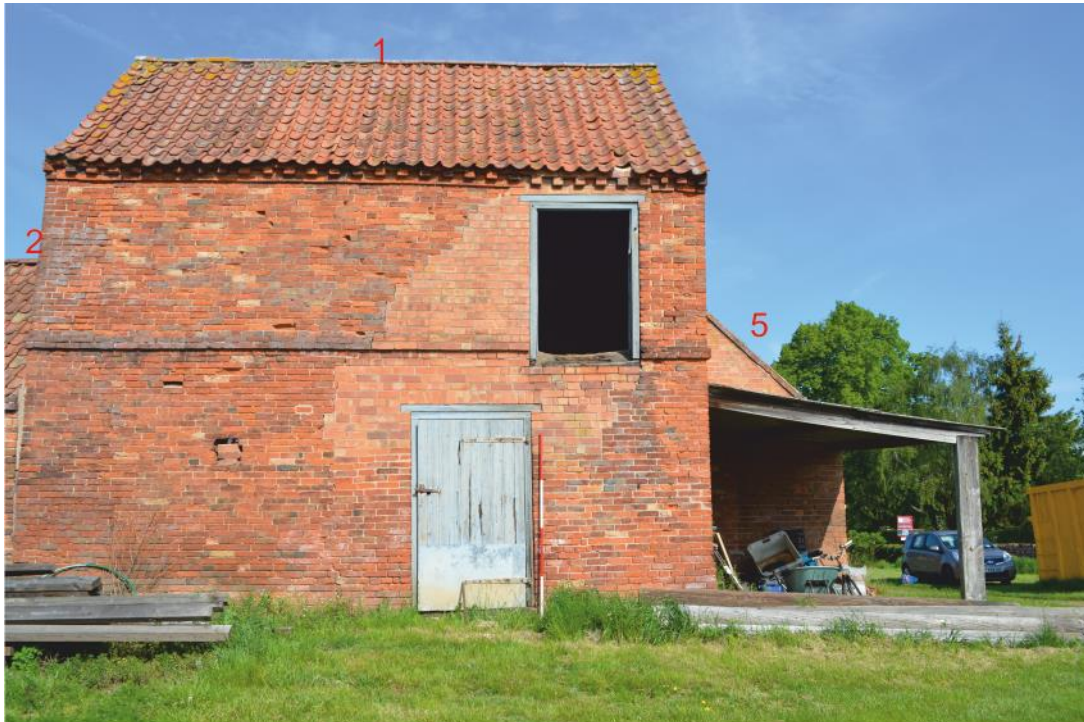
into the crewyard. It is not known whether this was blocked when the small shed 6 was constructed, or beforehand. There is hayloft above which was not accessible for recording, with access from the east elevation (Pl. 11).

Pl. 11 Building 1, east elevation showing taking in door and repaired wall and door into area 1a.

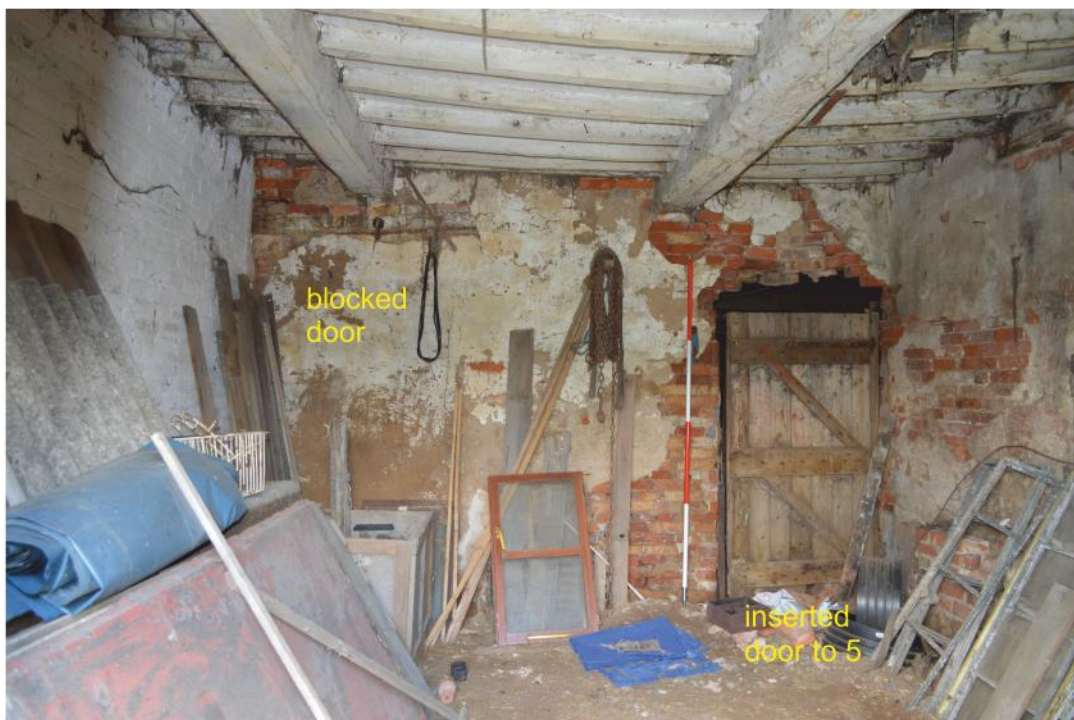
Pl. 12 Building 1a interior showing blocked door, and inserted door to building 5

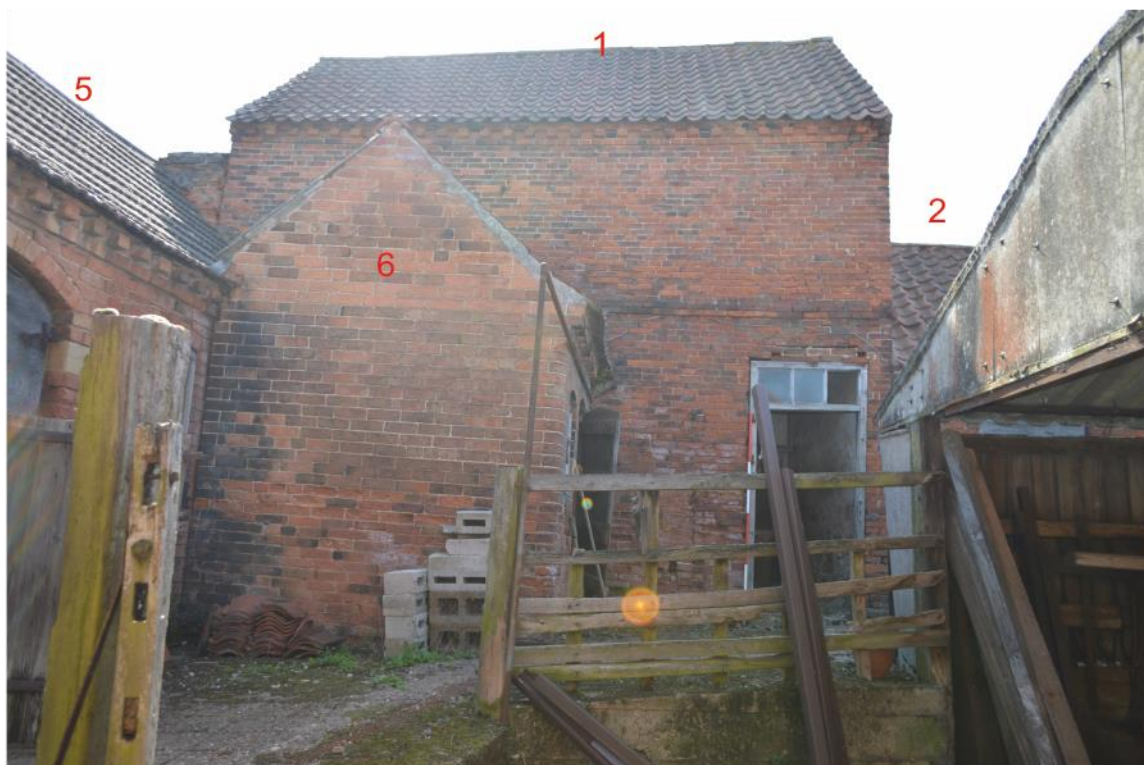
Access to the southern half of barn 1 is from the crewyard through an inserted door, contemporary with the installation of the partition wall (Pl. 14). This area has been converted into an animal shed with an inserted feeding trough and hayrack above probably for two horses (Pls 15 and 16). The stone foundations contain a piece of an architectural fragment of unknown source or date (Pl. 17).

Pl. 14 Building 1 from crewyard showing inserted door to 1b

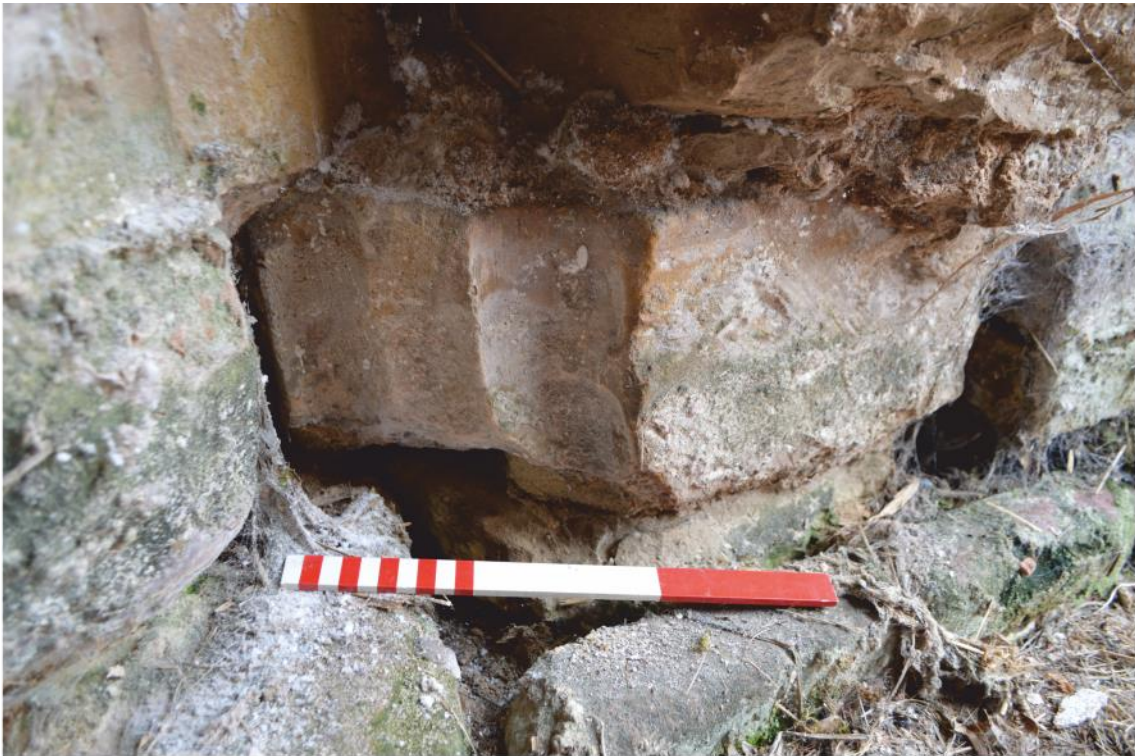
Pl. 17 Architectural fragment reused in stone plinth at base of wall

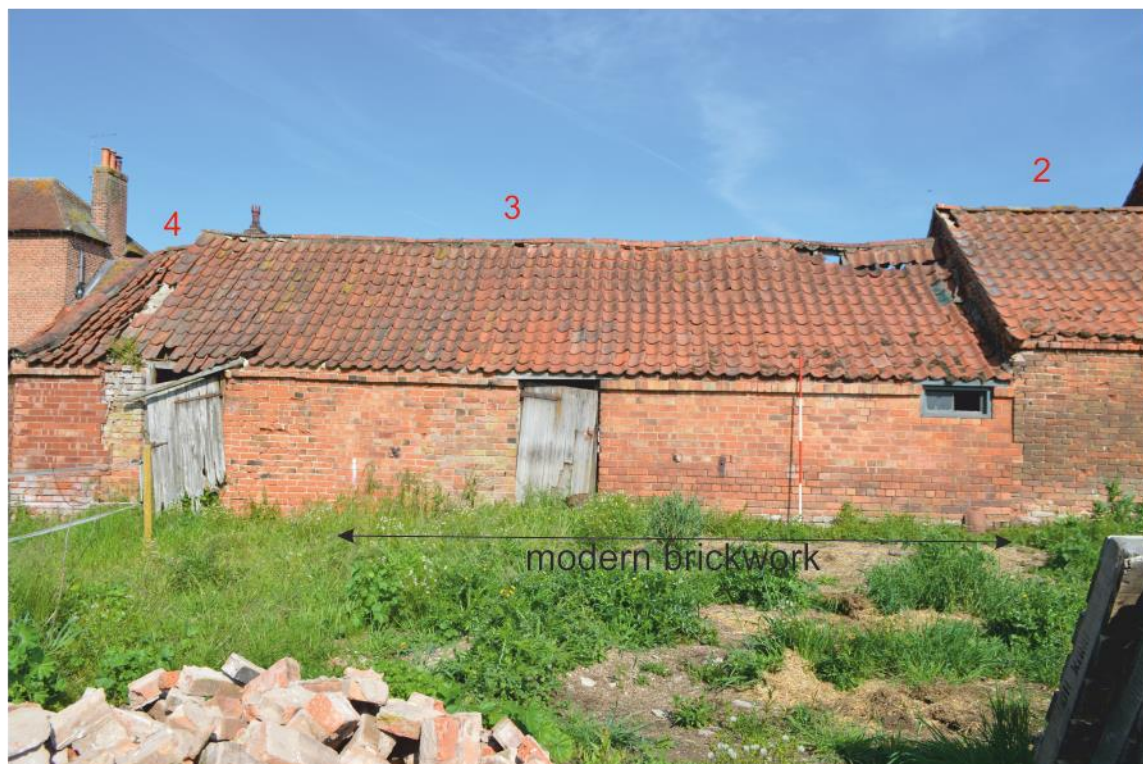
This long shed abuts the south wall of shed 2. It has been substantially rebuilt, especially on the elevation facing the field (Pl. 22), as well as the north end of the wall facing the crewyard (Pl. 23, 24). The shed has a concrete floor and is divided into three by two modern low brick subdivisions (Pls 25-26). The roof has old purlins and trusses with some modern rafters, most components being nailed not pegged (Pl. 27). There are doors at both sides of the middle bay, but the external door is contained within an area of new brickwork and there was probably no door on this side of the building (Pl. 28).

Pl. 22 Building 3 viewed from the field, much rebuilt with inserted window

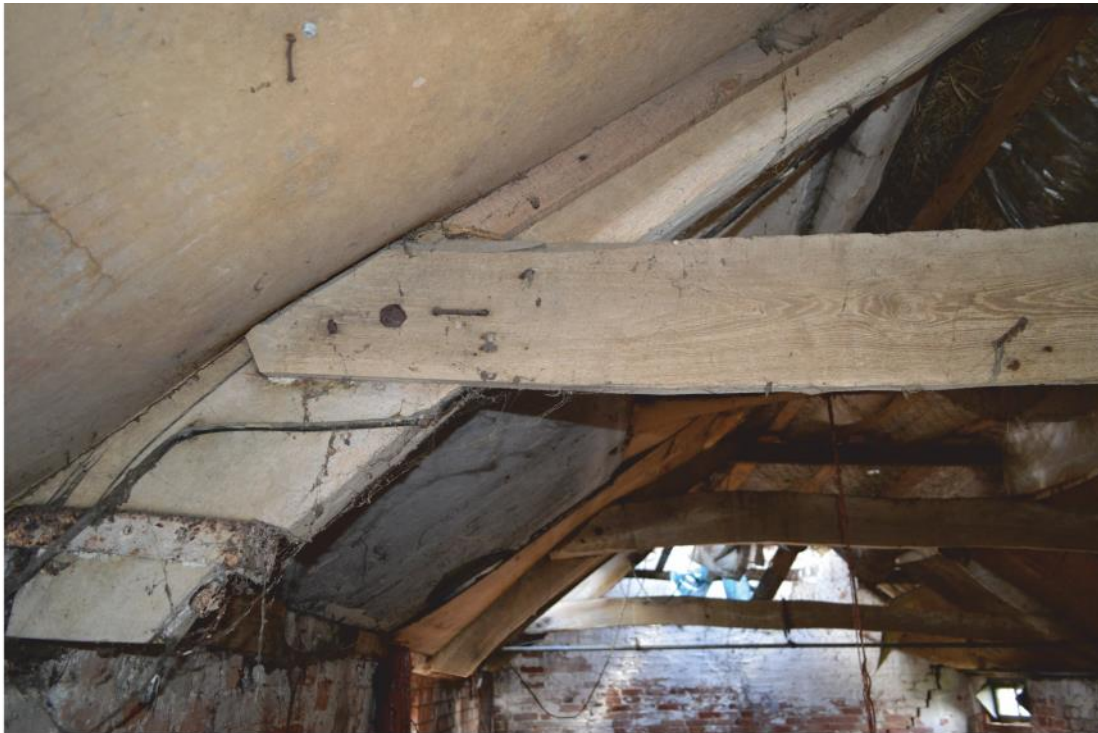
Pl. 27 Building 3 detail of nailed roof truss

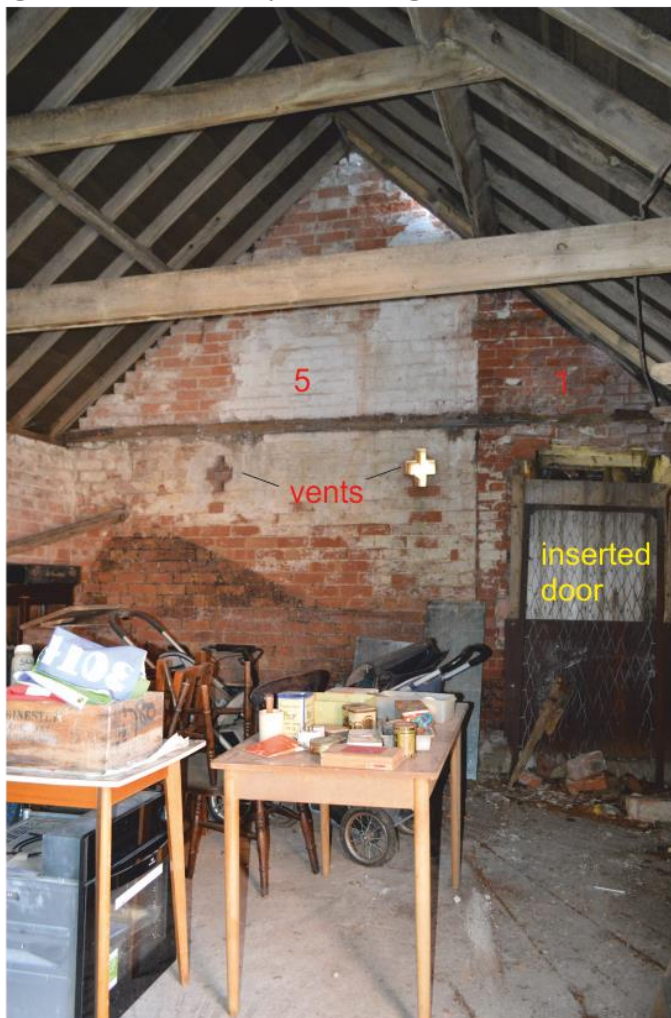
Pl. 40 Building 5 looking east. Inserted door to building 1
and machine sawn roof timbers

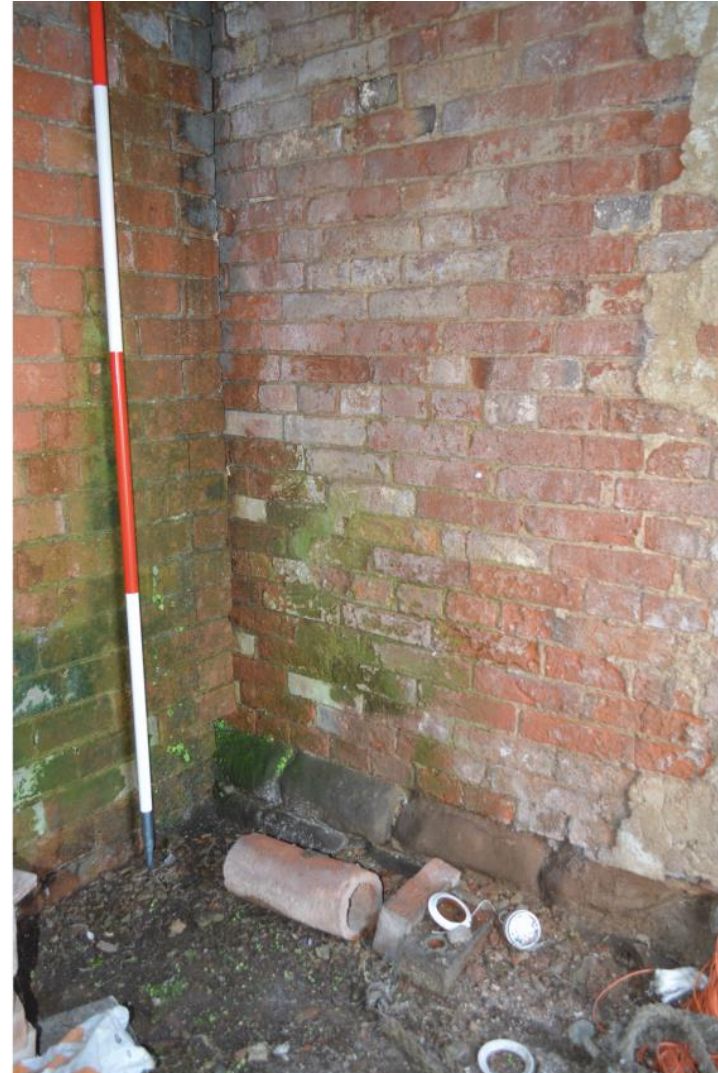
- 5.1.4 Abutting the angle formed by Buildings 1 and 5 is a small shed (Pls 14 and 41). The chamfered stone plinth at the base of Building 1 is visible in the east wall (Pl. 42). There is a fireplace on the west wall (Pl. 43) but the chimney has been removed externally. An original door leading into building 1 has been blocked (Pls 14 and 44).

Pl. 42 Building 6 north wall (south wall of Building 5)
built over stone chamfered plinth of Building 1

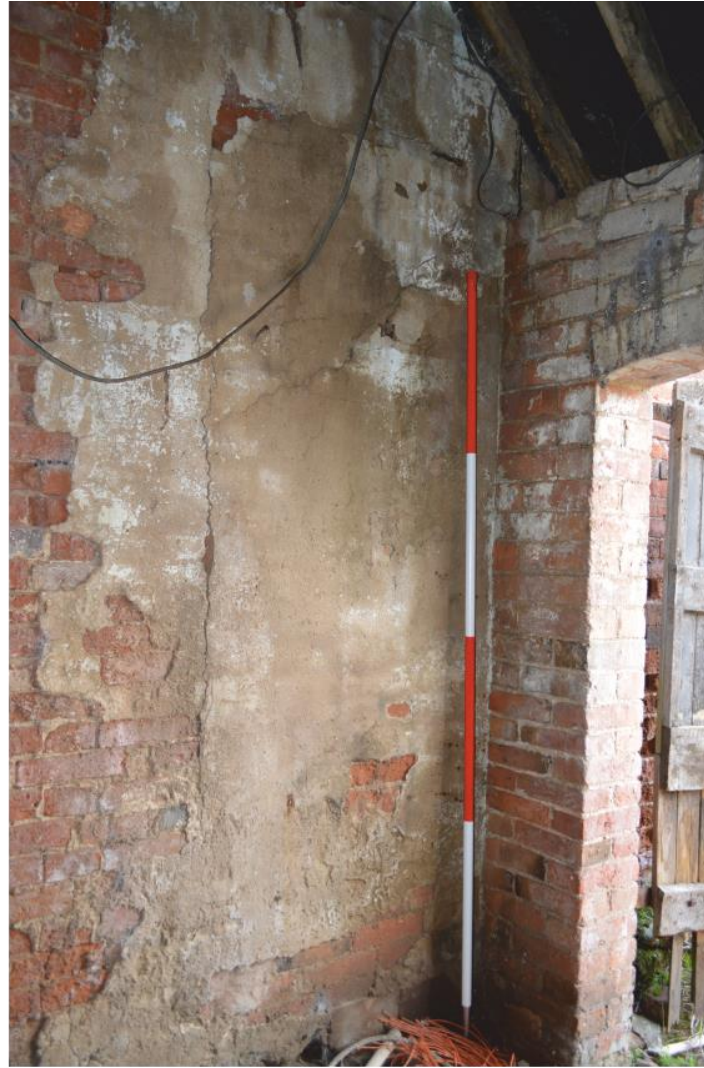
Pl. 44 Building 6, interior with blocked door in wall of building 1

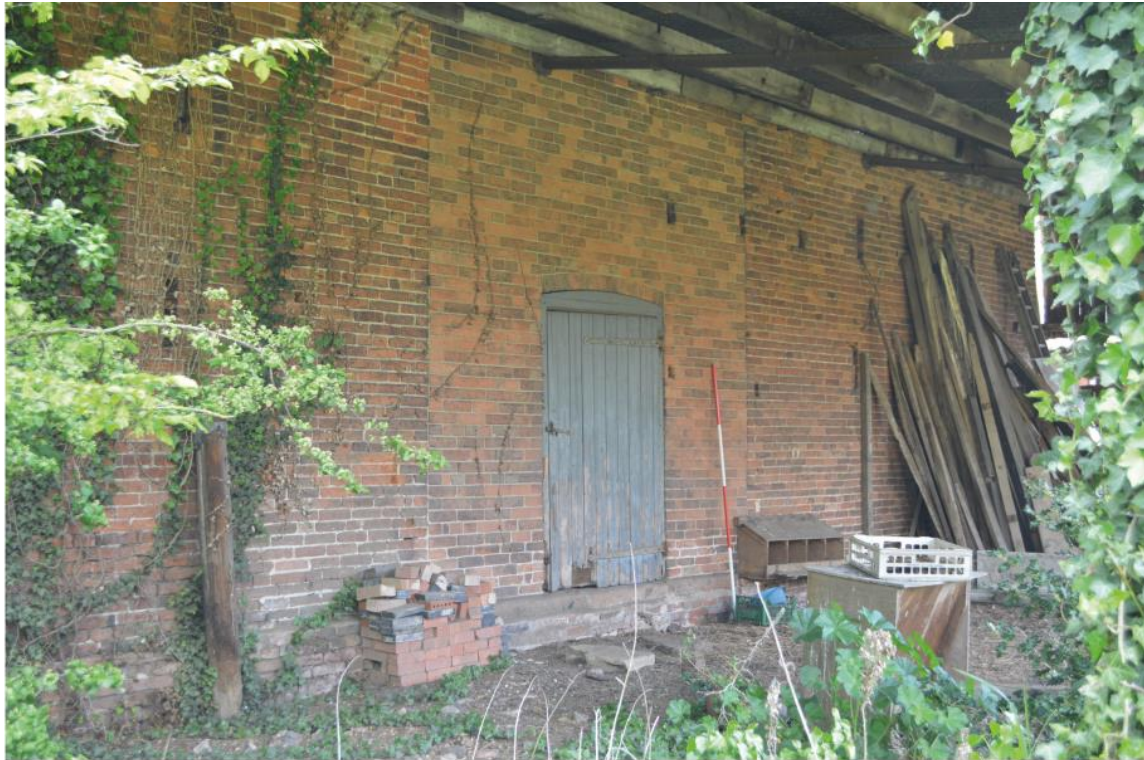
Pl. 47 Building 7, threshing barn, blocked door with inserted entrance on south-west elevation facing the crewyard

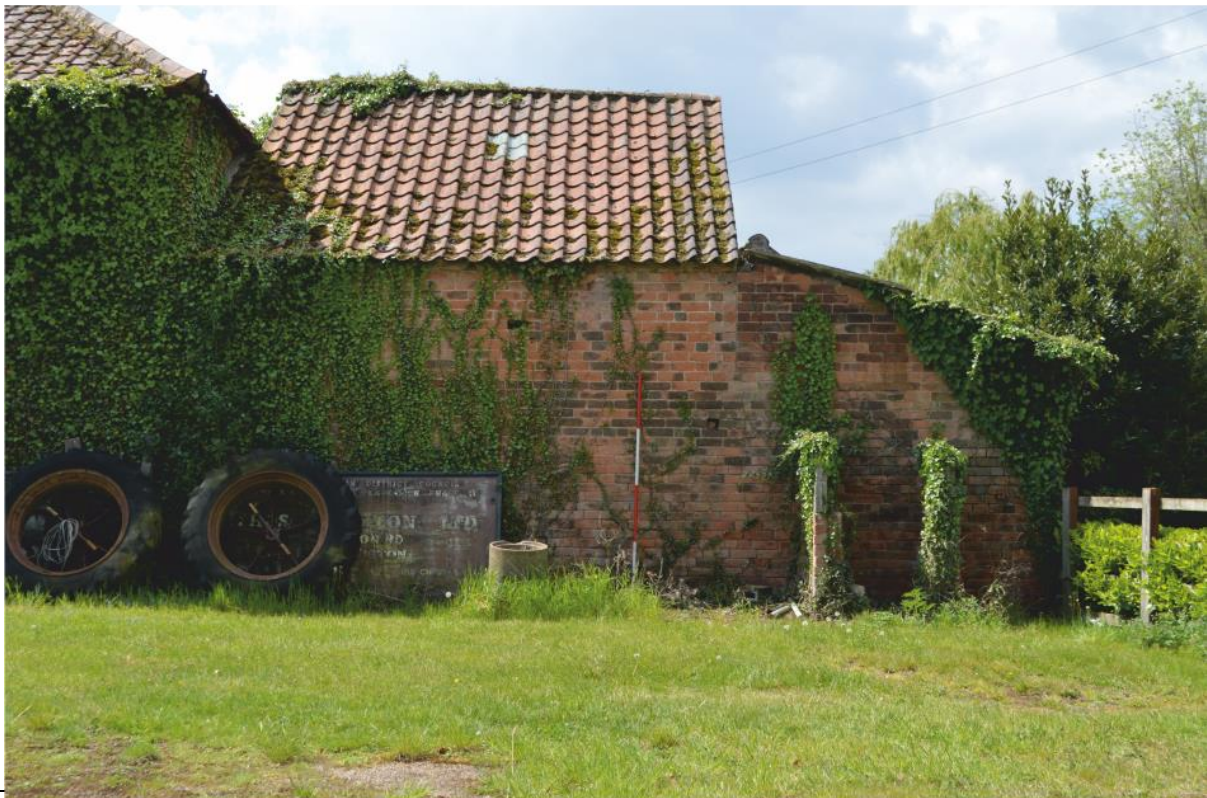
- 5.1.6 This building abuts the west side of the threshing barn. It has lost half of its roof which has been lowered and covered in corrugated asbestos (Pl. 52, 53, 56). The roof trusses and rafters are machine sawn and the joints are bolted together. The remnants of a hayrack are located along the north wall (Pl. 55) and the building was probably originally stabling. Low walls subdivided the area into smaller pens, probably for pigs (Pls 55 and 57). A stable door on the west gable led into a yard west of the building (Pl. 56). This area is now in

Pl. 52 Building 8 north-east elevation

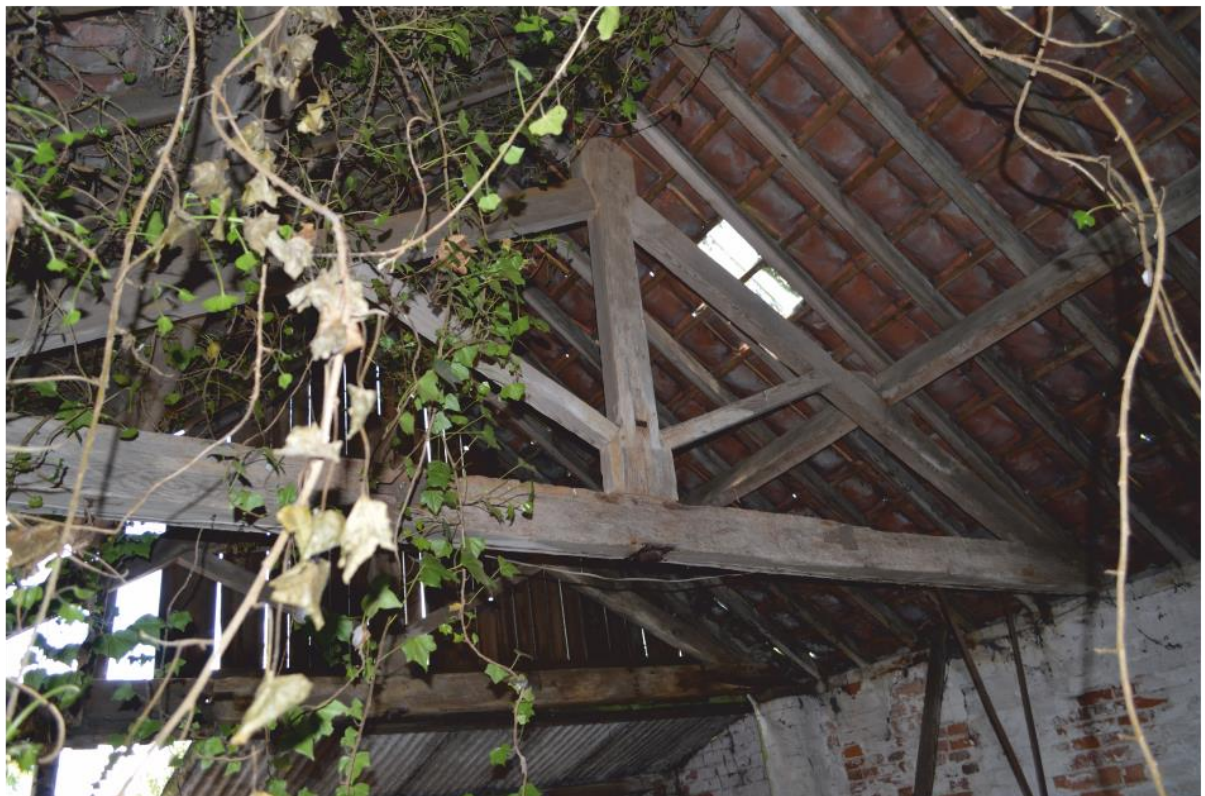
Pl. 54 Building 8, bolted roof truss of machine-sawn timbers

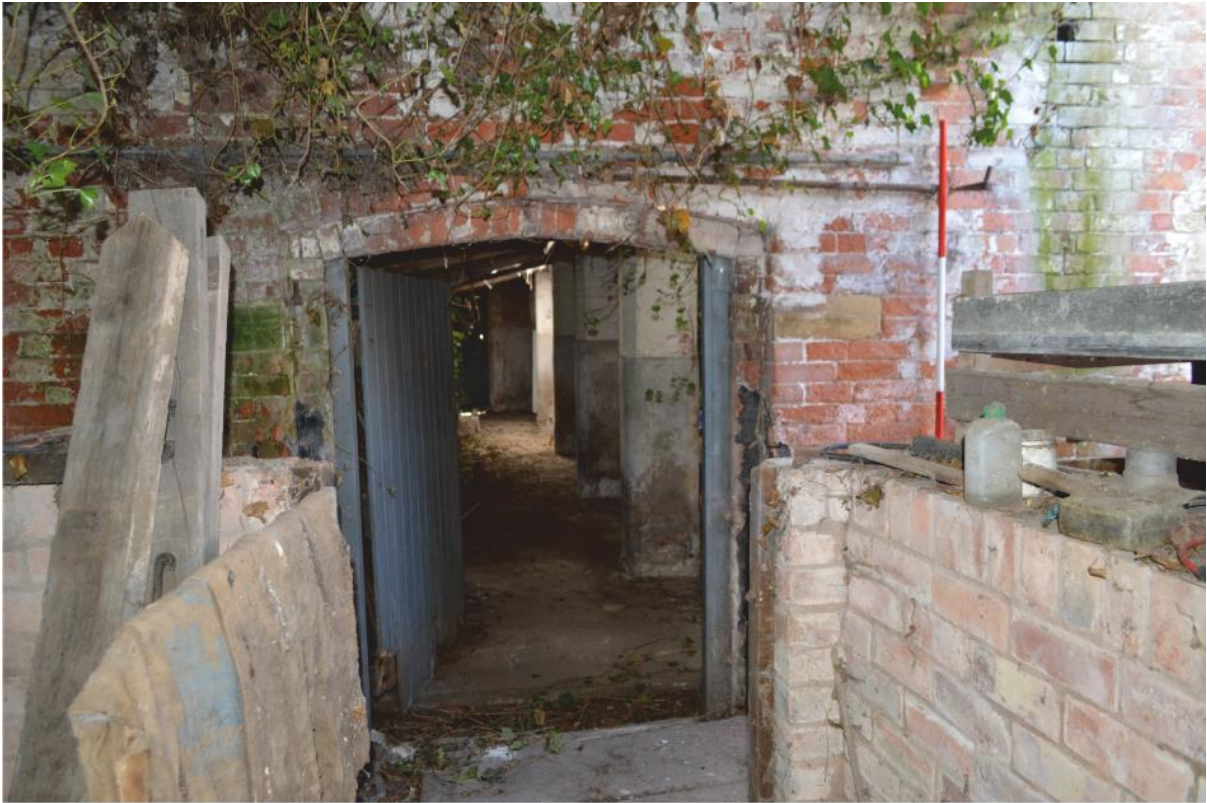
separate ownership and contained further farm buildings that have now been converted for residential use. The external elevation of this building and building 9 was not accessible for inspection. In the south wall of the building is an exit, originally into the crewyard but now leads into the cowshed 10 (Pl. 57).

Pl. 57 Building 8, original external access to crewyard (now leads into milking shed 10)
