# Naomi Field Archaeological Consultancy

## St Helen's Church, Barnoldby le Beck, NE Lincs. Archaeological Monitoring and Recording

### Report

**NFAC Report No. 0904  
October 2009**

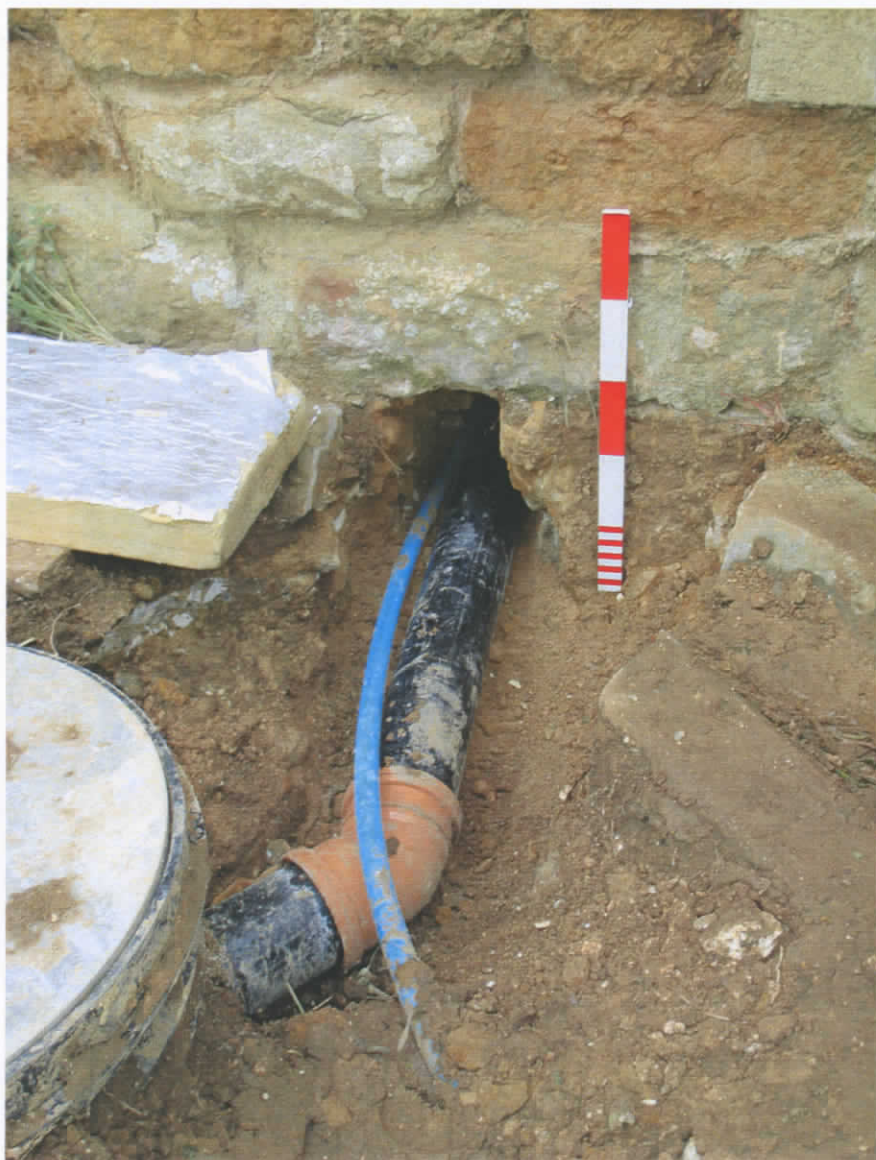
Two visits were made to the site on April 2<sup>nd</sup> and June 11<sup>th</sup> 2009. A pit for an inspection chamber (No.1) was dug adjacent to the south west corner where a hole was drilled through the wall to connect a pipe to the interior of the church (Pl. 3). A trench, 0.30m wide and c.0.50m- 0.70m deep, was dug westwards from the inspection chamber for 5m towards the churchyard boundary, where a second inspection chamber was installed (Pl. 4). The trench turned southwards along the western boundary of the churchyard for a further 9 m to the steps next to Church Lane (Pls 5 and 6) to join the main sewer in the road.

Beneath the turf in the churchyard was a dark brown clayey topsoil 0.20m in depth which overlay the churchyard soil comprising a mid-brown soil with chalk flecks. The ground next to the tower contained stone fragments which are interpreted as being associated with the construction of the church (Pl. 3). A few fragments of human bone were found during the excavation of the trench but no graves *in situ* were disturbed. There were no other finds.

Pl. 3 Connection of the pipe from Inspection Chamber 1 into the church, looking east. Scale 0.50m

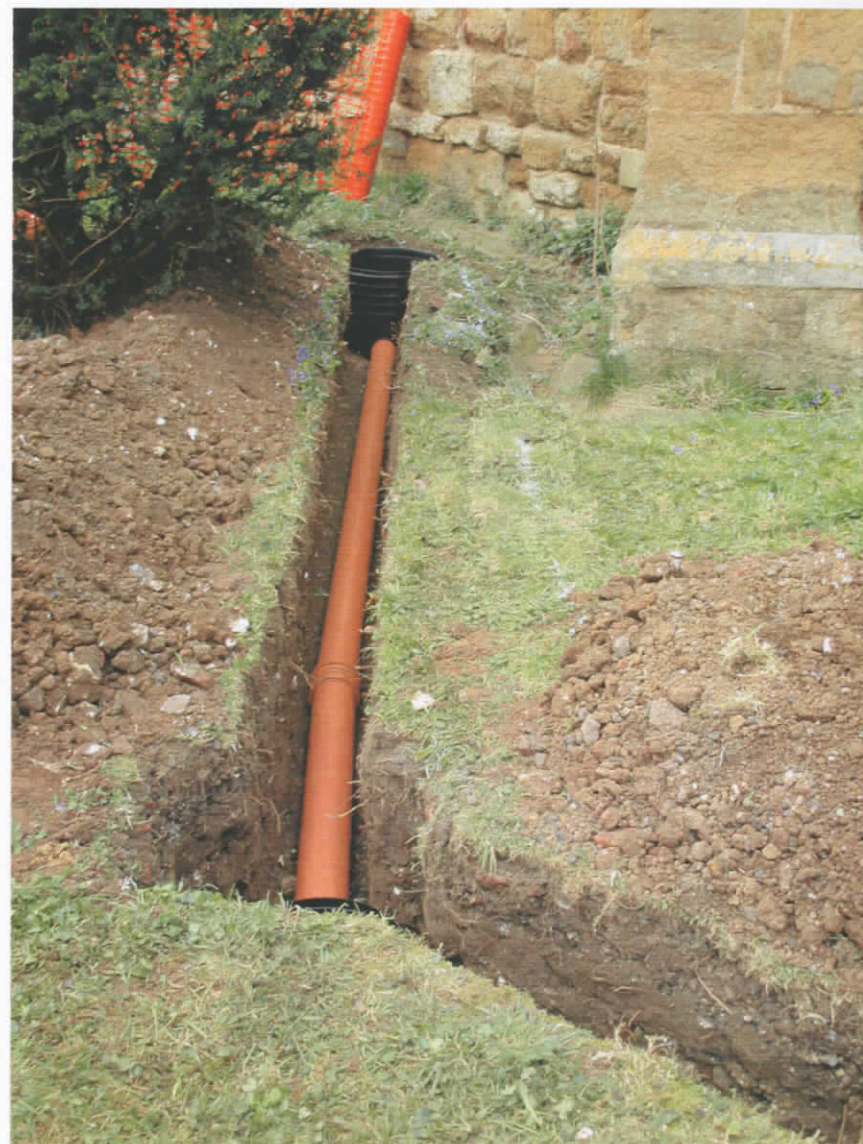
Pl. 4 The pipe trench extending eastwards from Inspection Chamber 2 towards Inspection Chamber 1 next to the tower

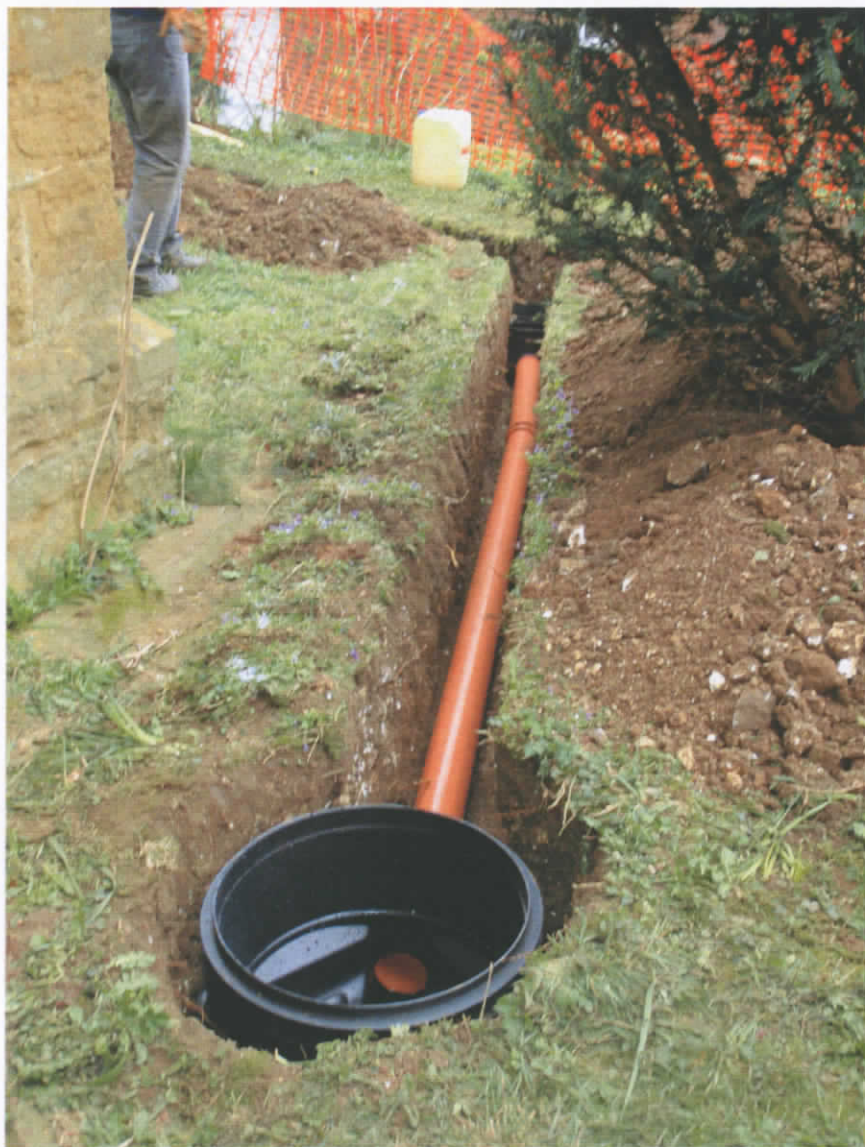
Pl. 5 The pipe trench extending south from Inspection Chamber 2 towards the main road, looking south.

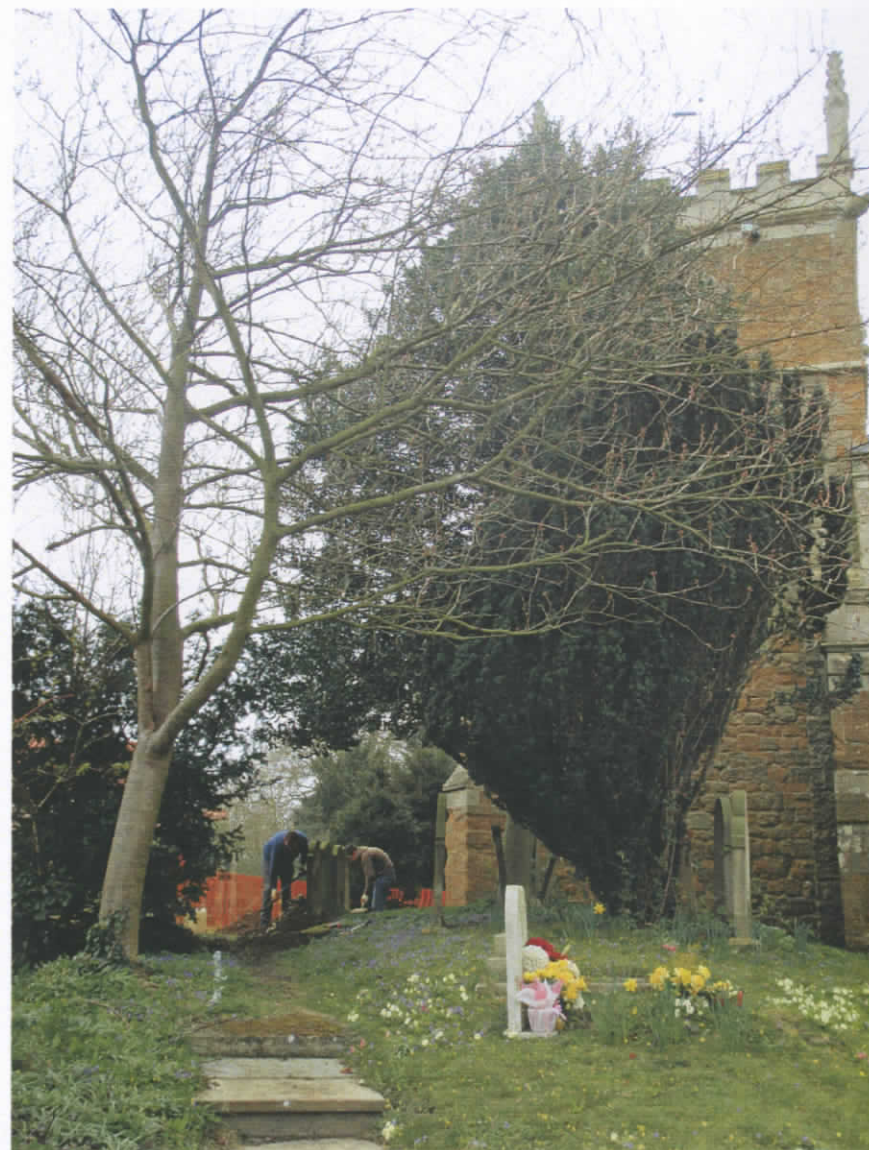
Pl. 6 Excavation of the pipe trench along the western boundary of the churchyard

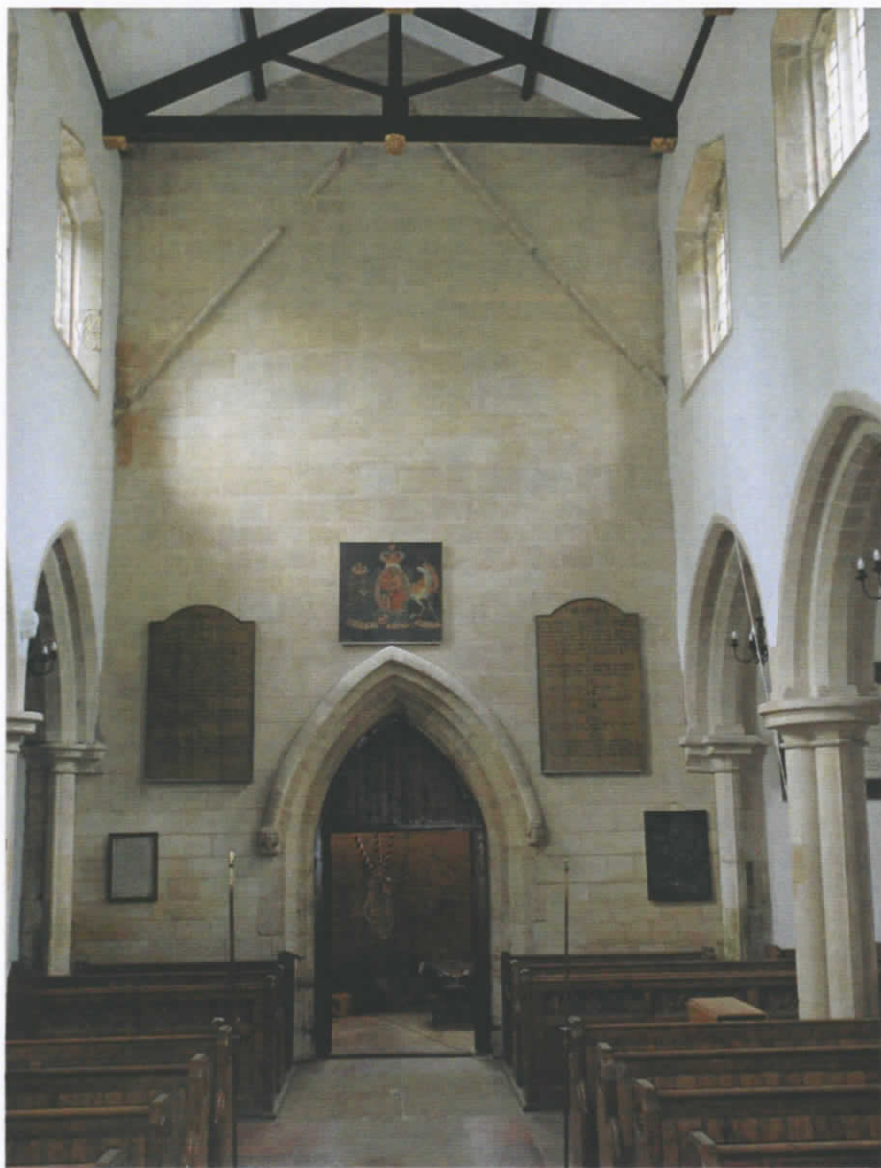
The tower arch appears to have been rebuilt and on the elevation facing the nave has mostly been replaced with modern ashlar (Pl. 7) and may be contemporary with the rebuilding of the tower north wall in 1901. There is evidence on the elevation inside the tower that the original arch was wider, and the current arch has probably been constructed partly reusing the original stones. It is badly affected by damp (Pl. 8). Plasterwork on the walls inside the tower which was 15mm thick had been stripped to a height of 2.34m above floor level on three walls (north, south and west) to reveal a yellow brick lining which may also be part of the 1901 work (Pl. 9).

Pl. 7 The Nave, looking west towards the tower. Note the scar of the original nave roof above the tower arch.

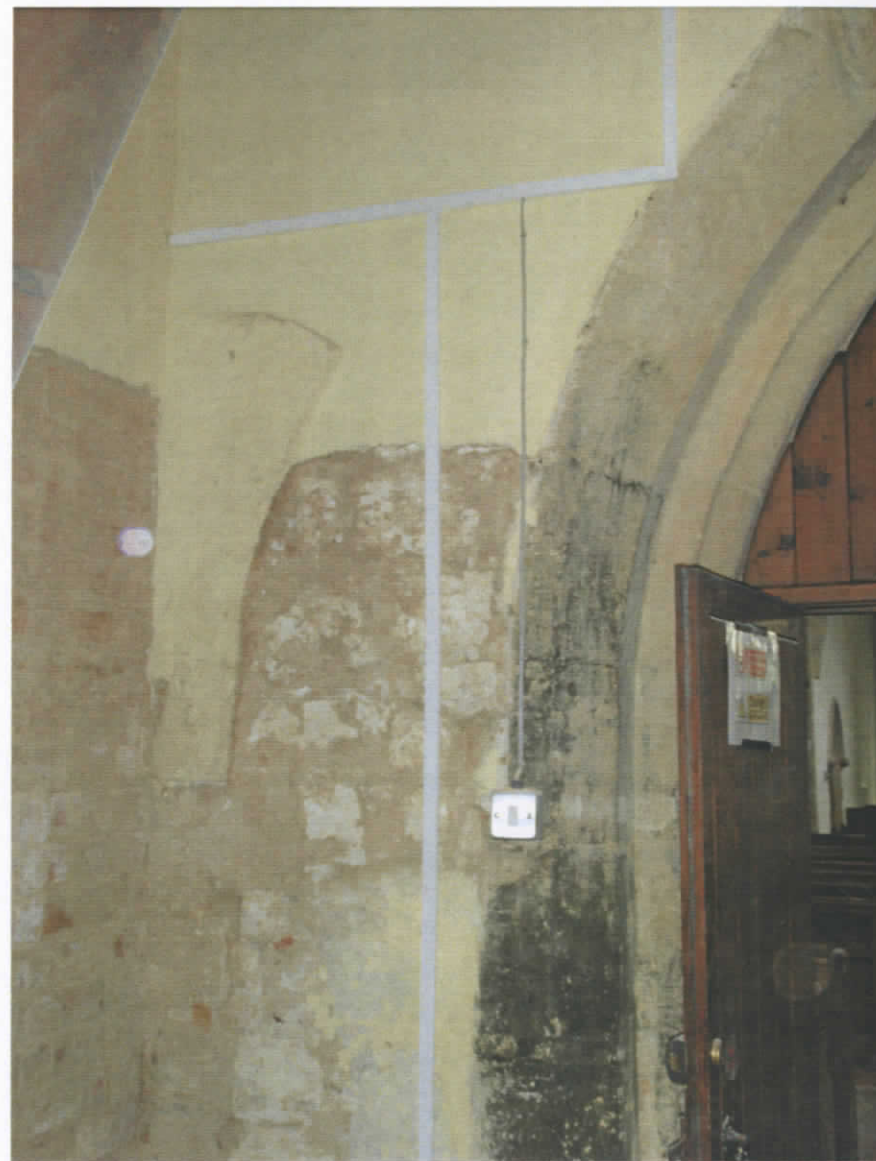
Pl. 8 Remnant of the original tower arch to the north of the present arch. Note severe damp on the present arch.

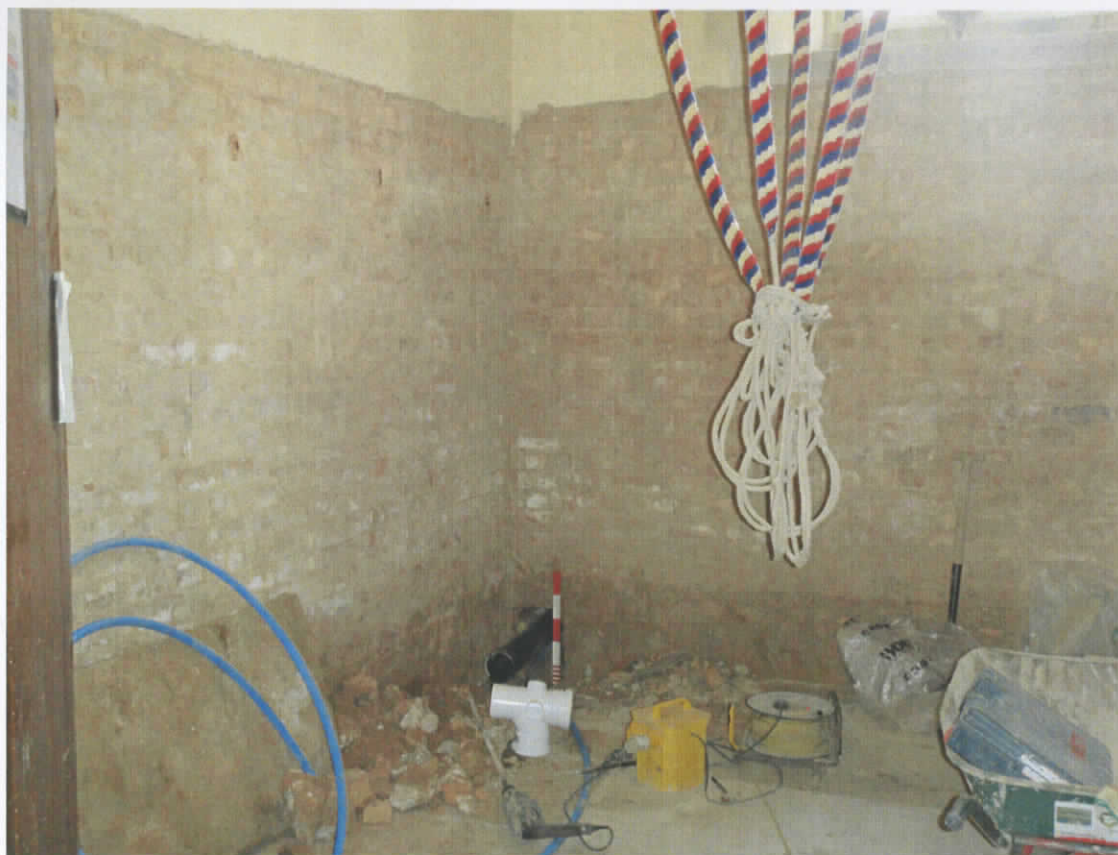
Pl. 9 The tower, looking west showing sewer pipe connection in the south west corner. Note stripped plasterwork showing the brick lining on the tower walls. Scale 0.50m

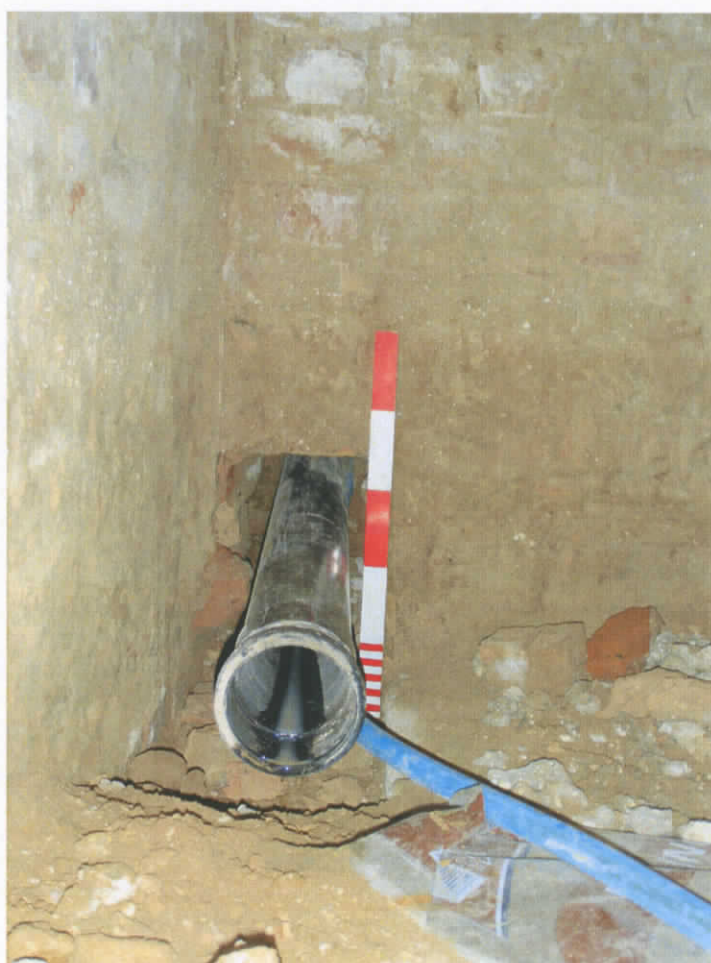
The tower floor comprises flagstones over a concrete base 0.08m thick. (The nave also appears to be concrete beneath stone and quarry tile floor). The flagstones, and concrete beneath, were removed in the south-west corner of the tower over an area 0.34m x 0.25 and to a depth of 0.12m. A hole was drilled through the 0.98m thick tower west wall, just above floor level, to enable the insertion of the sewer and water pipes (Pl. 10). No earlier floor surfaces were observed and the remainder of the existing floor surface was left undisturbed, with the toilet and its cubicle being constructed on top of the flagstones.

Pl. 10 Detail of the sewer pipe connection through the west wall of the tower. Scale 0.50m
