**All Saints Church North Collingham, Notts
Archaeological Watching Brief**

Site Code: NCAS 10

**NFAC Report No. 0918
July 2010**

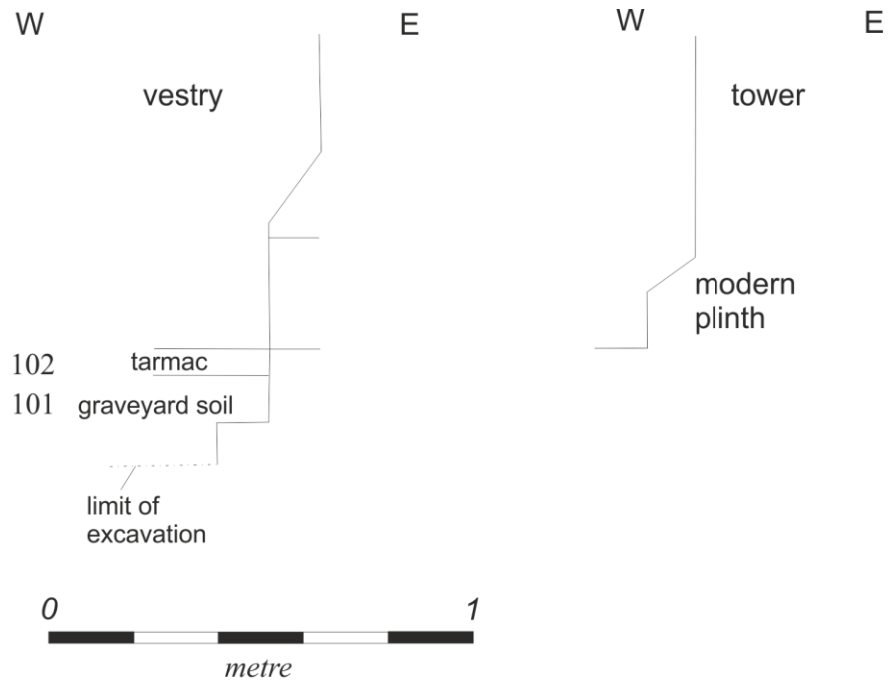
A narrow trench was cut through the tarmac from the junction of the tower and vestry and ran 7.80m northwest to the septic tank pit situated 1m from the churchyard wall. The trench was 0.30m deep and 0.30m wide following the natural fall in the ground level on the west side of the church. The tarmac **102** was 0.10m thick at the junction with the vestry wall and forms a skirt 3.10m wide around the west side of the church, connecting to the paths running along the north side of the church and to the gate in the corner of the churchyard. The tarmac overlay the churchyard soil **101** which was a red-brown sandy soil. Beyond the tarmac the turf overlay a thick dark-brown sandy topsoil **100**, 0.50m thick. At a distance of 5.80m along the trench was a stone-capped, brick-lined soakaway with a ceramic pipe draining into it from the northwest corner of the vestry.

Fig. 3 Sections at A marked on Fig. 2 showing profile of vestry and tower walls at point where the service trench exits the church. Scale 1:20.

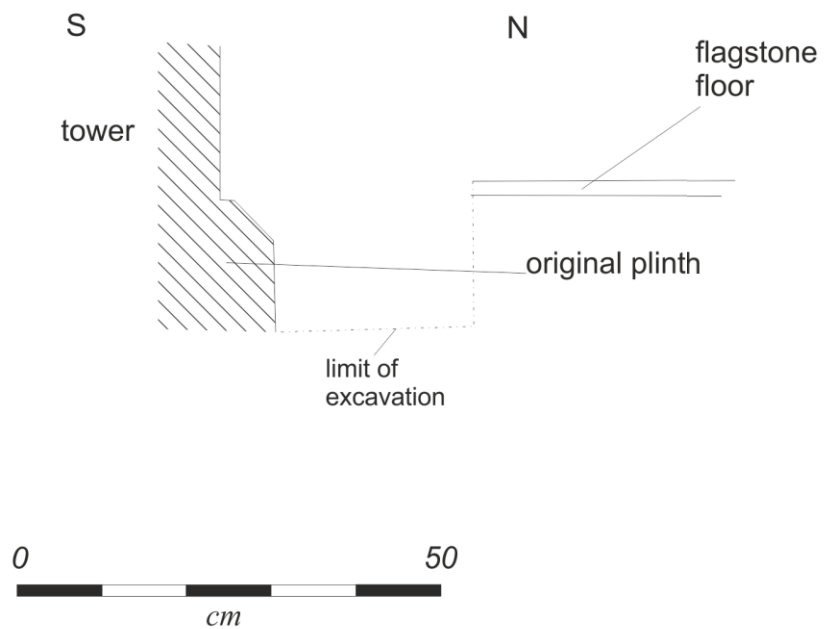
Inside the vestry there is an existing sink unit along the west wall. The new toilet facilities were inserted into the south-east quadrant of the vestry and the flagstone floor was lifted along the south side of the vestry wall in order to lay the connecting sewer pipe. The trench was 2.50m long, 0.28m wide and 0.20m deep and ran from 0.50m inside the partition for the toilet to the south-west corner of the vestry and out through a hole in the vestry wall had previously been drilled at its junction with the tower for gas and water pipes, serving a sink and the boiler.

Fig. 4 Section at B marked on Fig. 2 showing service trench dug along north side of tower inside the vestry. Scale 1:10

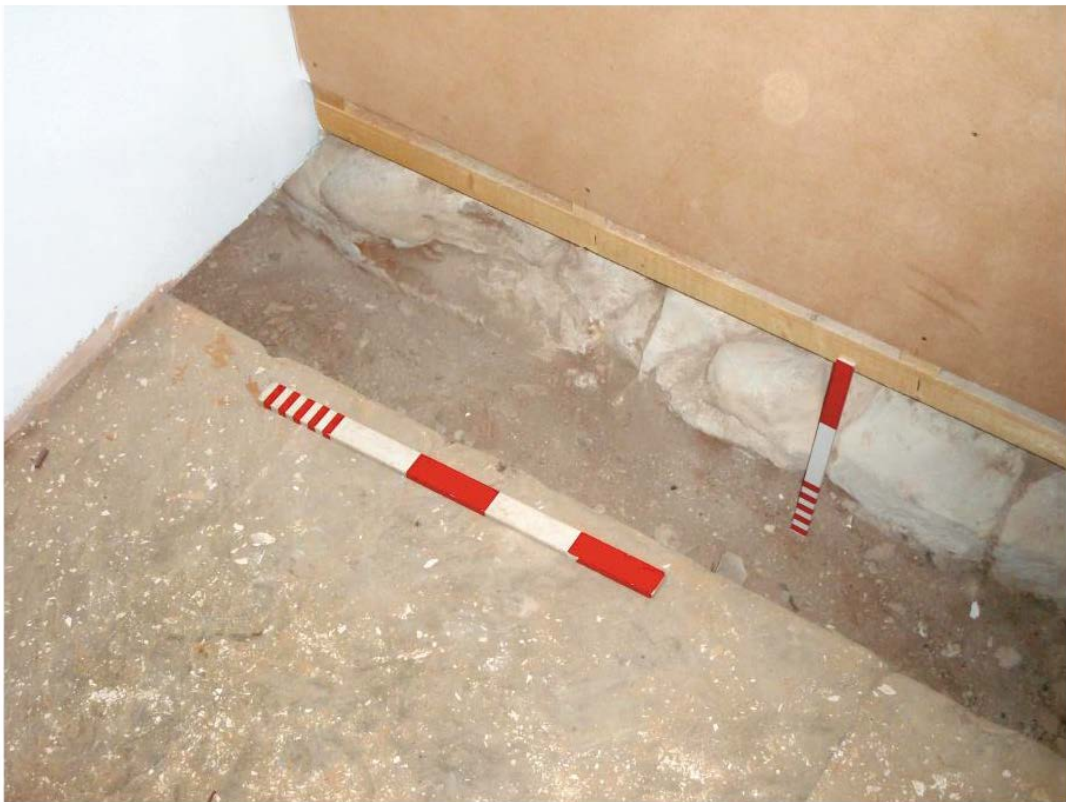
The whole of the south wall of the vestry (which is the north face of the tower) had already been clad in plasterboard to a height of 2.60m, concealing the wall behind. The only visible part of the wall was at the base where it had been exposed in the pipe trench. The excavation of the pipe trench exposed the original external plinth of the tower. It was badly damaged, presumably as a result of the insertion of the gas pipe, serving the boiler. Only one complete stone survives intact, 0.46m in length. The plinth projects from the wall by 0.08m and is 0.19m high and the top of the plinth sits immediately below the level of the stone flag surface. The plinth on the west wall of the tower is a modern repair so this is the only place where the original plinth survives.

Pl. 2 Original plinth at the base of the tower north wall, revealed in the service trench in the vestry. Scales 0.50m and 0.30m

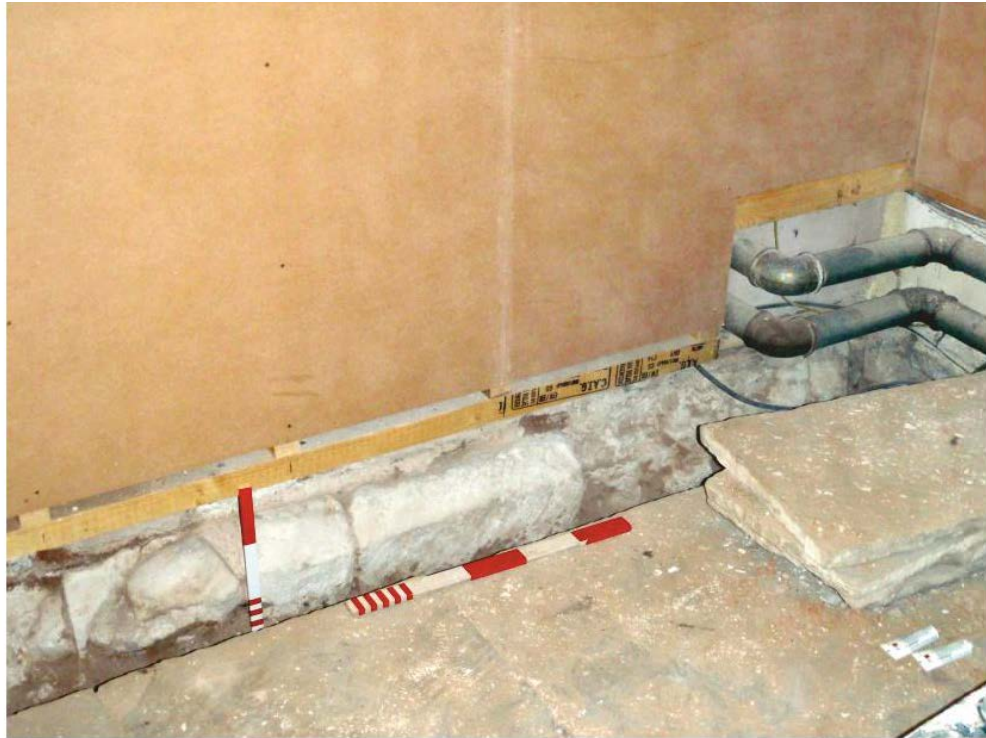
Pl. 3 Plinth at base of tower north wall showing diagonal tool marks on the undamaged stonework. Scales 0.50m and 0.30m.

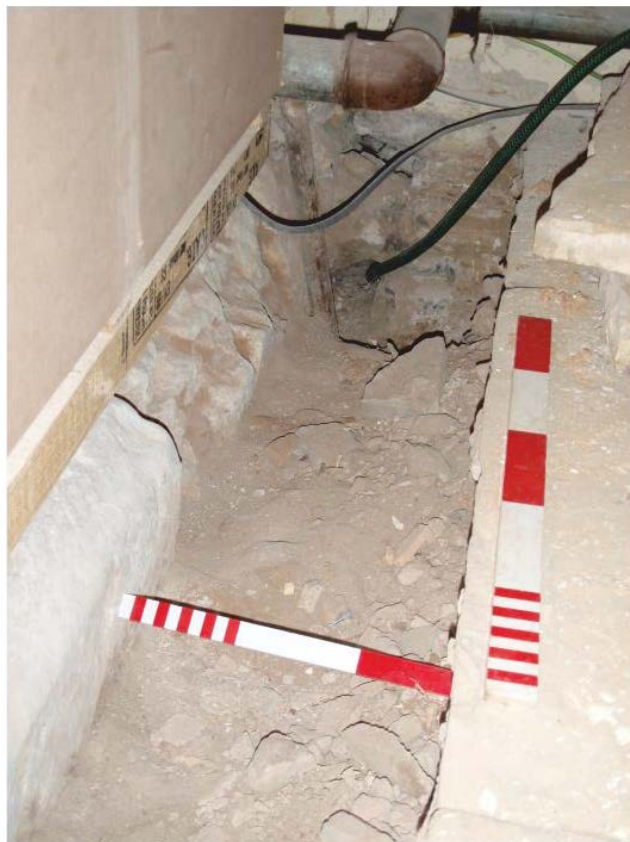
Pl. 4 The service trench at junction with west wall of vestry, looking west. Scales 0.50m and 0.30m.

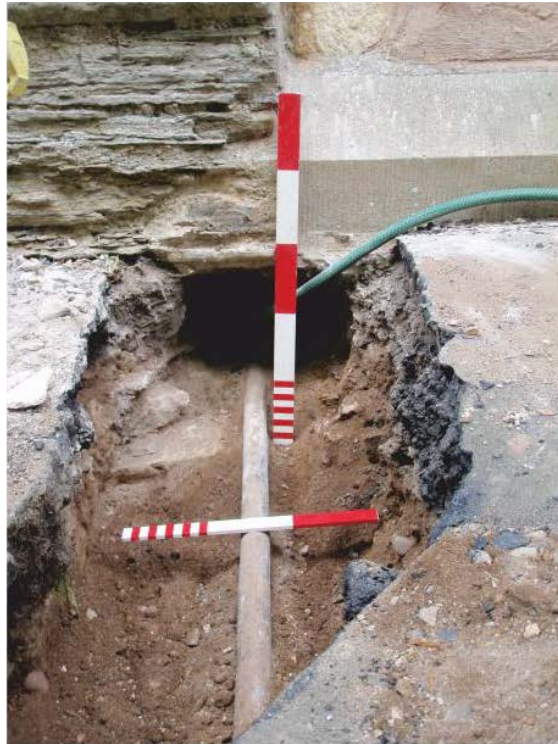
Pl. 5 The service trench at its exit from the vestry showing the vestry foundations and the pre-existing water and gas pipes, looking east. Scales 0.50m and 0.30m

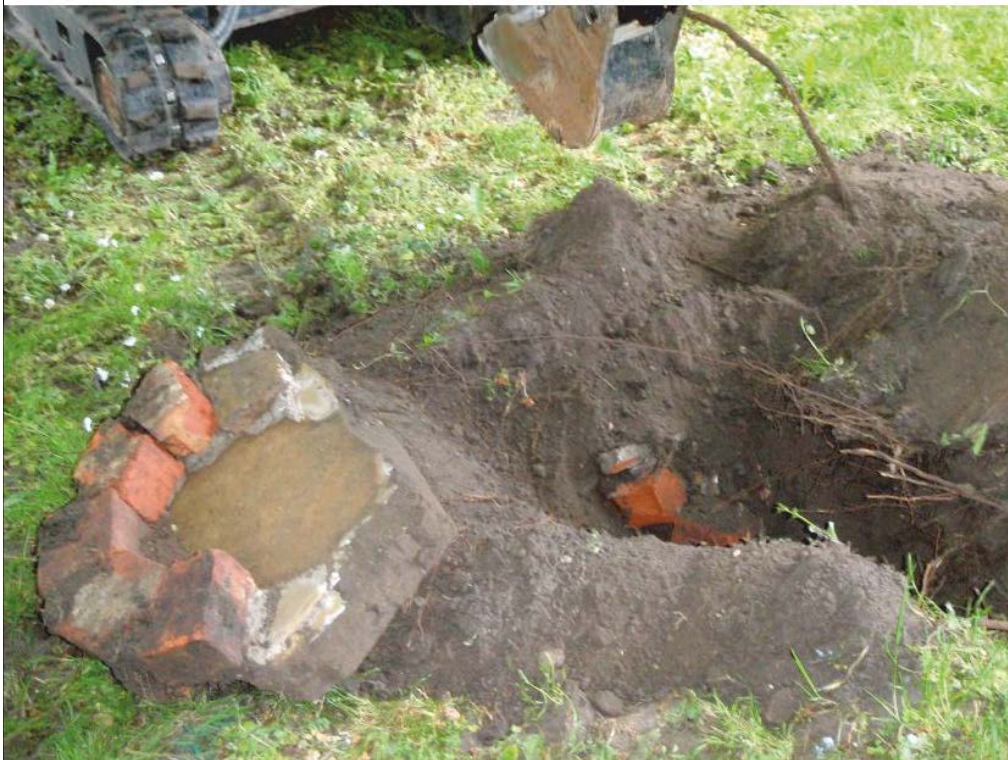
Pl. 6 Stone capping of old soakaway found in service trench west of the vestry.

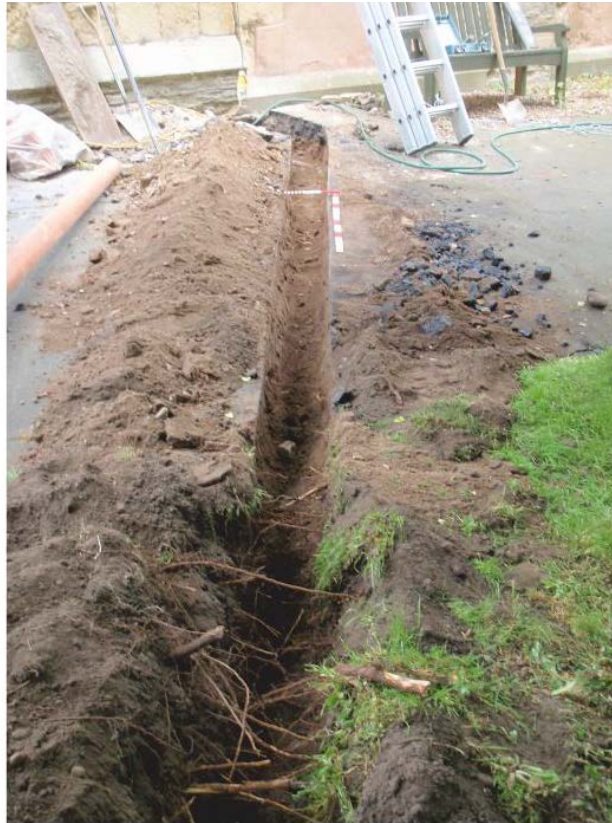
Pl. 7. Service trench running from the vestry to the septic tank, looking south-east.

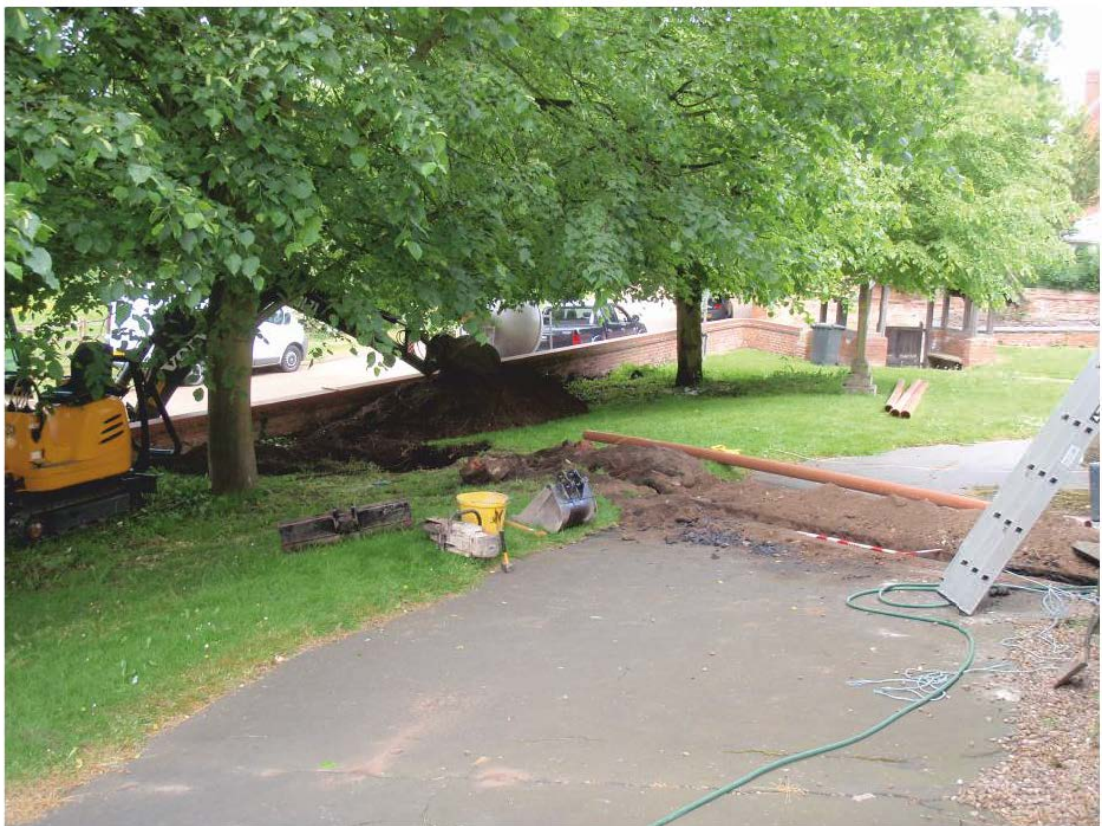
Pl. 8 General view of the service trench crossing the churchyard to the septic tank at the boundary wall of the churchyard, looking north-west.

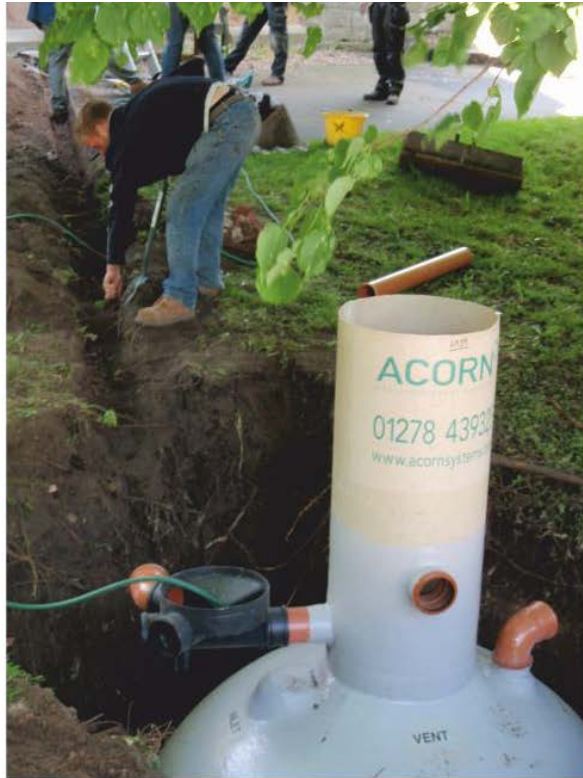
The septic tank pit was 3.10m x 2.50m in area and 1.95m deep. Beneath the topsoil its fill comprised a very dry loose sandy soil with occasional pieces of sandstone and pebbles. The area was also heavily disturbed by tree roots and there were no human

Pl. 9 The septic tank and connecting service trench, looking south-east

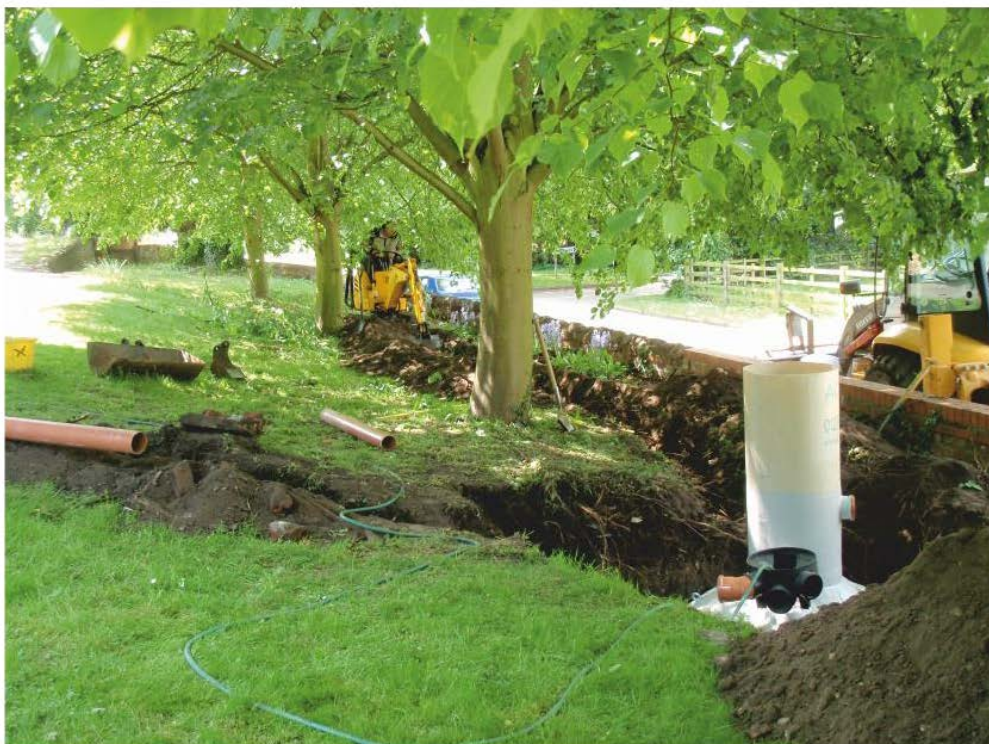
remains present. A trench was dug southwards from the septic tank pit for 15m parallel to the boundary wall. The whole length of the trench was heavily disturbed by tree roots.

Pl. 10 General view showing excavation of the service trench south from the septic tank, along the churchyard boundary.

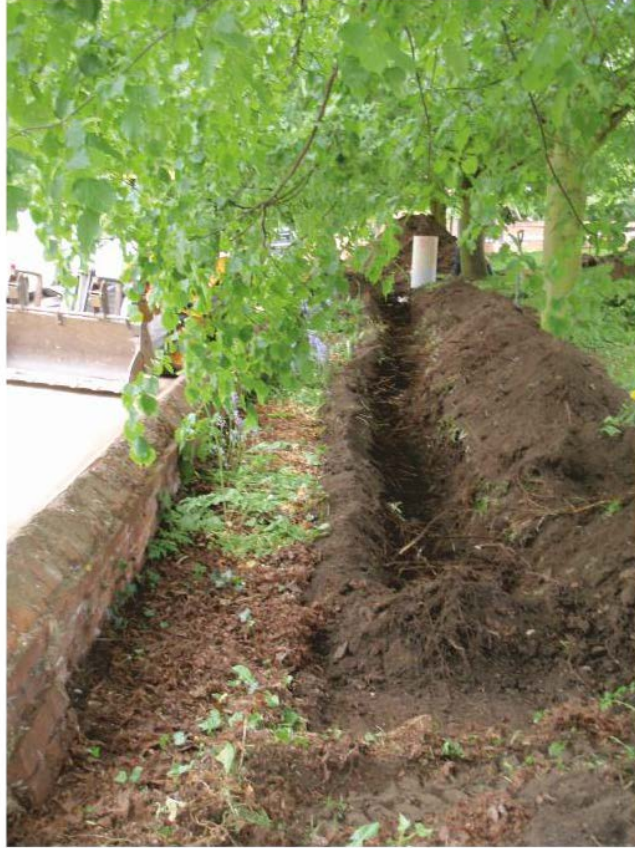
Pl. 11 Service trench along the churchyard boundary looking north towards the septic tank

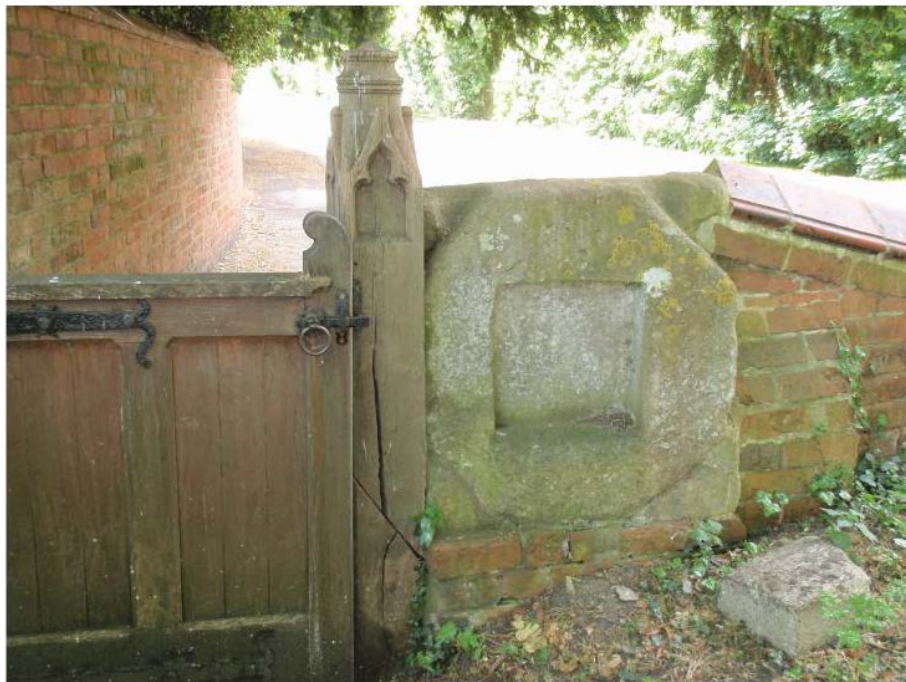
Next to the south gate into the churchyard is a large stone block 0.75m x 0.80m set into the wall with chamfered stops at each corner. There is an almost square socket in the centre 0.38m x 0.35m and 0.12m deep. This stone is probably the base of a cross, which presumably once stood in the churchyard. The underside which is visible on the outside face of the churchyard wall is inscribed FLOOD IN 1795 with a horizontal line marking the flood level. This indicates that the cross must have gone before this date.

Pl. 12. Re-used base of churchyard cross in churchyard wall
