Introduction

This report sets out the results of recording undertaken by the writer in advance of repair work to the wall forming the northern boundary of Castle Dikes House, 37 Castlegate, Malton (SE 78977155 - 79037157). This wall allegedly forms the south-west part of the wall of Malton's former medieval castle.

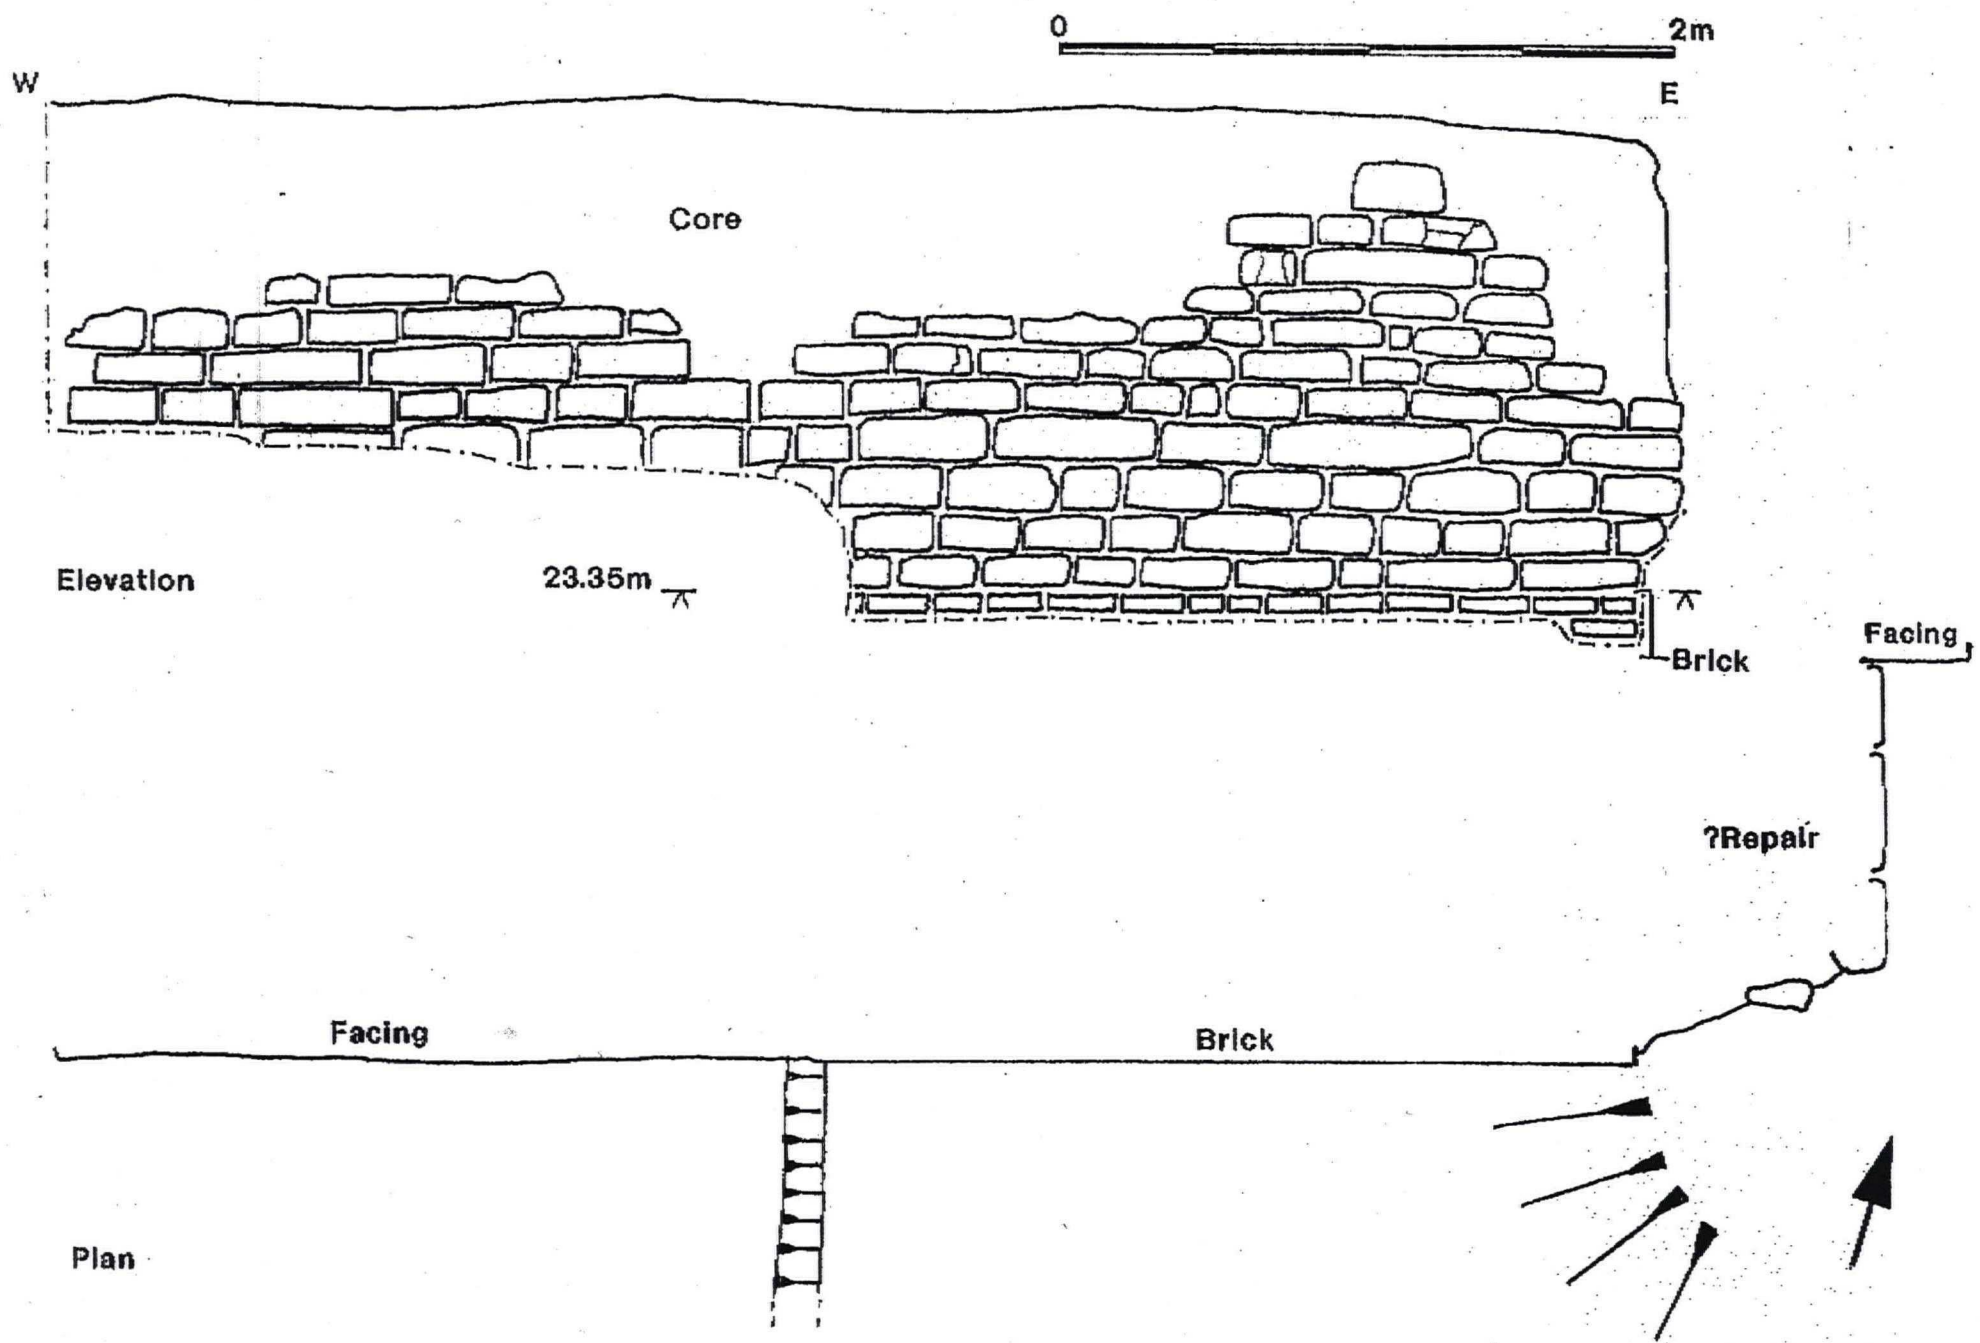
Figure 3 - Area 1, Elevation and Plan

Area 1 (Figs. 2 and 3)

Area 1 was situated at the west of the site, adjacent to the point where the wall is believed to return northwards. Also at this point, the face of the wall is offset c.1.3m to the south from Area 2, a feature visible on Wise's plan of Malton (Wise, 1843).

A substantial amount of facing stone was present at Area 1. The stones were laid in squared regular courses, each c.13 cm high. The quoins at the eastern end, where the wall returns northwards to Area 2, were unstressed. Also at the eastern end, the squared limestones rested on a brick foot. Where the wall returned northwards, the facing stones ran behind a roughly mortared mass of uneven masonry, apparently a modern repair or reinforcing to the offset part of the wall.

It is noteworthy that the masonry of the 'corner turret' at Area 1 is of slightly different build to that of the rest of the wall, the courses being slightly narrower, and hence the stones smaller, than the other areas surveyed. This might imply a different date of construction, but the crucial point at which the feature joins the rest of the wall is obscured by a later area of uneven masonry, presumably a relatively recent repair.

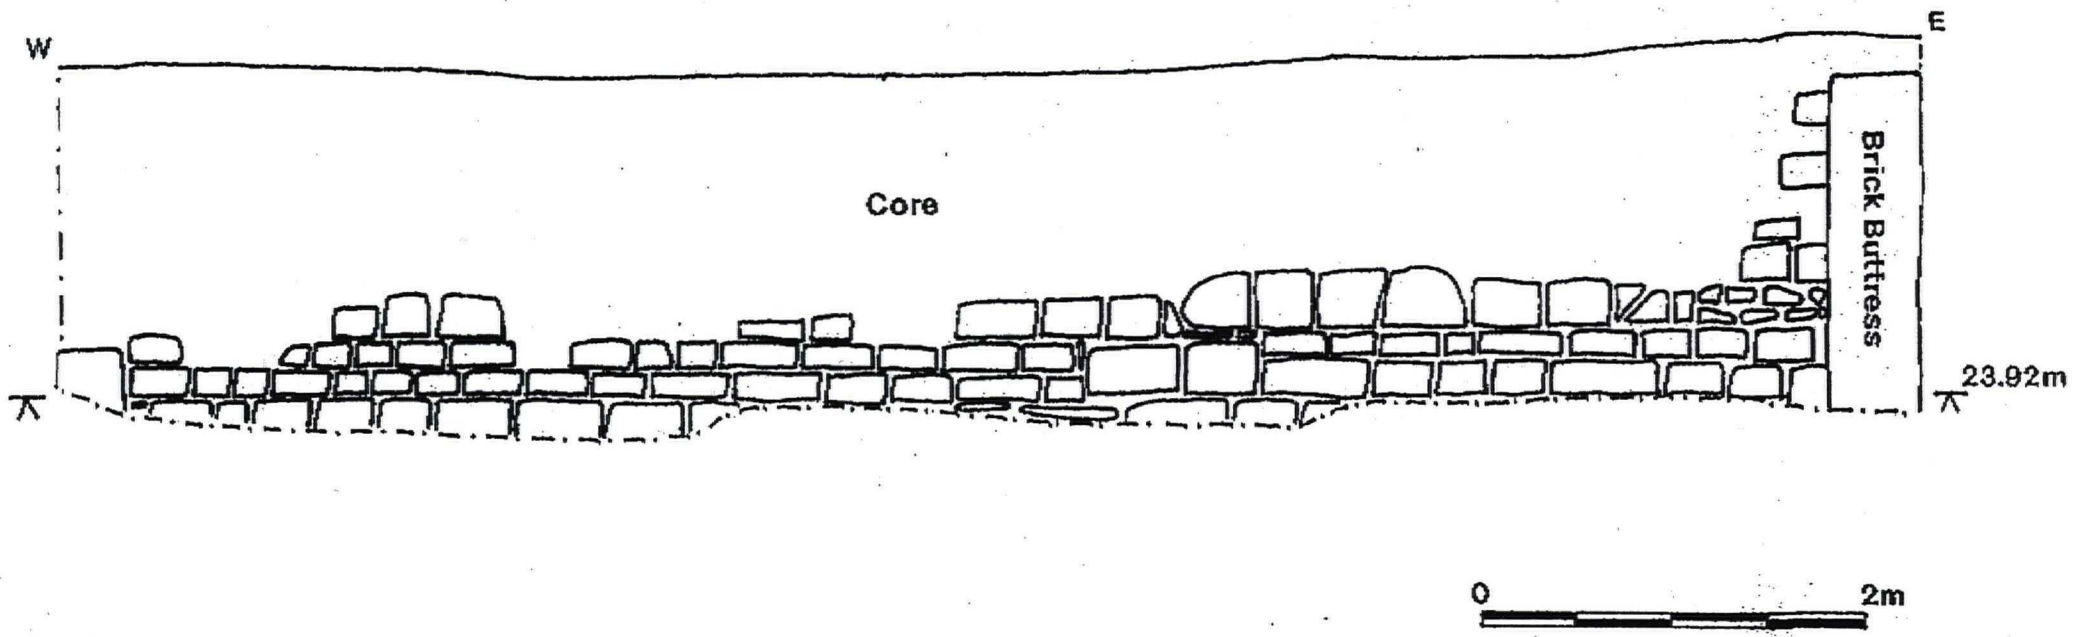
Figure 4 - Area 2, Elevation

Area 2 (Figs. 2 and 4)

Area 2 was situated immediately east of Area 1, and extended as far as the westernmost brick buttress. The western half of the area showed two courses of regular squared limestones, each c.15 cm in height. These two courses rested on a squared regular course 22 cm in height. The eastern half of the area showed three somewhat uneven courses, with two courses, 22 cm and 30 cm high respectively, separated by a probable string course, which had a height of 11 cm. A patch of random masonry, presumably a repair, occurred immediately west of the brick buttress.

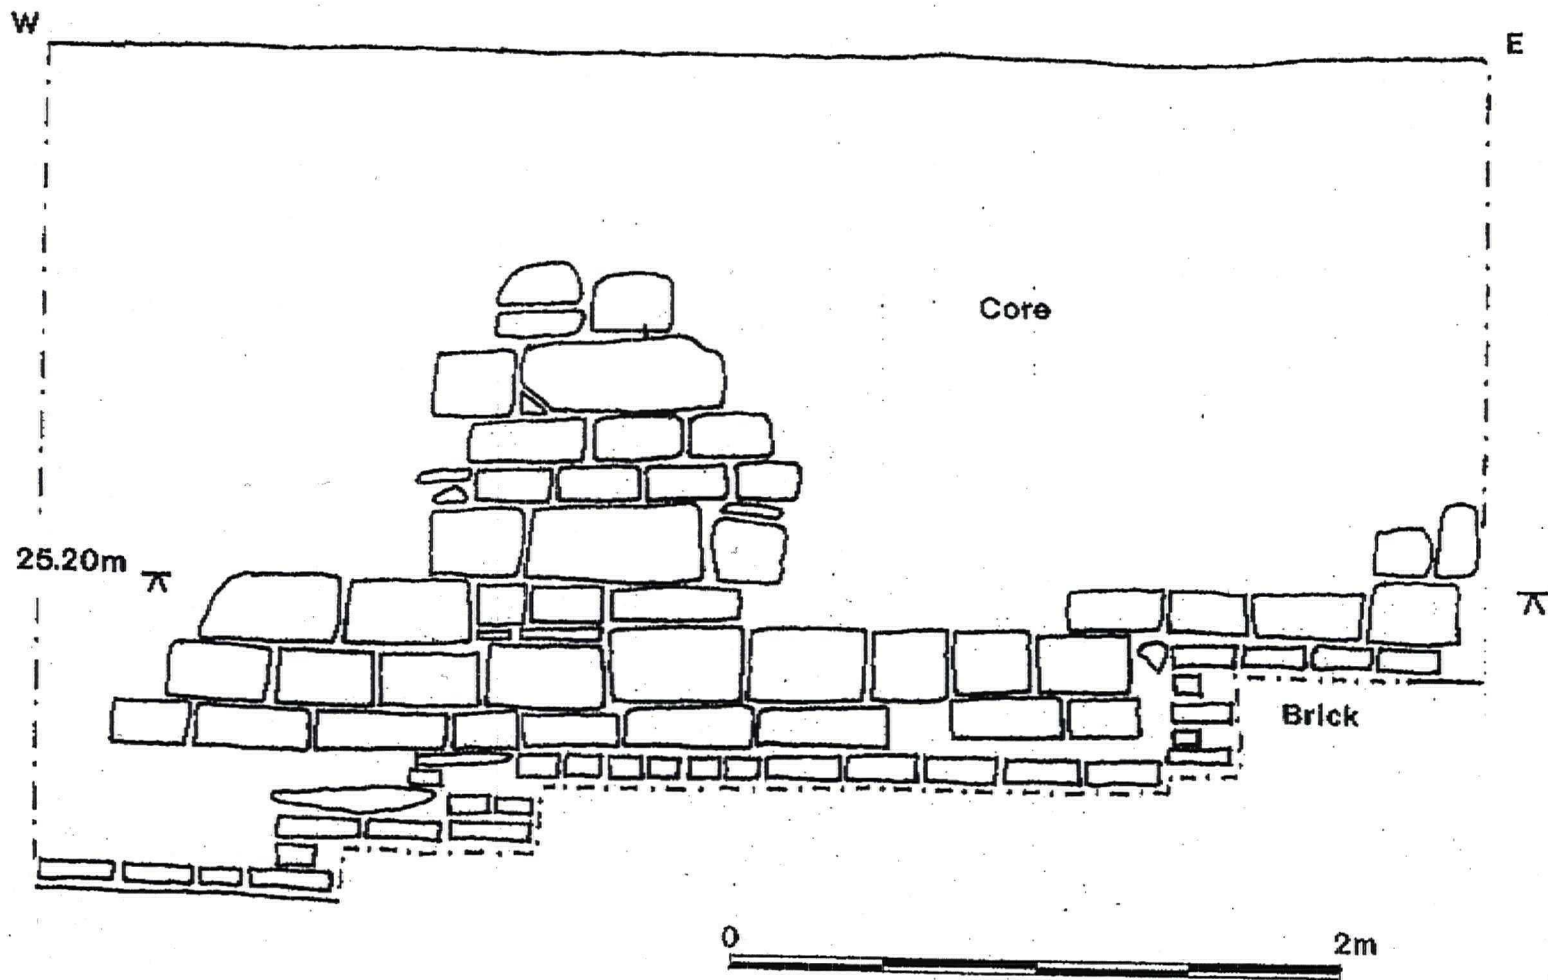
Figure 5 - Area 3, Elevation.

Area 3 (Figs. 2 and 5)

Area 3 was situated c.4m east of Area 2, between the western and central brick buttresses. The remaining facing stones were situated above a brick foot laid in a random arrangement of headers and stretchers. The facing stones were of squared uneven courses between 12 and 25 cm in height.

It is possible that the variation in the height of the courses reflects a number of previous repairs.

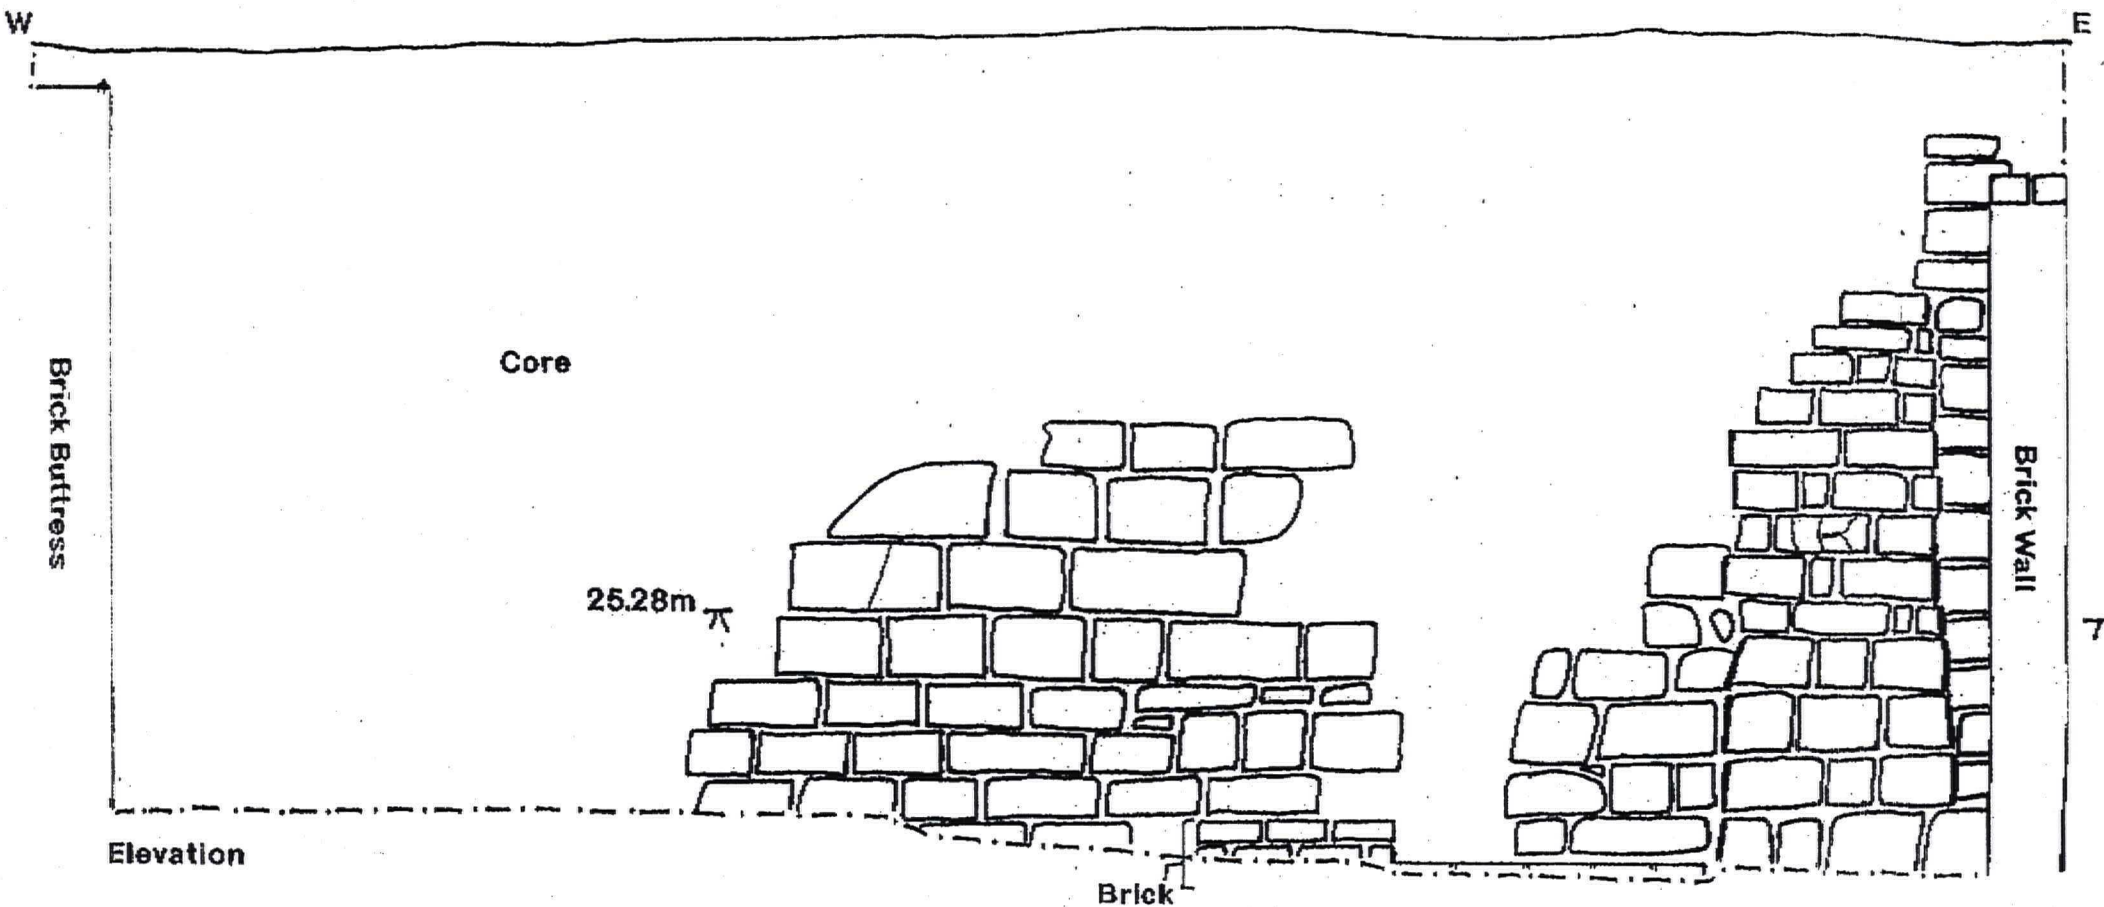
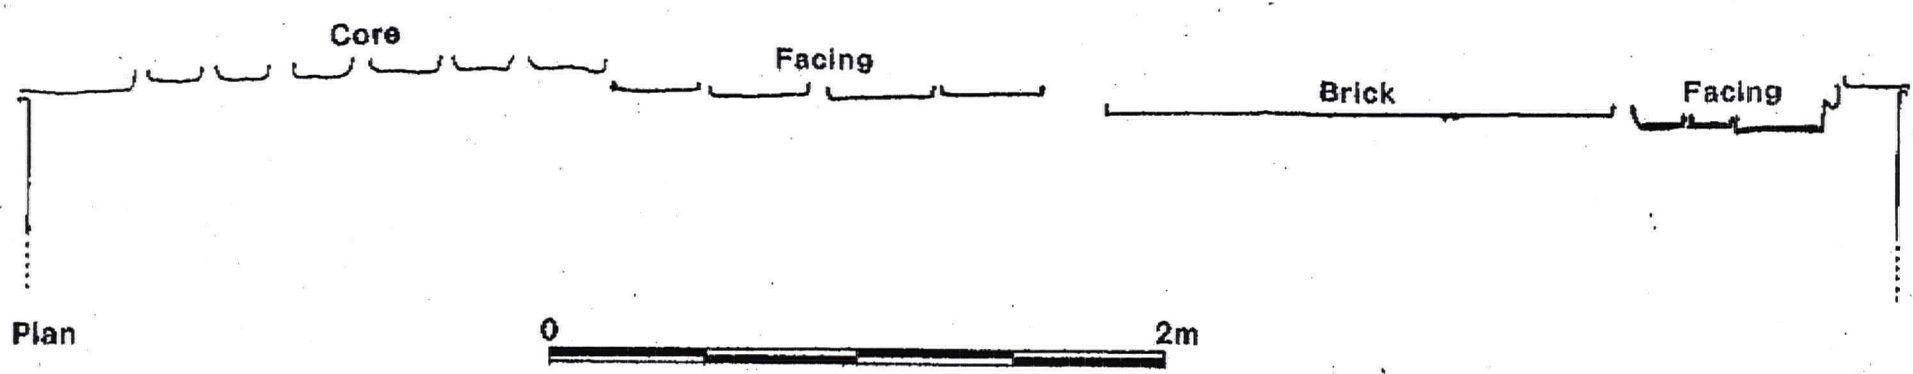
Figure 6 - Area 4 Elevation and Plan

Area 4 (Figs. 2 and 6)

Area 4 was situated c.1.5m east of Area 3, between the easternmost brick buttress and the western wall of a roofless outhouse.

The western block of surviving facing work had a brick foot, which was present below three squared courses of limestones, each having a height of c.14 cm. These were overlain by three squared uneven courses, each c.22 cm in height. Traces of a further squared, uneven course, c.16 cm high, occurred above.

The eastern part of Area 4 showed a masonry feature, possibly a buttress, whose face was offset c.17 cm from the general line of the wall's face. The masonry of this feature was laid in uneven squared courses, the lowest four courses of which each had a height of 16-18 cm, with the upper nine courses each having a height of 11-12 cm.

The adjoining facing stones to the west of the 'buttress' formed a straight joint with the 'buttress'. The masonry adjoining the 'buttress' to the east extended behind the stones of the 'buttress'. There was a difference in character to the masonry on either side of the 'buttress', with the facing stones to the east having narrower courses (14-16 cm), than those to the west (16-20 cm), and generally conforming to different levels.

The other feature of note is the 'buttress' in Area 4. This feature would appear to be later than the masonry which adjoins it to the east, as this masonry extends behind the 'buttress'. The adjoining masonry to the west shows a straight joint for three courses at the base of the 'buttress', suggesting that the facing was cut to receive the 'buttress' at this point. It seems reasonable to interpret the feature as reinforcing to the wall, in the manner of the later brick buttresses. However, the variation between the masonry on either side of the 'buttress' make it possible that some further process is involved, such as the existence of a gang joint.

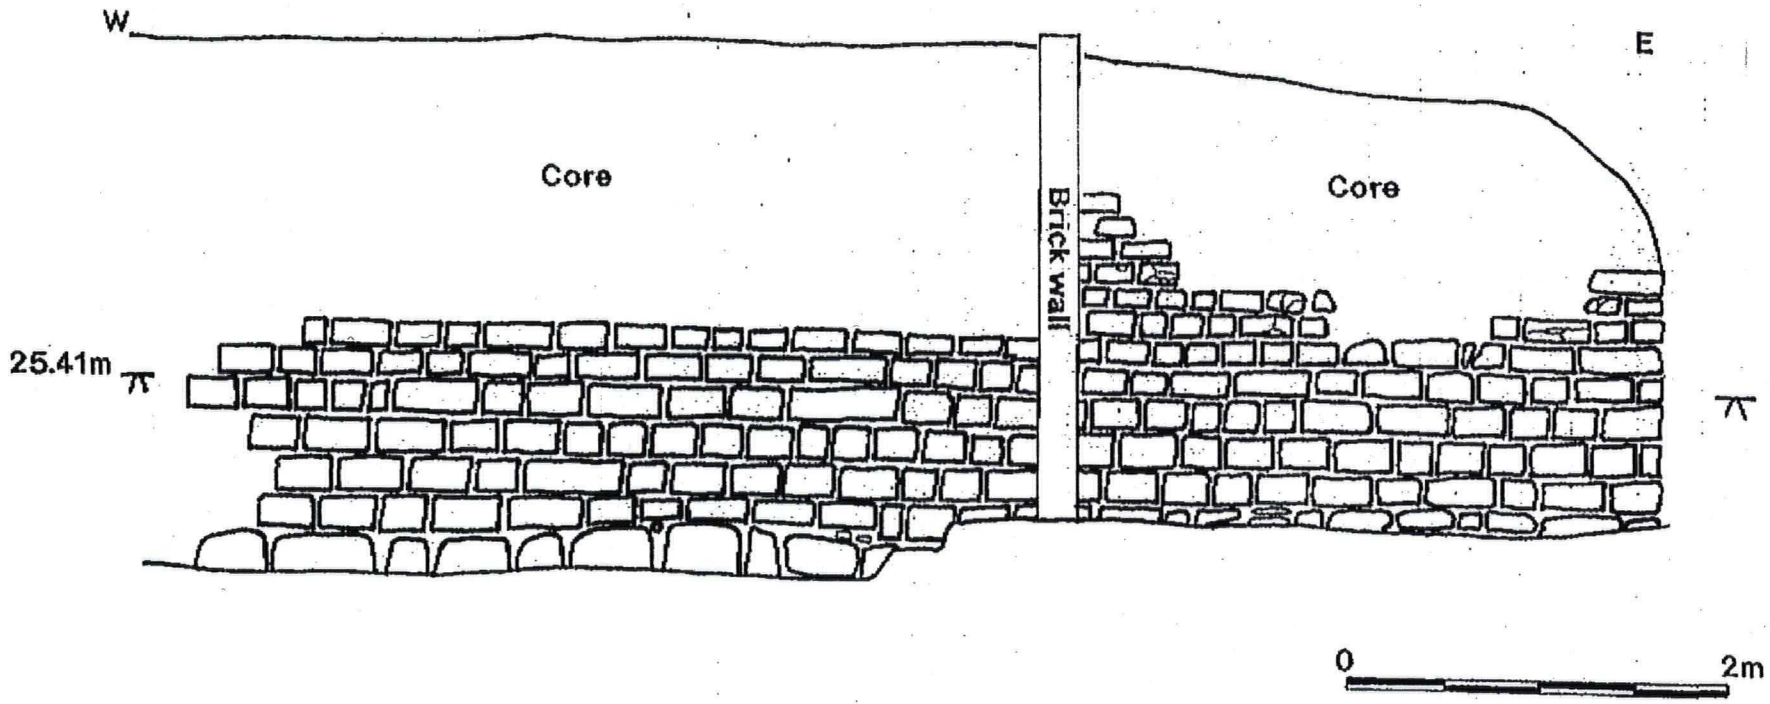
Figure 7 - Area 5, Elev 1

Area 5 (Figs. 2 and 7)

Area 5 was situated at the eastern end of the site. Twelve courses of facing stone survived, probably due to the relatively sheltered nature of the area and the fact that the western part of the area had been protected by a now roofless brick outhouse.

The squared masonry had been laid in fairly regular courses, c.16 cm high, with stones of between 18 and 50 cm in length. The foot of the wall at the western part of the area was composed of more massive, and rather irregular, rounded limestones, which were at least 20 cm in height. This area of footing probably represented a repair at ground level.

The facing stones at the eastern end of the area formed a straight joint, to the east of which no facing survived and slumping had occurred. The wall did not return at this point. However, it is doubtful that an entrance was represented here because the quoins were unstressed, and showed none of the ashlar detailing that might be expected at a gateway.
