SHERIFF HUTTON CASTLE,  
SHERIFF HUTTON, NORTH YORKSHIRE

ARCHAEOLOGICAL AND ARCHITECTURAL SURVEY  
OF THE NORTH-EAST TOWER

Report no: 2002/158.R01  
Version: Final  
Date: April 2008  
Author: Shaun Richardson & Ed Dennison

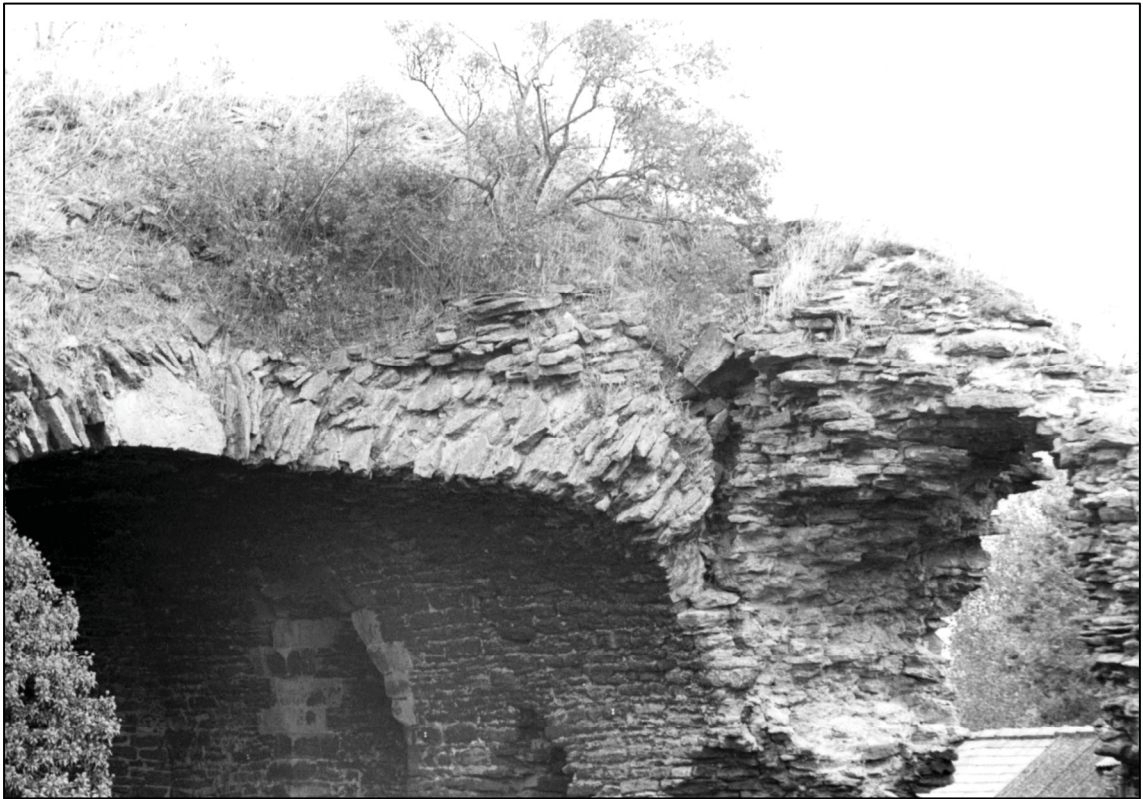
Plate 13: South edge of ground floor vault, showing fracture, looking NE  
(September 1996).

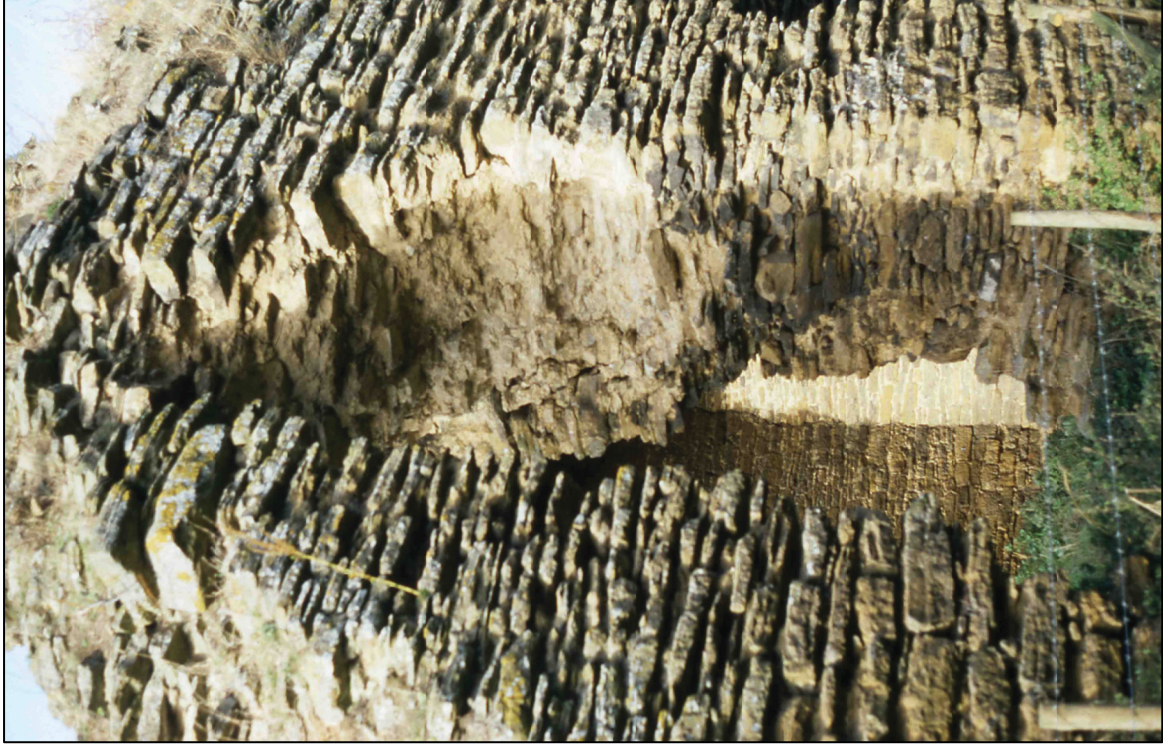
Plate 15: Area of collapse, east external elevation, prior to consolidation (September 1996).

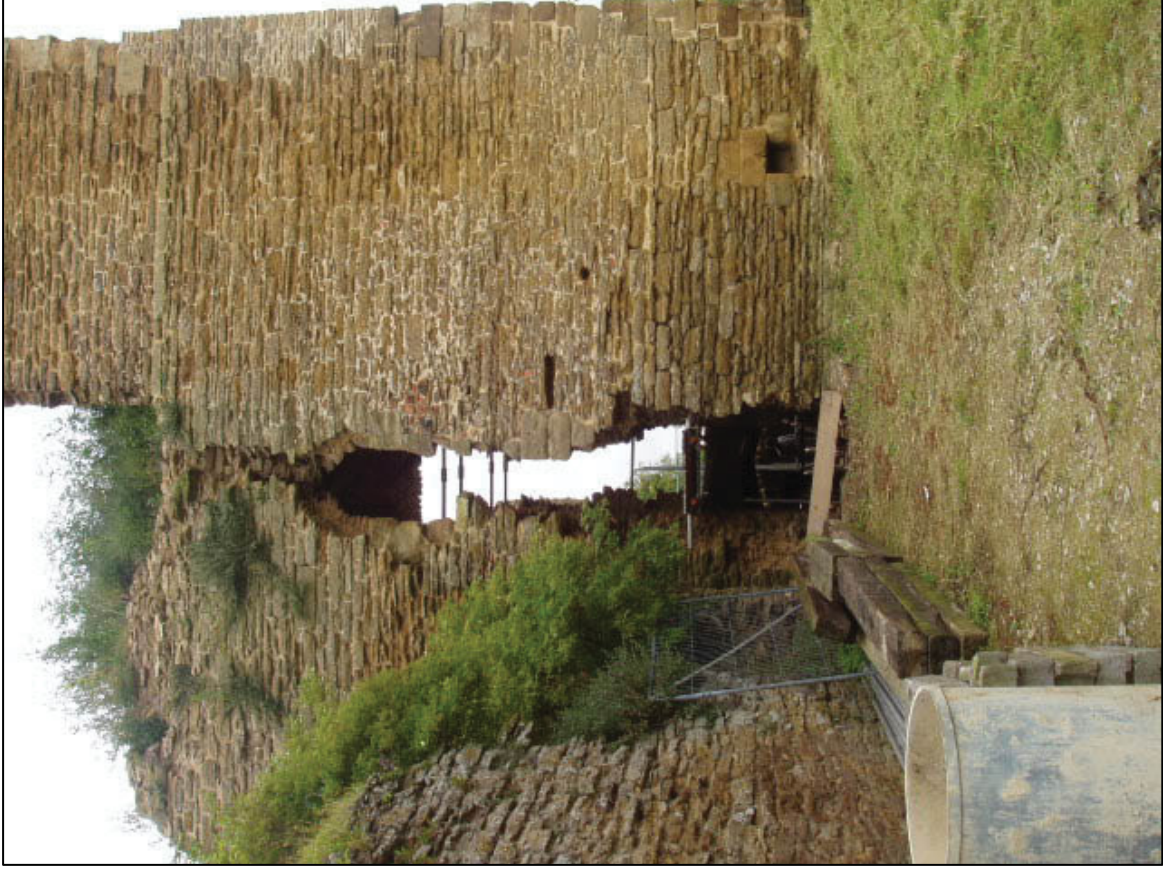
- 3.26 The earliest evidence for repairs noted on the north-east tower is an area of repointing to the lower part of the north external elevation (see figure 9 and plate 16). The repointing rises to c.8.2m above ground level and is largely confined to

Plate 16: Lower part of north external elevation, showing crack over window W2/3, prior to consolidation, looking S (May 2002).

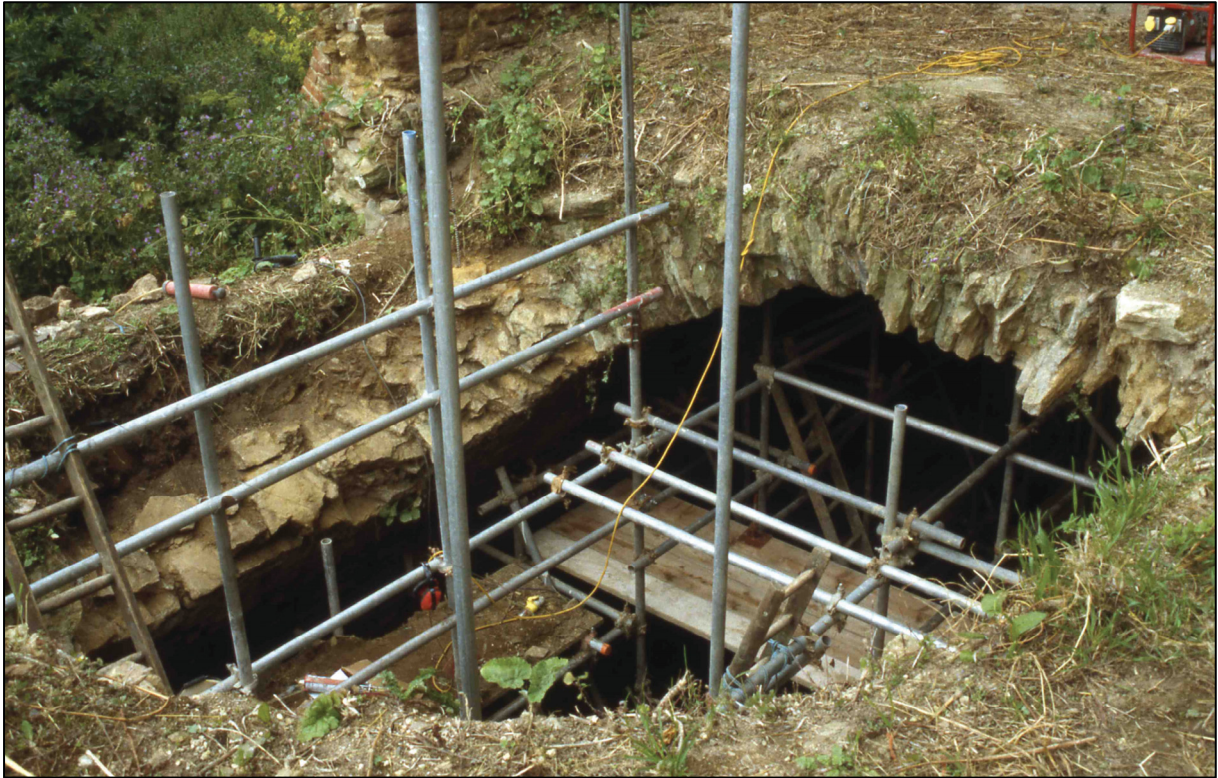
- 3.4 As noted in Chapter 1 above, the recording of the north-east tower was an integral part of a major programme of consolidation and repair, brought about because of the potential risk of the collapse of the structure. In particular, the vaulted roof of the ground floor room was in a precarious state, with some fracturing and flattening evident together with a large crack against the east wall which had got progressively worse between 1996 and 1997 (see plates 13 and 14). There had also been some collapse over an opening in the east elevation at some point between 1982 and 1993 (Dennison 1998, 75) (see plate 15), and there was a large structural crack in the north elevation over the ground floor window (see plate 16). Finally, there was a significant collapse of the basement vault (see plate 17).

Plate 17: Hole in basement vault, prior to consolidation, looking north-west.

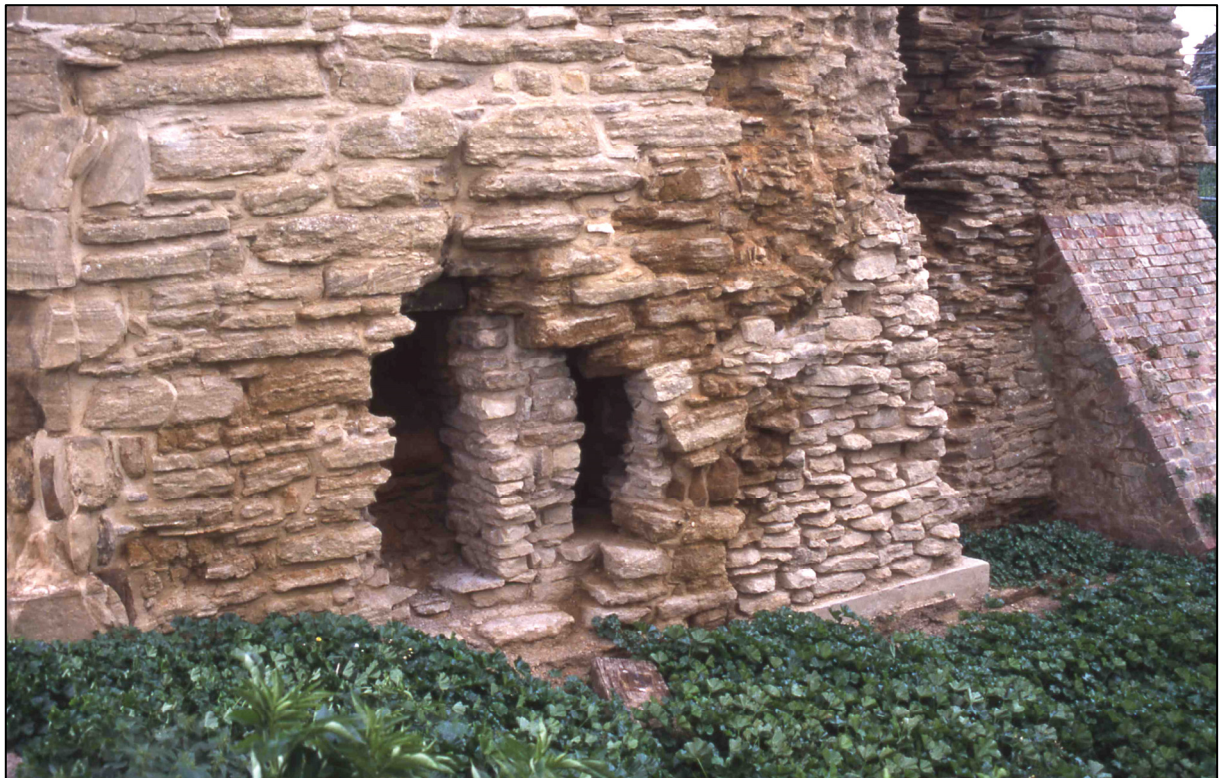
Plate 18: Garderobe chutes (C2/2 & C2/3) in west external elevation, after selective rebuilding and consolidation.

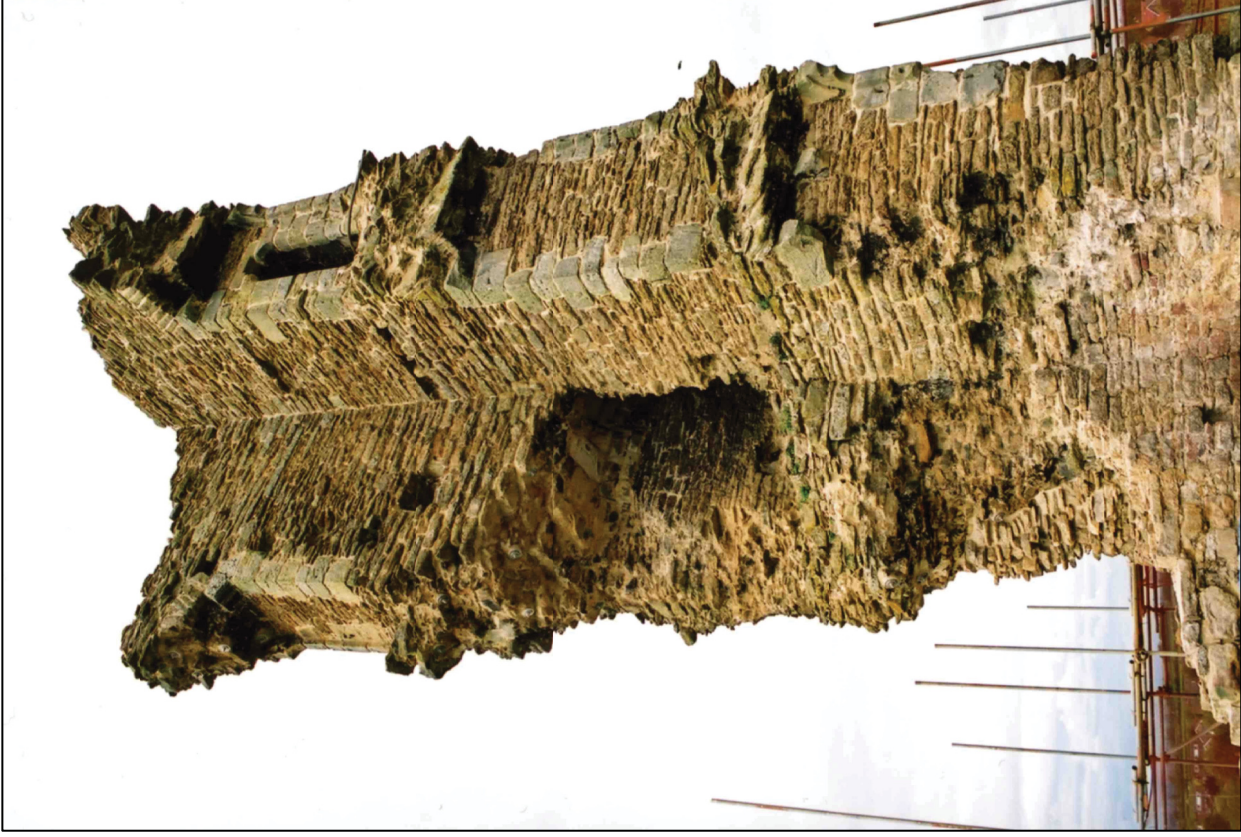
Plate 20: Upper levels of north-east tower, after consolidation.

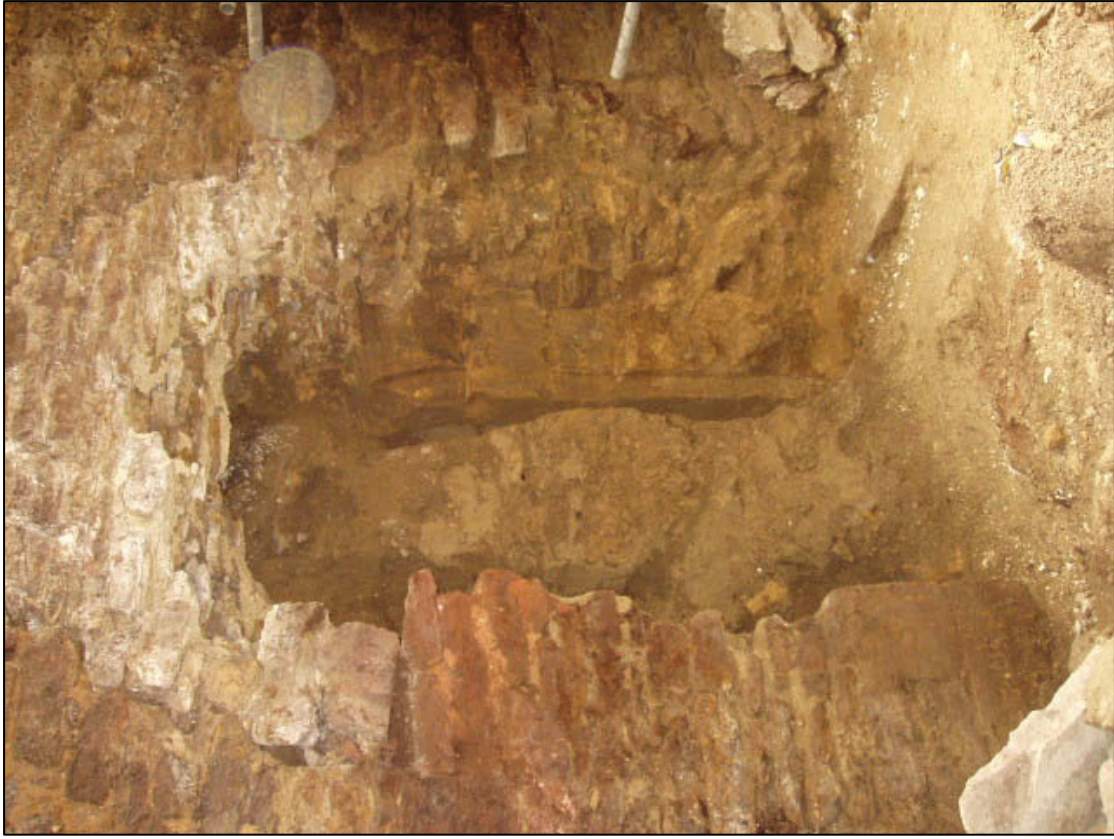
Plate 19: Newly exposed door opening (D2/3) in south wall of basement, prior to consolidation.

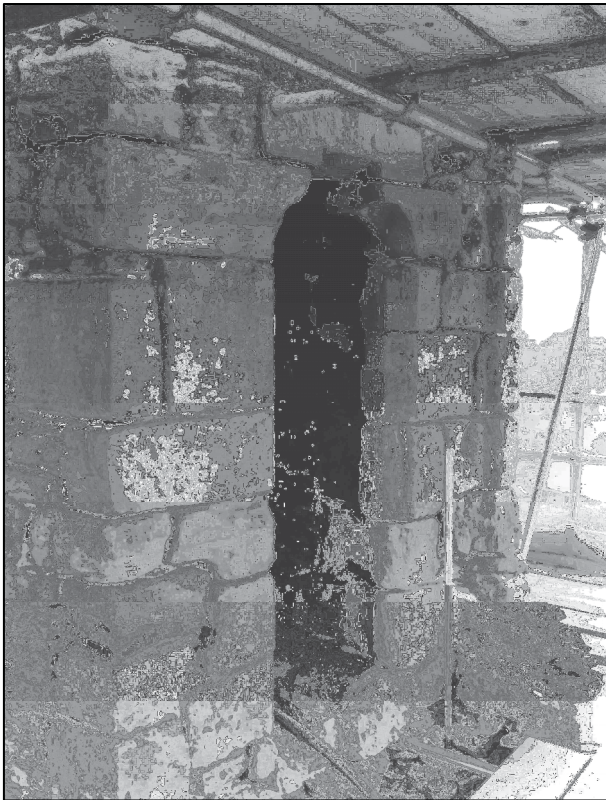
- 3.52 The west side of the window (W2/6) in the north wall contains a well preserved shouldered doorway (D2/2) (see plate 23) which leads into a mural garderobe passage. At the beginning of the repair/consolidation scheme, this passage was filled to a substantial depth with dried pigeon guano, which was subsequently cleared out. The passage is aligned east-west and is 3.80m long with a corbelled ceiling (see figure 8 for profile); the floor was formed by rubble set with a lime mortar. The passage returns to the south at its west end, and part of the raised slab forming the seat (L2/3) still survives. The wardrobe chute (C2/2) itself was offset to the south but unfortunately the seat proper had been removed (see plate 24). The chute emerges from the wall face on the ground floor. The garderobe

Plate 23: Doorway (D2/2) into third floor garderobe passage, prior to consolidation.

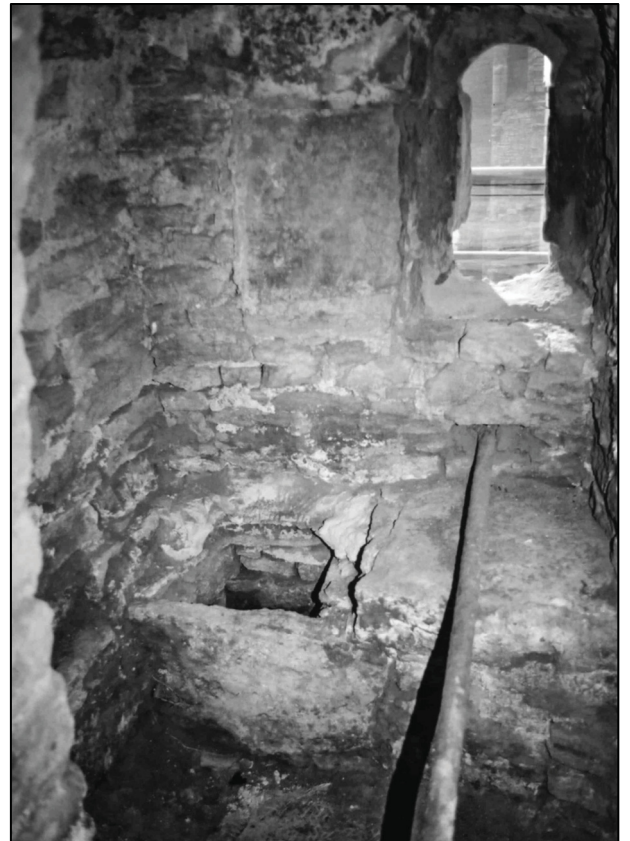
- 3.28 It appears that attempts to repair the north-east tower continued well into the late 19th century. It is thought that the tie-rod running through the uppermost garderobe passage of the tower (emerging through doorway D2/2 on the third floor) was put into place by Noah Banks of Lilling, who then carved the letters “N B L” on the adjacent door jamb (Robin Wardell, *pers. comm.*). This work is traditionally ascribed to the 1880s, and if so could have formed part of an attempt to prevent further decay following the major collapse of 1875.

Plate 24: Third floor garderobe seat (L2/3), chute (C2/2) and window (W2/8) with tie bar.

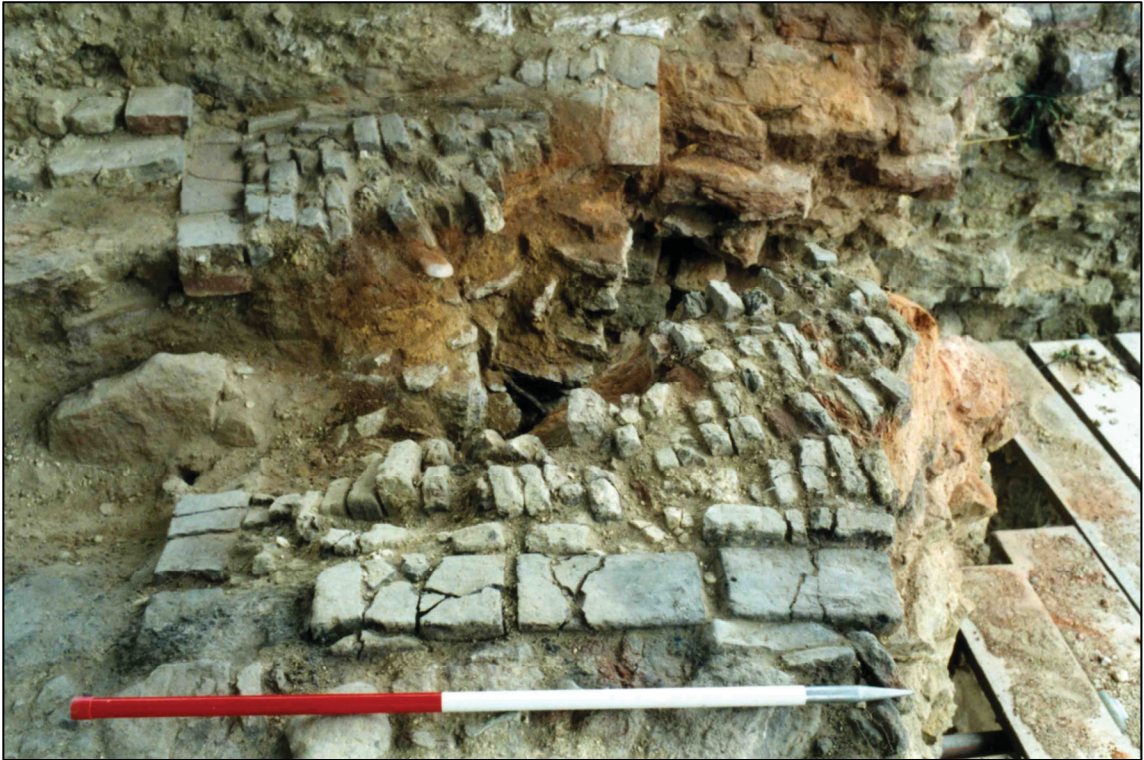
Plate 36: Excavation Area D - fireplace (context 019), split by fissure, looking E.

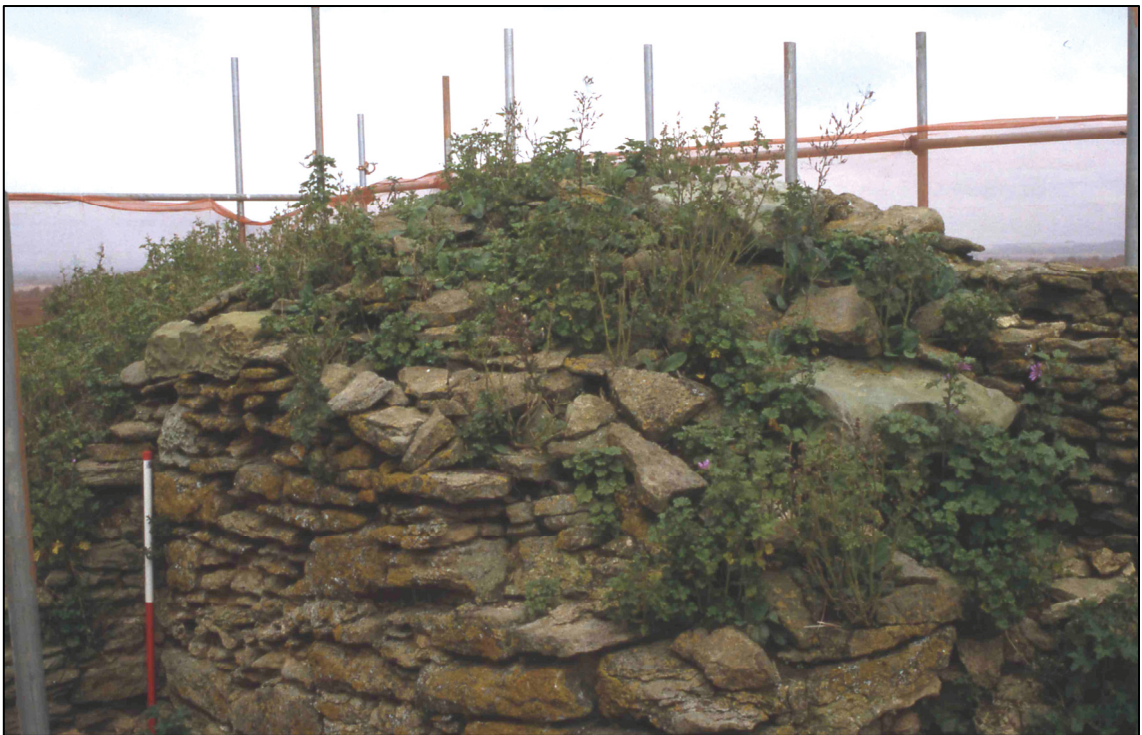
Plate 37: Vegetation at the top of the north-east tower, prior to consolidation.

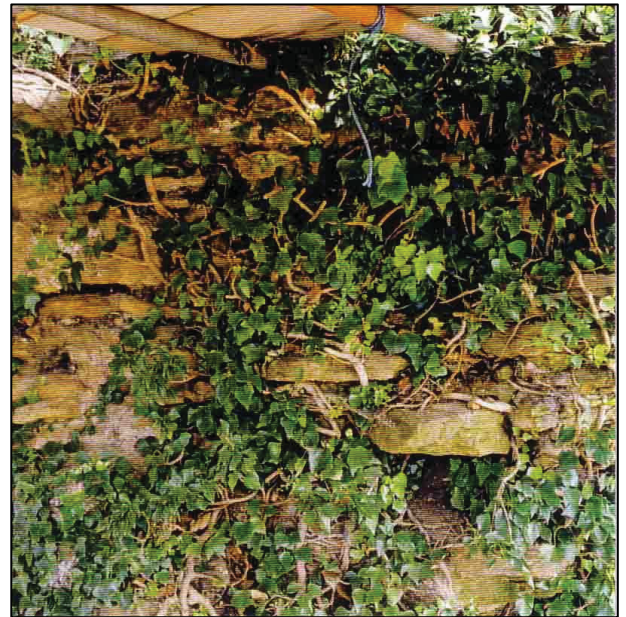
Plate 43: Ivy stems and loose masonry  
7.5m above ground level.

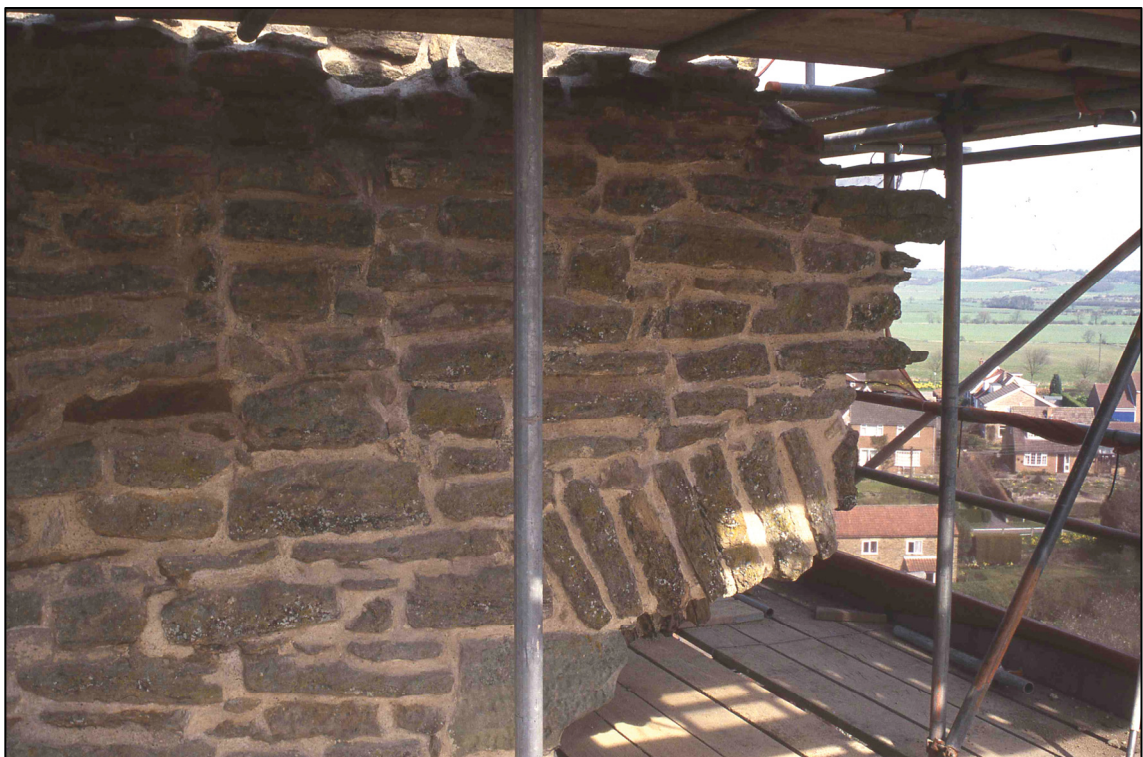
Plate 44: Area of repointed masonry, third floor, north internal elevation.

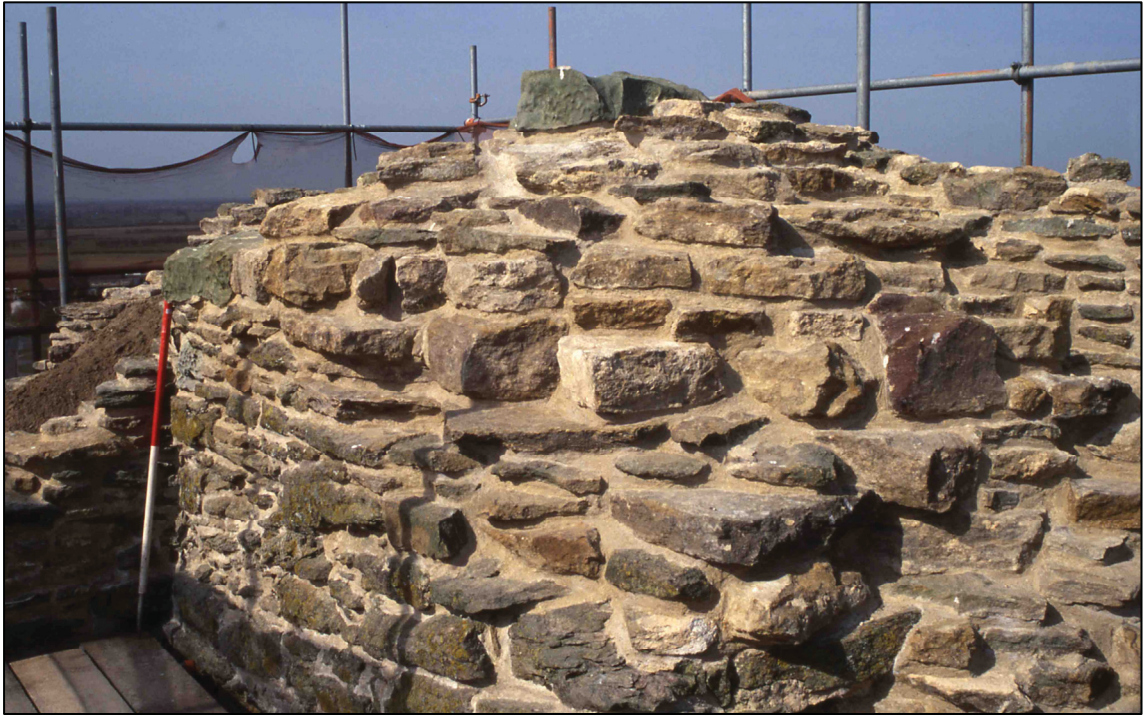
Plate 45: Rebuilt and reset stonework at the top of the north-east tower (compare with plate 37).

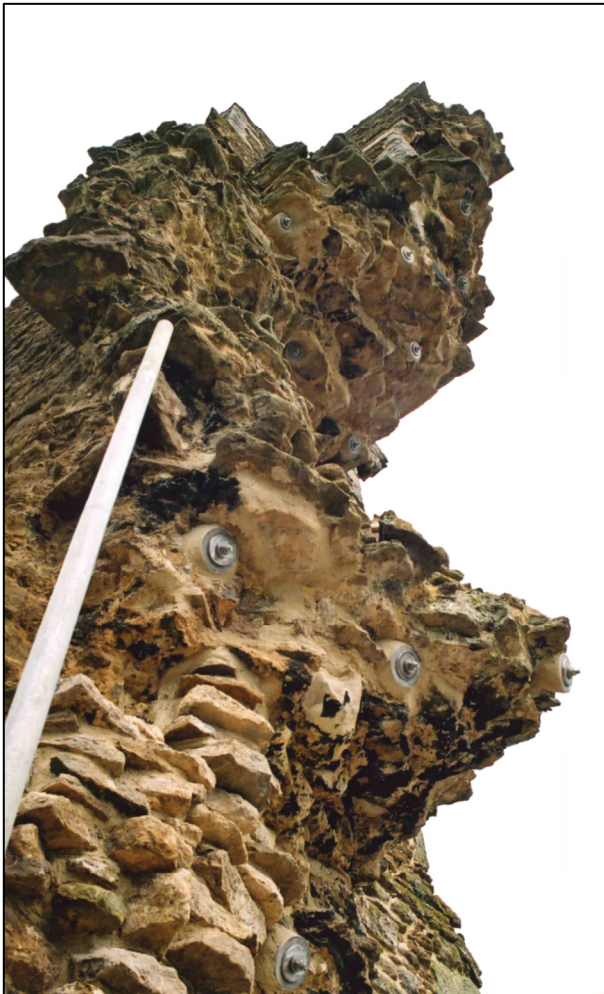
Plate 46: Structural ties inserted to support overhanging masonry.

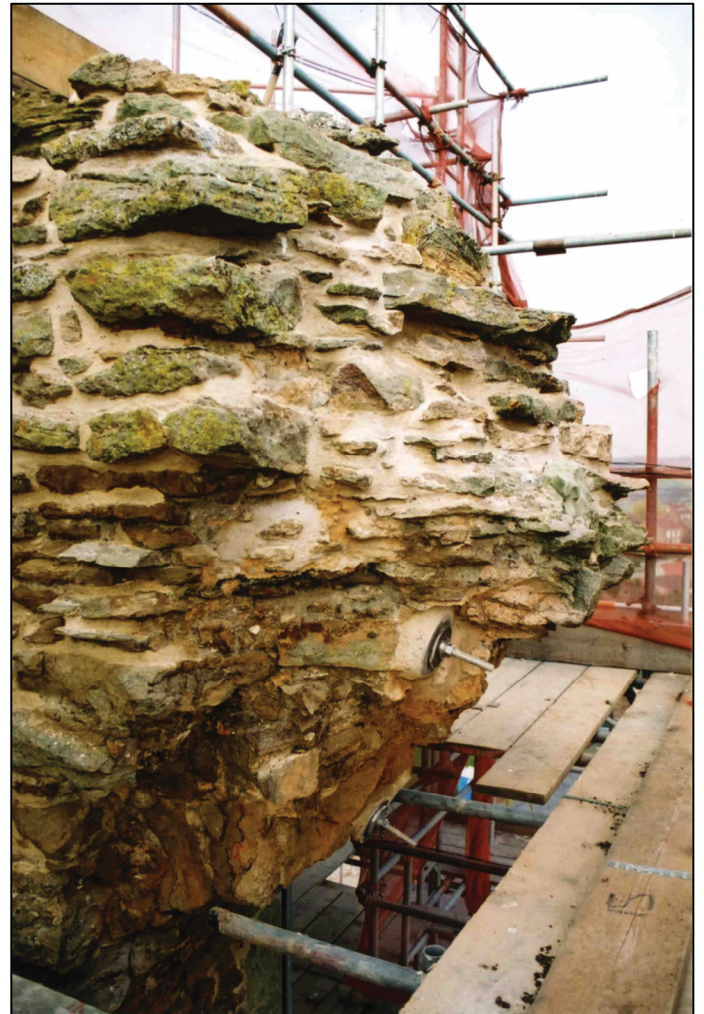
Plate 47: Detailed view of structural ties.

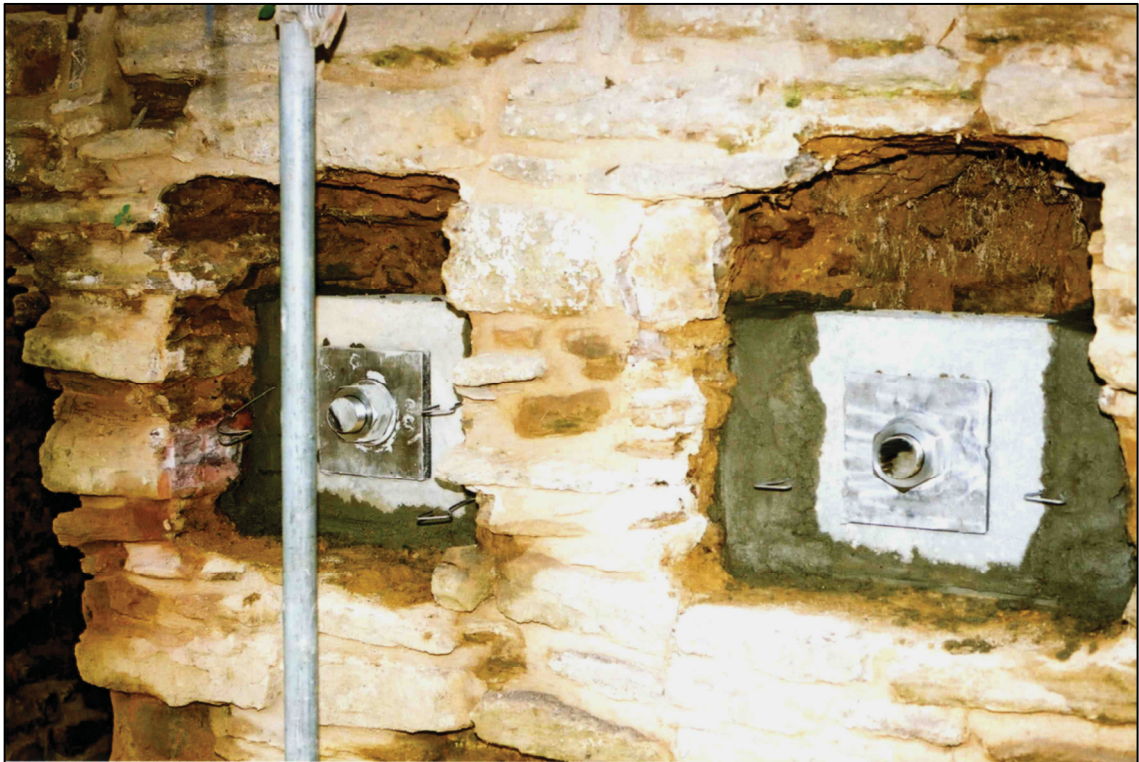
Plate 48: Inserted anchors to support structural ties running across the ground floor space.

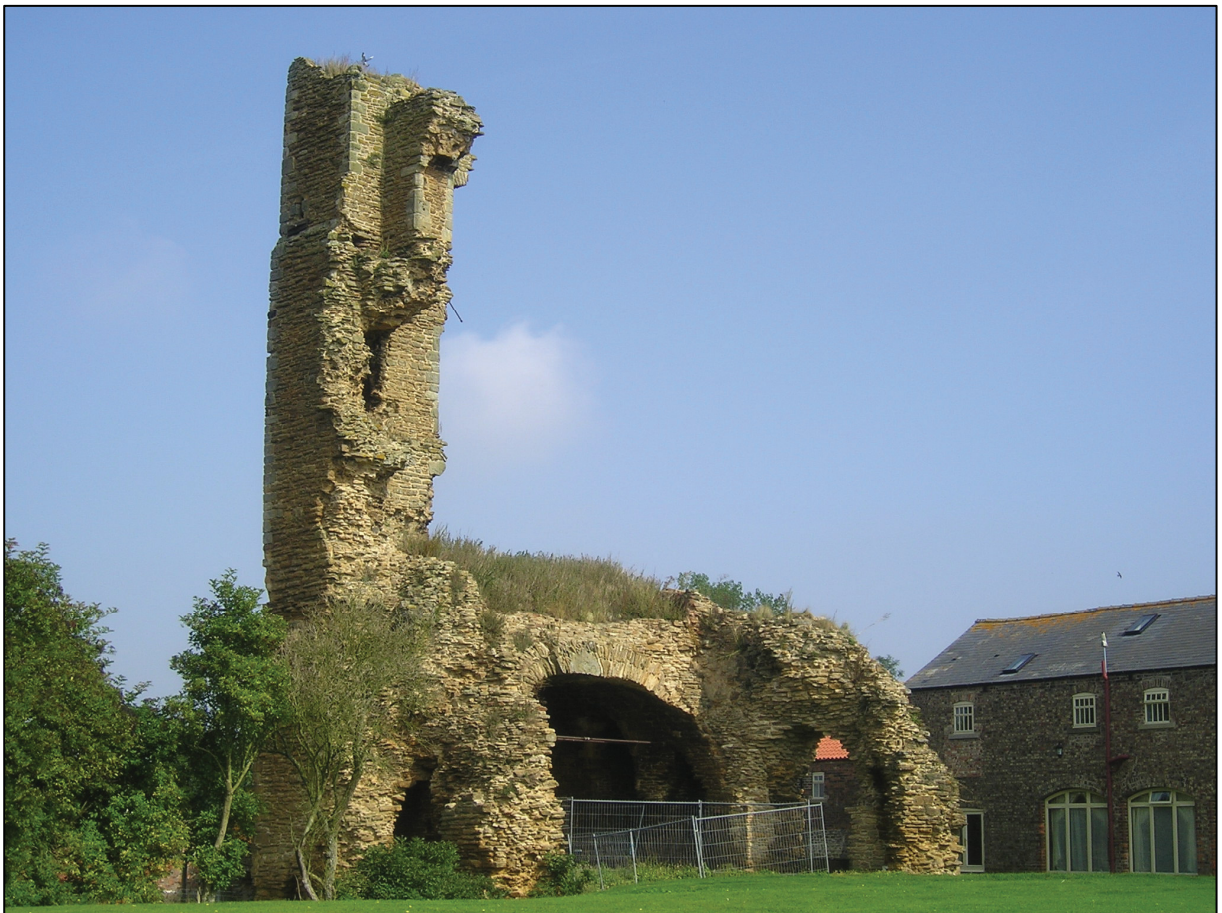
Plate 51: Consolidation and repair work complete.
