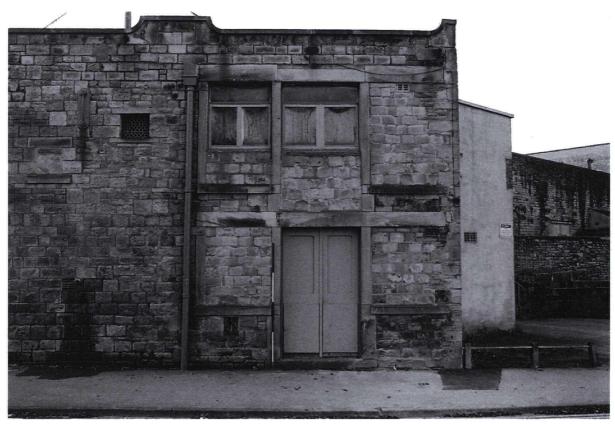
Photograph 1 9984/19 NE Ground-floor double door and first-floor double windows. Note the early blocked opening to the side of the doors

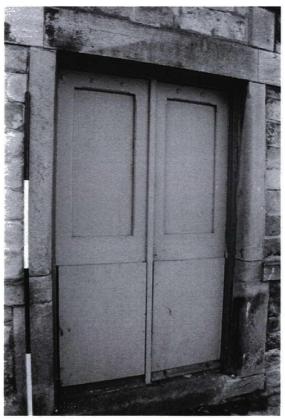
Photograph 2 9984/21 NE Detail of a large double door with worn stone architrave which shows evidence of chamfering

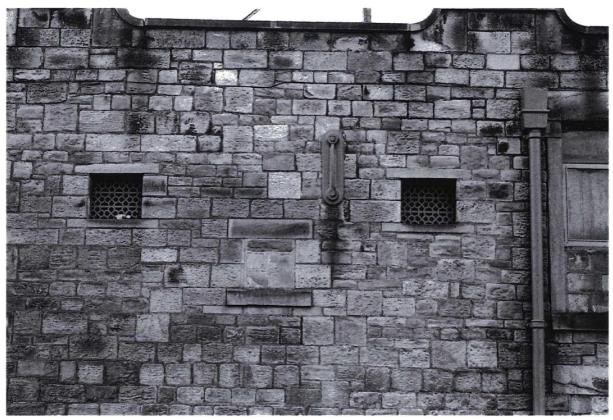
Photograph 3 9984/20 NE Two first-floor ventilator grilles with a central blocked opening

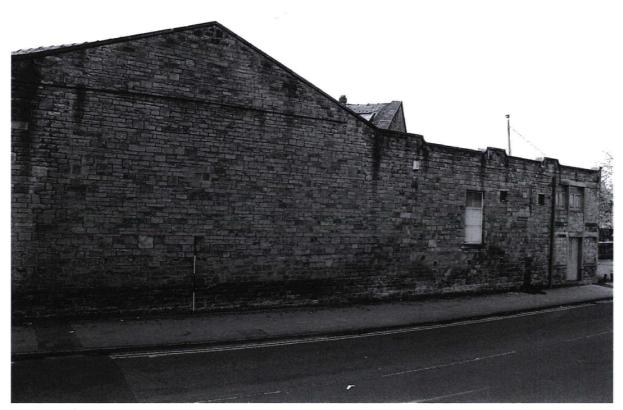
Photograph 4 9984/18 NE Angled gable wall

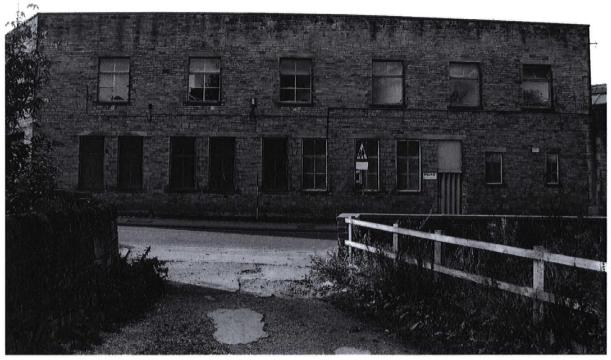
Photograph 5 9984/16 NE Two-storey elevation

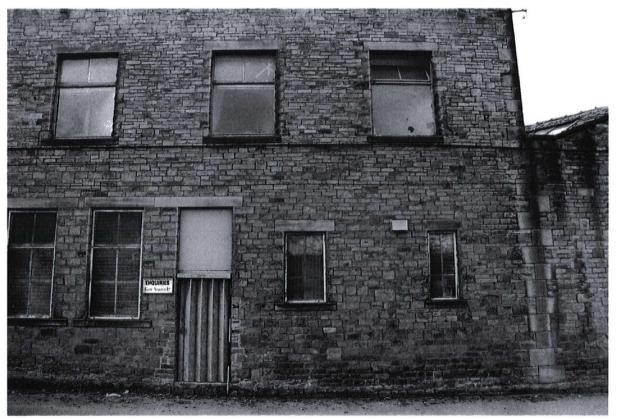
Photograph 69984/17NEBuildings join at quoined corners with windows to two floors

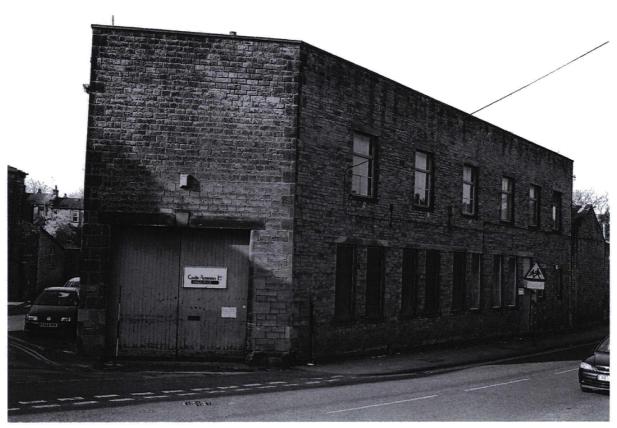
Photograph 7 9984/14 E Large loading doors in the corner elevation

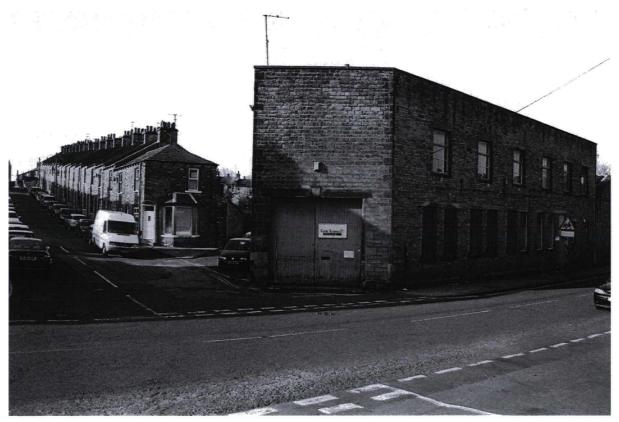
Photograph 7a 9984/15 W The corner elevation looking down Shortbank Road

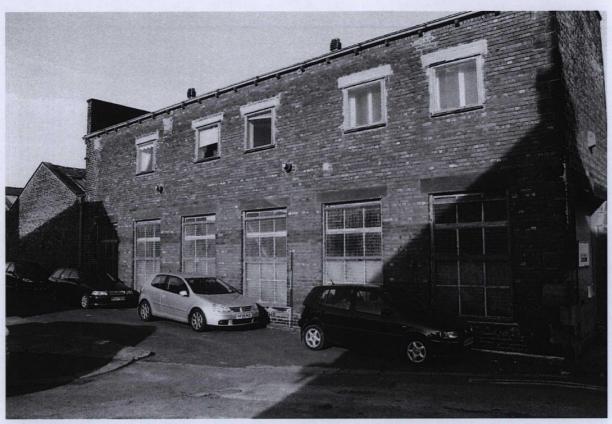
Photograph 8 9984/12 S The rear of the building showing large ground-floor windows and smaller first-floor windows

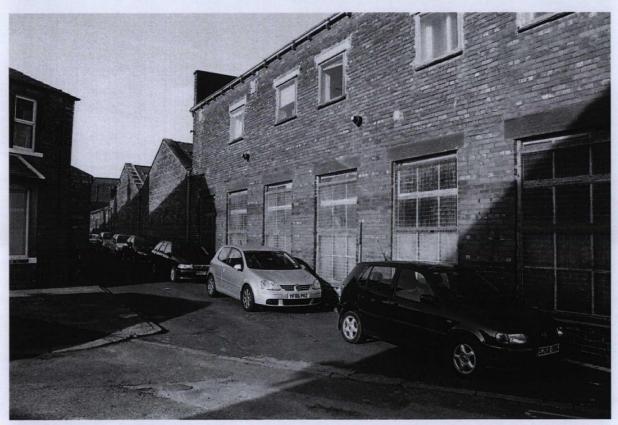
Photograph 9 9984/13 SE A similar view looking down the back lane

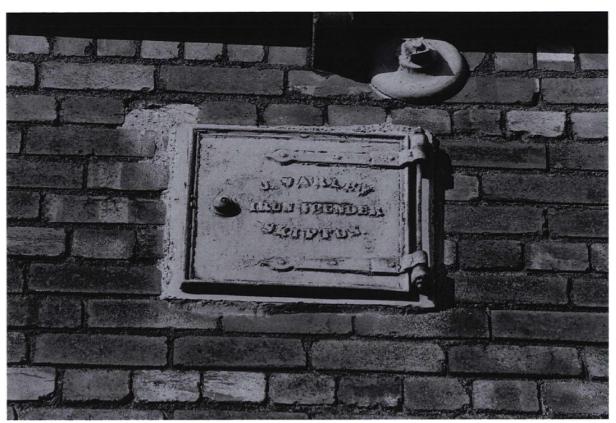
Photograph 10 9985/2 S Detail showing a cast-iron hatch. The cast reads, 'J. VARLEY IRON FOUNDER SKIPTON'

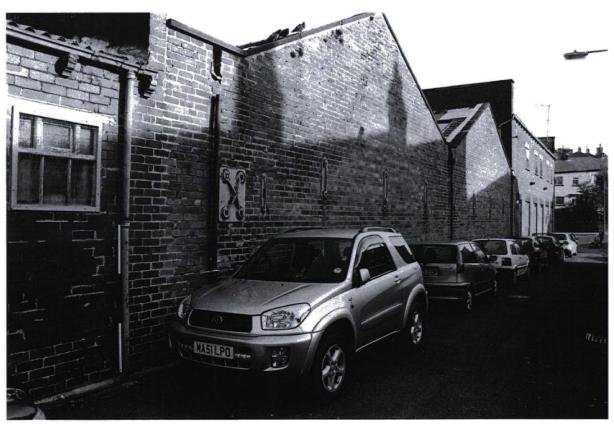
Photograph 11 9984/11 SW A pattress plate on the outer wall. Other cast-iron plates are visible

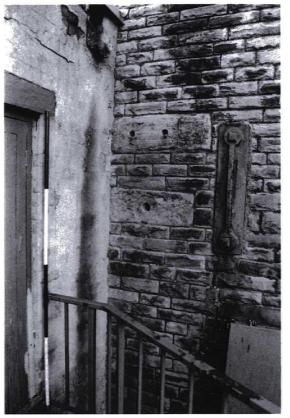
Photograph 12 9984/23 N Cast-iron plates and evidence of previous wall fixings

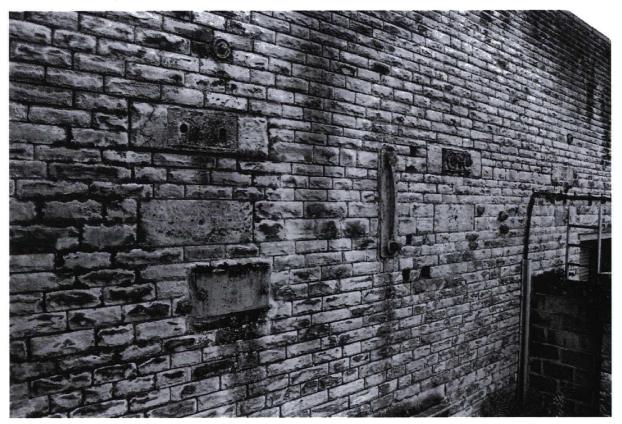
Photograph 139984/24NEFront wall with cast-iron plates flanked by steel bolting positions set in ashlar blocks

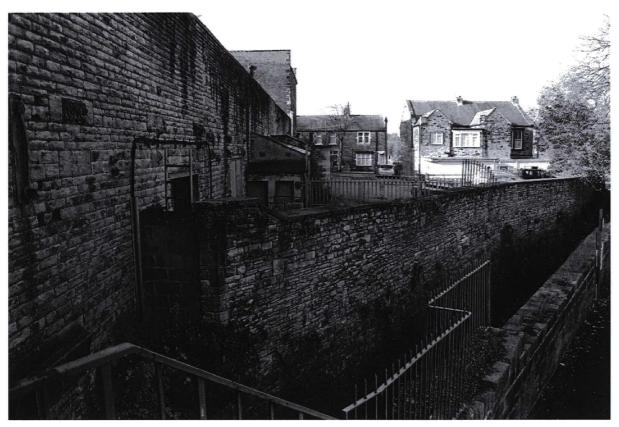
Photograph 14 9984/22 E Culverted watercourse

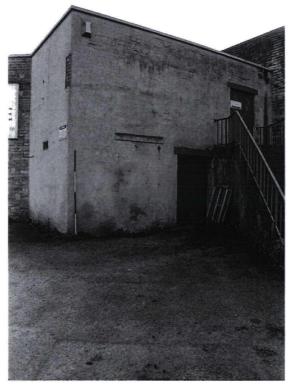
Photograph 15 9984/25 W Rendered outer wall and stairway. A blocked doorway is also visible

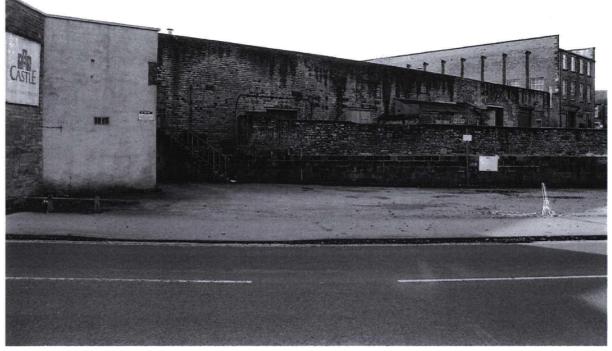
Photograph 15a 9984/26 NE General view showing the watercourse wall in front of the building

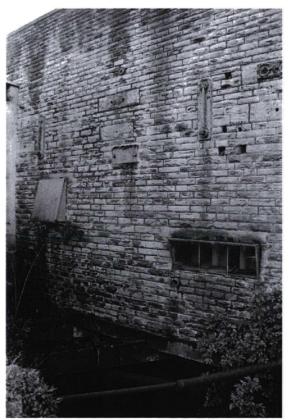
Photograph 16 9984/27 NW Wall with bolting positions, cast-iron plates and a low-level ventilator

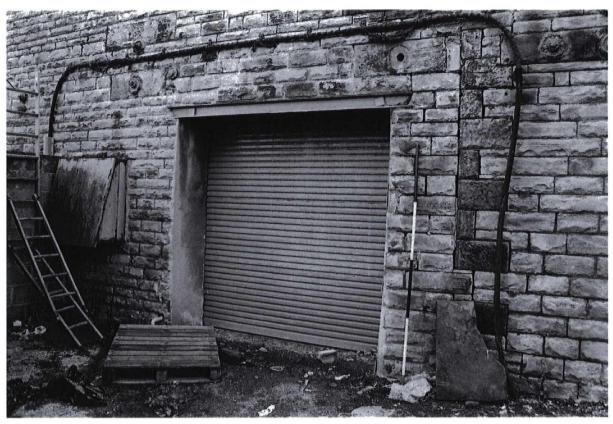
Photograph 17 9983/8 NW Modern roller-shutter door

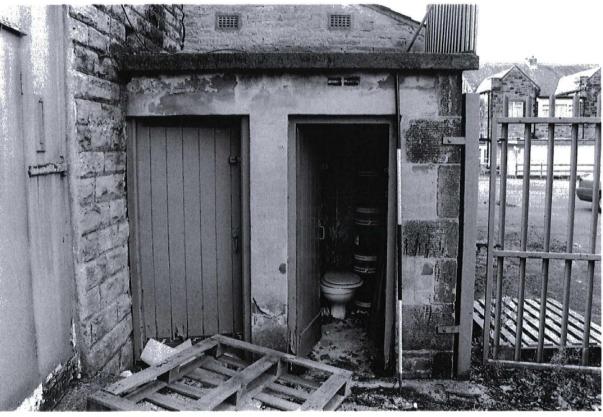
Photograph 18 9983/7 E External modern toilet block

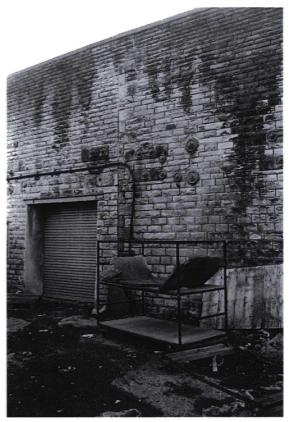
Photograph 19 9984/6 NW Wide roller-shutter door with straight joint to the side

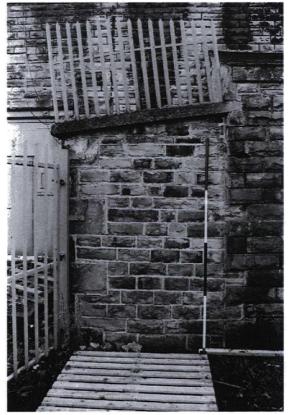
Photograph 20 9984/7 N Side elevation of the modern toilet block

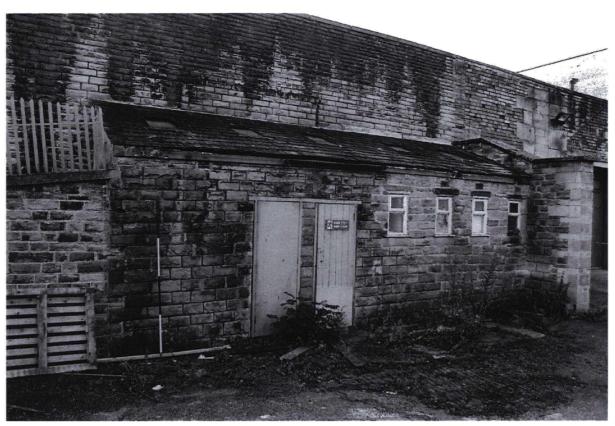
Photograph 21 9984/5 NE Single-storey lean-to store and toilet block

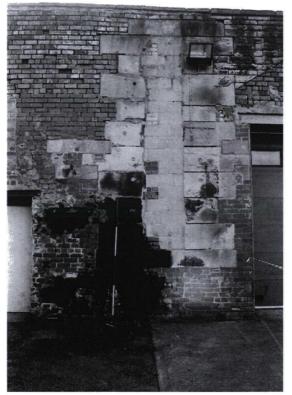
Photograph 22 9984/1 N Straight joint with ashlar quoins. Also, some later brick blocking

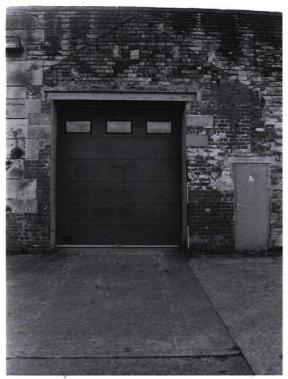
Photograph 23 9984/2 N Modern roller-shutter door. Note the encased gable wall and brick infilling

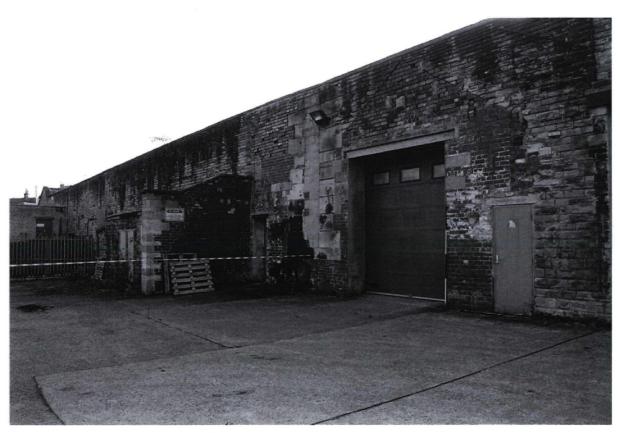
Photograph 24 9984/3 NW Oblique view across the face of the building

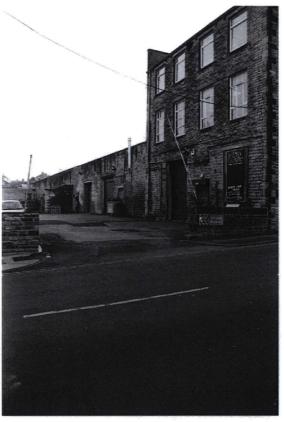
Photograph 24a 9984.4 W View of the building and car park from across the road showing the low stone boundary wall

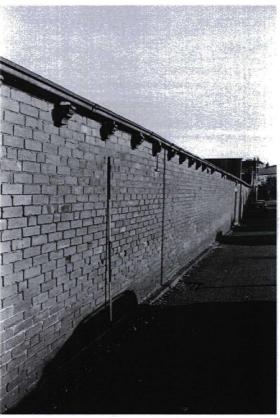
Photograph 25 9984/8 SW Rear shed wall. Note the corbels running below the guttering

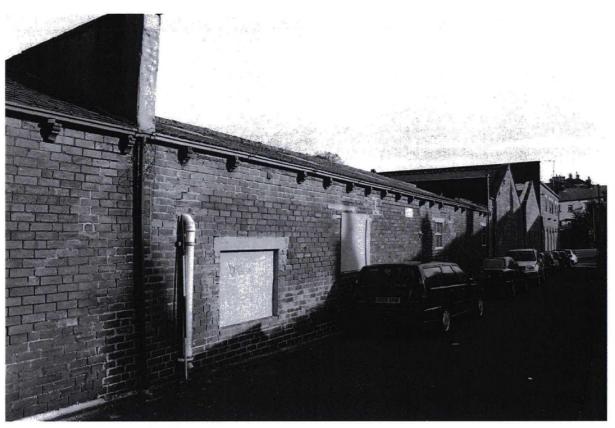
Photograph 26 9984/9 W Rear shed wall with window openings

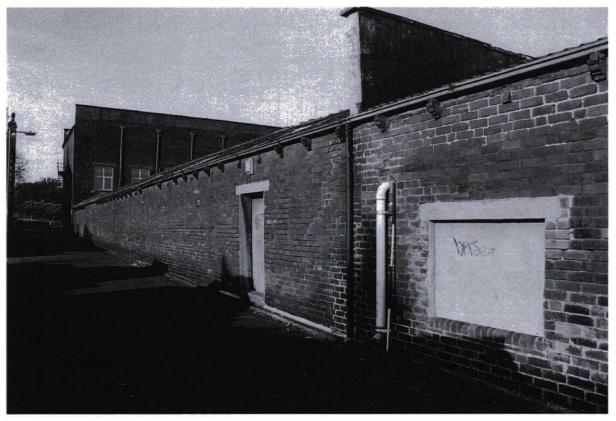
Photograph 27 9984/10 SE Rear shed wall with window and door openings

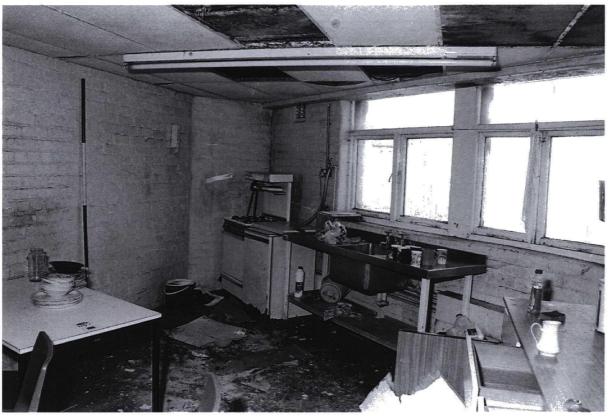
Photograph 28 9983/29 S First-floor area now used as a kitchen and rest room

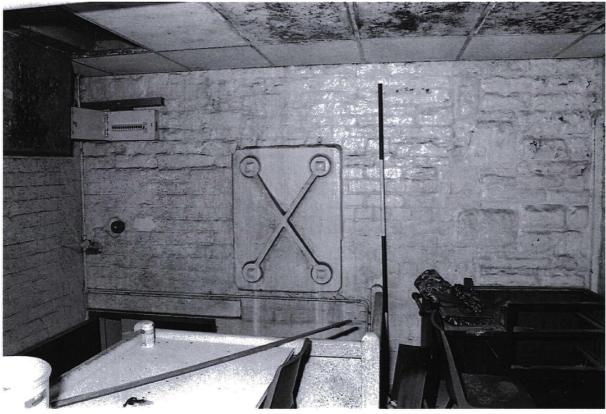
Photograph 29 9983/30 N Detail of a brick wall and pattress plate

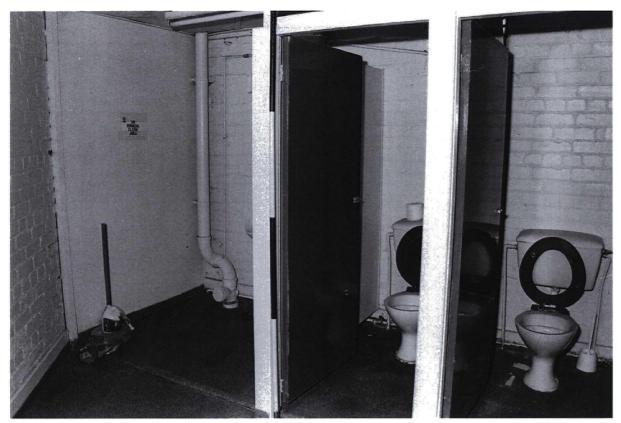
Photograph 30 9983/33 S Toilet area showing partitioned cubicles; all walls are of brick

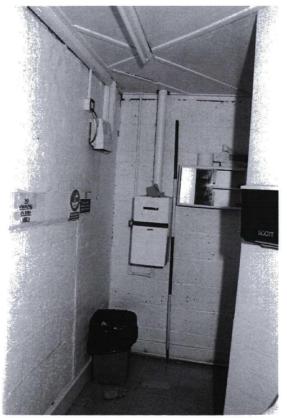
Photograph 31 9983/34 E Toilet area with breeze-block walls

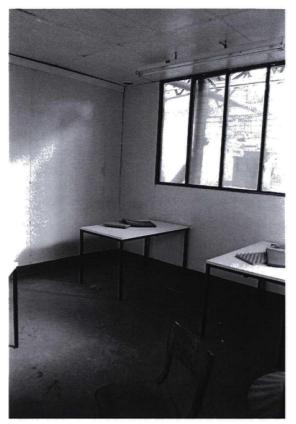
Photograph 31a 9983/35 NW The interior of the later smoking room

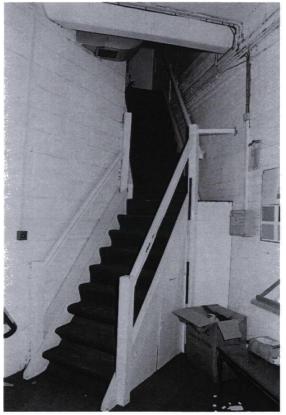
Photograph 32 9985/3 N Staircase with breeze-block wall and earlier brick wall

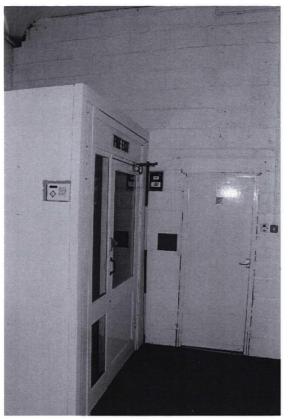
Photograph 33 9985/4 W Partitioned lobby leading to the fire exit

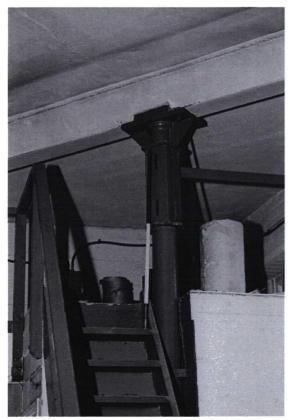
Photograph 34 9985/26 SE The top of a cast-iron column where it is bolted to the beam. Note the single bolting face for a drive shaft hanger
