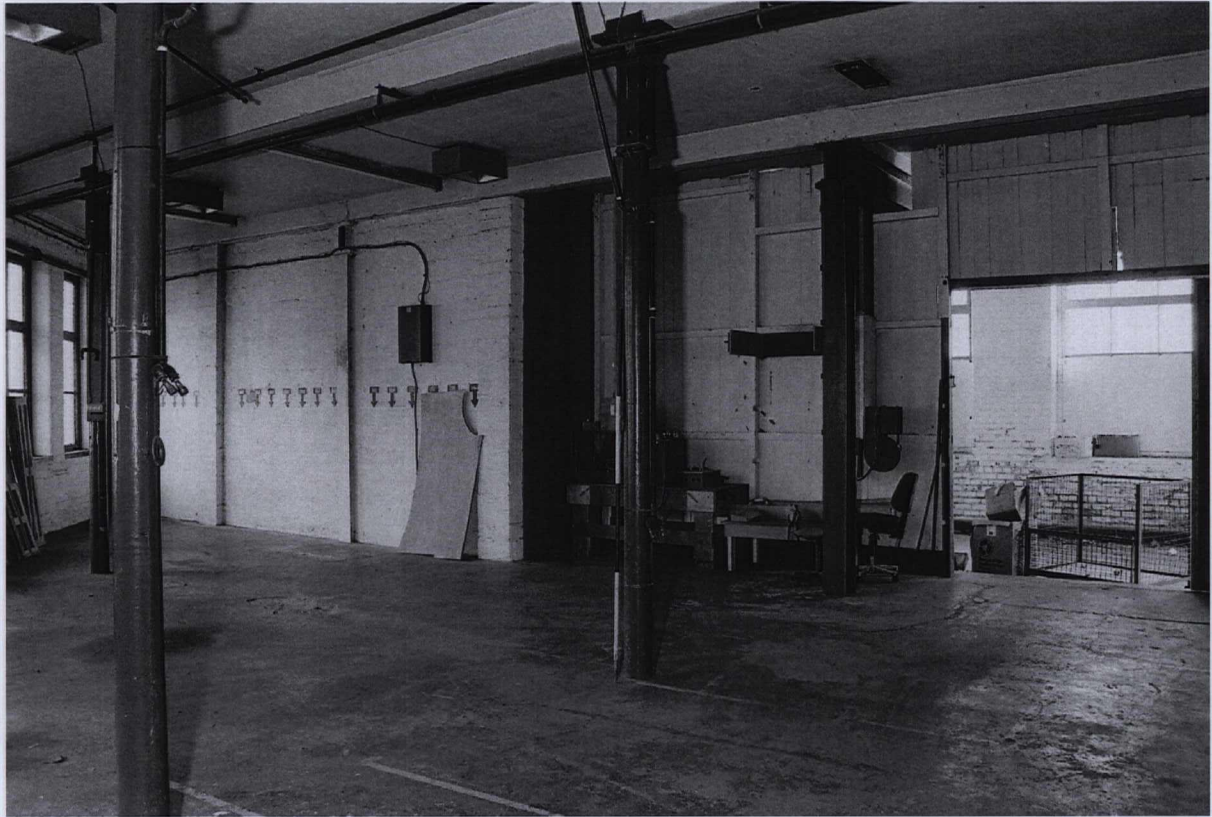
Photograph 35 9985/25 NW  
View showing cast-iron columns and a steel stanchion

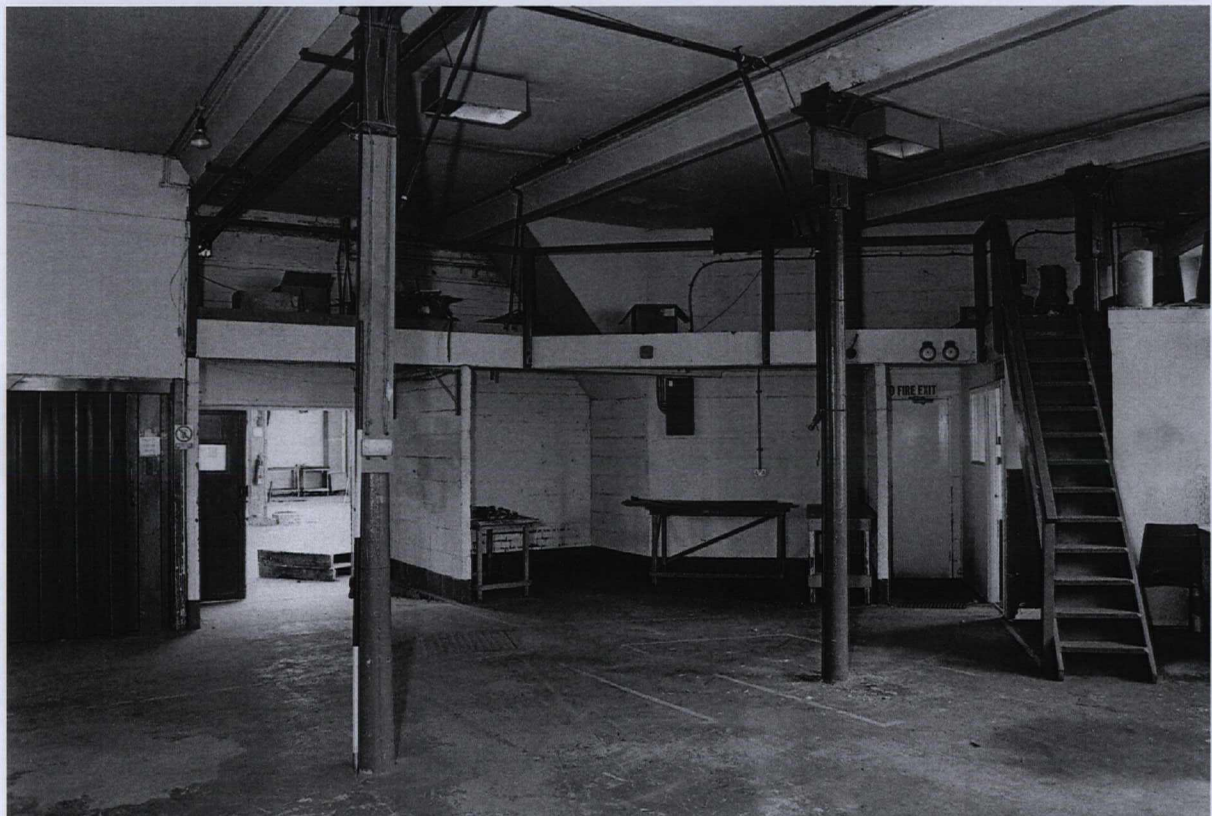
Photograph 36 9985/28 SE  
Cast-iron columns and a small mezzanine floor

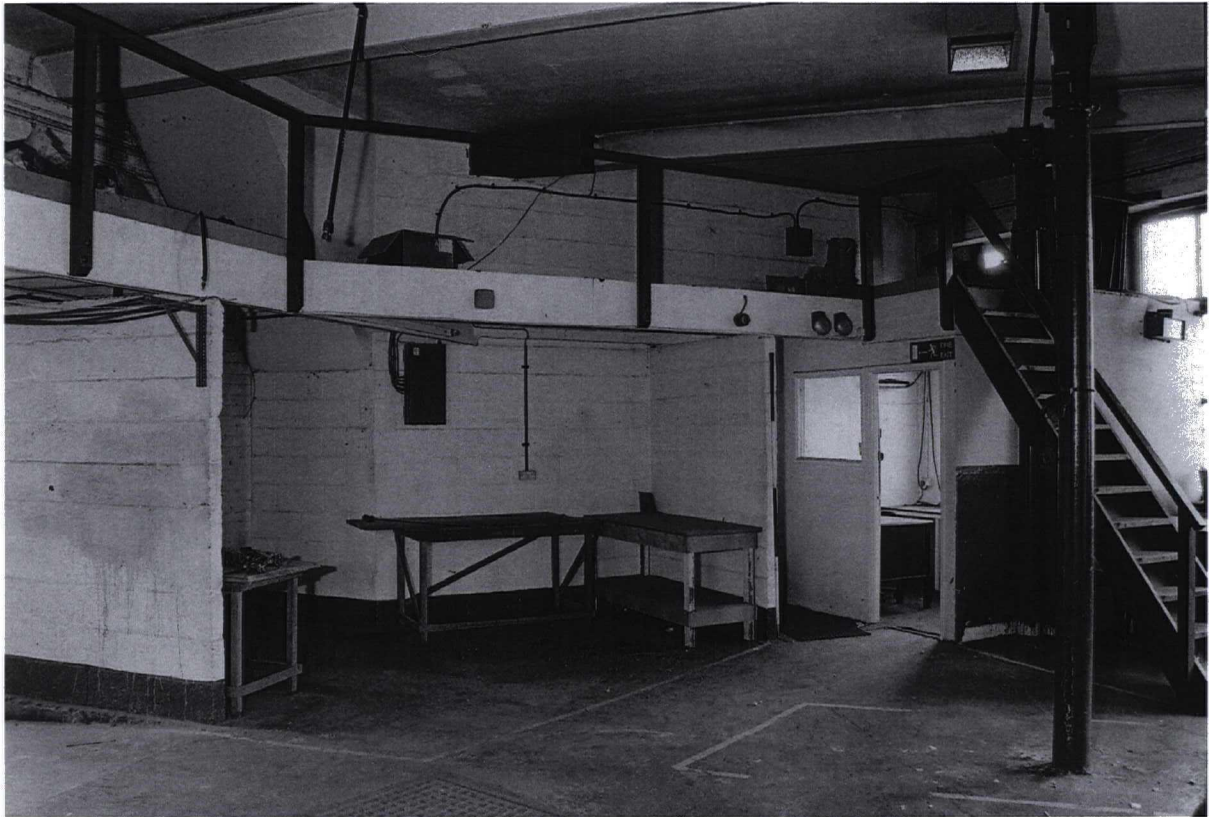
Photograph 37 9985/24 S  
Wooden stair leading up to the later mezzanine floor

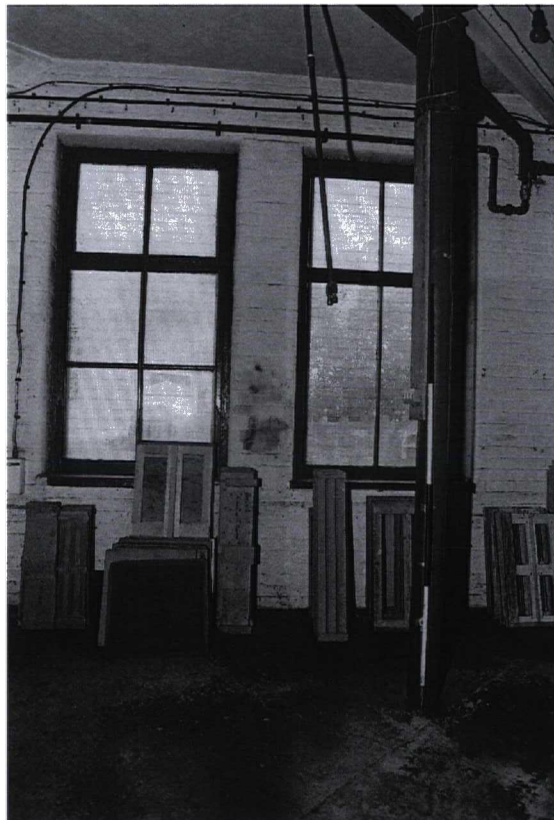
Photograph 38 9985/27 SW  
A cast-iron column in the foreground and a pair of two-over-four, top-opening, case-  
ment windows beyond

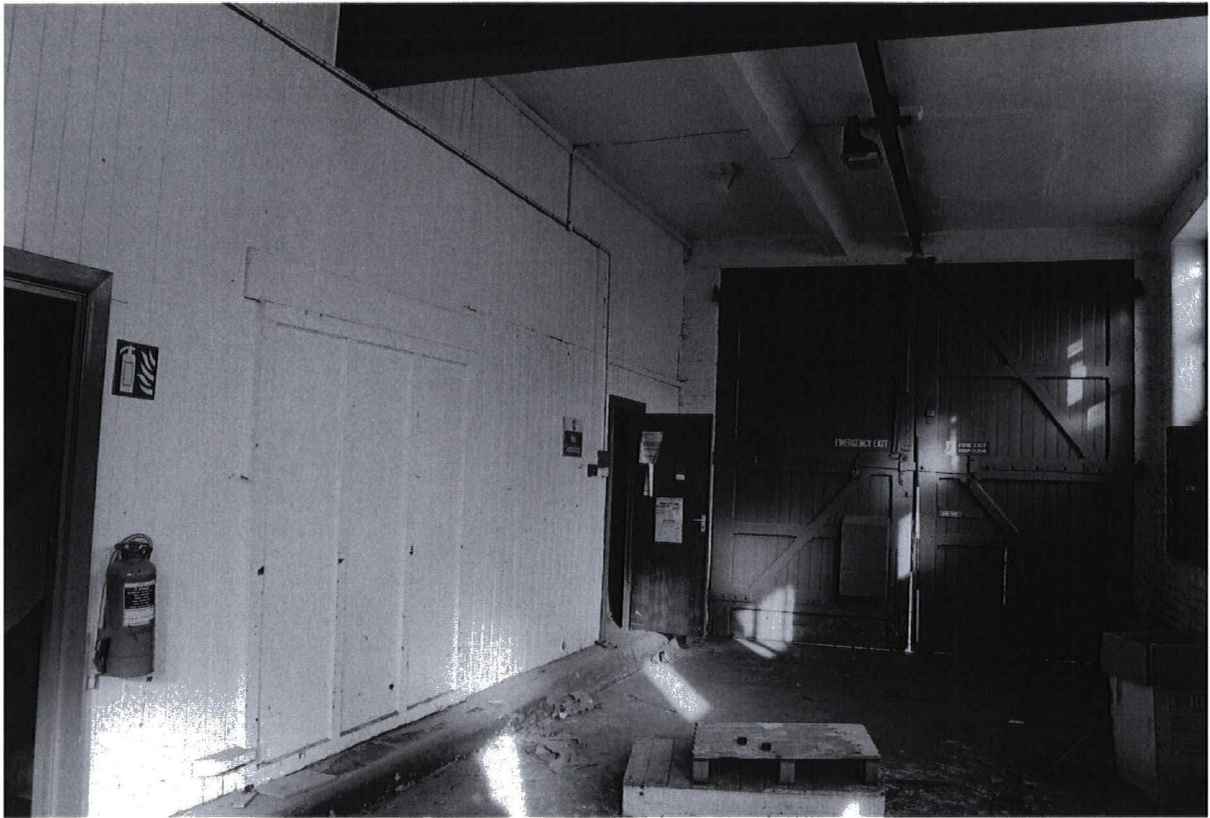
Photograph 39 9985/22 W  
Large double loading doors

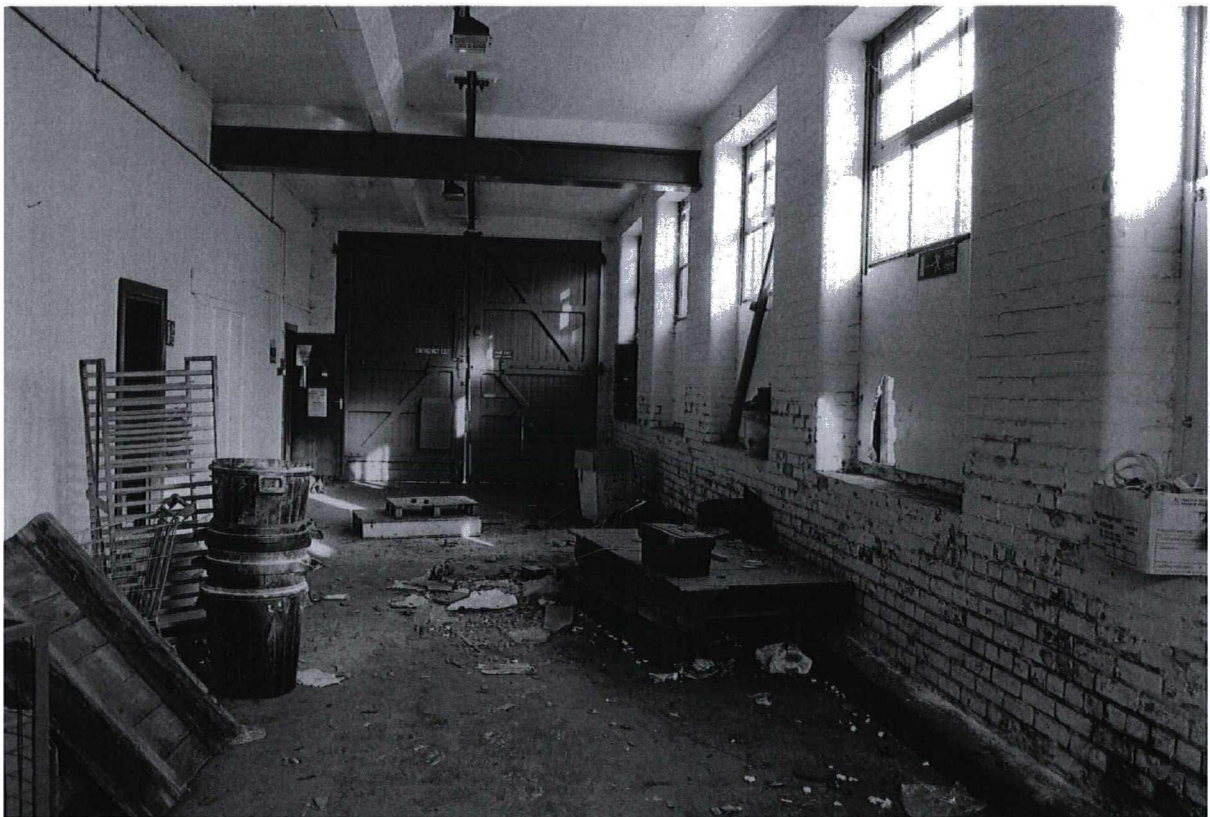
Photograph 40 9985/23 W  
A view of the loading bay

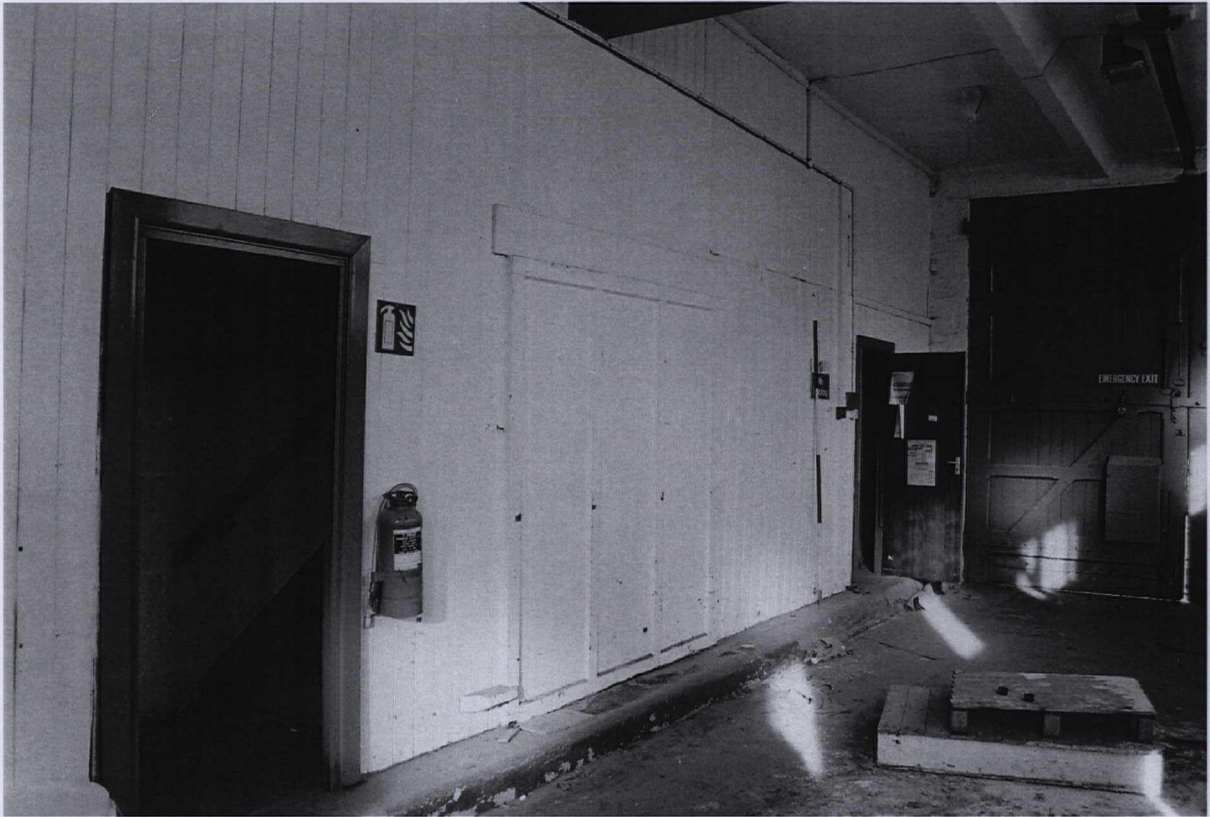
Photograph 41                      W  
Partition wall to the side of the loading bay

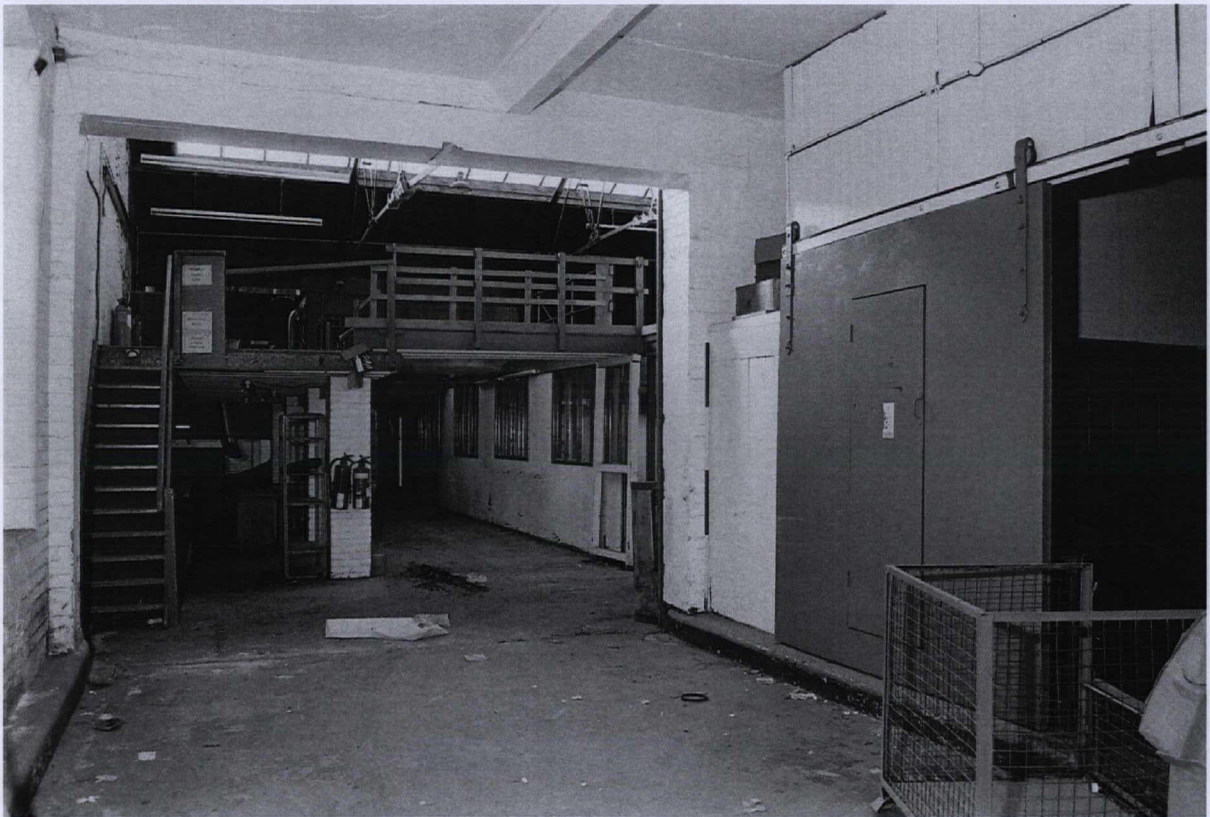
Photograph 42    9985/21    E  
A mezzanine floor supported on a row of brick columns

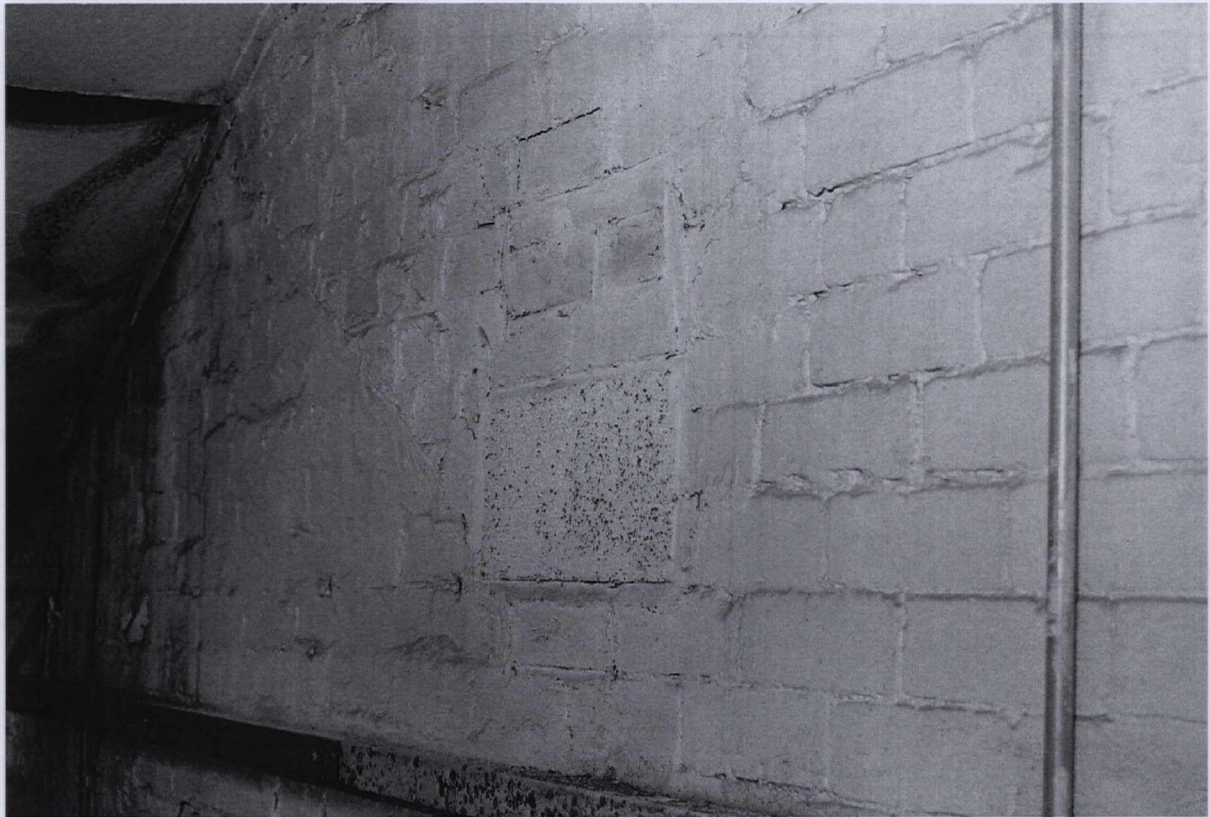
Photograph 43 9985/5 W  
A blocked opening, possibly a wall box

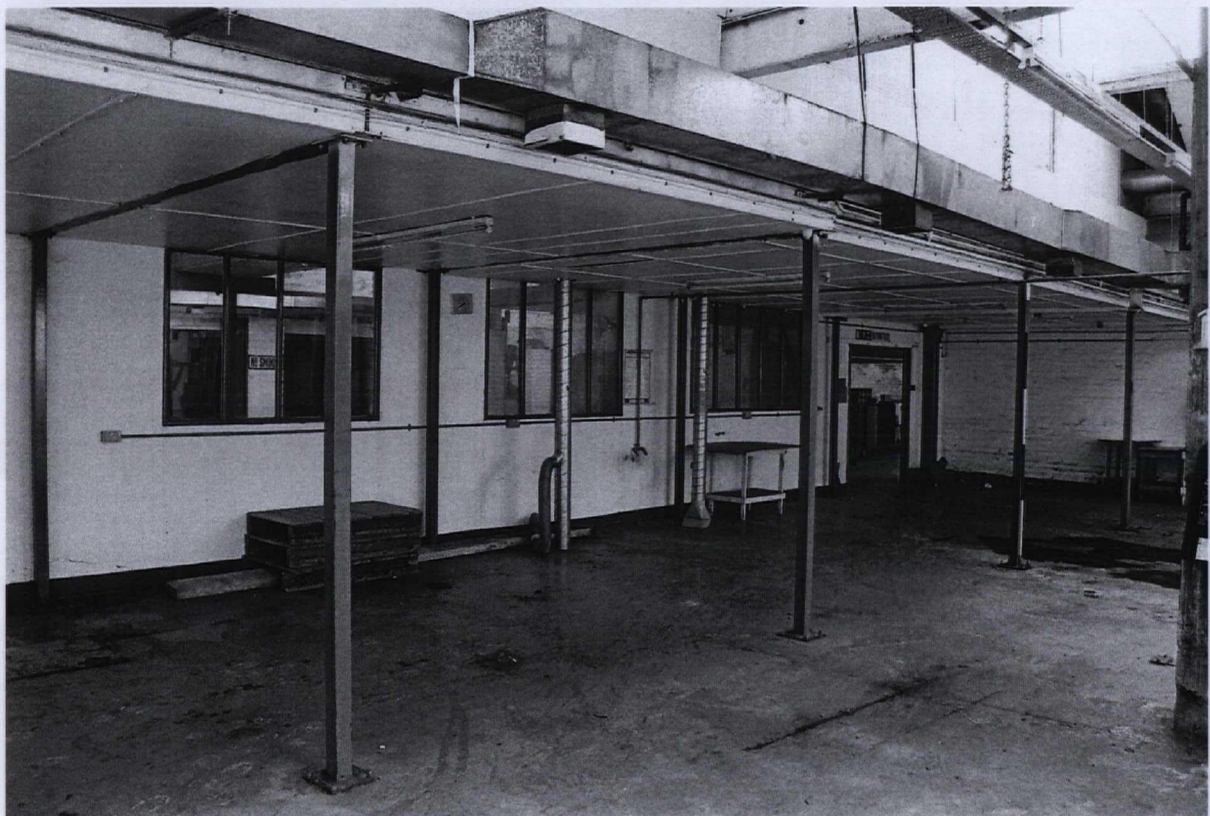
Photograph 44 9983/25 NE  
Mezzanine storage area supported on a steel framework

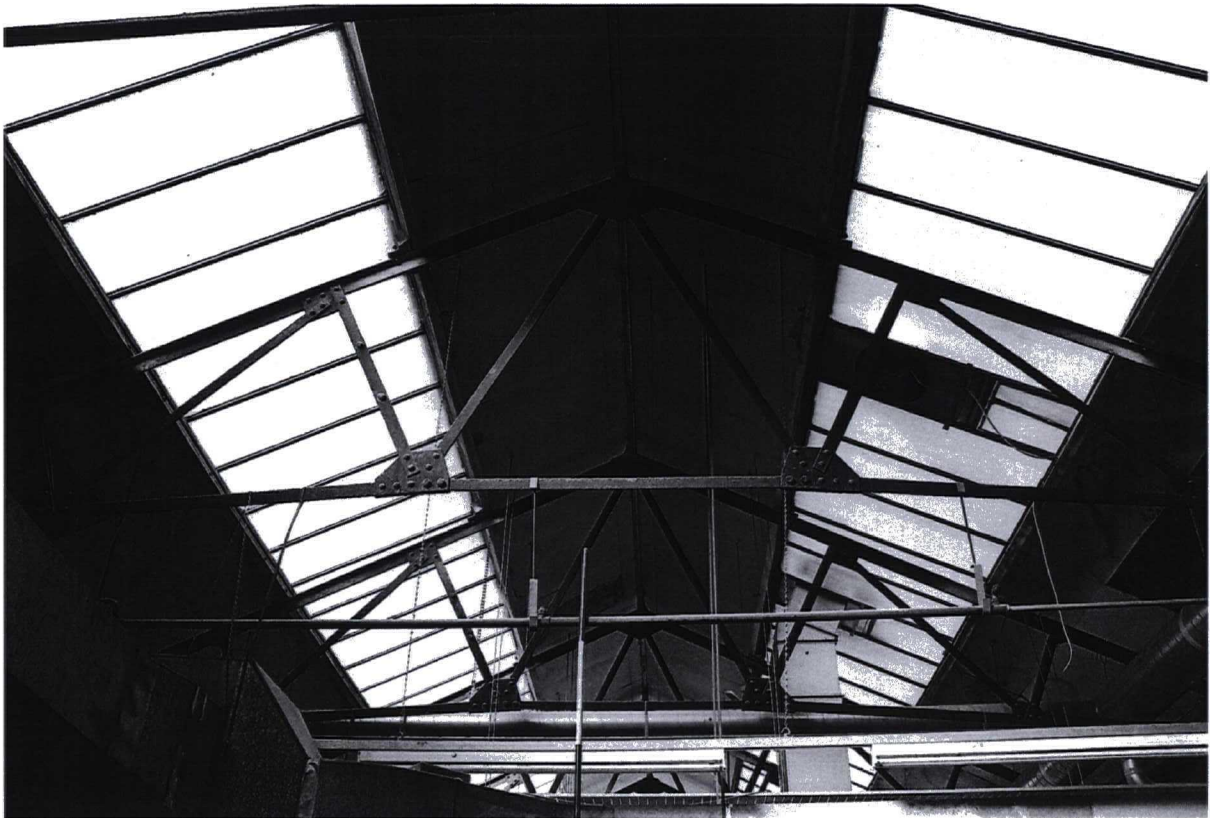
Photograph 45 9983/24 S  
Bolted steel roof trusses

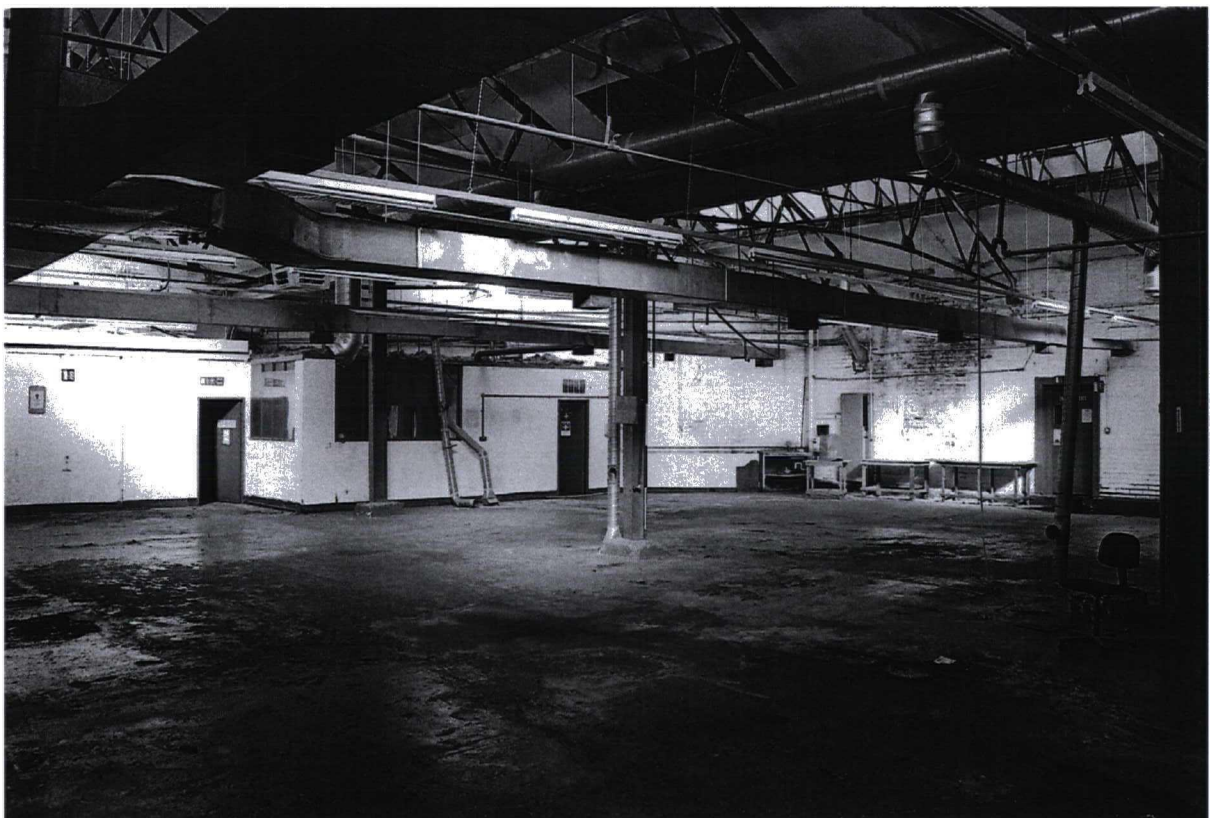
Photograph 46 9983/23 SW  
General internal view showing steel, 'T' section stanchions and the ventilation system

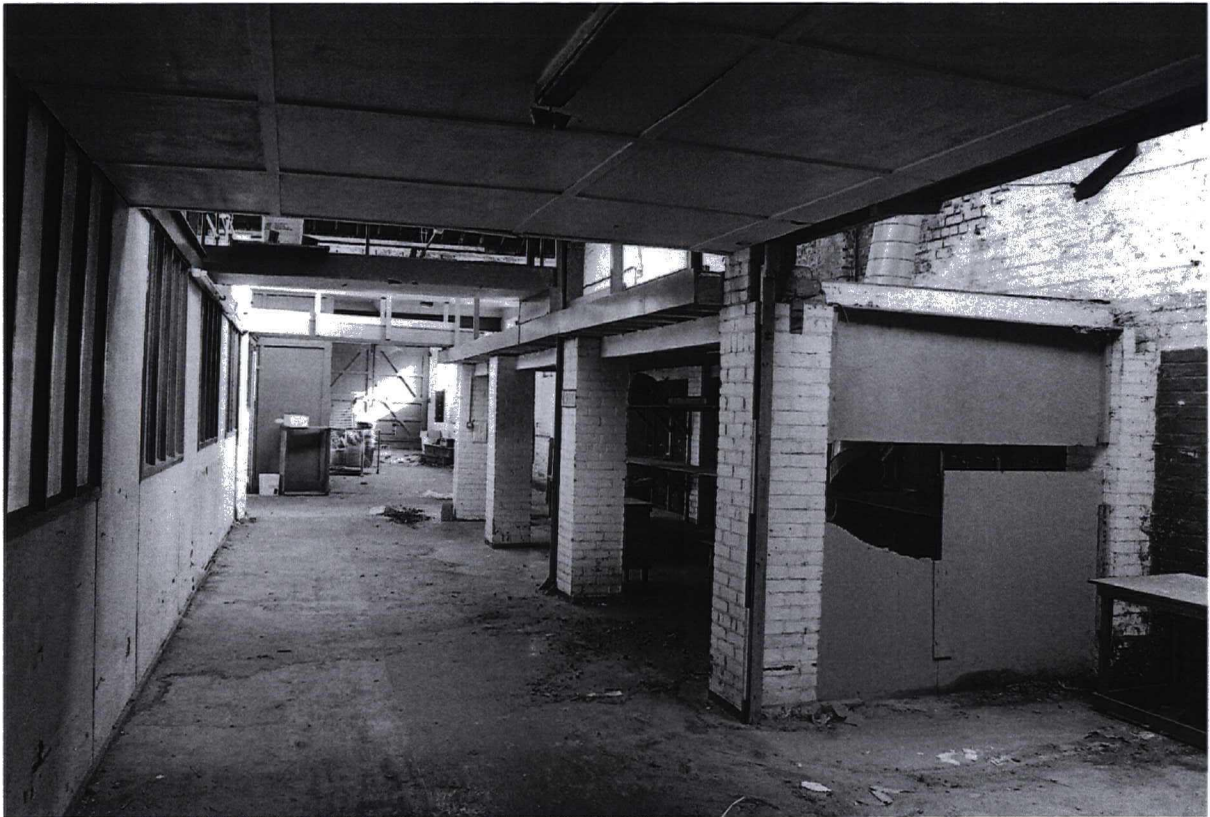
Photograph 47 9983/22 W

Mezzanine supported on brick columns with a part-glazed partition to the side

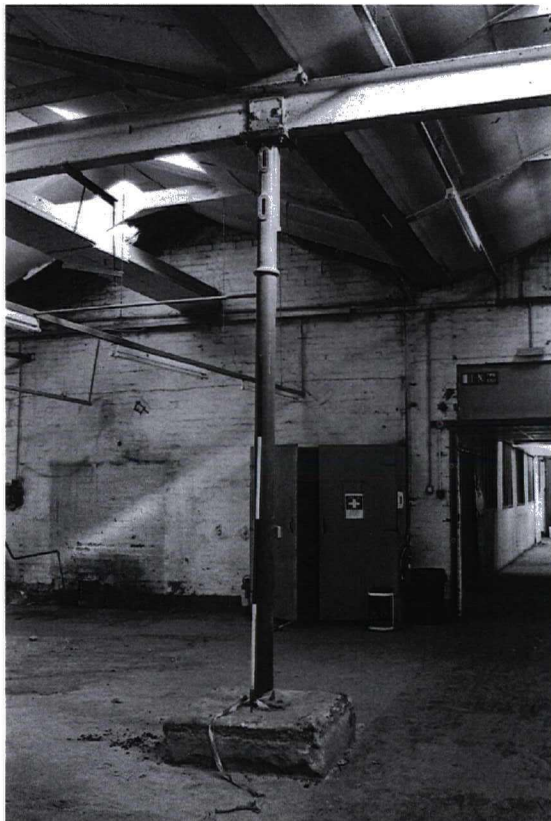
Photograph 48 9983/9 W

A cast-iron column set on a raised stone plinth. The column features a single bolting face for a drive shaft hanger and is supporting a steel, 'I' section beam

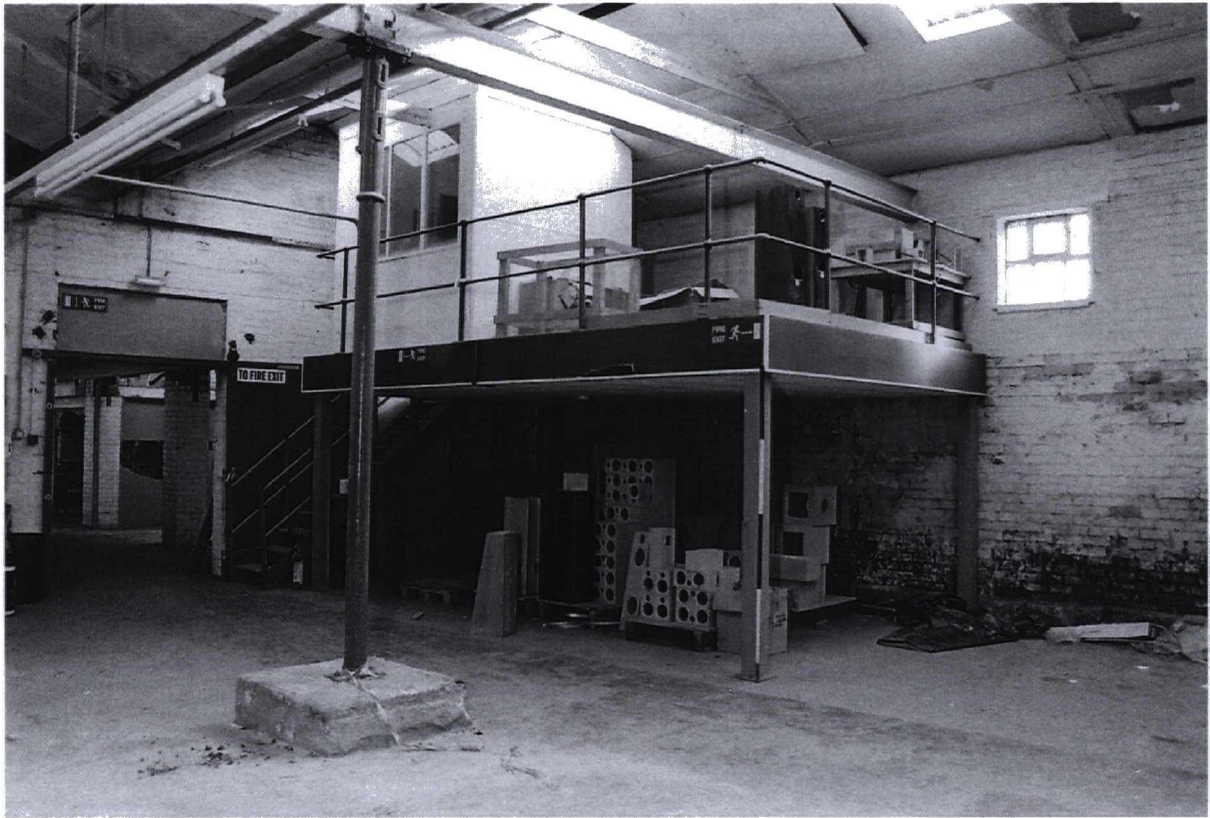
Photograph 49 9983/14 NW  
Mezzanine store supported on steel stanchions

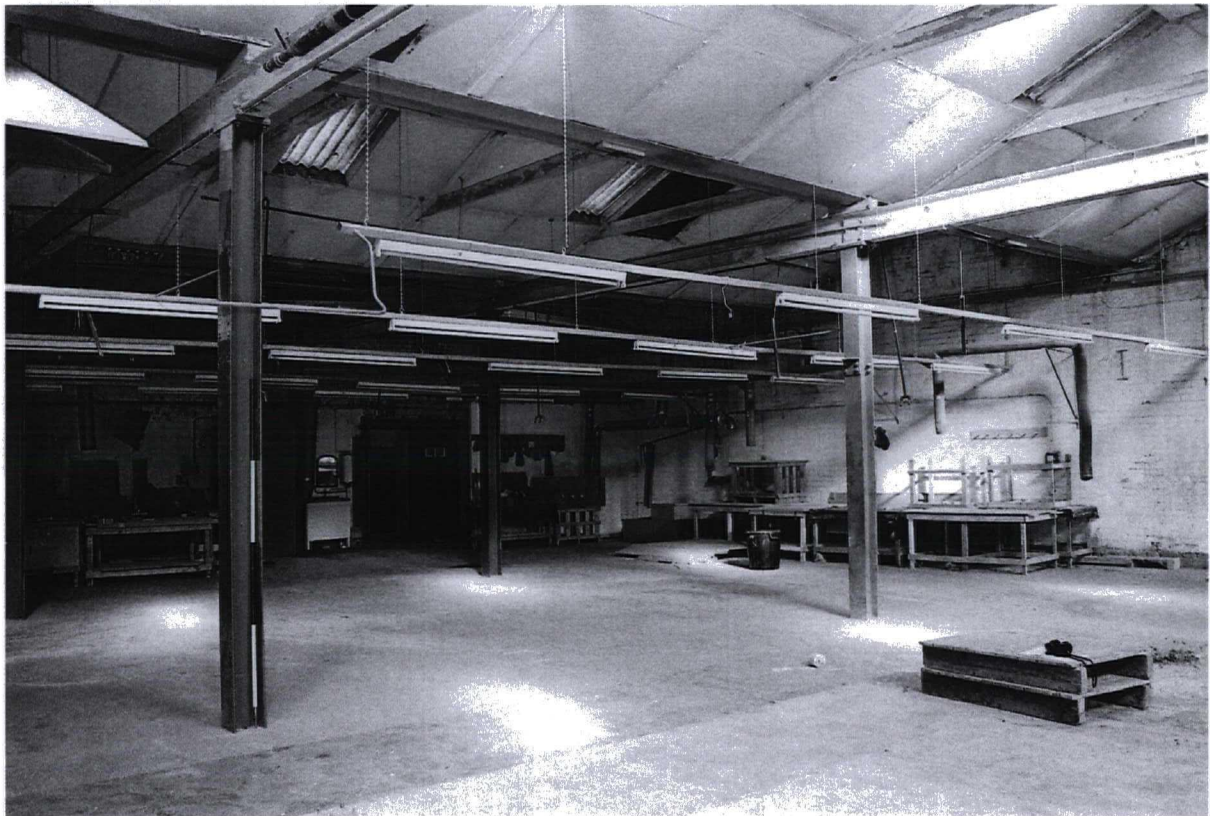
Photograph 50 9983/12 SW  
Steel stanchions supporting steel beams

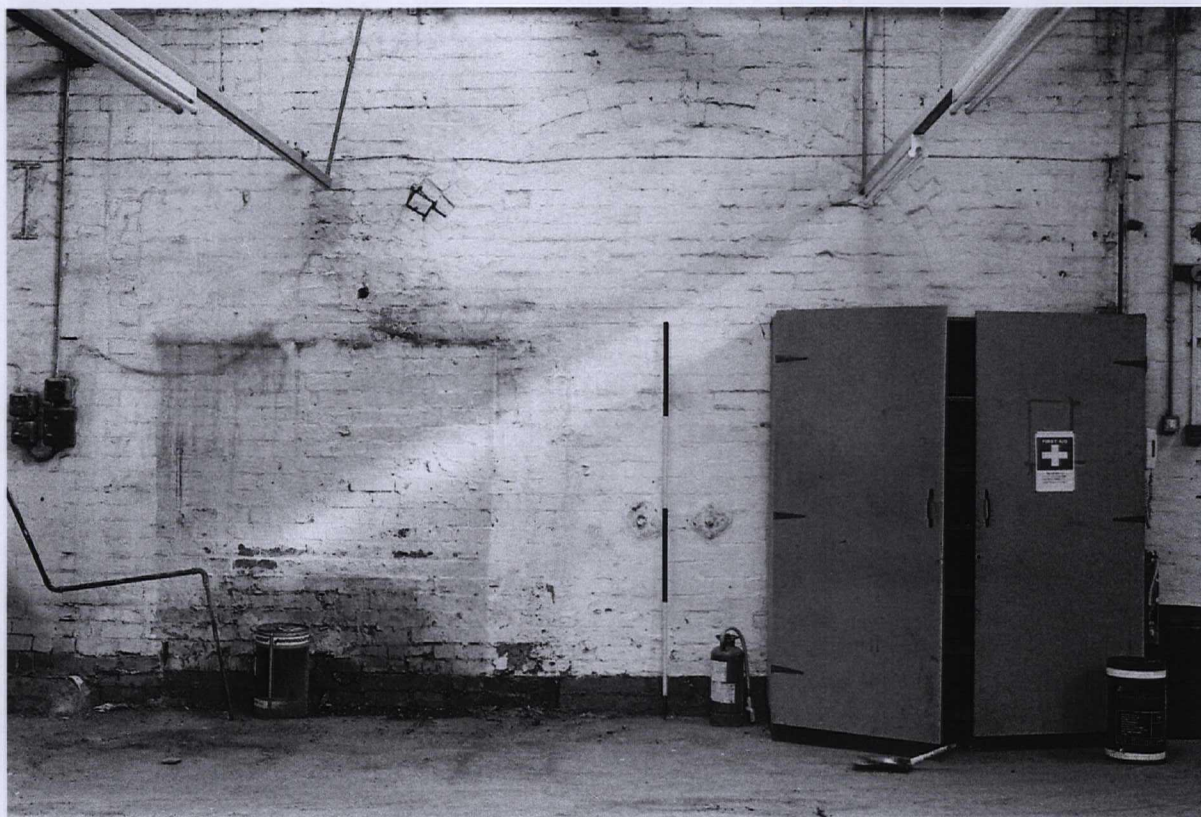
Photograph 51 9983/10 W

A small bricked-up opening truncating a previously bricked-up, segmental-arched opening. Note the twin passers plates

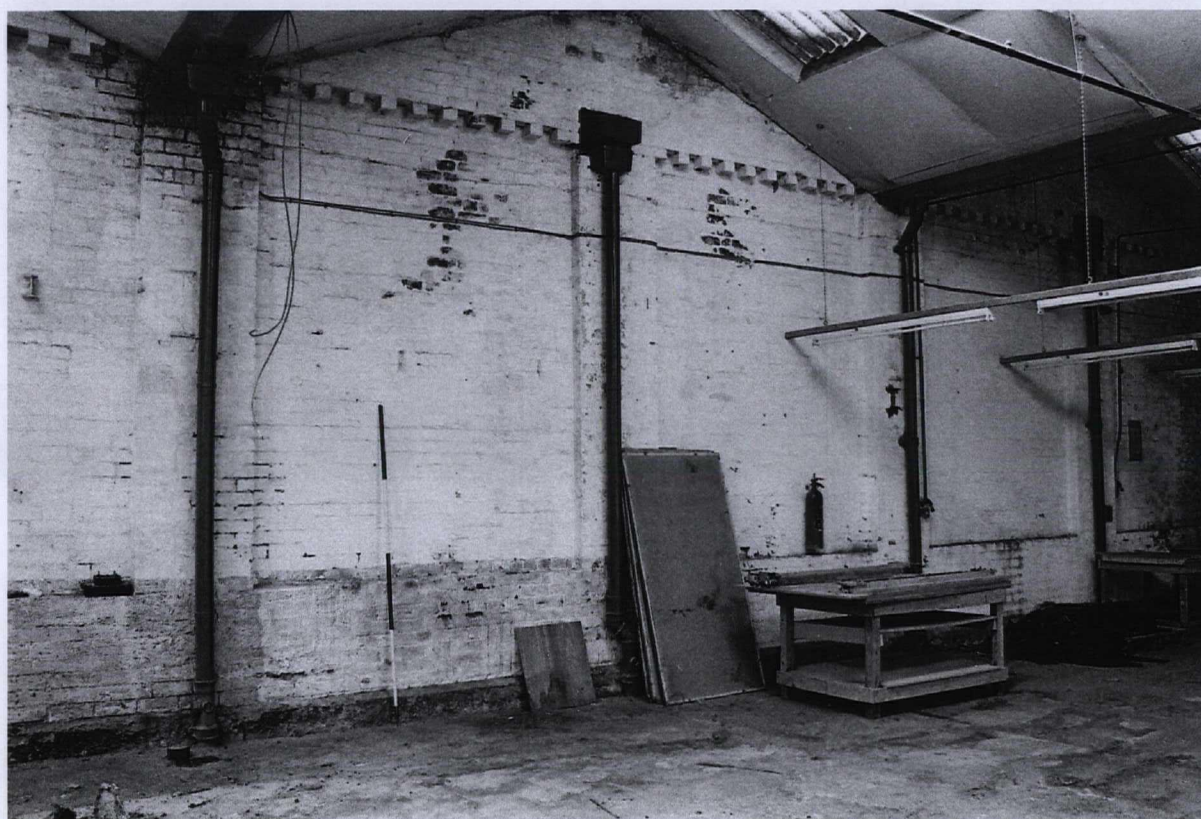
Photograph 52 9983/11 NE

Cast-iron fall pipes draining the valley gutters

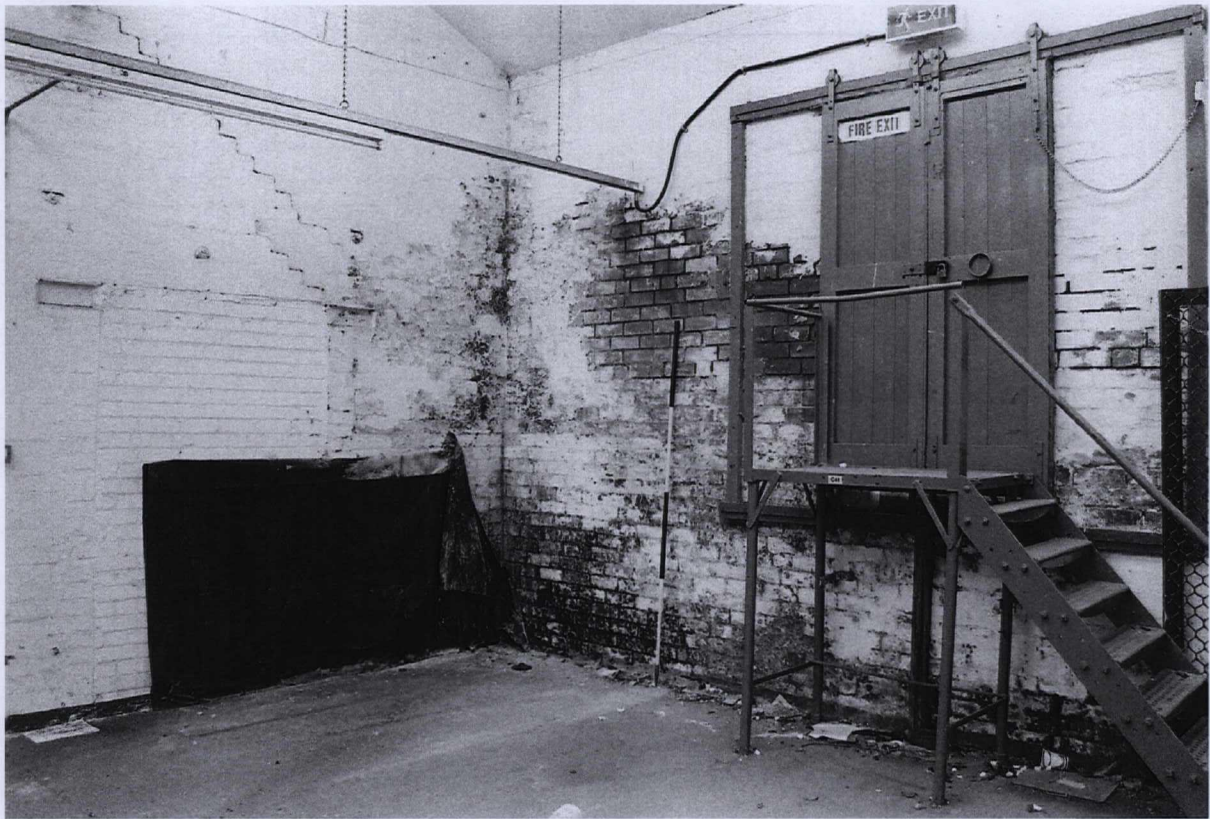
Photograph 53 9983/4 NW

Brick-blocked opening to the left with raised fire door to the right

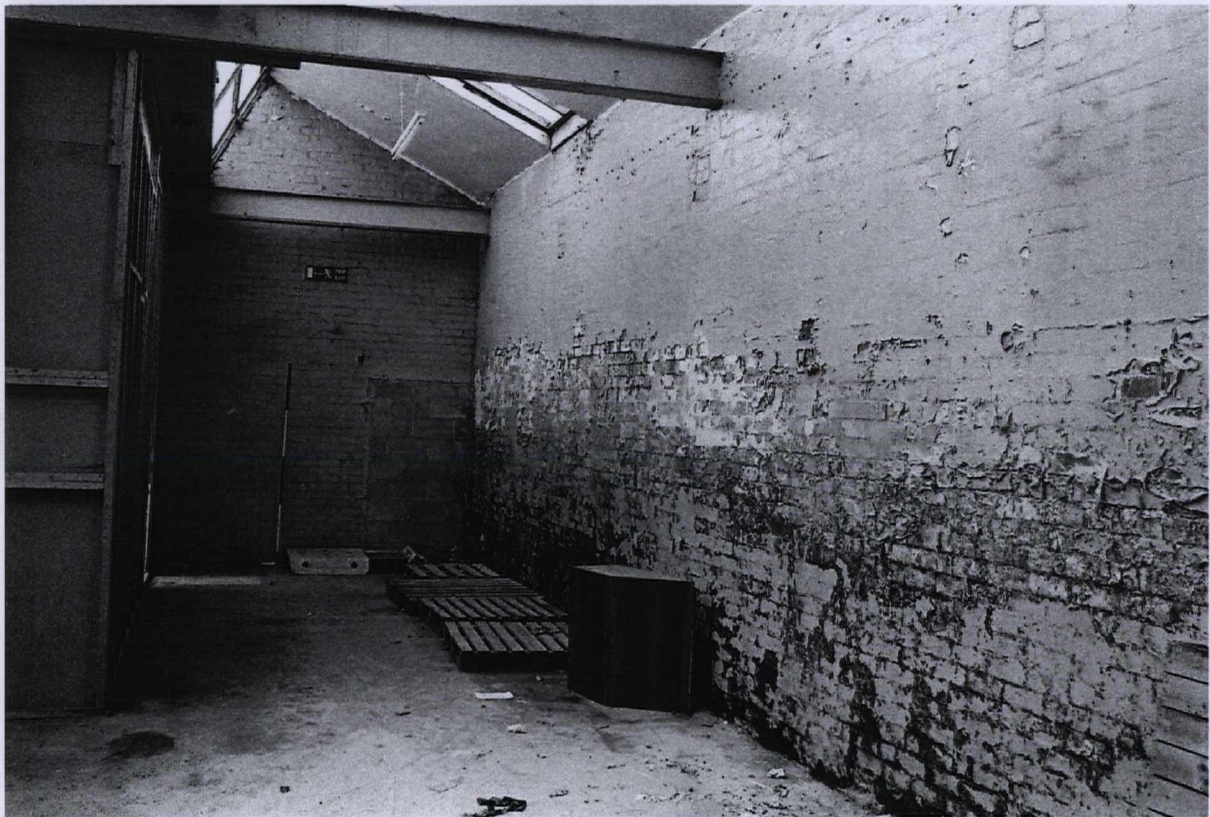
Photograph 54 9984/37 W

Breeze-block blocked door in an earlier brick wall

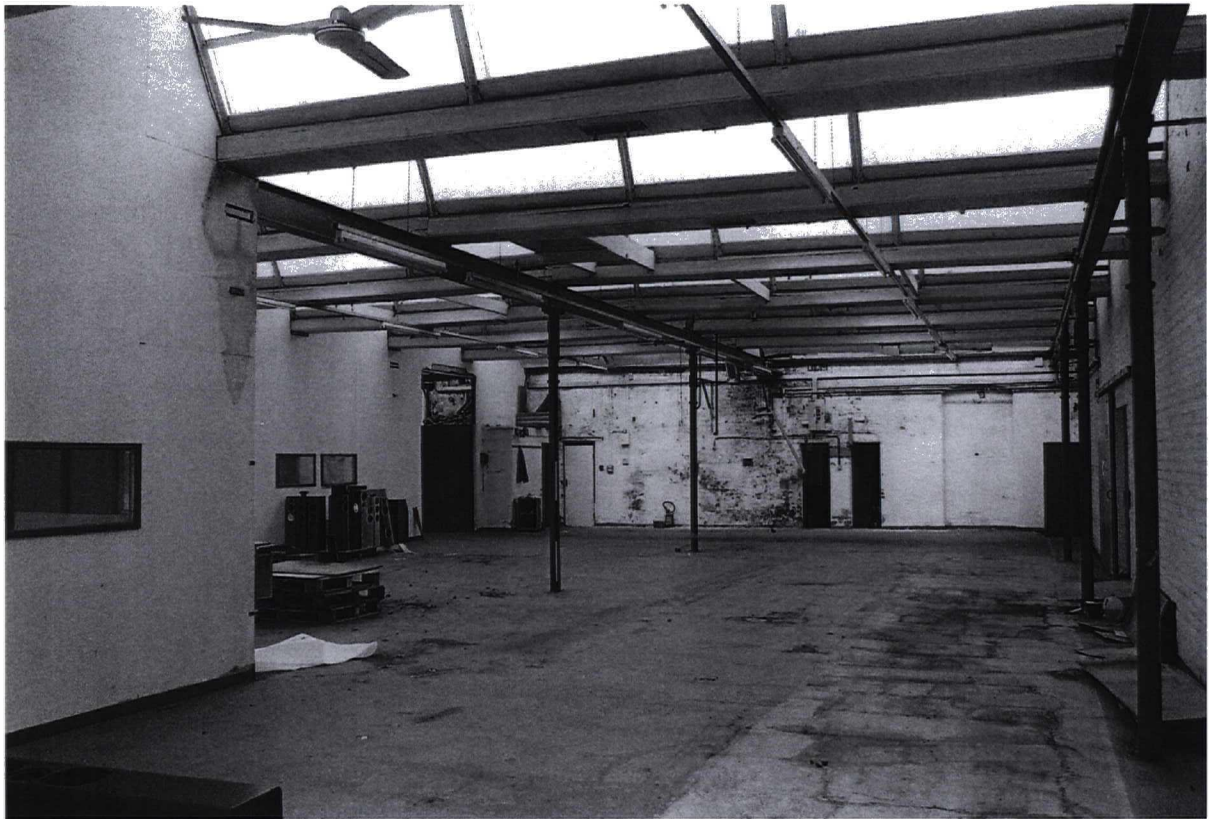
Photograph 55 9983/1 S  
General view showing cast-iron columns supporting steel beams

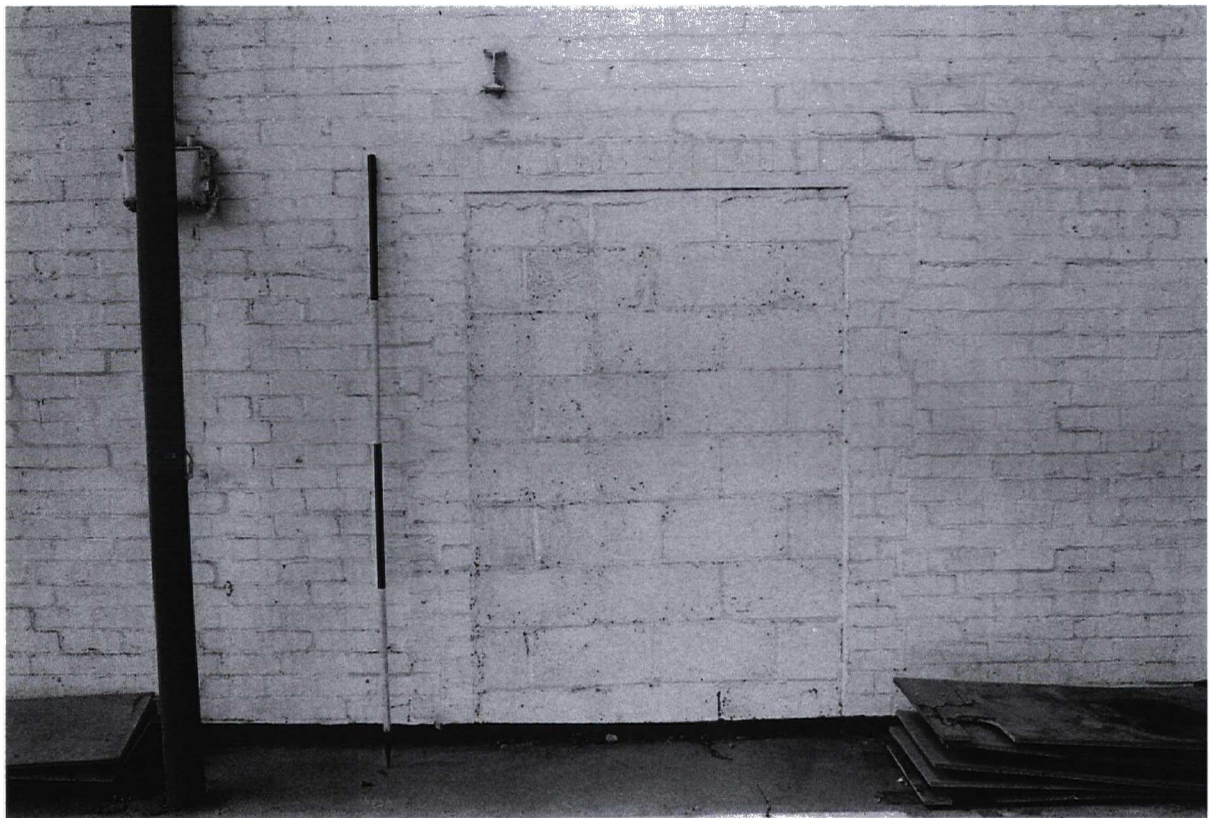
Photograph 56 9984/35 W  
Breeze-block blocked doorway

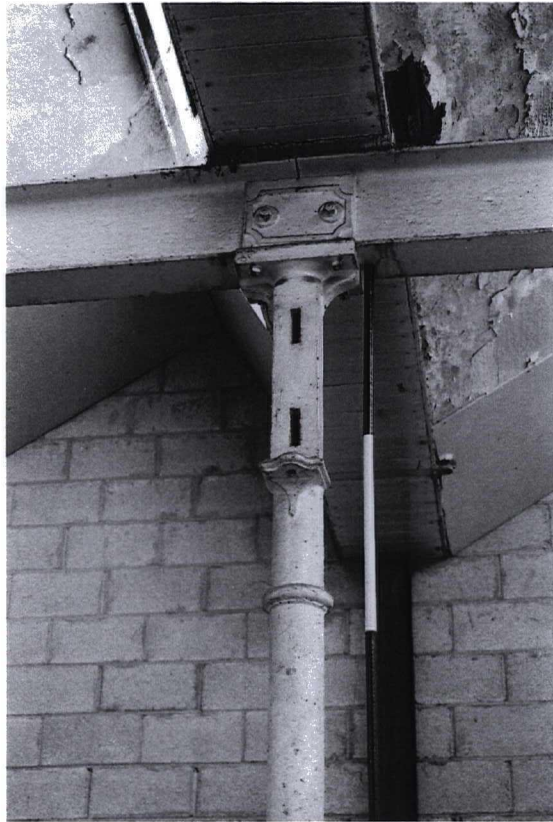
Photograph 57 9984/30 E  
Cast-iron column supporting steel beams

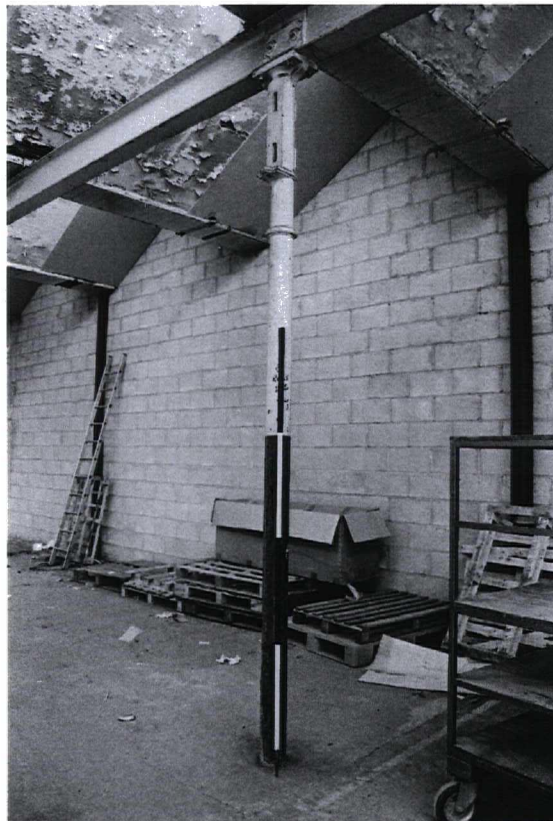
Photograph 58 9984/29 NE  
Breeze-block wall dividing the adjacent property

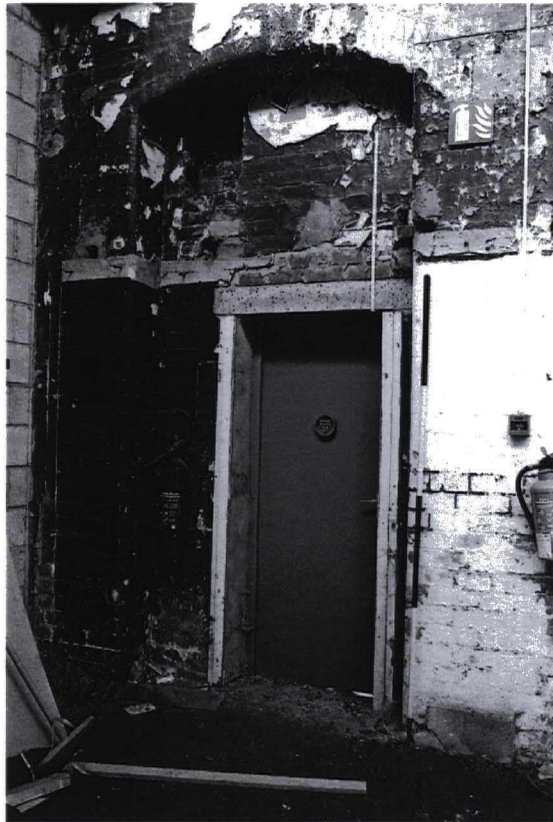
Photograph 59 9984/28 S  
A blocked, segmental arched, opening with a later doorway installed
