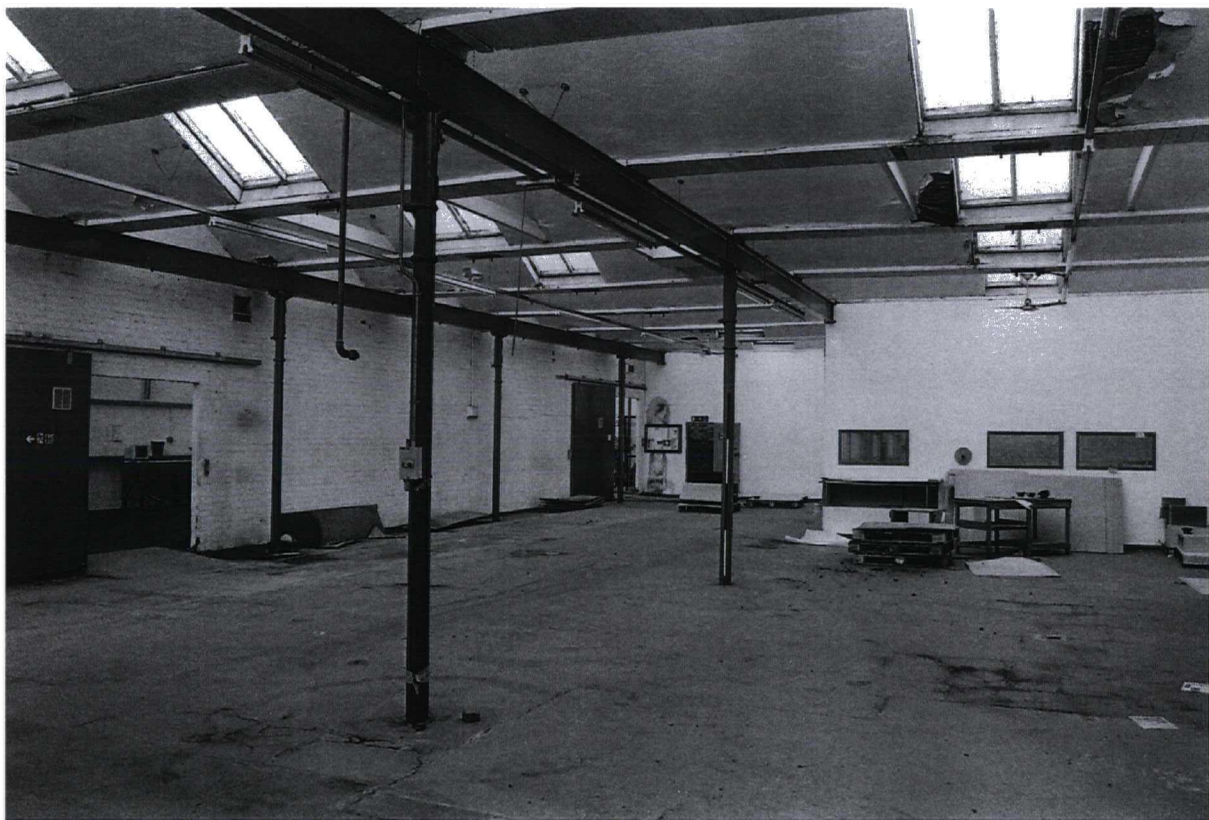
Photograph 60 9983/3 NW  
General view showing cast-iron columns and a later partitioned wall

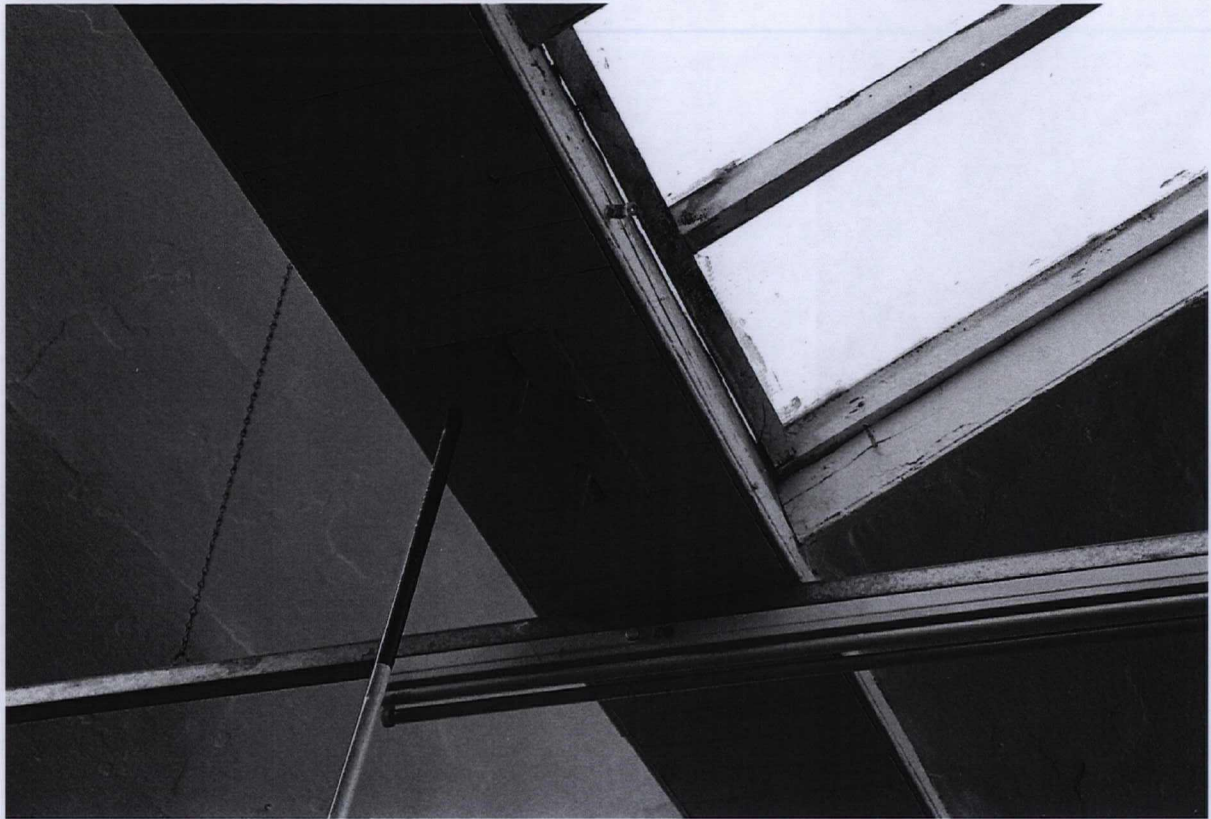
Photograph 61 9984/32 NW  
Former position of a drive shaft hanger

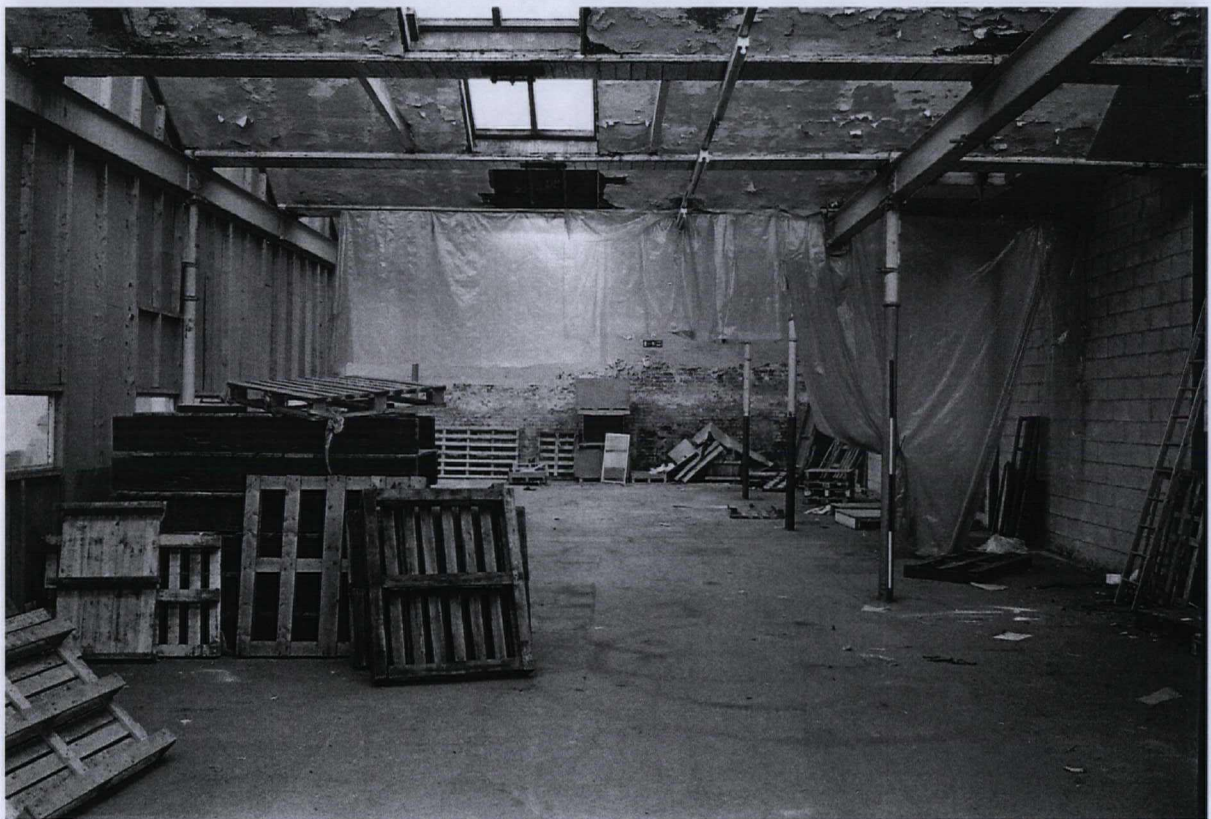
Photograph 62 9984/36 N  
View showing cast-iron columns and roof-lights. Note the internal partition on the left

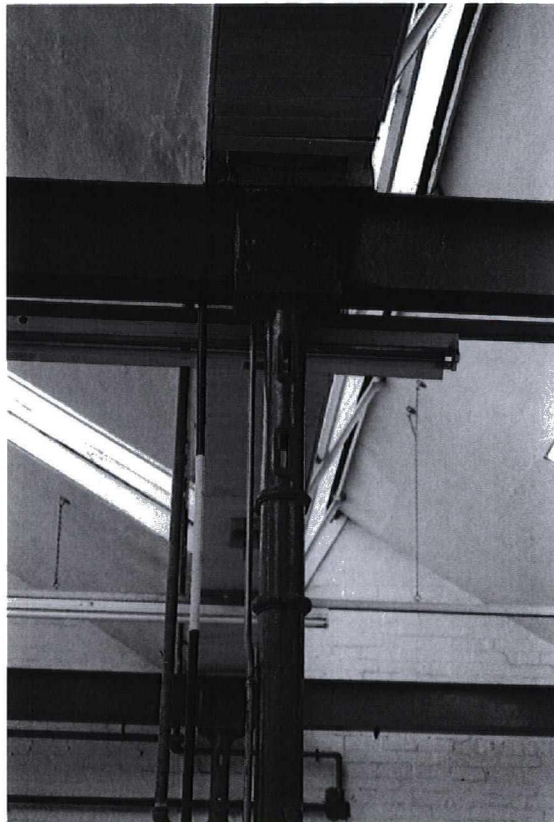
Photograph 63 9984/31 W  
Detail of a column head

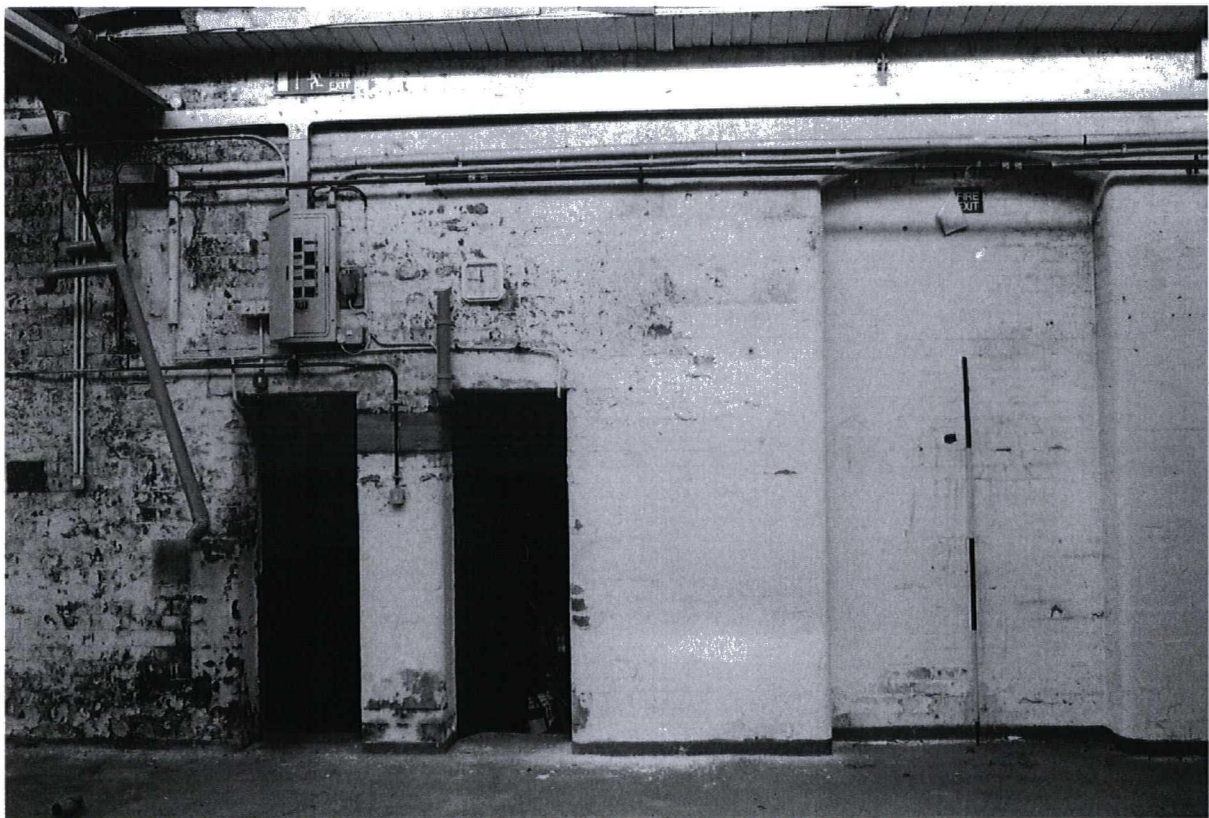
Photograph 64 9984/34 S  
View showing two small doorways and a large, segmental-arched, blocked opening

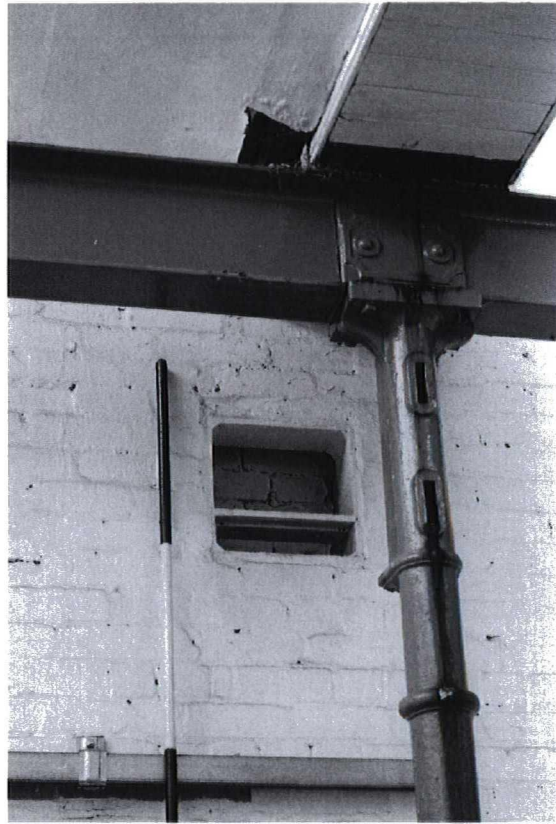
Photograph 65 9984/33 NW  
Blocked cast-iron wall box

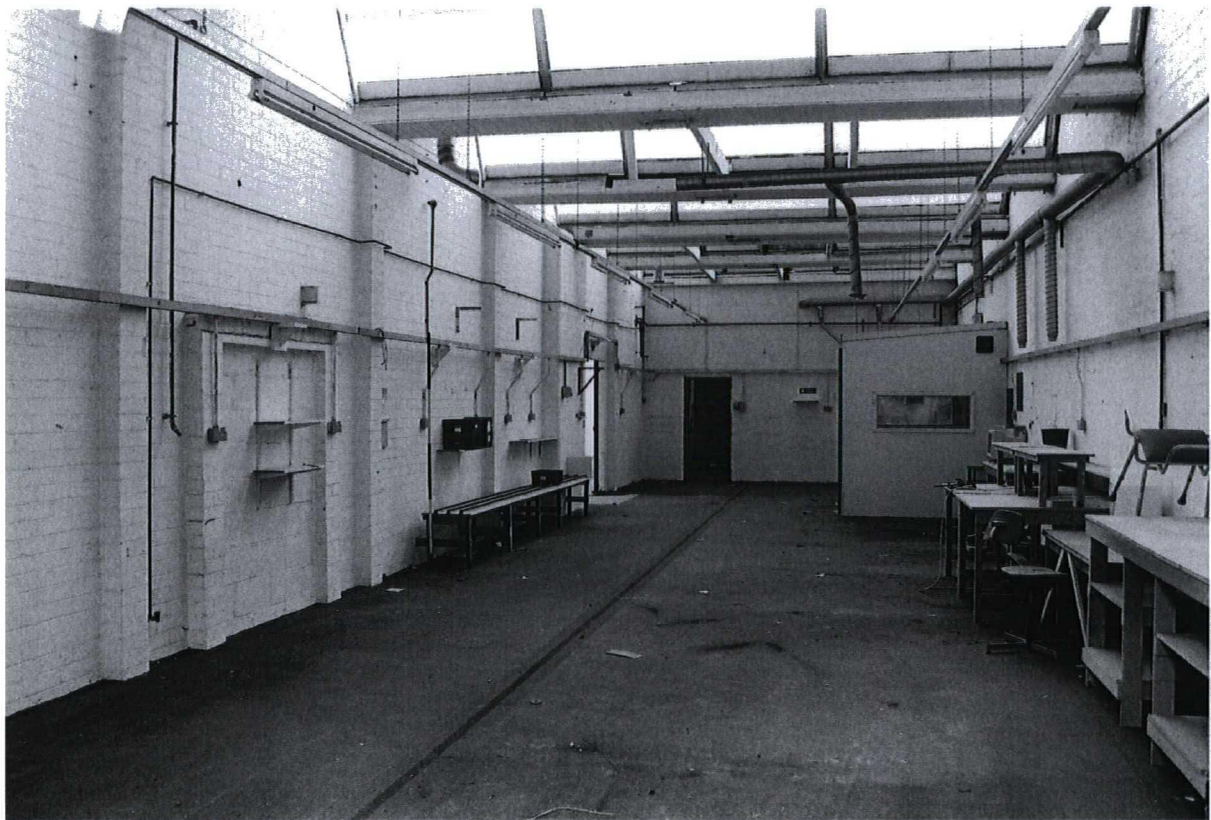
Photograph 66 9983/5 N  
Partitioned area of a former open shed

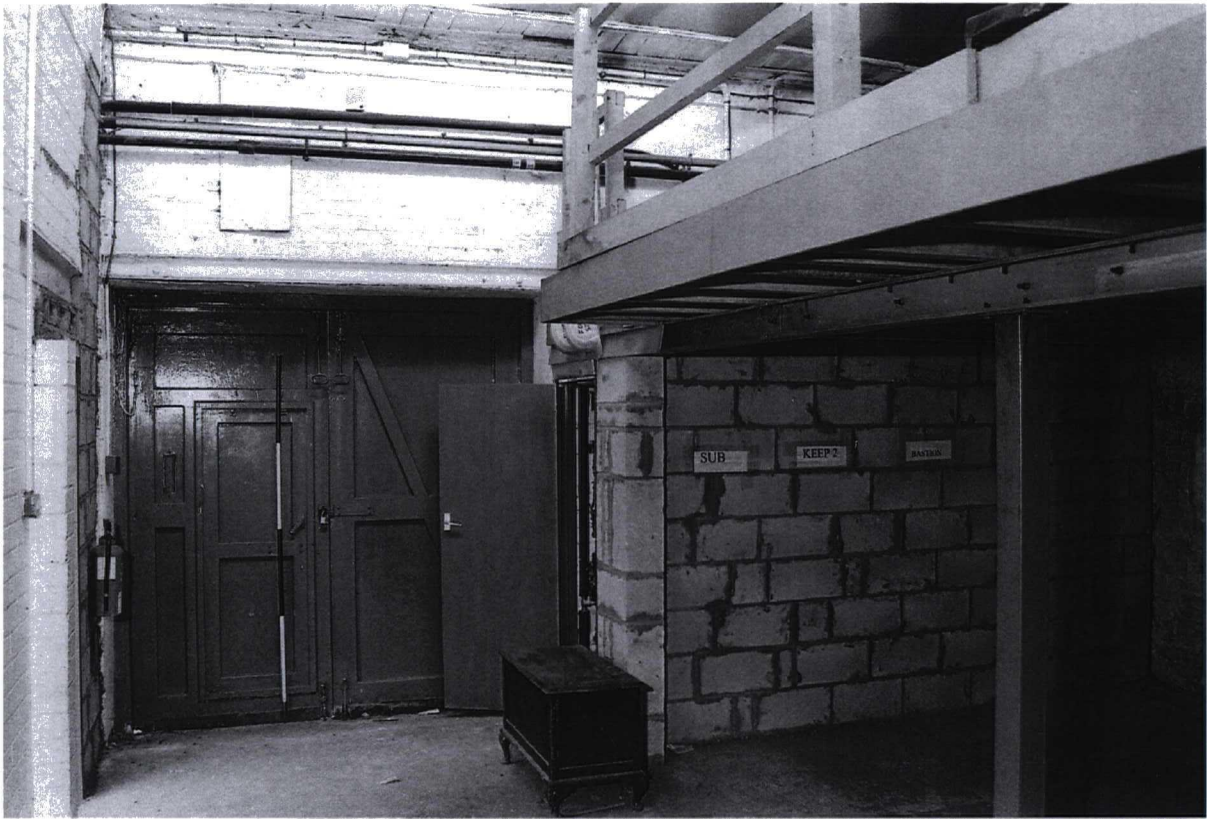
Photograph 67 9983/6 SW  
Large double door with a smaller door set within

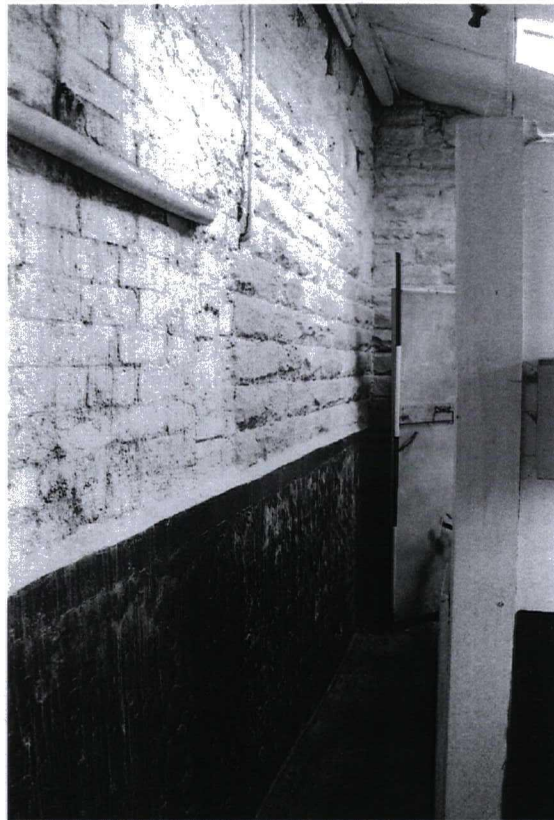
Photograph 68 9983/2 E  
Interior of a later toilet block

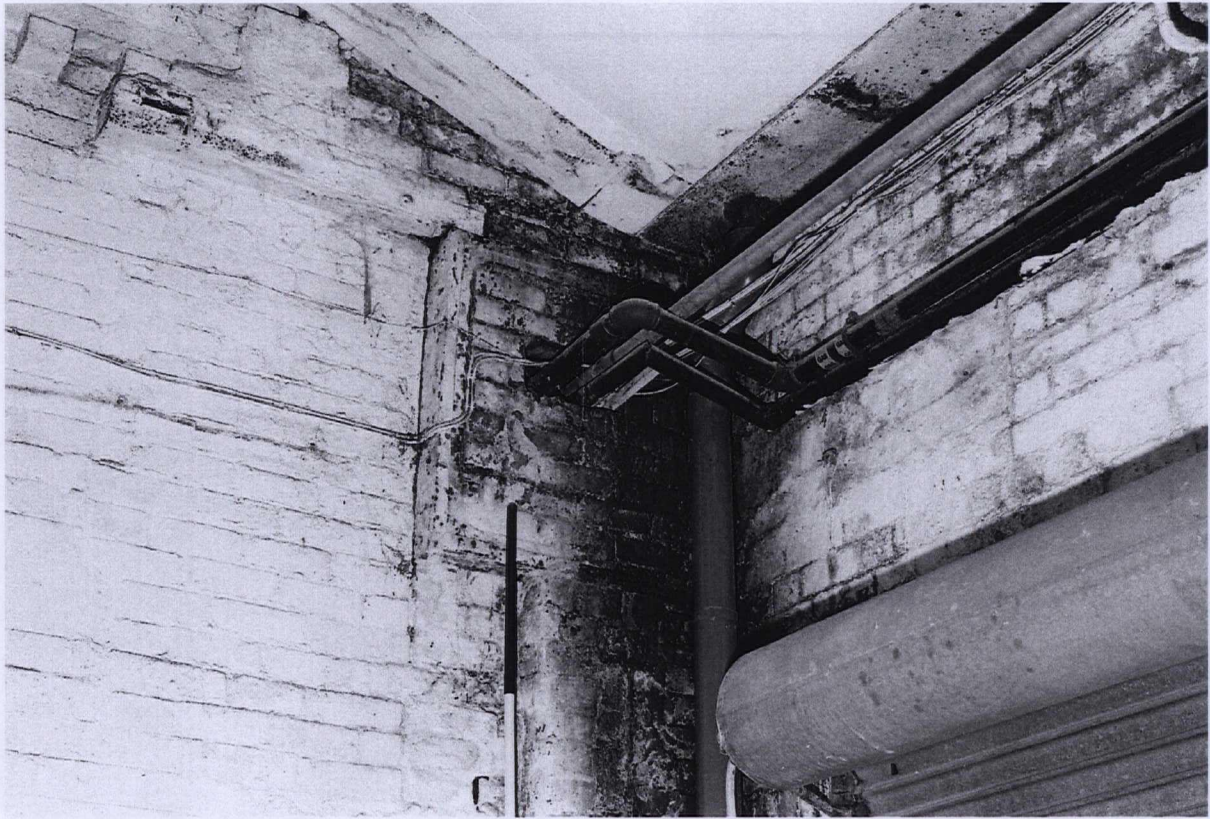
Photograph 69 9983/18 E  
Large brick-blocked cast-iron wall-box

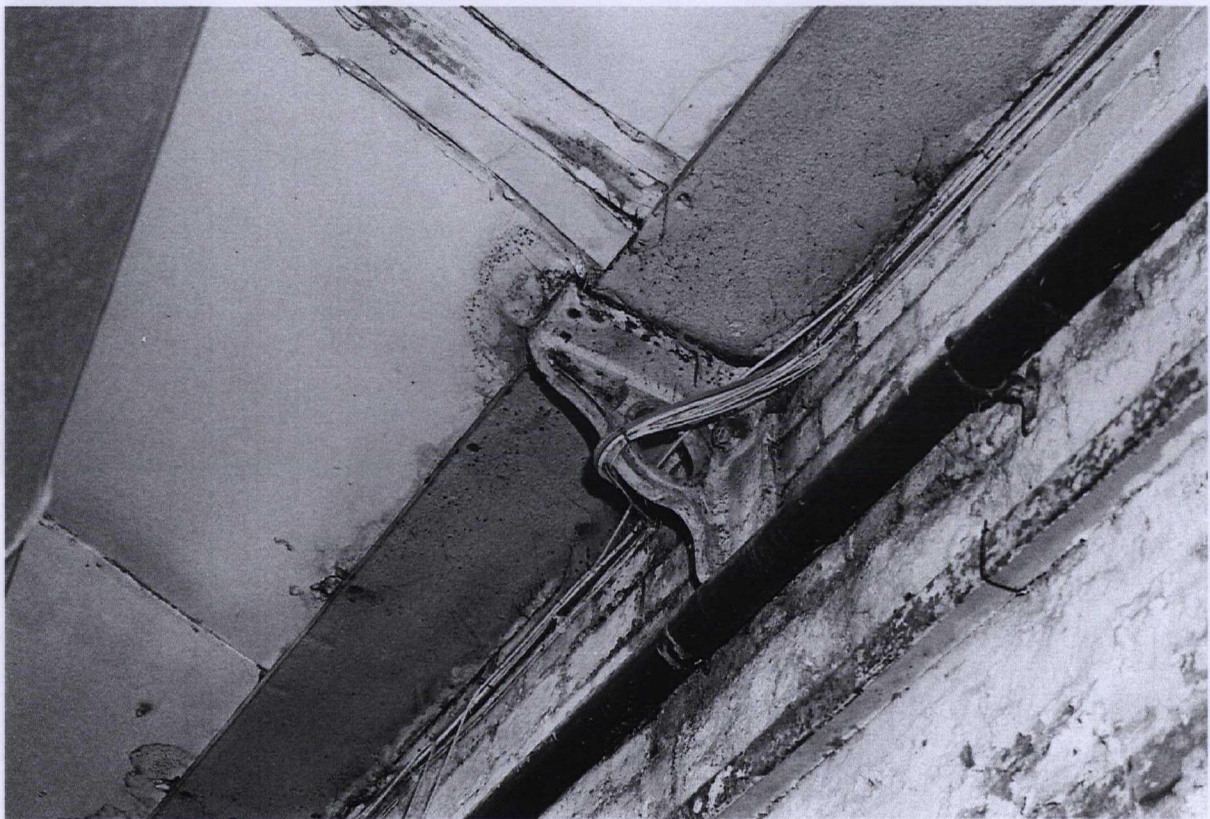
Photograph 70 9983/17 SE  
A cast-iron bracket supporting the side gutter
