8/10/1258/PA.

**The Nook
Selby
North Yorkshire
Archaeological Watching Brief**

February 1997
MAP Archaeological Consultancy Ltd.

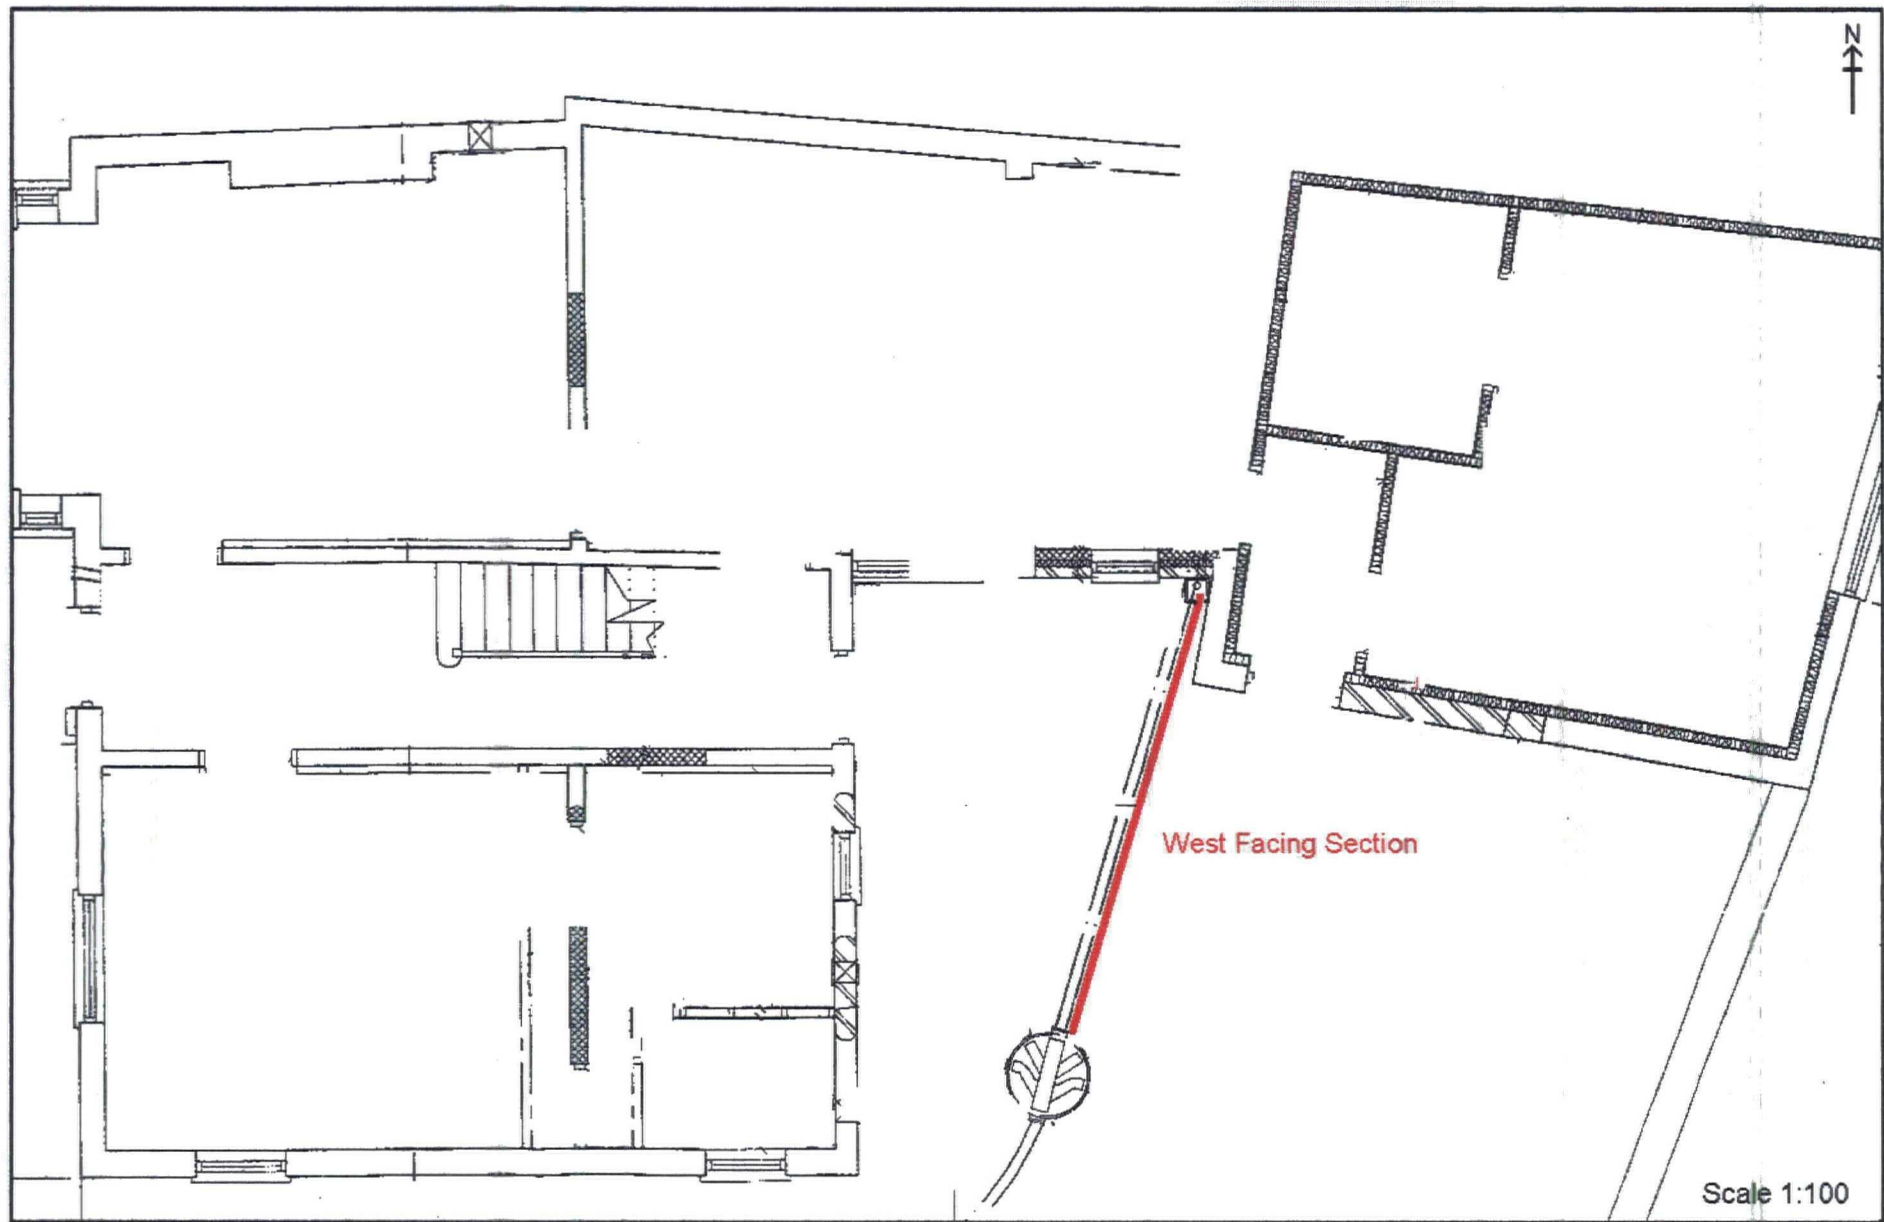
Figure 2. Location of Section.

On the 22nd January 1997 MAP Archaeological Consultancy Ltd undertook a Watching Brief at The Nook, Selby, North Yorkshire (SE 6166 3251: Fig. 1) during the machine excavation of a services trench (Fig. 2)

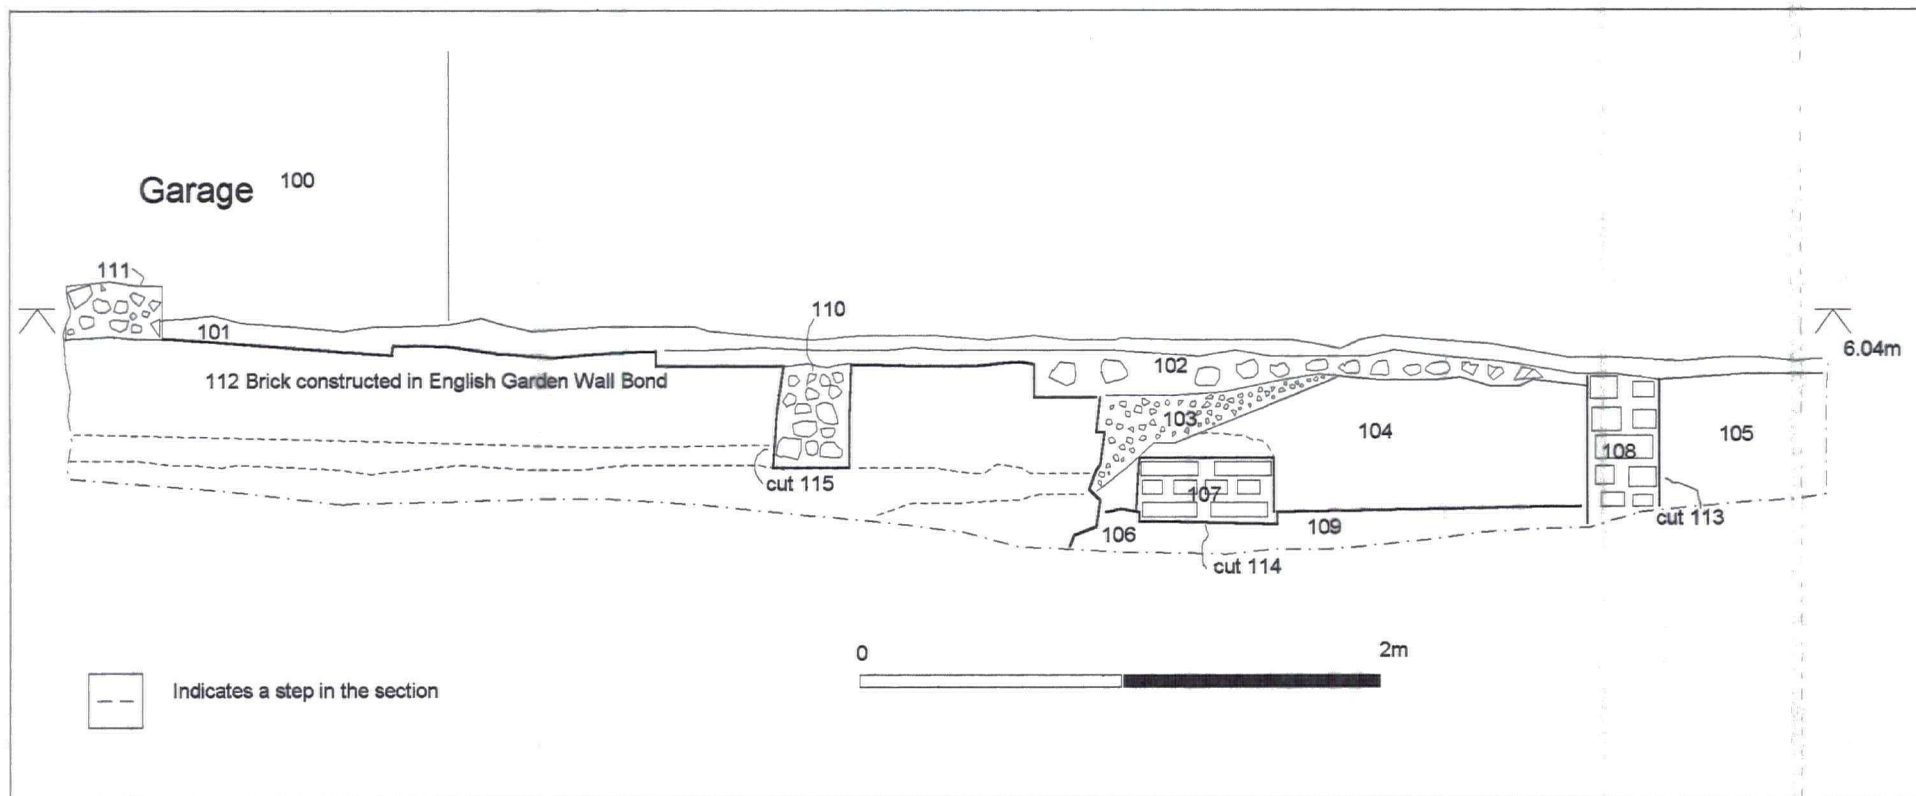
Figure 3. West Facing Section.

The earliest deposit revealed was a laminated silty sandy clay (context 105 : Fig. 3), which may represent undisturbed natural deposits, or, more likely, dumps of redeposited natural used to raise the ground level to prevent flooding in a vulnerable riverside area site. This was truncated by the construction cut (context 113), for a brick wall (context 108), which is most likely to have been the southern wall of a brick lined latrine pit or tank. This appeared to have been associated with the fragmentary, north - south aligned, stepped brick foundation, (context 112), of a demolished dwelling. Abutting both walls (contexts 108 and 112), was a deposit of silty clay (context 109), which was used as the bedding layer for a floor of unglazed quarry tiles and sandstone slabs, which provided an easily clean base to the tank. The dark coloration of the bedding layer (context 109), may have been due to seepage (of whatever was held in the tank), through the base contaminating the underlying deposits. The construction cut (context 114), for a brick wall (context 107), was cut directly into the top of deposit 109 and may represent the rebuild of a timber lining (context 106; which survived as a deposit of decayed wood between walls 107 and 112), originally forming the north side of the tank.

The area then appears to have undergone a dramatic change that involved the demolition of the building (contexts 112, 107 & 108), and the area being leveled (contexts 104 and 103). The new

phase of building involved the construction of a new wall (context 111) and the laying of a concrete floor (context 101). Part of this rebuild may have involved the cutting of a service trench (cut 115, fill 110), prior to the leveling (context 102), of the surface for the laying of the concrete floor. The function that the rebuilt wall performed is uncertain as only a small area was exposed where it had been demolished and incorporated into the garage (context 100), that forms part of the new development. This garage also utilises the concrete floor originally associated with wall 101.
