**WORKSHOPS IN ROBERT STREET
SELBY**

**OUTBUILDING TO THE SOUTH OF
LEES TERRACE
SELBY**

1. Introduction

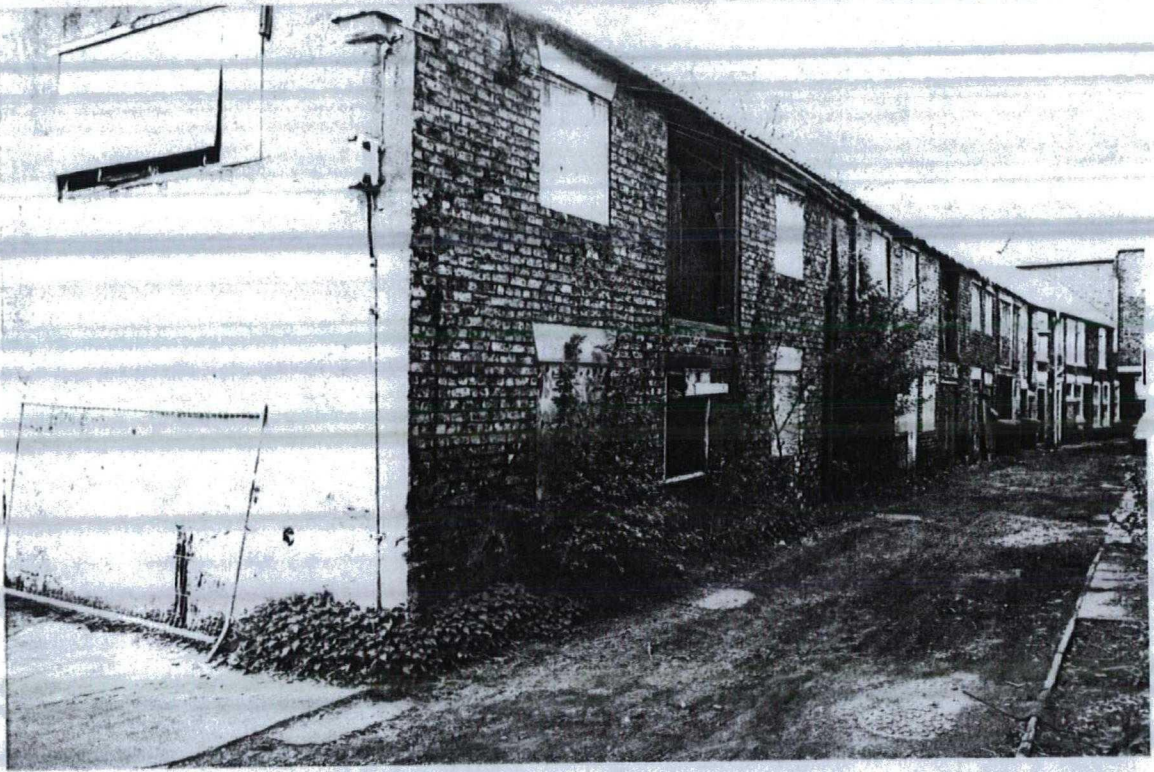
1

These workshops form a continuous range at the west end of the north side of Robert Street. In their present form they are ten bays long but a straight joint between the seventh and eighth bays from the east indicates that they were constructed in two Phases of which the seven east bays are the earlier in date.

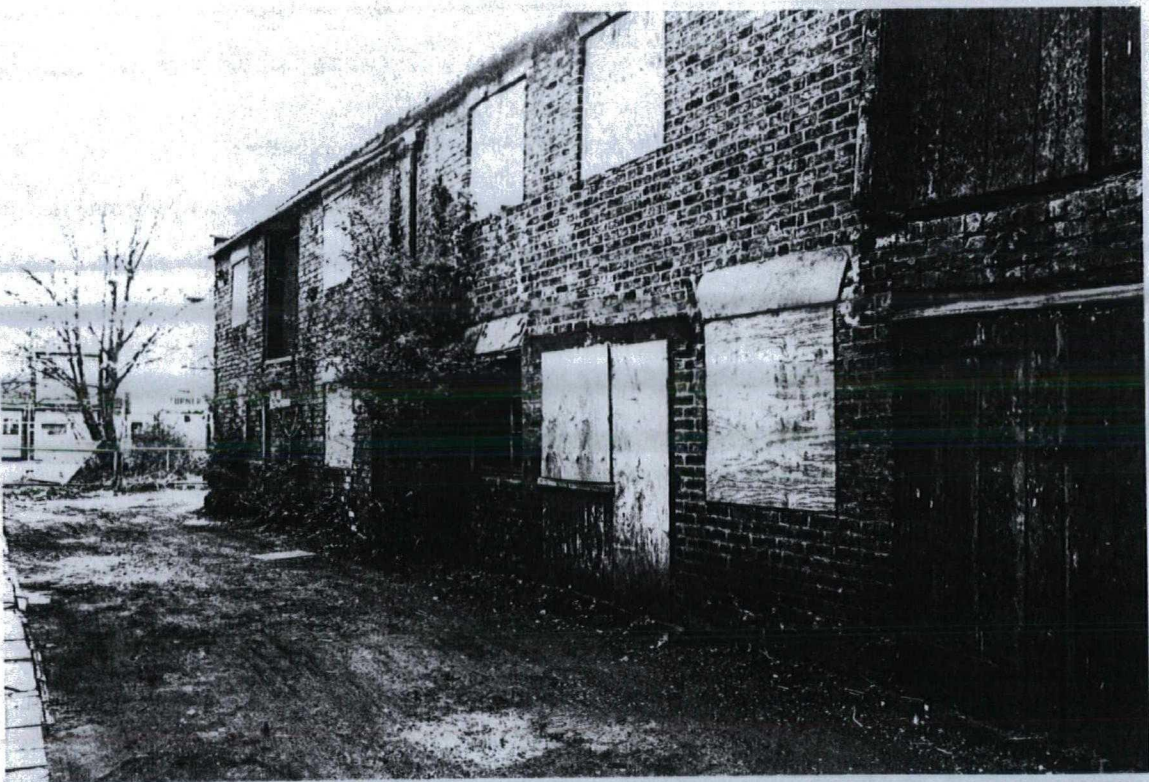
Phase I: Two stories, seven bays. Red-brown brick in an irregular English Garden Wall bond consisting largely of stretchers with occasional header courses. Pantiled roof. The original openings are under sandstone wedge lintels all of which seem to be false-bedded giving rise to considerable erosion. Ground floor: a boarded door to Bay 1 in a pegged and moulded architrave; modern inserted doors to Bays 2 and 3. Bay 4 has a curious opening in which sections from two different late C18 doors have been used to form a six-panelled door of four sunk moulded panels over two flush beaded panels; further beading separates the sections. There is a narrow overlight while the door-opening itself is placed asymmetrically beneath a wedge lintel. This seems to be an original feature as there are no obvious signs of insertion. Double boarded doors occupy Bay 5 and casements under wedge lintels take up Bays 6 and 7. First floor: similar fenestration throughout with modern inserted openings to Bays 1 and 2 and a double boarded door to Bay 5.

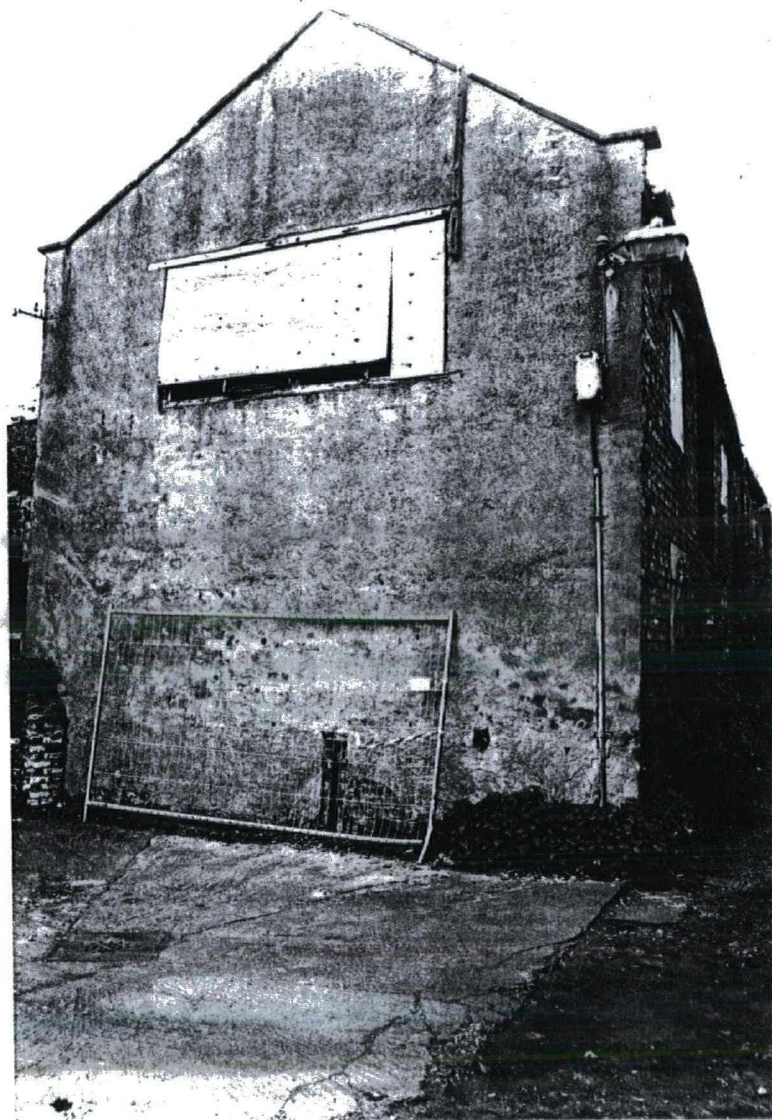
4

These three bays have a balanced elevation; at ground floor level there is a central opening with paired boarded doors flanked to right and to left by casements under wedge lintels. The treatment to the first floor is similar: here the taking-in doors retain a wrought-iron crane mounted in the opening. The west gable is rendered with a modern inserted window to the first floor.

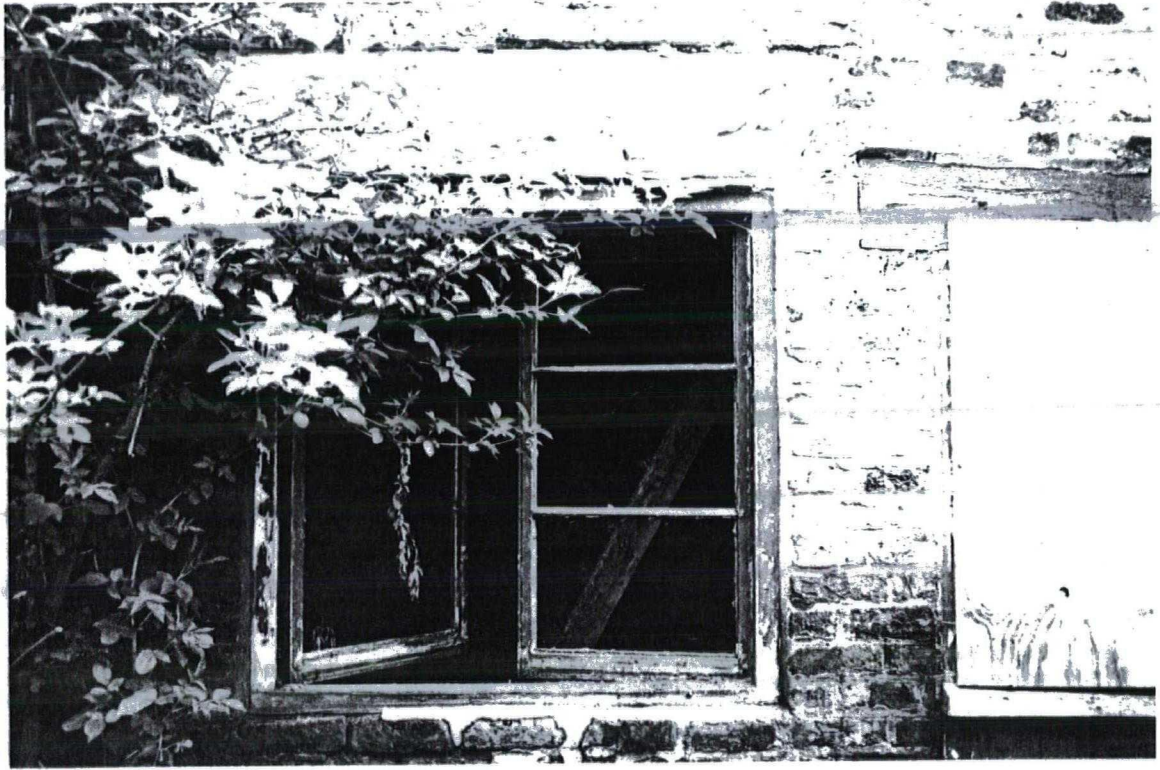
5

Phase II: Reddish brick of later character than that in Phase I; English Garden Wall bond. The detail is similar to that of Phase I and indicates both a conscious desire to continue in the style of the earlier work and also a date separated by only a few years.

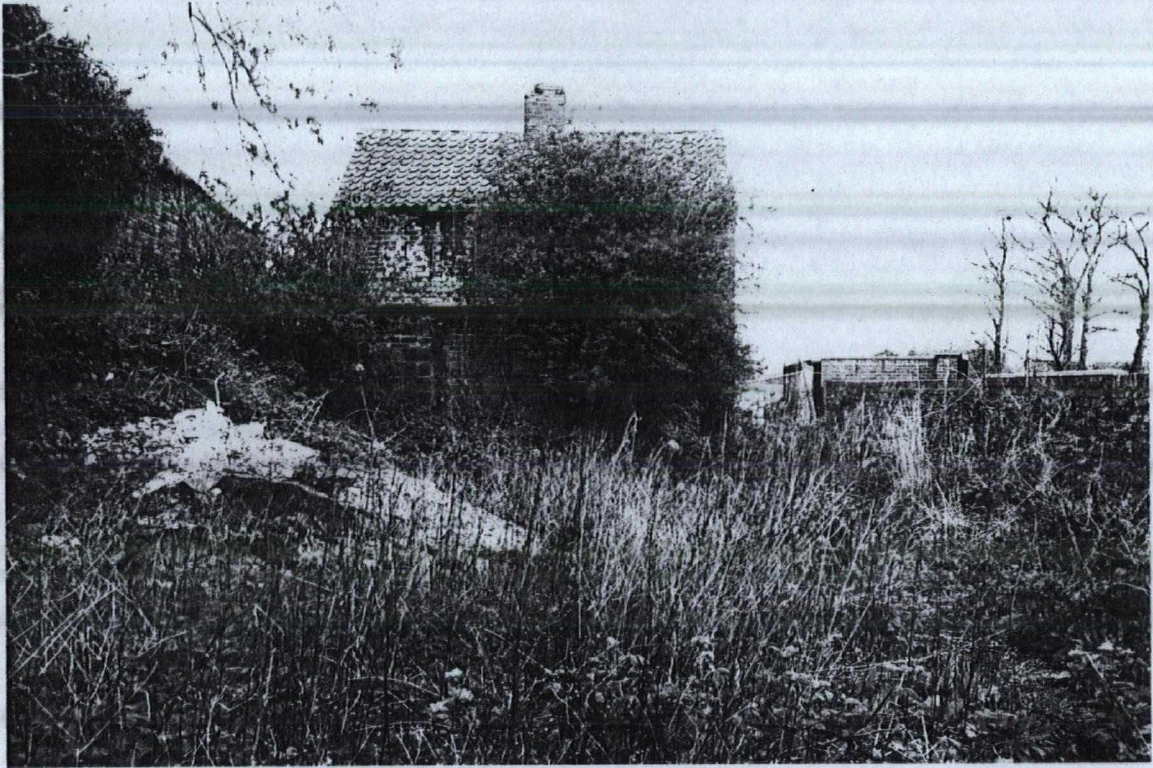
8

This small building, which may have been a stable, was also constructed in two Phases. The earlier of the two is the east end: a single, two-storey, bay of brick in English Garden Wall Bond with openings - including a south door - under segmental brick arches. There is an end stack to the west.

A little later an additional bay was added to the west; for some reason this bay did not extend through the full depth of the earlier bay leaving a re-entrant angle on the north side. The brickwork is an irregular English Garden Wall Bond and the openings - all now blocked as in the earlier build - repeat the segmental heads as before.
