BURTON LEONARD LIME QUARRY, NORTH YORKSHIRE.

REPORT ON AN ARCHAEOLOGICAL LANDSCAPE SURVEY.
OSA REPORT No: OSA10LS01

December 2010

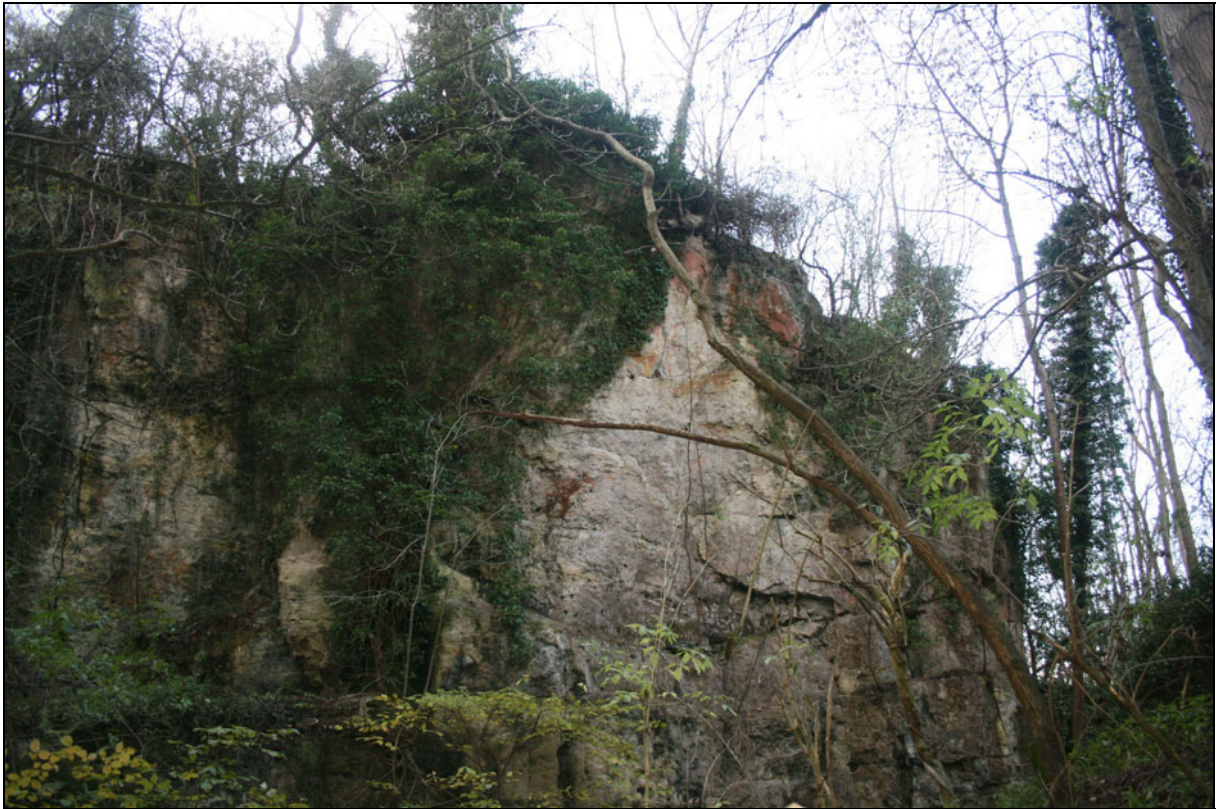
Plate 1. The northern quarry face

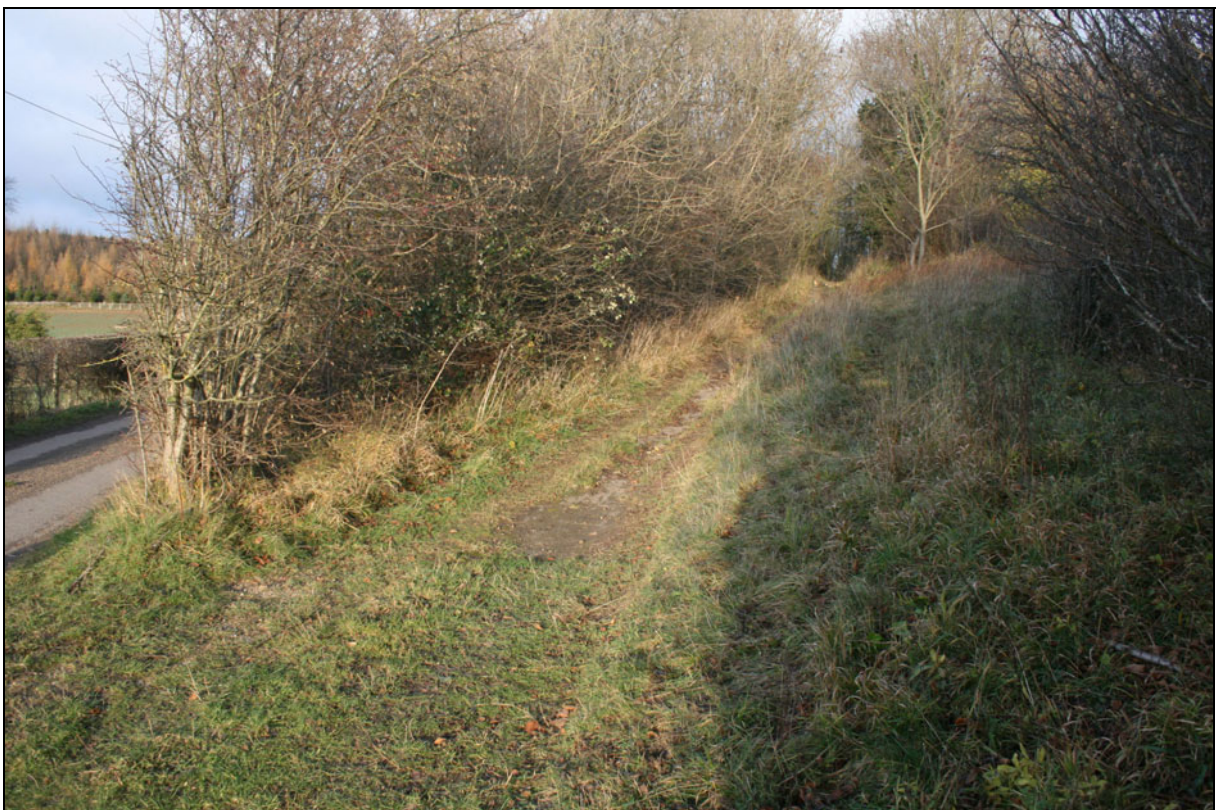
This lime quarry appears to have been in use for the period 1838 to 1941 (information provided by the Yorkshire Wildlife Trust). The northern quarry has been used for landfill. The track leading to it from Limekiln Lane is tarmaced and was probably the route used by

tipping lorries (Plate 2). The exact dates of the landfill period are unknown but the nature of the remains suggests it may have extended into the 1980s (Plate 3).

Plate 2. The tarmac track leading to the landfill. Limekiln Lane on left

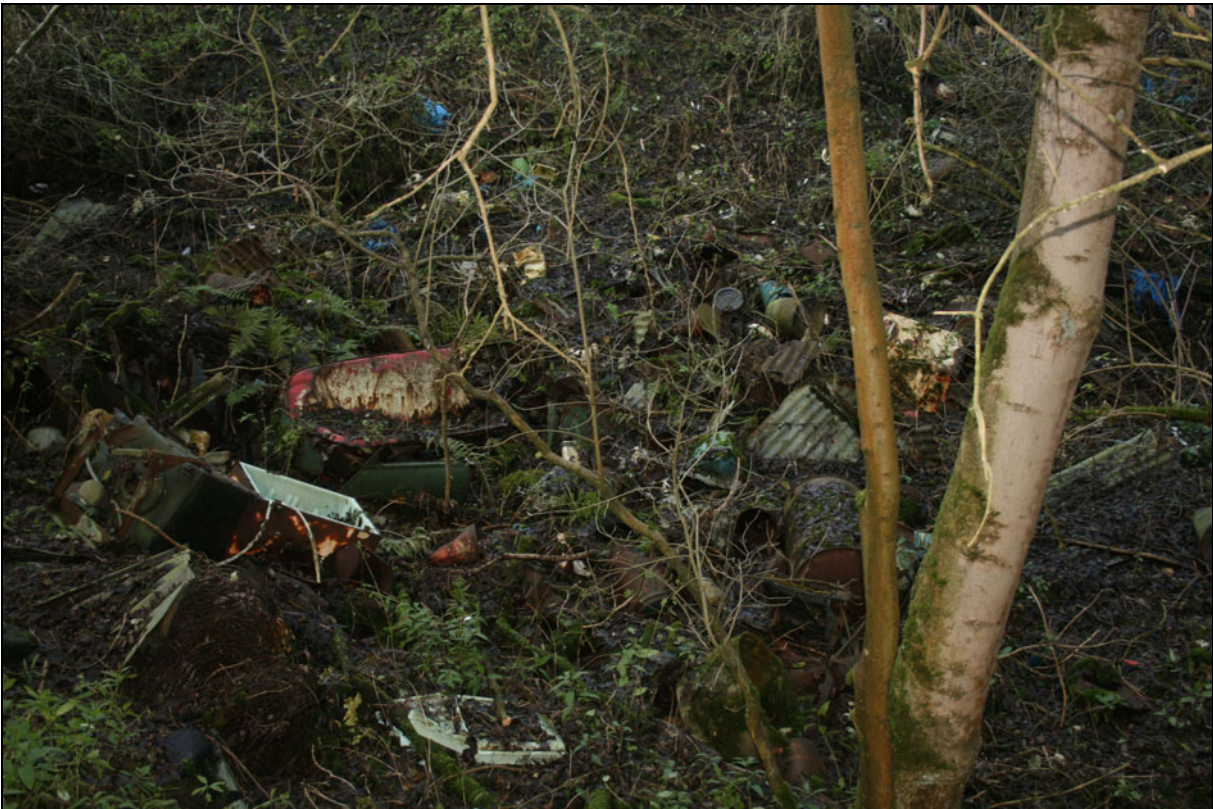
Plate 3. Landfill close to Kiln F

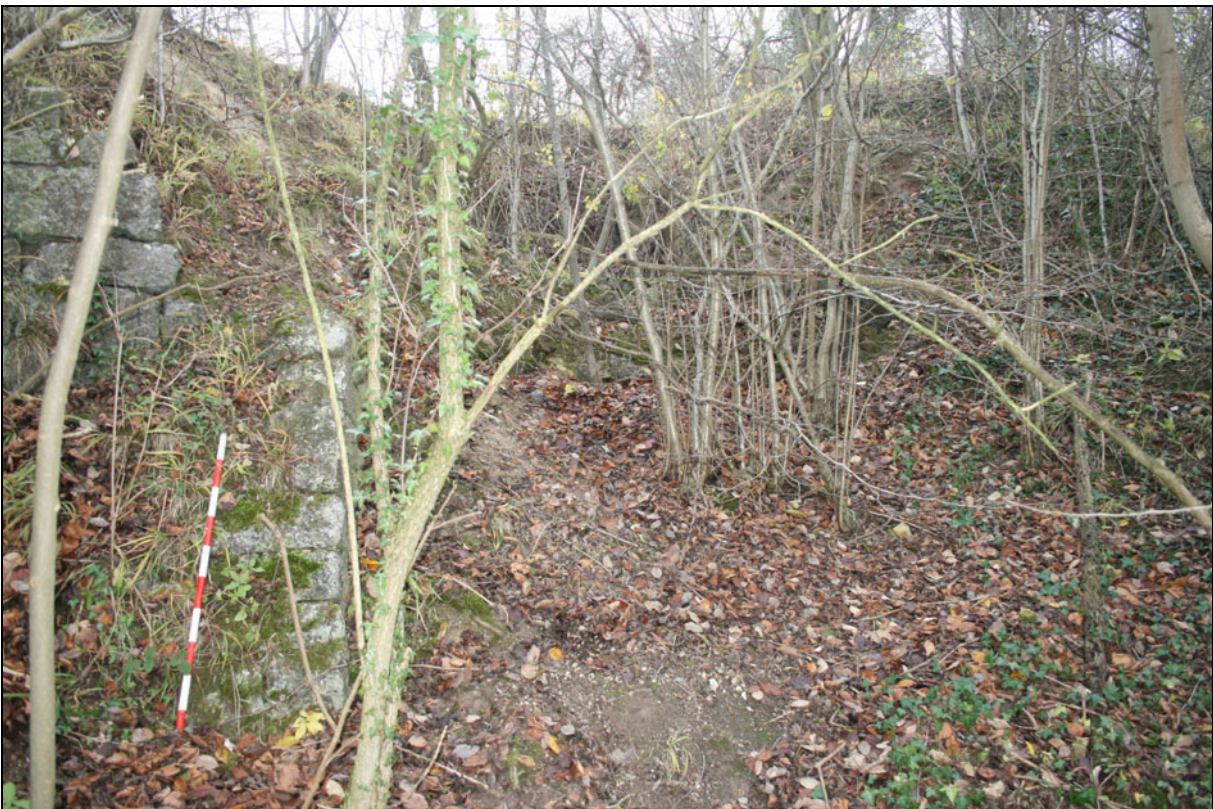
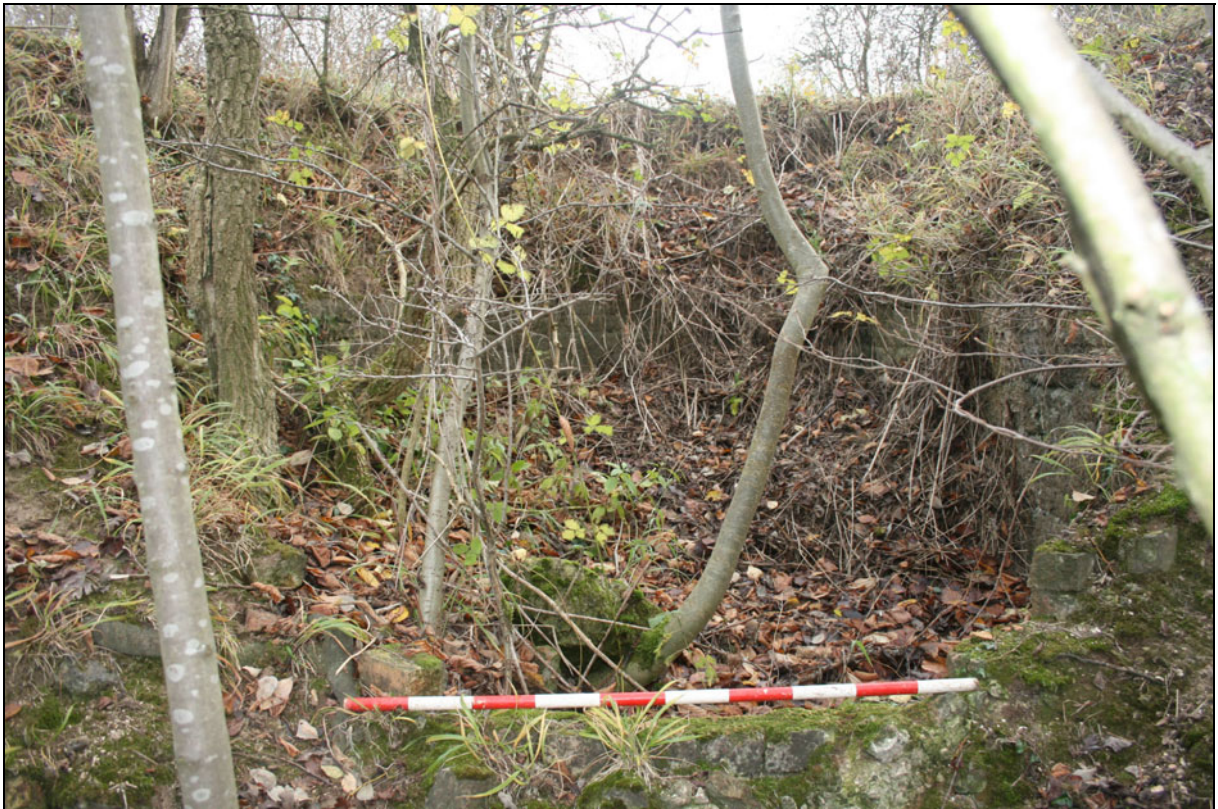
This was positioned on the western edge of the quarry site close to Limekiln Lane. It was of moderate preservation and was heavily overgrown (Plates 4 and 5). The kiln comprised an oval bowl with the collapsed remains of a single draw arch facing to the west. The charging platform was a sizeable flat raised area with ramp access to the quarry floor. The remains of revetting walls were present adjacent to the collapsed draw arch. The kiln was built before 1854 as it is shown on the 1854 OS map.

BOWL: The bowl was of oval plan and mostly filled in. It measured 2.4m x 2.8m, the E-W being the longest axis. Up to 90cm height of masonry was visible. The bowl was made of a mixture of brick, limestone rubble and mortar. It was lined with a single course of mortared brick that was heavily vitrified over much of the visible surface.

DRAW ARCH: The superstructure of the draw arch was collapsed with only a small amount of mortared rubblestone masonry present on the northern side of the original arch location. It was possible to estimate that the draw arch would have originally projected from the front face of the kiln by at least 1m.

MANAGEMENT FACTORS	KEYWORD OPTIONS
Condition	Moderate
Stability	Slow deterioration
Actively damaged by:	Vegetation: trees are growing from the bowl and the collapsed remains of the draw arch; Scrub is growing in the revetting wall. Visitor erosion: The charging platform at the top of the bowl is crossed by visitor tracks. However, this is a less significant part of the monument and at present there appears to be no significant damage.
Management recommendations	Control scrub & bracken Remove trees or shrubs but leave stumps <i>in situ</i>

The structure of Kiln A is heavily overgrown and it is likely that the masonry is being actively damaged by the roots of the various trees and shrubs that are growing out of the bowl remains in particular. As this kiln is moderately well-preserved, the control of scrub and bracken and the removal of the trees growing out of the bowl are likely to be advantageous to the future preservation of the feature. It is not considered that the path running over the charging platform will result in erosion to any significant remains.

Plate 4. Kiln A. Retvetting wall on left, bowl in centre

Plate 5. Kiln A. The bowl.

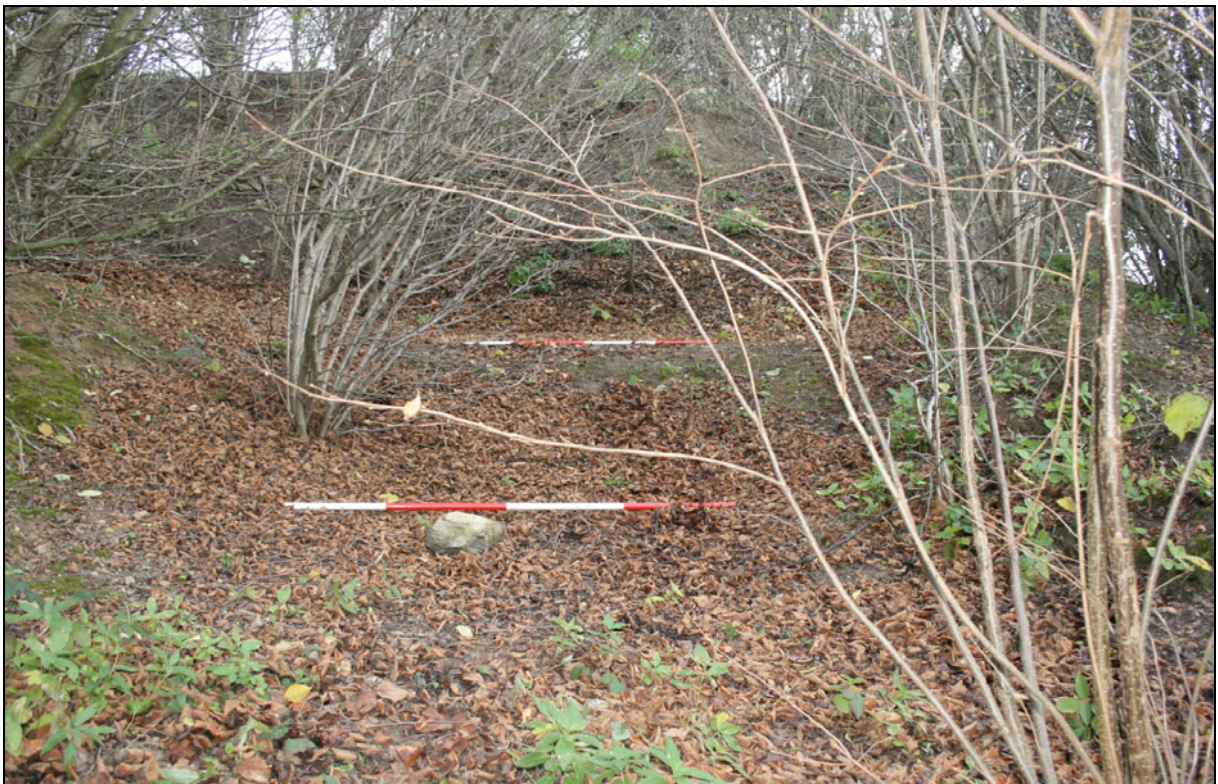
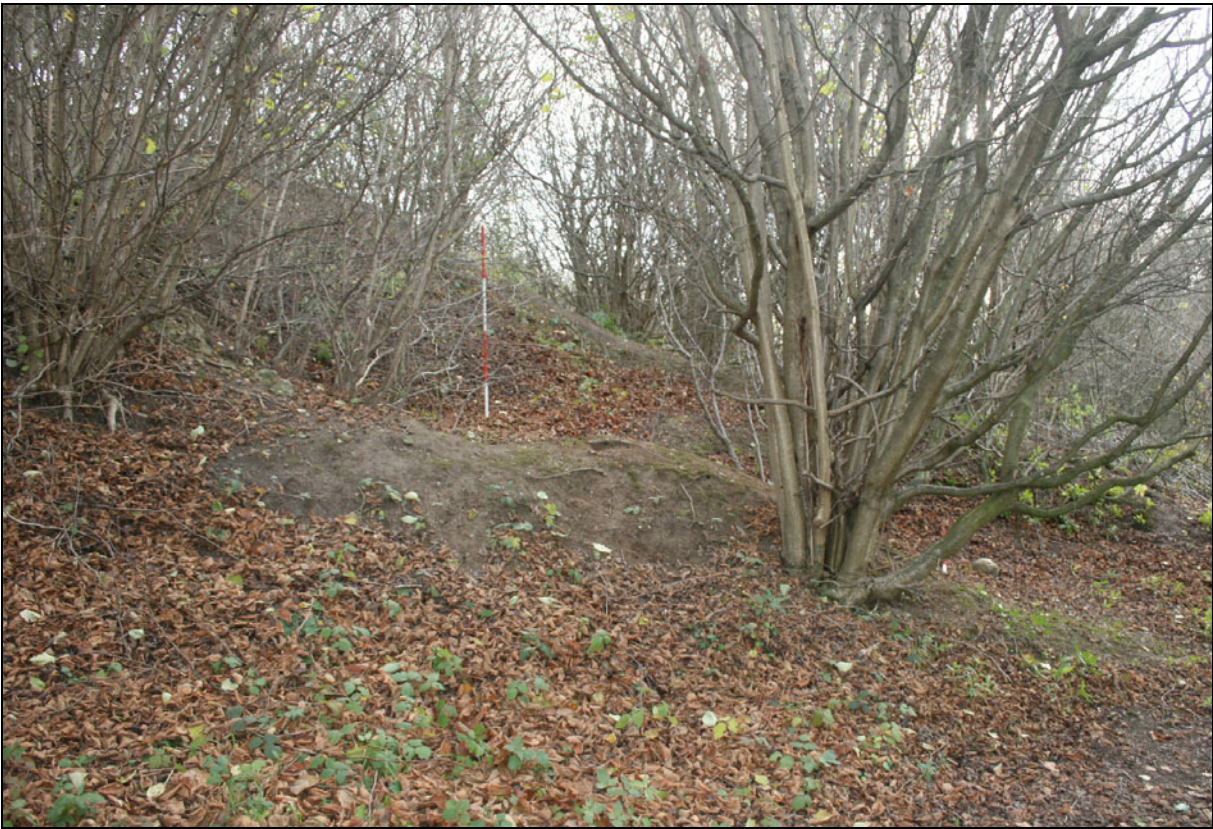
Kiln B was positioned on the west side of the site, close to Kiln A (Plates 6 and 7). In contrast to Kiln A however, Kiln B was poorly preserved with no substantial visible masonry. It was identified on the basis of the shape of the earthwork remains, which comprised the bowl (with a small amount of exposed masonry/rubble at the top) and the collapsed remains

BOWL: The earthwork of the bowl indicated an oval bowl measuring 2.5m x 2.2m, with the longest axis orientated north-south. The exposed rubble at the top of the bowl structure did not include any brick lining but comprised limestone rubble and mortar. The maximum surviving height of the bowl is 1.75m.

MANAGEMENT FACTORS	KEYWORD OPTIONS
Condition	Bad
Stability	Slow deterioration
Actively damaged by:	Vegetation: scrub and trees are growing from the bowl and the collapsed remains of the draw arch. These are likely to be damaging the buried remains of the structure
Management recommendations	None

Kiln B is in poor condition, surviving only as earthworks. Even though vegetation is likely to damage any buried elements of the feature, such damage is likely to be limited in comparison with the kiln's already poor state. The value of the feature does not justify intrusive measures.

Plate 6. Kiln B. The earthworks as seen from the track. Draw arch remains at front, bowl remains at rear

Plate 7. The remains of the bowl of Kiln B

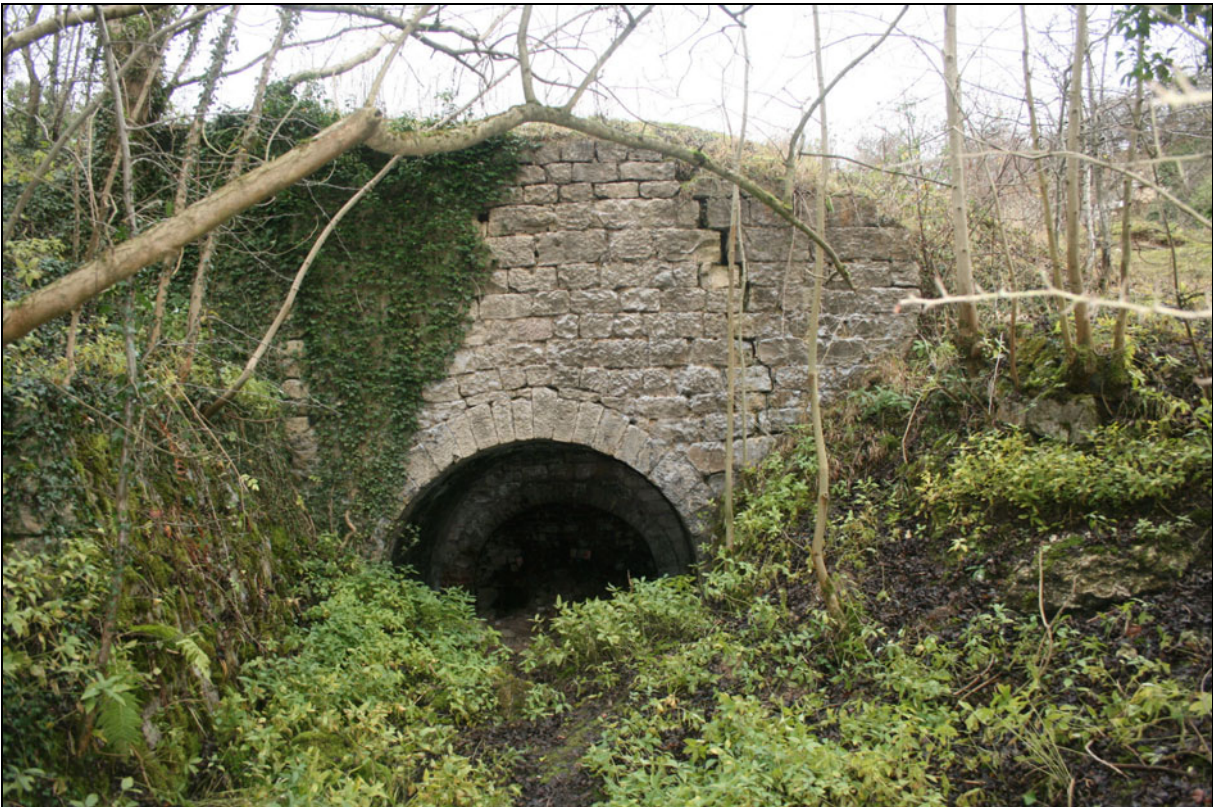
FAÇADE: The front of the kiln, facing to the south, was faced with mortared and roughly coursed rubble limestone. The façade stood at 4m high and the surviving masonry was 4.5m wide – the same as the diameter of the bowl behind it. A wide crack was observed in the eastern side of the façade running from top to bottom and up to 80mm wide.

MANAGEMENT FACTORS	KEYWORD OPTIONS
Condition	Good
Stability	Fast deterioration
Actively damaged by:	Vegetation: scrub and trees are growing from the area of the revetting walls. These are likely to be damaging the buried remains of the structure. Ivy is growing over the front façade and is likely to damage the structure. Neglect: serious-looking structural cracks are present in the masonry.
Management recommendations	Control scrub & bracken Remove trees or shrubs but leave stumps <i>in situ</i> Consolidate relict structures

Plate 8. General view of the facade of Kiln C

Kiln C, by contrast, is one of the best-preserved kilns in the quarry. It is under threat from tree and ivy growth and intrusive management measures to remove/control the vegetation are justified by the value of the feature. Of particular concern are structural cracks visible in the front façade and the roof of the draw arch. It is recommended that the structure be assessed by a suitably qualified person and steps taken to stabilize the masonry and prevent access to the draw arch if it is deemed necessary on safety grounds.

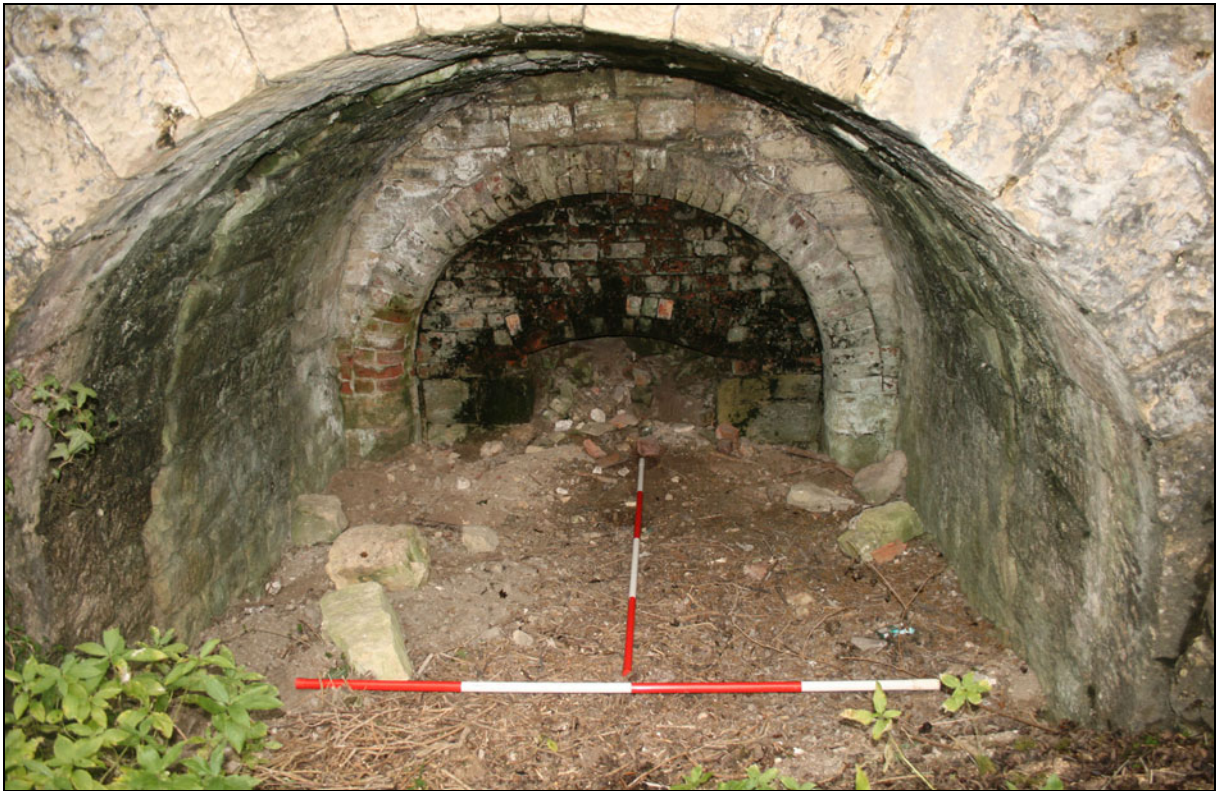
DRAW ARCH: In the lower part of the façade was the draw arch structure comprising three recessed arches leading to the draw hole. The first arch was 2.8m wide and 1.93m high (although the floor is covered by an unknown depth of rubble and soil) and led into a working area with an arched roof that was 2.9m deep. The first arch was constructed of well-shaped limestone voussoirs with a slightly larger but otherwise not elaborate keystone. The well-made barrel arched roof of the working area ended at the second arch. A large structural crack up to 70mm wide ran across the arched roof 1.35m from the outer arch.

Plate 9. Detail of the draw arch and draw hole

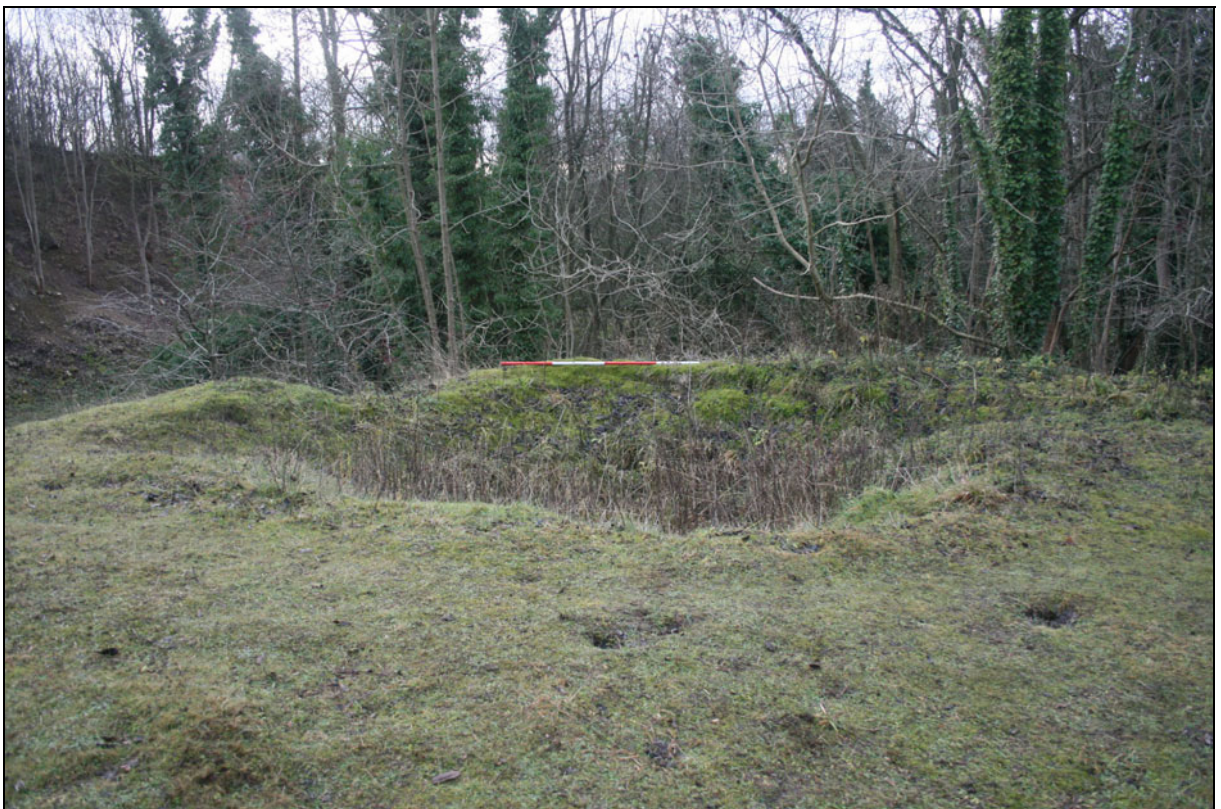
BOWL: The bowl was almost fully in-filled. No visible masonry was present and only a shallow depression (less than 50cm deep) remained. It was possible to measure the diameter of the bowl as 4.5m. The rear of the bowl was within the large mound forming the charging platform.

Plate 10. The infilled bowl of Kiln C

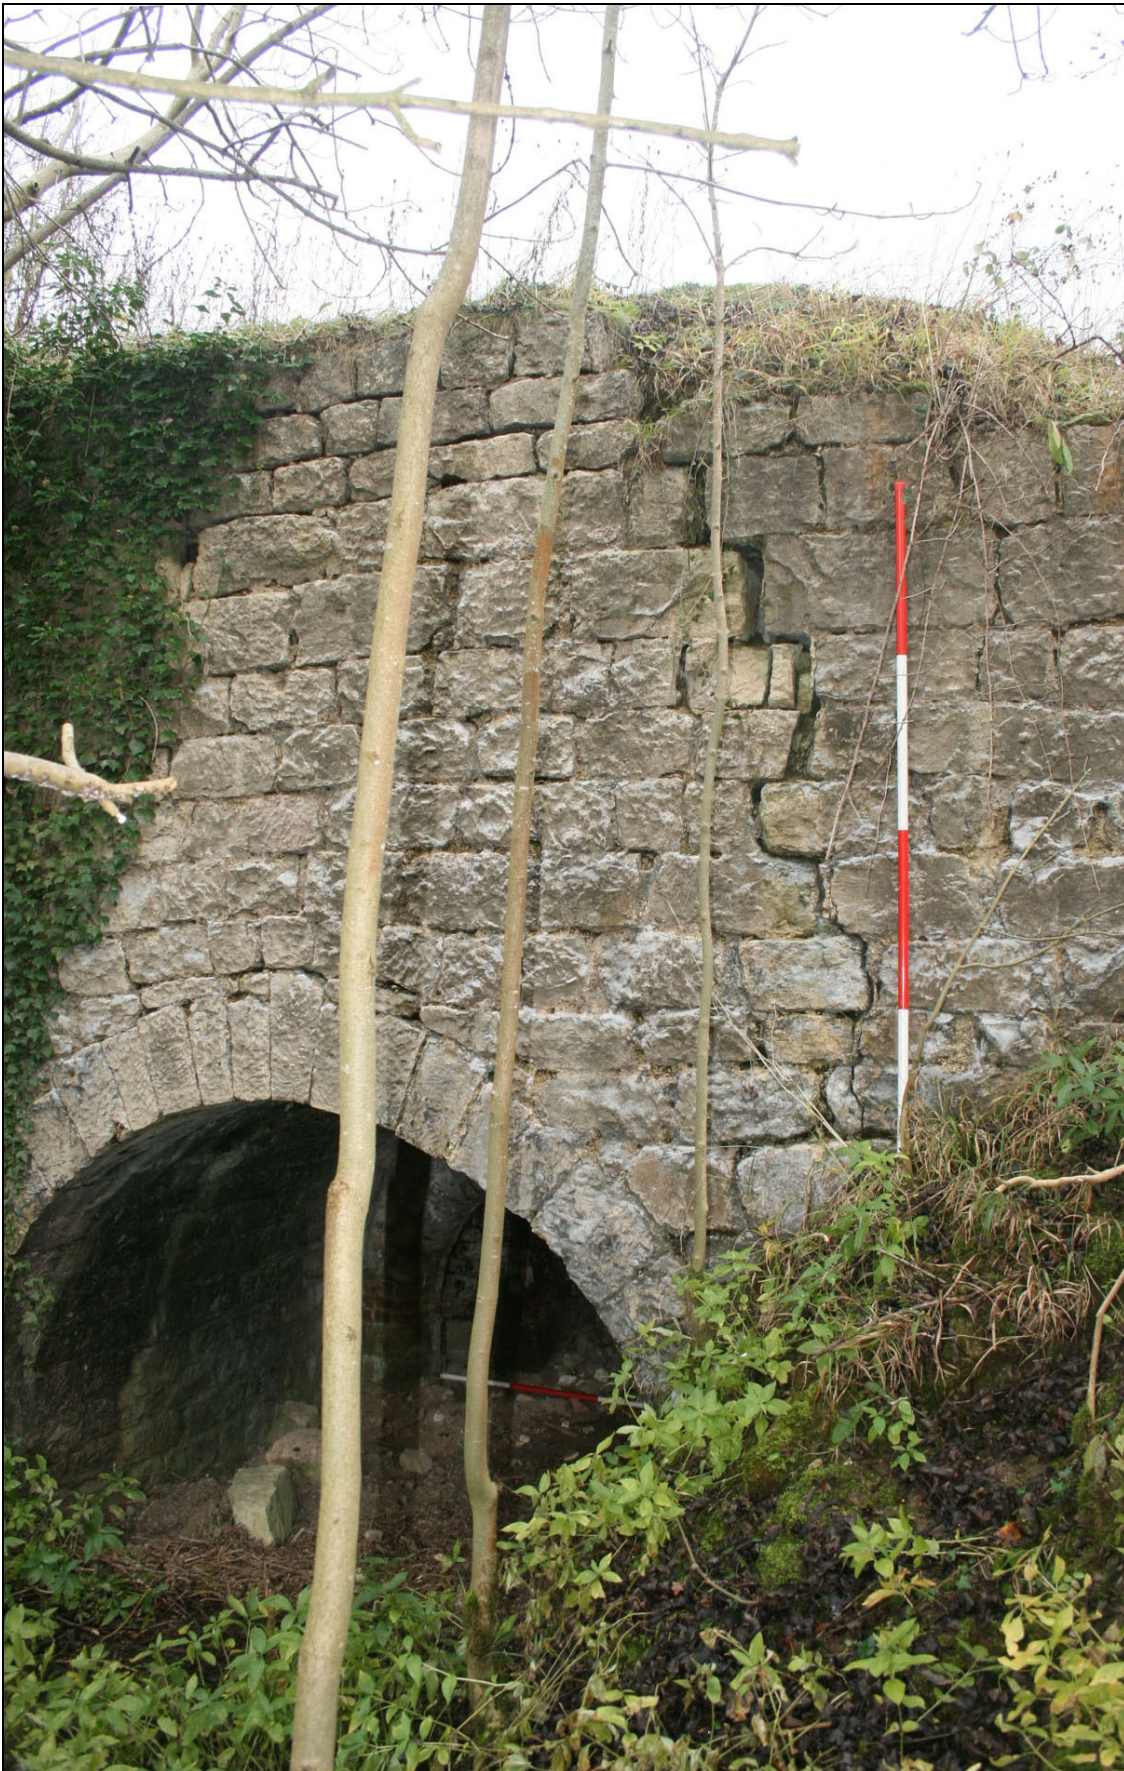
Plate 11. The crack in the facade of Kiln C

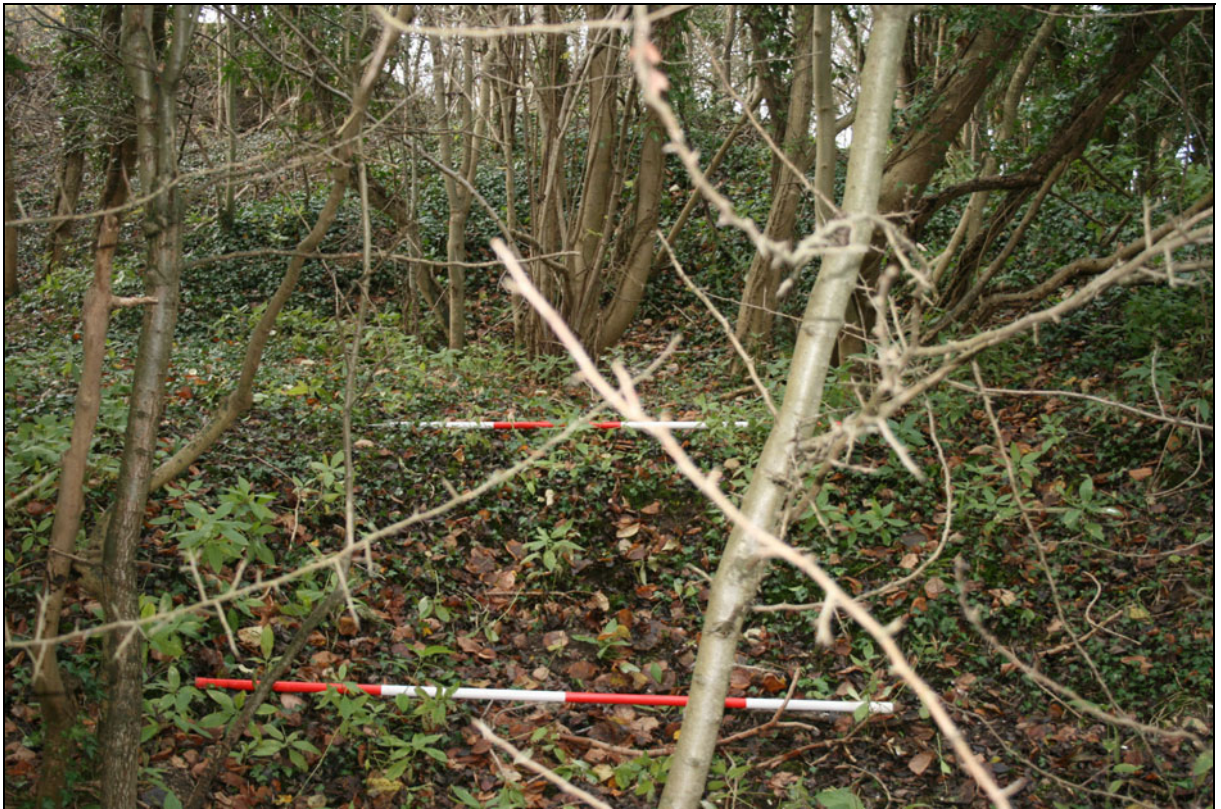
Located just to the south of Kiln C, Kiln D comprised the earthwork remains of a bowl and draw arch (Plate 12). A charging ramp could also be seen. The kiln was very poorly preserved and there is a degree of uncertainty about the identification. The kiln was definitely built after 1854 as it is beyond the quarry face shown on the 1854 OS map.

BOWL: The bowl is an earthwork up to 1m high with no visible masonry. It is oval in plan and measures 2.6m north-south and 2.9m east-west. The south side of the bowl is particularly poorly preserved.

DRAW ARCH: The draw arch structure is completely collapsed and is represented by an earthwork up to 0.4m high with no visible masonry. It measures approximately 2m square and lies on the east side of the bowl.

MANAGEMENT FACTORS	KEYWORD OPTIONS
Condition	Bad
Stability	Stable
Actively damaged by:	Vegetation: trees are growing from the area of the bowl. Although these are likely to be damaging any buried deposits, the general poor preservation of the feature doesn't really justify their removal.
Management recommendations	None.

Plate 12. The earthwork remains of Kiln D. Draw arch in foreground, bowl in centre ground

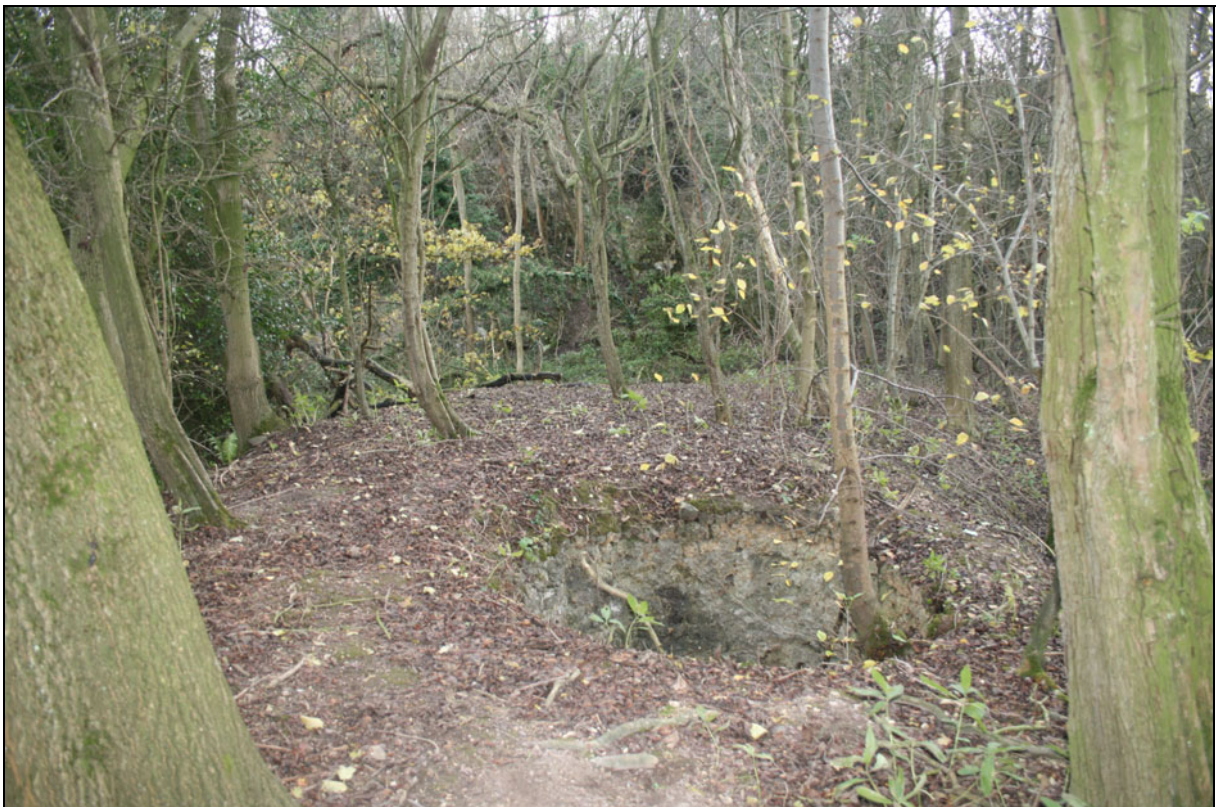
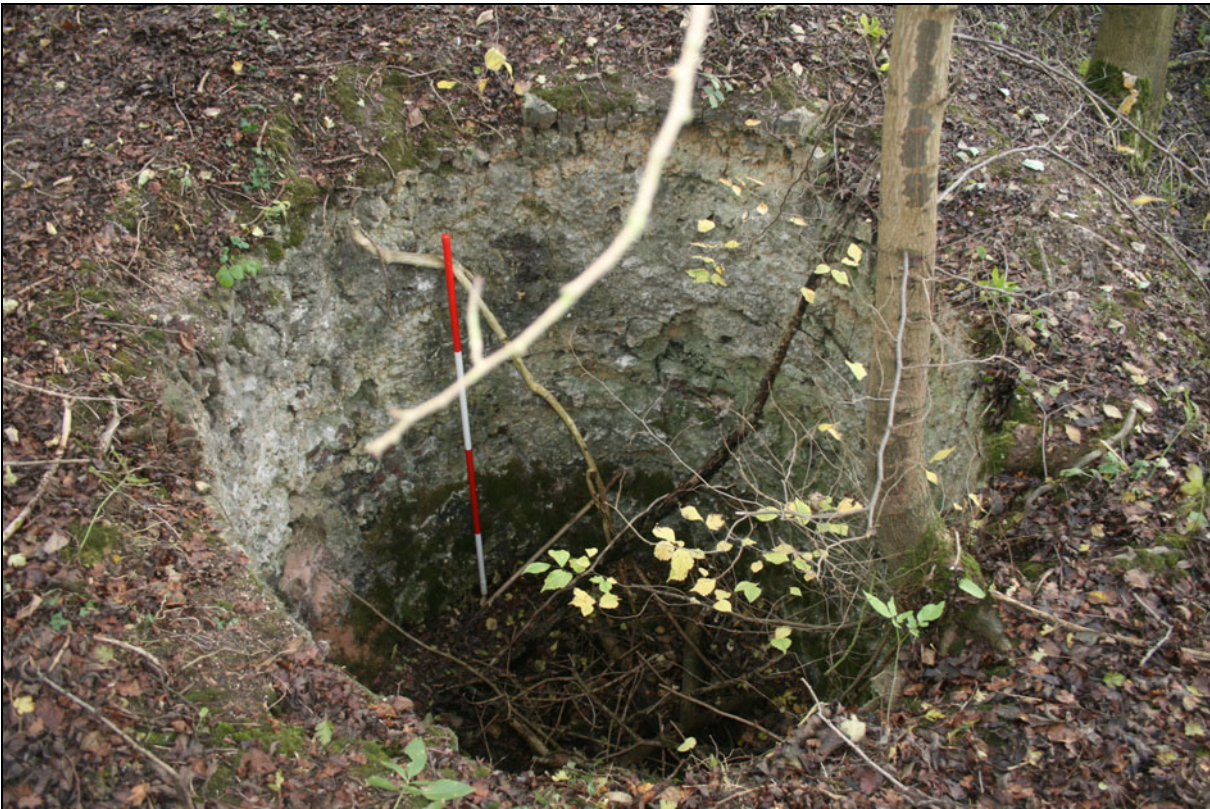
Kiln E was situated near to the northern quarry face. It was well-preserved and comprised a charging platform, bowl, revetting walls and draw arch (Plates 13, 14, 15 and 16). The 2.1m deep bowl was unfenced and hazardous. The kiln was almost certainly built after 1854 as it is not shown on the 1854 OS map.

BOWL: The bowl was 2.1m deep and slightly oval in plan measuring 2.3m east-west and 1.95m north-south. Enough backfill was present in the base that the draw hole was not visible. The bowl was faced with brick although this was heavily calcined.

MANAGEMENT FACTORS	KEYWORD OPTIONS
Condition	Good
Stability	Slow deterioration
Actively damaged by:	Vegetation: trees are growing from the bowl. These are likely to be damaging the structure. Hazard: The open bowl is a hazard.
Management recommendations	Control access to hazardous remains/areas Remove trees or shrubs but leave stumps <i>in situ</i>

Plate 13. The approach to Kiln E showing its charging platform and bowl

Plate 14. the deep bowl of Kiln E (2m scale)

The well-preserved structure of Kiln E has trees growing from its bowl that are likely to damage the kiln's structure. Given the high value of this feature it is recommended that the trees be removed. Although the lower part of the kiln, i.e. the draw arch area, has been backfilled, it is not recommended that this be removed. Although detrimental to the appearance and understanding of the kiln it is probably beneficial to its structural stability. The only other consideration with this kiln is the deep bowl, which at the moment is a hazard to visitors. Even though the kiln is not on a right of way, it is easily accessible from the main route through the quarry and the 2.1m deep bowl is dangerous, especially if the trees growing from it are removed. Simply filling the bowl or capping in with a concrete lid would be detrimental to the character of the kiln; either a fence or a grille would be better options.

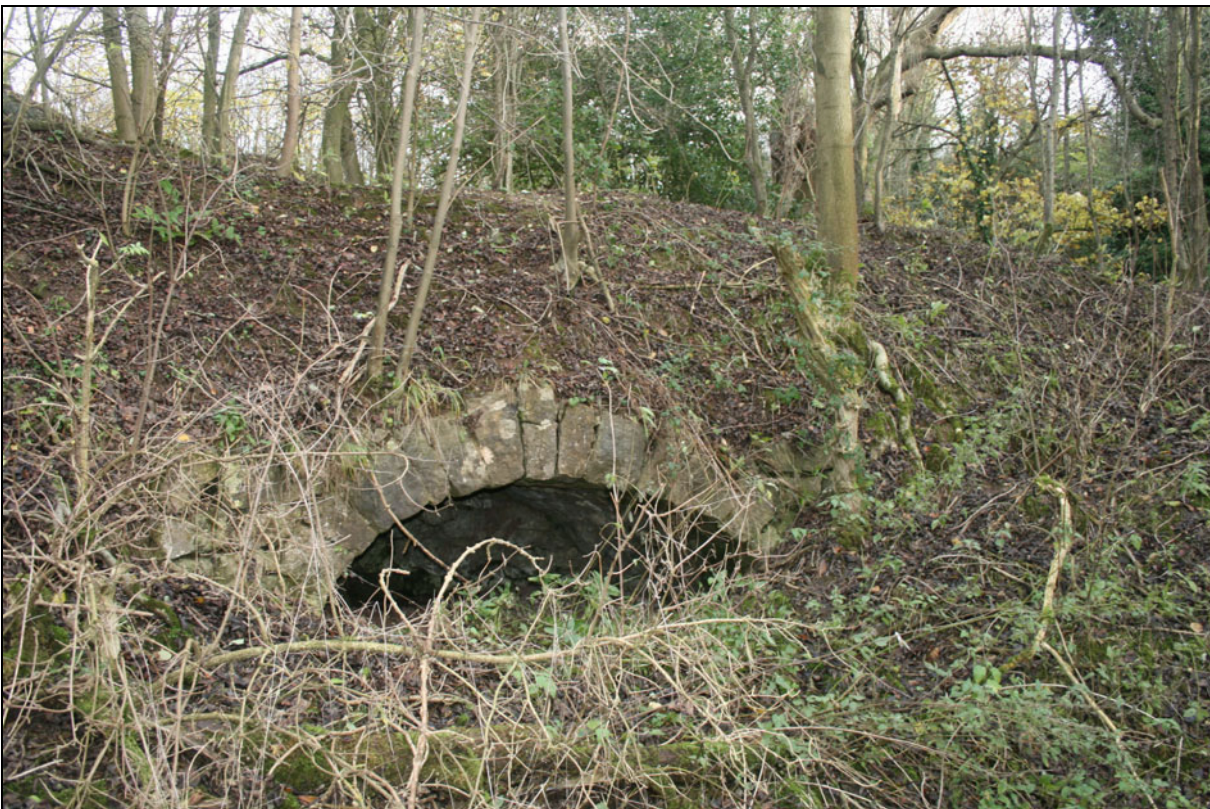
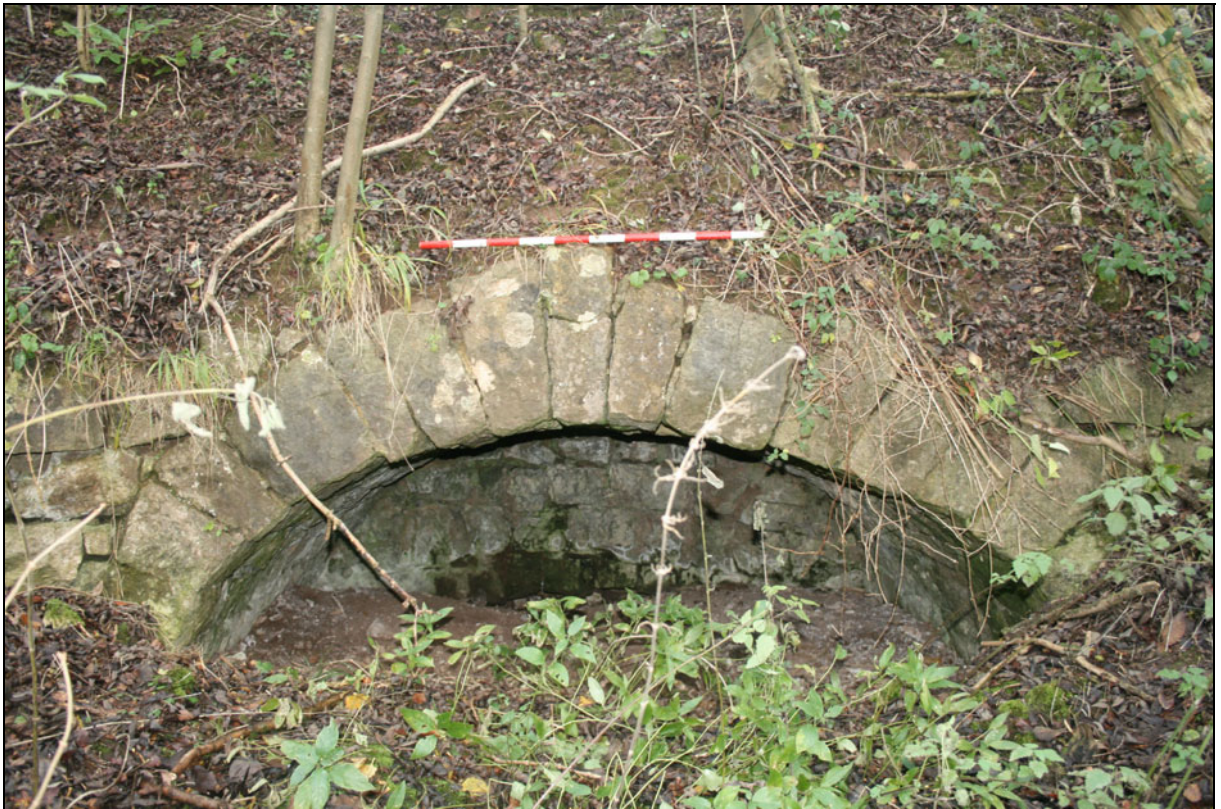
DRAW ARCH: The outer arch was made of crudely-shaped voussoirs. It was 2.65m wide but the area of the draw arch had been backfilled so that the roof of the draw arch was only 0.9m high. The draw arch structure was barrel arched and extended back 2.17m. The arch of the inner draw hole was just visible above the back fill and was made of brick.

Plate 15. The draw arch of Kiln E. Lower part of kiln is backfilled

Plate 16. The draw arch and draw hole of Kiln E

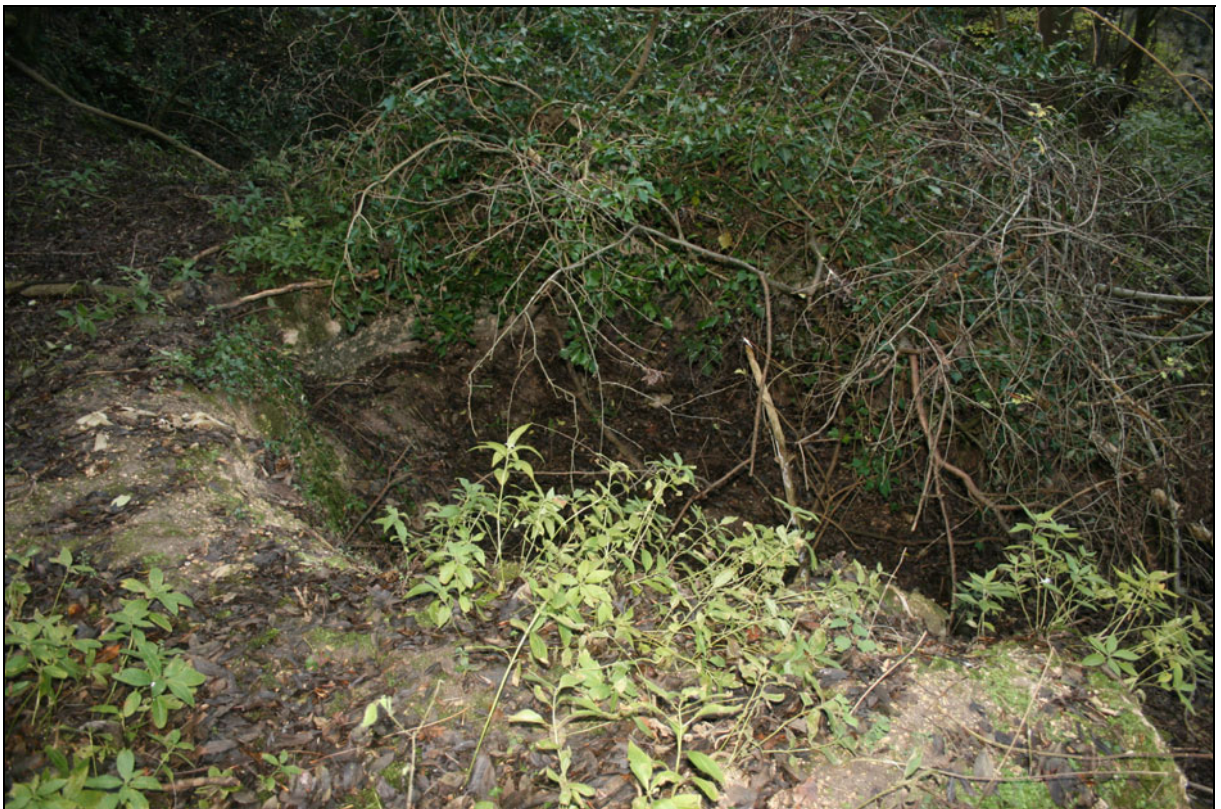
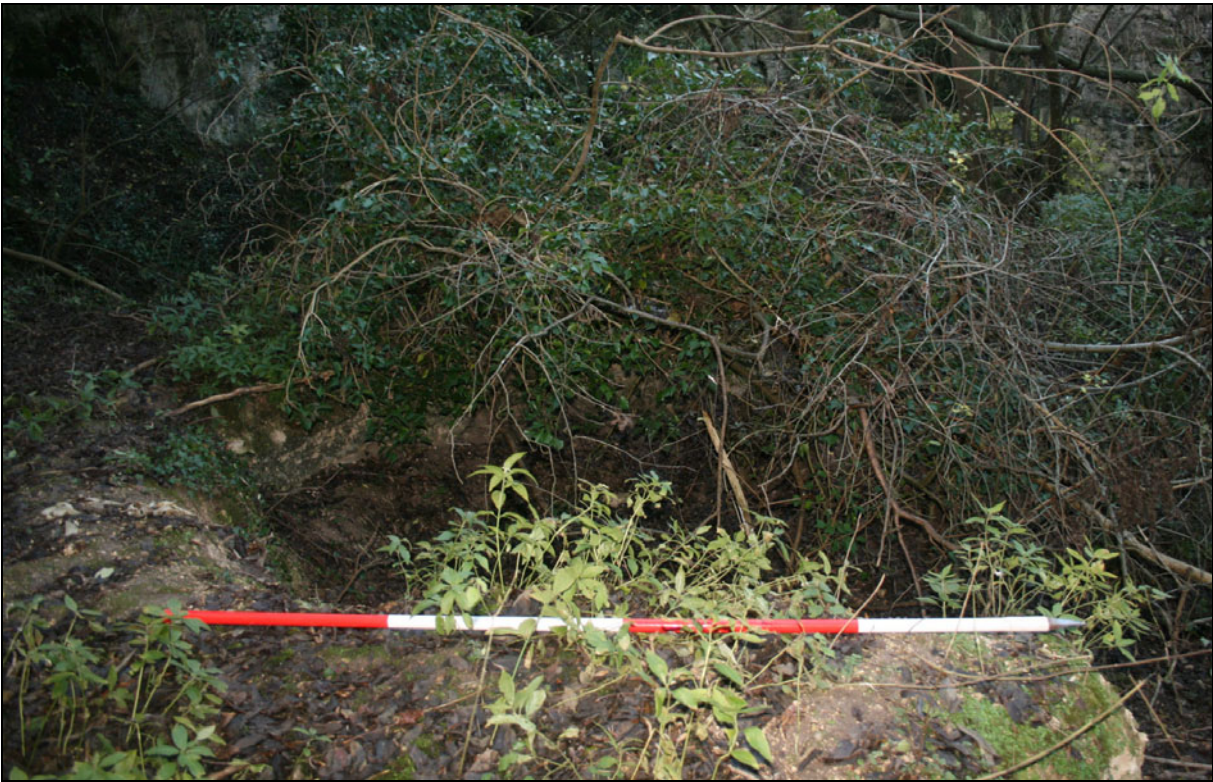
Kiln F was located in the north quarry close to the rock face (Plates 17 and 18). It had been damaged; probably by the landfill operation in the north quarry and only the earthwork remains of the bowl were present. The kiln had originally had a draw arch facing to the west but this was no longer present. The kiln was built before 1854 as it is shown on the 1854 OS map.

BOWL: The bowl was heavily overgrown with only a small area of masonry visible in its northwest. It was slightly oval and measured 2.9m north-south and 2.5m east-west. The visible masonry was the remains of a heavily calcined brick lining. The bowl remains were up to 0.95m deep.

MANAGEMENT FACTORS	KEYWORD OPTIONS
Condition	Moderate
Stability	Slow deterioration
Actively damaged by:	Vegetation: trees are growing from the bowl. These are likely to be damaging the buried remains of the structure.
Management recommendations	Remove trees or shrubs but leave stumps <i>in situ</i>

Plate 17. Kiln F heavily overgrown

Plate 18. Kiln F

Kiln F has been damaged by landfill activities but is still worth preserving. Therefore it is recommended to remove the trees growing out of it.
