BURTON LEONARD LIME QUARRY, NORTH YORKSHIRE.

REPORT ON AN ARCHAEOLOGICAL LANDSCAPE SURVEY.
OSA REPORT No: OSA10LS01

December 2010

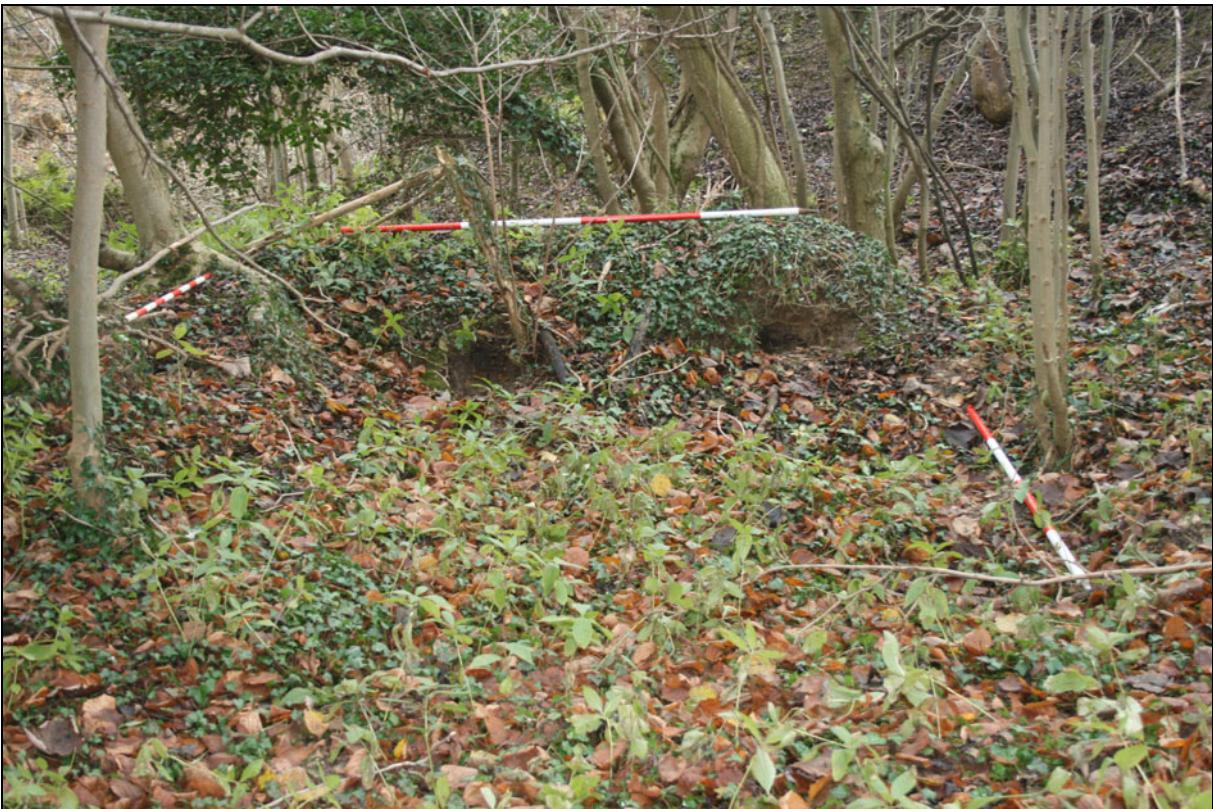
This was located close to Kiln D and may have been a lime shed, for storing the lime after burning. The building survived only as earthworks up to 0.6m high and 0.5m wide demarcating two sides of the structure (Plate 19). It is possible that the other walls of the shed were of wood. The shed would have measured 2.6m square internally. In 1854, the site of this building, like Kiln D, was beyond the quarry.

MANAGEMENT FACTORS	KEYWORD OPTIONS
Condition	Destroyed
Stability	Stable
Actively damaged by:	Vegetation: trees and other vegetation are growing from the remains. These are likely to be damaging the buried remains of the structure. Animal burrows: found extensively in and around the building.
Management recommendations	None

Plate 19. The earthwork remains of Building 1 (two 2m scales and one 1m)

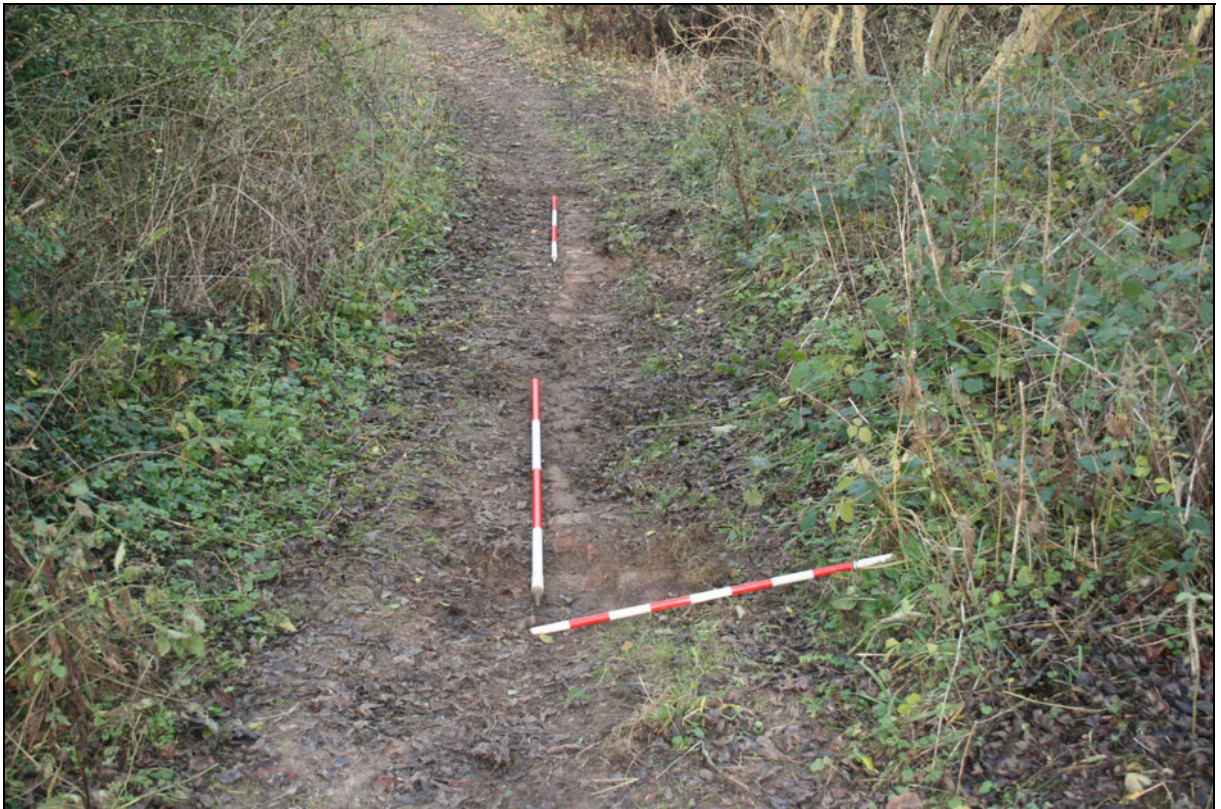
This was located in the northern part of the site but away from the quarried face or the two northern kilns. The building survived only as earthworks up to 0.5m high and a brick foundation course, only visible because it had been eroded by the path (Plate 20). The foundation comprised bricks laid in a header bond and mortared. The building was originally approximately 6.2m north-south and 4.3m east-west.

MANAGEMENT FACTORS	KEYWORD OPTIONS
Condition	Destroyed
Stability	Stable
Actively damaged by:	Vegetation: trees and other vegetation are growing from the remains. These are likely to be damaging the buried remains of the structure. People (erosion)
Management recommendations	None

Plate 20. The remains of Building 2 as exposed in the eroded path

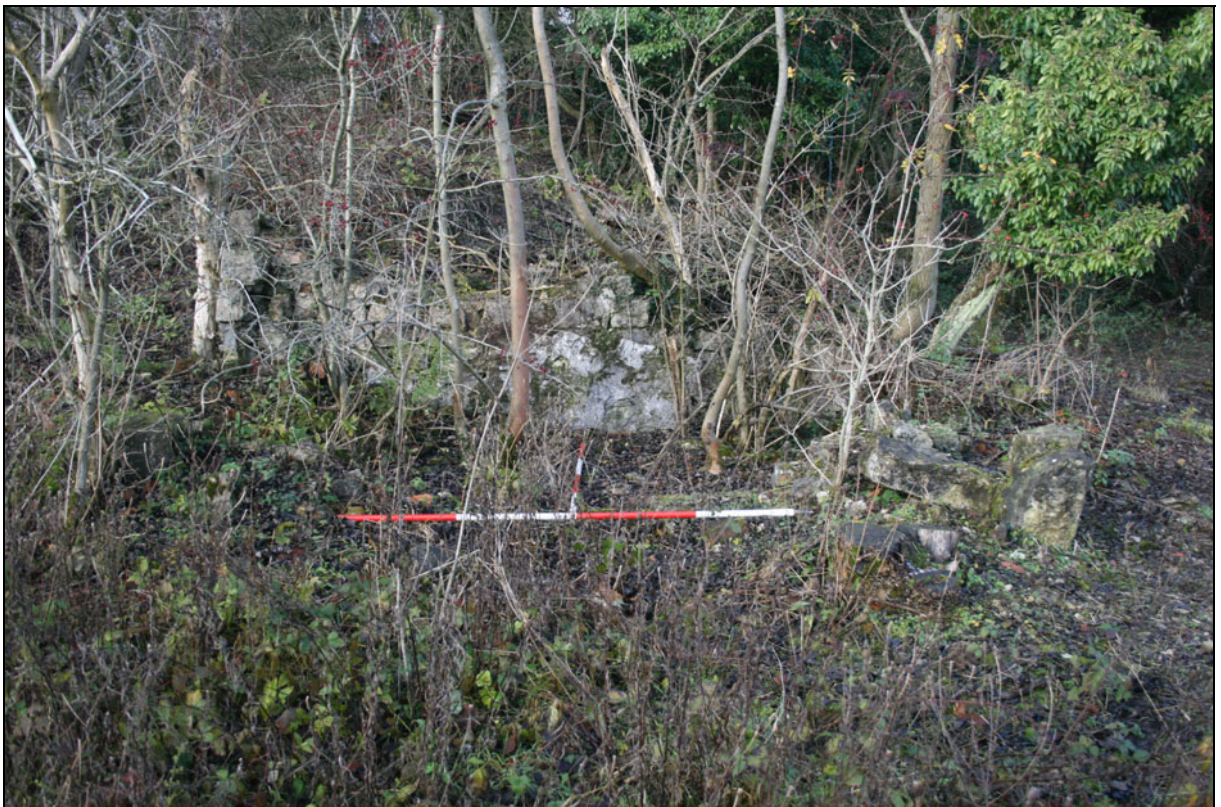
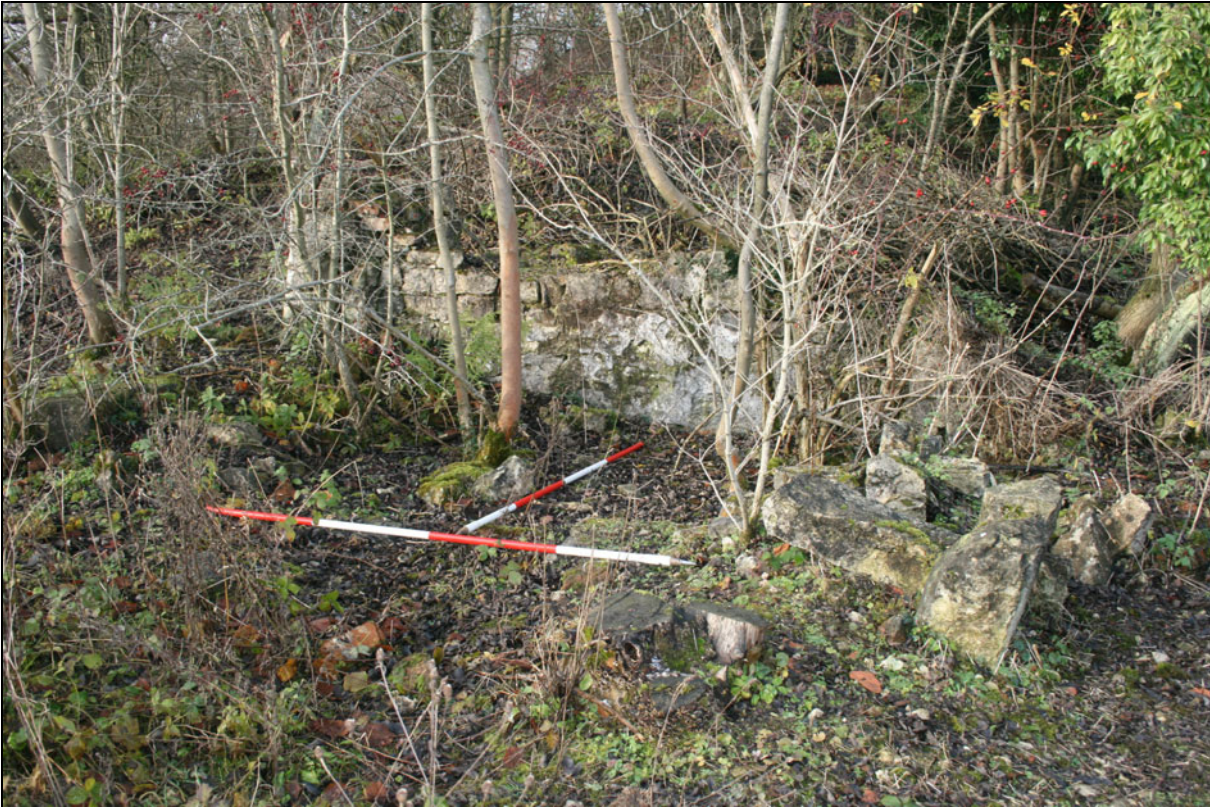
MANAGEMENT FACTORS	KEYWORD OPTIONS
Condition	Bad
Stability	Slow deterioration
Actively damaged by:	Vegetation: trees and other vegetation are growing from the remains. These are likely to be damaging the buried remains of the structure.
Management recommendations	Control scrub & bracken Remove trees or shrubs but leave stumps <i>in situ</i>

Plate 21. The ruins of Building 3

Plate 22. Another view of Building 3
