# SAINT GREGORY'S CHURCH, BEDALE NORTH YORKSHIRE

# ARCHAEOLOGICAL WATCHING BRIEF

**Bedale PCC**

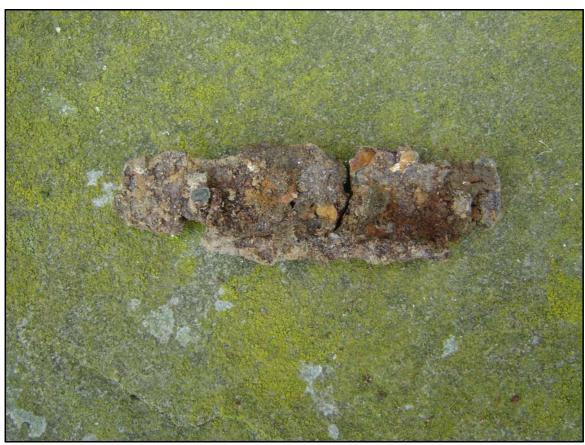
- 5.1 Not unexpectedly the watching brief recorded extensive evidence for human burials. This was in the form of a relatively small amount (given the age of the church) of disarticulated and unstratified human bone along the length of the trench. The commonest skeletal elements found were long bone, particularly femur, fragments. Smaller numbers of fragments of skull and rib were observed along with the occasional phalange.
- 5.2 In addition to the human bone the remains of a very badly degraded, iron coffin handle was noted (Plate 3). As with the human bone this too had been re-deposited and was not in its original burial location.
- 5.3 One minor feature of interest was noted on the outside of the church. This was a small collection of, presumably, 19<sup>th</sup> century graffiti (Plate 4).
- 5.4 No other archaeological features or artefacts were encountered during the ground works.

Plate 3. Badly degraded iron coffin handle.

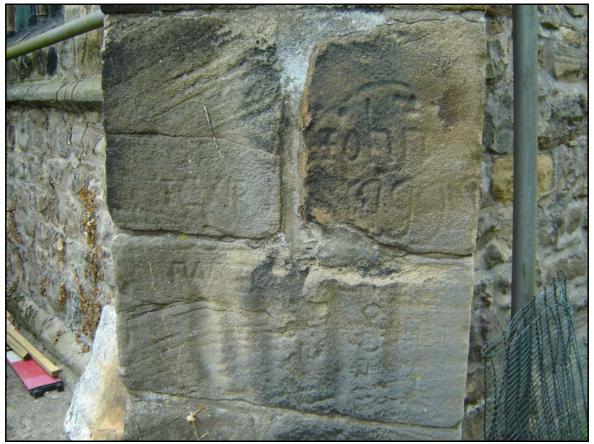
Plate 4. Graffiti on south-east buttress.
