COURTHOUSE AND ADJACENT BARN RANGE
TO EAST OF COLBURN HALL,
COLBURN, NORTH YORKSHIRE

ARCHITECTURAL AND
ARCHAEOLOGICAL SURVEY

Report no: 2009/361.R01
Version: Final
Date: February 2012
Authors: Shaun Richardson & Ed Dennison

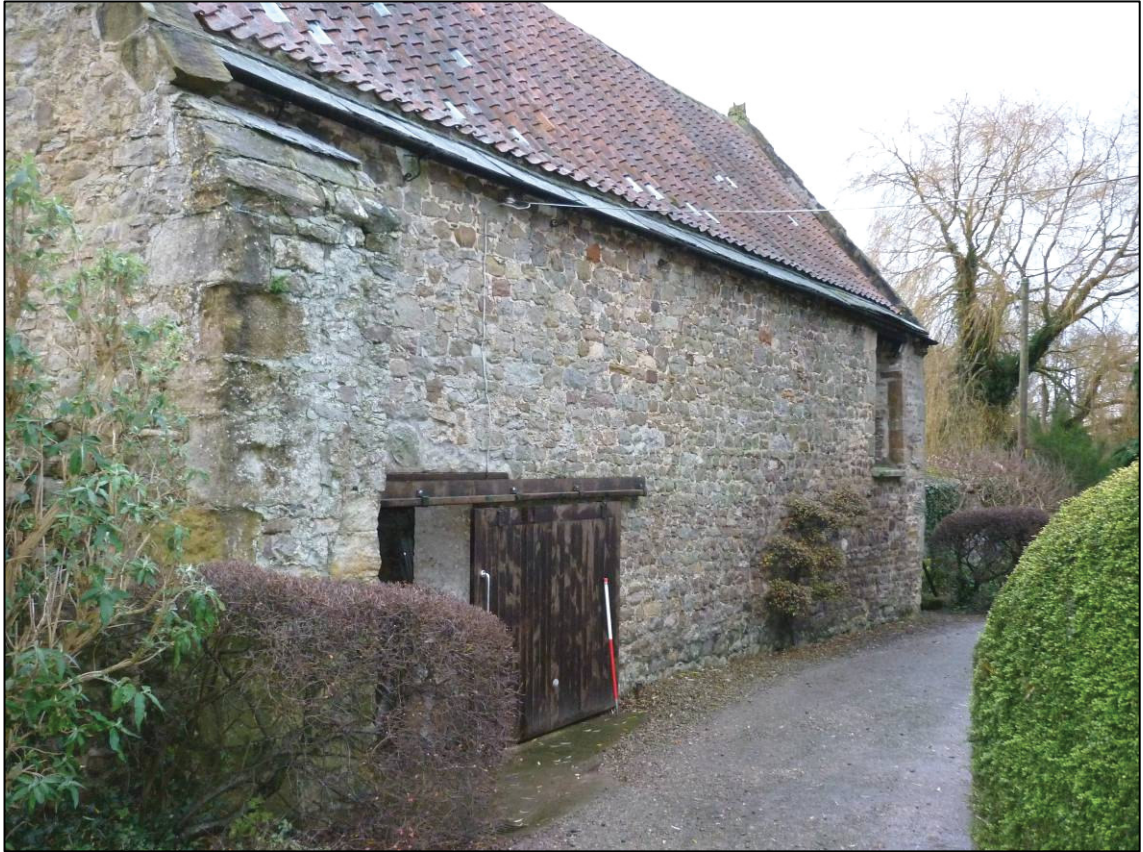
Plate 1: Medieval building, west elevation, looking SE (photo 2/732).

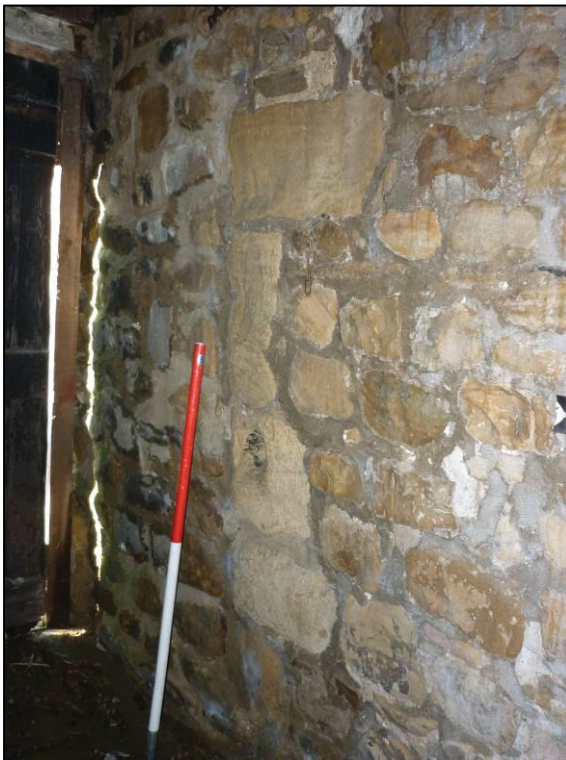
Plate 2: Medieval building, blocked doorway in base of south gable, looking NW (photo 3/827).

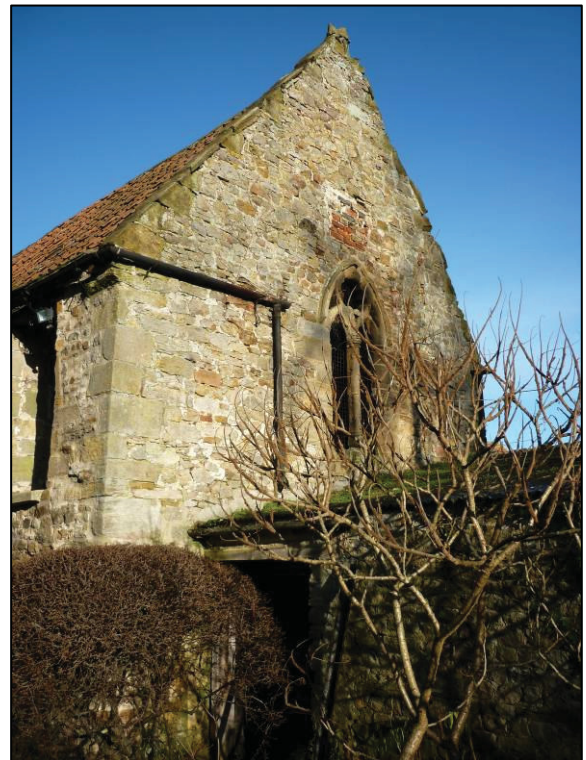
- 3.8 As previously noted, the lower part of the south gable is obscured by the adjacent single storey piggery; a building is shown in this position on the 1842 tithe map and the 1857 Ordnance Survey map, although the existing structure has been substantially modernised internally [2/738]. From within the piggery, a blocked doorway is visible at the west end of the south gable's ground floor. The east jamb retains sandstone quoins for part of its height, as does the west jamb [3/827 and 4/852] (see plate 2). The latter is chamfered and incorporates a small circular recess set at 0.80m above ground level. At the top of the west jamb, there may be fragmentary evidence for the remnants of a curved head, although this is far from certain. To the east of the doorway, there is an enlarged eight-pane casement

Plate 3: Medieval building, south gable, looking NE (photo 3/819).

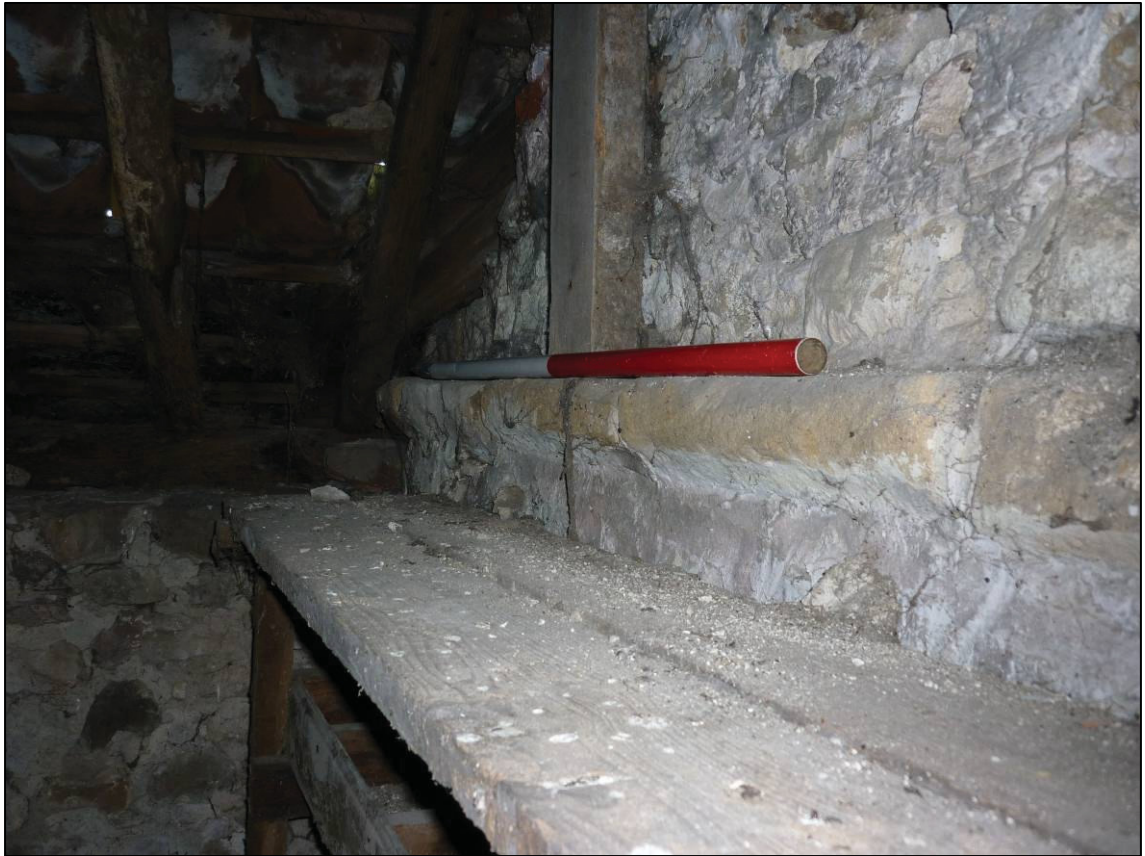
Plate 4: Barn, first floor west cell, showing string course to east elevation of medieval building, looking SW (photo 3/840).

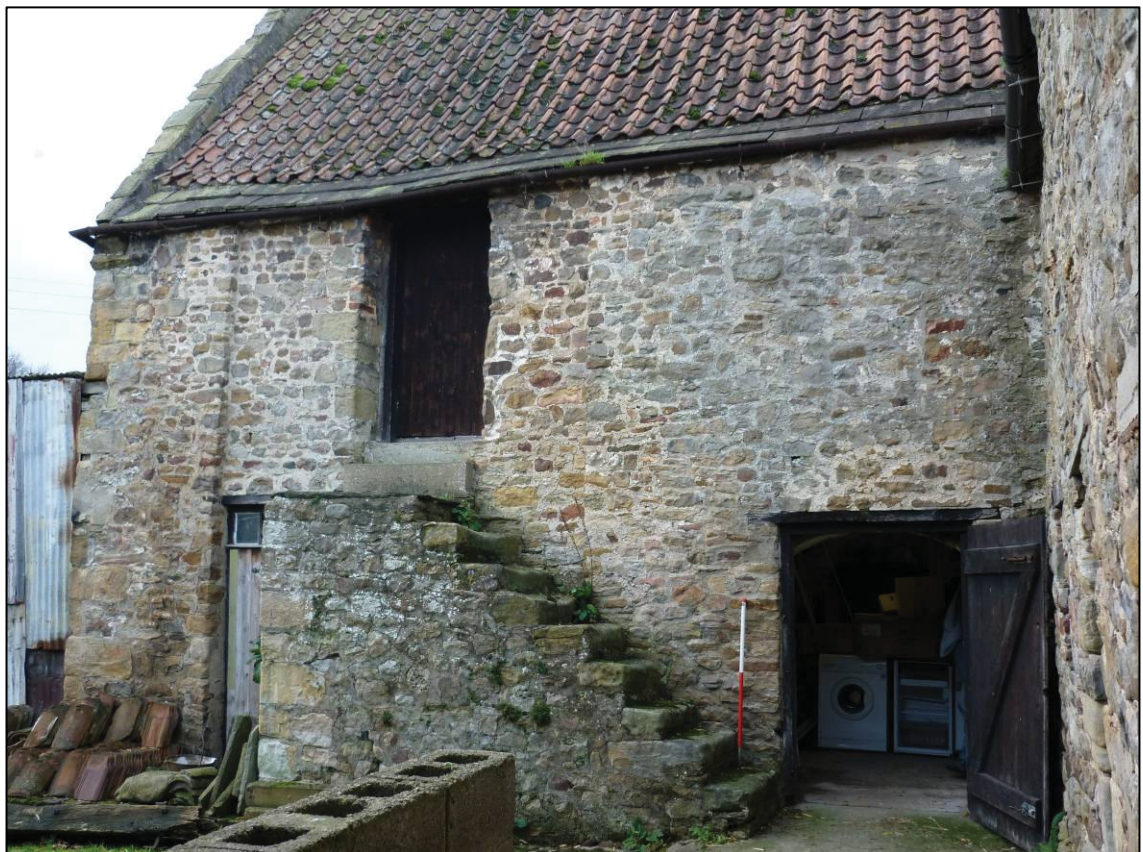
- 3.13 That part of the east elevation not contained within the later structure is essentially divided into three parts, a slightly recessed central panel flanked by projecting panels of masonry of differing widths [1/532] (see plate 5). On closer examination, the projecting panels can actually be seen to at least partly form a thin external skin to the main wall face, represented by the central panel. This may suggest that adjoining or attached structures to either side were removed, necessitating the repair of the wall face. Geophysical survey uncovered evidence for a compacted yard surface to the immediate east of this area but no structural remains (Harrison 2012), although it is of course possible that a yard surface itself may obscure what lies beneath it. The wider north panel contains a flat-headed ground floor doorway with a wooden lintel. Above the doorway, the elevation has been thickly re-pointed, obscuring much detail, although there appears to be at least one or perhaps two low straight joints here. These might represent the jambs of former openings, although they could also relate to an internal first floor fireplace (see para 3.16 below). To the south of the doorway, the ground floor of the central recessed panel is butted by a flight of stone steps, rising from north to south in the opposite direction to those shown here by Buck in the early 18th century (but see comments to para 3.11 above). The steps rise to a first floor doorway containing a recessed plank and batten door; the north jamb of the doorway comprises the same rubble used in the rest of the elevation, but the south jamb has proper quoins, albeit only

Plate 5: Medieval building, south end of east elevation, looking SW (photo 1/532).

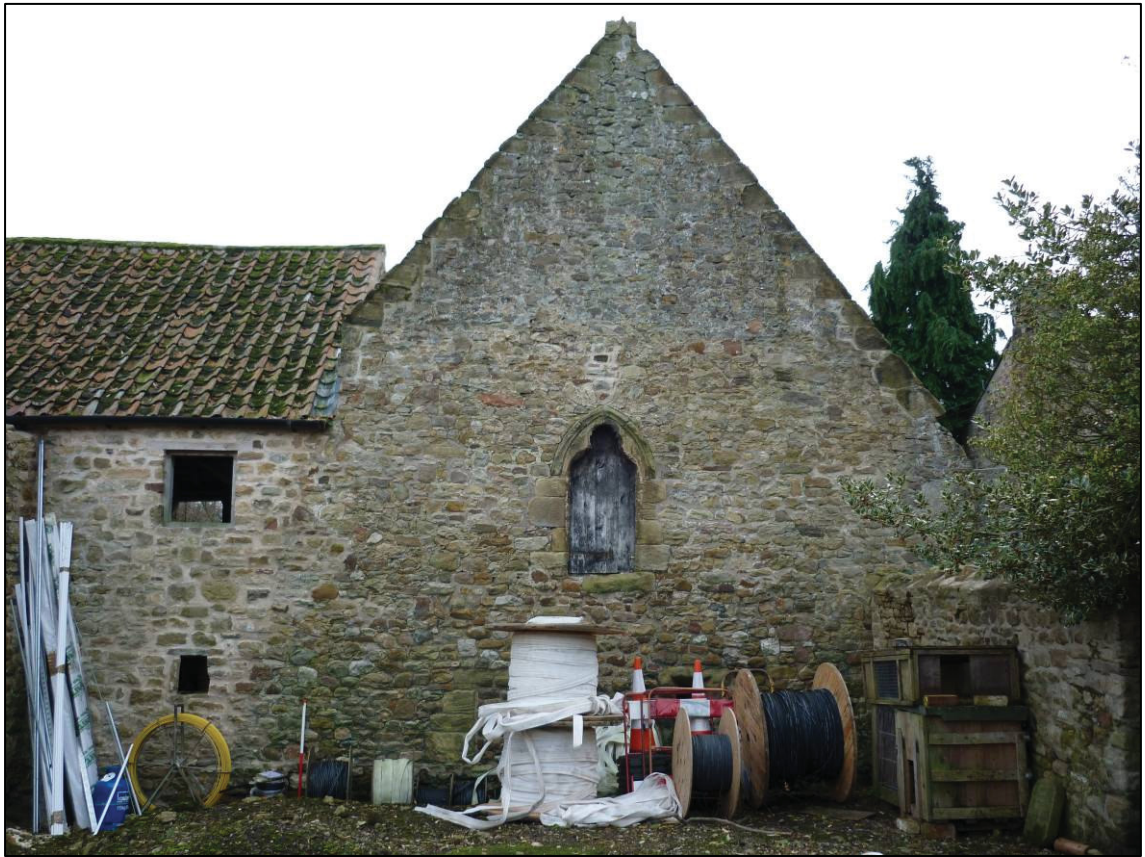
Plate 6: Medieval building, north gable, looking S (photo 1/536).

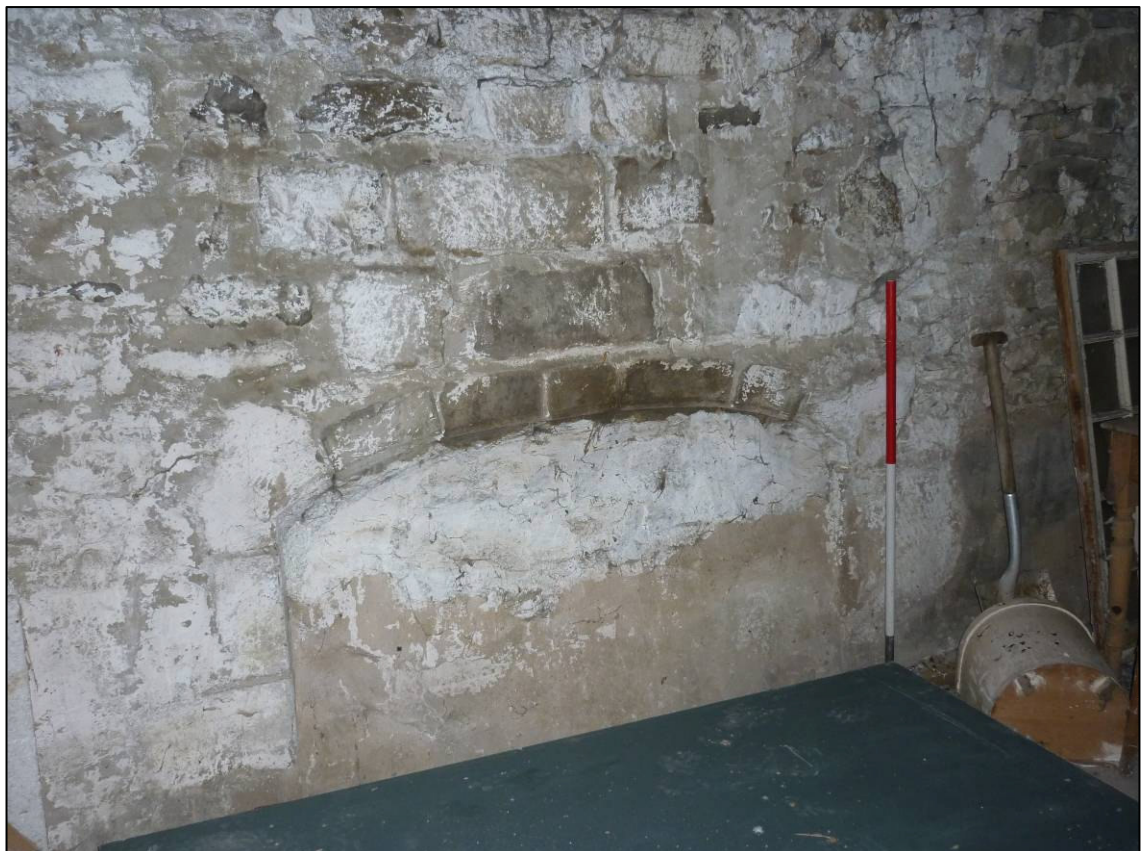
Plate 7: Medieval building, first floor blocked fireplace in east wall, looking SE (photo 3/865).

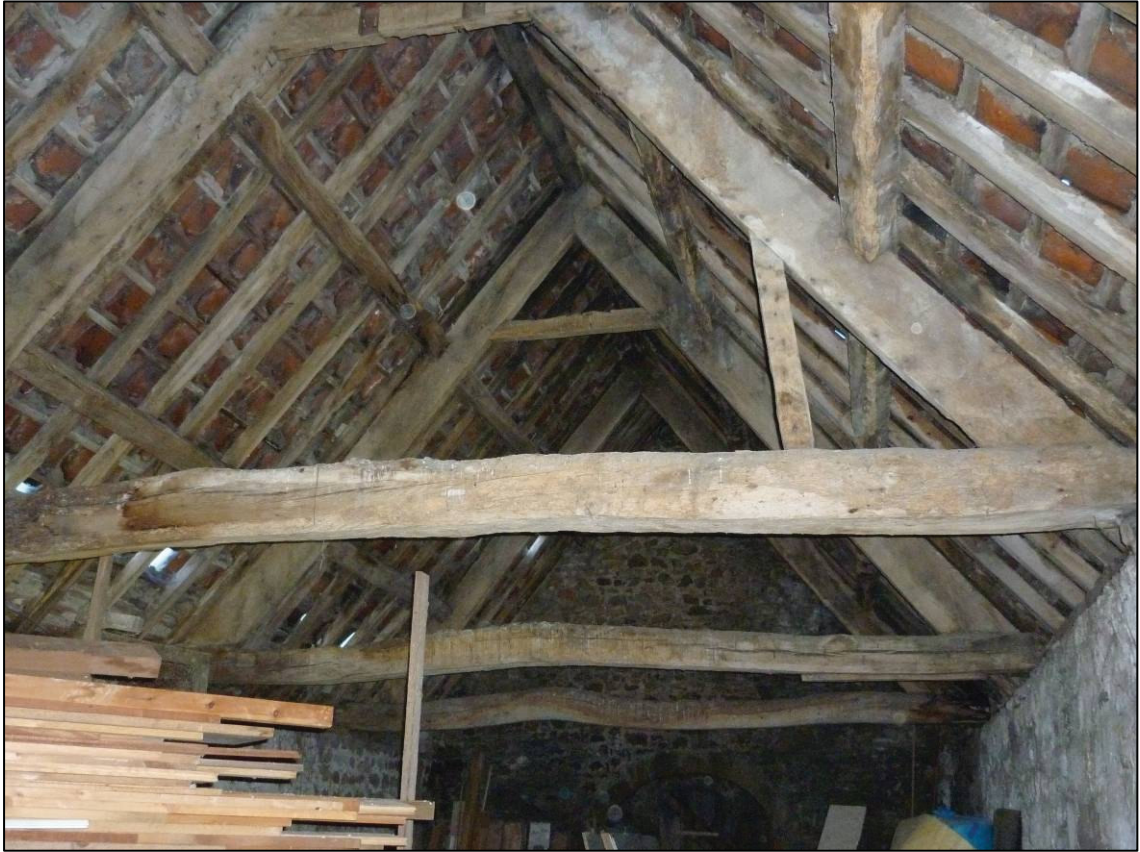
Plate 8: Medieval building, first floor truss ('III'), looking N (photo 3/866).

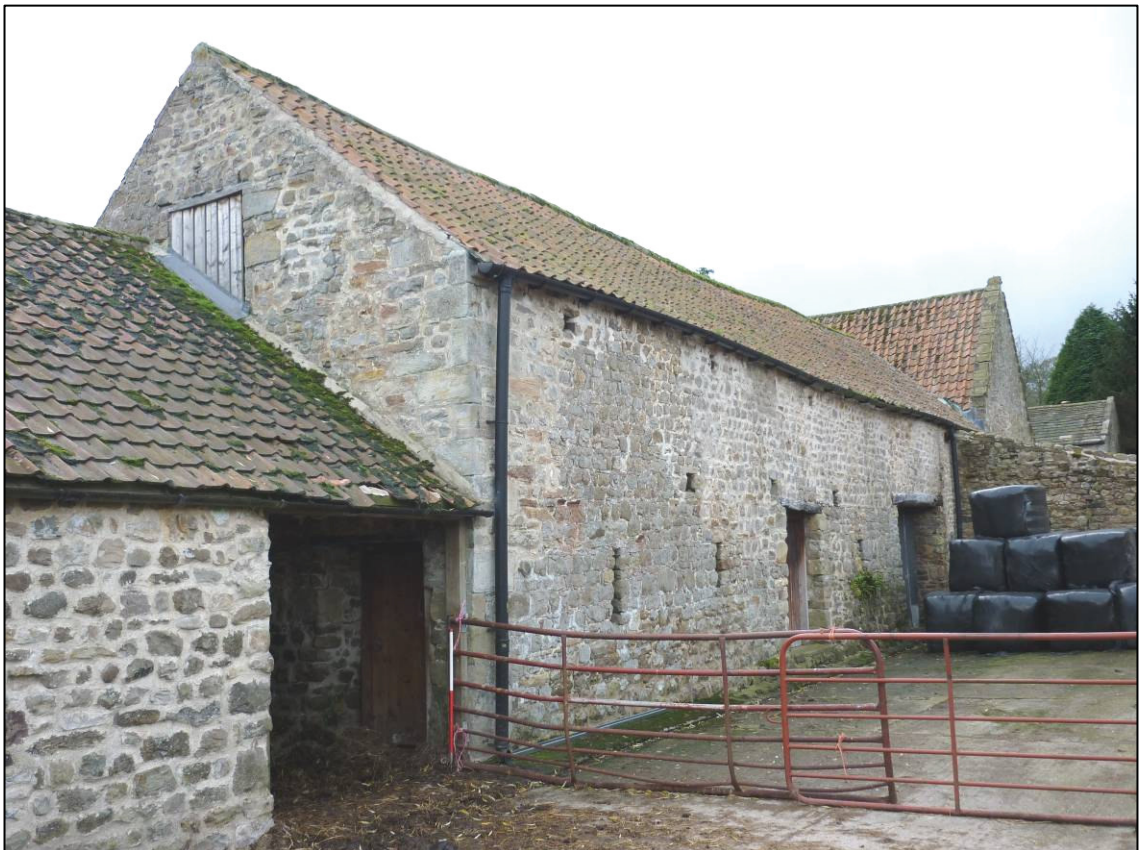
Plate 9: Barn, east gable and north elevation, looking SW (photo 1/541).

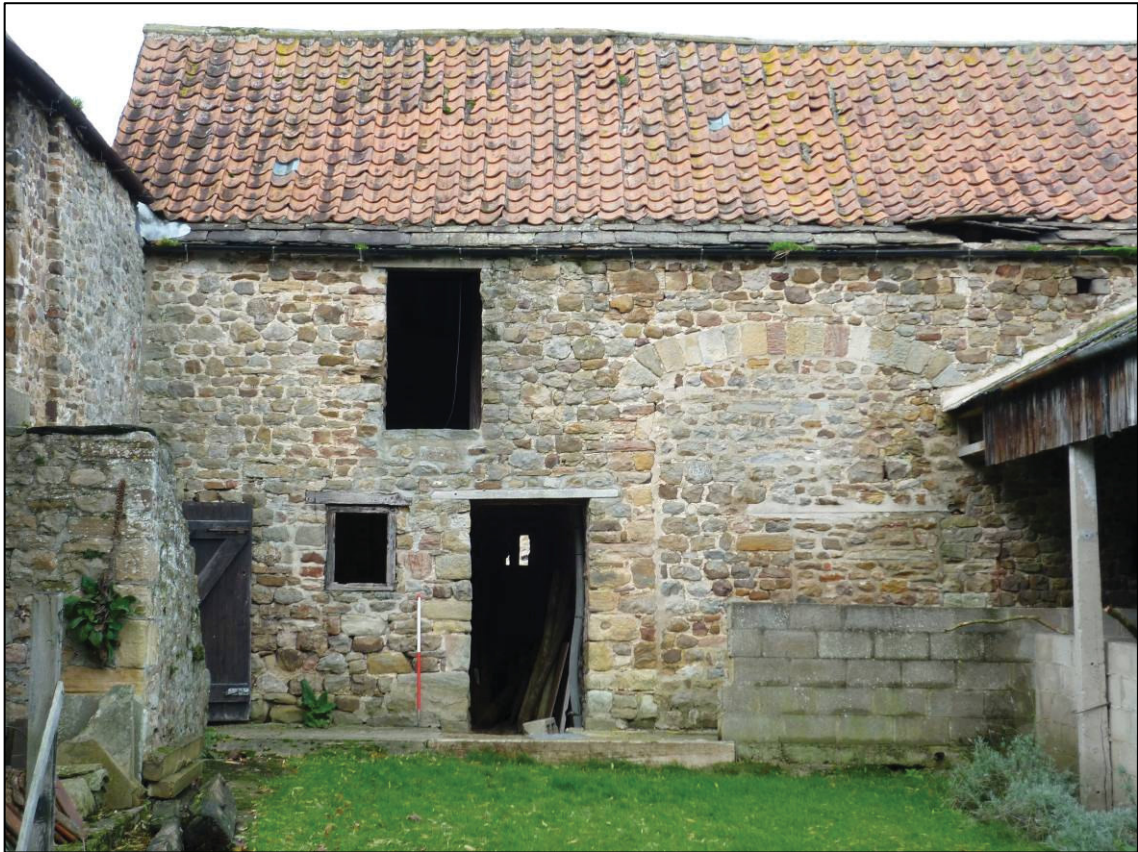
- 3.32 The smaller cell to the west has a ground floor doorway with quoined jambs and a timber lintel (see plate 10). One of the quoins to the east jamb retains a small oval recess, and also some very worn carved graffiti perhaps reading 'W C I'. The doorway has a small square window to the west. Below the window, this part of the elevation again rises from a shallowly projecting plinth, while above it appears to be slightly inset at first floor level, with the face built of slightly smaller stones. There is a loading door to the centre of the first floor [1/535]. As has already been noted above, the doorway could have been moved to this position after 1718, perhaps as a result of external steps formerly leading to the first floor of the medieval building being removed. The ground floor doorway to the cell below the hayloft can be seen on Buck's 1718 sketch, as can the tall double doors of the cart entrance (see figure 3).

Plate 10: Barn, west end of south elevation, looking N (photo 1/535).

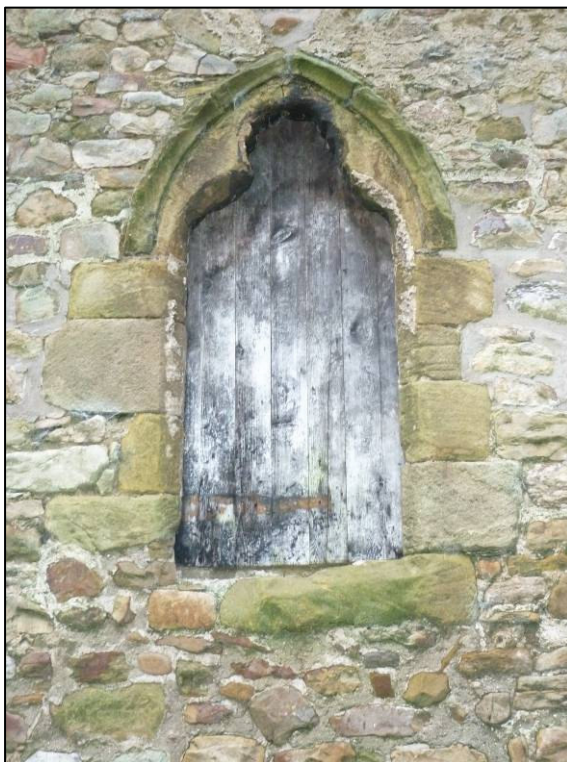
Plate 11: Medieval building, first floor window to north gable, looking S (photo 2/731).

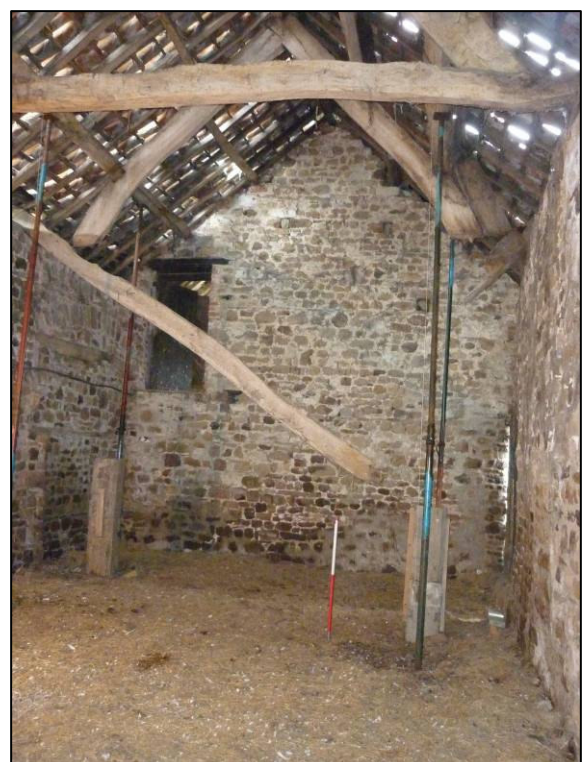
Plate 12: Barn, interior looking W (photo 1/527).

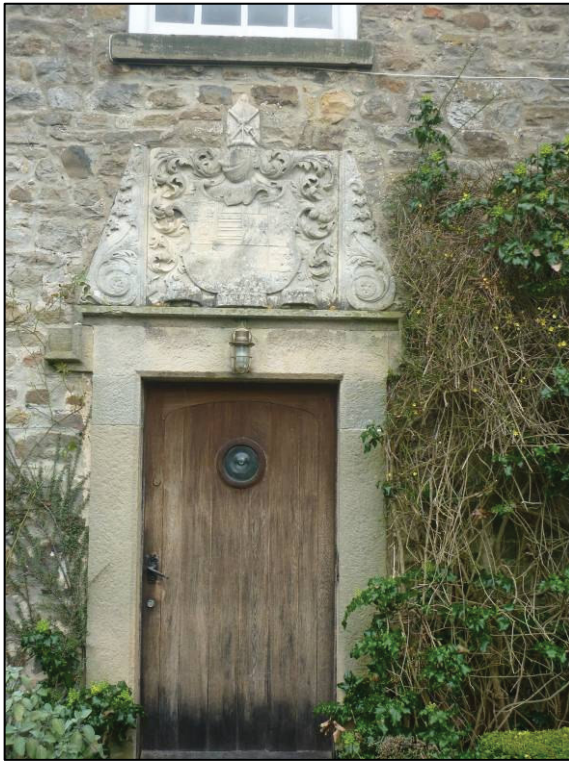
Plate 13: Hall, detail of doorway in south elevation, looking N (photo 4/845).

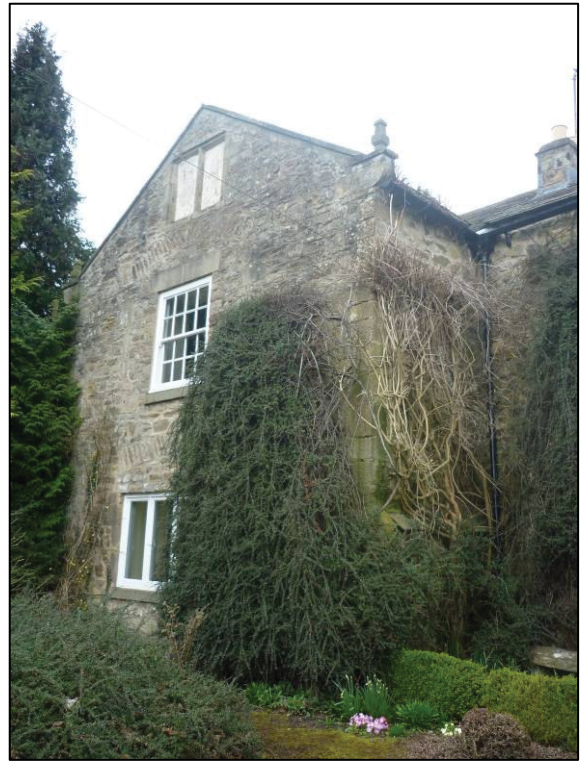
Plate 14: Hall, south gable of cross wing, looking NW (photo 4/846).

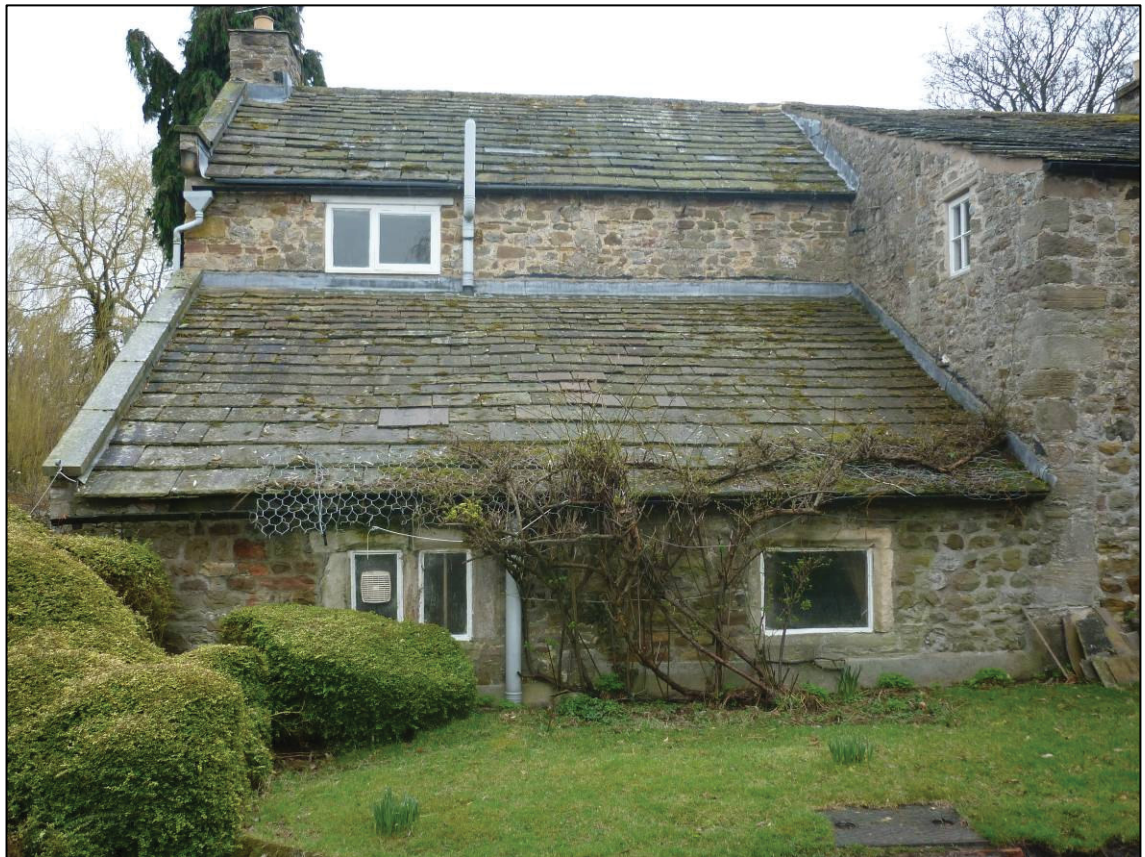
Plate 15: Hall, north elevation of outshut, looking S (photo 4/836).

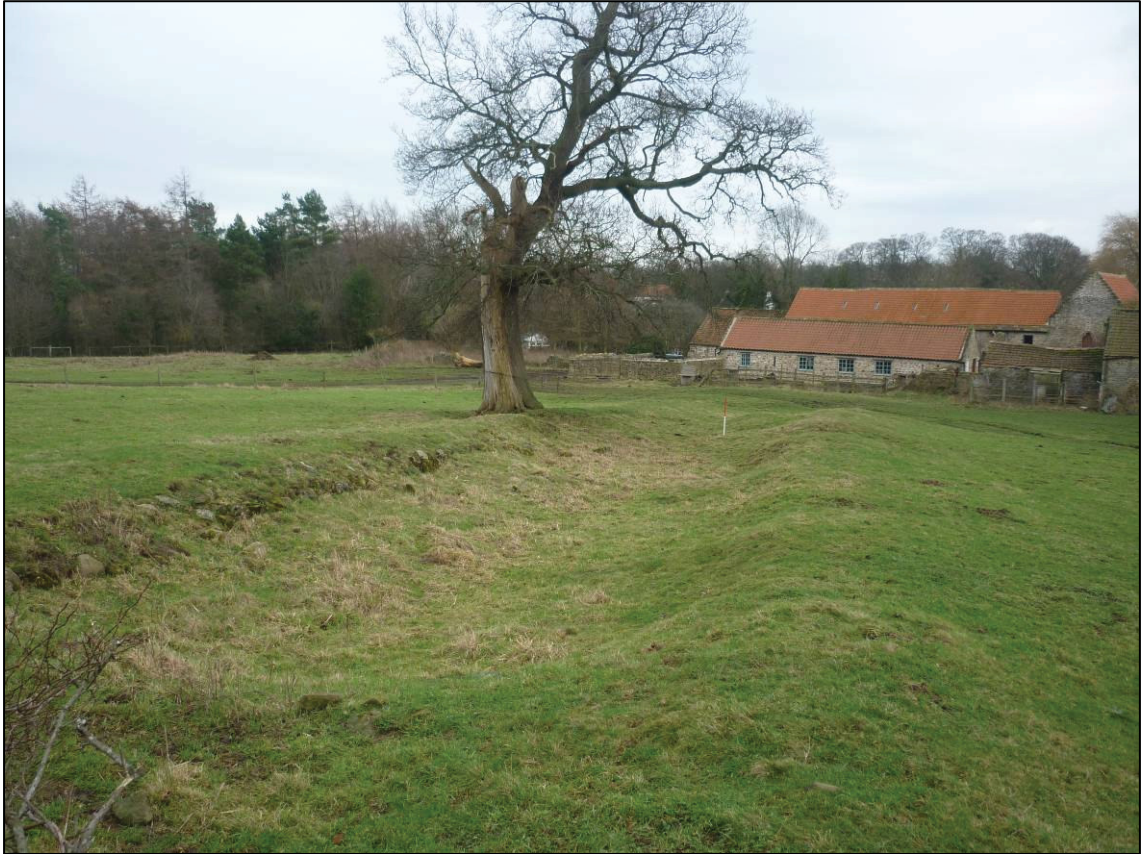
Plate 16: Possible building ('c') and east side of precinct, looking SE (photo 6/258).

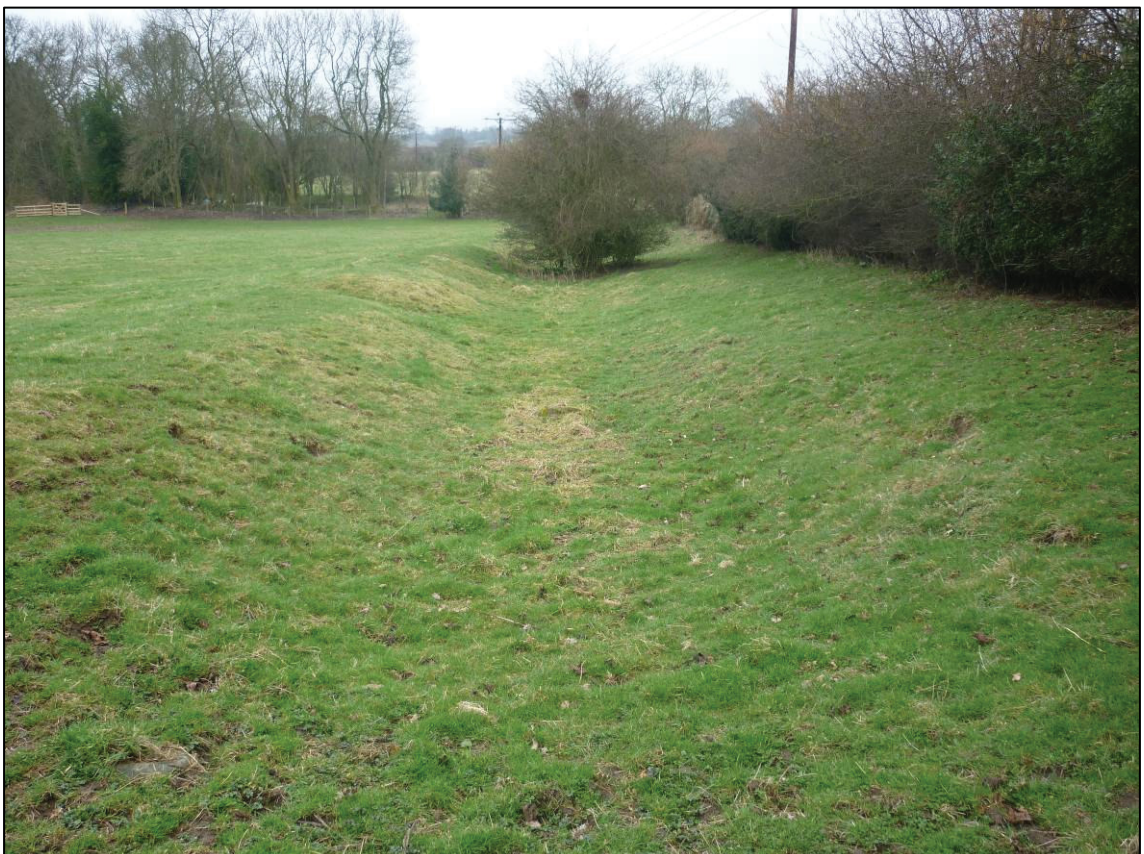
Plate 17: North precinct boundary, looking SW (photo 4/816).

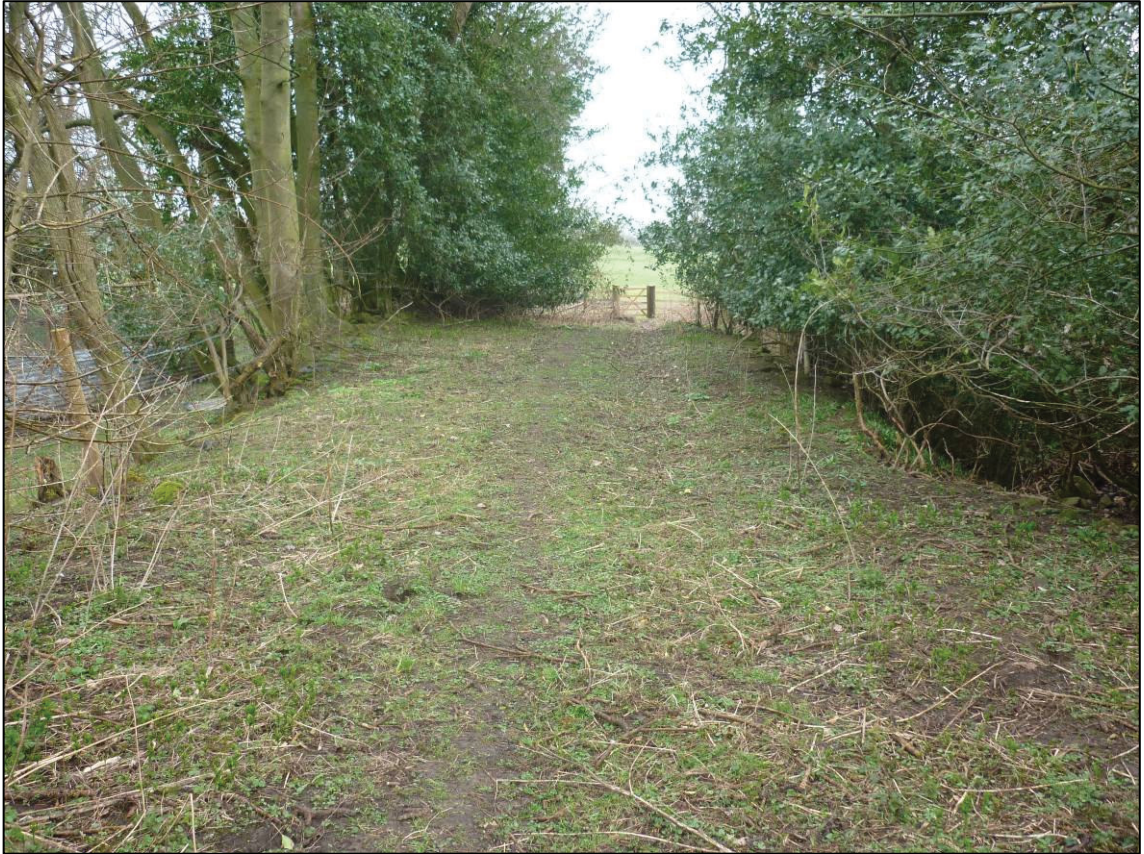
Plate 18: Causeway between ponds, looking SE (photo 4/861).

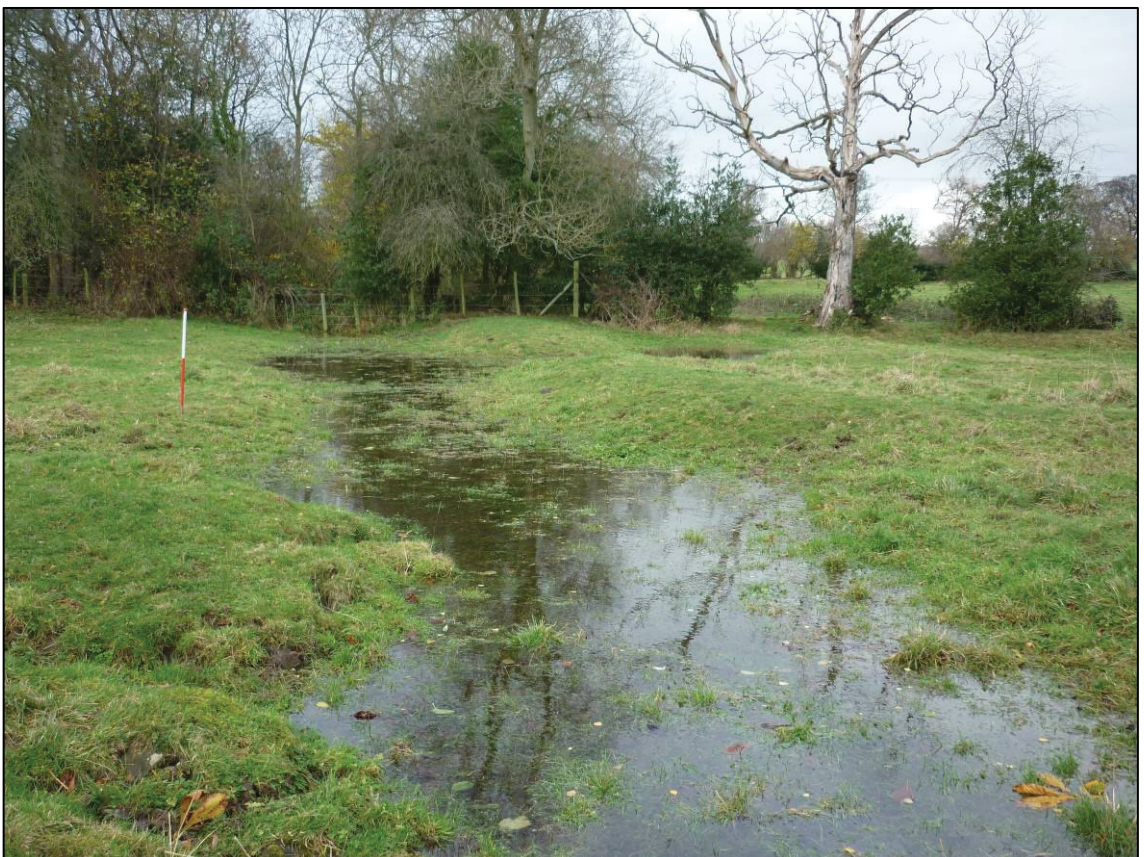
- 5.25 One linear earthwork is represented by a shallow north-west/south-east aligned depression defined by banks on the east and west sides which runs across the field to the west of centre ('k' on figure 12). The flat-bottomed depression is on average 5m wide and up to 0.8m deep [1/524, 7/317 and 7/318] (see plate 19) and, as has been noted above (para 5.18), its base is set at a level which would have allowed water to flow between it and the pond to the north; it remained very marshy at the time of the survey. It appears to cut a second linear depression running at right angles ('l'), although the banks on the east side return around the second depression to form its north and south sides. A shallow sub-oval depression diverges from the north end of the east side of the linear earthwork, which can be traced as far as a modern post and wire fence. The south end of the linear earthwork also merges with a much smaller north-east/south-west linear depression, and appears to continue beyond it for a short distance before meeting the south boundary wall of the field [7/319]. Segments of the linear earthwork were also identified by the magnetometer survey (see figure 13) (Harrison 2012). It is possible that this ditch represents a southern continuation of the west side of the enclosure and/or be associated with former settlement in this area (see Chapter 6 below).

Plate 19: North half of linear ditch ('k'), west of the Hall, looking NW (photo 1/524).
