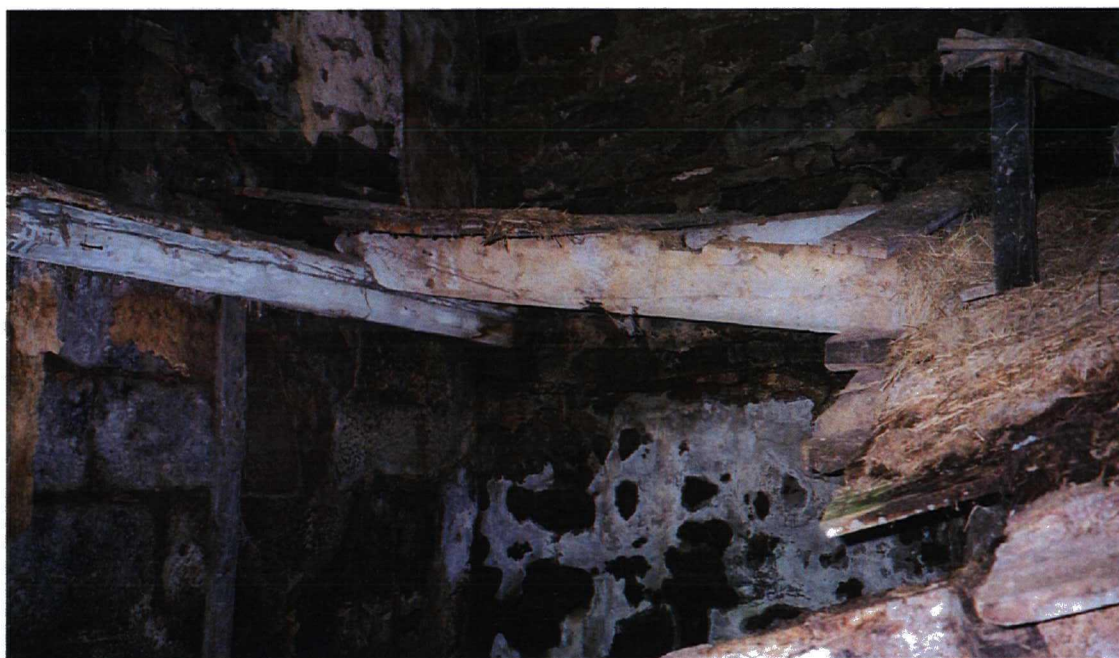
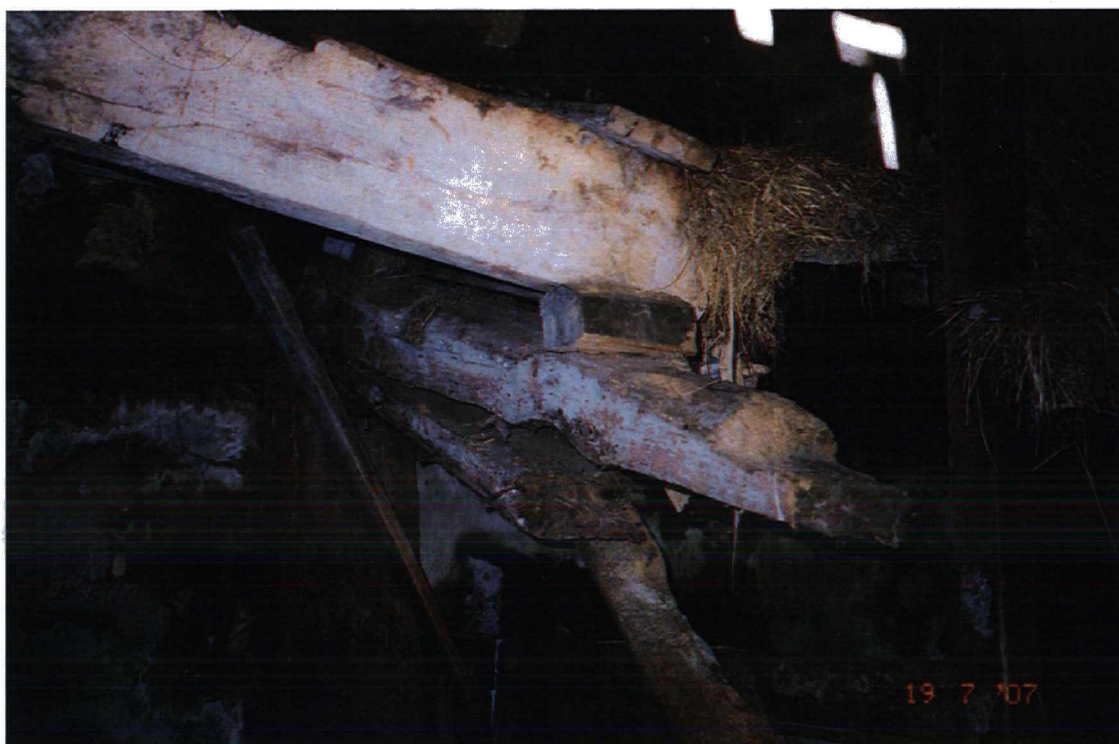
Figs 37 & 38 (below). Brackenridge OF. The collapsed first floor in the north-east corner of the main house (above) and along the north wall, showing original timbers.

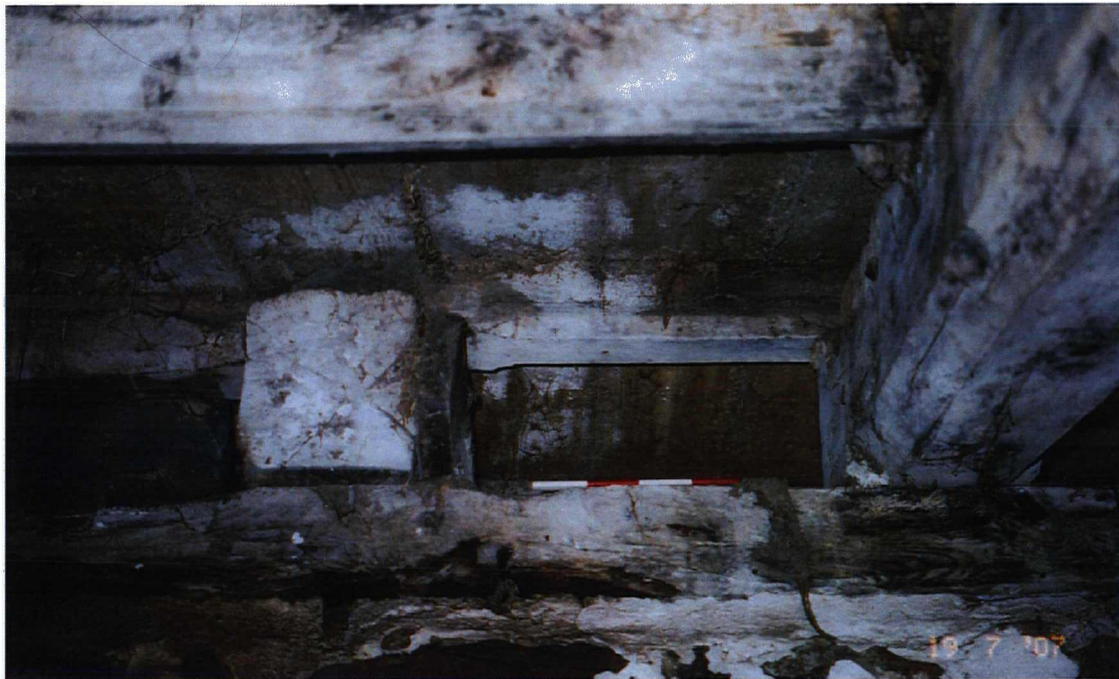
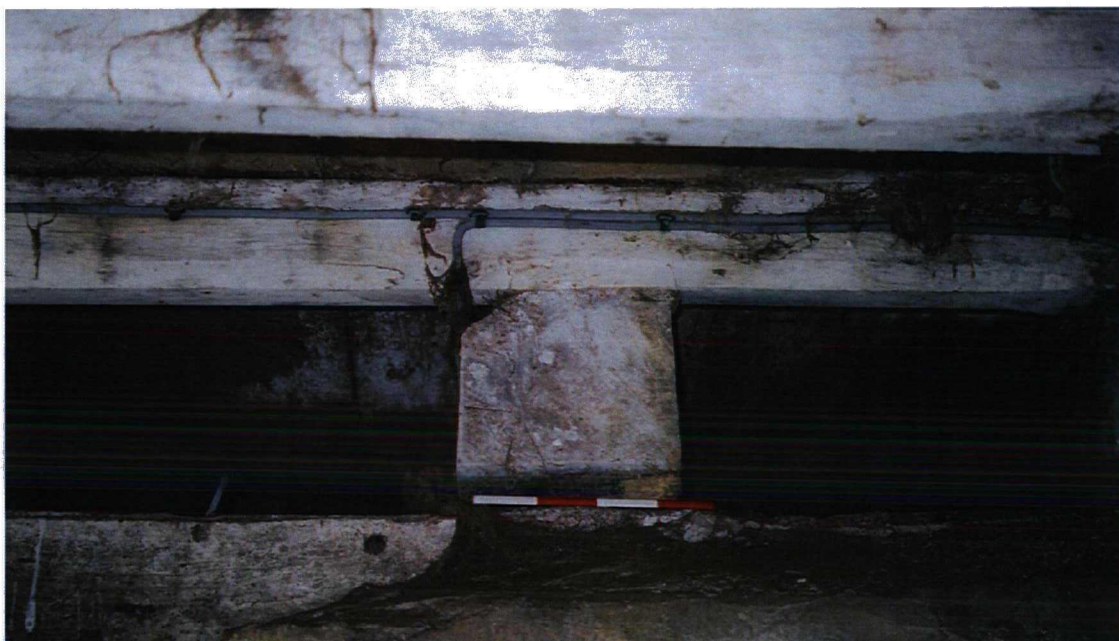
Figs 39 & 40 (below). Original timbers, still in place (right) or re-used (left) supported on the replacement partition wall. The re-used beam below has been turned so the chamfer is on the top left instead of the bottom.

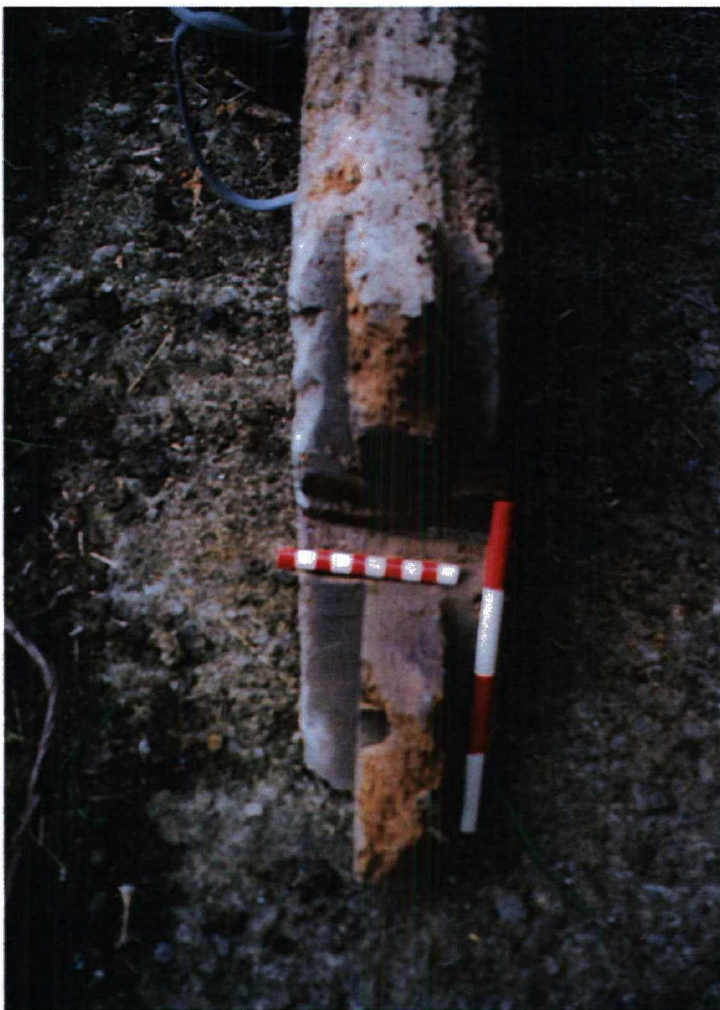
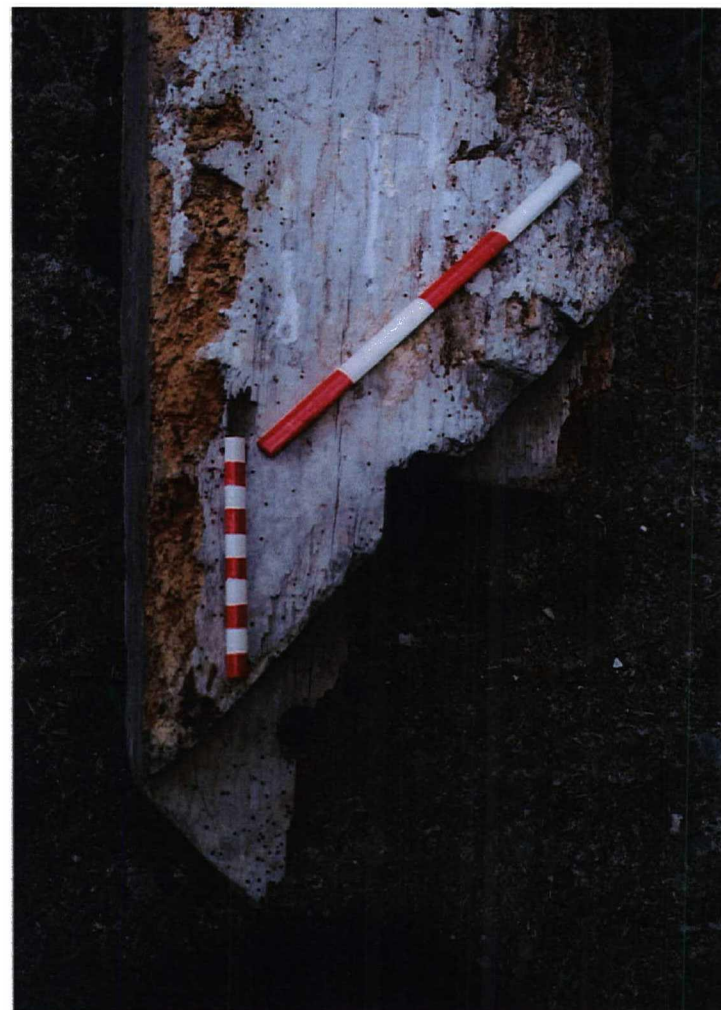
Figs 41 & 42; details of carpentry.

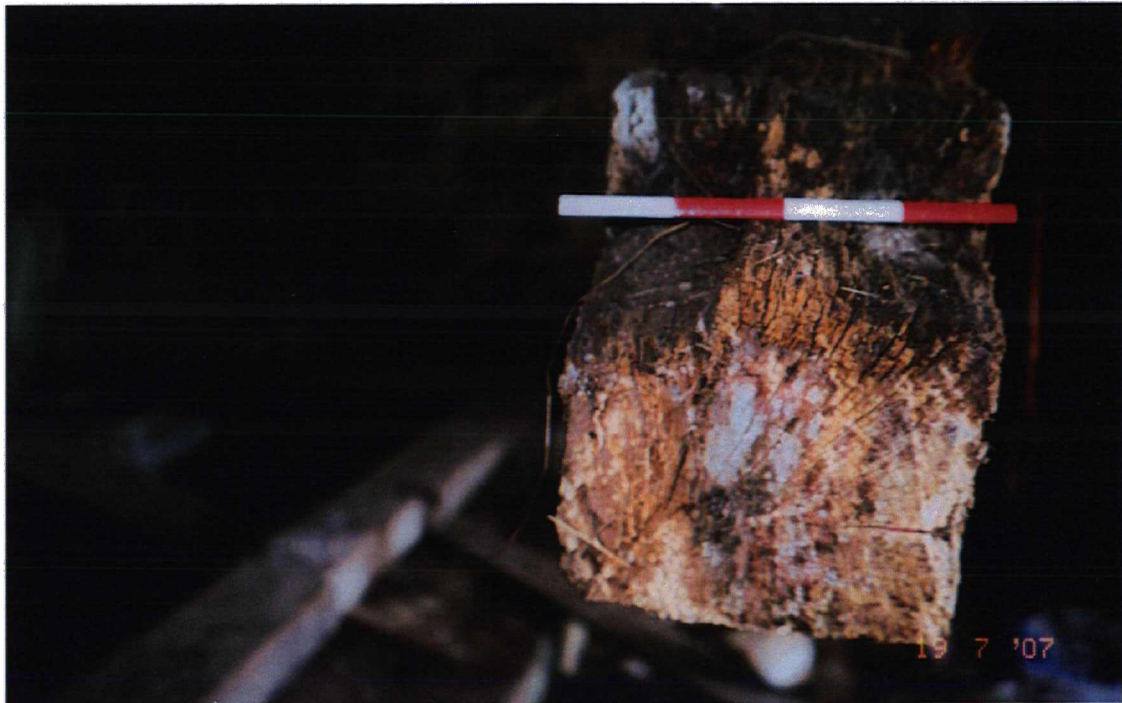
Fig 43 The recently sawn-off end of the original east-west beam supporting the first floor in the main house.

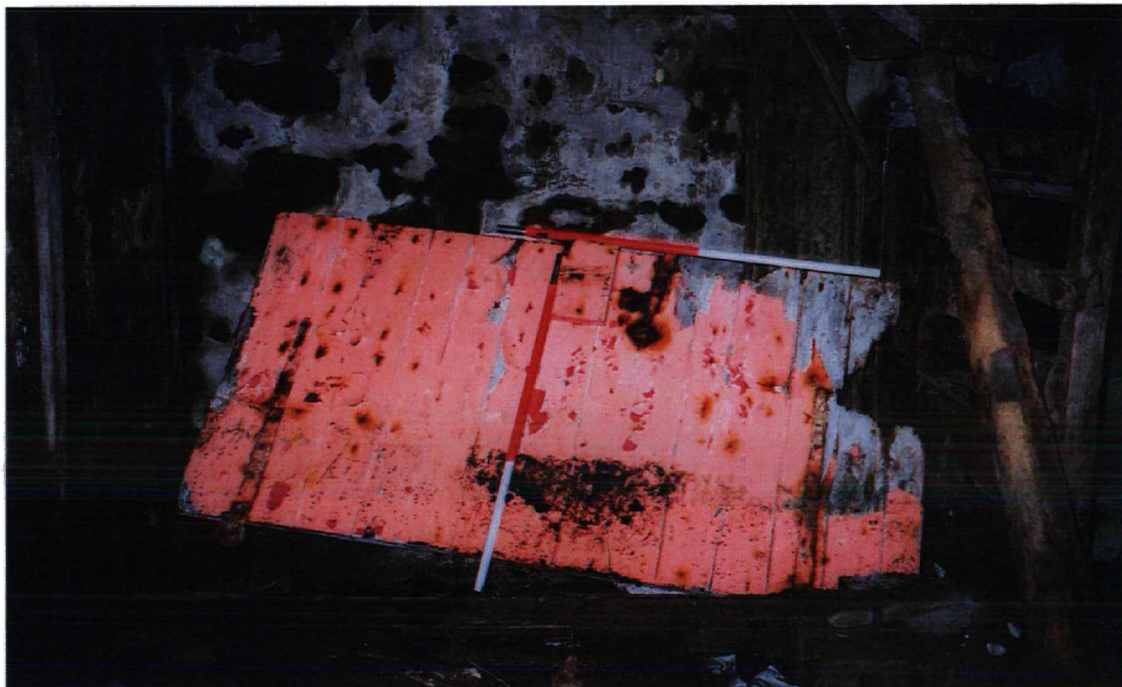
Fig 44 An exterior door, found in the main house, with horizontal planking. This may be the original front door.

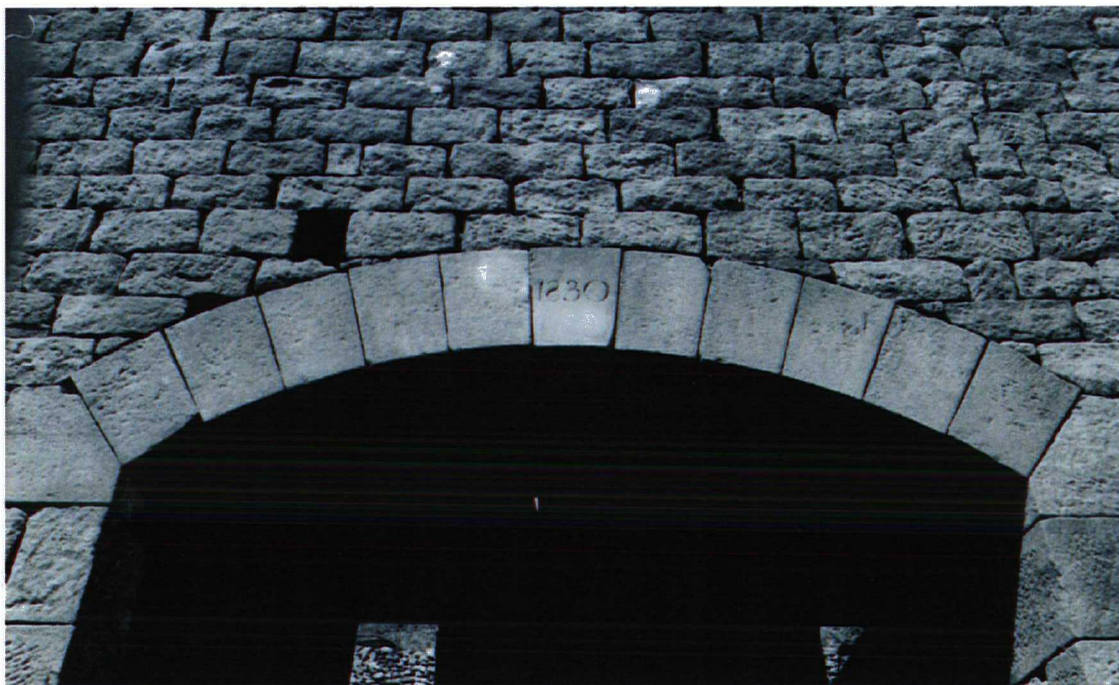
Fig 46. Brackenridge Field Barn. Detail of entrance with date.
