PICKHILL BECK IMPROVEMENT SCHEME

ARCHAEOLOGICAL WATCHING BRIEF

PICKHILL VILLAGE GREEN AND MONEY HILL

LOWER SWALE INTERNAL DRAINAGE BOARD

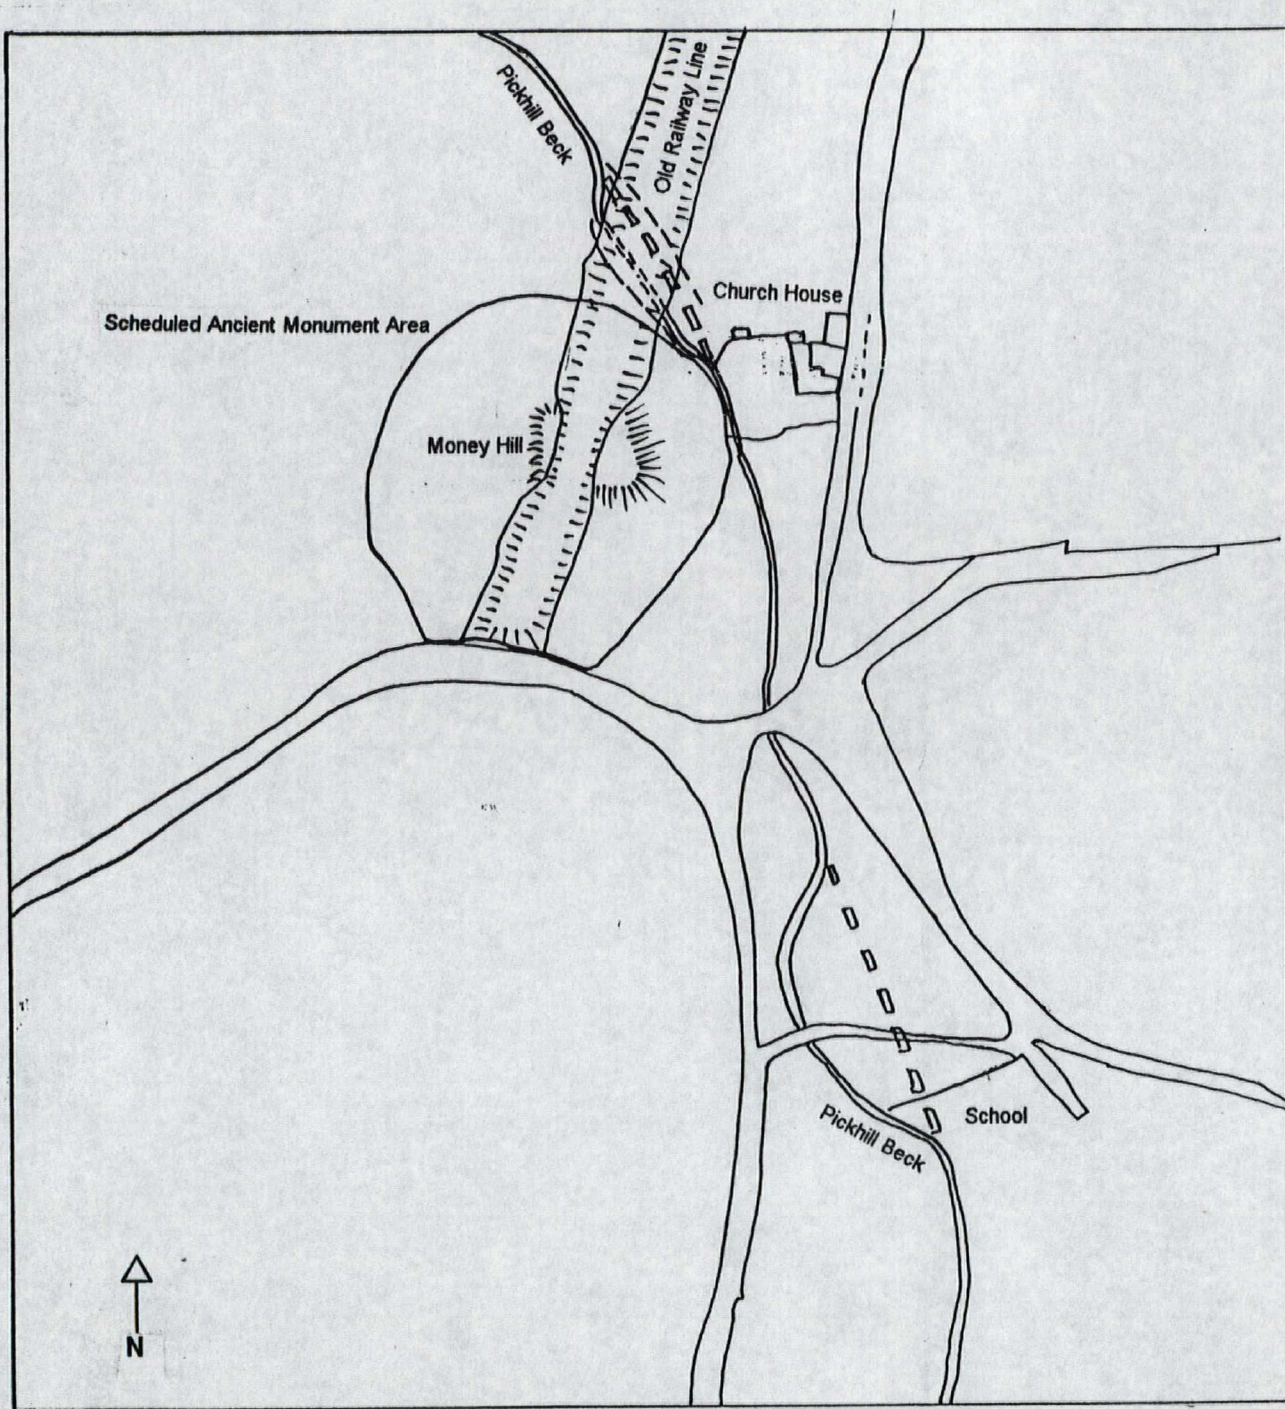
PICKHILL BECK IMPROVEMENT SCHEME PLAN 1

To the north of the Monument, a new line for the beck was cut to the east of a culvert under the disused railway line which bisects Money Hill. The edge of the cutting for this new line is extremely close to the limit of the Monument, but the ground here is made-up ground for the railway embankment and there is no damage to the Monument itself assuming that the new cutting bank is stabilised.

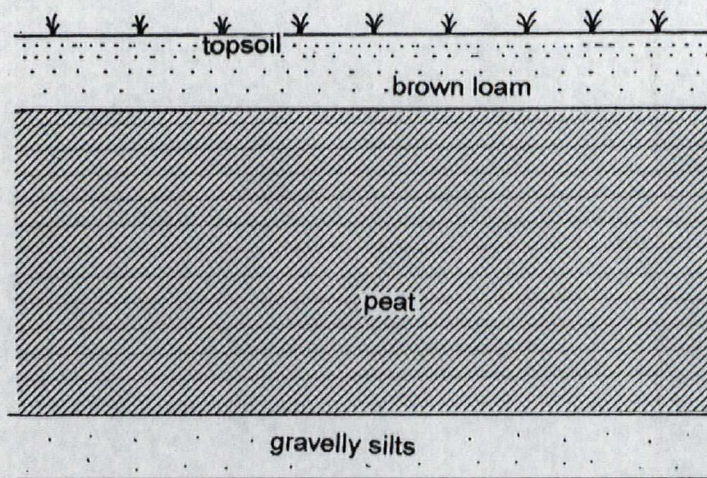
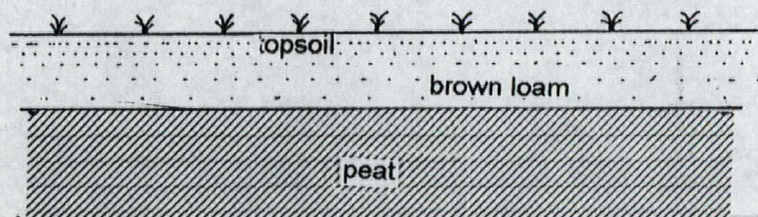
PLAN 2 SCHEMATIC SECTIONS THROUGH TRENCH

a) IN SCHOOL GROUNDS

b) ON VILLAGE GREEN

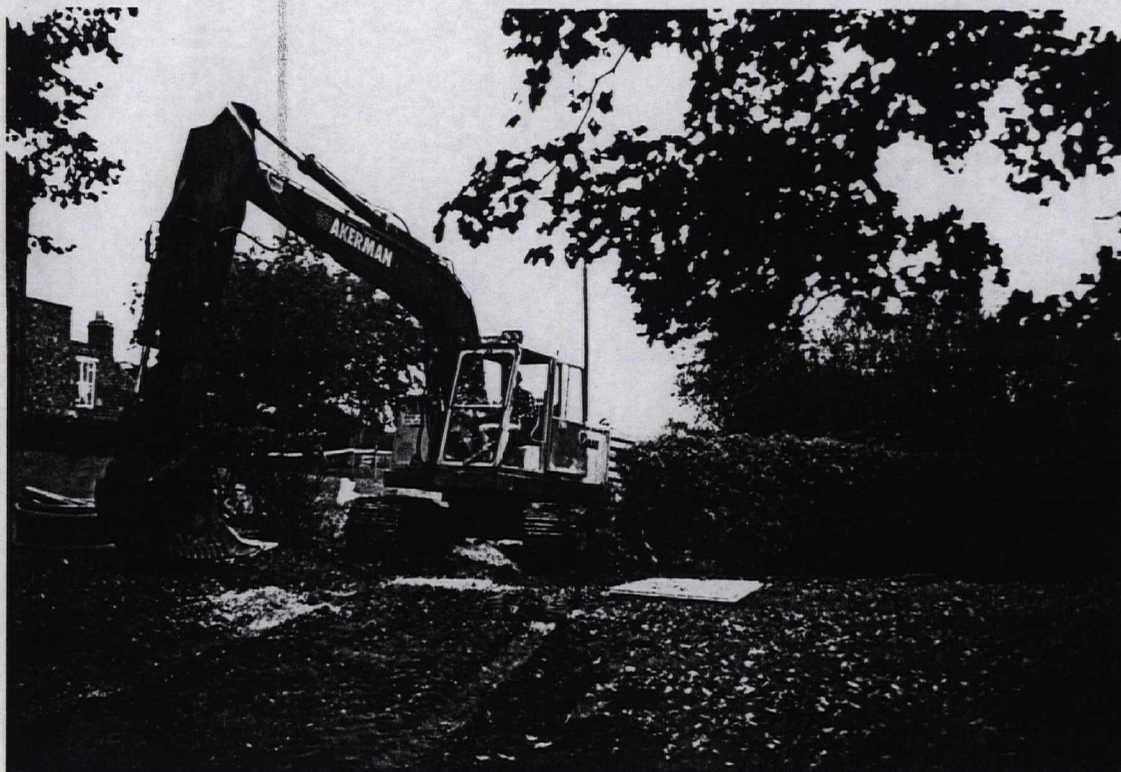
PLATE 1 SCHOOL GROUNDS LOOKING NORTH

Work started on culverting the beck to the south of the green, in the grounds of the school (plate 1), and moved northwards across the green. The machine cut trench was 2.8m. to 3m. deep, and 2m. wide. The topsoil was approximately 10 cm. deep, and overlay 30 to 40 cm. of brown loam which became paler towards the bottom (plate 2). In the school grounds there were some signs of modern disturbance in this layer, including the base of a brick wall, tile fragments and pottery.

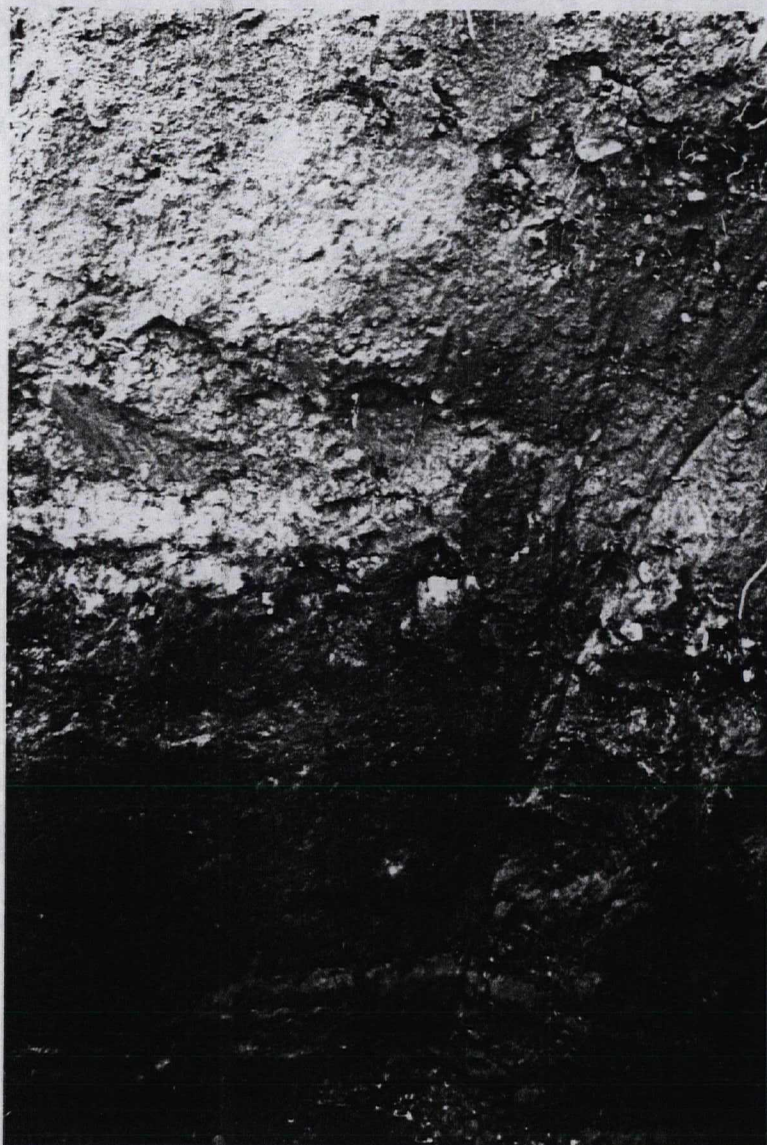
PLATE 2
SECTION SHOWING
TOPSOIL AND PEAT

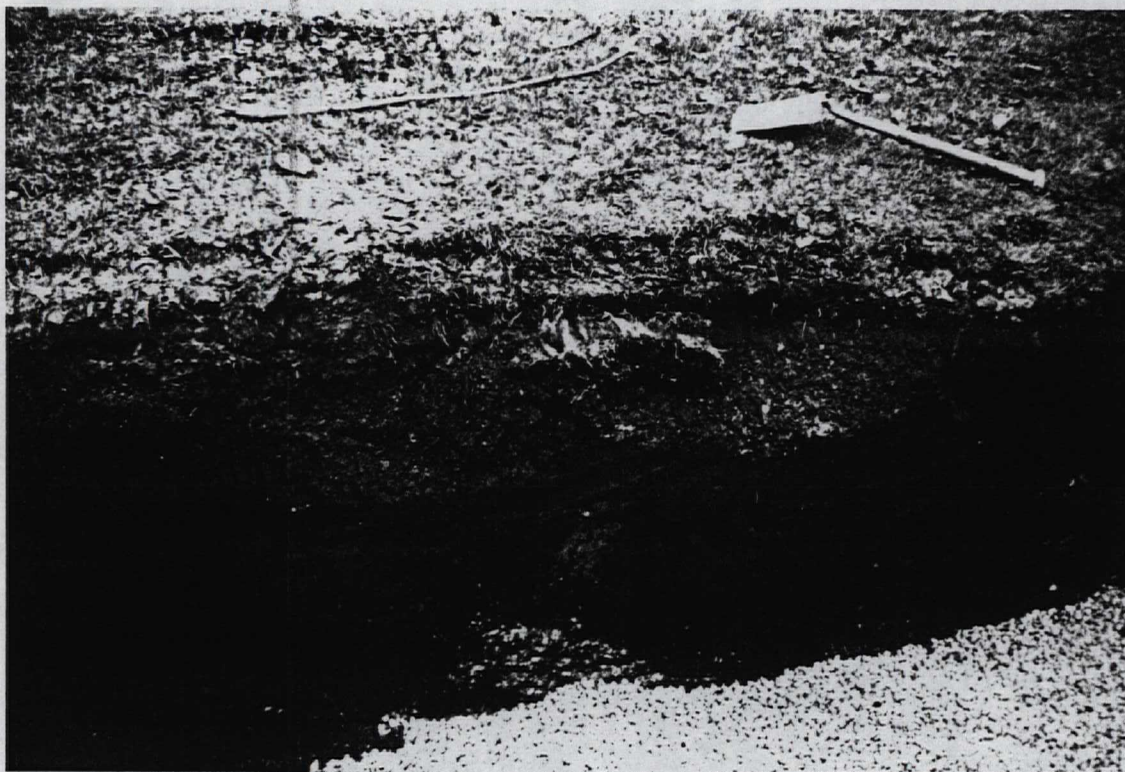
There was a generally clear interface between the brown loam and the underlying black peat (plate 3) which formed a band up to 2m. thick at the southern end of the trench (plate 4), narrowing to 50 cm. by 5m. north of the school grounds. The thickness of the peat varied from here northwards right across the green between 50 cm. and 1m., beginning at between 40 and 50 cm. below the surface (plate 5). There was no evidence visible of medieval rigg and furrow. The peat itself contained large pieces of wood and was very wet and unstable. No finds of archaeological material were recovered.

PLATE 3 SECTION SHOWING TOPSOIL/PEAT INTERFACE

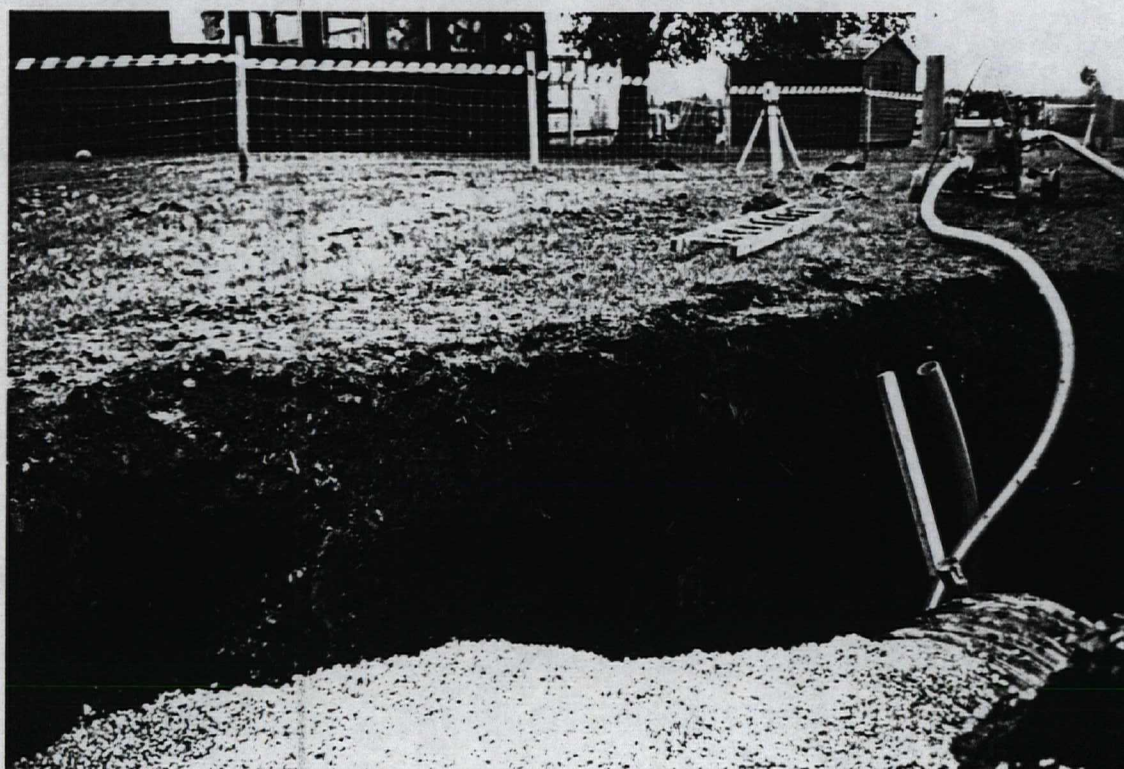
PLATE 4 SECTION SHOWING PEAT BAND

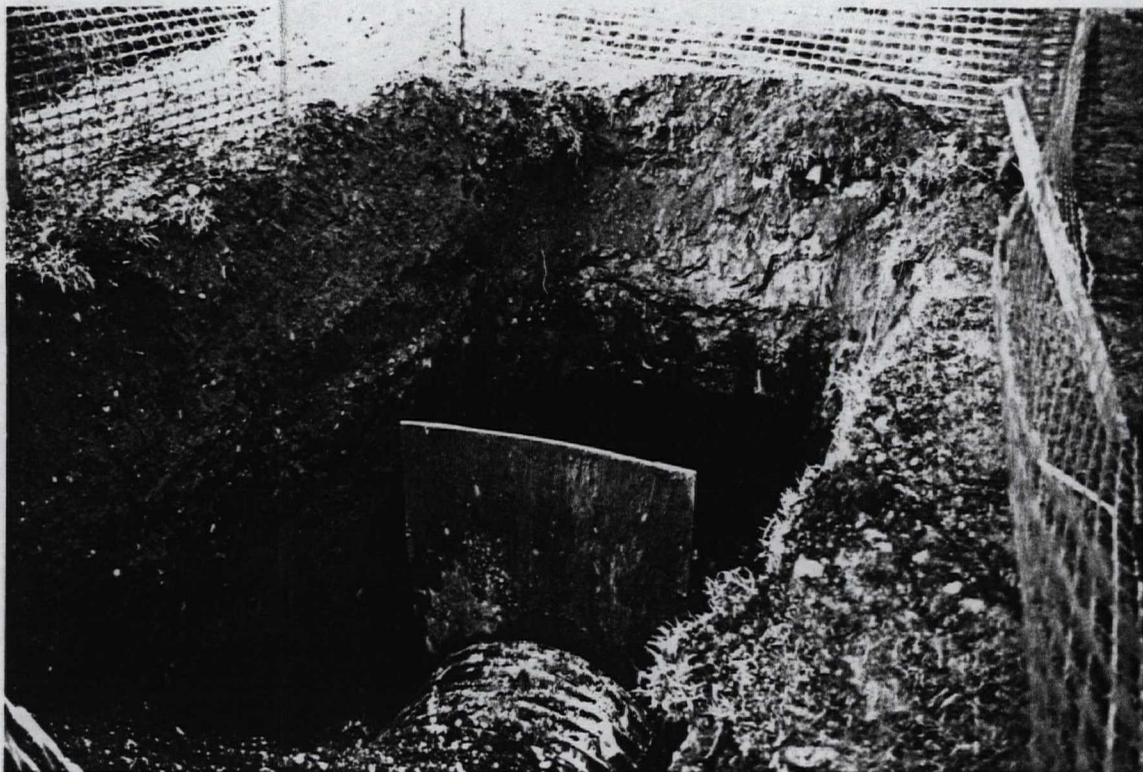
PLATE 5 SECTION IN CENTRE OF VILLAGE GREEN

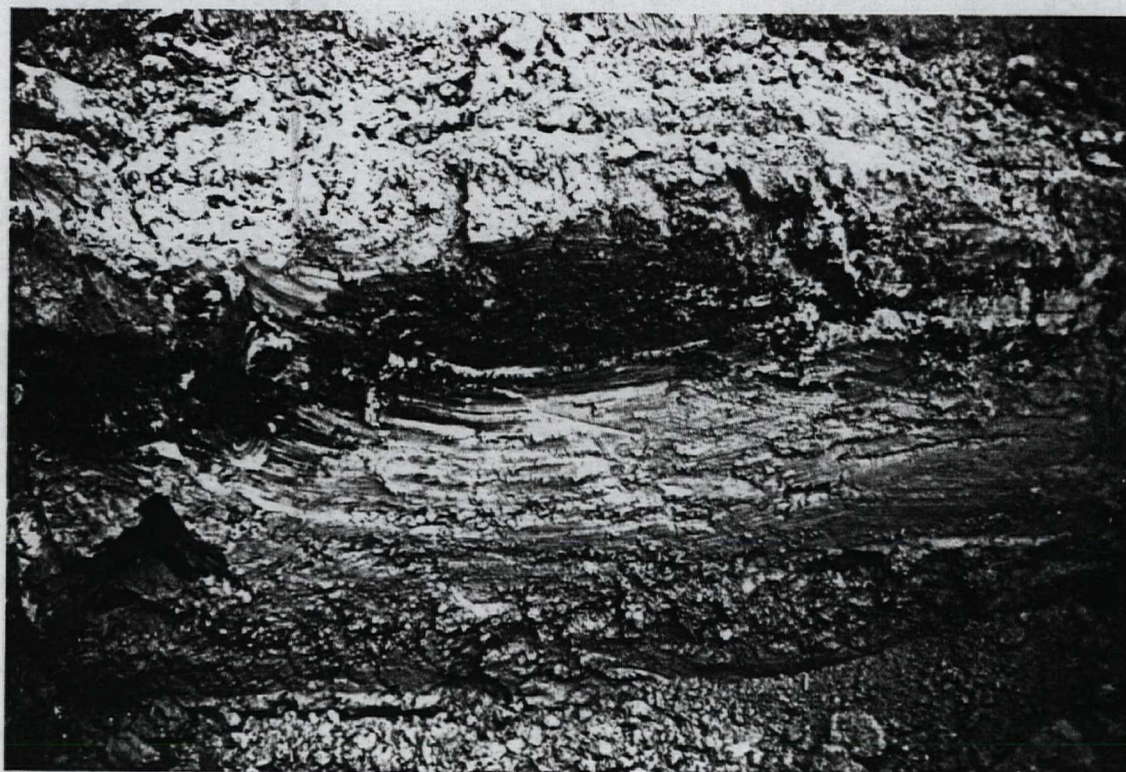
The peat overlay variable silts and clays. In the school grounds these were very gravelly silts, pinky grey in colour, changing to stony blue-grey or pink-brown clays and silts in the south of the village green. In the central part of the green, yellow silty clay beneath the peat gave way to blue and grey-pink clay (plate 6). To the north, near to the road, the clay was brown-red with patches of pale grey coarse gravel immediately below the peat.

PLATE 6 SECTION SHOWING PEAT/CLAY INTERFACE
