***AN ARCHAEOLOGICAL WATCHING BRIEF
AT THE BARN PUBLIC HOUSE
OSGODBY, NEAR SCARBOROUGH***

**SCARBOROUGH ARCHAEOLOGICAL AND HISTORICAL SOCIETY
INTERIM REPORT NUMBER 28: 1997**

This report covers an archaeological watching brief carried out by the Scarborough Archaeological and Historical Society in September 1997 at the Barn Public House, Osgodby (NGR TA0556 8473, Site Code TB/97).

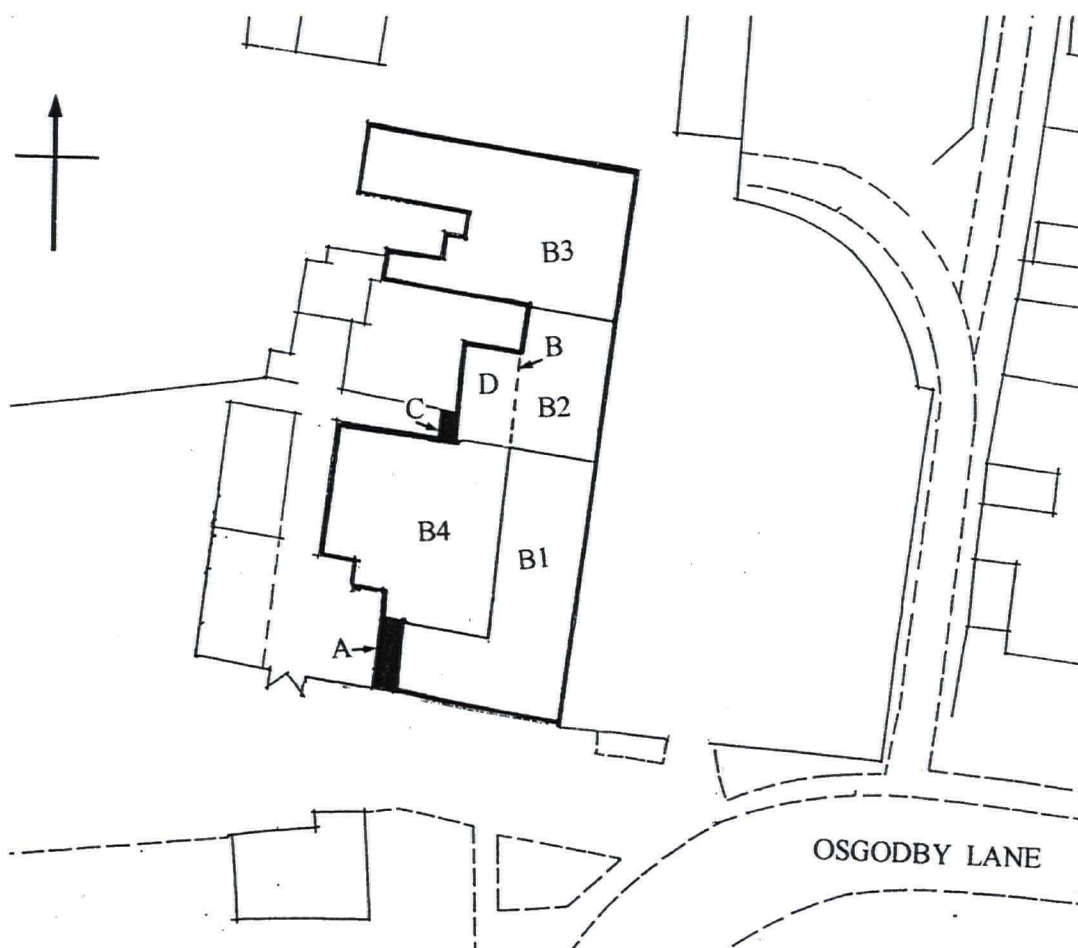
FIGURE 2 The location of various elements of the buildings complex and the location of the archaeological investigations. Scale 1:500

The locations of the works covered by the watching brief are shown on Figure 2. They comprised the following:-

A. Erection of a disabled toilet extension at the rear in the re-entrant between a wing to the former barn and the 1974 extension B4.

B. Formation of an opening in a stone internal wall in B2 i.e. the central of the two former houses. This would have been an external wall, but an extension had been added against it at this point before the large scale 1852 Ordnance Survey map was surveyed.

C. Erection of a covered entrance in the re-entrant between the 1974 extension and the outbuilding referred to in 'B' above.

D Installation of drainage runs within the catering kitchen in B2

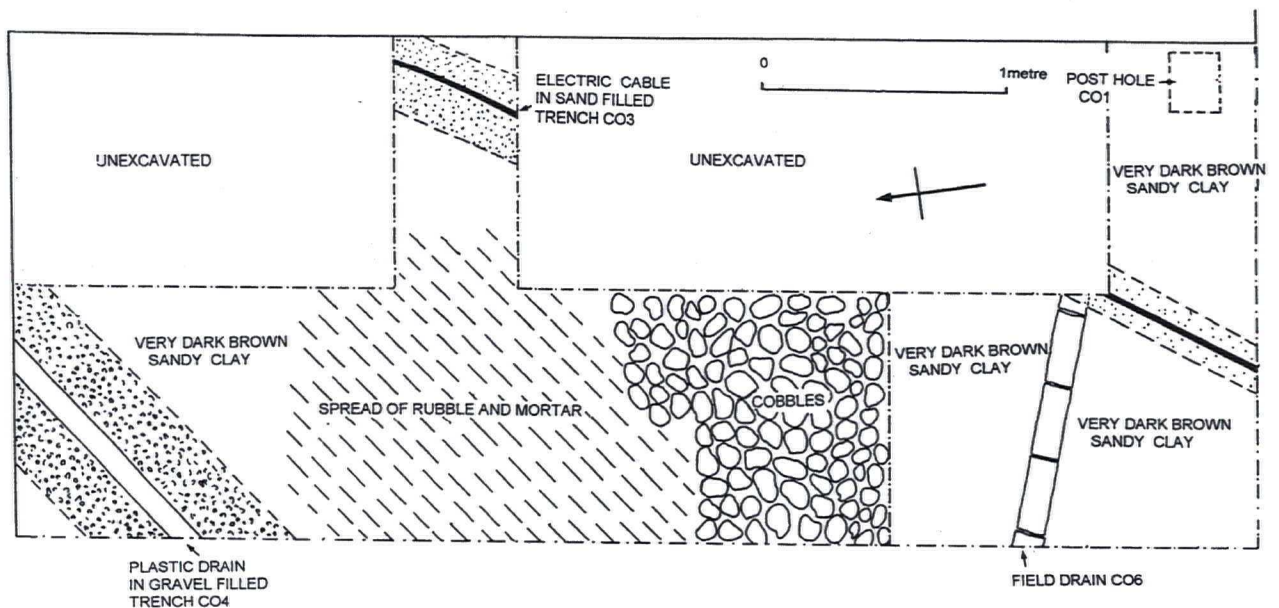
FIGURE 3 Plan of Excavation of area A

The stone and concrete surface were removed to allow the excavation of foundation trenches comprising a 1.0 metre wide north-south aligned trench and two shorter trenches between the latter and the stone building (Figure 3). The intervening areas were left undisturbed.

Within the main trench a small area of cobbled surface was revealed, whilst to the north of this lay a spread of rubble and mortar, the latter either being a spread of demolition rubble or the base course for the concrete. In the other locations the stone/concrete surface lay directly onto a dark brown sandy clay which was subsequently interpreted as natural.

This natural was cut by four features:-

CO1 adjacent to the building was a post hole containing a dark brown soil and a large fragment of timber, interpreted as a gate post or support for the farm building which was erected here between 1928 and 1938.

CO3 an electric cable in a sand filled trench running diagonally across the site.

CO4 a plastic drainage pipe in a 600mm wide gravel filled trench associated with the 1974 extension to the north.

CO6 a field drain cut directly into the natural clay

No foundation trench for the stone barn was evident. The presence of features CO1 and CO3 would have largely destroyed any evidence of a foundation trench but in any event it was also apparent that this building had virtually no foundations, being built directly off the natural clay.

Apart from the cobbled surface, which was only fragmentary, nothing of archaeological significance was revealed or destroyed. No dating evidence for the barn was found.

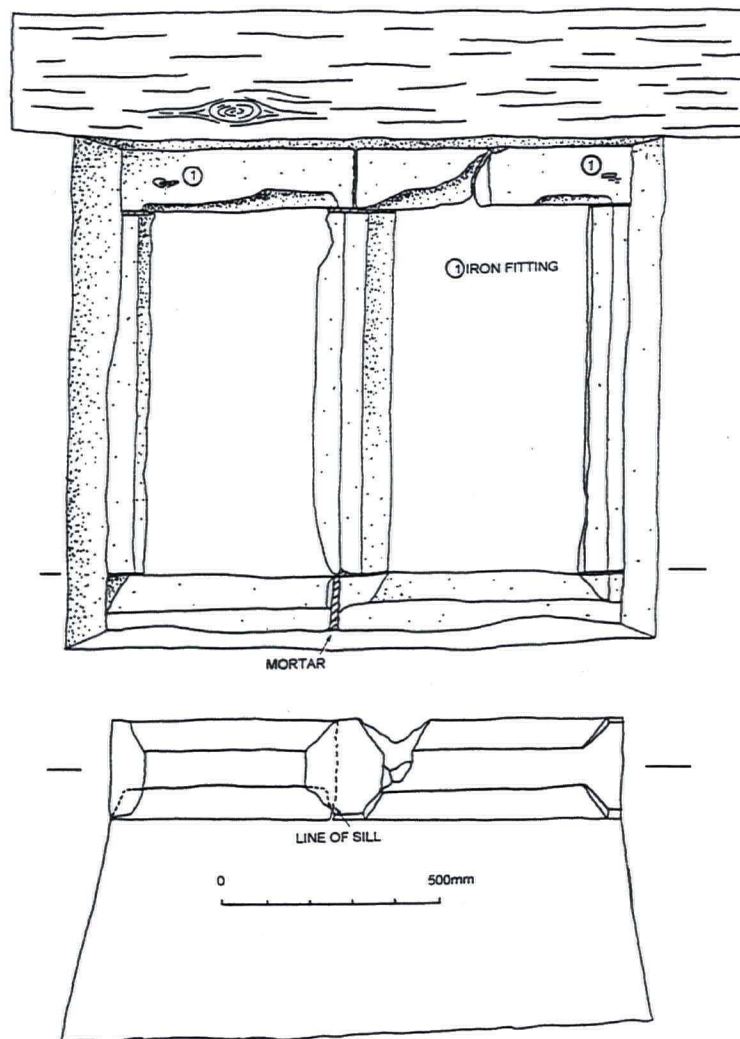
FIGURE 4 Elevational and sectional drawing of the two light mullioned window

The ground floor wall in building B2 to be demolished to form the new opening was 700mm thick, with a rubble core. It contained a two light mullioned window, 1400mm from the cross wall between building B2 and B1 which had been blocked from the outside when the pre1852 kitchen extension was built. The plaster infill was removed revealing that the former outside face had been damaged by the later building work which had included a cross wall built against the mullion. The remainder of the window was in poor condition. The lintel was a fake plaster one which proved to mask a much decayed oak lintel which was recorded photographically on its removal.

Two other points to note were a straight joint in the masonry between the window and the cross wall referred to above (850mm from the window) and a projecting stone block 140mm to the right of the window (looking from within the room) and 500mm below the lintel line. No explanation for these features could be ascertained.

This window was recorded in detail photographically and by measured drawing (Figure 4) before its removal. The poor condition of the window could perhaps be attributed to the period when the Old Hall fell into ruin after the last Osgodby Wyvill died in 1705, without issue. The hall was left to a relative Sir Marmaduke Wyvill and was not lived in again, it was subsequently rebuilt in the form in which we know it today [Rimington, 1960]. The lower left hand sill appeared to be a replacement.
