The historic farm buildings at Scalby Lodge Farm, numbers 6, 7, 10, 12-15, 19-21 and 23 are worthy of preservation. They have minimal agricultural use today and appear to be in receipt of little maintenance. Certain elements of these buildings including for example some windows, fireplaces, fittings, etc have also been lost and replaced over the years. It is probable that the longer term survival of these buildings will only be secured by conversion to alternative usage. The context of conversion and renovation needs to be a sympathetic one in which the basic forms and openings are retained with any alterations to these key characteristics being kept to a minimum. Paramount to acceptable conversion should be the use of traditional materials. It was noted during the survey that the already converted Buildings 7 and 20 had been totally re-pointed ribbon style with a hard cement. This style of pointing is at odds stylistically and ultimately, by using a bonding agent harder than the stone, prevents the movement of moisture and leads to the decay of the stonework. The use of lime mortars, which are readily available and commonly used by conservation orientated companies and organisatio

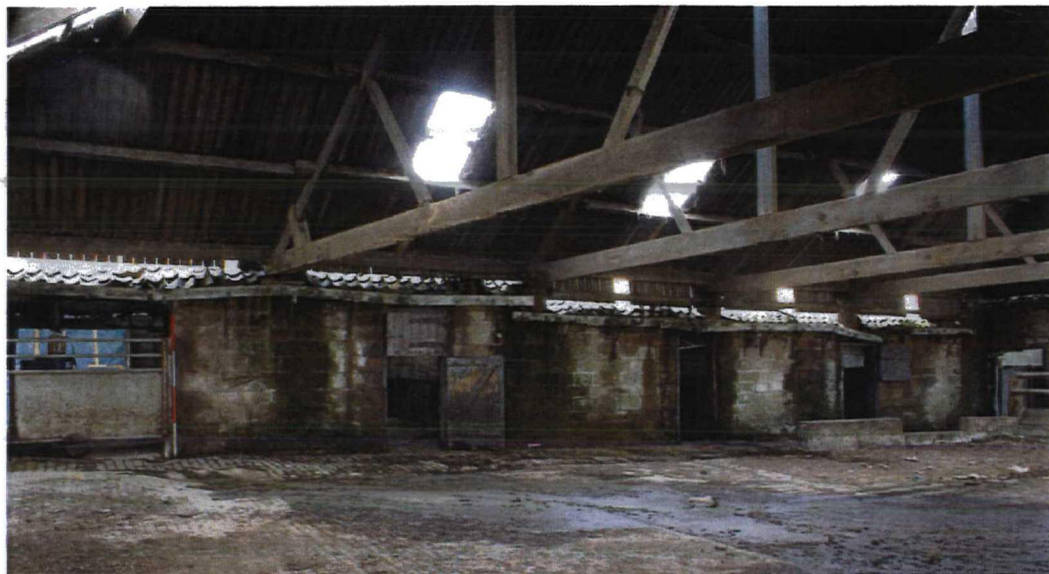
Plate 1 Part of S elevation of Building 6, roofed fold-yard of Building 9 over. Looking N

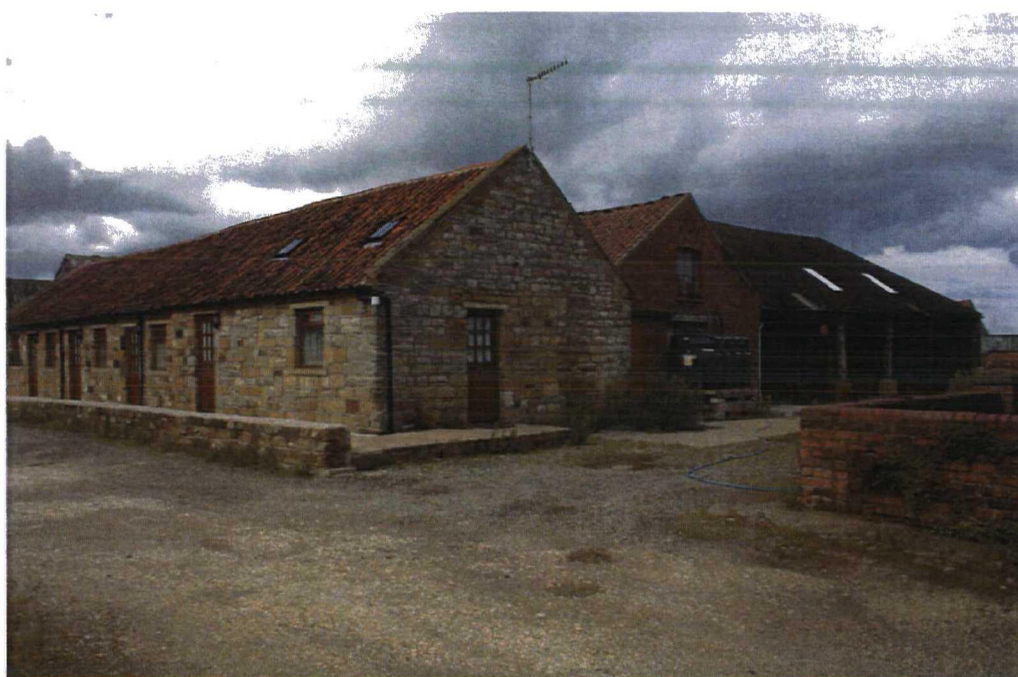
Plate 2 Building 7, with Buildings 8 and 9 to right. Looking NNE

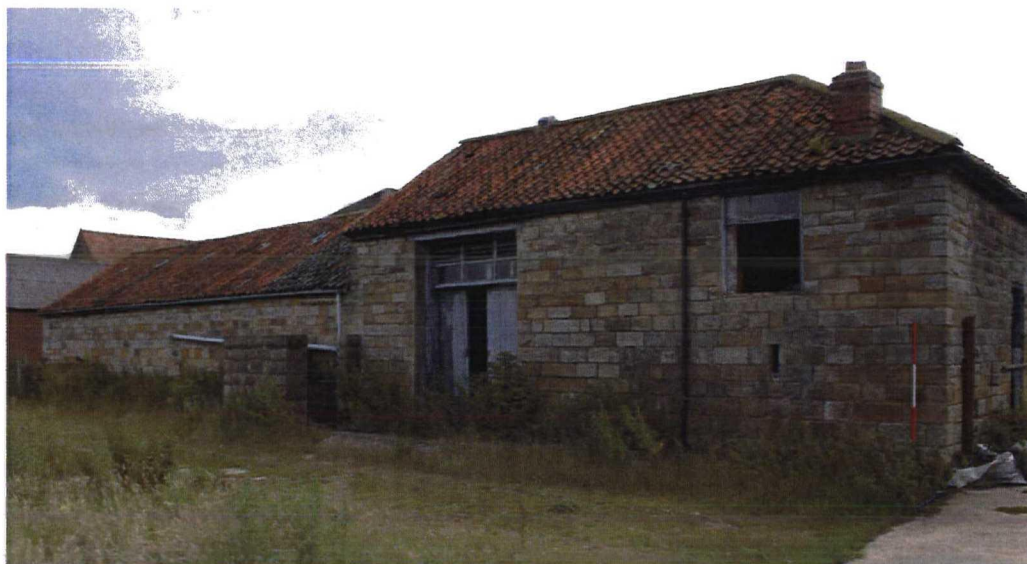
Plate 3 Building 10 with taller N end. Looking SSW

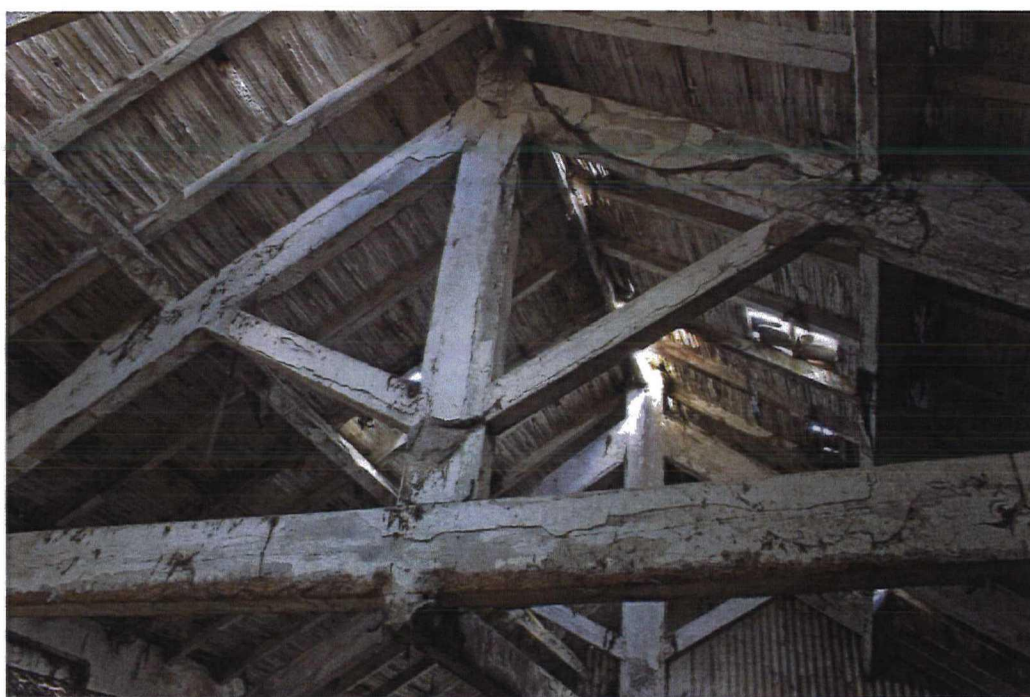
Plate 4 Building 10, detail of king-post roof trusses; roof covering of pantile over laths secured to rafters.

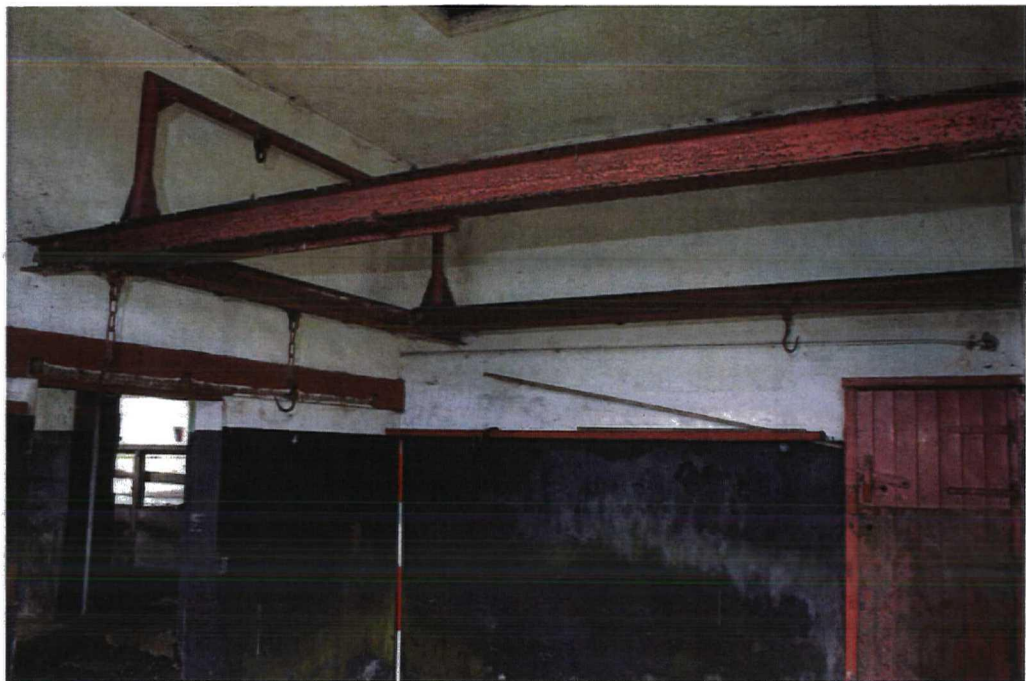
Plate 5 Building 10, the northernmost slaughter room and some of its fittings. Looking S

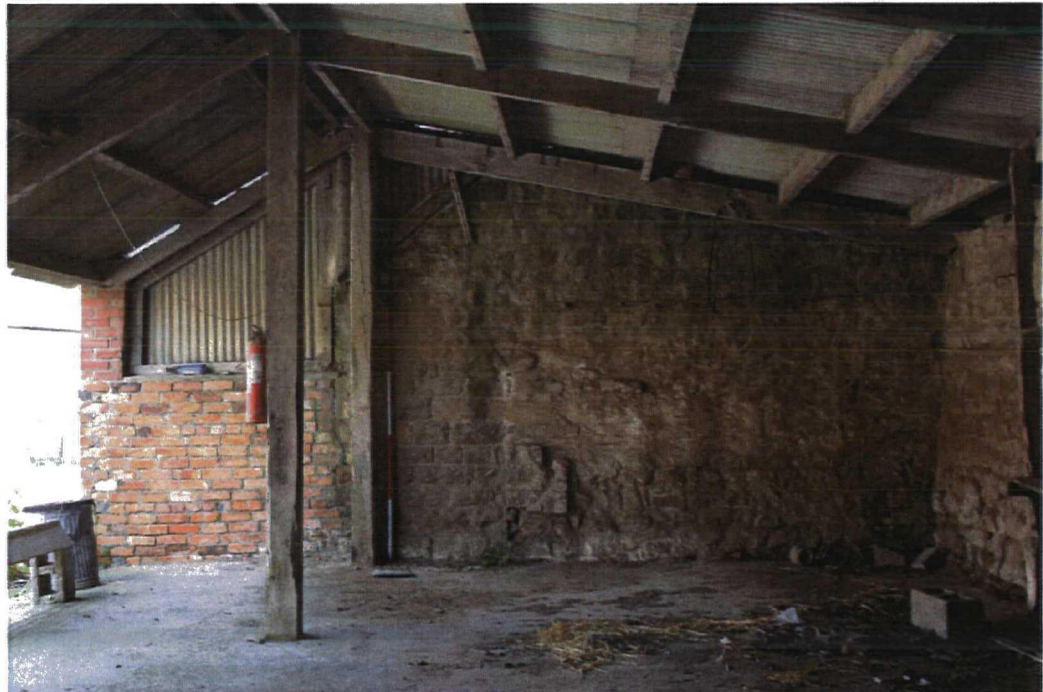
Plate 6 Building 12, internal face of older SE wall with later brick expansion to left. Note old roof line above scale and wall stub to right of this. Looking SE

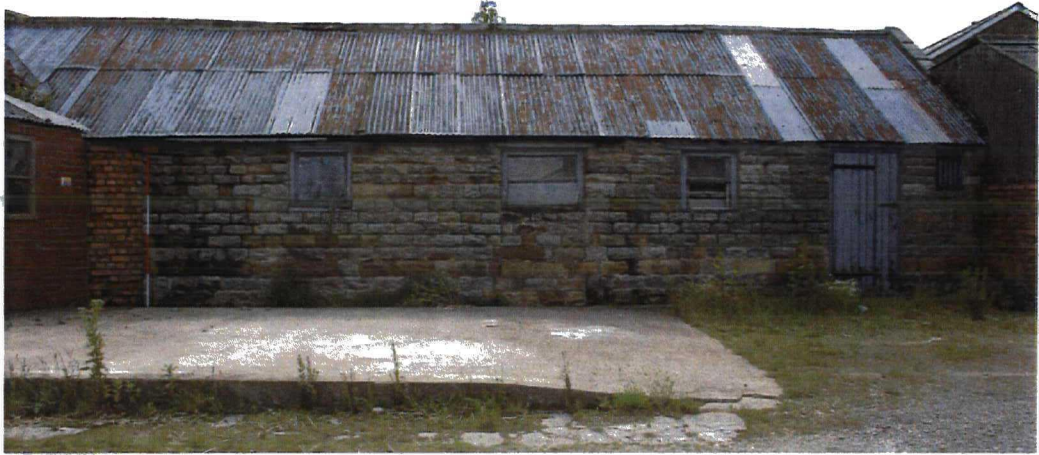
Plate 7 Building 13, E elevation. Looking WSW

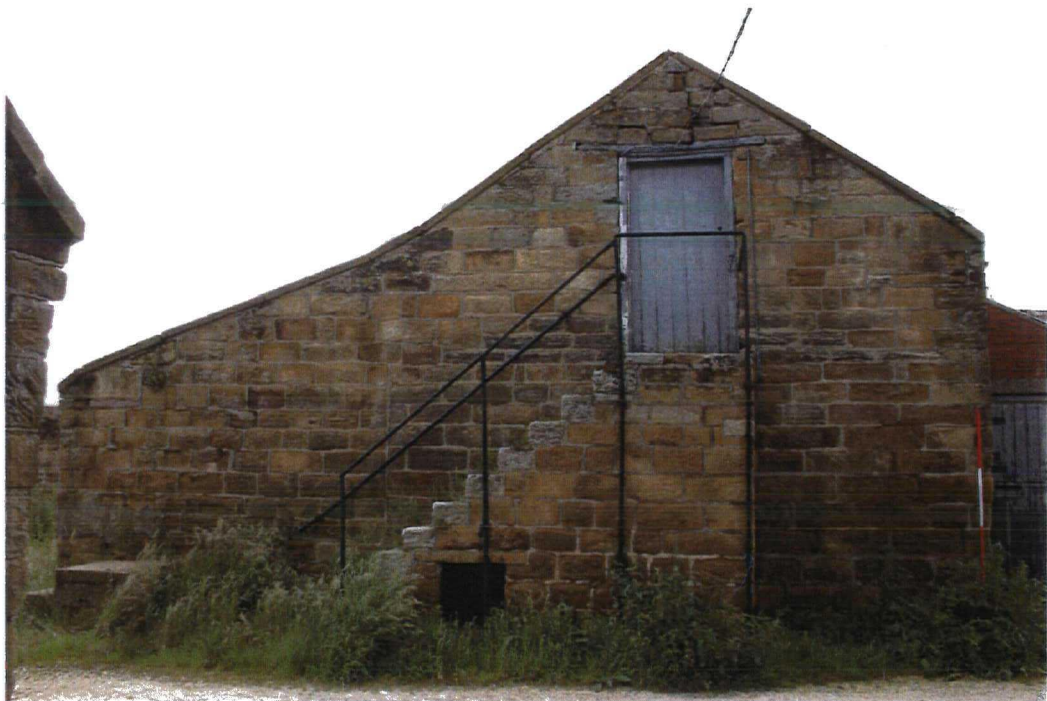
Plate 8 Building 14, E elevation. Steps to loft with kennel and store under. Stable extension to left (note mounting block) and later brick extension to right. Looking W

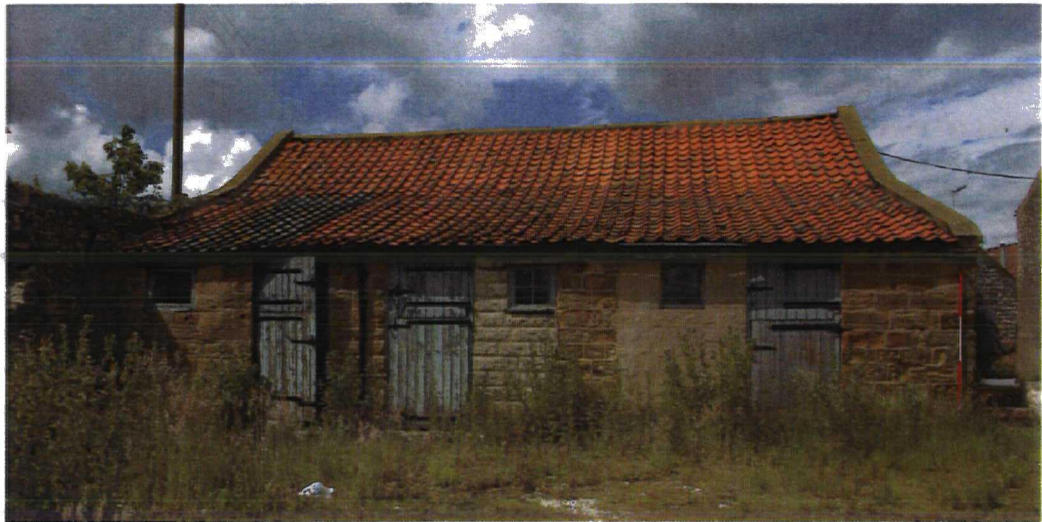
Plate 9 Building 14, S. elevation (stable block extension) note change in roof pitch. Looking NNW

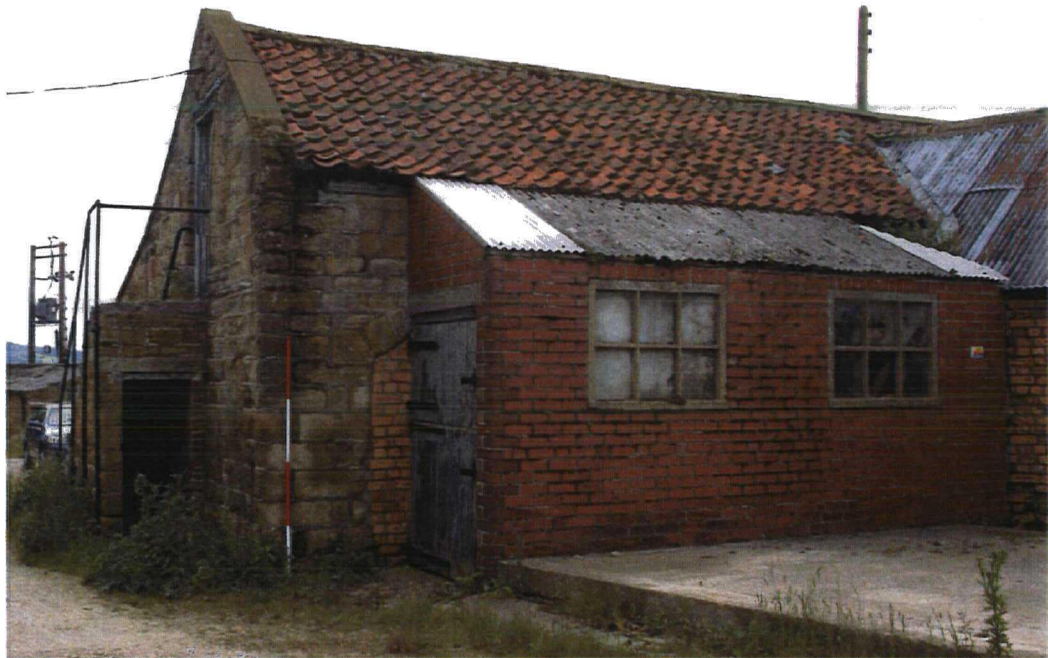
Plate 10 Building 14, N elevation. Showing 30th century brick extension with concrete windows. Note that this extension masks much of the blocked-up eastern arcade of the old core of Building 14. Looking S

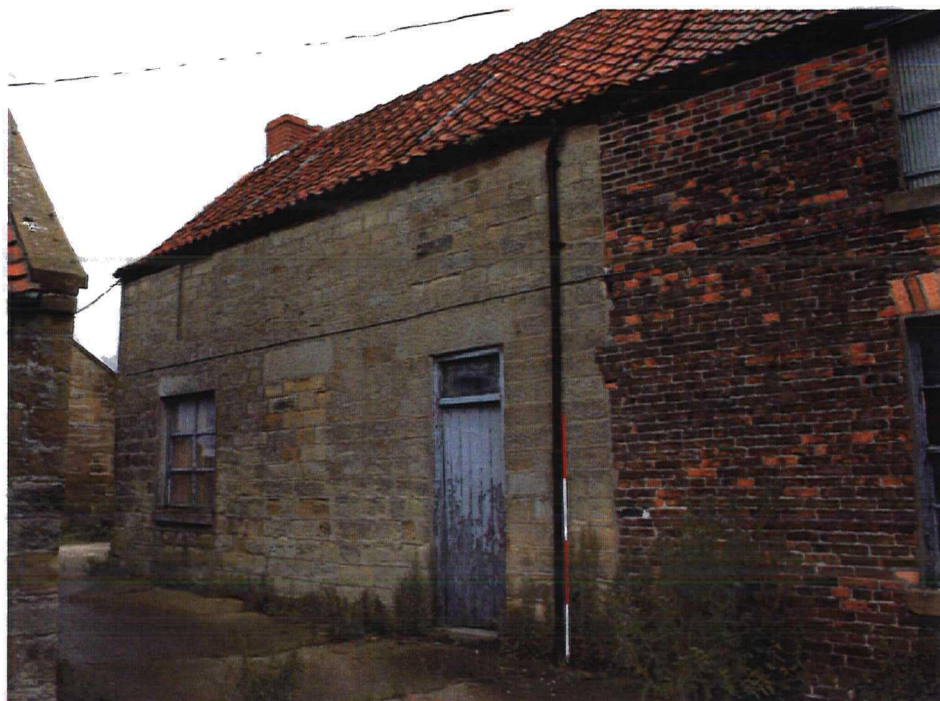
Plate 11 Building 15 (A). The stone S elevation of dwelling with 2 blocked openings to first floor and 1 to ground floor. Note dwelling extended into barn to right. Looking W

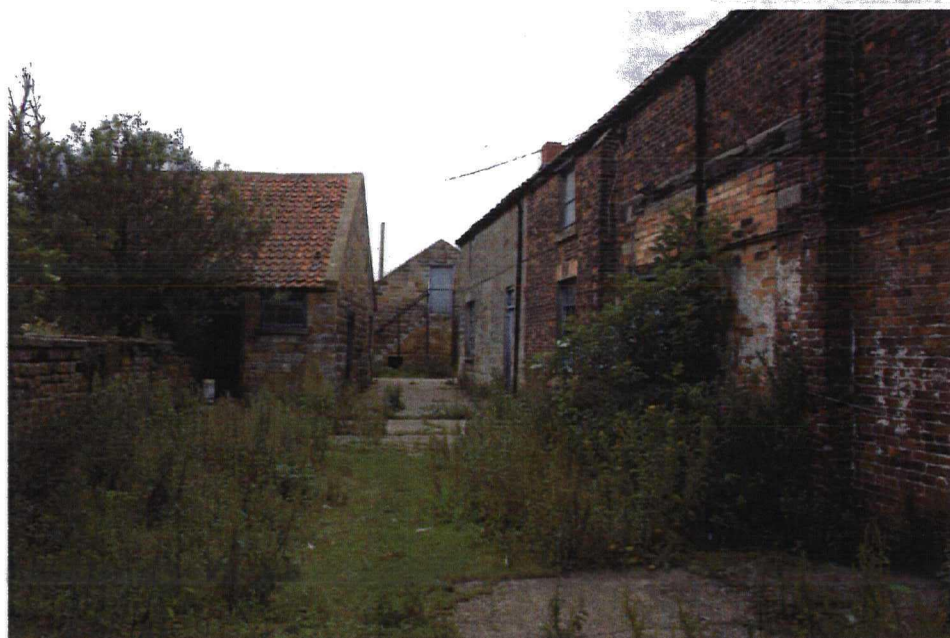
Plate 12 Building 15. Blocked barn door to right. To left is Building 19 with Building 14 in centre distance. Looking E

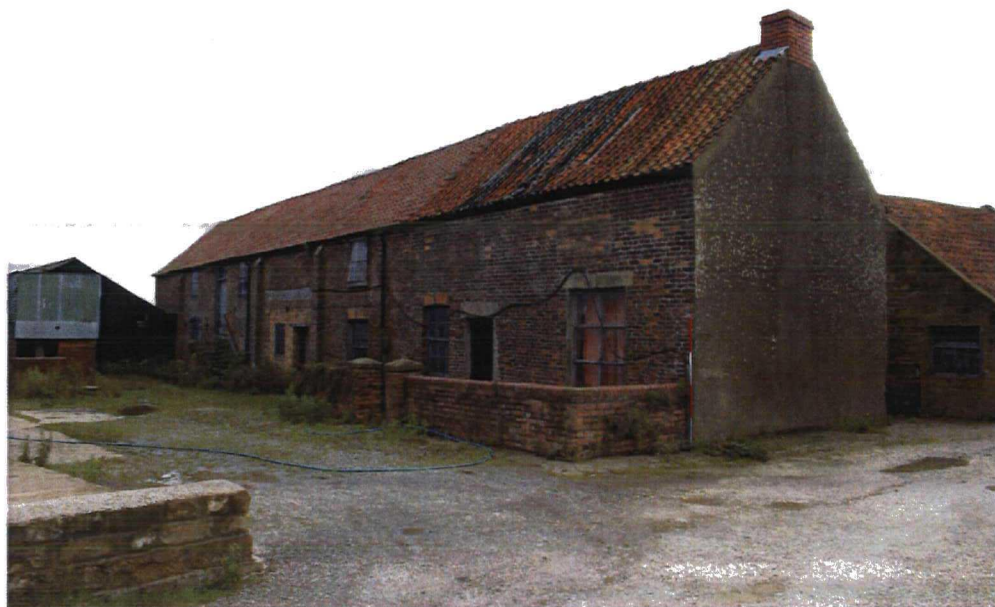
Plate 13 Building 15, N elevation – dwelling (A) to right and barn (B) to left. Note large blocked opening of barn door. Looking E

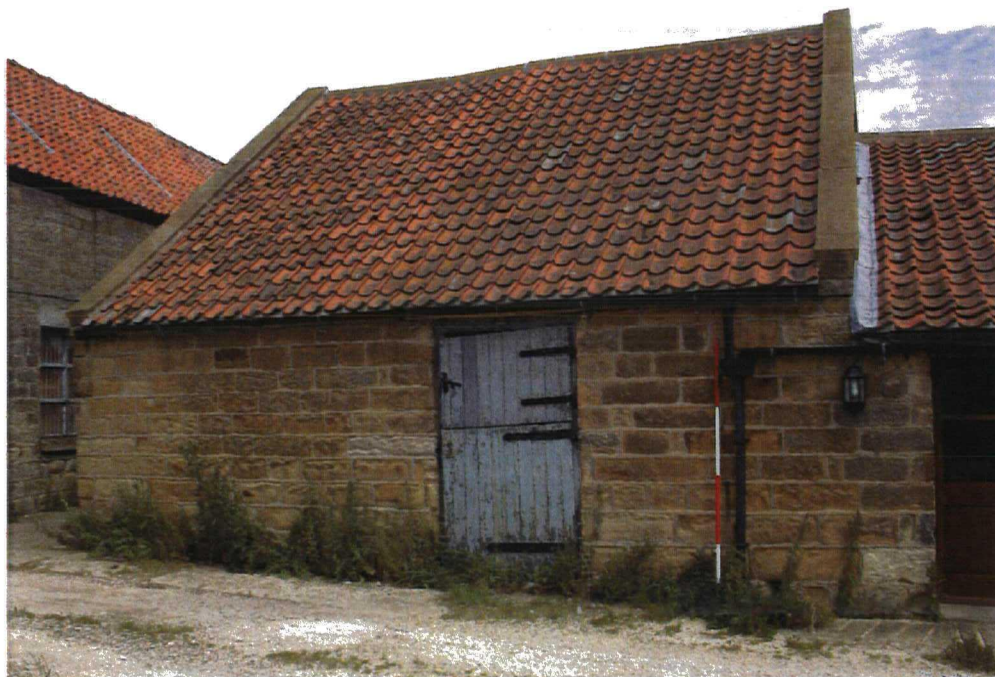
Plate 14 Building 19, W elevation, Building 15(A) to left and Building 20 to right. Note continuity of stone coursing between 19 – 20. Looking NE

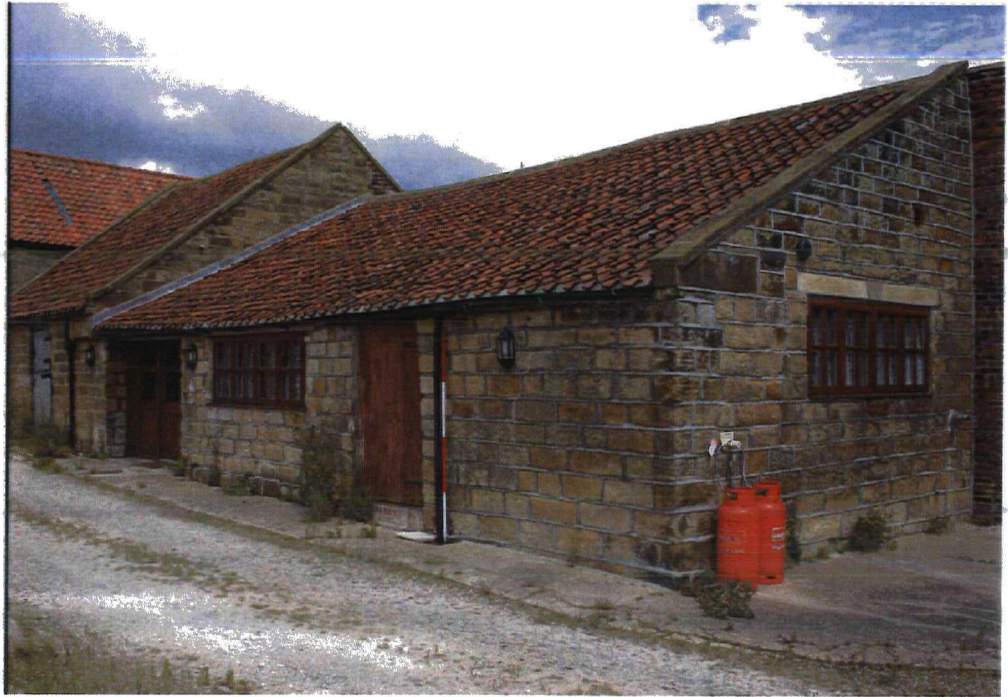
Plate 15 *Building 20, W elevation to left, S elevation to right. Converted to holiday accommodation and ribbon-pointed with hard cement. Looking NNE*

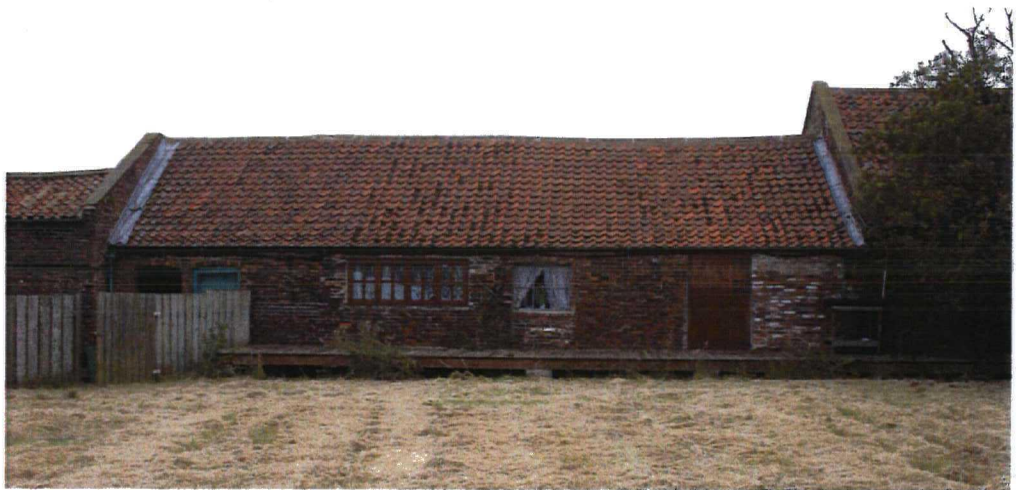
Plate 16 *Building 20, E elevation. This side of the building built (or re-built) in brick. Building 19 to right, Building 21(C) to left in area of green door. Looking W*

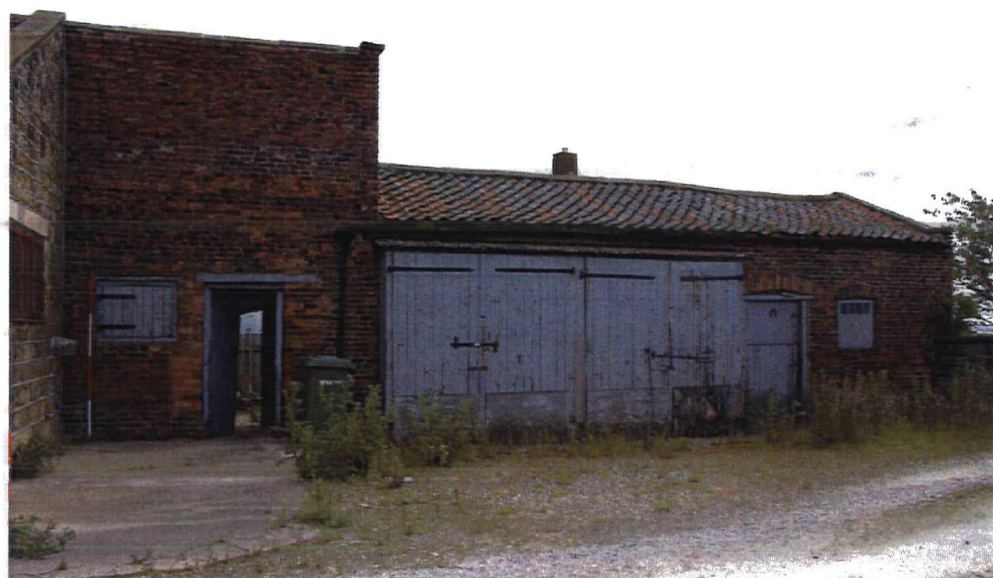
Plate 17 Building 21, W elevation. 21B to right with taller 21C to left. Note area of blue double doors extended a very short distance to W. Looking E

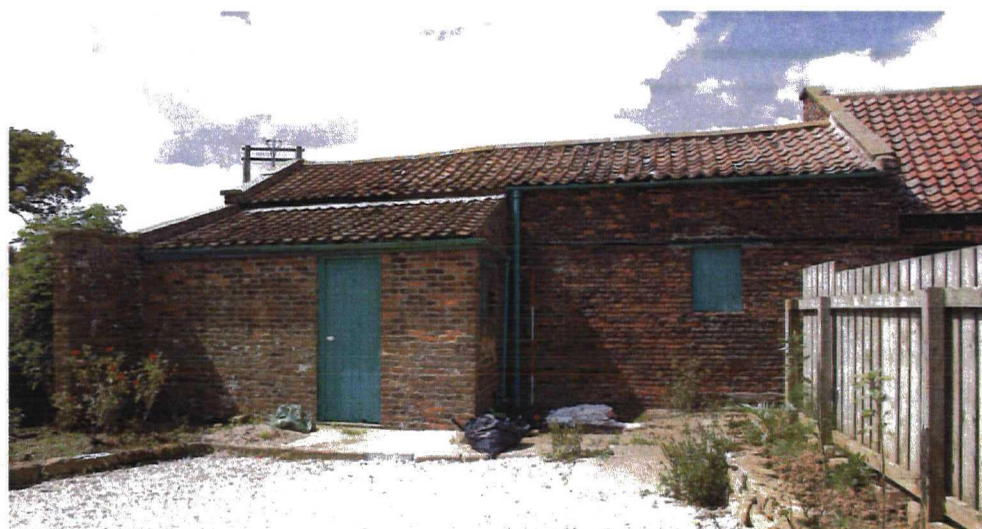
Plate 18 Building 21, E elevation, extension 21C to left foreground, 21B behind and 21C to right. Looking W
