AN ARCHAEOLOGICAL WATCHING BRIEF AT THE BARN PUBLIC HOUSE OSGODBY NR SCARBOROUGH

This report covers a watching brief carried out at a site at Osgodby, near Scarborough on 16th and 23rd April, 1998; Grid Reference TA 0556 8473, Site Code TB/97A.

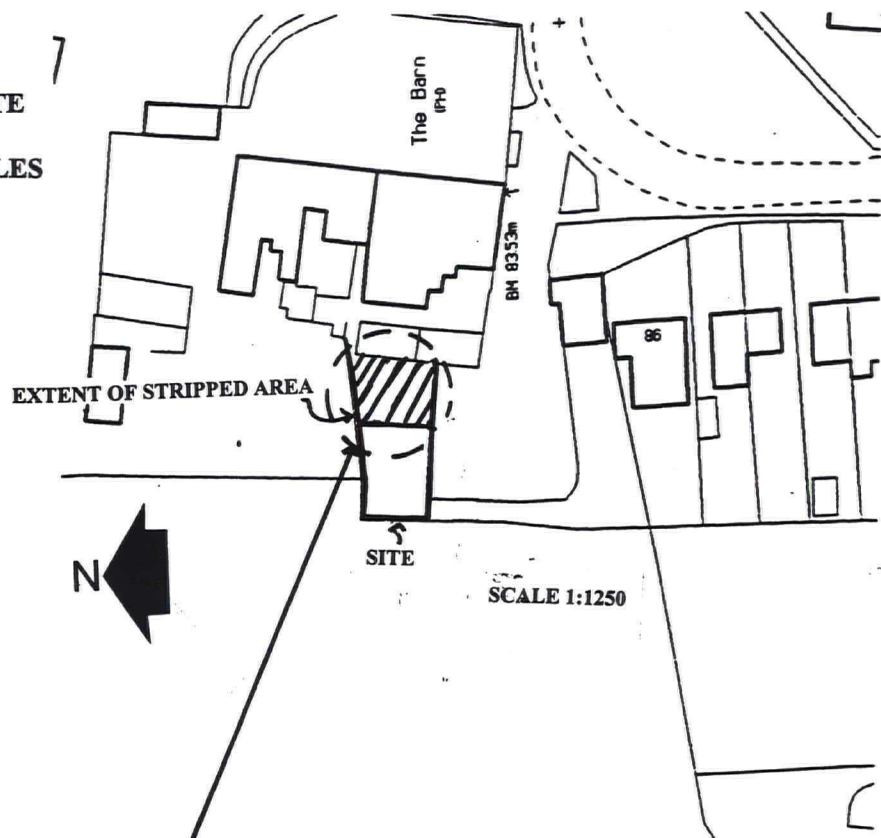
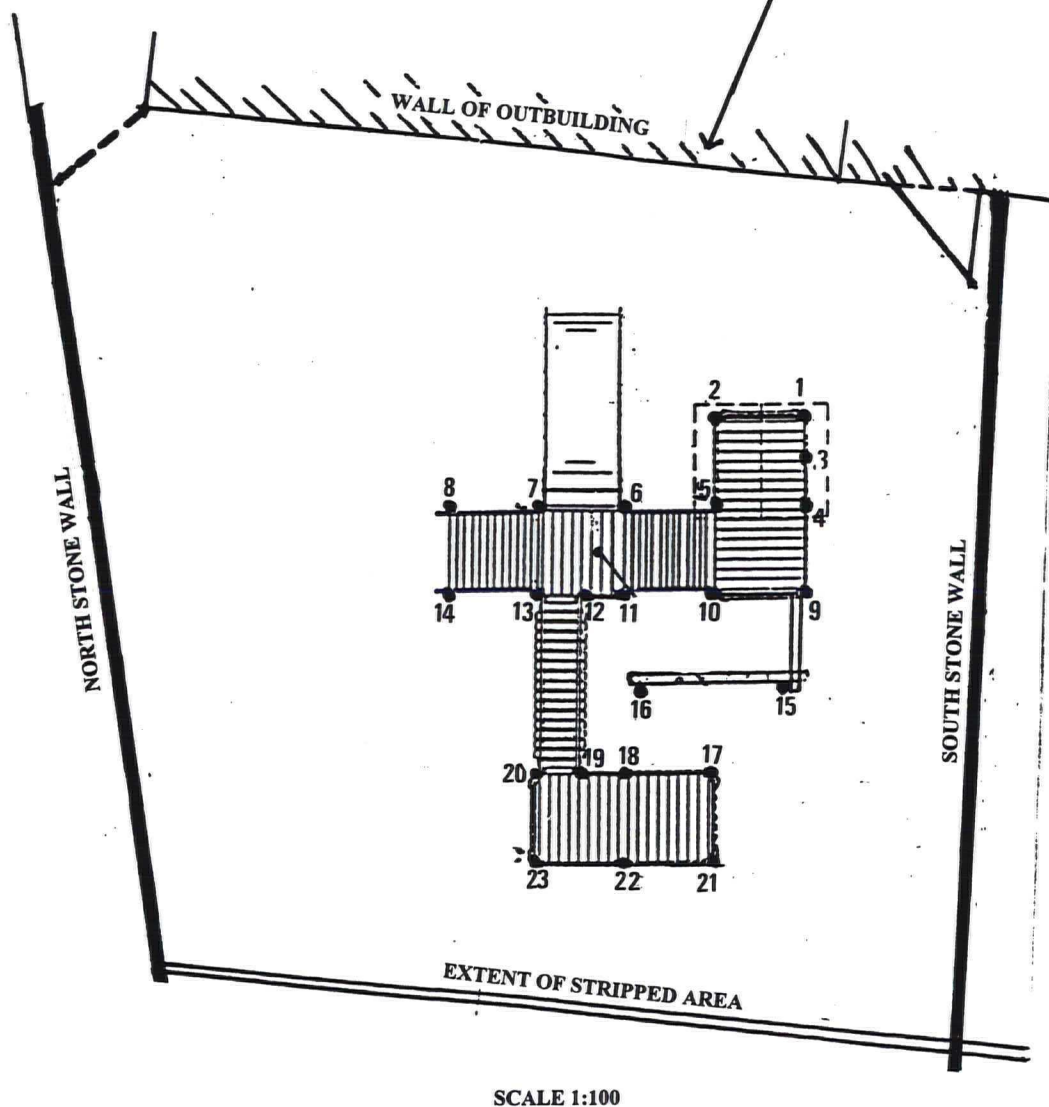
**FIGURES 1A LOCATION OF THE SITE
AND
1B LOCATION OF EXCAVATED HOLES**

Planning permission was granted for the formation of the play area subject to an archaeological condition. The proposed play area is within a totally enclosed grassed area located immediately to the West of a range of brick and stone outbuildings (Figure 1A). Whilst all the boundary walls are stone, both the north and south walls are relatively recent; the north wall is not shown on the 1938 Ordnance Survey map, whilst the south wall is in a different position to that shown on the same map. Re-used masonry is evident in the north wall and this is referred to later.
