ARCHAEOLOGICAL
SERVICES
DURHAM UNIVERSITY

Gilling Castle Historic Landscape Study
North Yorkshire

archaeological desk-based assessment
and field survey

report 2547
March 2011

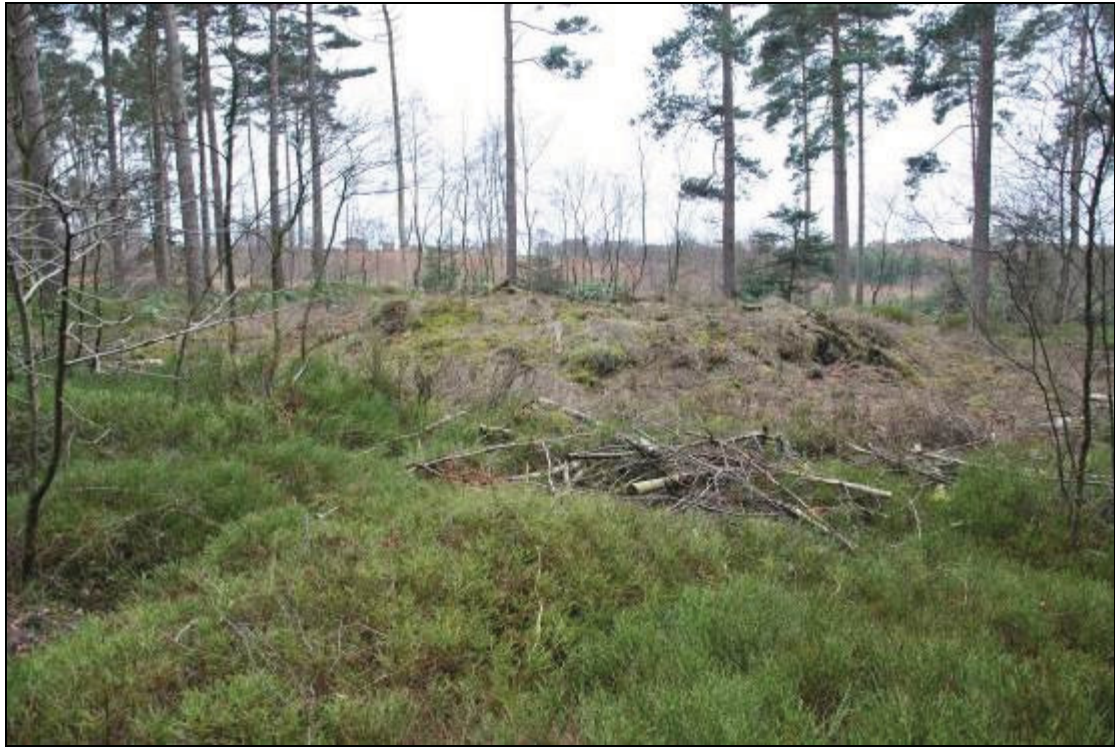
- 5.1 The single Scheduled Ancient Monument within the Park is a round barrow 250m north of Coney Hills Farm. This is a burial mound of the late Neolithic or the Bronze Age, and is part of a larger group that includes Coney Hills and other mounds just south of the Park. The barrow stands in an area of mature plantation, just off a ride that links Piper Hill with the road near Coney Hill Farm. It is a low earth mound with some evidence of a kerb of vertical stone slabs (Figure 2). There is a hollow at the centre which looks like the result of excavation, probably in the 19th century. The mound has been planted but the trees have now been cleared, leaving decaying stumps. The earthwork is badly damaged by rabbit burrows.

Figure 2
Round barrow north of Coney Hills Farm

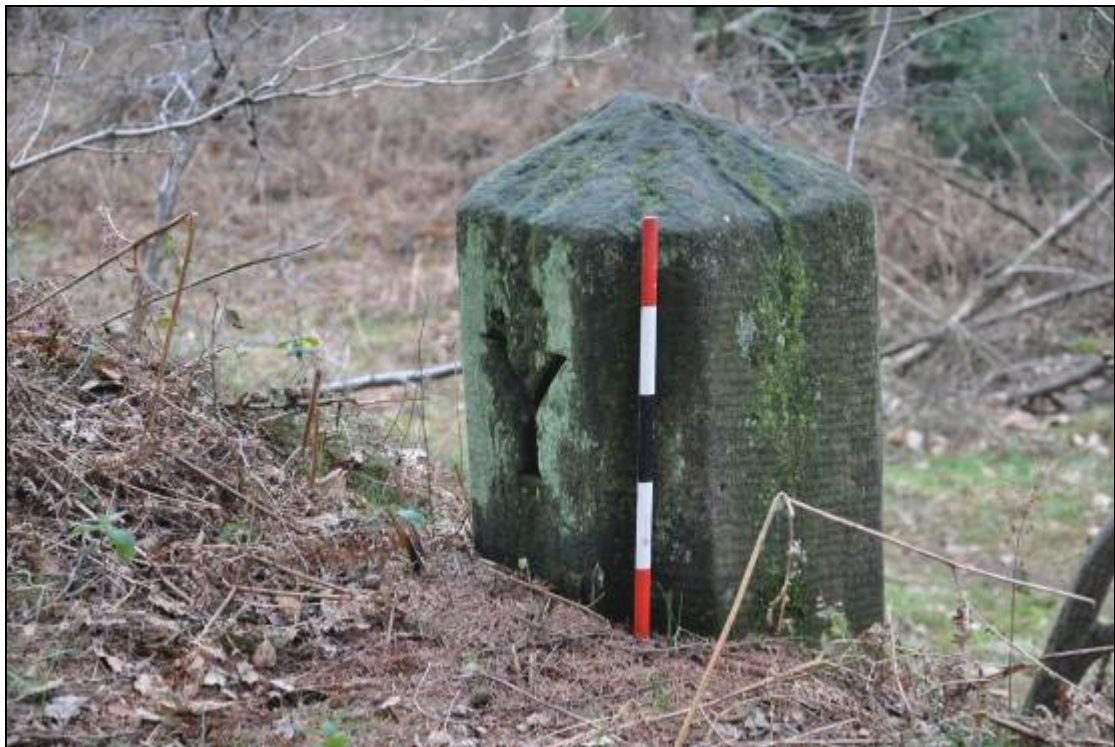
- 5.3 A dry stone wall and a series of inscribed stones marked a boundary that was fixed between the Fairfax and Fauconberg estates after a dispute in the late 18th century. The boundary runs north-west - south-east across the west end of the Park, and survives as a partly-ruinous wall. This is up to 1.2m high and 0.4m thick, though over much of its course, where it has collapsed, it is reduced to its lowest courses or to a disordered spread of stones. The boundary stones are marked on opposite faces with Y and G, for Yearsley and Gilling. Some have additional markings on the top. They date from 1796.
- 5.4 Two stones remain in the Park; these are on Shepherd's Rigg [MNY11574] and at Whinny Cross Hill, not far from the modern radio mast [MNY32470]. The latter is shown in Figure 3.

Figure 3
19th-century boundary stone at Whinny Cross Hill

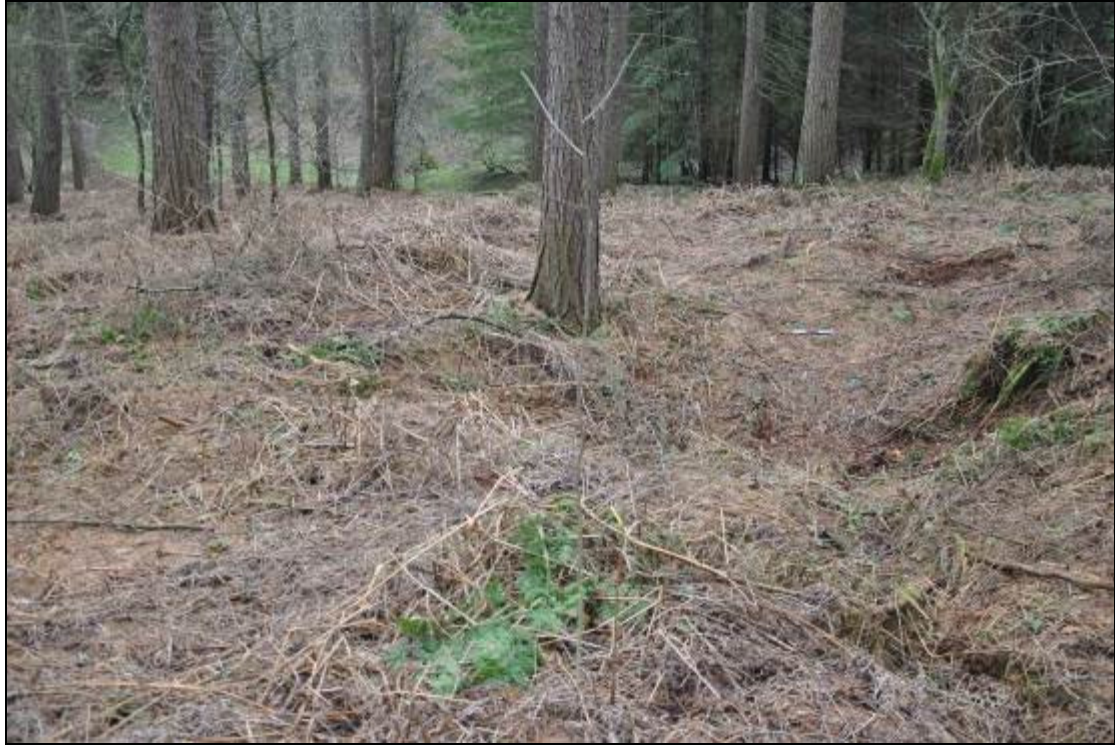
Figure 4
Bell pit south-west of Piper Hill

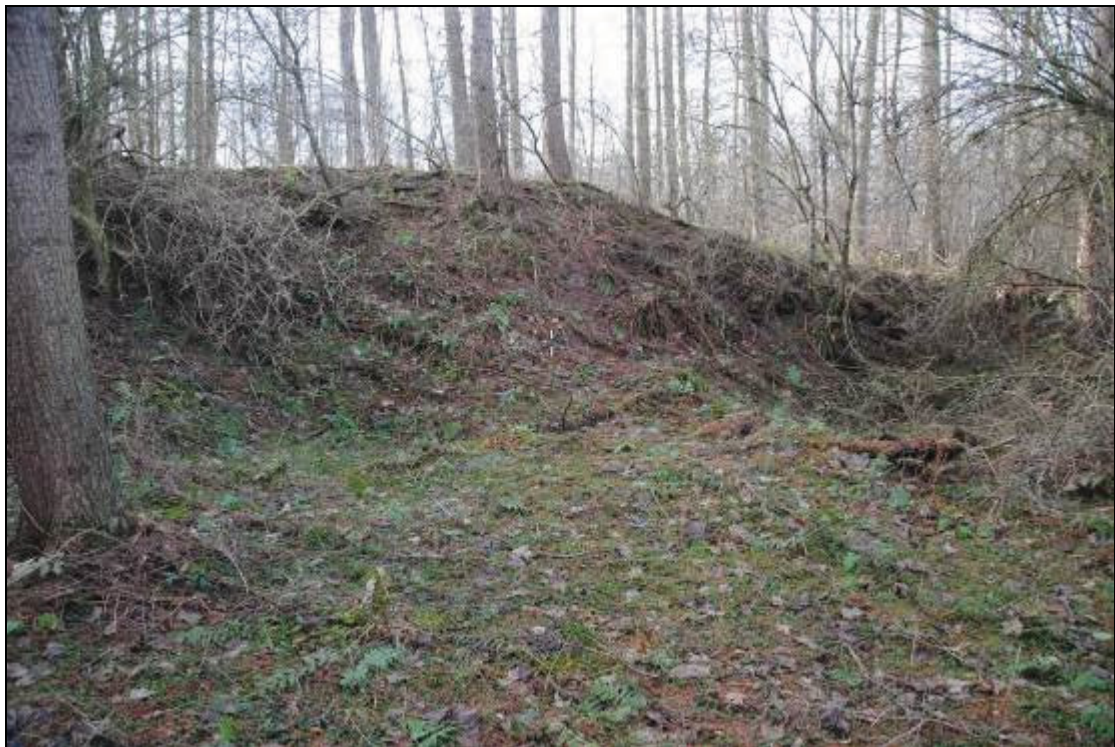
Figure 5
Overgrown sandstone quarries at the west edge of the site

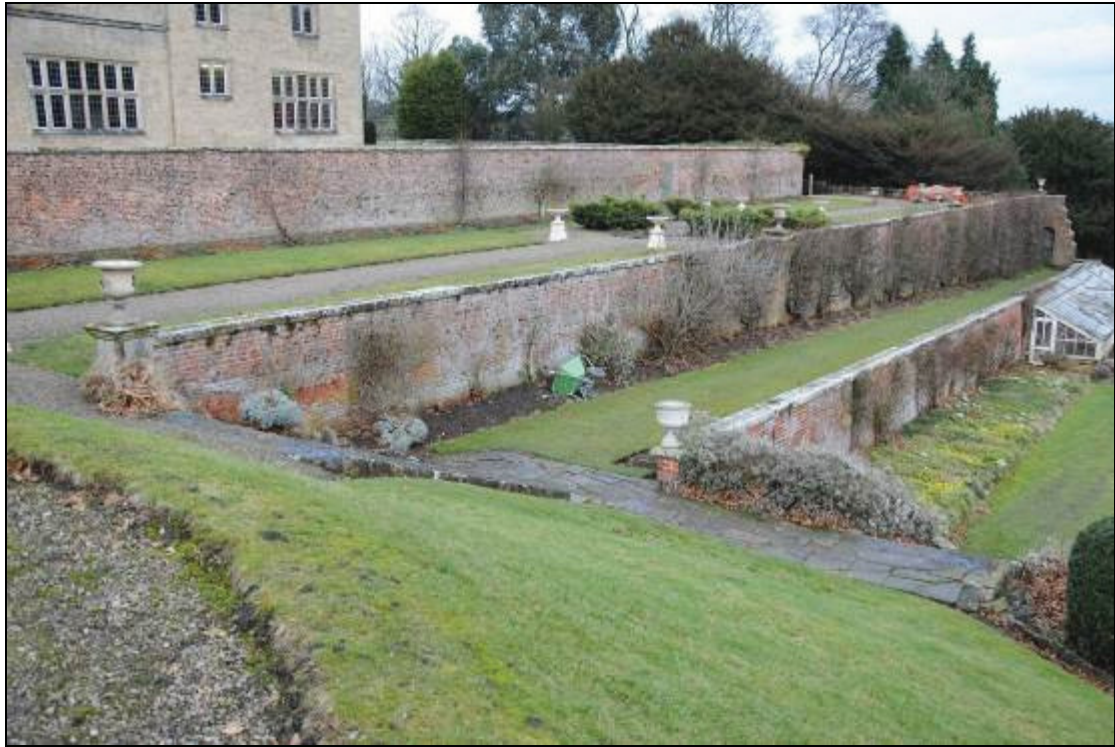
Figure 6
Terraces south of the Castle

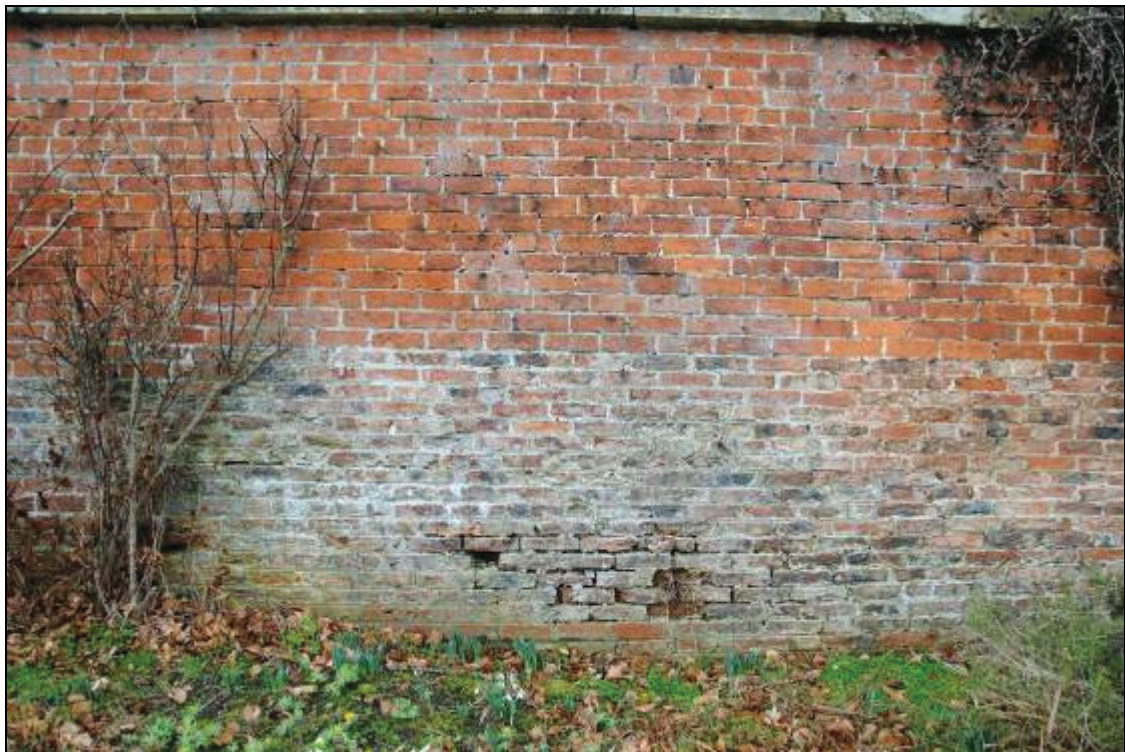
Figure 7
Detail of the retaining wall on the lower terrace

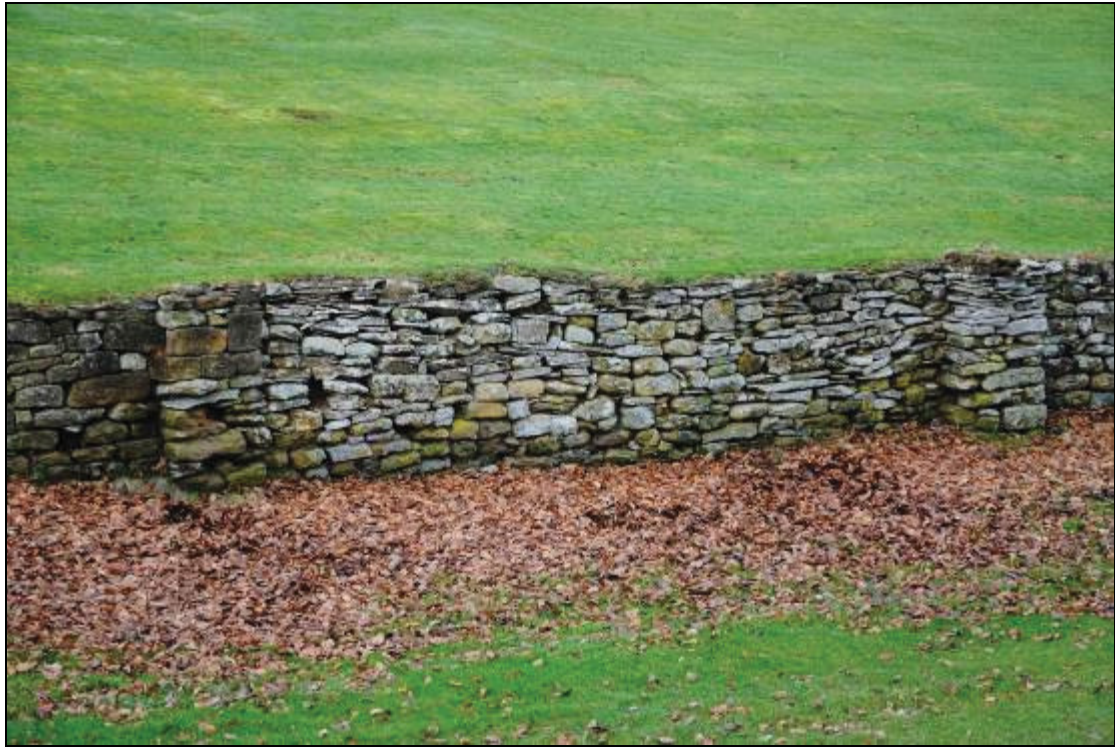
- 5.7 There are three brick terrace walls at the south side of the Castle. At the foot of the lower terrace there is a stone ha-ha wall [MNY31000] just above the floor of the valley. The brick walls appear to be in two different builds, as the lower courses are made of thinner brick (Figures 6 & 7). However, as the bulk of the fabric consists of 2.5-inch brickwork, it must be assumed that the terraces seen today are the result of rebuilding in the later 19th century. The ha-ha wall (Figure 8) is older and appears to

be of dry stone construction, with shallow buttresses; however, this may be the result of the washing-out of lime mortar in what is certainly a damp setting.

Figure 8
The ha-ha wall below the terraces

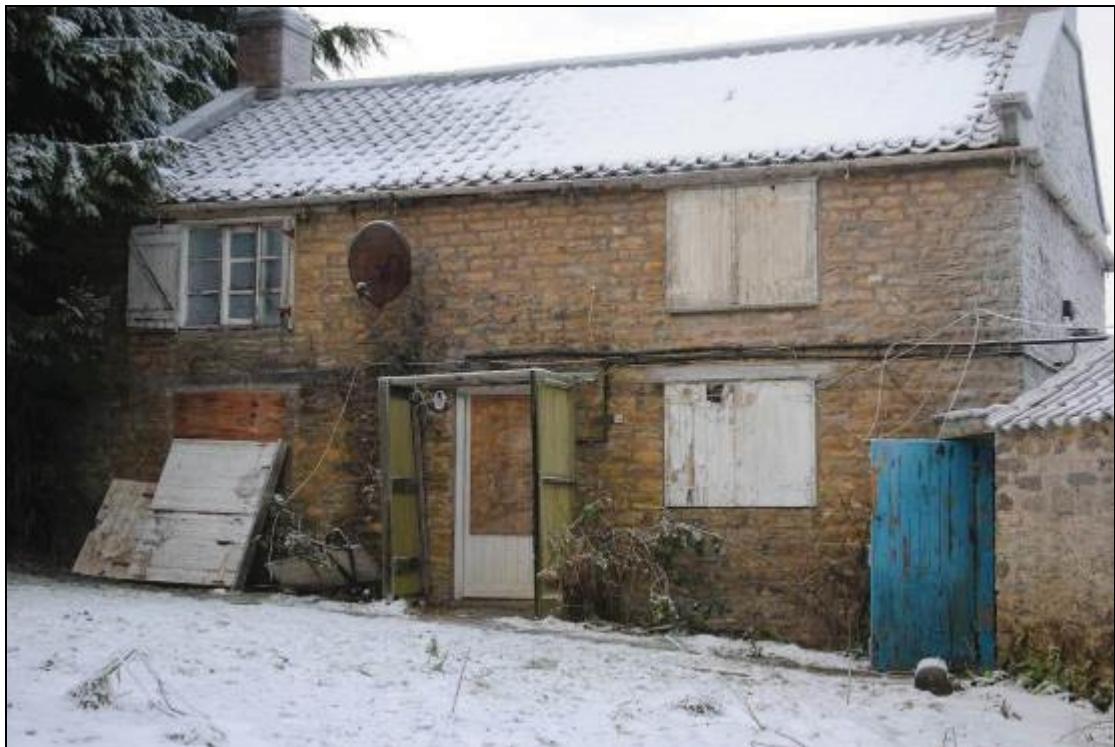
Figure 9
Windy Gate Farm; the house

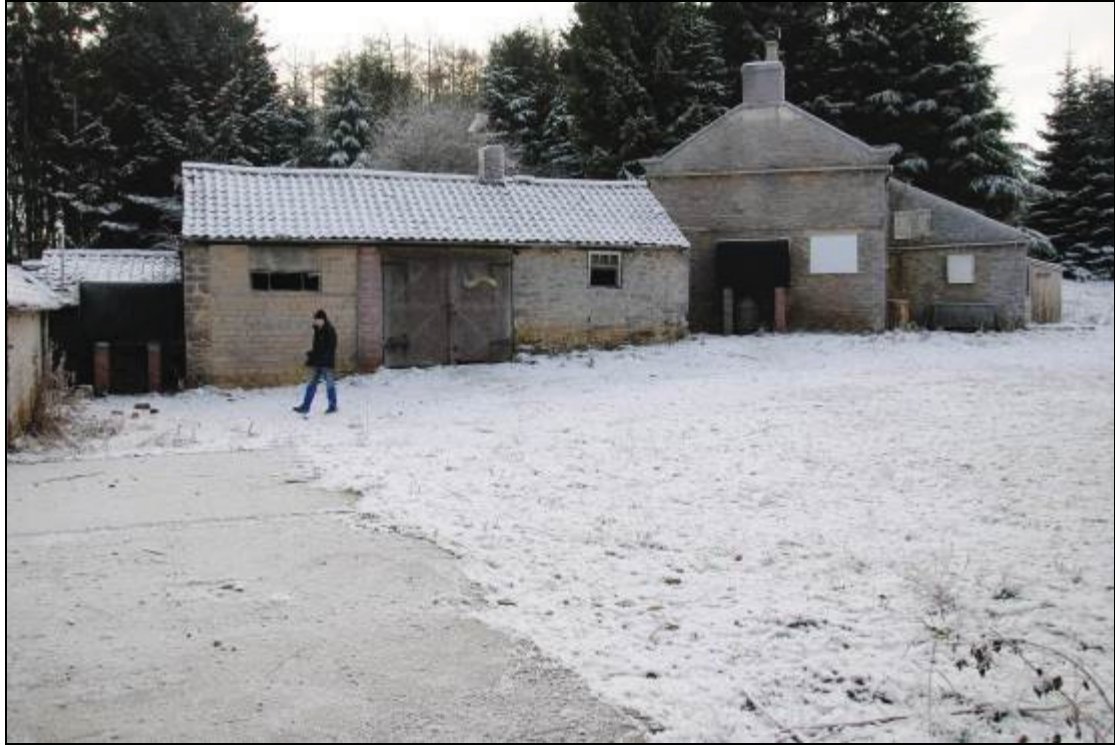
Figure 10
Windy Gate Farm; view south-west across the yard

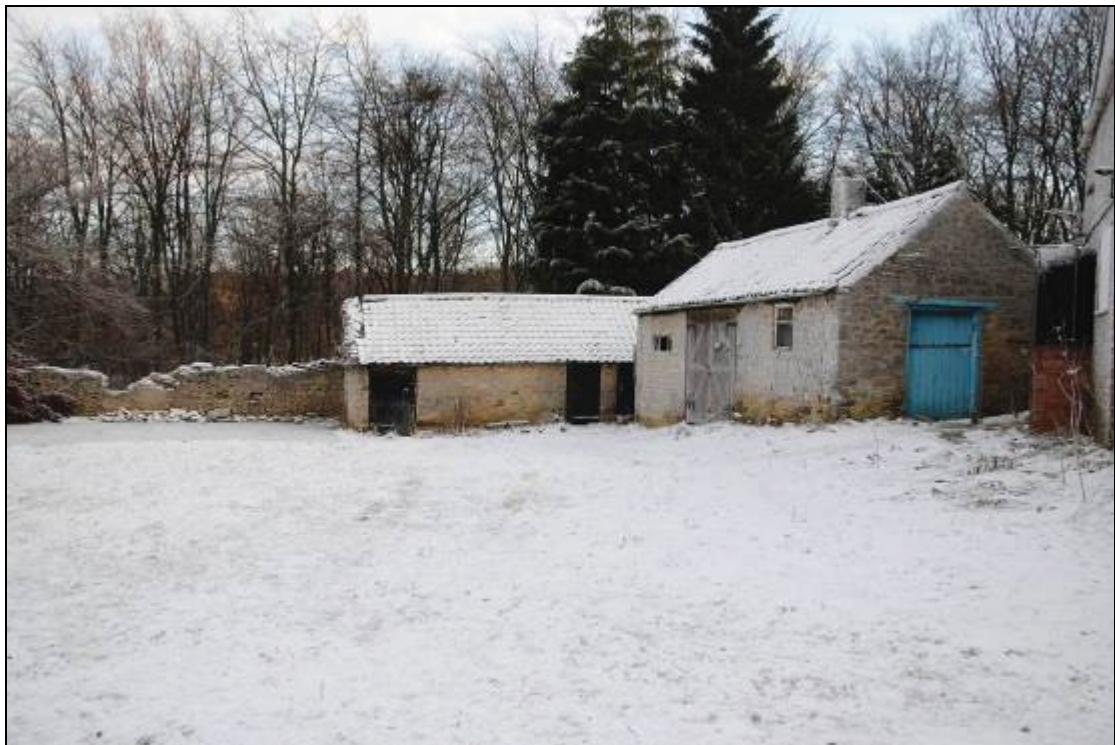
- 5.10 The pantiled south and east outbuildings are in a fair state of repair, as is the boarded-up house, but the north building has been significantly altered with the removal of its east wall and the replacement of its roof. The west end of the south building, closest to the house, contains a wash-house, and the remains of the copper survive in one corner. Two brick kennel yards have been added to the east face of the eastern building; these have 19th-century iron railings. The farmstead appears to date from the late 18th century.

Figure 11
Windy Gate Farm; the south and east outbuildings

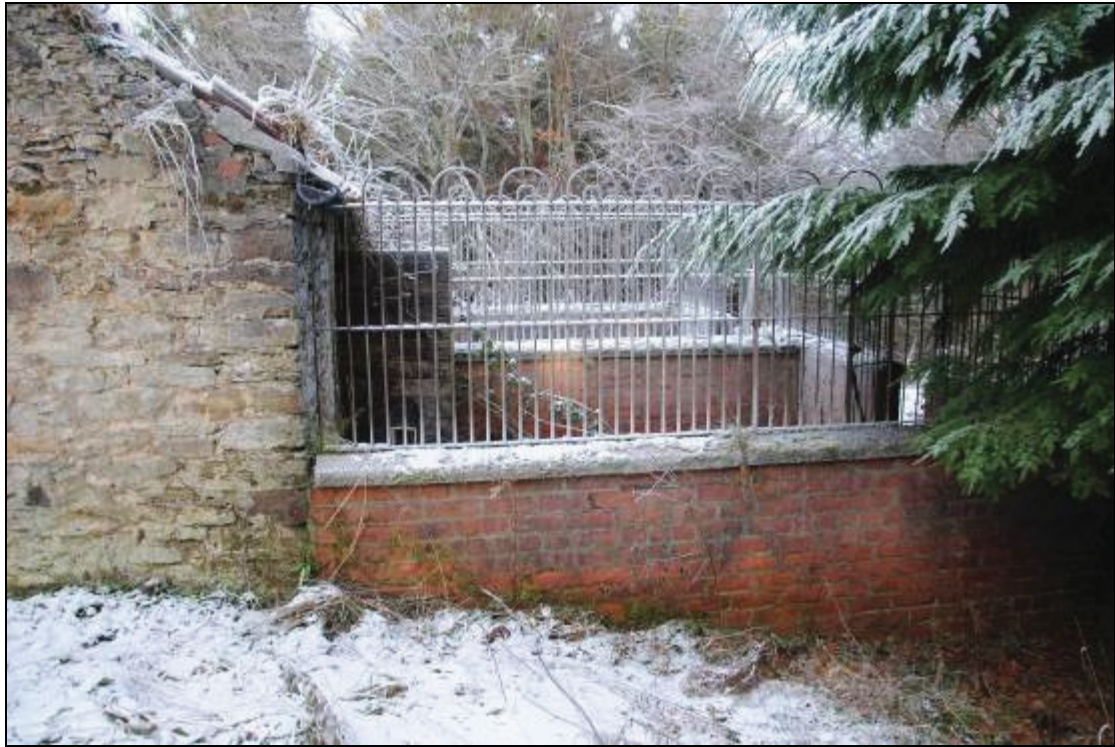
Figure 12
Windy Gate Farm; the kennel yards

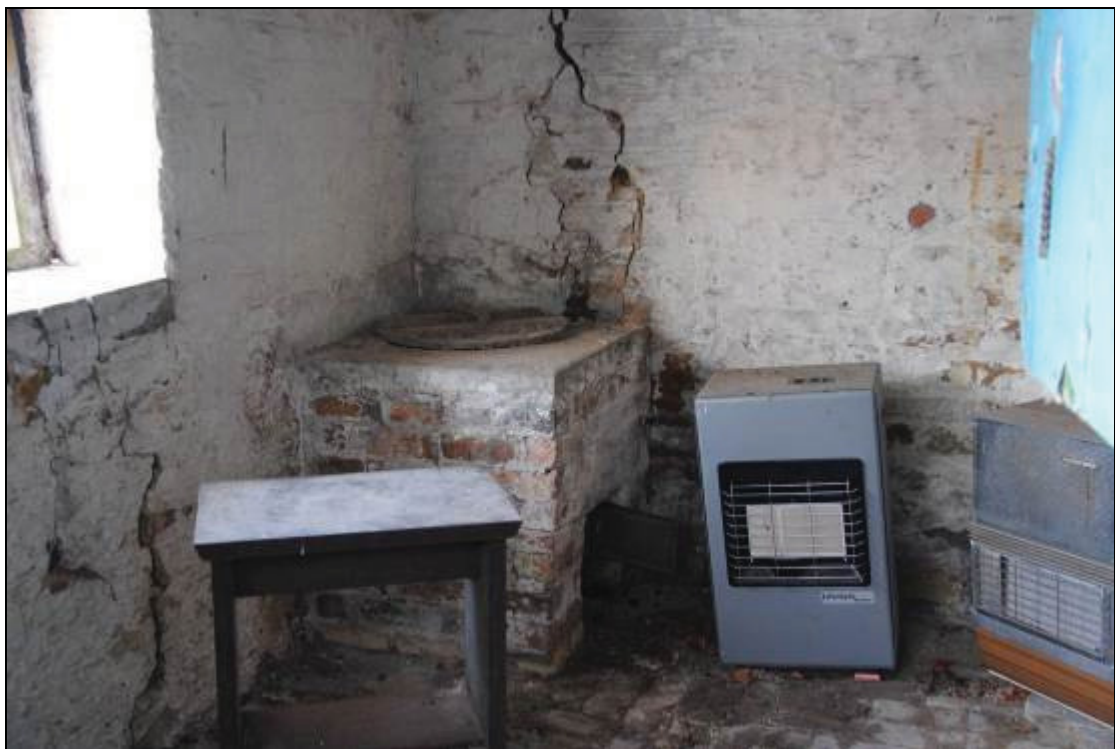
Figure 13
Windy Gate Farm; the old copper in the wash house

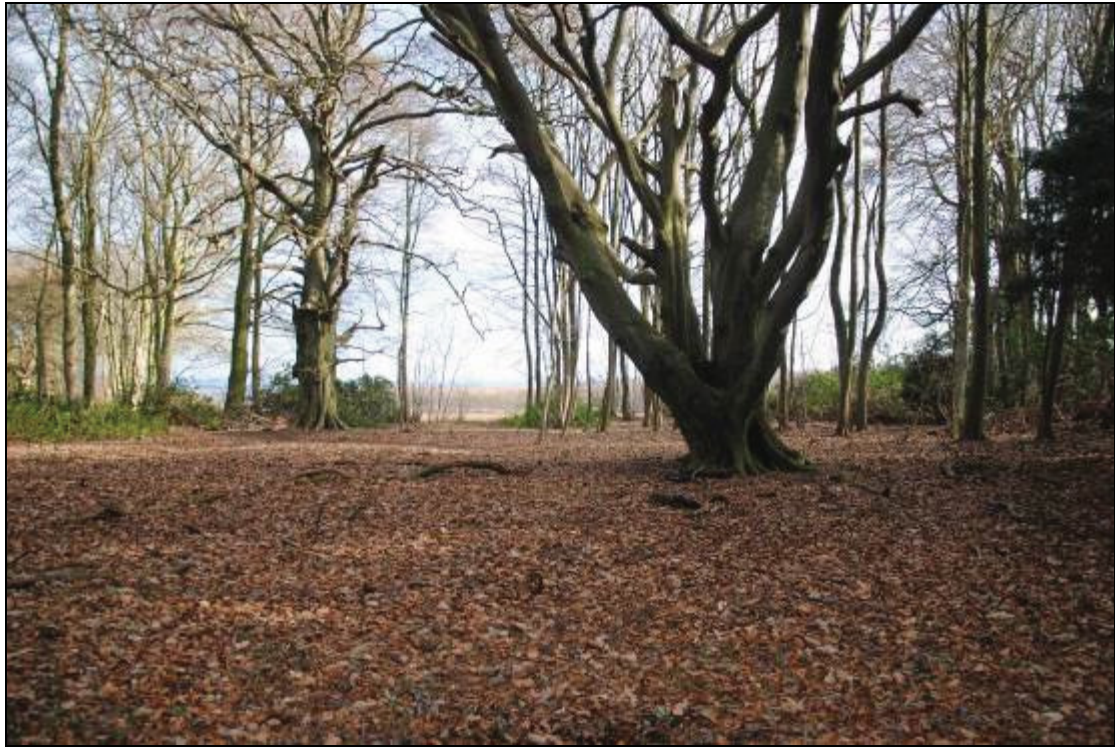
Figure 14
The site of the Temple

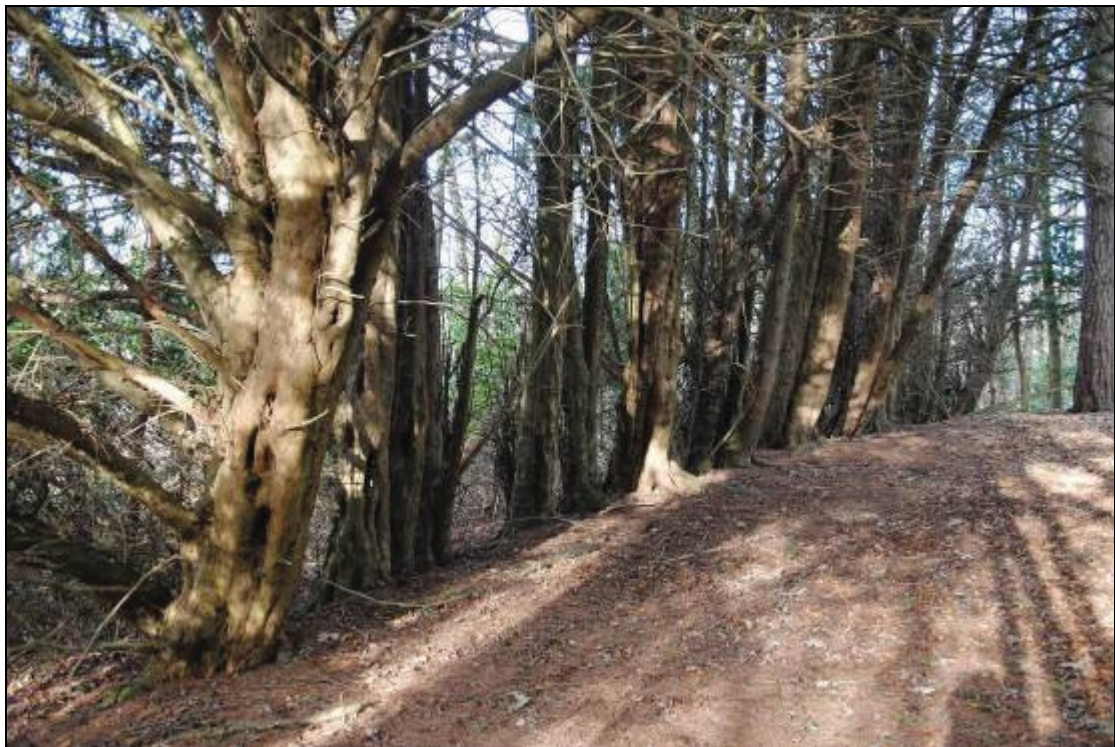
Figure 15
Overgrown yew hedge on the lip of The Scar, west of the Temple

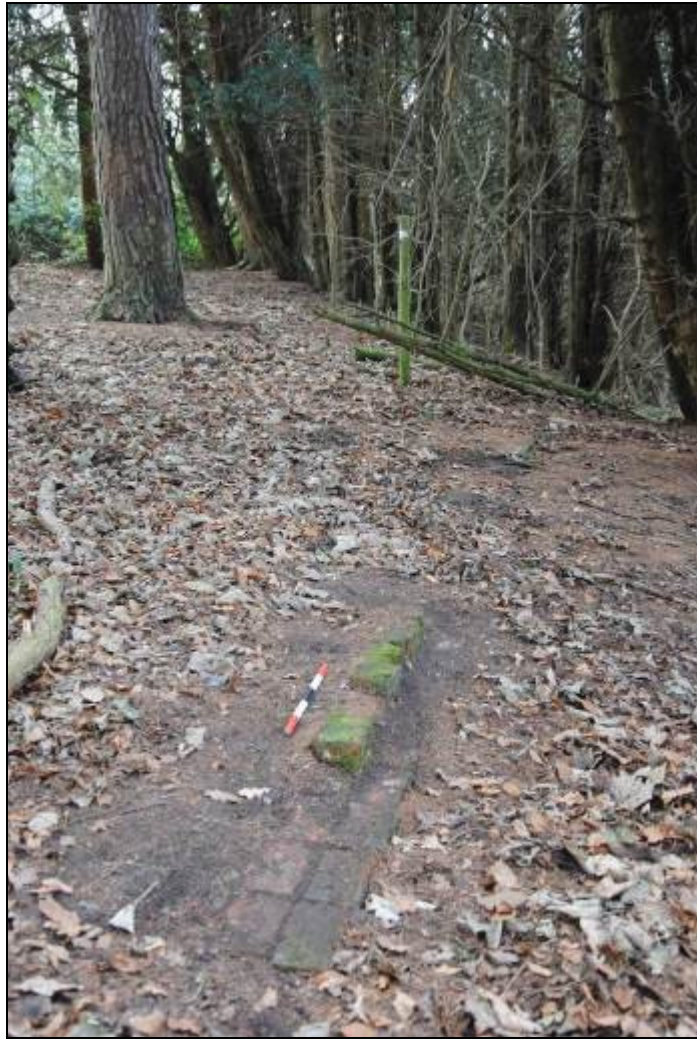
Figure 16 (right)

The Temple; the base of a modern brick wall, with the overgrown yew hedge in the background. Looking south-west

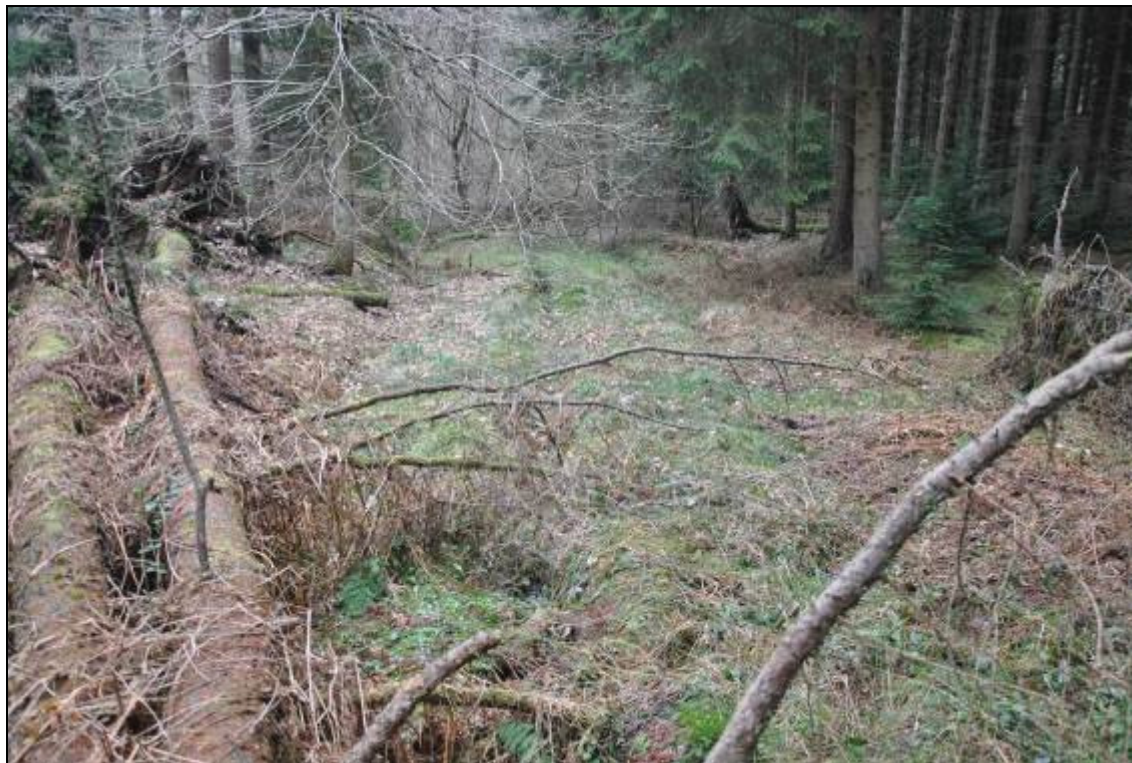
Figure 17 (below)

- 5.14 The trees along the North Walk mentioned above are probably associated with a formal walk that led from the house to the Temple. In the western part of the Park there are some sections of other drives or paths. These are in poor condition in some places, and in others they now form parts of the network of forestry roads. The main drive from the South Lodge to the end of the Avenue and down to the house was a most important route, and a large part of this is in good repair; so is the drive from the road to Windy Gate Farm. Another important route was a drive around the lakes in The Wilderness, and this is in a much poorer state. A section is shown in Figures 17 & 18. The road shows no hard surface, but there are well-defined ditches at either side. It passes close to the breached dams (see below) and may have run over the western one in its course through the valley. On the opposite side of the valley there is another road which is still in use, and this runs close to the ends of both of the broken dams. Today the disused western road is blocked by fallen trees and overgrown with saplings. Failure of the old drains has led to large areas becoming waterlogged.

Overgrown drive on the south side of the Little Holbeck valley; looking north-west

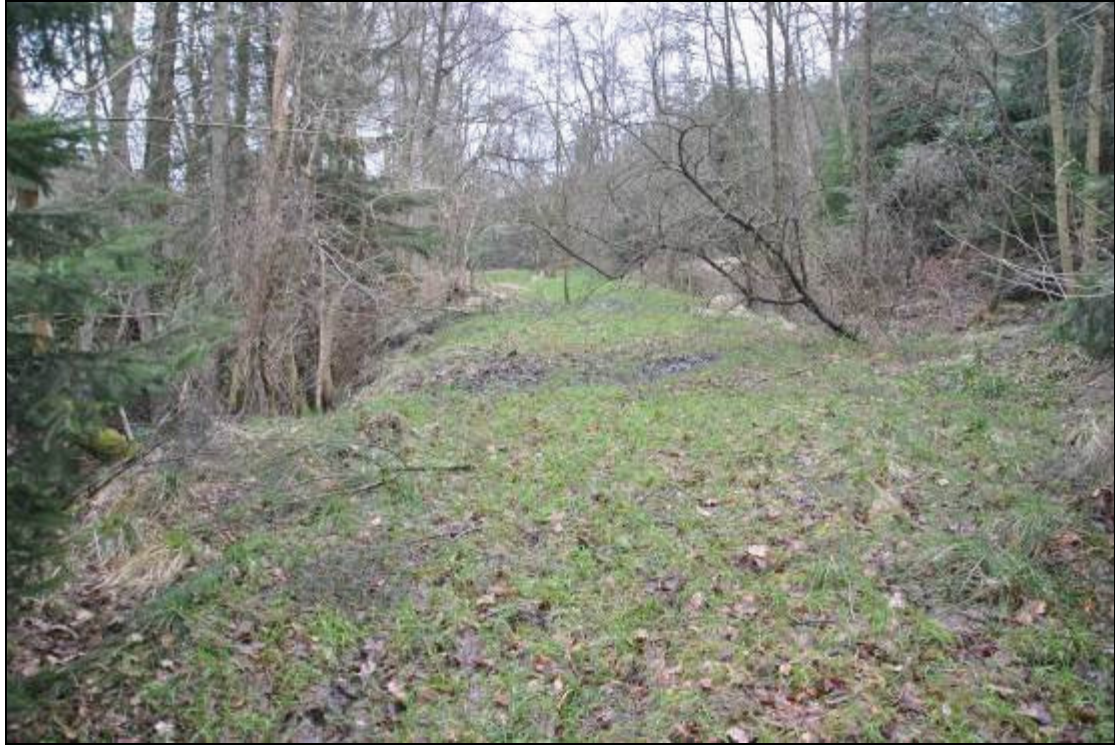
Figure 18

Overgrown drive south of the east dam, with the overflow channel at the left of the view. The grassy drive is ditched but flooded

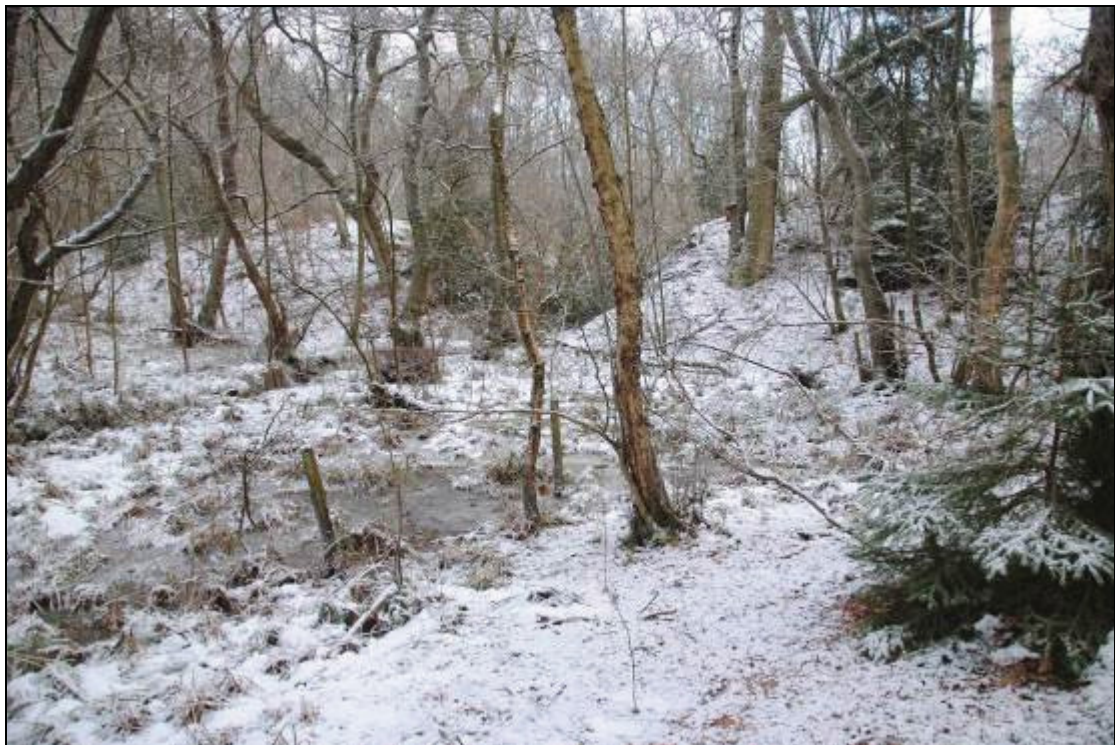
- 5.16 The west dam runs WNW-ESE about 140m upstream from the lower pond. It is a substantial bank, roughly 100m long and 5m high, with a large steep-sided breach near its centre (Figures 19 & 20). Despite the obstacle posed by the breach, a well-used path runs along the top of the dam. A small hole in this path exposes the top of a narrow stone-lined well or shaft (Figures 21 & 22). A YMAP investigation by Geoffrey Snowdon and Elizabeth Sanderson has found the top of a horizontal culvert in the upstream face of the dam close to this shaft, and on the downstream face a lower depression from which water seeps. It appears that the shaft is part of a draw-off mechanism to regulate the level of water behind the dam.

The west dam. Looking south-east from the downstream side

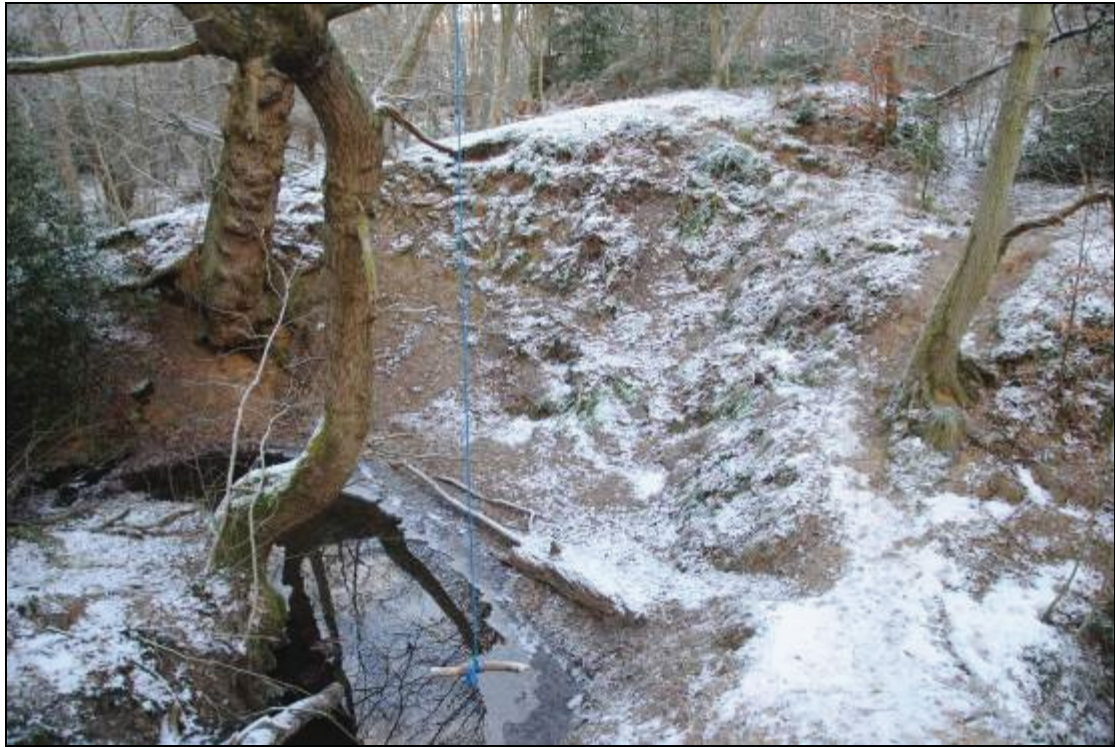
Figure 20
The breach in the west dam, looking north-east

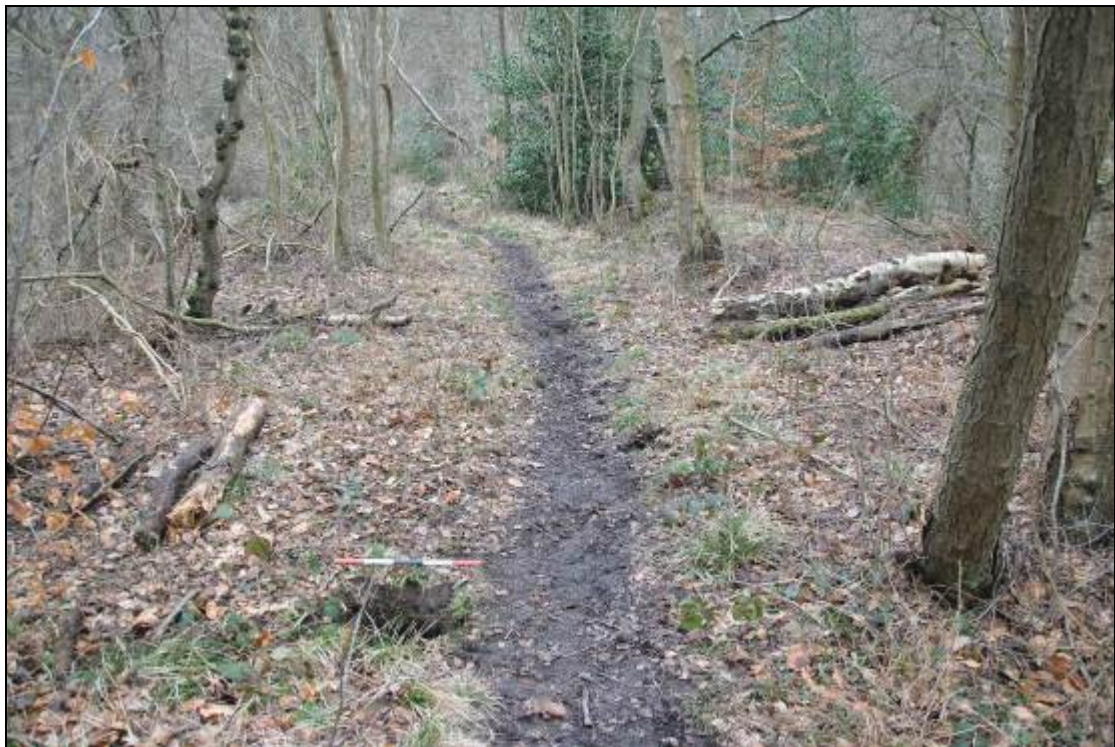
Figure 21
Looking west along the path on the west dam. The small hole in the left foreground is the stone shaft, and the bank to the right the crest of the dam wall

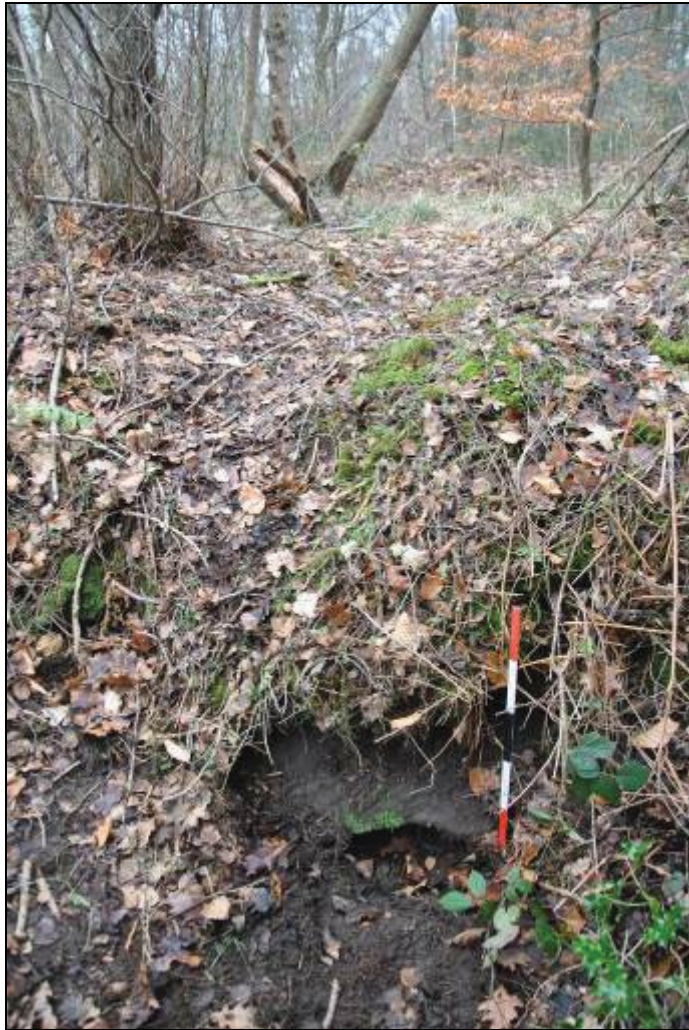
Figure 22 (left)
The lintel of a culvert on the upstream side of the west dam. This links with the stone-lined shaft, which is marked by the vertical logs at top centre of the picture

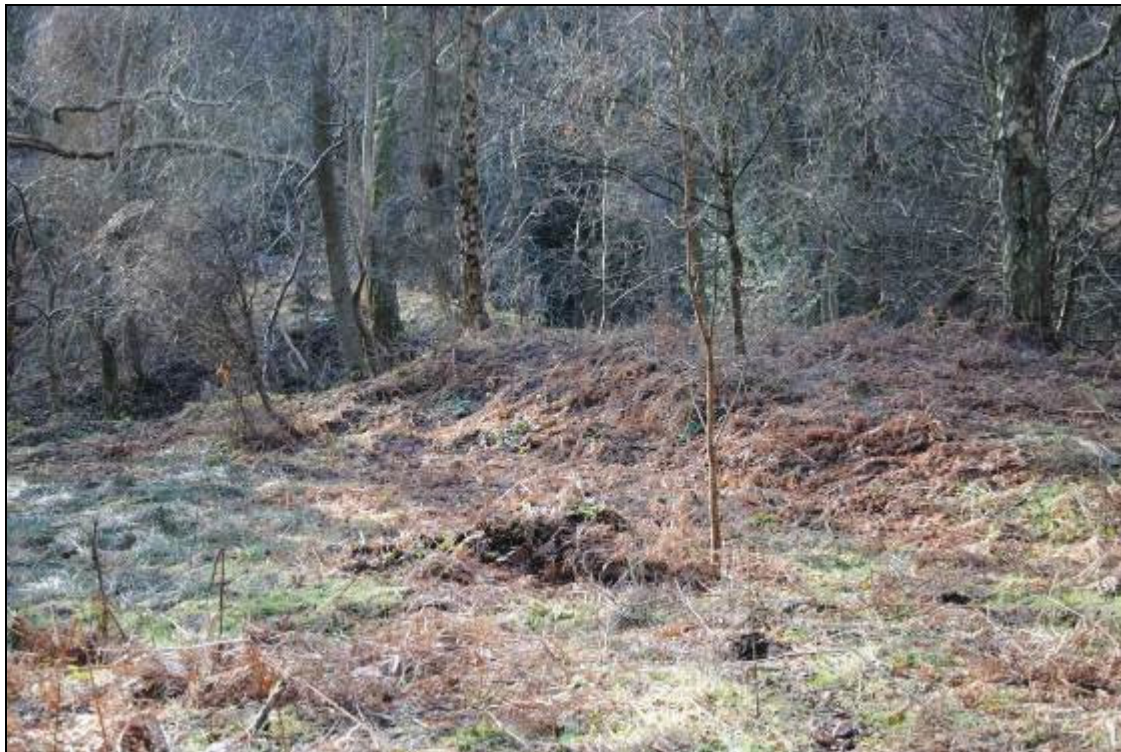
- 5.17 The east dam runs almost north-south across the valley. It is similar in size to the west dam and has a large breach near its centre (Figures 23 & 24). South of this there is a big depression in the top of the wall, and in this another stone-lined well can be seen. The well has been damaged by excavation and the growth of a tree on its east side, but is still clearly recognisable (Figure 25). The YMAP team suggest that there is a culvert from the upstream side of the base of the dam; this has not been seen. As is the case at the west dam there is a possible outlet close to the well on the downstream side. In addition to this means of controlling the water, there is a large and well-marked overflow channel at the south end of the embankment (Figure 26). The dams of the existing ponds all have overflows at their south ends; the lower pond also has a narrow stone channel at its north end (Figure 27).

Figure 23 (below)
The east dam, looking south-east from the forestry road. Note the large breach left of centre

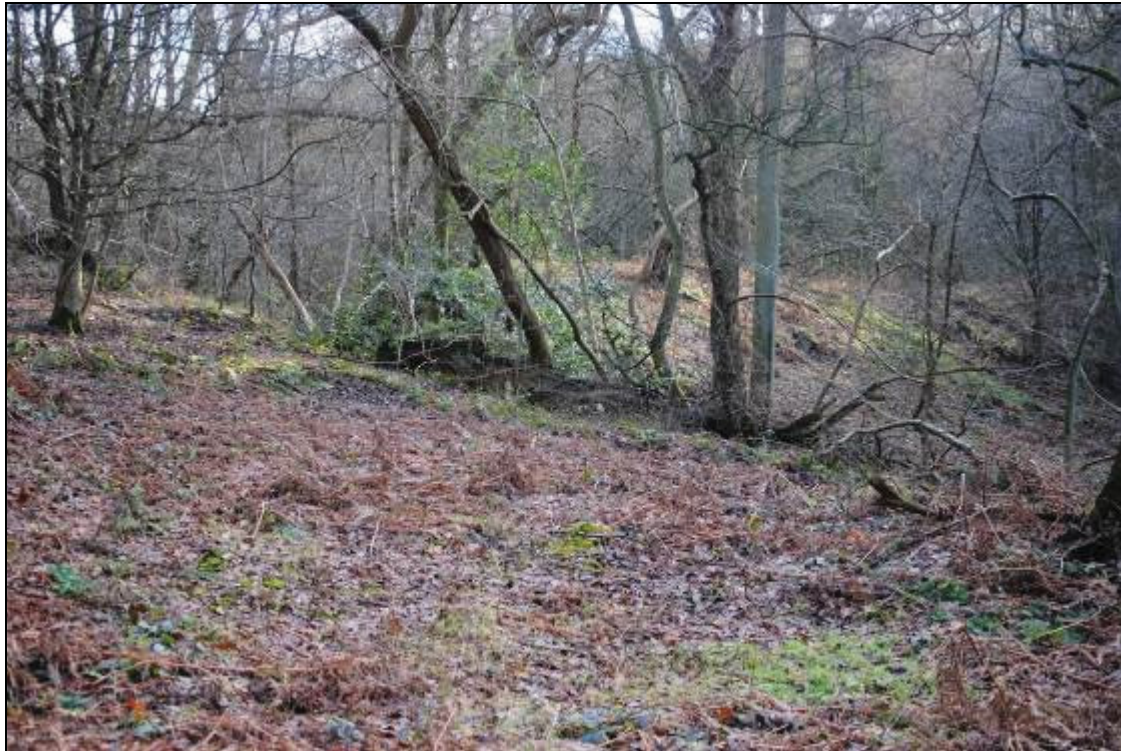
Figure 24
The north face of the east dam and the breach, looking south-east

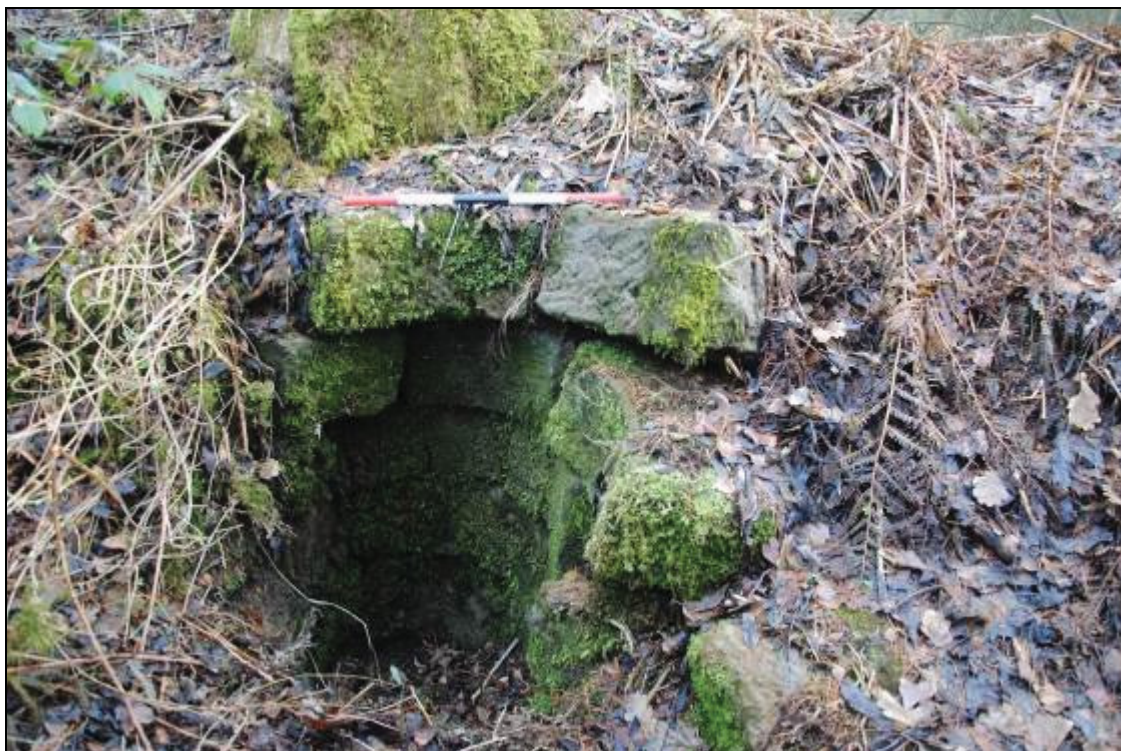
Figure 25
The stone-lined shaft in the east dam; 0.5m scale

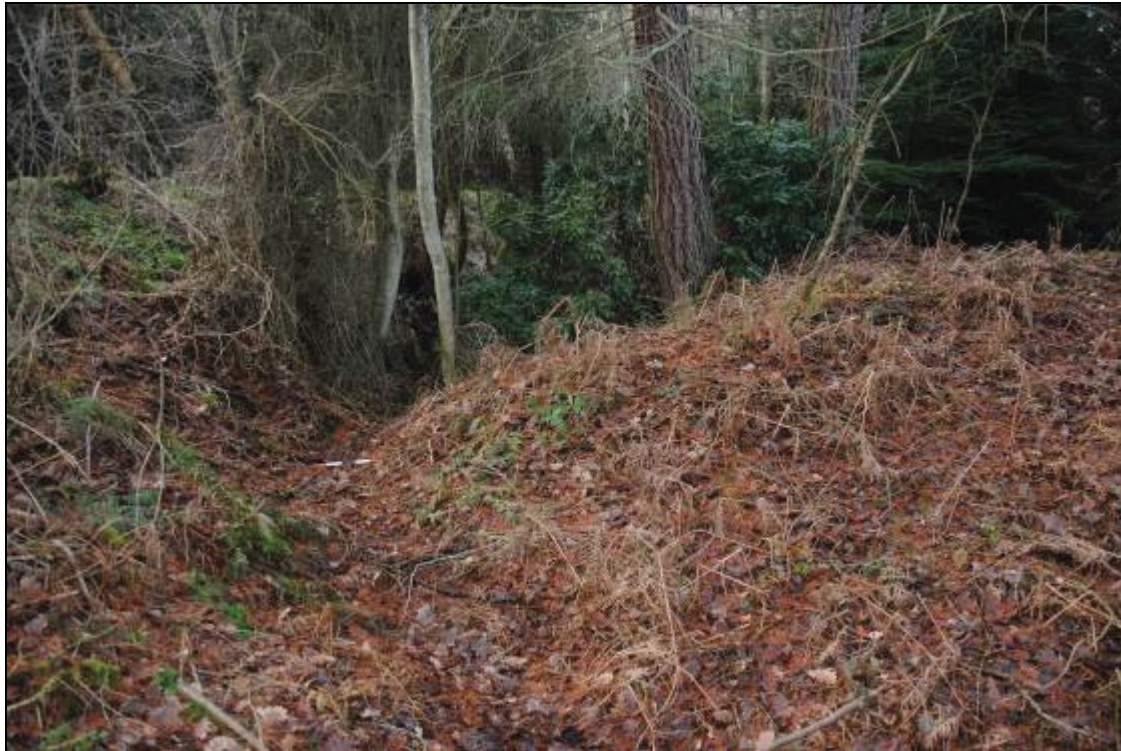
Figure 26 (above)
The overflow channel at the south end of the east dam;
looking west
