ARCHAEOLOGICAL
SERVICES
DURHAM UNIVERSITY

Gilling Castle Historic Landscape Study
North Yorkshire

archaeological desk-based assessment
and field survey

report 2547
March 2011

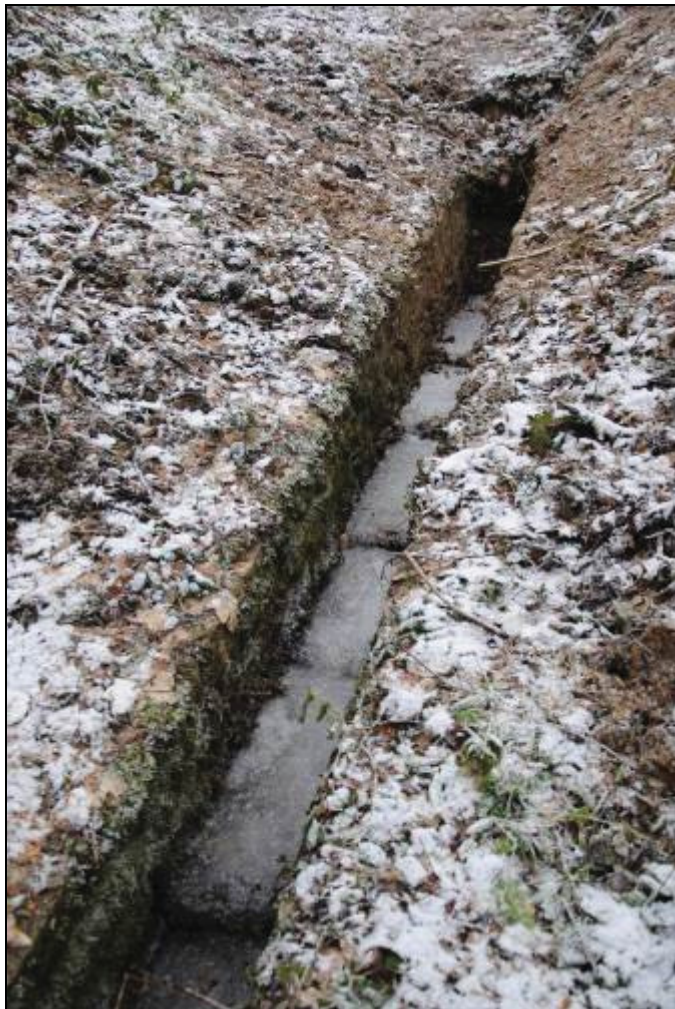
Figure 27 (left)
Stone overflow channel at the east end of the lower pond's dam
