**SCAR NAVVY CAMP, SCAR HOUSE RESERVOIR**

**NIDDERDALE, NORTH YORKSHIRE**

**HISTORIC ENVIRONMENT SURVEY**

August 2013

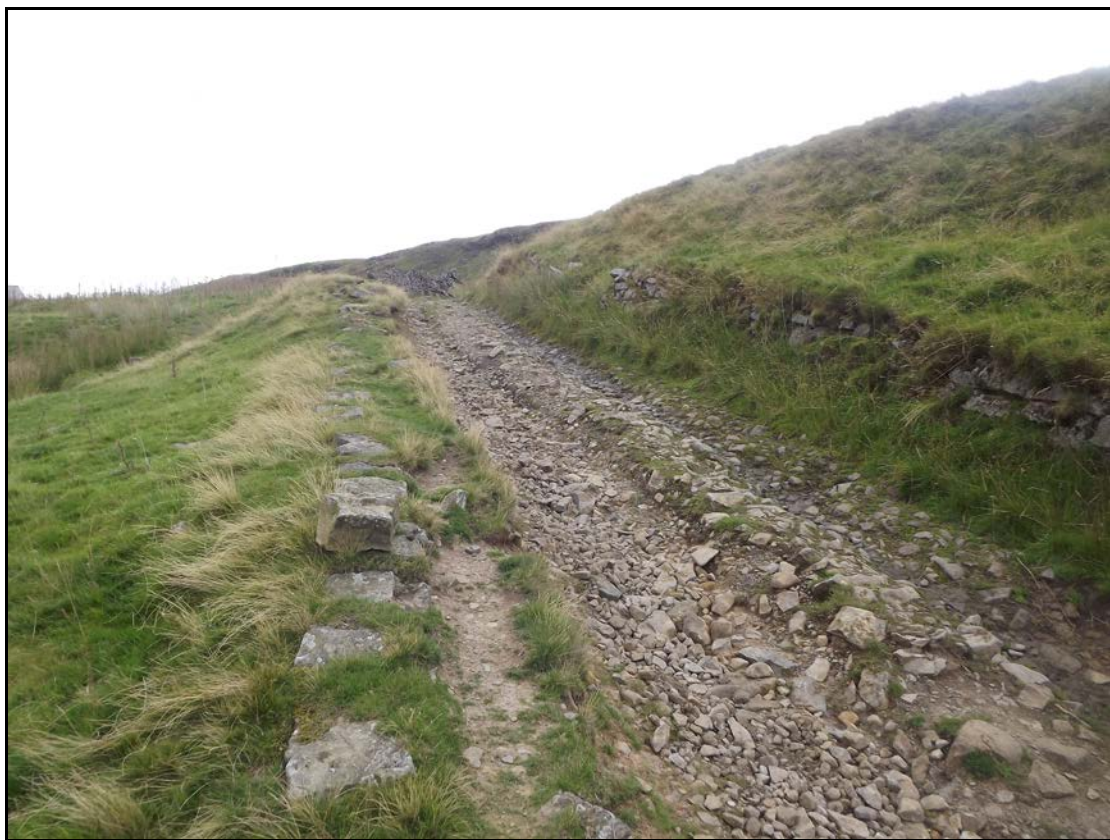
- 4.6 The ‘old road to Middlesmoor’ (Site 8) shown on Figure 3 could be the route of the medieval (or even earlier) track between the now submerged Haden Carr and Middlesmoor. The site visited recorded that the track-way appeared to have the remains of a surface, which had been cobbled with small water rolled stones (Figure 4) in a very similar manner to Carle Fell Road (Buglass, 2011). It also appeared to have the remains of a possible stone trod (Figure 4) along the north-eastern side of a section of the track – again very similar to the one seen on Carle Fell Road. It is possible that this line of stones is the remains of a dry-stone wall along the side of the track. However this would not seem to be the case here. Firstly, there was not the amount of tumbled stone that would normally be expected if this was the case, and secondly, the stones appear to be spaced slightly too far apart to be from a wall base. If these two features are similar to Carle Fell Road and therefore possibly contemporary, it is quite possible that they have a medieval origin, as has been suggested for Carle Fell Road.

Figure 4. Old Middlesmoor Road with remains of cobble surface and possible trod on left hand side

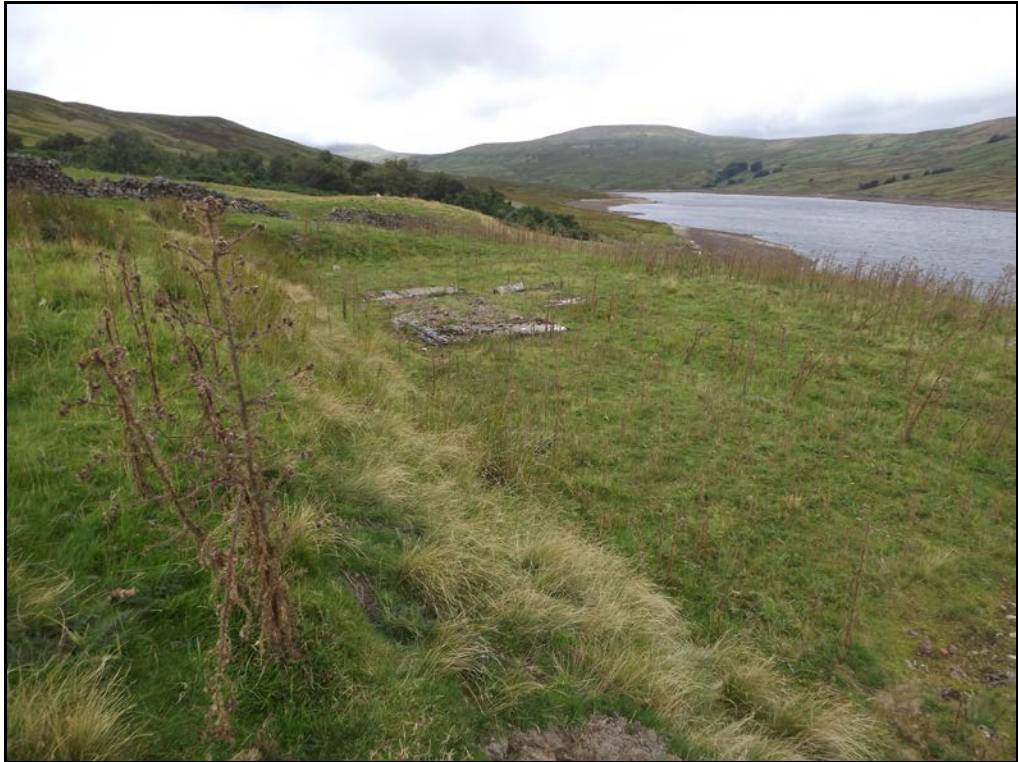
Figure 6. Foundations for West View Bungalows – Site 3, looking west

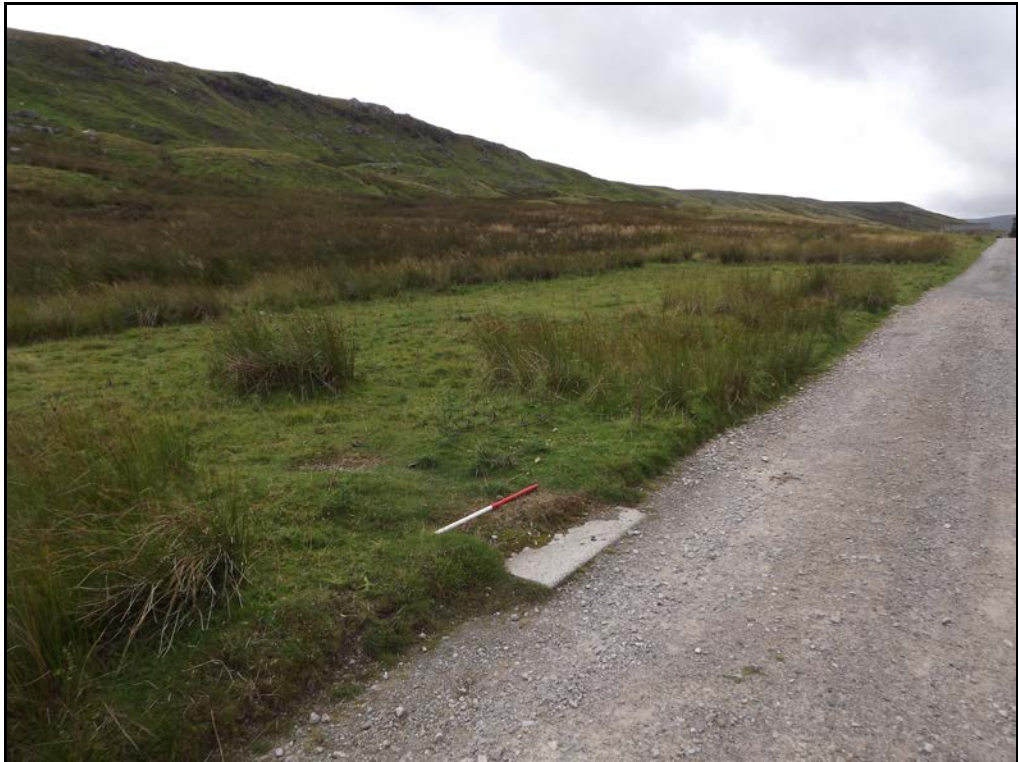
Figure 7. Foundations for Married Quarters – Site 13, looking west

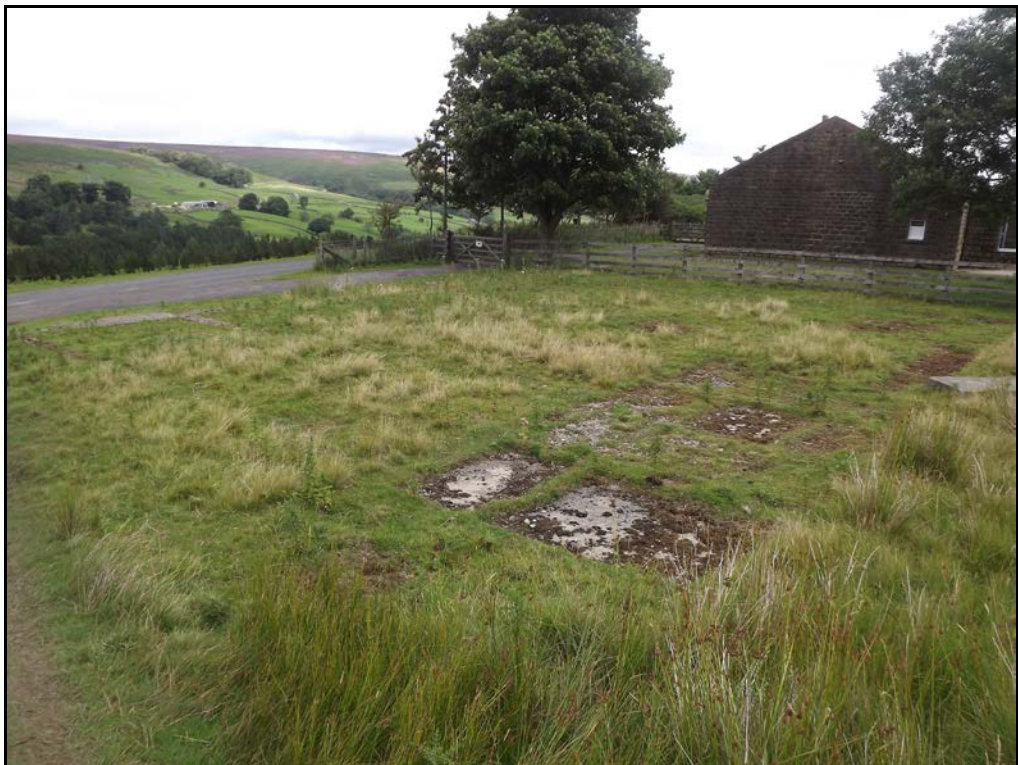
Figure 8. The Crescent – Site 14, looking north-east

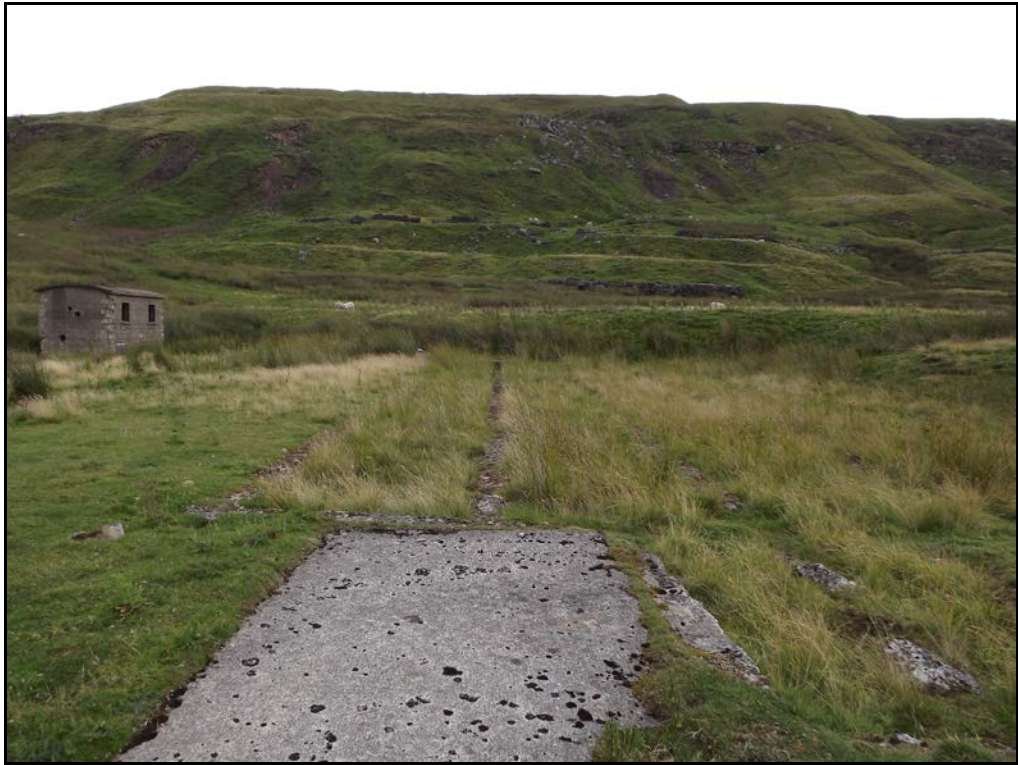
Figure 9. The church – Site 17, looking south

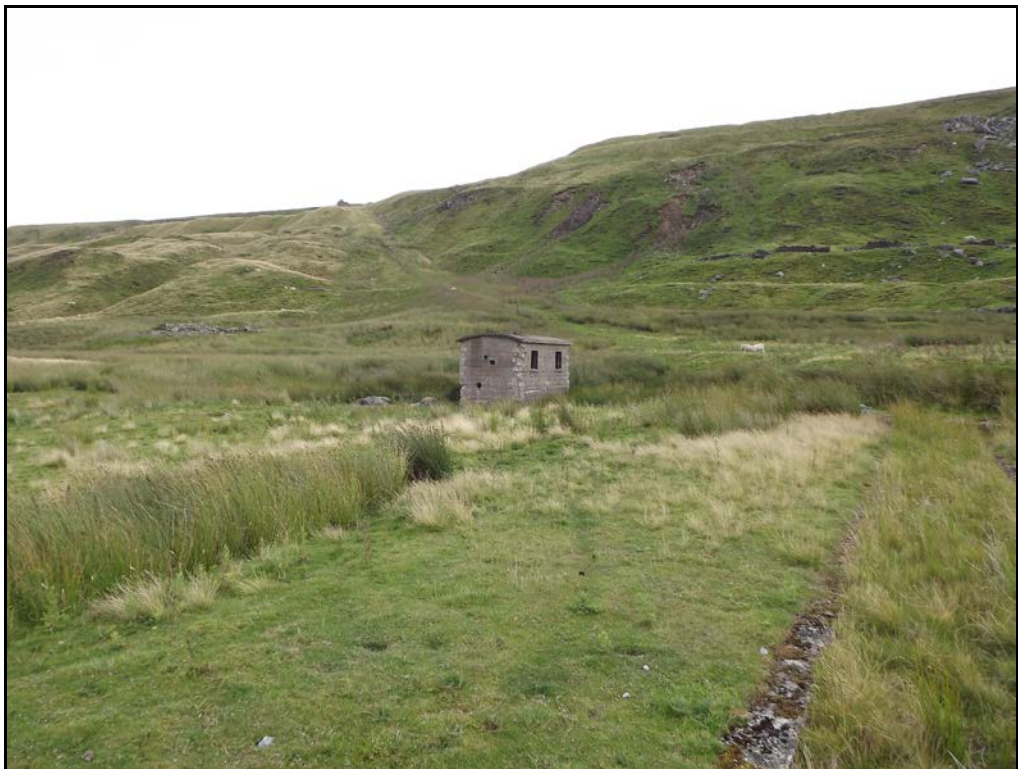
Figure 10. The Projection Hut for the Cinema – Site 18, looking south

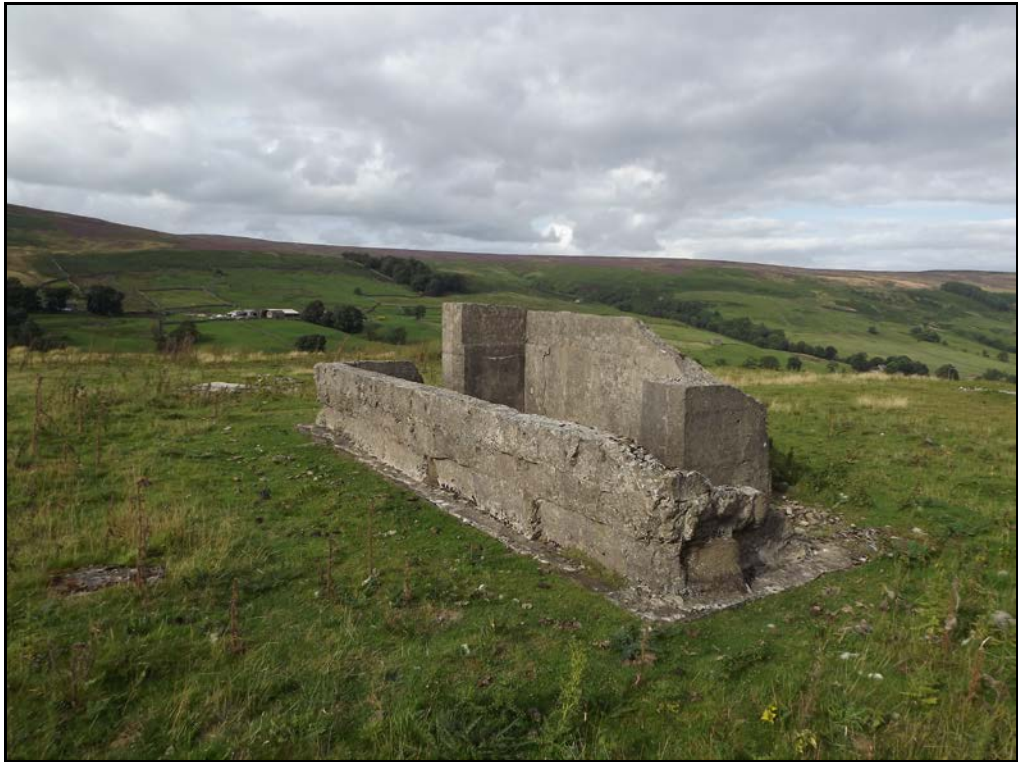
Figure 11. The Gents Urinal of the Canteen – Site 20, looking north-east

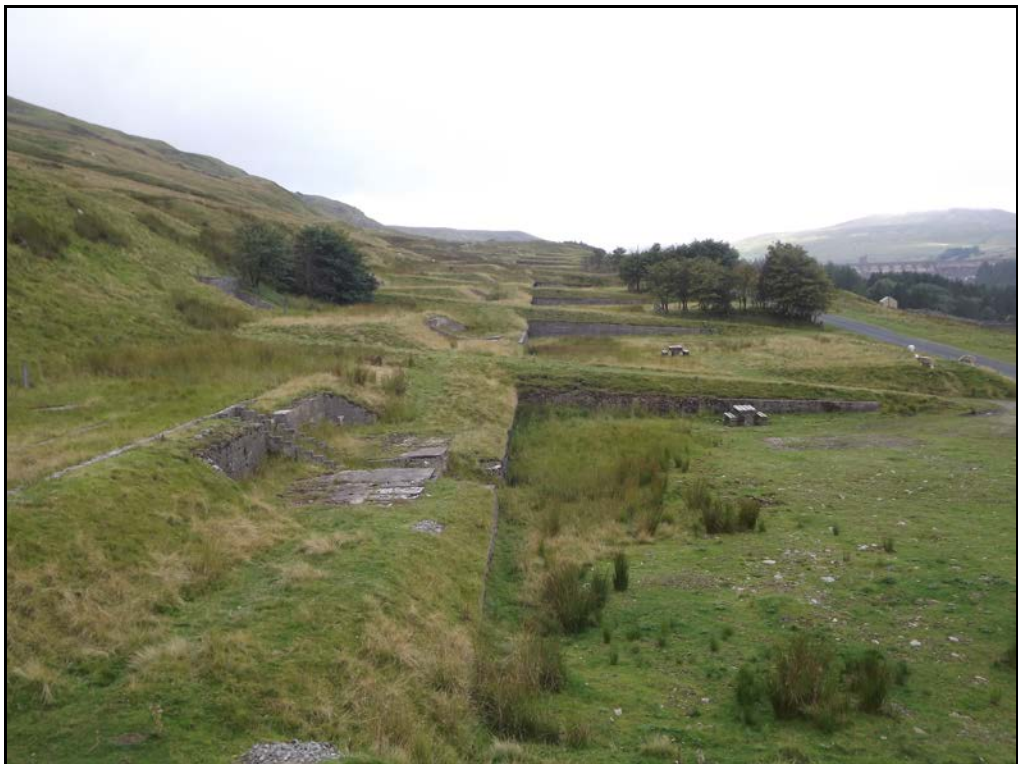
Figure 12. The Single Male Hostels – Site 34, looking west

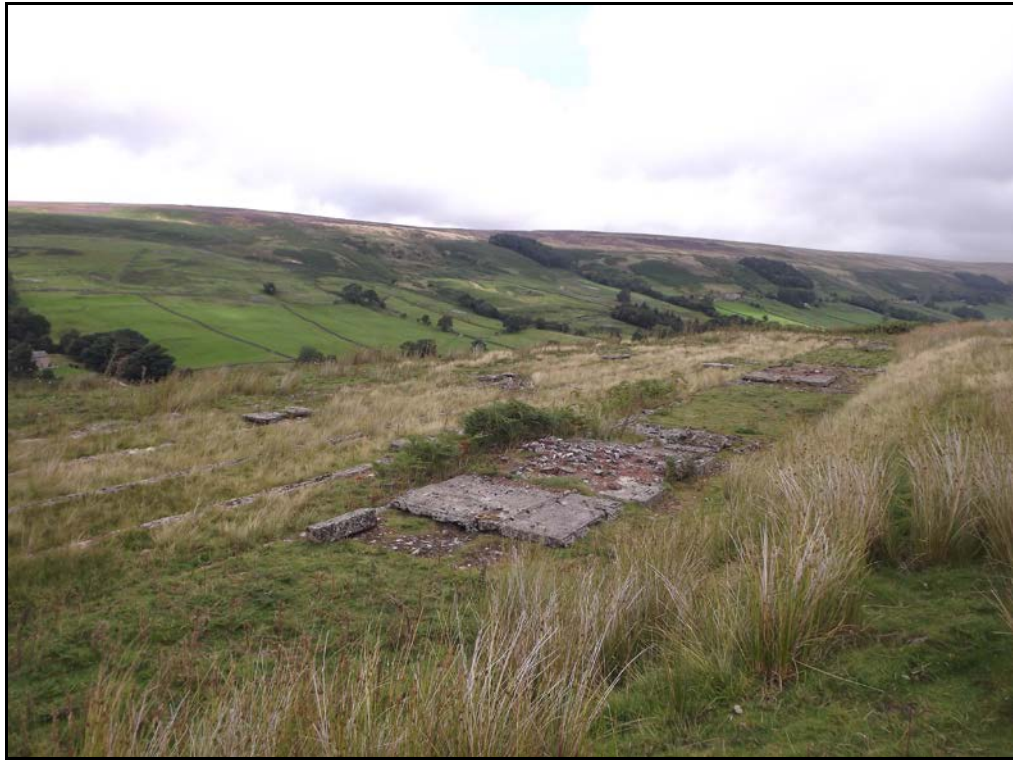
Figure 13. East View Houses – Site 35, looking north-west

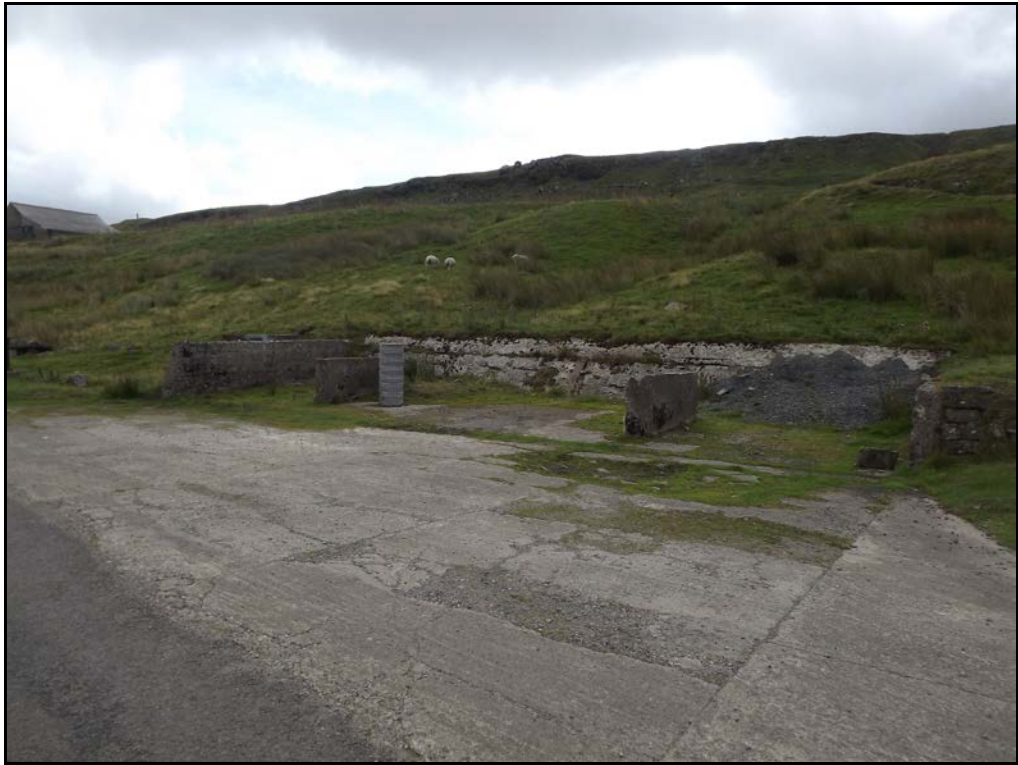
Figure 14. Coal Bunkers – Site 2, looking south-east

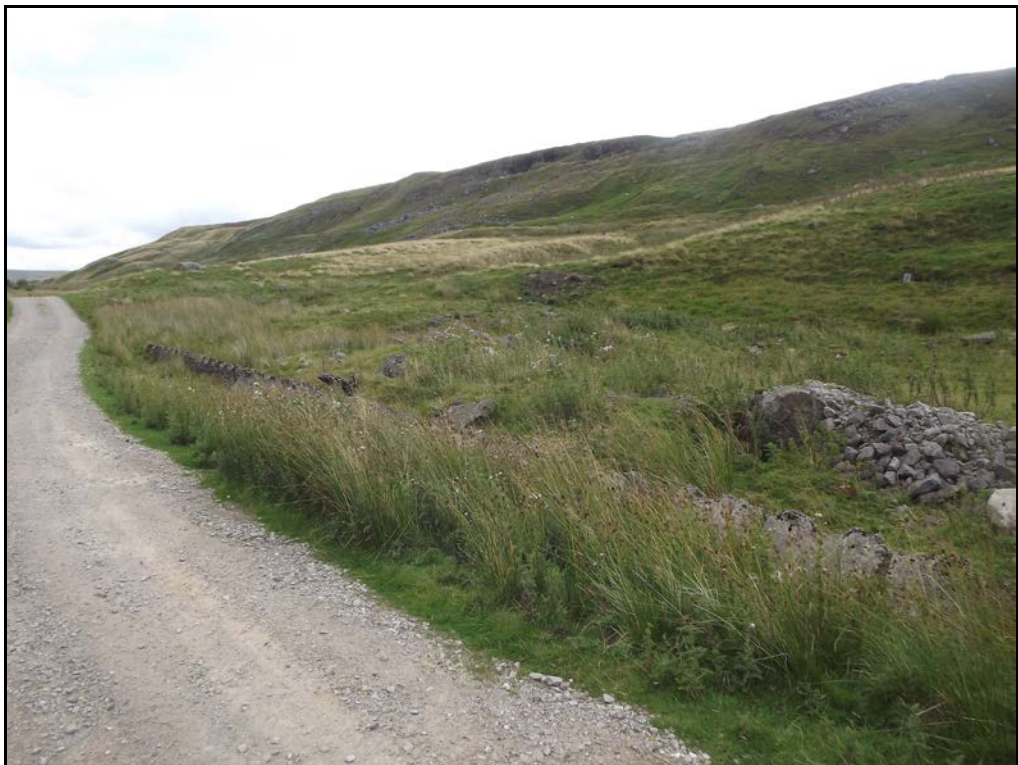
Figure 15. Blondin No 1 Crane – Site 9, looking ESE

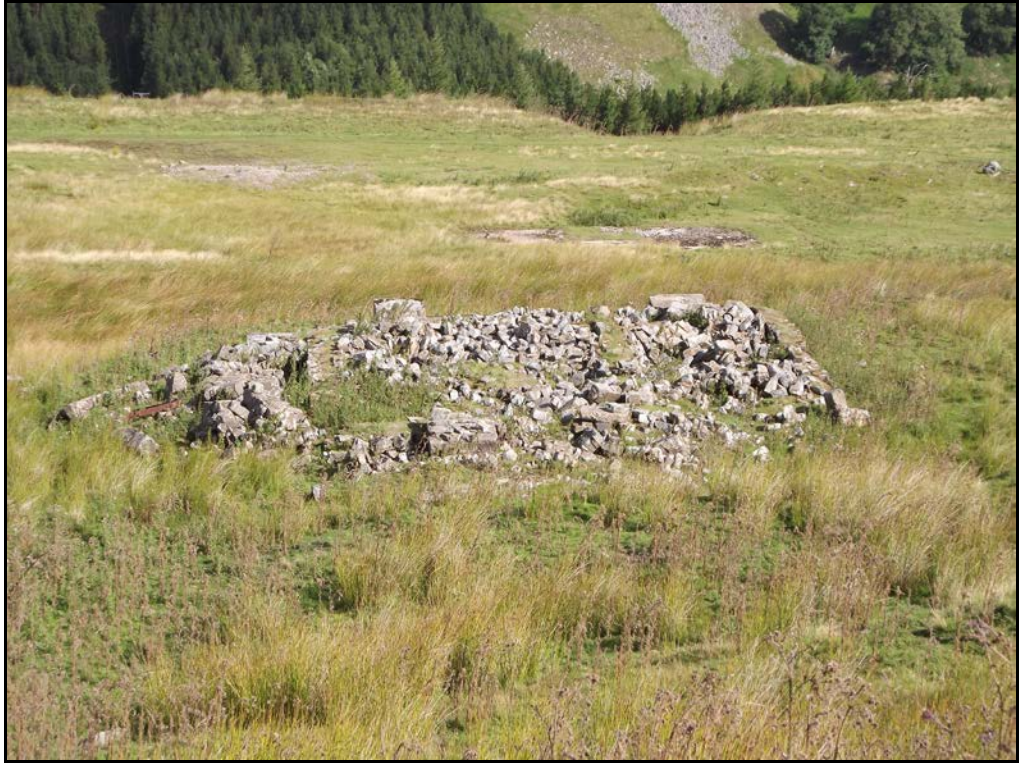
Figure 16. Electricity Sub Station No 2 – Site 24, looking north

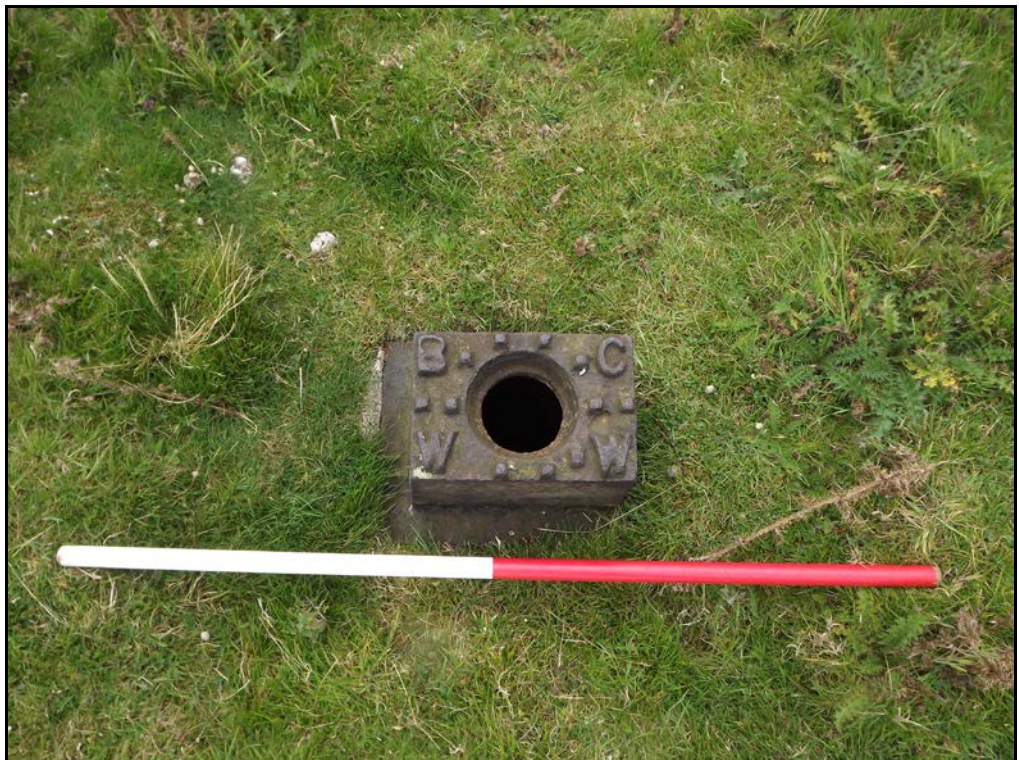
Figure 17. Part of water supply system, scale 1m

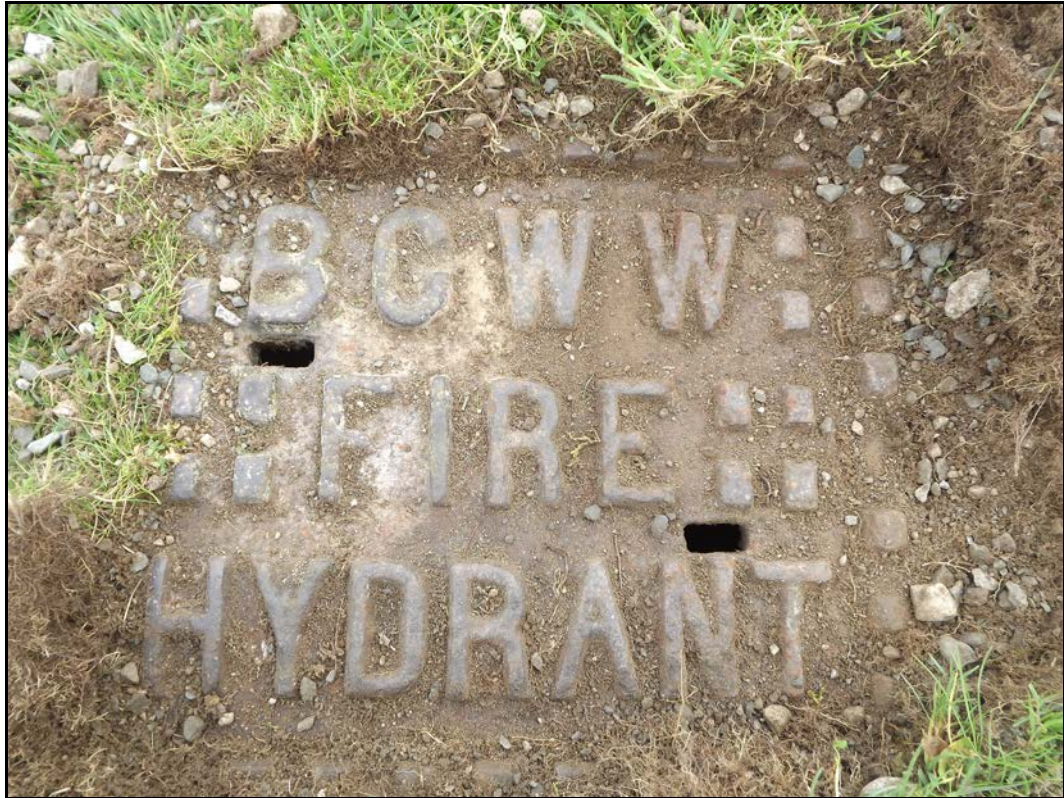
Figure 18. Part of fire hydrant supply system

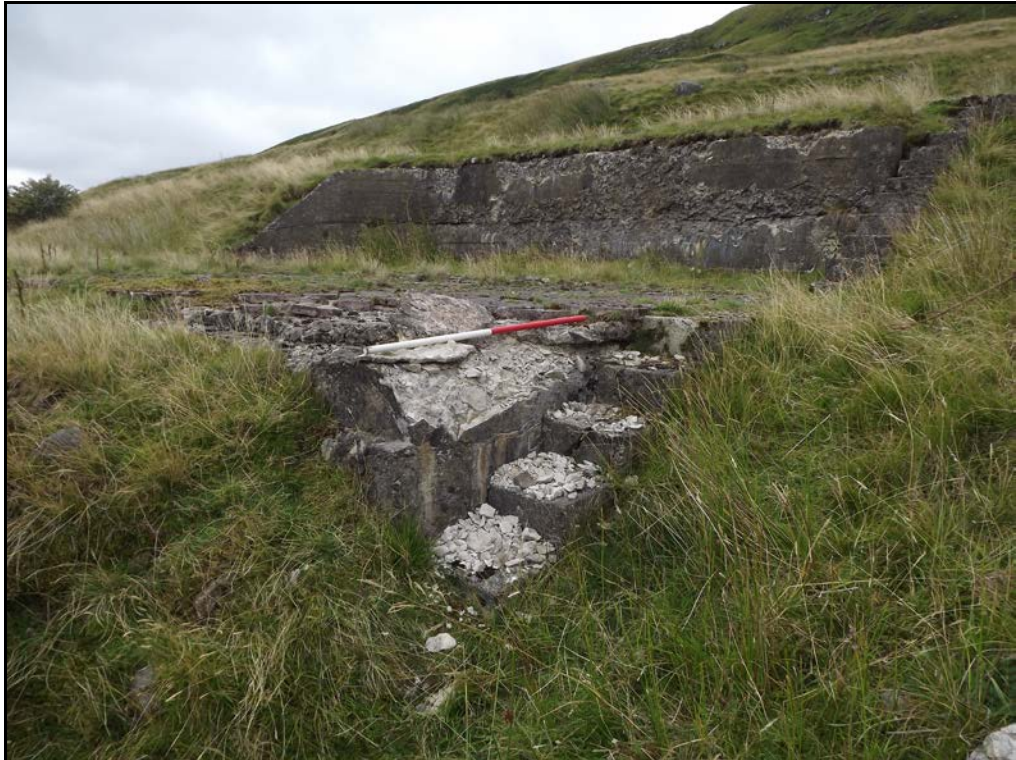
- 5.5 Overall the majority of the remains of the settlement can be classified as being in a fair condition. This said, due to the location of the site high up in Nidderdale and its exposure to constant weathering, there is extensive evidence for an increasing rate of decay (Figure 19). This means that unless repair and consolidation is undertaken the site as a whole will continue to steadily approach a point where it will no longer be possible to define the extent of the many of the features.

Figure 19. Recent loss of structure in one of the hostels, scale 1m, looking SE

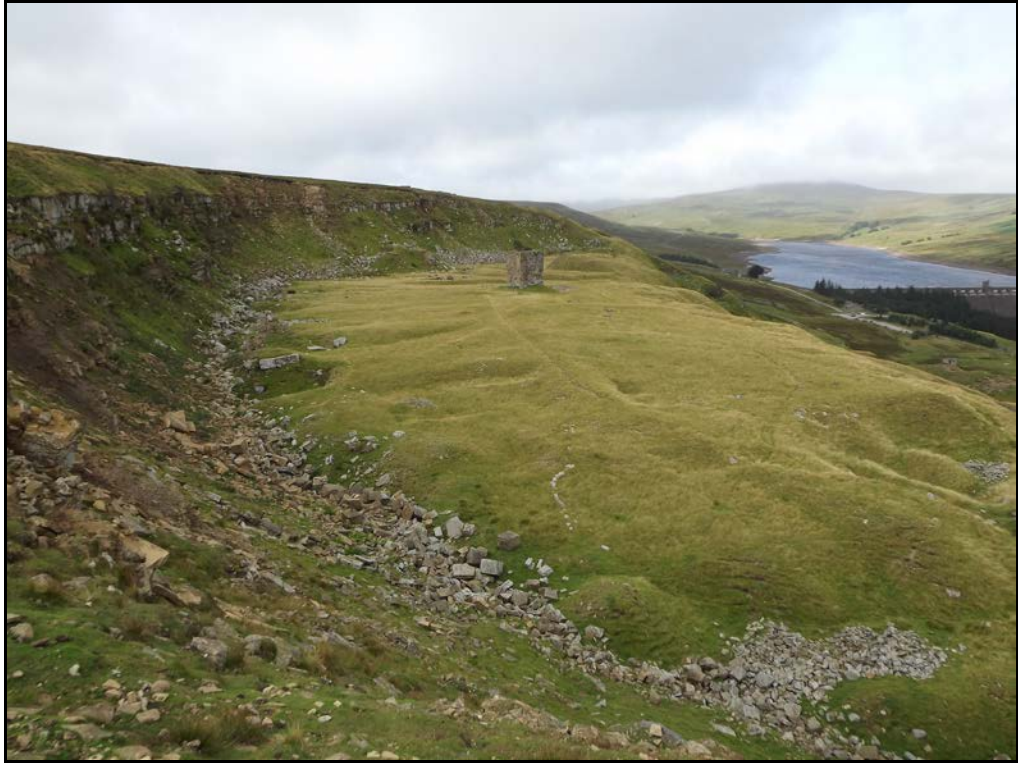
Figure 20. Scar Quarry, looking west

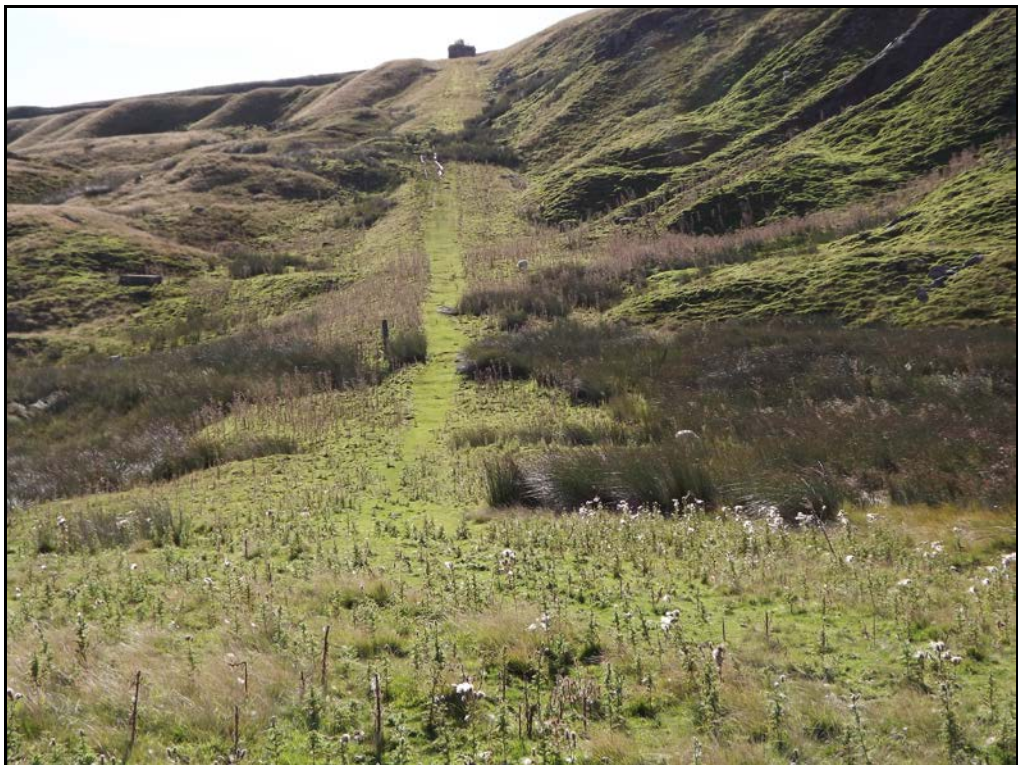
Figure 21. Incline for moving the stone from the quarry to Angram

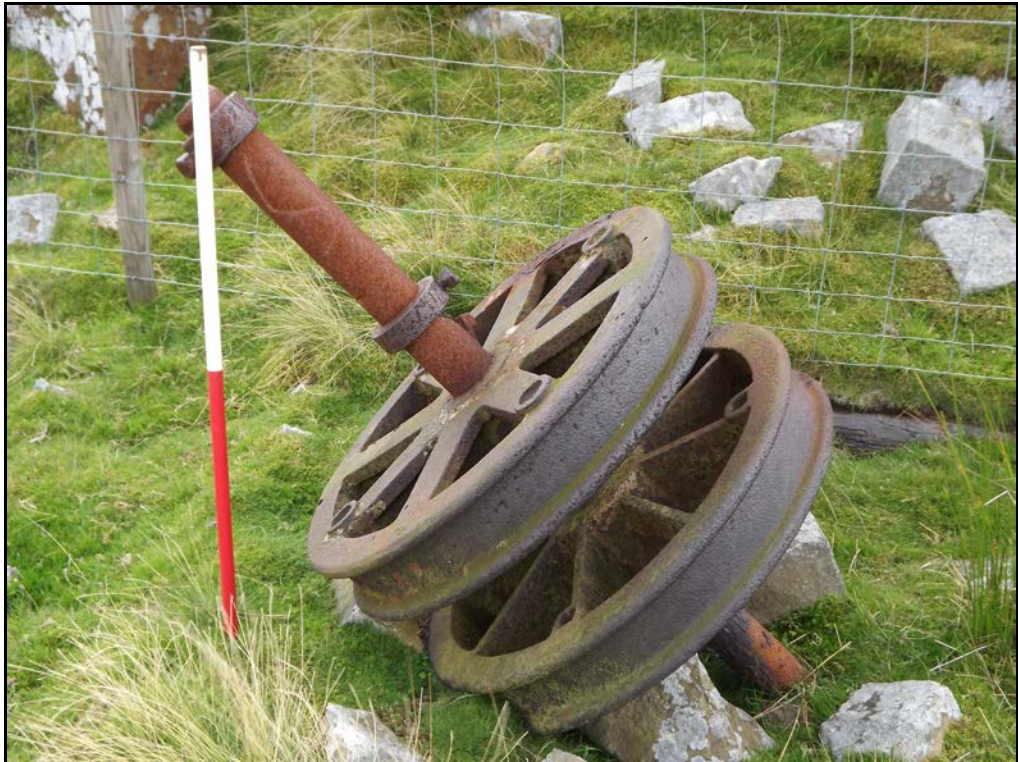
Figure 22. Remains of part of the winding gear for the incline, scale 1m

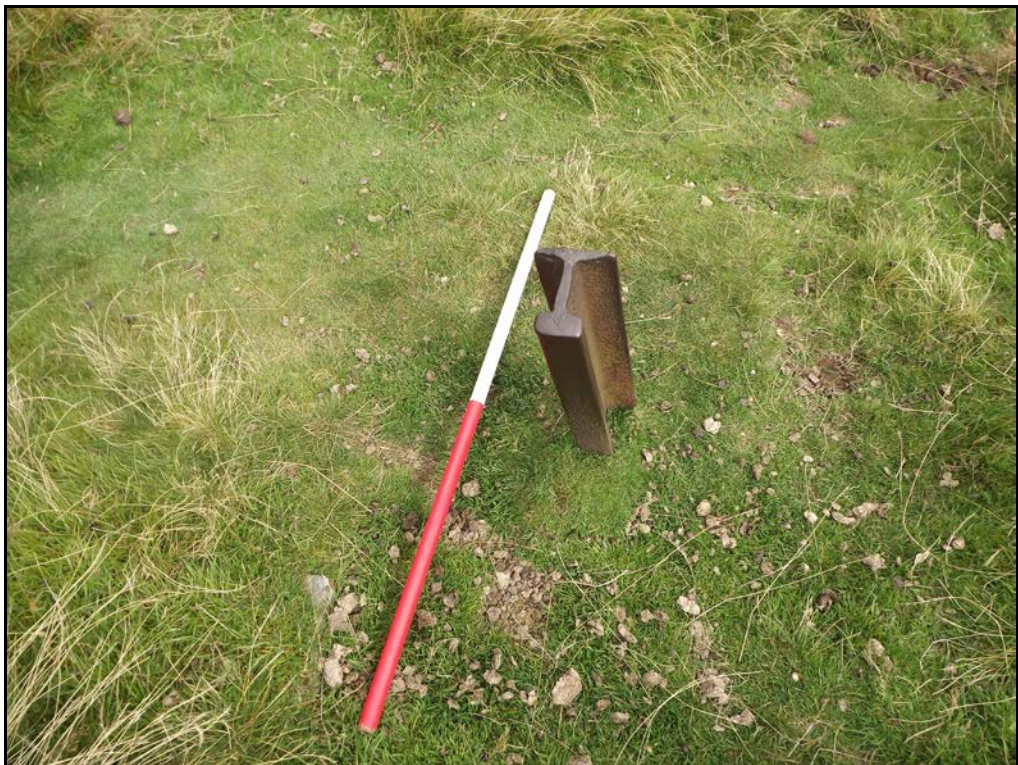
Figure 23. Fragment of railway line in one of the spoil tips, scale 1m

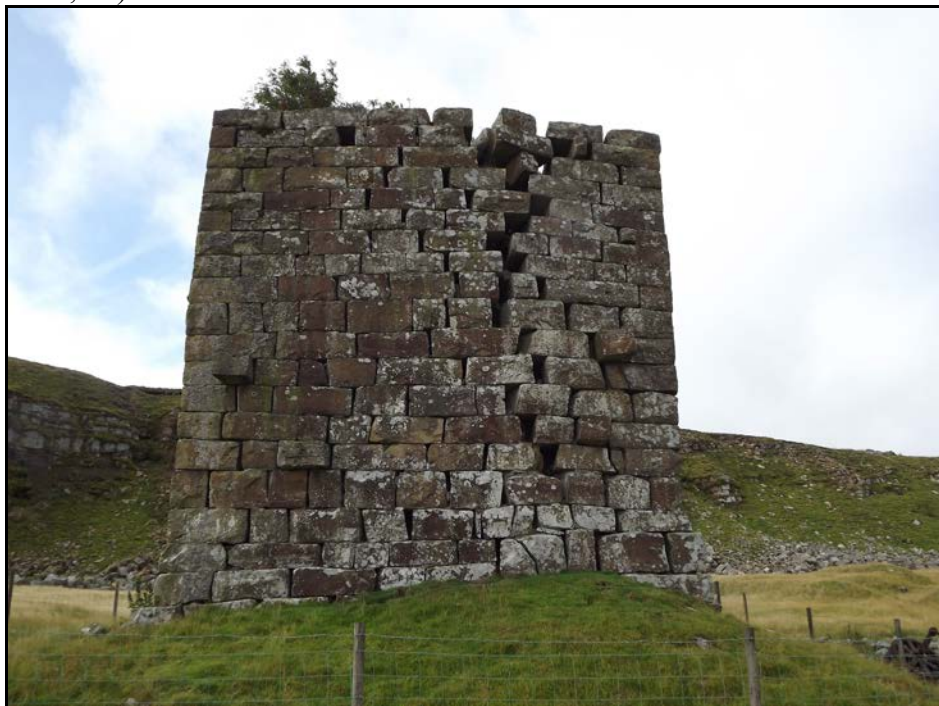
- 5.8 Within the quarry itself there are several obvious features. The first of these is the large stone tower (Figure 25) which was used for the winding gear for the gravity railway. The second obvious feature is the stone stack which has been left un-quarried (Figure 26). Currently there is no obvious reason for this, though it once may have acted to secure bracing cables for the main tower. Less obvious features include the remains of a concrete base (Figure 27) and possible building remains (Figure 28) which could be sub station no. 4 (Bolt, 2007, 74).

Figure 25. Stone tower for winding gear, looking north-east

- Repair/stabilise the tower in the quarry.
- Expose and/or outline key buildings – e.g. church, cinema, school etc. along with an example of each of the different sets of accommodation (Crescent bungalows, hostel, West and East View houses).
- Re-instate benches in the quarry along with an interpretation board.

- Assess the stability of the tower in the quarry
- In a small number of areas within the settlement there are a number of open pits/drains partially covered with vegetation which should be covered or fenced off

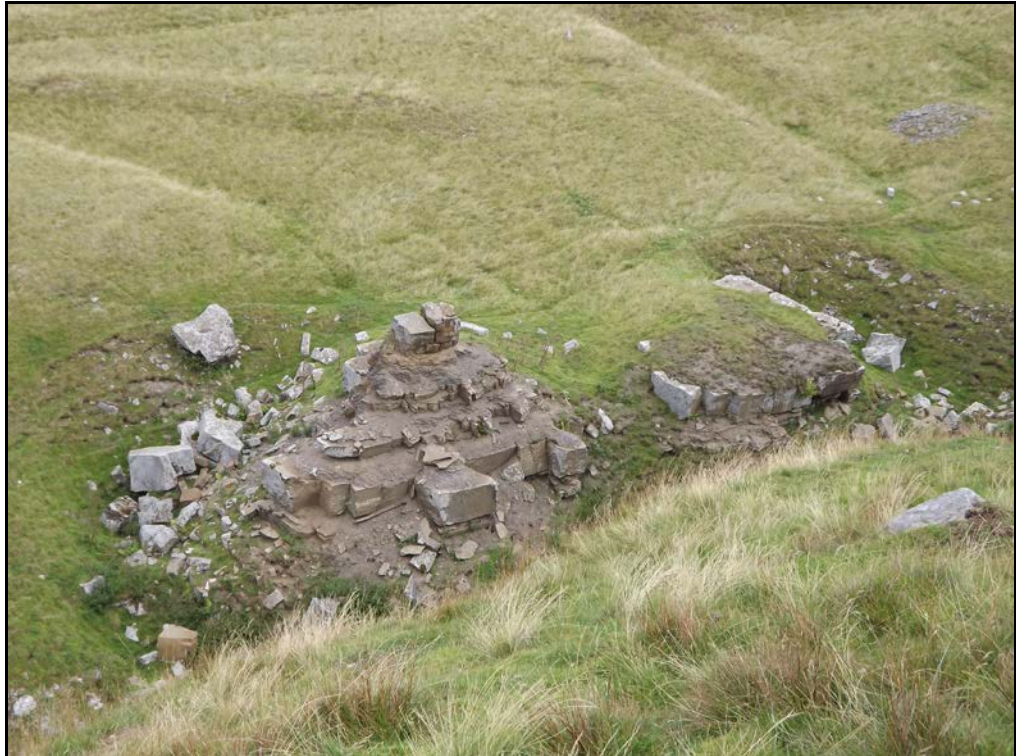
Figure 26. Un-quarried stone stack on south side of the quarry, looking NE

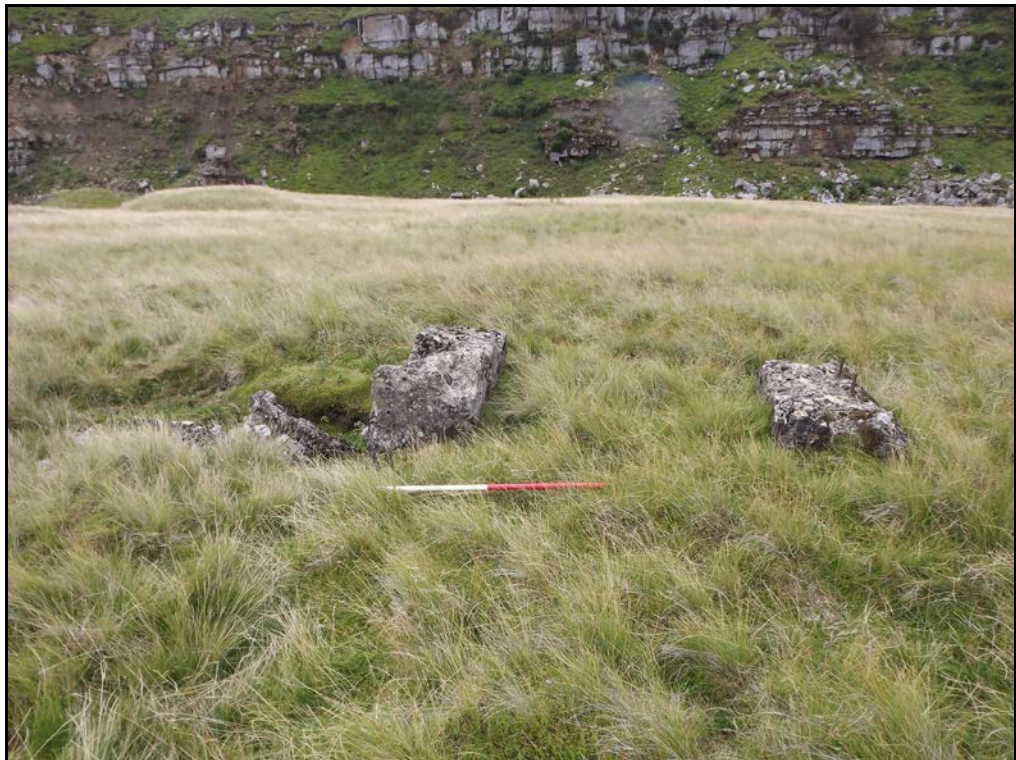
Figure 27. Remains of concrete base, scale 1m, looking south

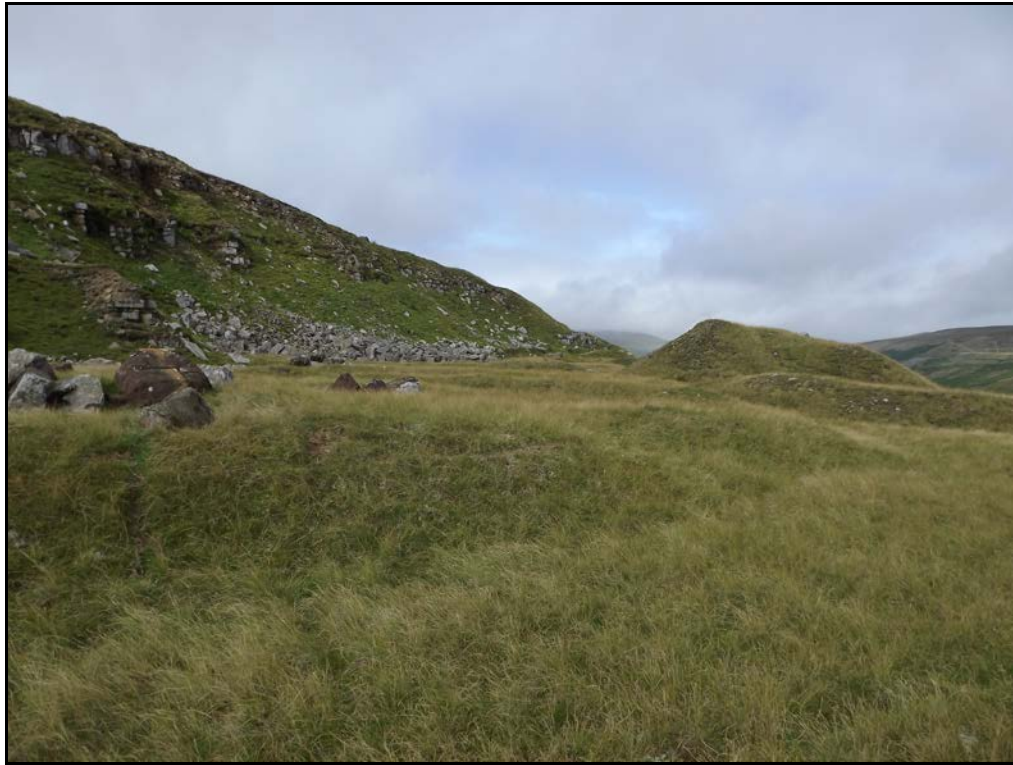
Figure 28. Area of possible buildings at the western end of the quarry

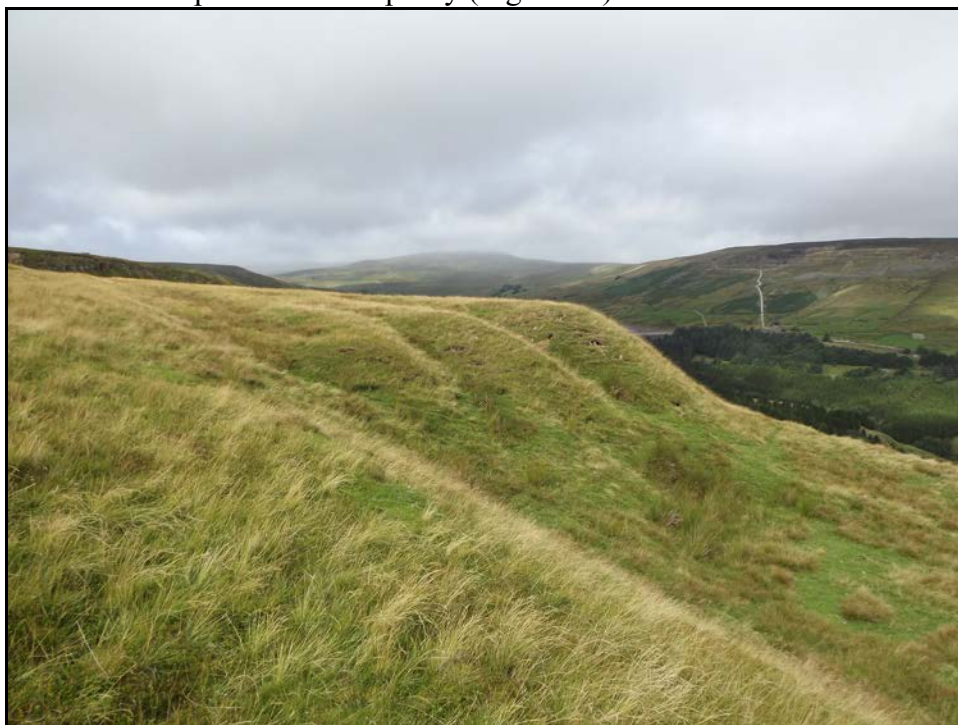
- 5.9 An examination of the hillside around the quarry showed that there had been widespread and systematic dumping of quarry waste forming a series of terraces (Figures 29 & 30). These spoil tips appear to cover the whole of the hillside extending a considerable distance to the east and, in places, appear to continue all the way down the hillside to Scar Village itself. It may even be the case that the parts of the settlement from the church eastwards are actually terraced in to spoil from this quarry (Figure 12).

Figure 29. Ends of three spoil tips to the east of the quarry, looking NW

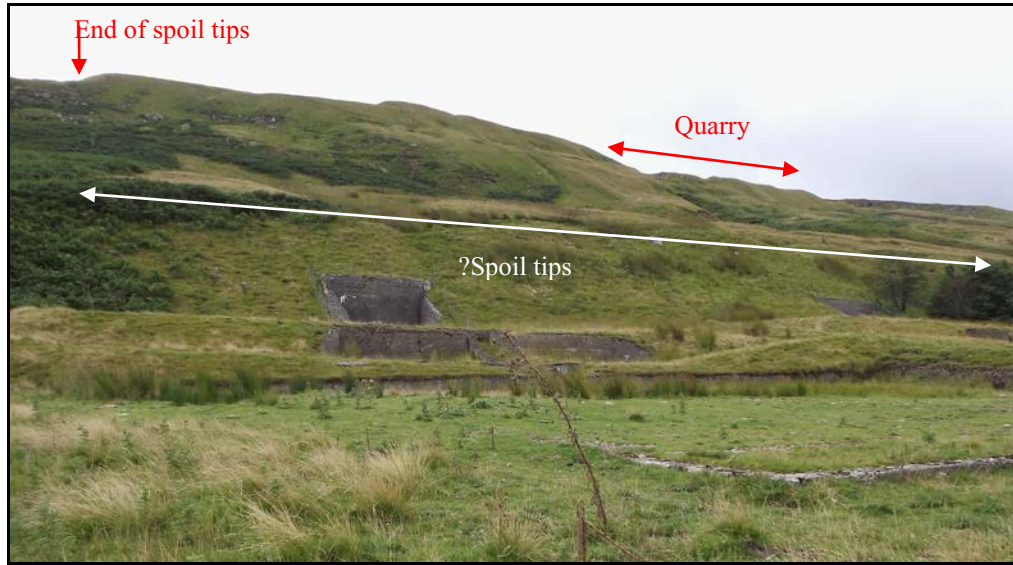
Figure 30. Extent of spoil dumping south of the hostels

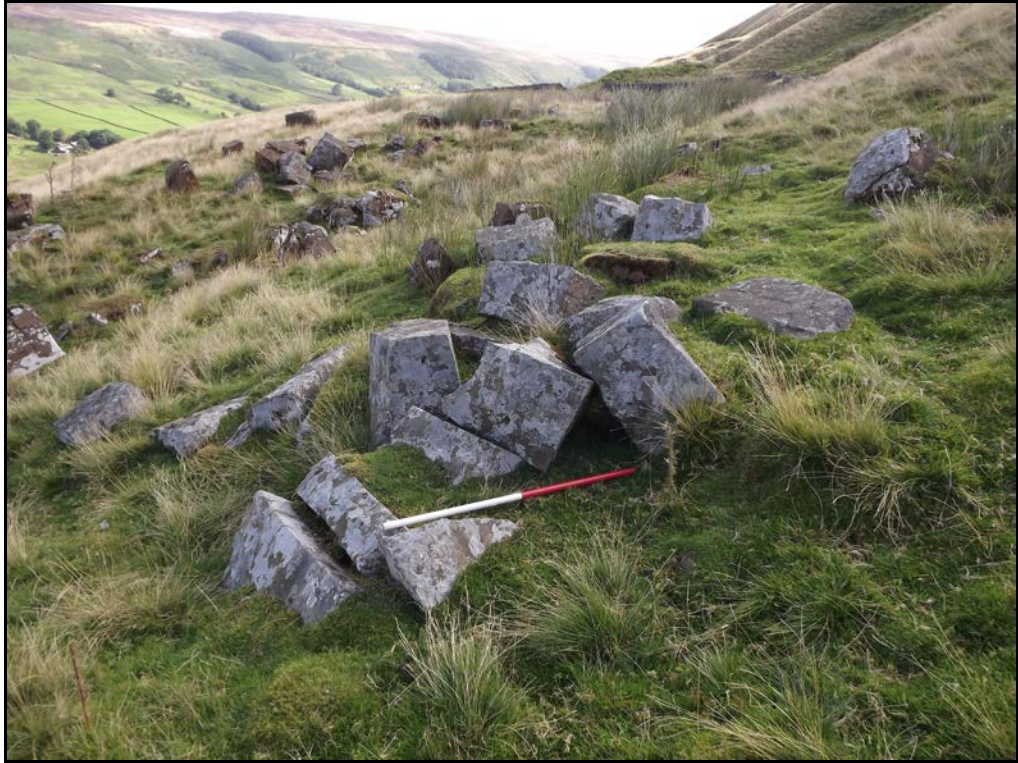
- 5.10 One unusual feature of the quarry is that there is no evidence for the stone extraction having been carried out by benching – as can be seen in the quarry on the opposite side of the valley which supplied the stone for Scar Reservoir dam. The use of benches in large quarries by this time would have been common practice and the lack here would seem to suggest one of two situations. Firstly, the stone was extracted from a simple vertical face. This would not have been a safe manner to do so as the stratigraphy of the rock has a number of softer layers within it, which would have caused a high degree of instability (Figure 26). Secondly, the evidence for the benches has been covered by dumping the spoil from the final phase of stone extraction. The latter situation would seem to be the most likely as the size of the quarry as seen today does not seem to be large enough to have generated both the vast amount of spoil surrounding it and sufficient stone to have built Angram dam. Other evidence for this suggestion can be seen in the significant amount of worked stone blocks visible partway down the hillside on the eastern side of the incline (Site 25, Figure 31), which may mark the level of an earlier quarry floor.

- 5.11 If this is the case, then the quarrying was carried out by backfilling the lower benches with waste as the working face cut deeper into the hillside. This could explain why the tower in the quarry has large gaps opening up as the base of it is on unconsolidated spoil. It would also explain why the stone for Scar dam was quarried on the opposite side of the valley as the Angram dam quarry would have been too congested with spoil to obtain enough new stone.

Figure 31. Stone blocks possibly from lower level of bench working, scale 1m

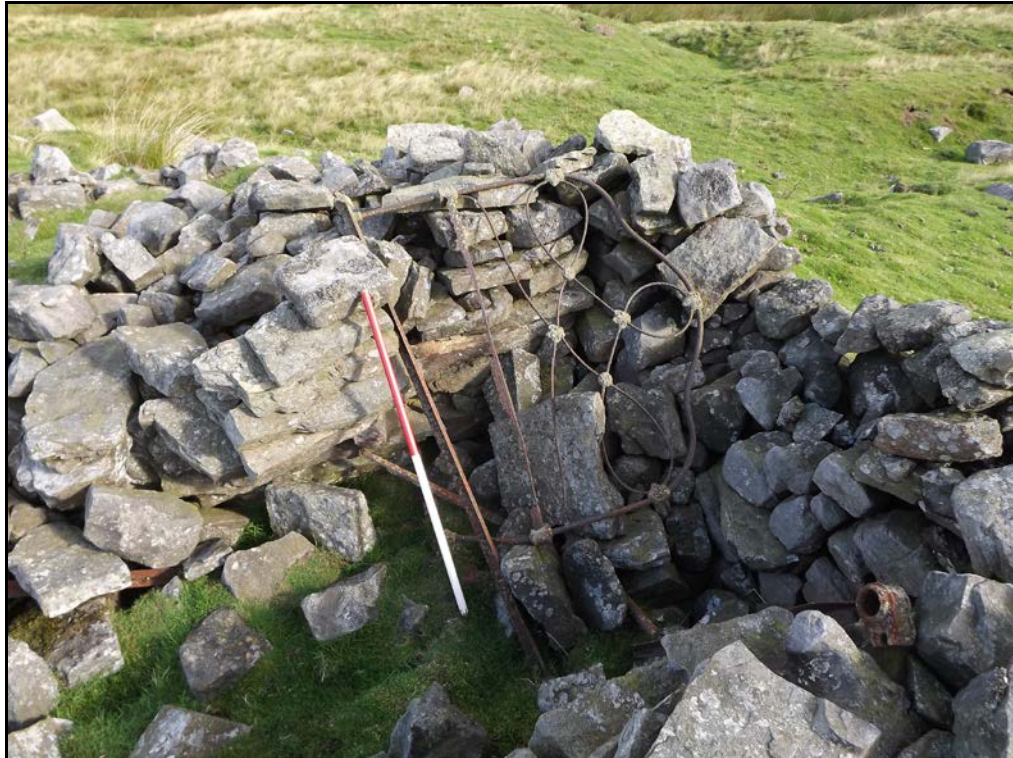
Figure 32. Remains of an iron bedstead, probably from Scar Village
