**SCAR NAVVY CAMP, SCAR HOUSE RESERVOIR**

**NIDDERDALE, NORTH YORKSHIRE**

**HISTORIC ENVIRONMENT SURVEY**

August 2013

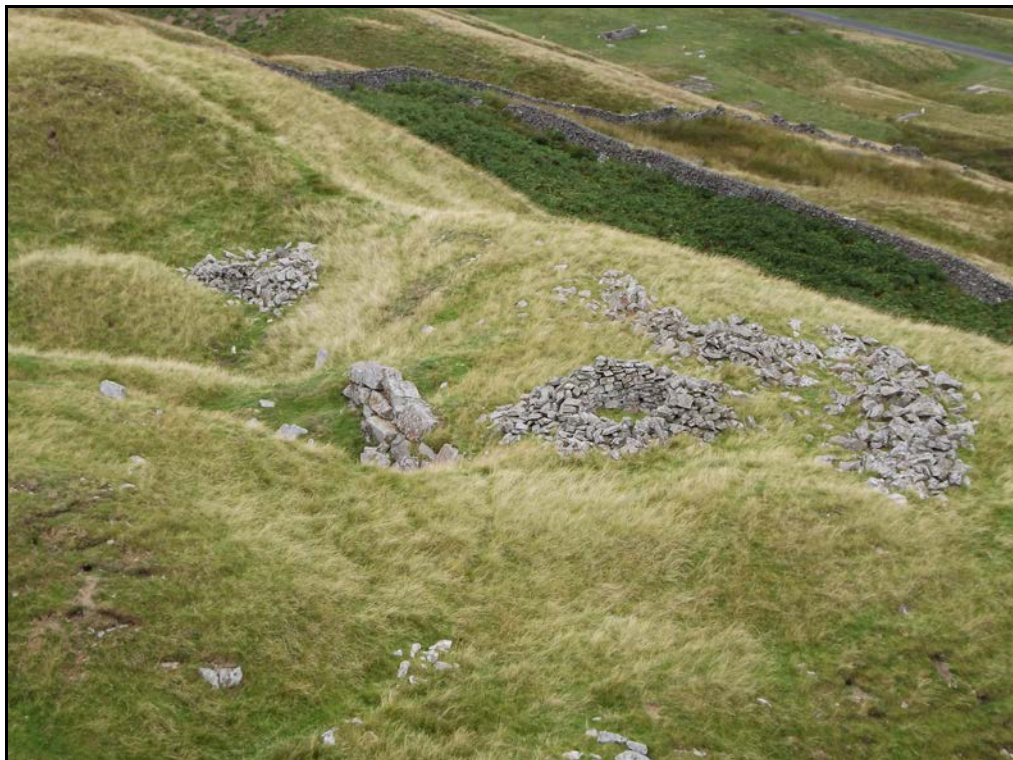
Figure 33. Grouse butts within the quarry, looking north-west
