An Earthwork Survey of Seamer Manor House

1. Introduction

Over the weekend of 29-30 March 2002, the Scarborough Archaeological and Historical Society surveyed the site of the medieval manor house on the west side of Seamer village (National Grid Reference TA 0132 8341). The survey was designed to provide a basic record of the main earthwork components of the site in order to assist the Seamer Heritage and Research Project 2000 (SHARP) with their investigations into the development of the village. This project is financed by an Awards for All grant from the Heritage Lottery fund. Technical support was provided by English Heritage.

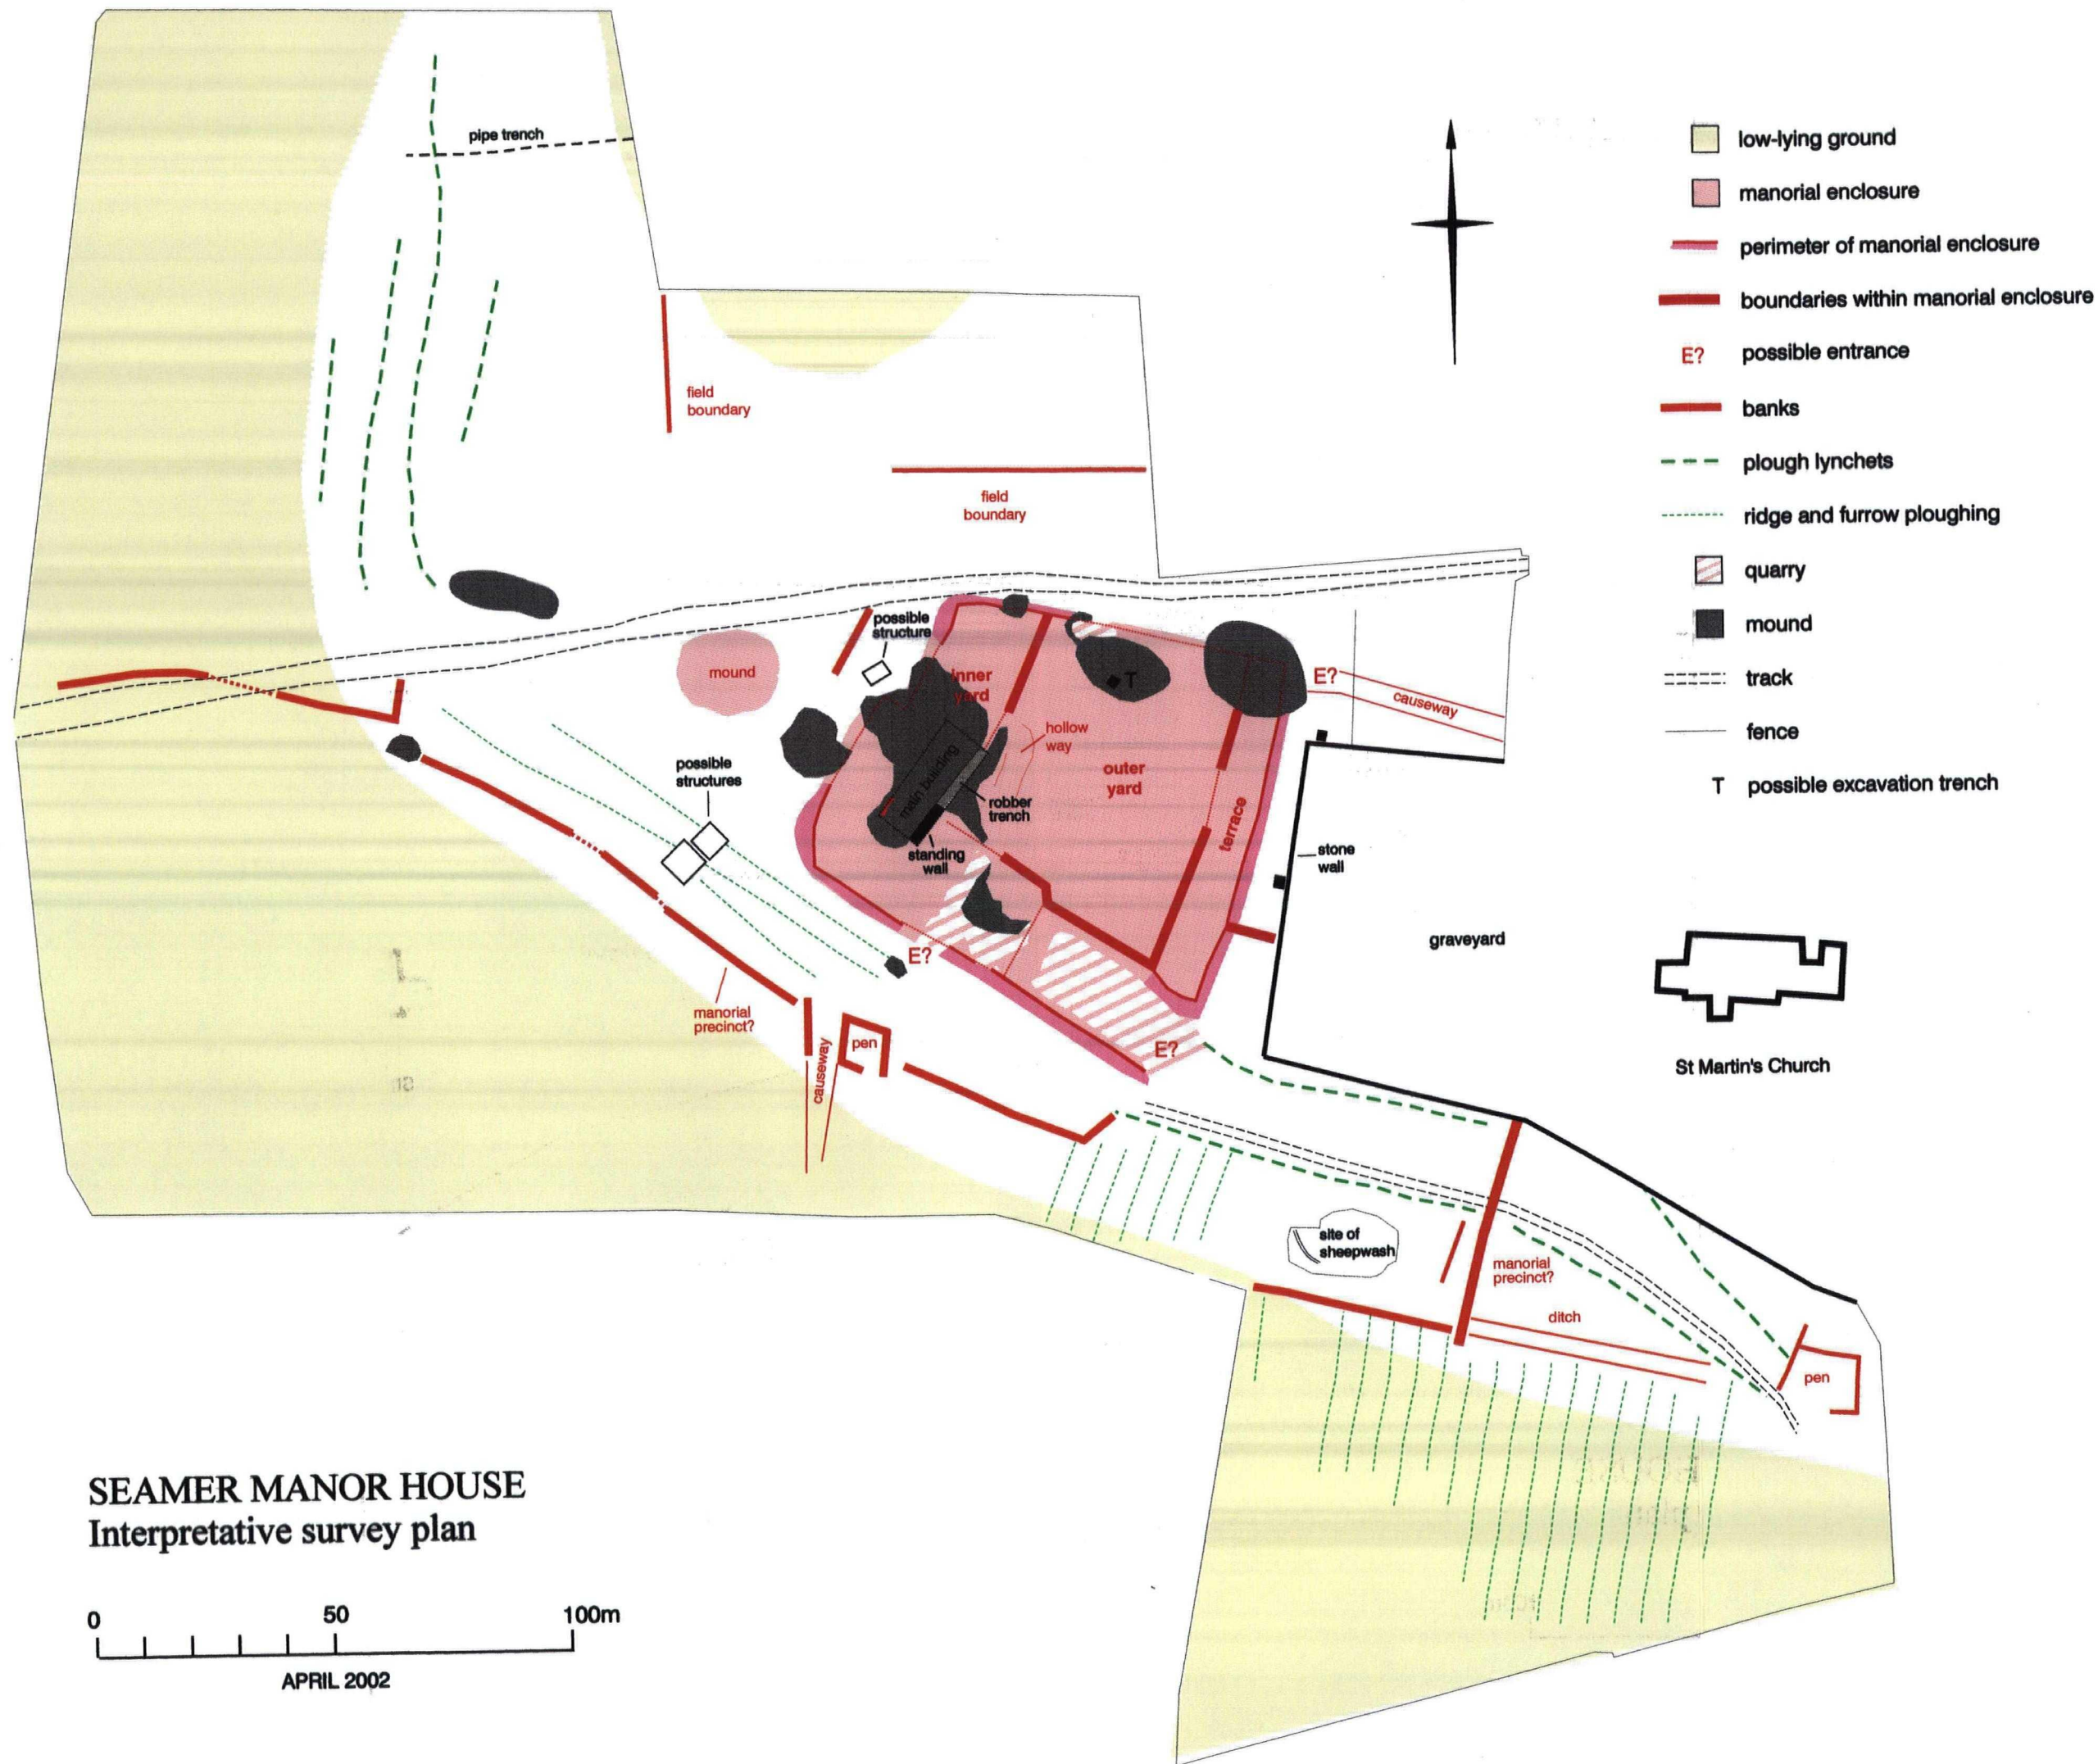
SEAMER MANOR HOUSE
Interpretative survey plan

The interpretative plan included in this report illustrates the following description and analysis of the earthworks of Seamer Manor house and its environs.
