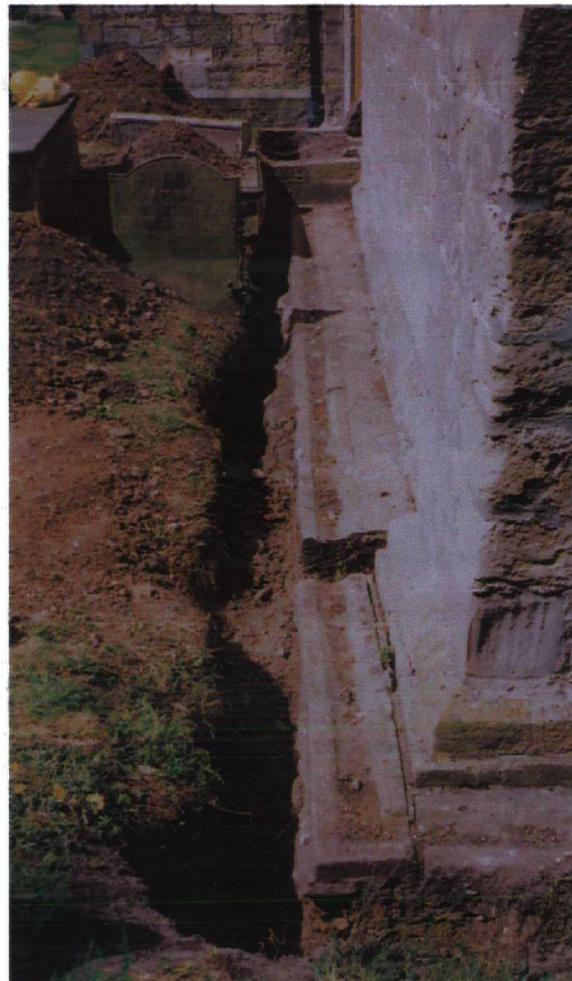
Immediately adjacent to the base of the church walls was a drainage channel (context 1000) consisting of stone slabs 0.25m wide or 0.58m wide, 0.13m high and ranging between 0.75m and 0.90m in length, with a shallow concave gully, 0.12m wide and 0.03m deep, running centrally along each block. The gully formed a continuous eaves-drip drain around the entire church, with the exceptions of the western elevation and the south side of the church porch. In places, such as the western elevation of a buttress at the south-eastern corner of the nave, the stone blocks of context 1000 were immediately adjacent to the church wall, but on the remainder of the southern side of the chancel context 1000 was separated from the church wall by a thin strip of concrete between 0.17m and 0.23m in width (context 1001, Figure 3 Section 2). On the northern and eastern sides of the chancel context 1000 was separated from the church wall by stone blocks 0.22m wide and between 0.42m and 0.98m in length (context 1002, Figure 3 Section 4). Contexts 1000, 1001 and 1002 rested on either poured concrete up to 0.14m thick (context 1003, Figure 3 Section 4), or directly upon cemetery soils (Figure 3 Section 2). Contexts 1000-1003 were all of modern date.

Plate 2 New drainage trench and contexts 1000 and 1001 adjacent to the south side of the chancel

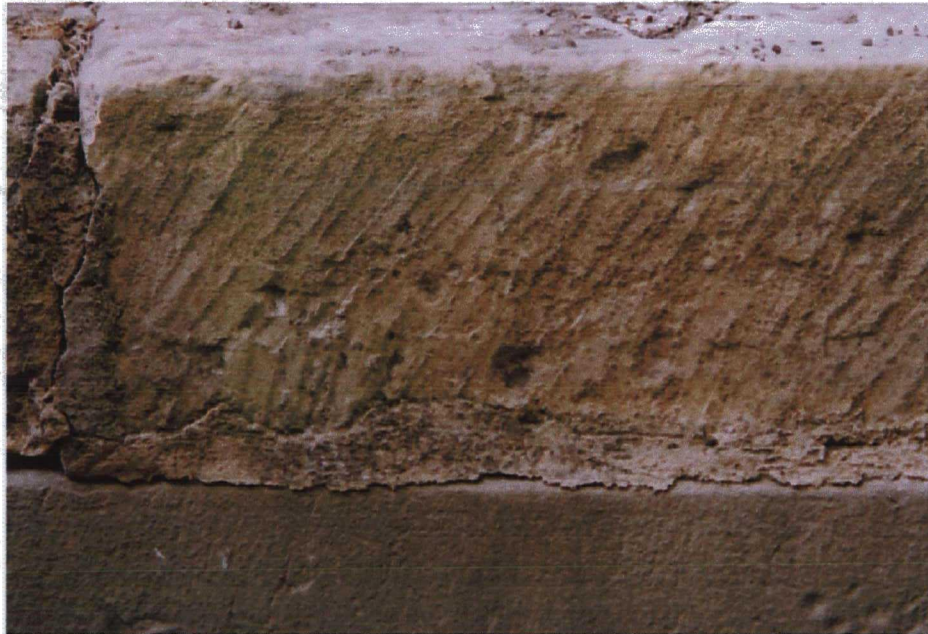
Two parallel kerbs were recorded each 0.80m in length, which ran at 90 degrees from either side of the south door of the chancel (context 1004 was the western and 1005 was the eastern kerb). These kerbs each consisted of two courses of sandstone blocks up to 0.40 x 0.22 x 0.15m in size, bonded with hard, coarse-grained, cream-coloured mortar. The blocks showed a variety of coarse striated tooling, and all seemed to have been re-used. The walls were stratigraphically above contexts 1001-1003 and were clearly therefore modern.

Plate 3 Tooling on kerb 1005

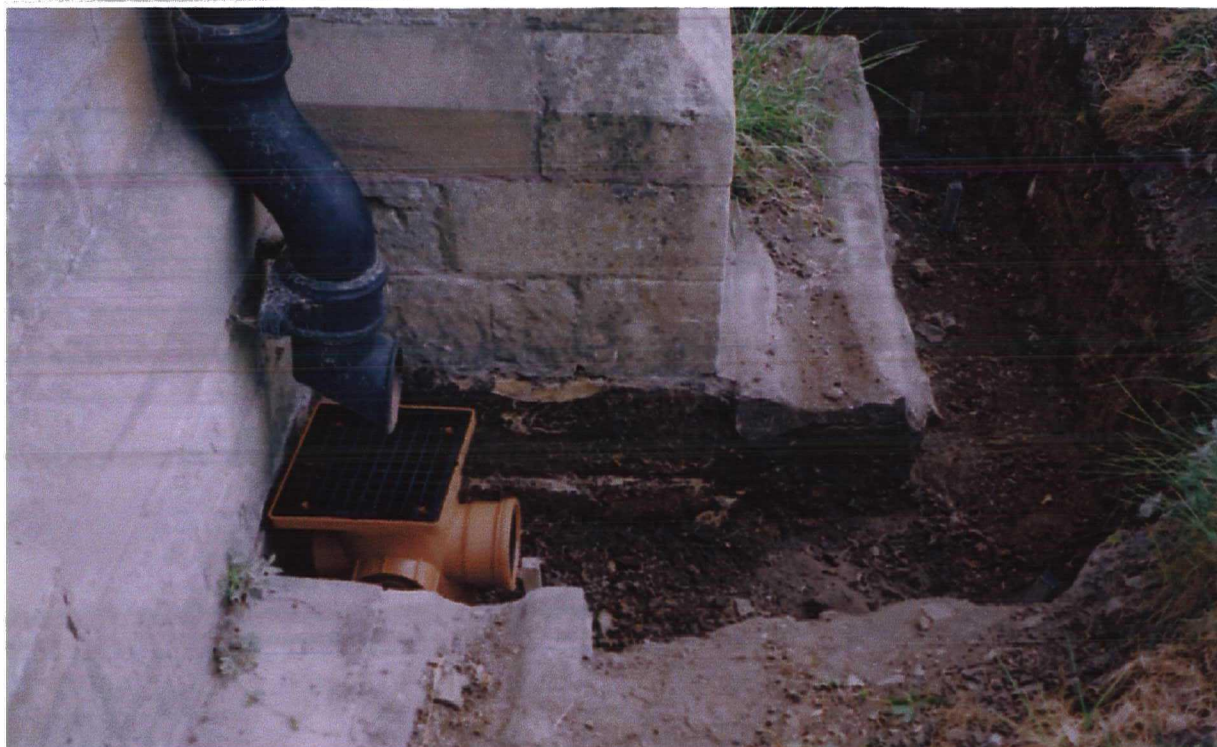
The presence of contexts 1000-1003 meant that relatively little could be learned of the structural history of the church. It was possible, however, to see lower portions of the chancel walls where new drainage down-pipes were being inserted. A down-pipe pierced context 1000 at the junction of a buttress and the eastern end of the south aisle of the church (Figure 2, Figure 3 Section 1 and Plate 4). The western elevation of this buttress continued 0.27m below the upper surface of context 1000, where it stepped out 0.015 to 0.02m. This step presumably represents an original footing.

Plate 4 Footing of church wall

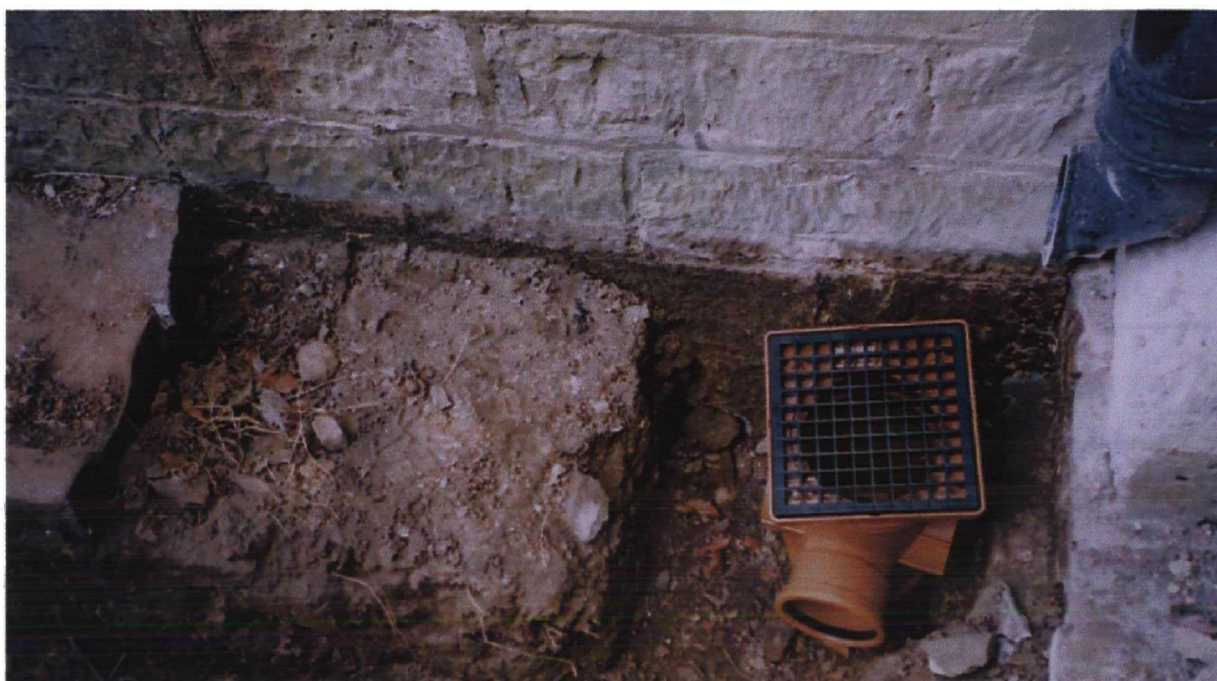
A second drainage down-pipe pierced contexts 1000 and 1001 at the junction of the south aisle and chancel. The church wall here continued 0.31m below the level of contexts 1000/1001, but there were no visible footings (Plate 5).

Plate 5 Church wall at junction of south aisle and chancel
