## 10.0 Appendix 3 ~ The Plates.

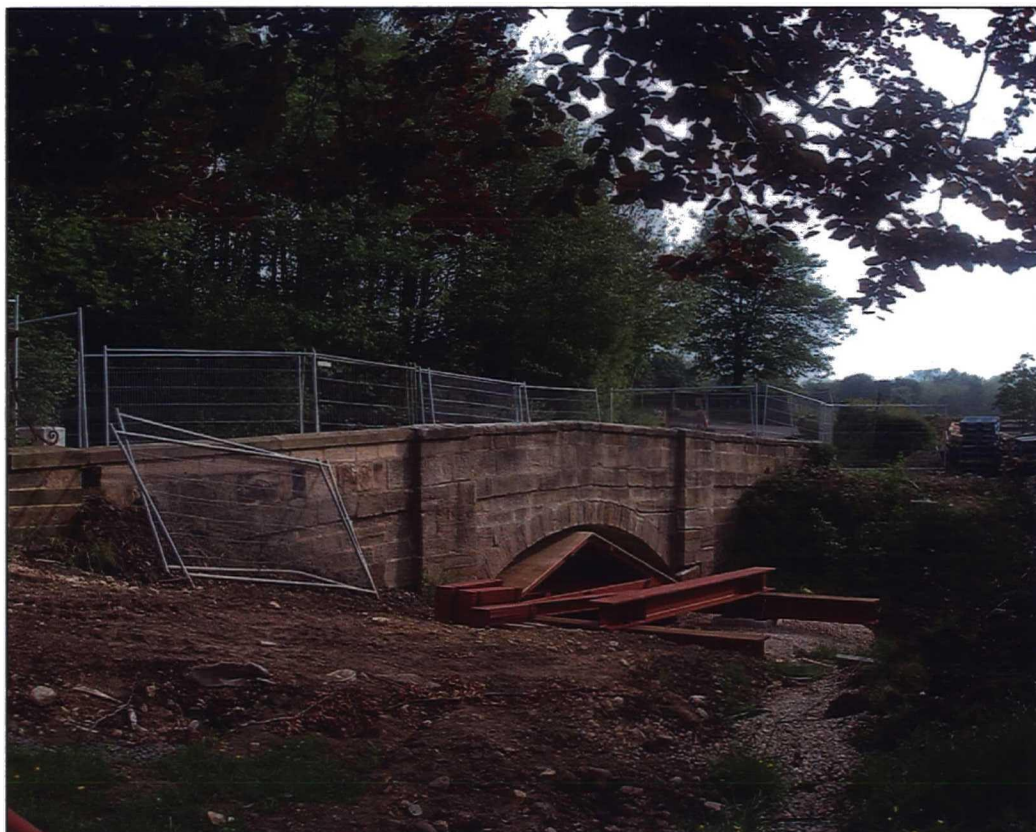
*Plate 1. General view of bridge and support structure from the south.*

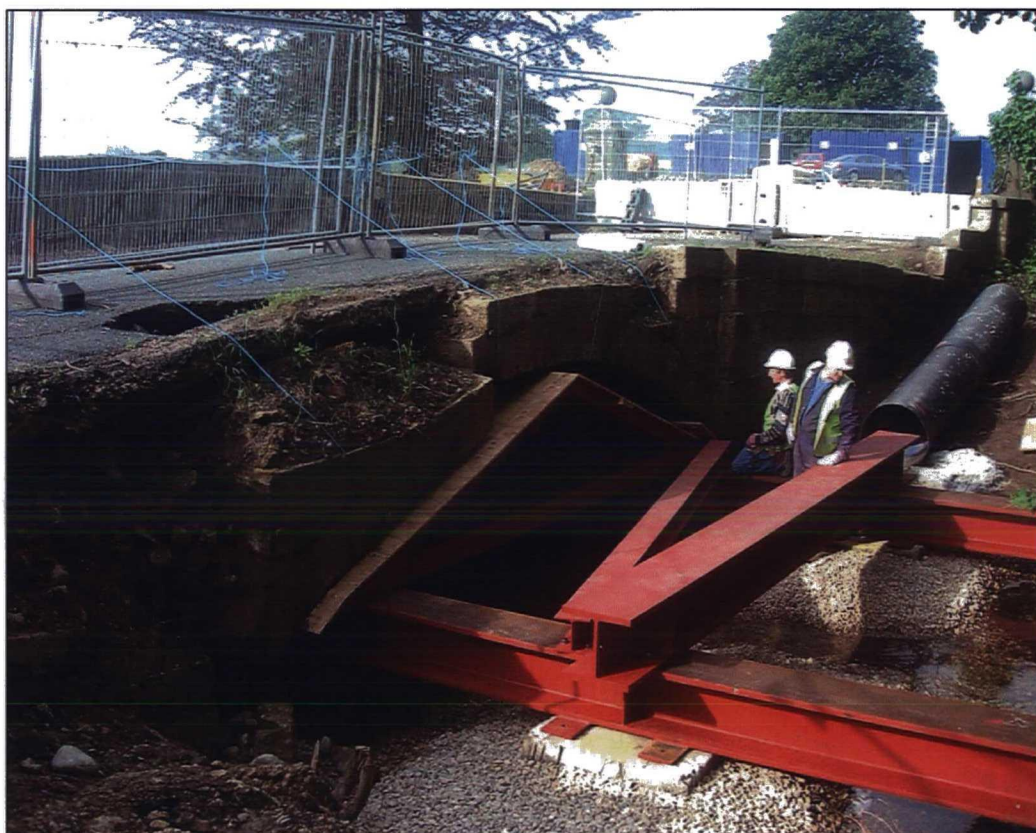
*Plate 2. Bridge viewed from the north, showing the failure of the arch and damage to the abutment.*

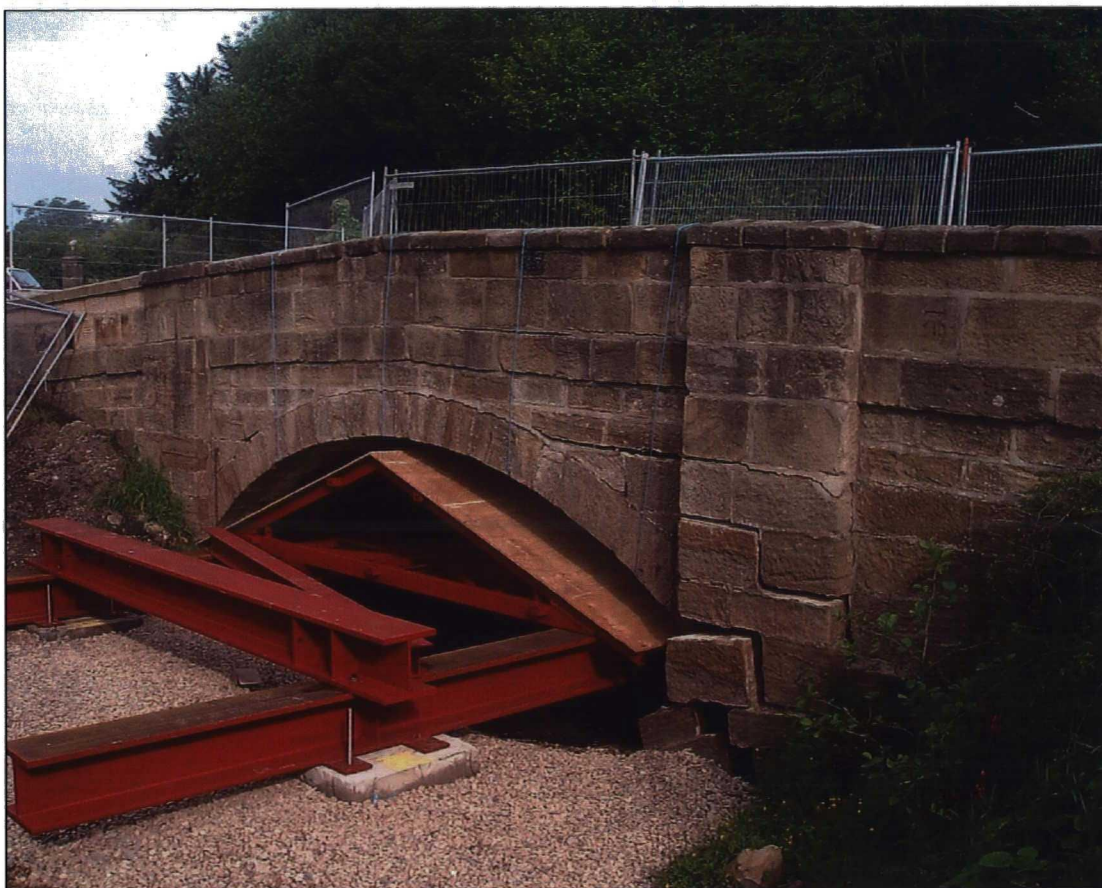
Plate 3. The east abutment viewed from the south, showing the failure of the lower portion.

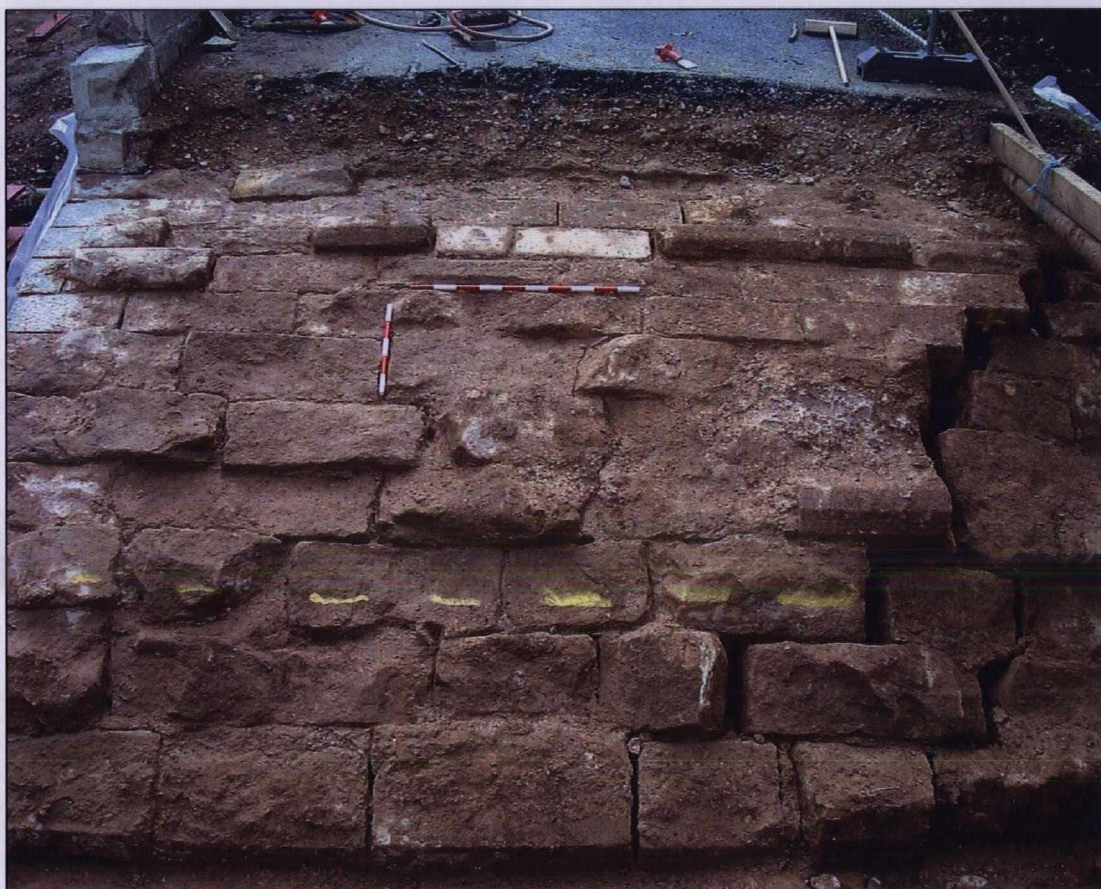
*Plate 6. The exposed vault of the arch (1006) viewed from the east.*
