### **Trial Trench No.3**

### Watching Brief on Repair Hole Excavations

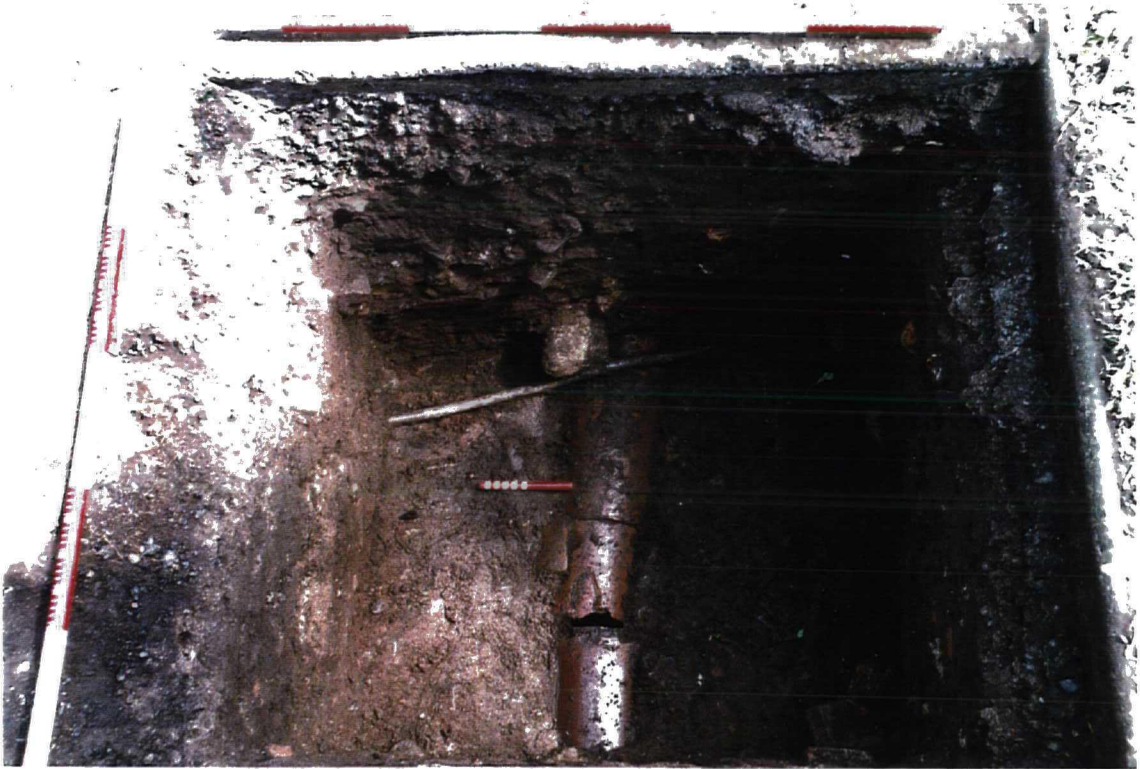
PLATE 2

Trial Trench No.1, ceramic drain and lead water service.

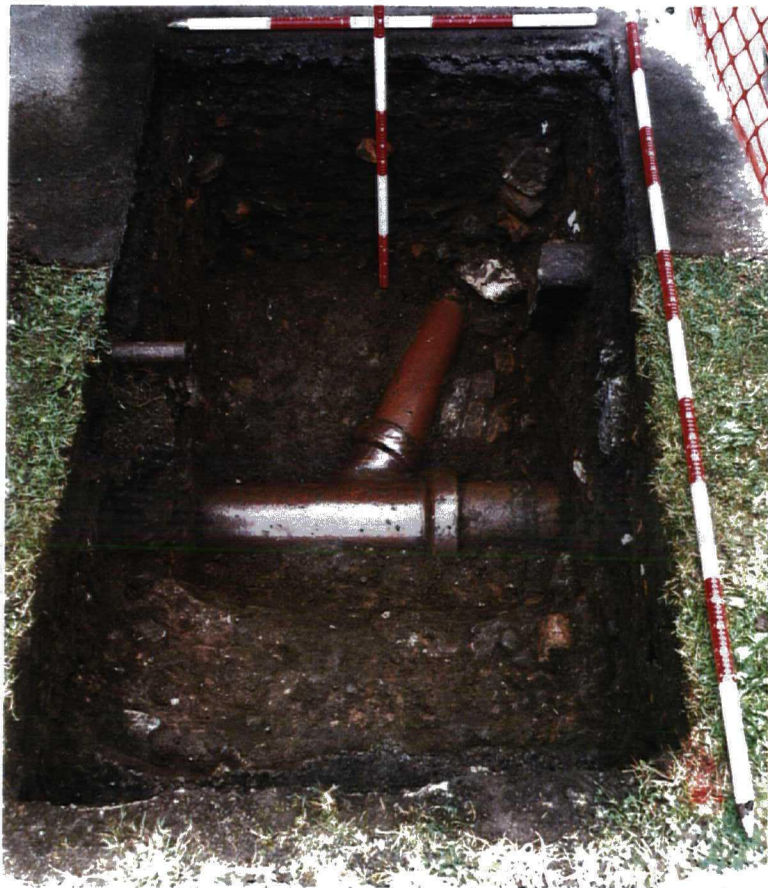
Trial Trench No.2, ceramic drain and branch.

The construction trench was aligned north east and contained a single fill of loamy sand (context 3006) within the base of which the salt glazed sewer pipe (context 3010) and branch connection from Brogden House was exposed. The invert of the sewer measured 22.016 m AOD. The surrounding fill contained a high quantity of broken brick and occasional fragments of broken sandstone flag. It was later established that this rubble was in fact the remains of an earlier brick and sandstone culverted sewer. The fill contained modern, Late 19th century and Roman pottery.

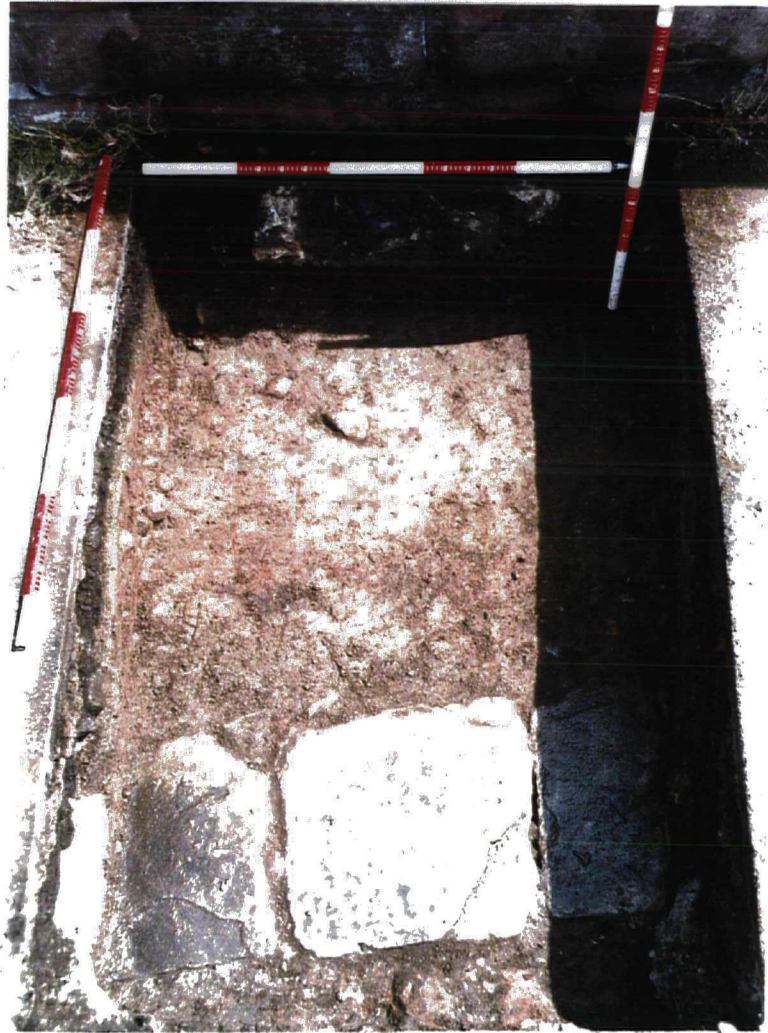
PLATE 3

Trial Trench No.3, surface of culvert.

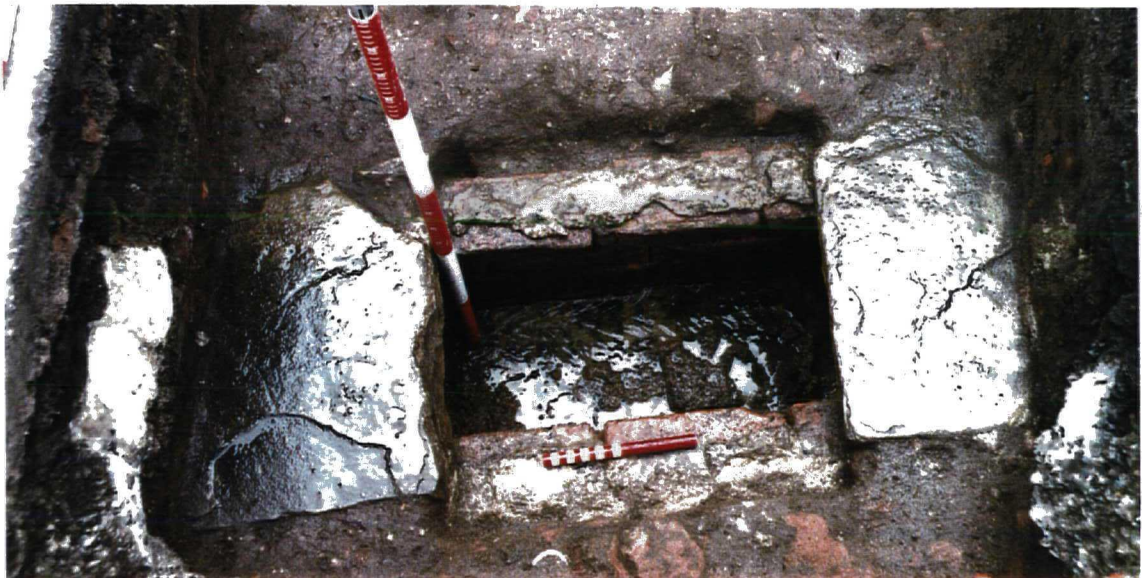
The invert of the sewer was identified at 21.818 m AOD.

Trial Trench No.3, invert of culvert.

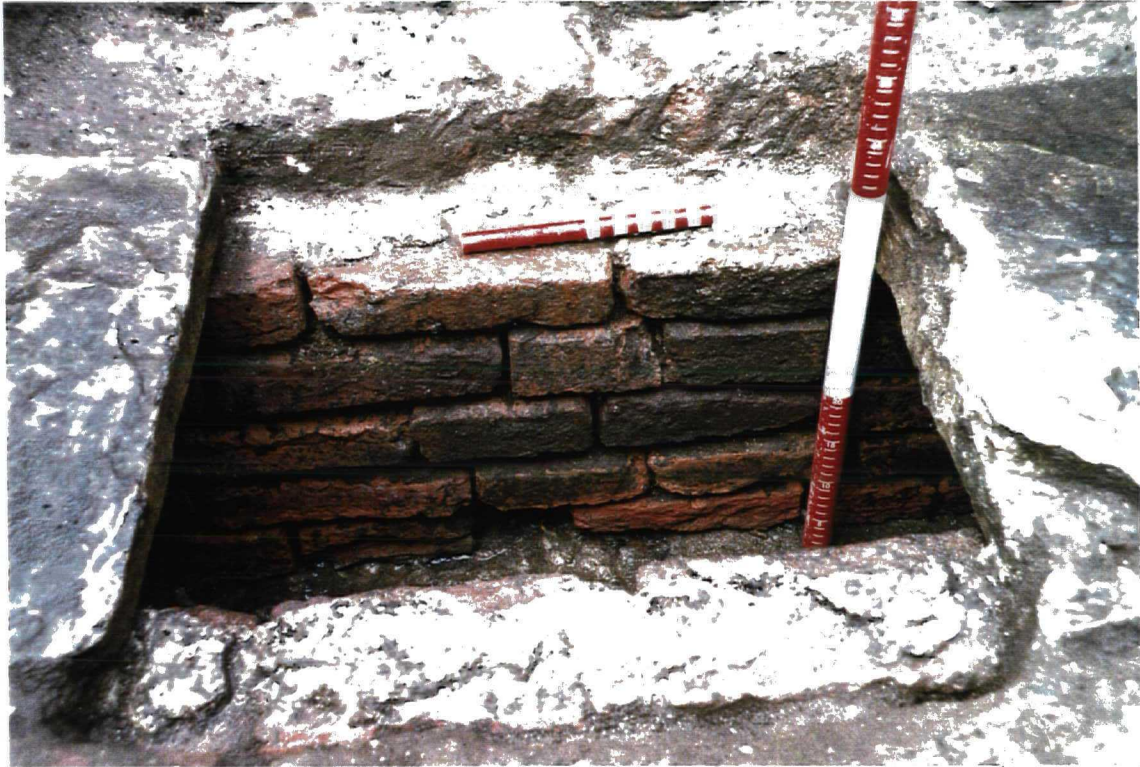
PLATE 6

The sewer culvert had been constructed out of a well bedded and tightly jointed arrangement of limestone sets that form the base of the structure and upon which the opposing brick sides had been constructed, these elevations were five courses in height and a single brick's width. The bricks were hand made, of a clamp type, in a soft pink orange fabric that contained a low quantity of inclusions. The brick size was unusual 0.23 m x 0.12m x 0.05 m, and are indicative of 18th century brickwork. The bricks were bedded on a soft, light grey, lime based mortar. The structure was capped with large slab-like fragments of roughly shaped Sandstone, the joints between which were earth filled. The internal dimensions of the culverted sewer measures 0.25m wide x 0.35m deep.

Trial Trench No.3 Detail of internal elevation of culvert

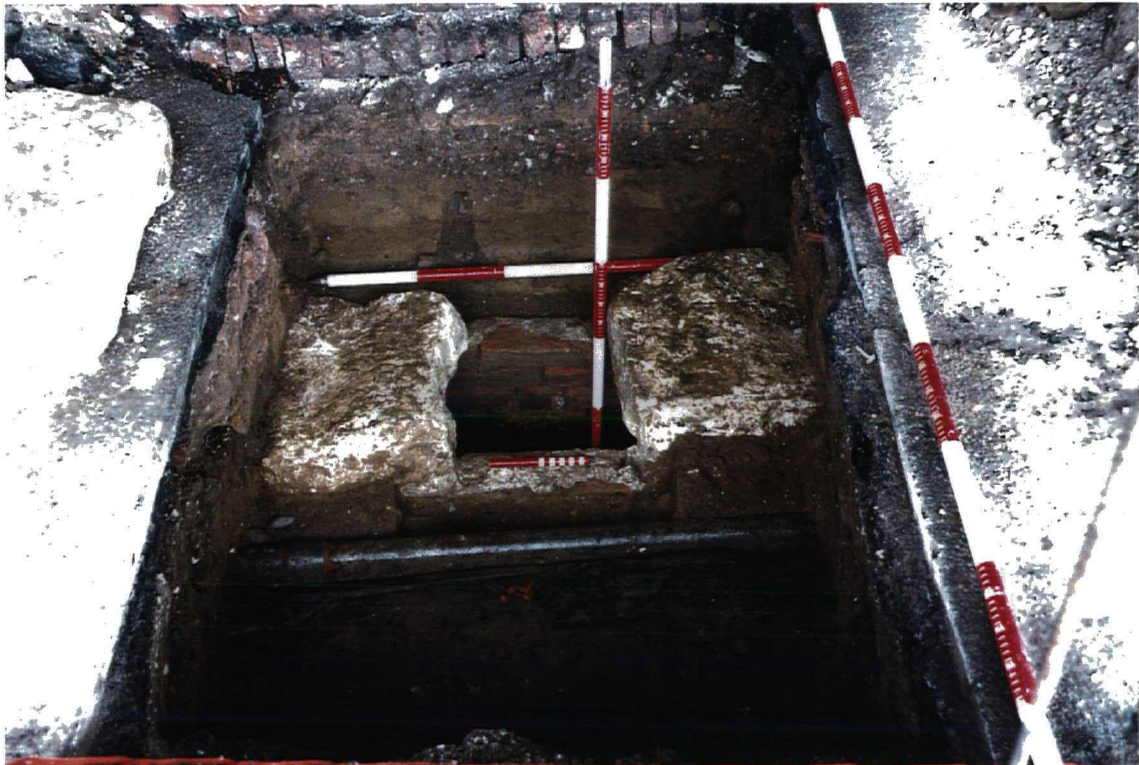
Trial Trench No.4 Internal elevation of culvert

The sewer culvert had been constructed out of a well bedded and tightly jointed arrangement of clamp bricks that form the base of the structure and upon which the opposing brick sides had been constructed, these elevations were five courses in height and a single brick's width. The bricks were hand made, of a clamp type, in a soft pink orange fabric that contained a low quantity of inclusions. The brick size was unusual 0.23 m x 0.12m x 0.05 m, and are indicative of 18th century brickwork. The bricks were bedded on a soft, light grey, lime based mortar. The structure was capped with large slab-like fragments of roughly shaped Magnesian Limestone, the joints between which had been pointed with a hard, light grey mortar. The internal dimensions of the culverted sewer measures 0.31m wide x 0.35m deep.

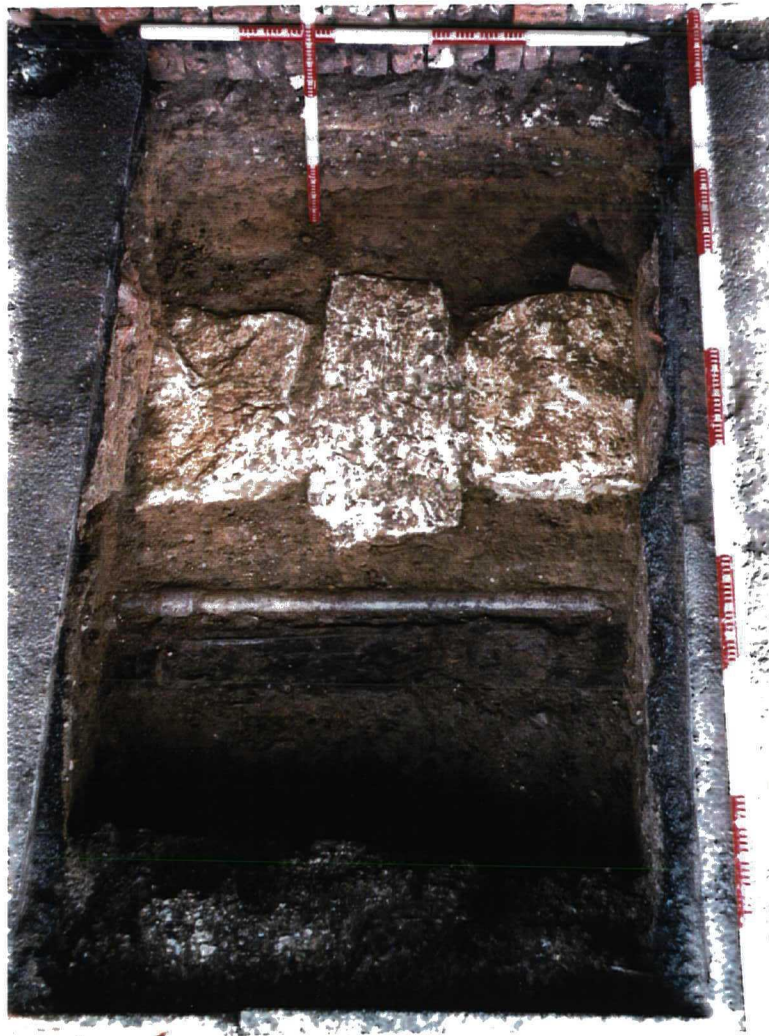
PLATE 4

Trial Trench No.4, surface of culvert.

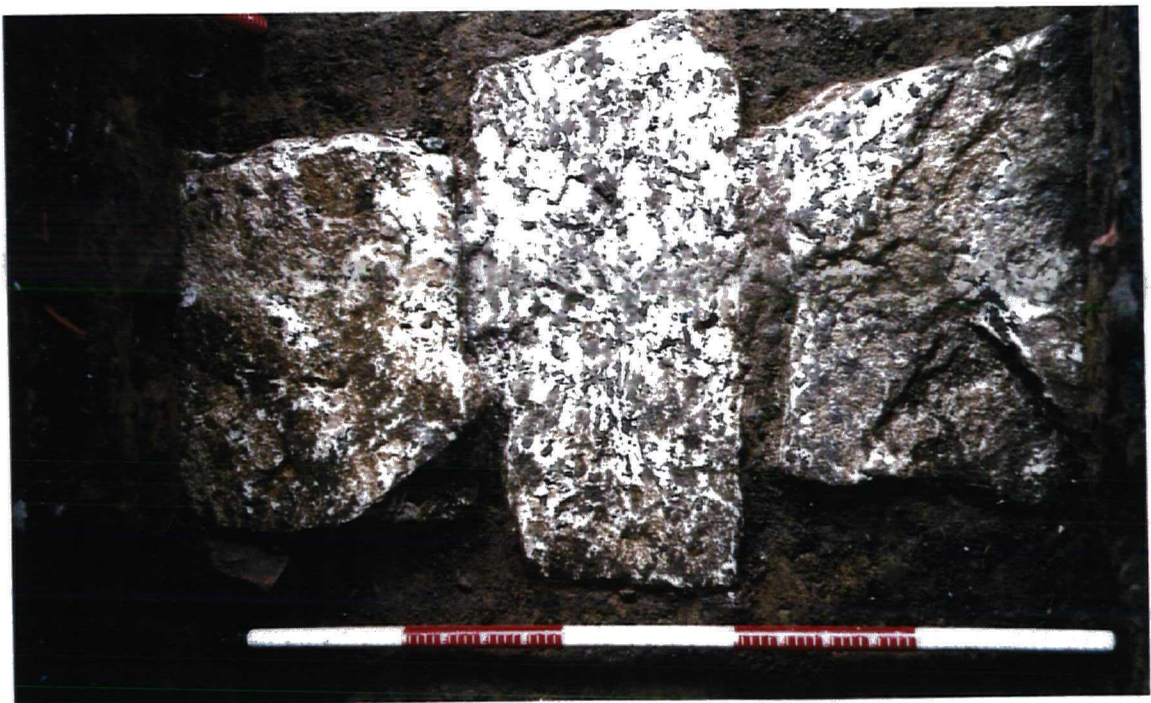
Trial Trench No.4, detail of surface.

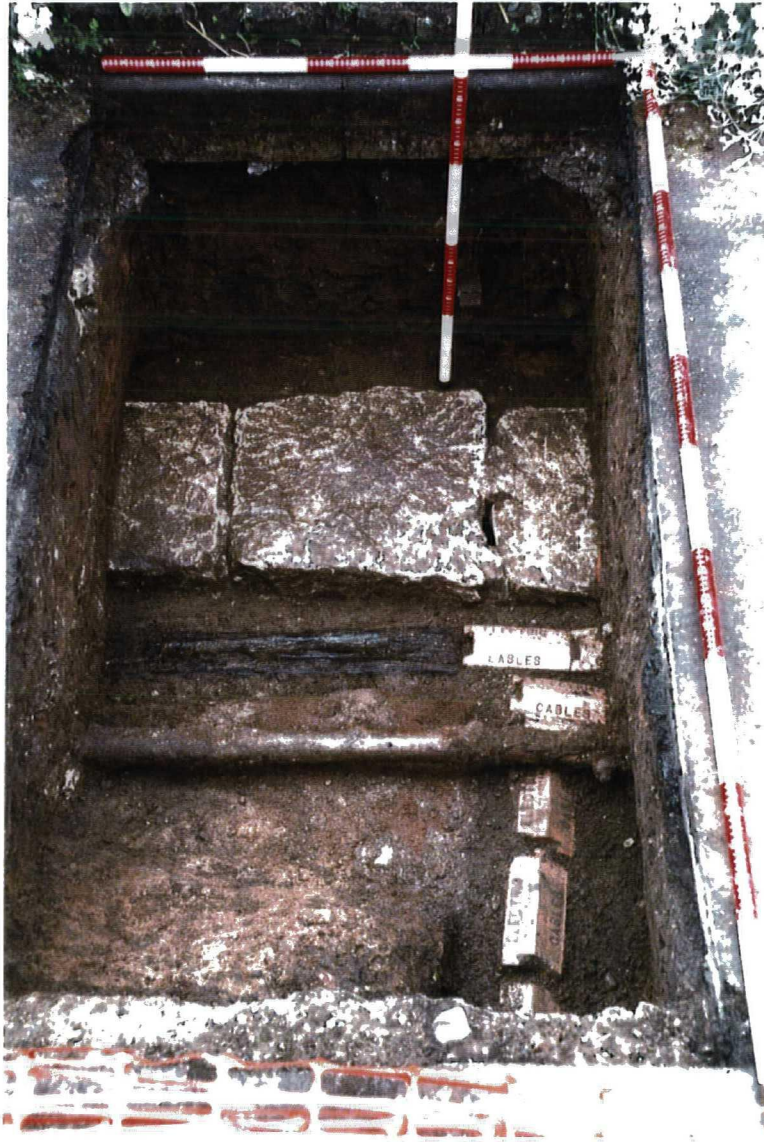
PLATE 5

It was revealed that the upper levels within the trial trench had been heavily disturbed during the installation of modern electric and water services. The water pipe had been placed within a large trench (context 5012) that bisected the study area on a northern alignment, the installation of the electric cable (context 5010) had displaced the south and south eastern extent of the trench. Within the north western corner of the trench the water service track had been excavated into a layer of sand (context 5017) it is likely that this layer was the natural sub soil the surface of which was situated at 25.568m AOD. The surface of the sand was cleaned and a narrow slot like cut (context 5016) was identified, this feature had the appearance of a beam slot and was filled by a sandy loam (context 5015). This feature was not excavated as it was not threatened by the proposed works, however, it is suspected that it may be structural component of a Medieval or possible Roman building.

Trial Trench No.5, surface of culvert and modern services.

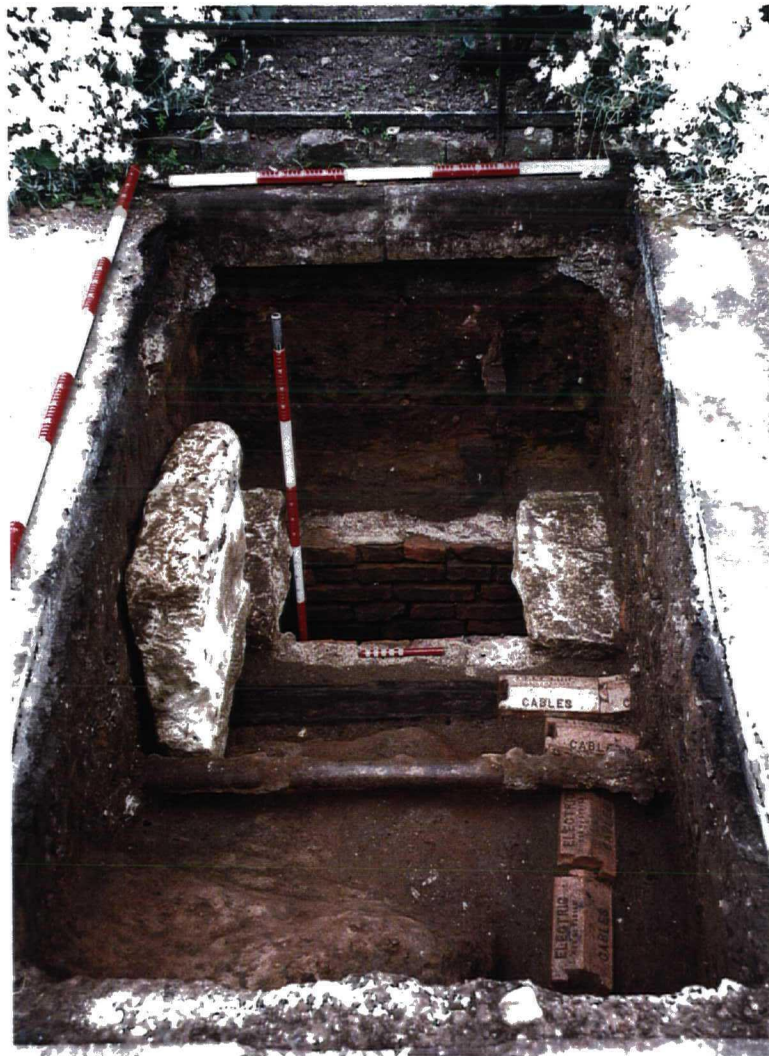
PLATE 7

The sewer culvert had been constructed out of a well bedded and tightly jointed arrangement of limestone sets that form the base of the structure and upon which the opposing brick sides had been constructed, these elevations were five courses in height and a single brick's width. The bricks were hand made, of a clamp type, in a soft pink orange fabric that contained a low quantity of inclusions. The brick size was unusual 0.23 m x 0.12m x 0.05 m, and are indicative of 18th century brickwork. The bricks were bedded on a soft, light grey, lime based mortar. The structure was capped with large slab-like fragments of roughly shaped Magnesian Limestone, the joints between which were pointed with a hard light grey coloured, lime based, mortar. The internal dimensions of the culverted sewer measures 0.33m wide x 0.34m deep.

Trial Trench No.5 Internal elevation of culvert

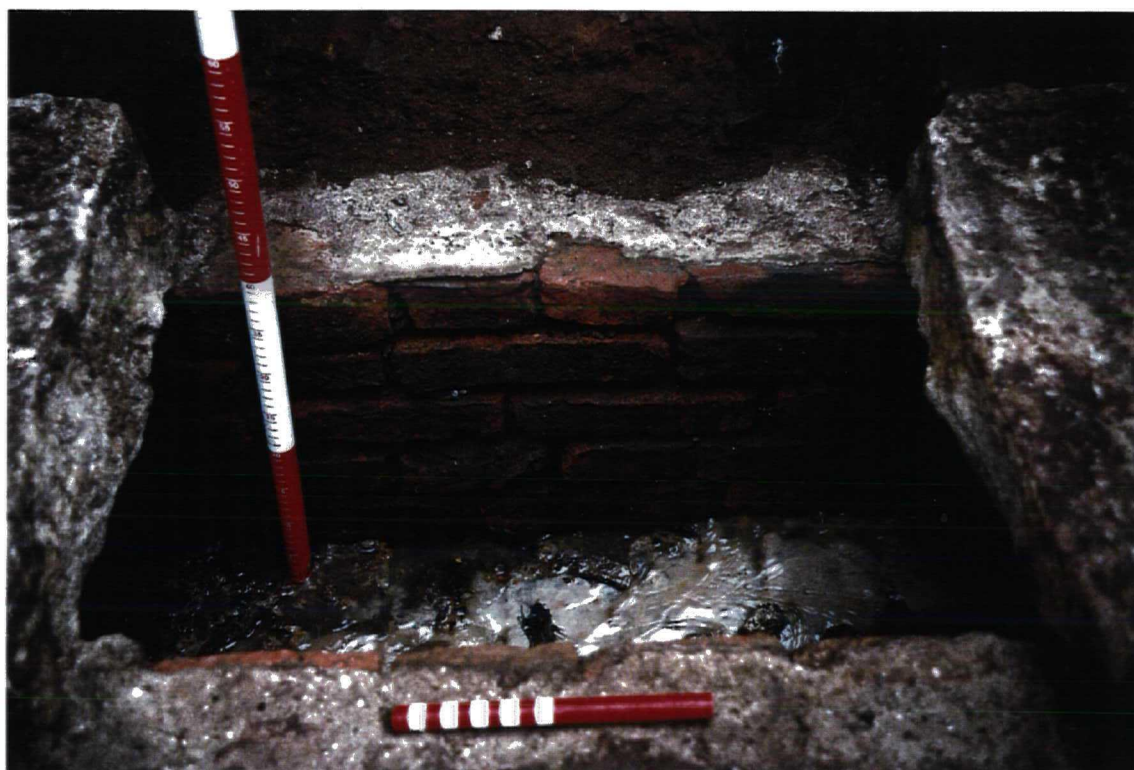
Trial Trench No.5 Detail of internal elevation of culvert

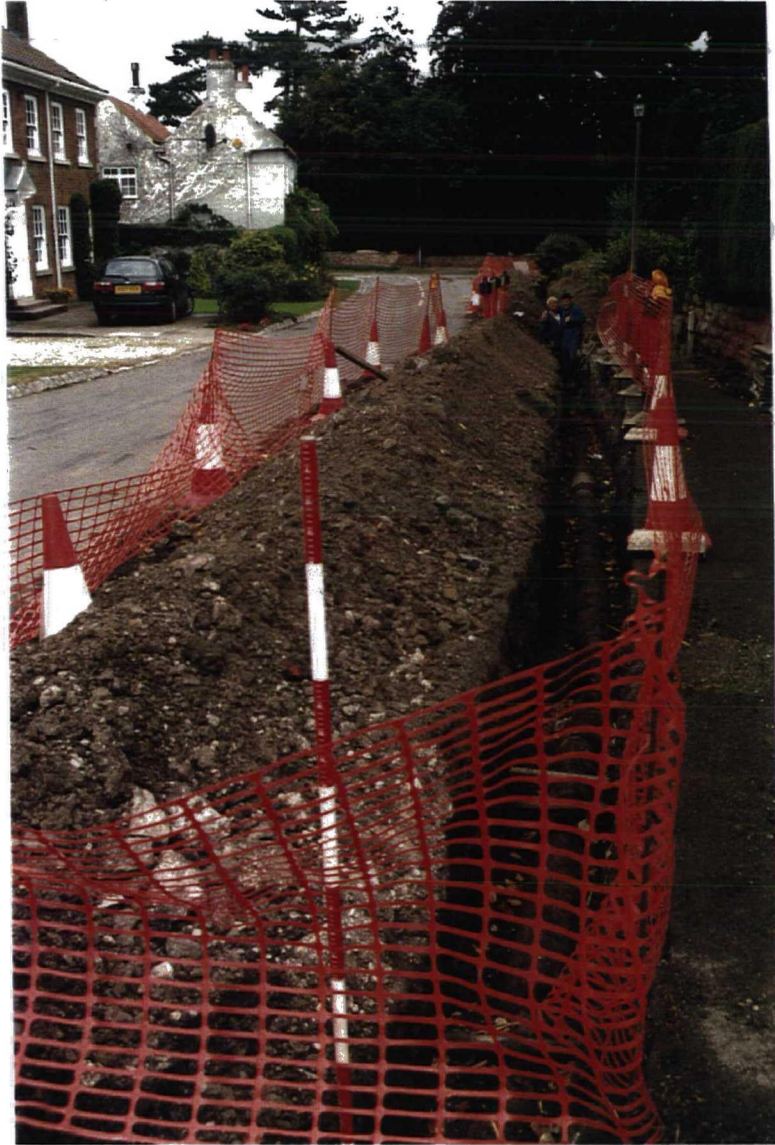
Service Trench A as excavated

A loamy sand fill (context 14002) was identified surrounding the partially demolished remains of the brick sewer culvert (context 14003), the layer was situated directly beneath the sub base, upon excavation it was revealed that the fill contained modern, 19th century, Post Medieval, Medieval and Roman pottery. The pottery assemblage includes at least two interesting fragments of Samian Ware, one being decorated with a zoomorphic scene depicted includes the torso of a bounding lion, the second with a makers manufacture stamp on it's base with the text **S T A**
