ARCHAEOLOGICAL WATCHING BRIEF

SKIPTON CASTLE

GATEHOUSE

SEPTEMBER 1998

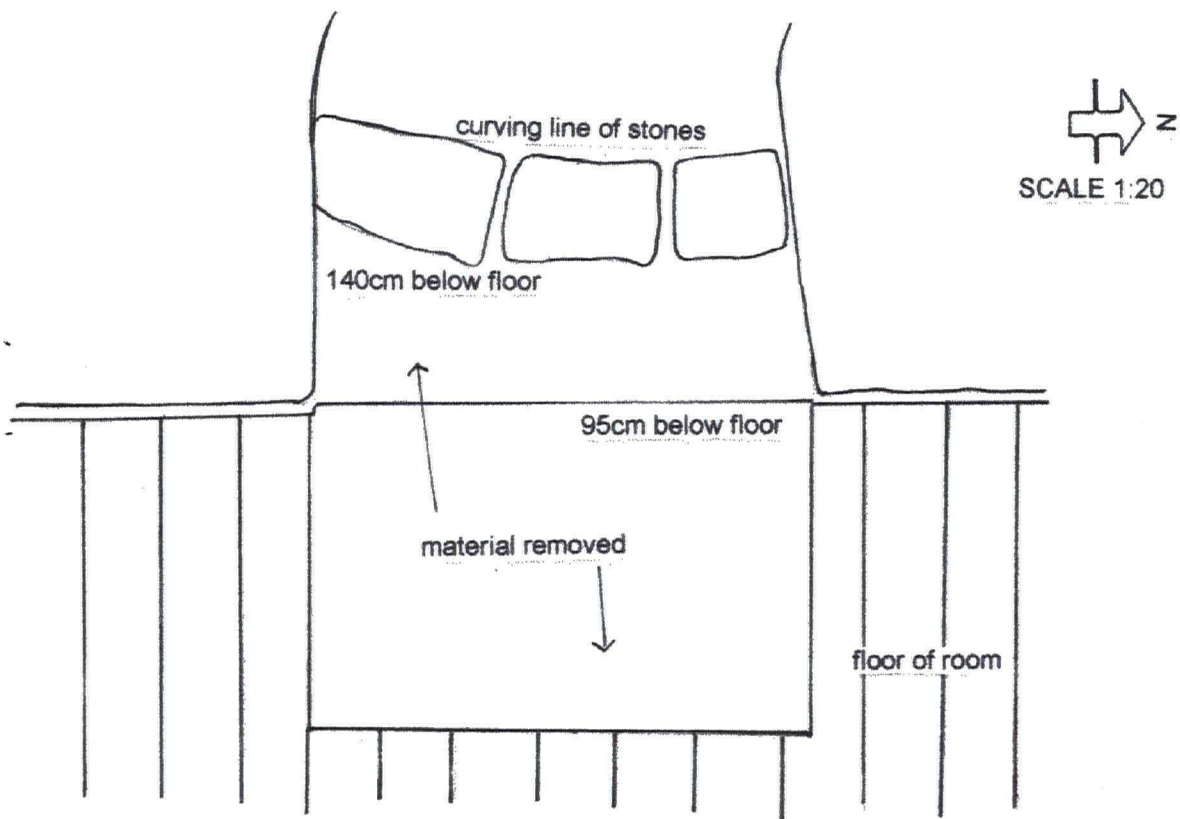
SKIPTON CASTLE GATEHOUSE PLAN 3 STAIRWELL

- 1.4 The second piece of work involved the removal of material from the top of a presumed former stairwell from the first floor of the western half of the gatehouse to the south-west corner of the room over the central part of the gatehouse (Plan 2, 3). The curved shaft is to be reused as a stairway, protruding into the central room by approximately 90cm. The floorboards from this section had been previously removed, revealing the rubble fill below.

- 1.5 Work was commenced from the top, with removal by shovel and hand. The material removed was a dry sandy mortar with large angular undressed stone rubble. The dressed stone walls of the sides of the stair-shaft continued down vertically. A step 65cm below the floorboards was excavated out. At this depth a plastered edge in line with the edge of the room was revealed. This was backed by large angular stones forming a rough platform, with rubble fill behind them.

- 1.6 A second step, 33cm below the first and commencing in line with the edge of the room, was excavated. It was 60cm wide and was fronted by large stones roughly squared off at their front edge and packed with rubble behind. Below these was another line of stones which were also removed, reaching a depth of 140cm below the floorboards of the room above. Neither line of stones was tied in to the vertical sides of the shaft.

The removal of material in the stairwell revealed a possible sequence of remodelling of the feature. The curving line of stones, tied in to the walls of the shaft, were the earliest, and presumably reflect part of a stone staircase. Subsequently, stones were piled on top of this line to form a vertical face when viewed from below. The rubble infill behind, reaching up to the floor level above, appears to extend beneath the existing wooden floor. It is possible that the original staircase continued to spiral up to a higher floor or to the roof, as its levels do not quite fit the level of the existing floor. The existing room may have been formed later in the development of the building, resting on rubble infill above the arch of the gateway itself.

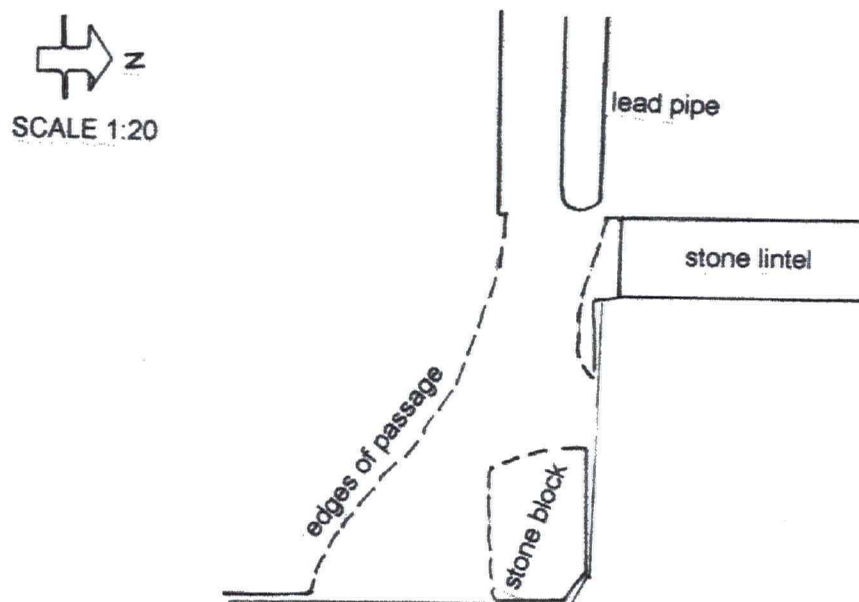
SKIPTON CASTLE GATEHOUSE PLAN 4 DRAIN

- 1.1 The first part of the work involved cutting through the inner wall of the eastern half of the gatehouse at first floor level to insert a drain (Plan 2, 4). The new drain was to connect with an existing lead drain (Plate 10) which runs down the channel of the former portcullis on the eastern side of the central opening of the gatehouse. The material was removed by electric drill and hand.

- 1.2 The channel was cut immediately above the level of the existing floorboards to avoid having to cut through joists, and adjacent to an existing doorway between the eastern half of the gatehouse and the central portion. At its eastern end the hole was 32cm high, with 7cm of this height below the level of the floorboards, and 50cm wide (Plate 11). At the western end the hole was 27cm high and 23cm wide. Its size varied along its length, and in the centre where it was cut through from the side of the doorway it was 34cm high (Plate 12). The level of the base of the hole gradually dropped from west to east by approximately 10cm relative to the floorboards.

- 1.3 The material of the wall which was removed consisted of roughly dressed stones at the outer faces of the wall, with stone rubble and mortar infill. The rubble consisted of stones up to 12cm long randomly set in a pale yellow mortar which occupied up to 50% of the space within the wall. The dressed stones at the surface were fully dressed only on their outer edges, and were up to 40cm in length. At the eastern face there were signs of some disturbance, with brick fragments and a piece of wood immediately behind the plaster of the wall. The central part where it was broken through from the doorway appeared to have a

missing dressed stone at the surface, and the space was filled in with rubble and mortar.

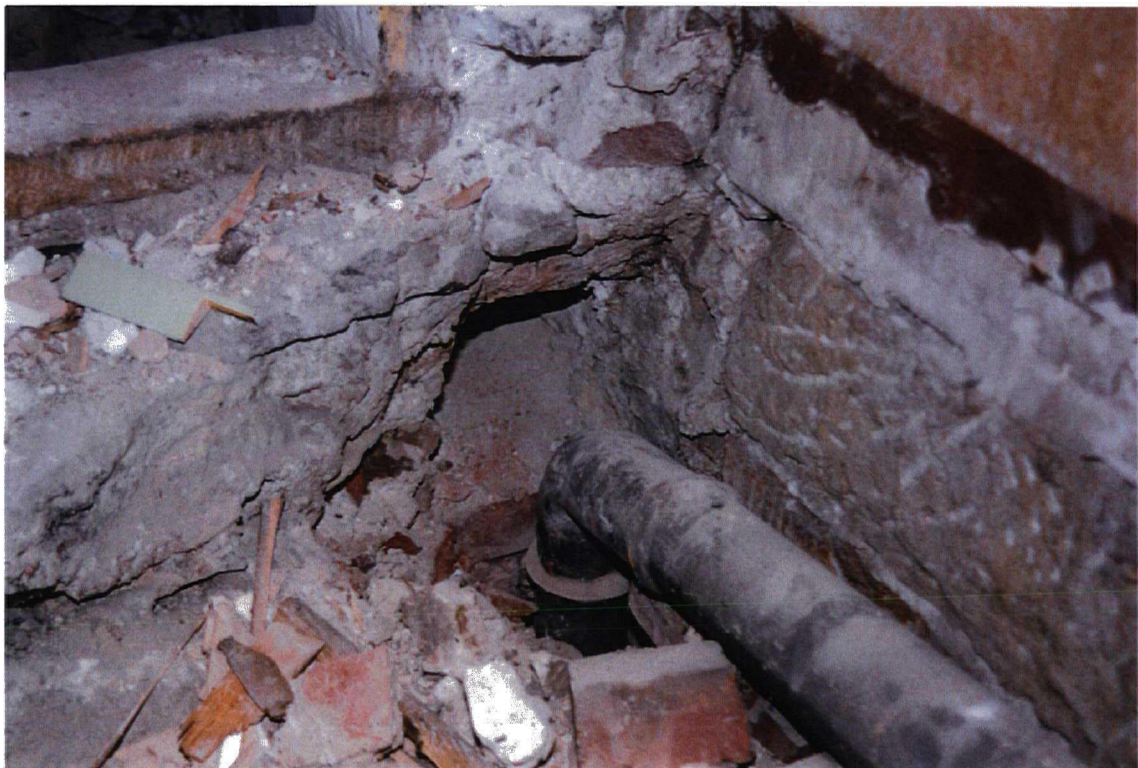
PLATE 10 LEAD DRAIN AT WEST END OF CHANNEL THROUGH WALL

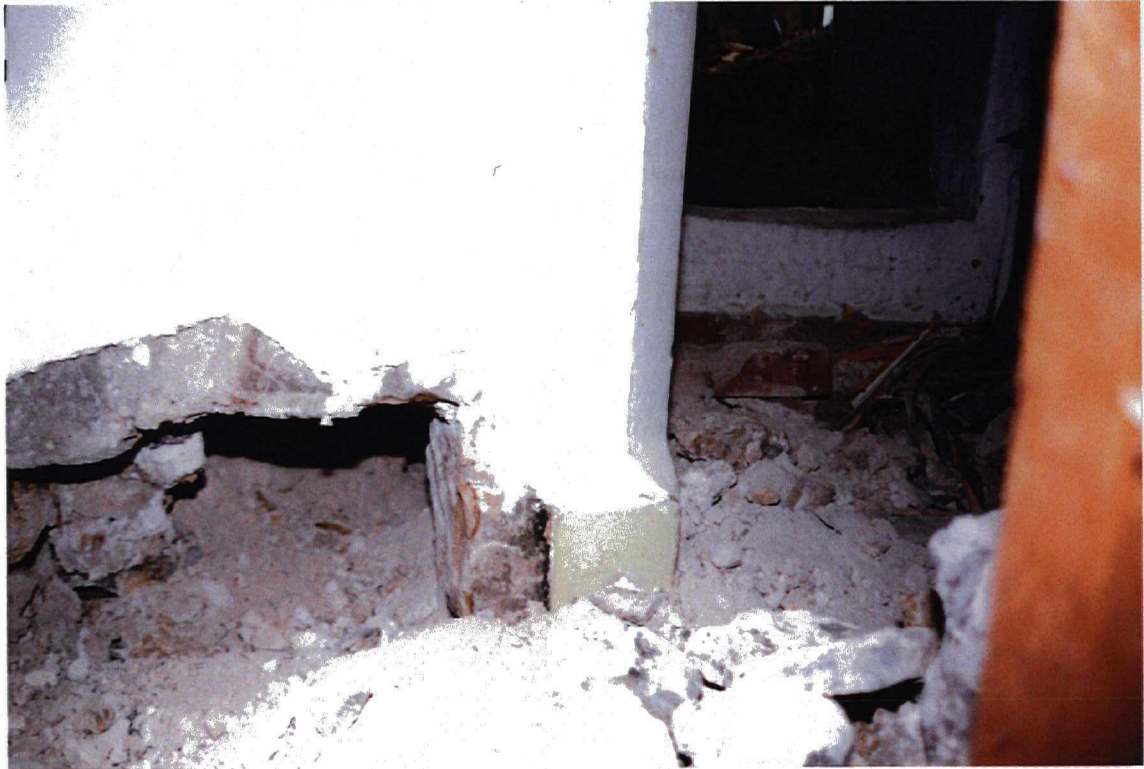
PLATE 11 EAST END OF CHANNEL THROUGH WALL

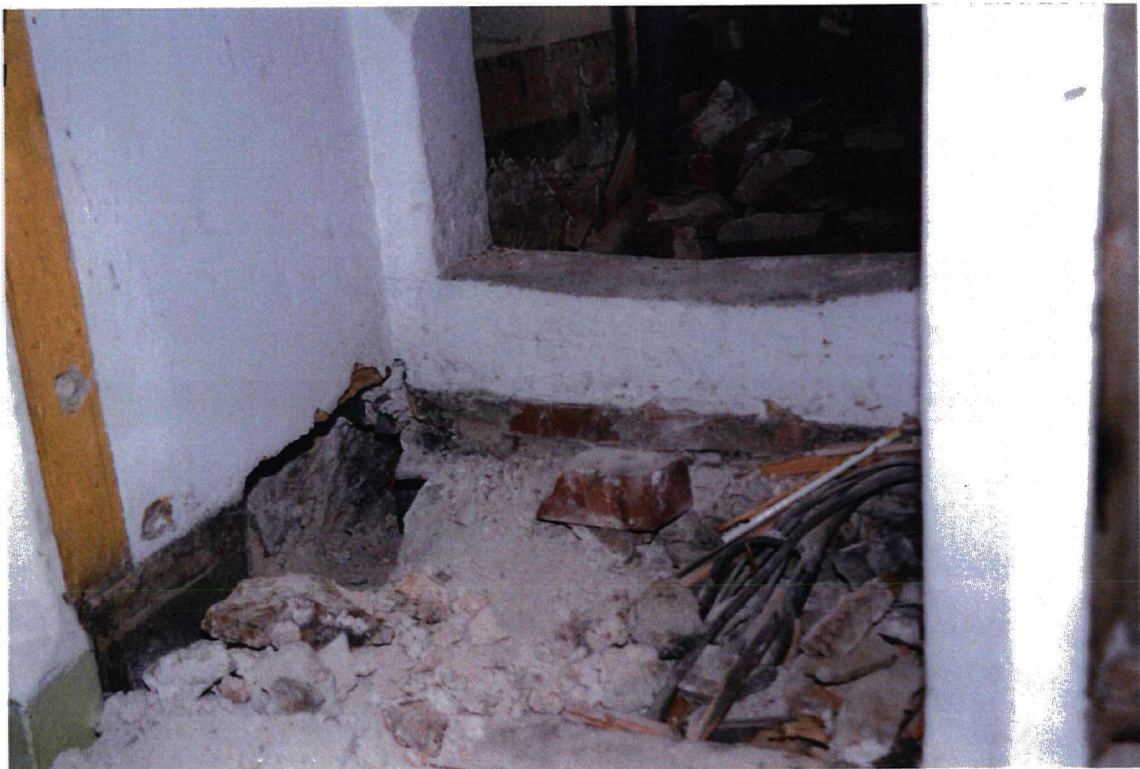
PLATE 12 CENTRAL PART OF CHANNEL THROUGH WALL

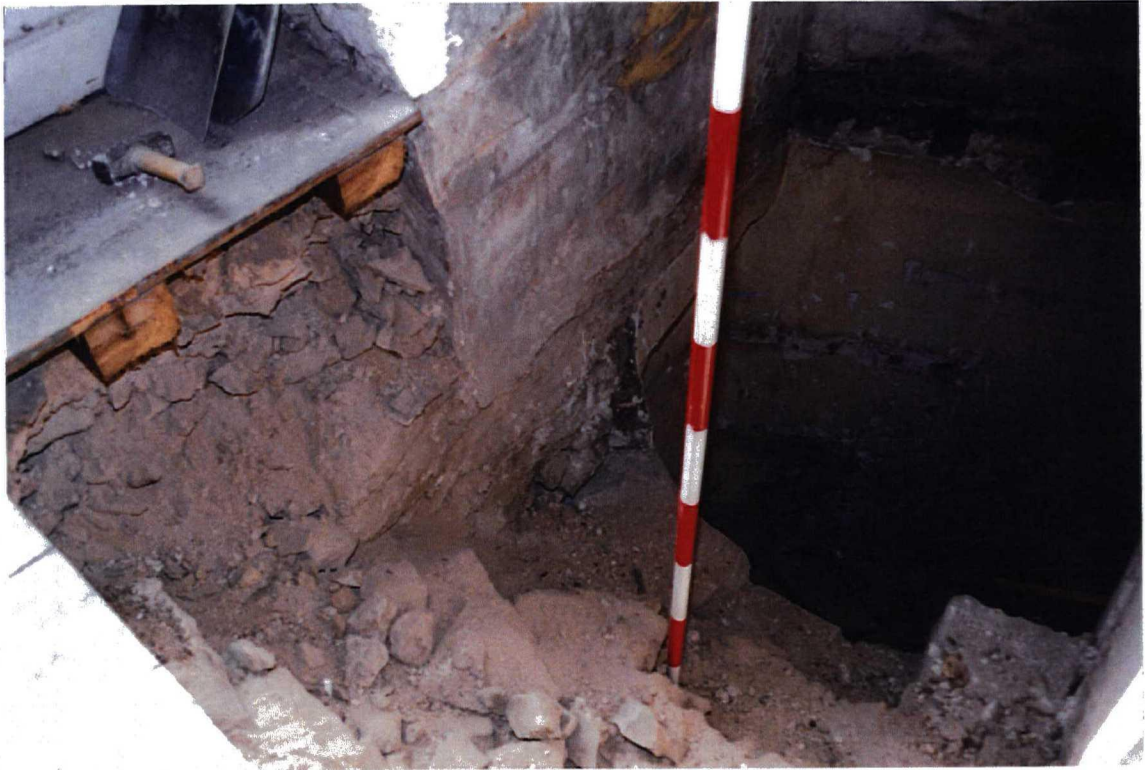
- 1.7 At this depth a further line of roughly dressed stones formed a curving edge to the shaft. These stones were tied in to the walls, and obviously formed part of the original structure of the stairwell (Plate 13). A plaster skim fronted them and continued onto the vertical side walls of the stairwell (Plate 14). The stones were left in situ.

PLATE 13 EXCAVATED STAIRWELL FROM ABOVE

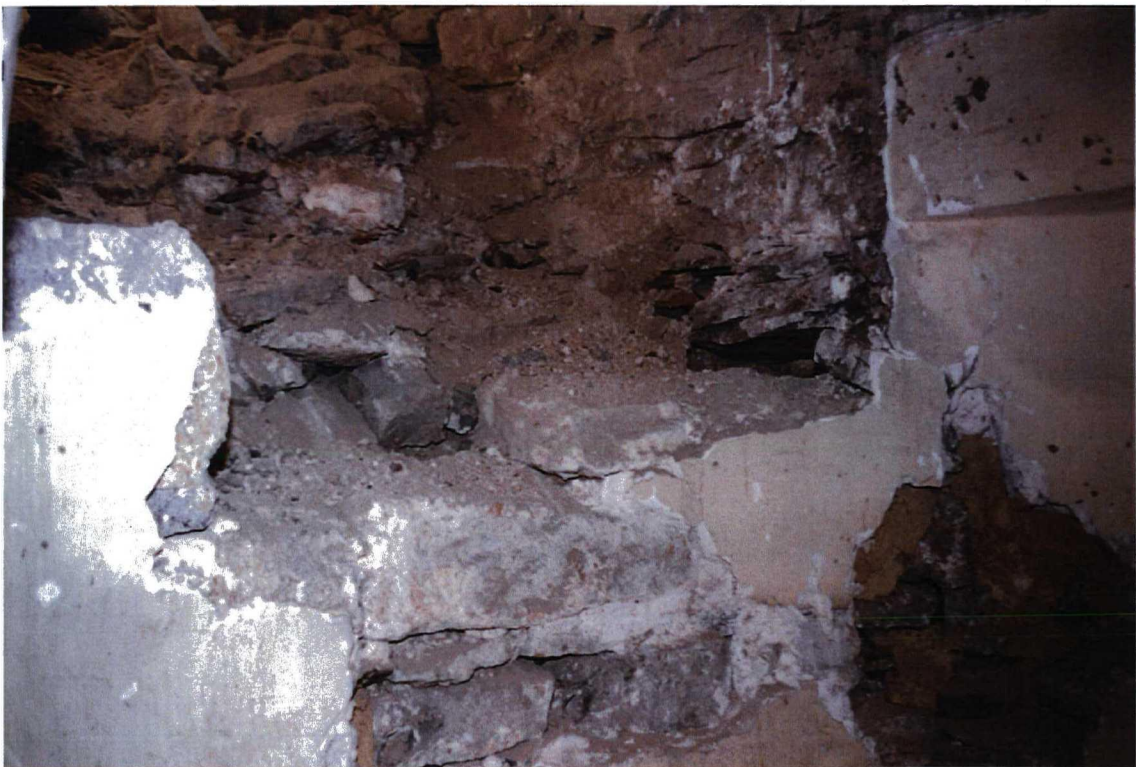
PLATE 14 EXCAVATED STAIRWELL FROM BELOW
