**Land Adjacent to Sheldon
(Sunset Cottage)
Main Street
Thixendale
North Yorkshire
SE 8400 6110**

Archaeological Watching Brief
03/01310/REM

**MAP
March 2004**

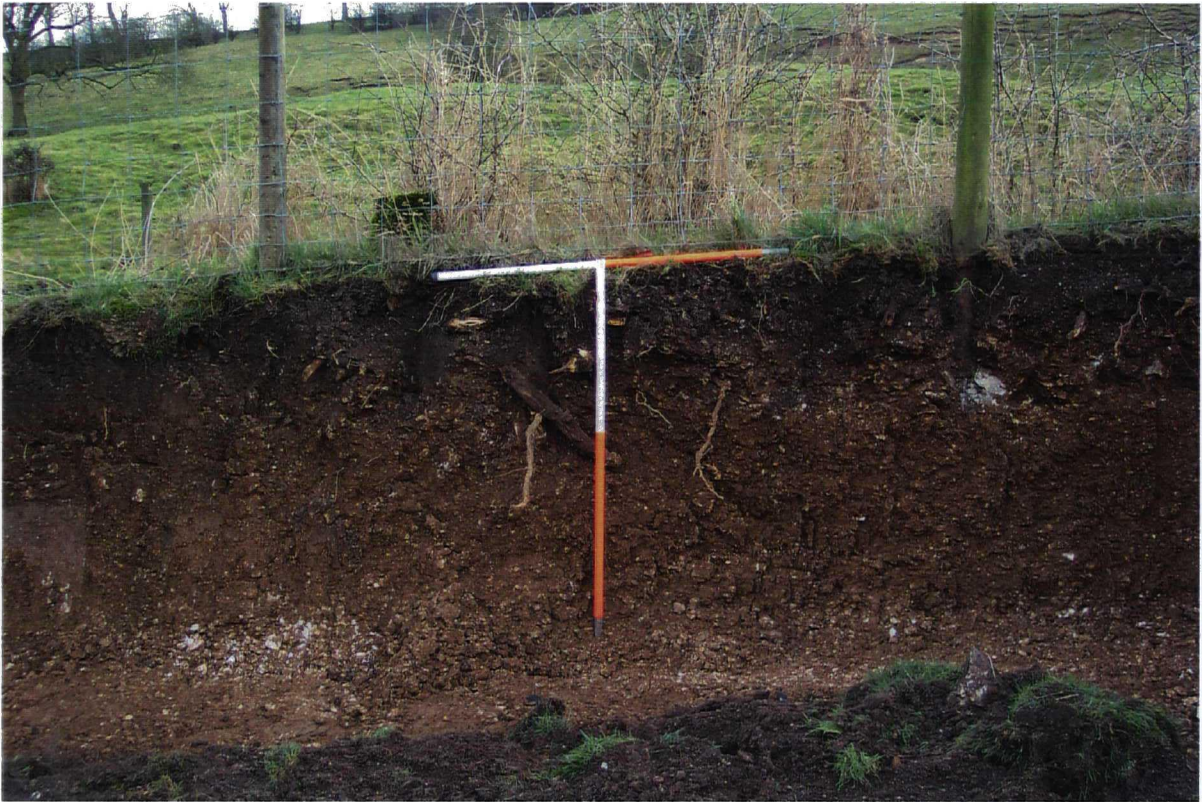
Prior to the excavation of the interceptor pits and the footings the natural slope on the site was taken back to create a larger area for the house footings. To facilitate this work the natural slope was altered providing a section through the deposits at the northern end of the site. The exposed section showed no sign of disturbance with the topsoil sealing a relatively thick deposit of subsoil over frost-fractured chalk (Pls. 3 & 4).

Plate 3. Section through northern end of the development plot. Facing south.

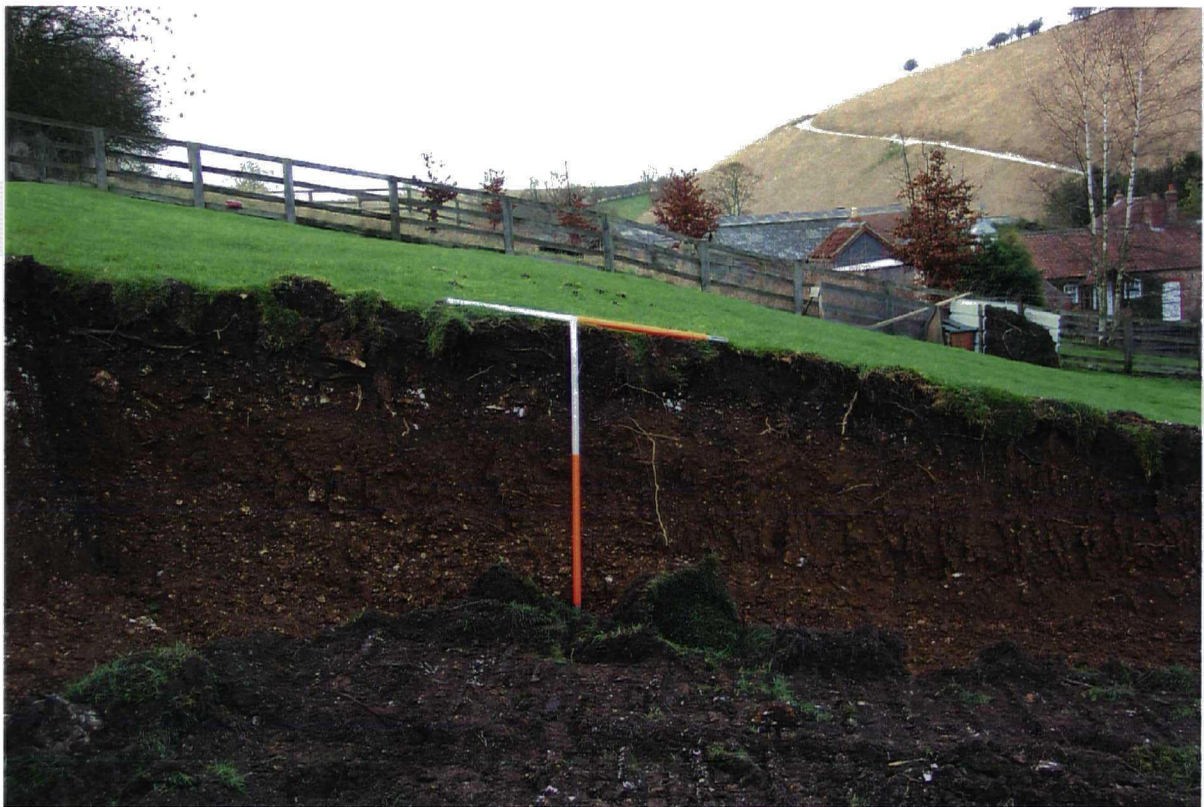
Plate 4. Section through northern end of the development plot. Facing west.

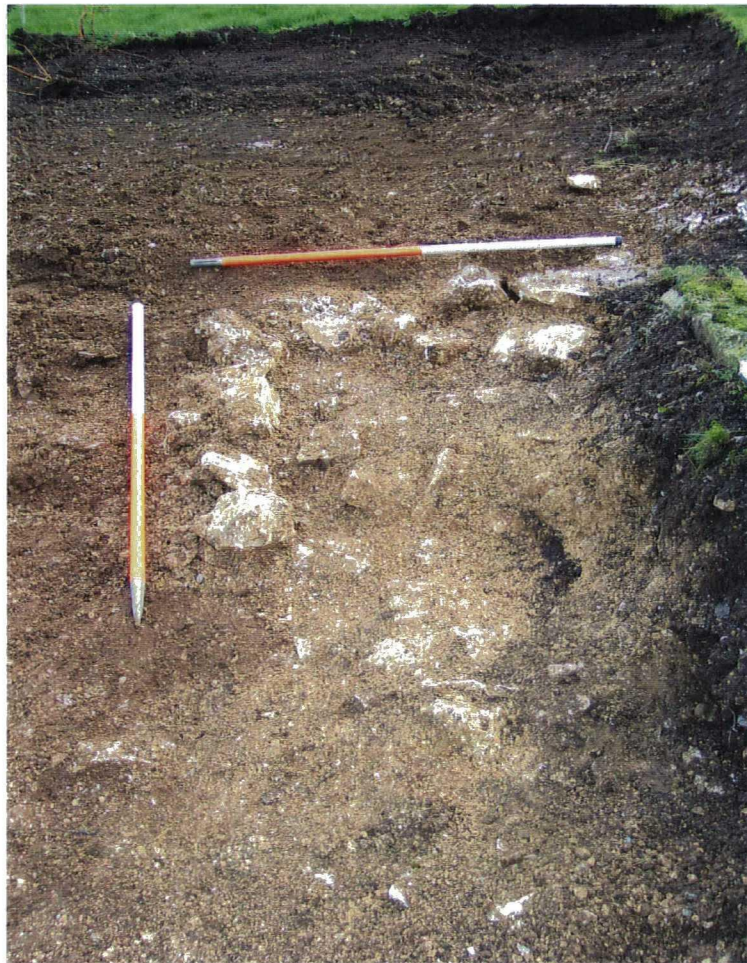
The only surviving element of this feature consisted of a section of walling, measuring 1.10m by 1.06m, which formed the south-east corner of a stone building (Pls. 5 & 6). Further cutting back of the terrace revealed that it survived to a height of 0.75m, with nine courses of unbonded cut chalk blocks (Pl. 7). No foundation cut was visible suggesting that the wall had been constructed against the edge of a terrace cut into the natural slope. Deposits of chalk and dark grey silty sand butting up to the wall represent material (probably re-deposited topsoil) used as packing behind a breeze block retaining wall constructed c. 1998.

Plate 5. Structure 1. Facing south.

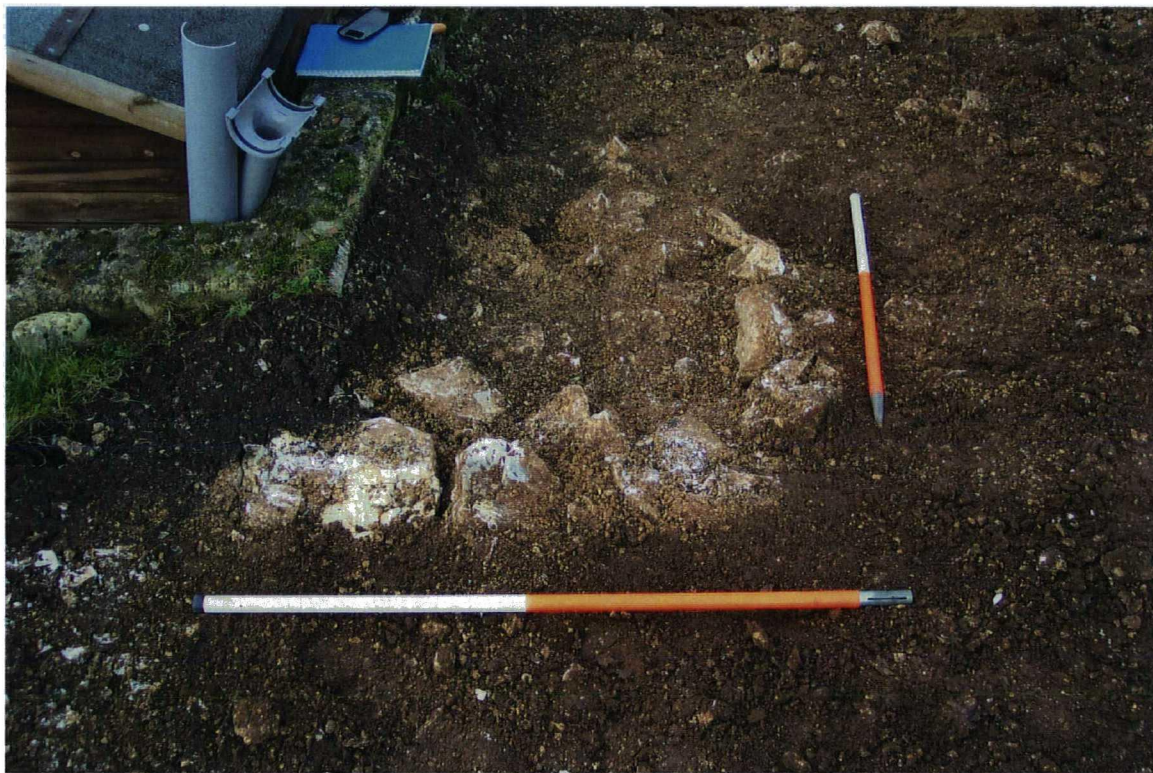
Plate 6. Structure 1. Facing north.

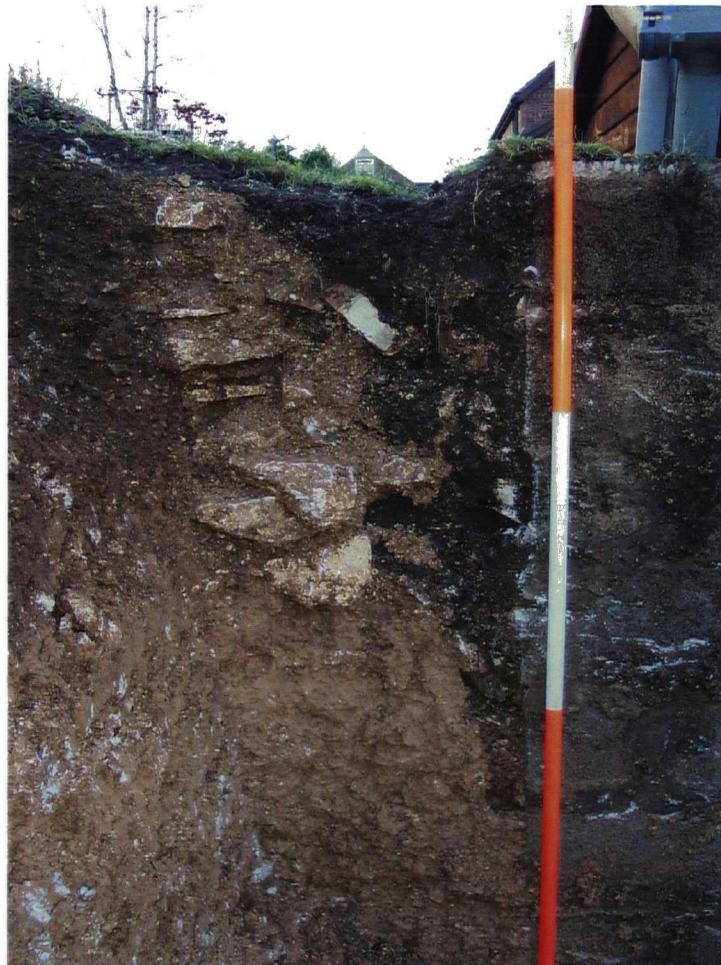
Plate 7. Structure 1. West facing section. Facing west.

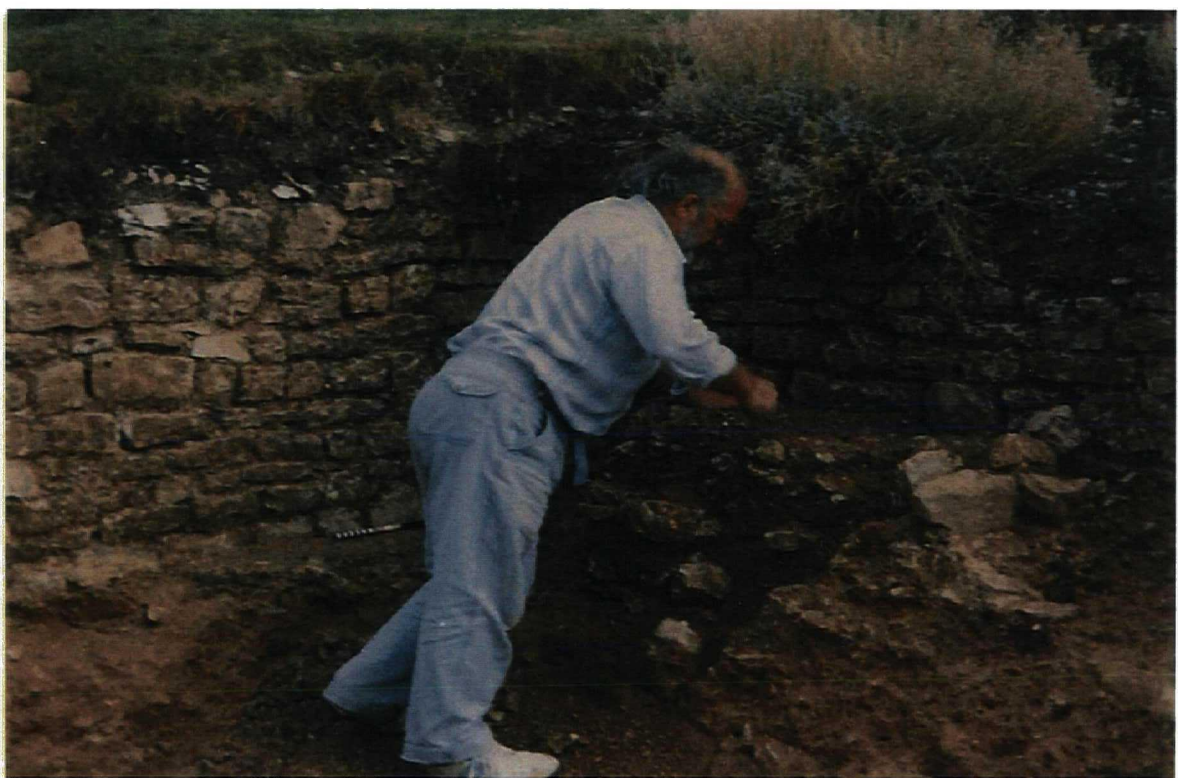
It was apparent that this structure continued into the garden of Sheldon and this was confirmed by discussions with the land owner who was able to provide a photograph of the building, when it was revealed during extension works to Sheldon approximately 6 years ago (Mr D Hepton pers com : Pl. 8). Recording of the feature, was apparently undertaken by archaeologists associated with the Wharram Percy Project, however it has not been possible to trace any report of their findings.

Plate 8. Structure 1. Previous excavation. Facing south.

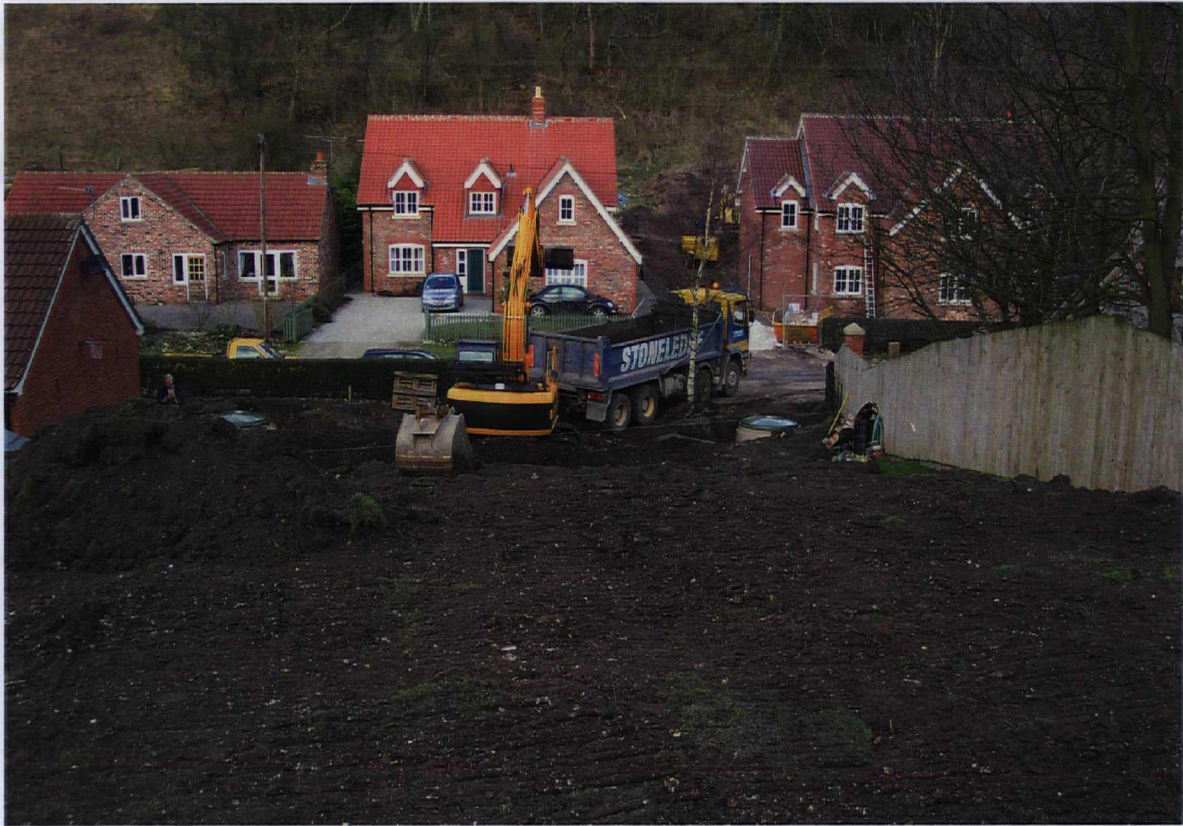
Two Interceptor Pits were excavated, one in the entrance to the site along the western boundary and the second in the south-western corner of the land belonging to Sheldon (Pl. 9). Both pits were approximately 2m² and over 3m deep. The soil profile exposed showed totally undisturbed deposits consisting of topsoil, subsoil, and frost-fractured chalk on to solid chalk.

Plate 9. View of site during on site works, showing location of interceptor tanks. Facing north.

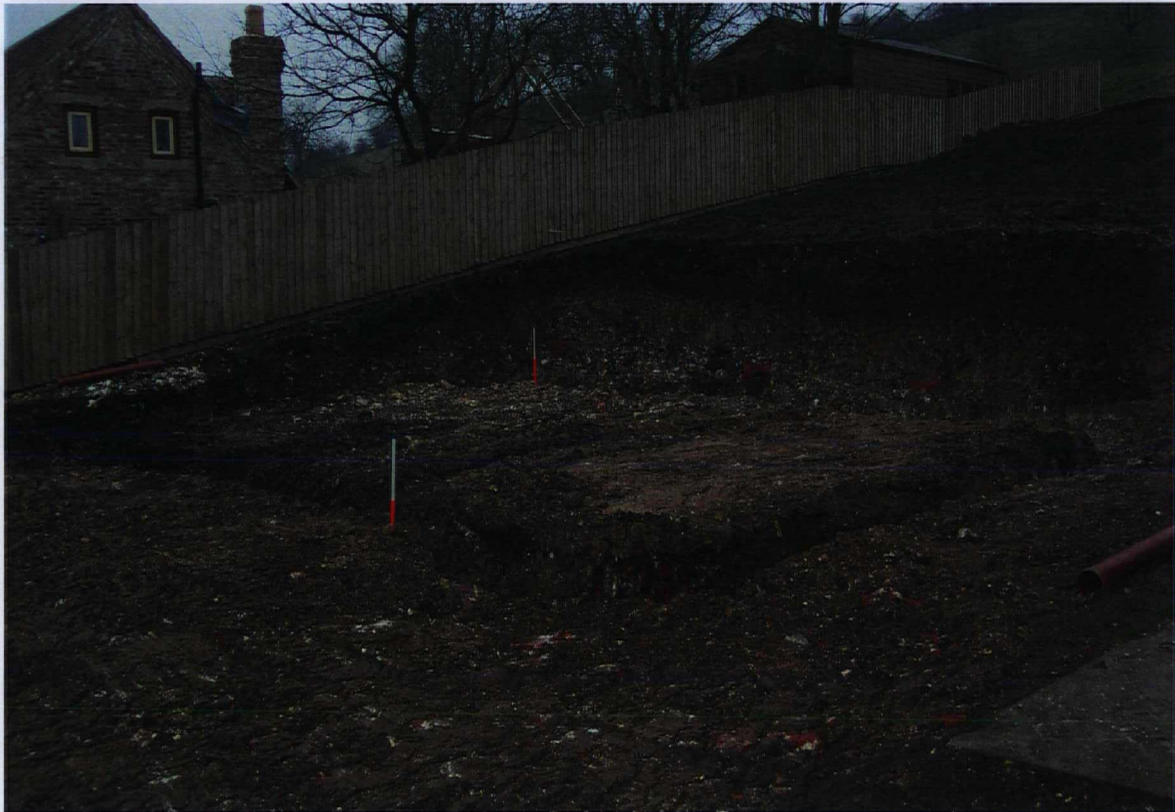
The footings measured 0.7m in width and were excavated to a maximum depth of 0.6m. The footings along the south boundary of the house footing excavation were much deeper than along the northern edge; this is accounted for by the remediation works (Pls. 10 & 11).

Plate 10. View of excavated footings. Facing south-east.

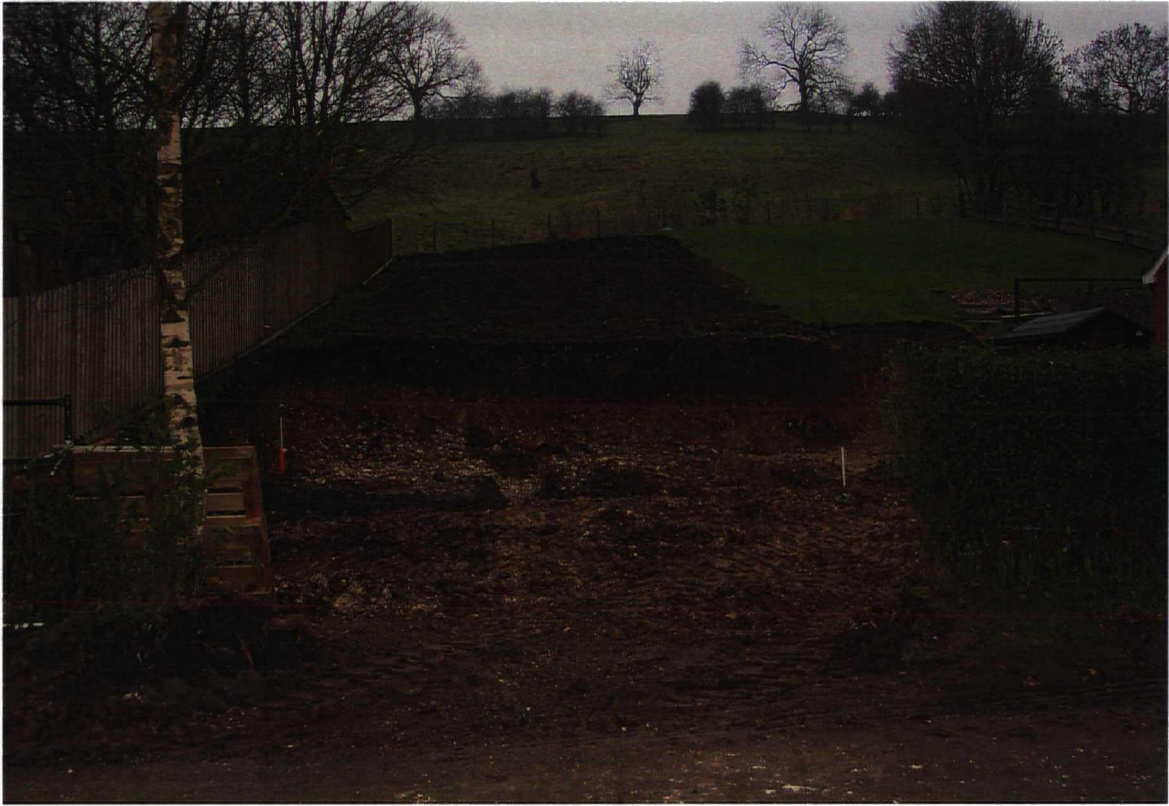
Plate 11. View of excavated footings. Facing south.
